Inspection Photos

Location Name: TEP ROCKY MOUNTAIN LLC, BORUCH-67S96W/11NESE

Location ID: 334847

Date: 4/10/2024

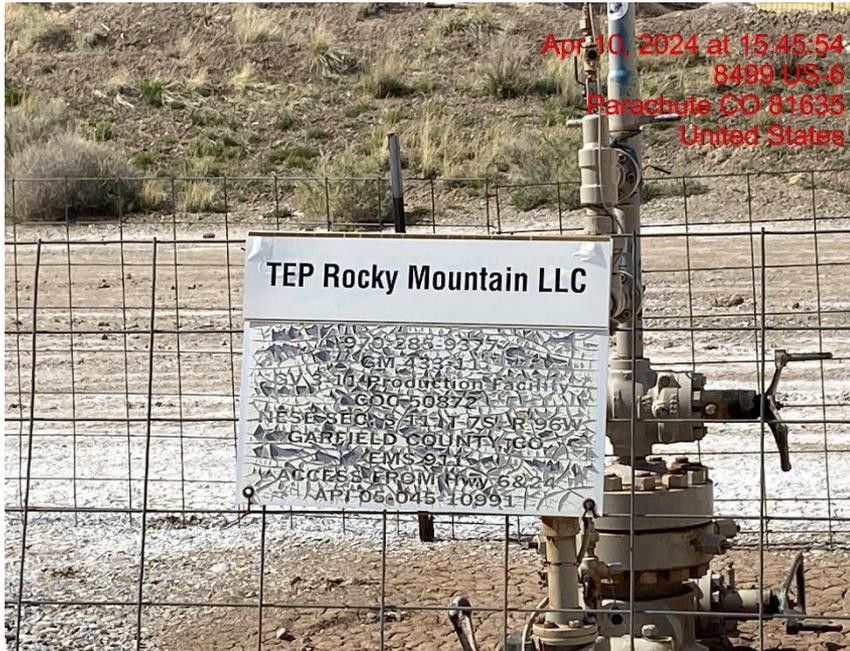
Illegible Wellhead Sign – Photo #00526

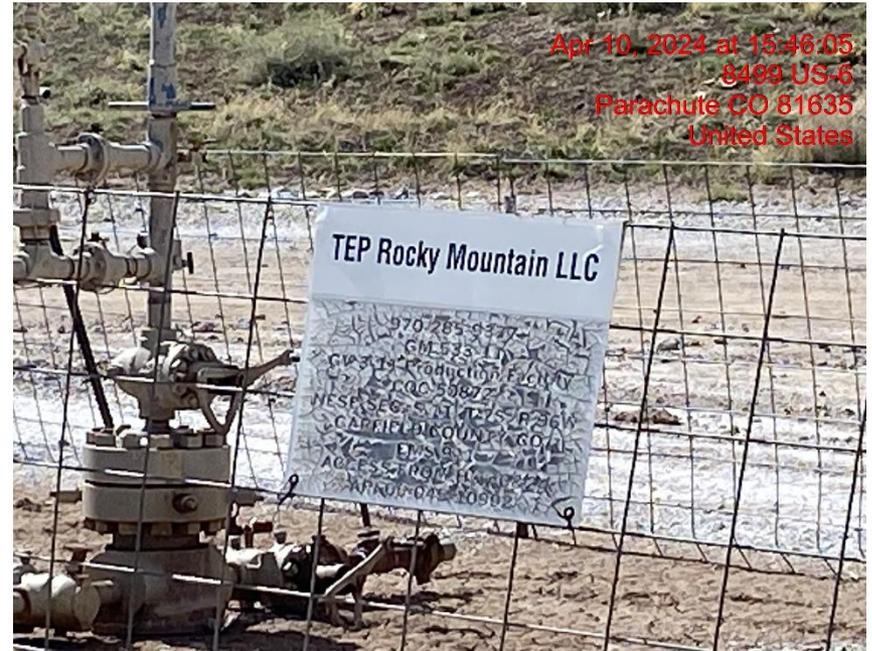
Illegible Wellhead Sign – Photo #00527

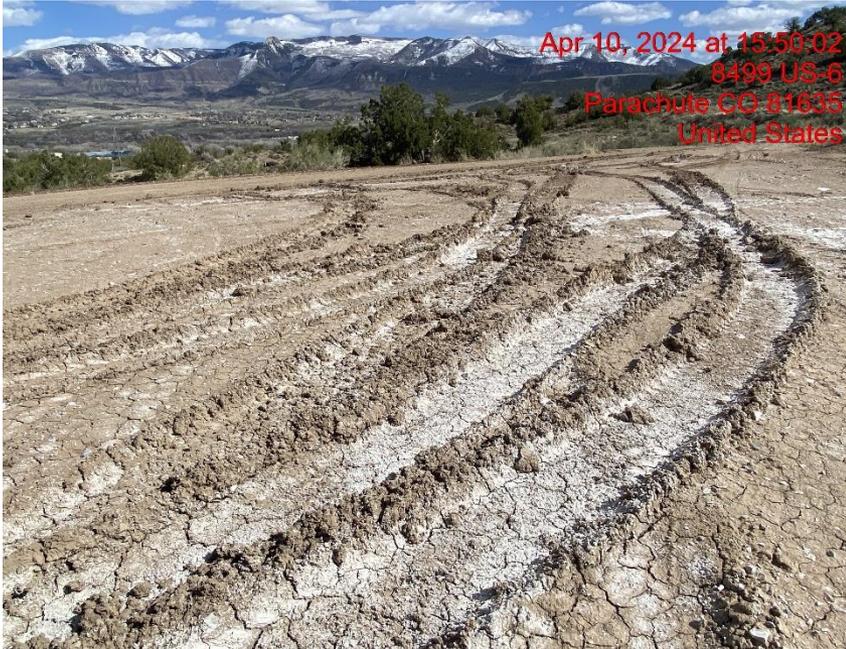
**Lack of Stabilization/Insufficient Vehicle Tracking BMPs at
Location Entrance/Exit – Photo #00533**
