Inspection Photos

04/12/2023

Operator: VISION ENERGY LLC - 10770

Location ID: 322369

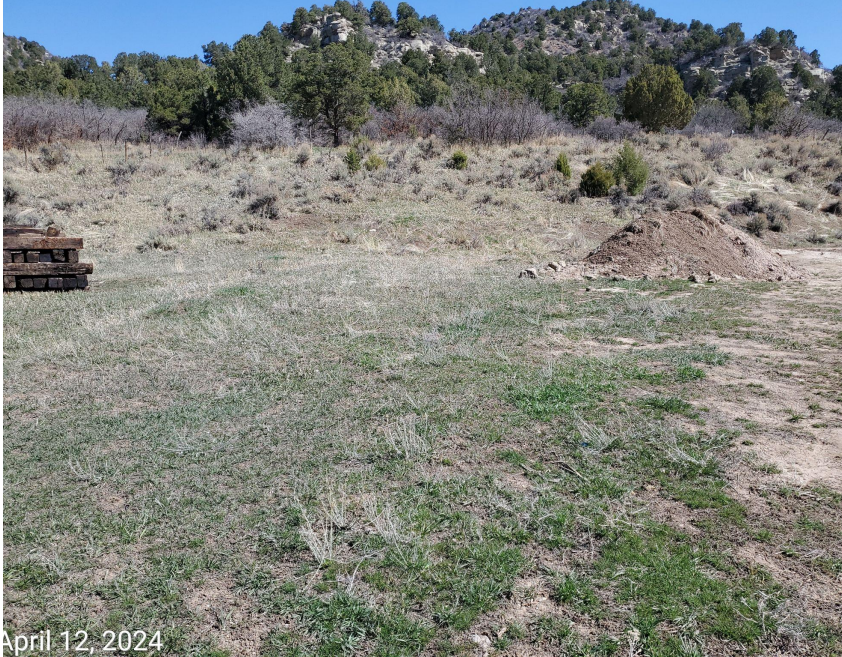
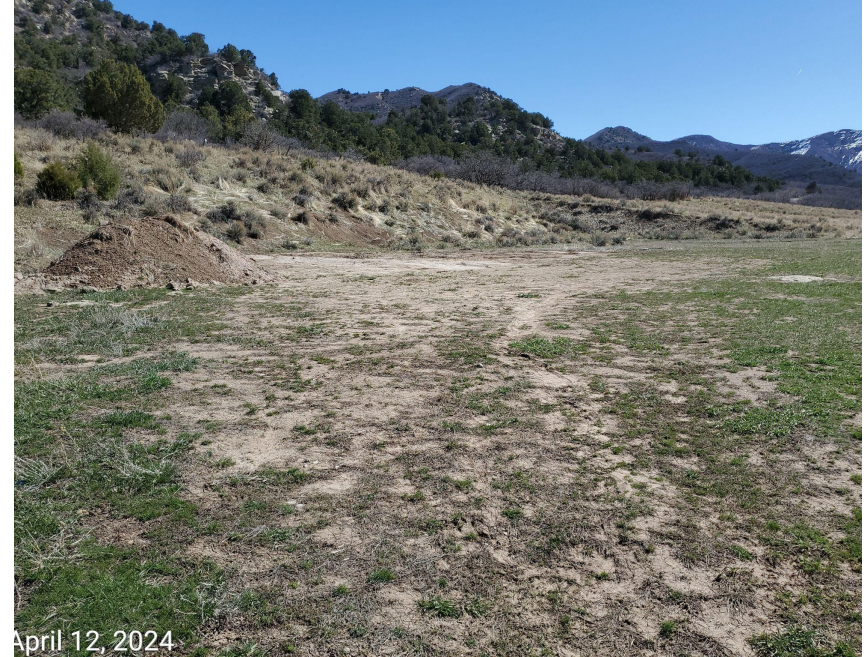
Photo 1: Photos 1-2 taken from the west end of the Location. Photos provide an overview from north, northeast, southeast to south.

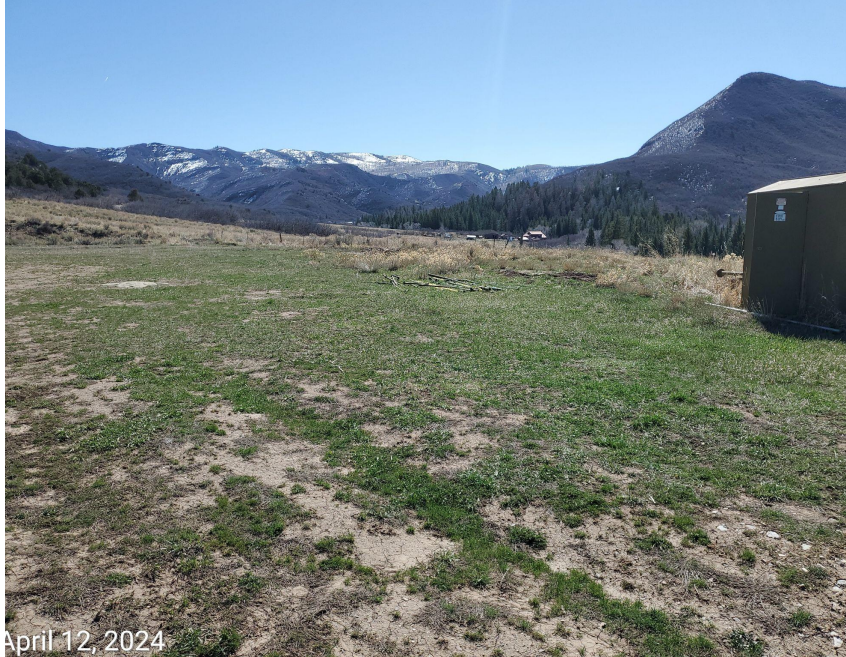
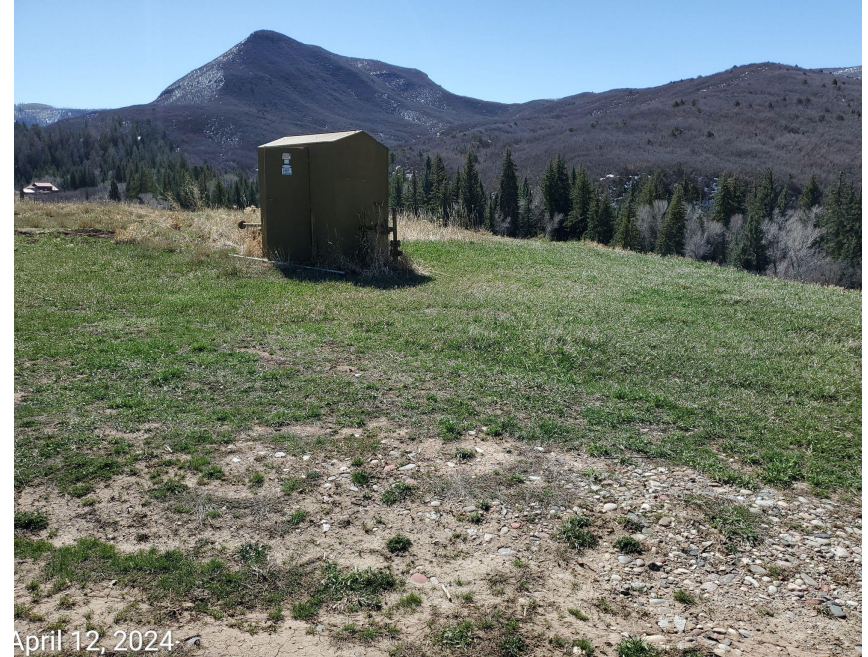
Photo 2: See comments under photo 1.

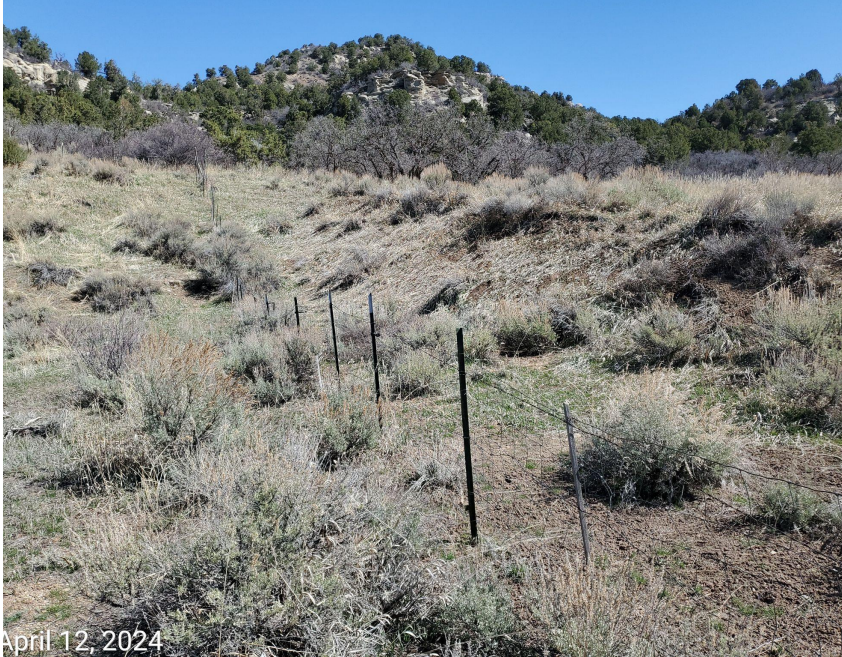
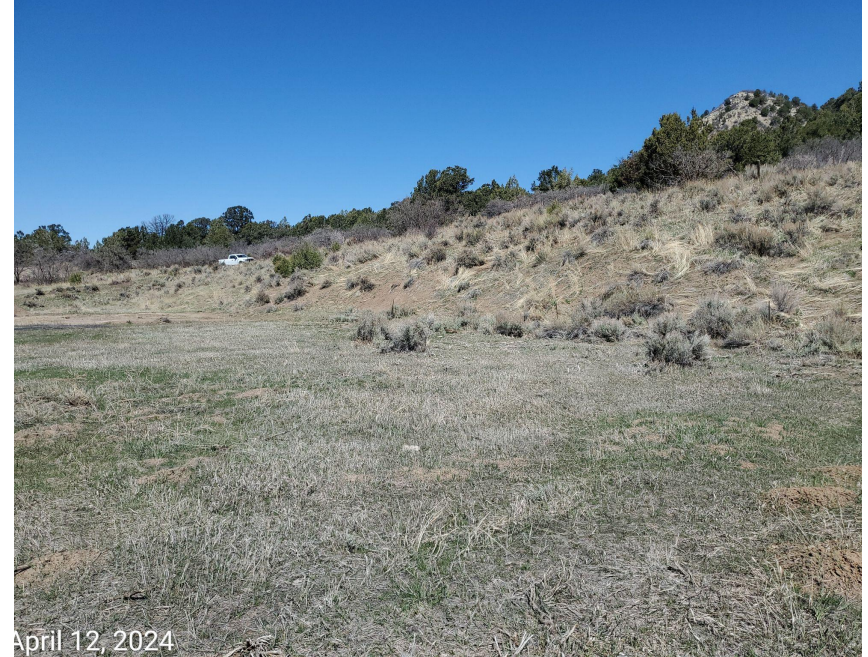
Photo 3: Photos examples showing cut slopes of the Location. 1004 reclamation requirements including, but not limited to, compaction alleviation, removal of gravel, recontouring/regrading and revegetation activities remain outstanding on the Location and access road. Reclamation work pursuant to Rule 1004.a required to be completed within 12 months after plugging well.

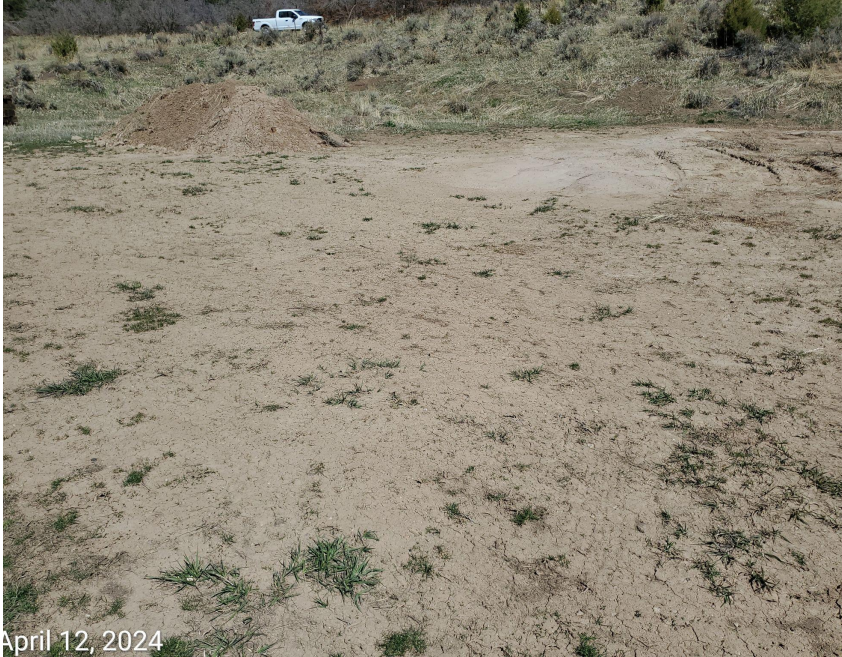
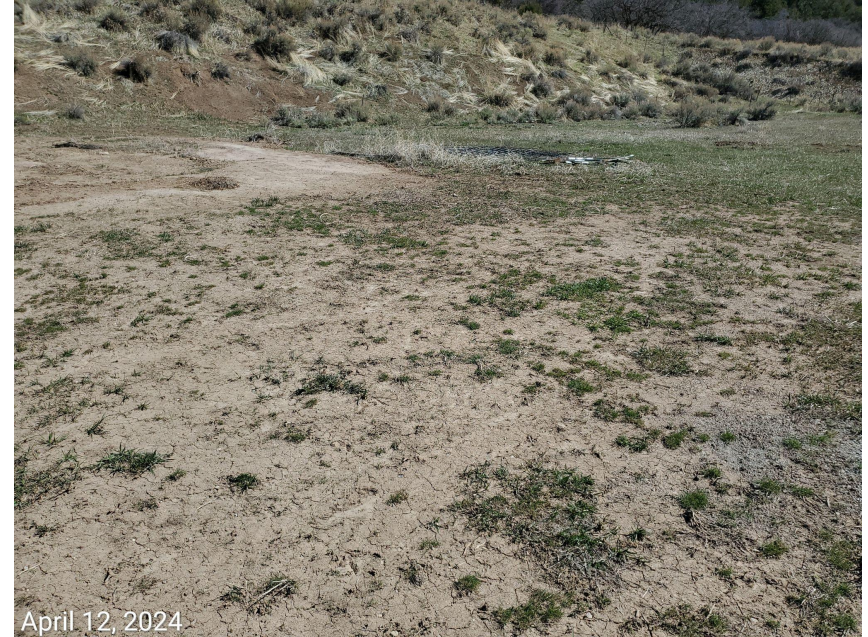
Photo 4: Photos show the location of the former tank battery facility.

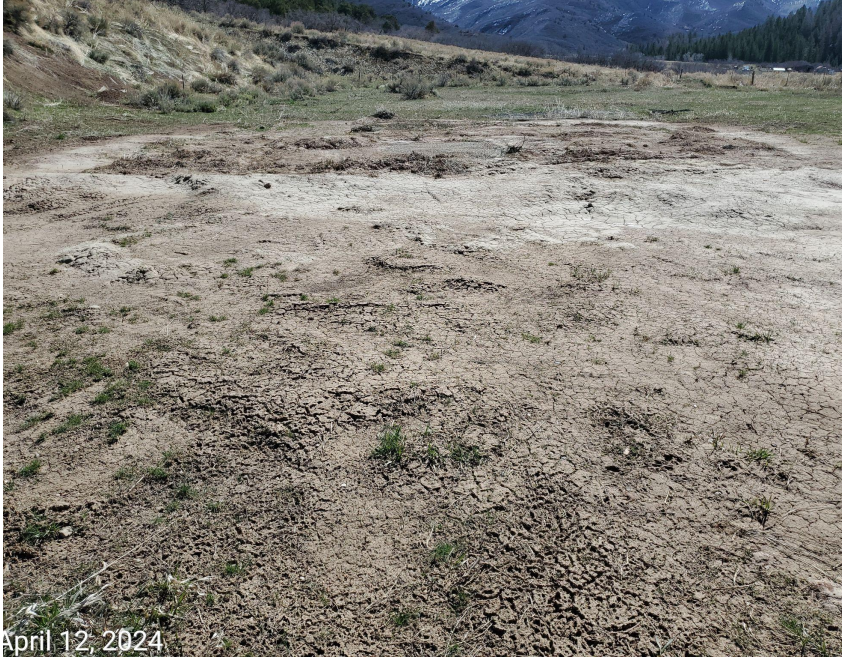
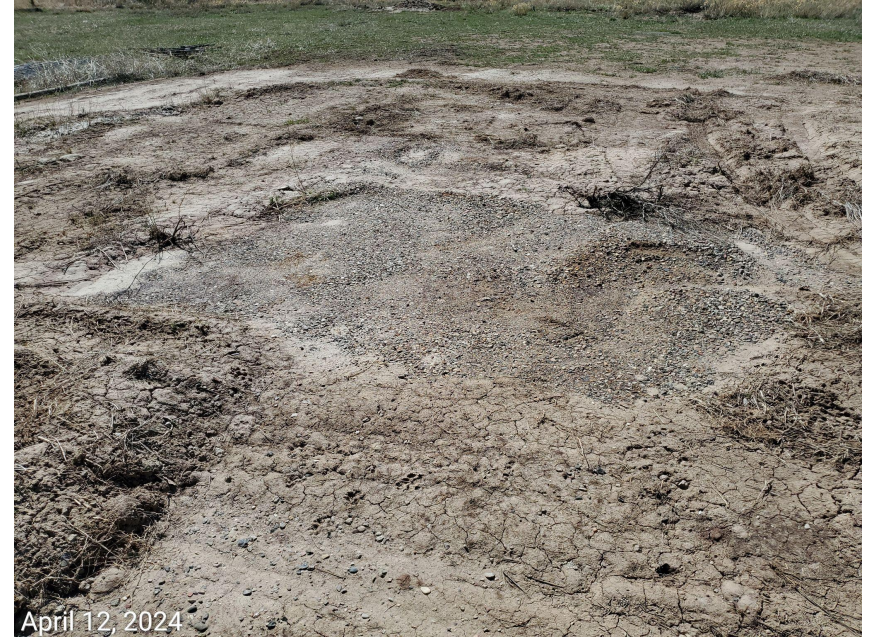
Photo 5: See comments under photo 4. Gravel requires removal.

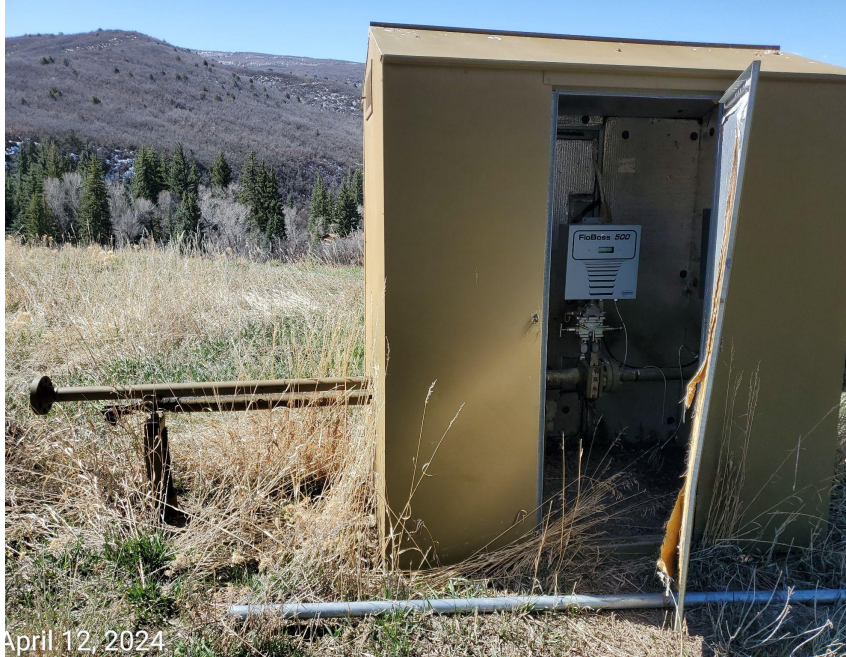
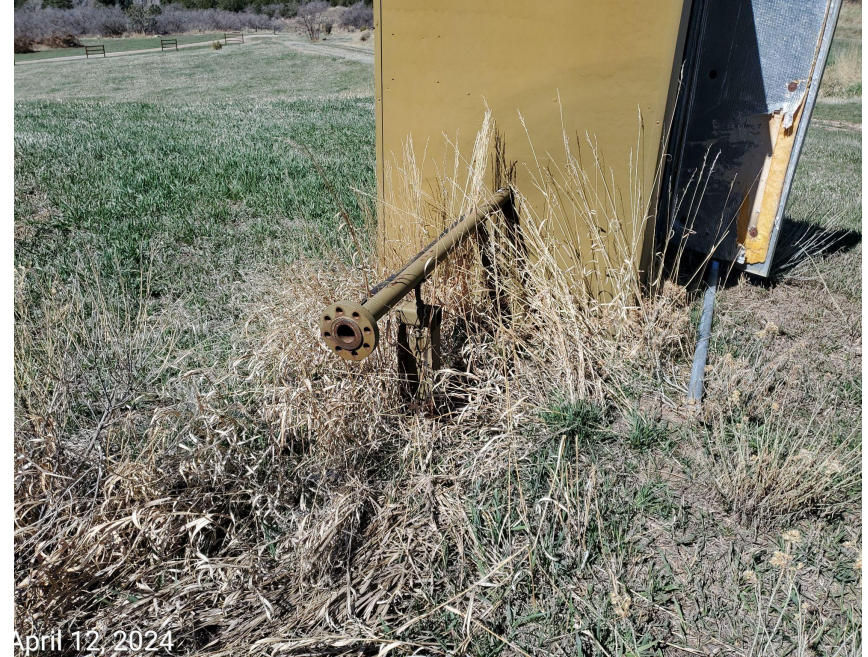
Photo 6: Photo taken from the southwest end of the Location. Photo shows meter-shed equipment remaining on the Location. Equipment requires removal.

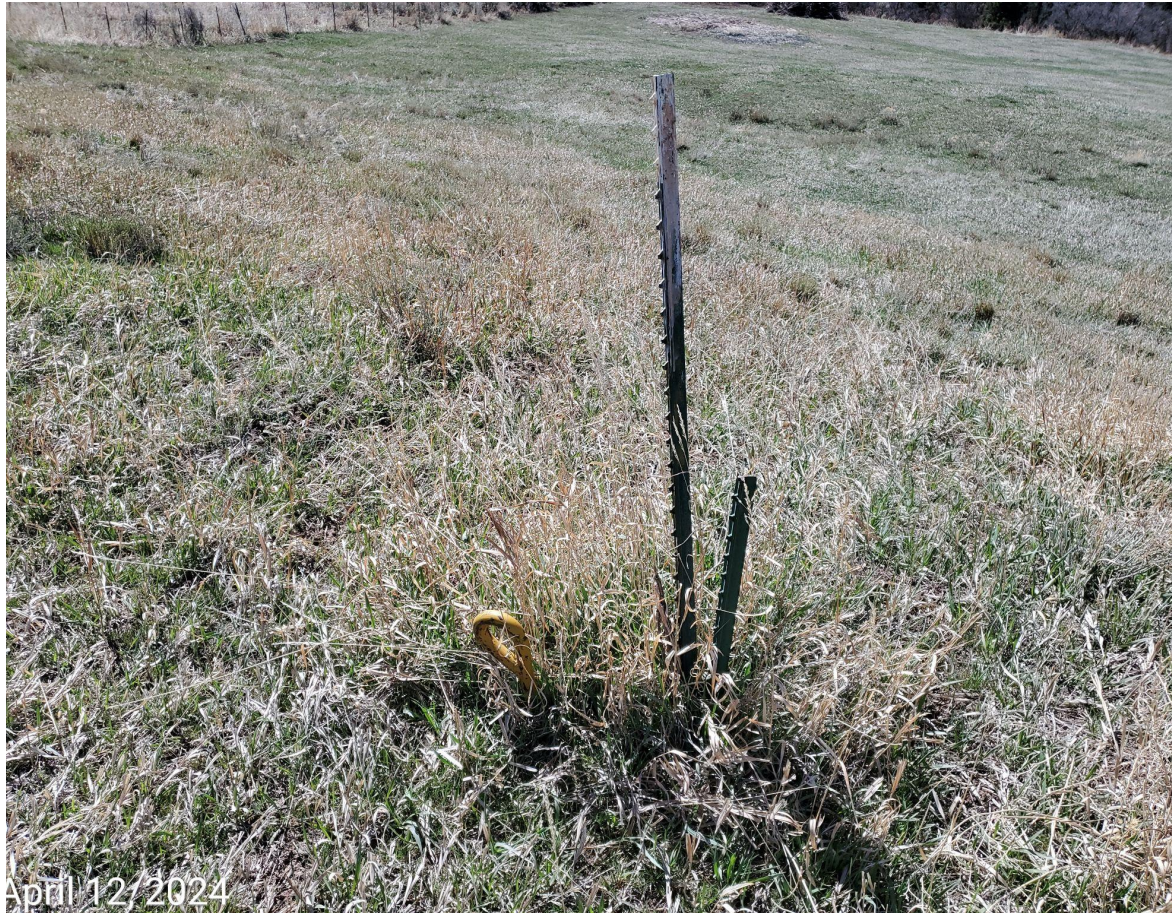
Photo 7: Photo example showing anchor equipment remaining. Equipment requires removal.

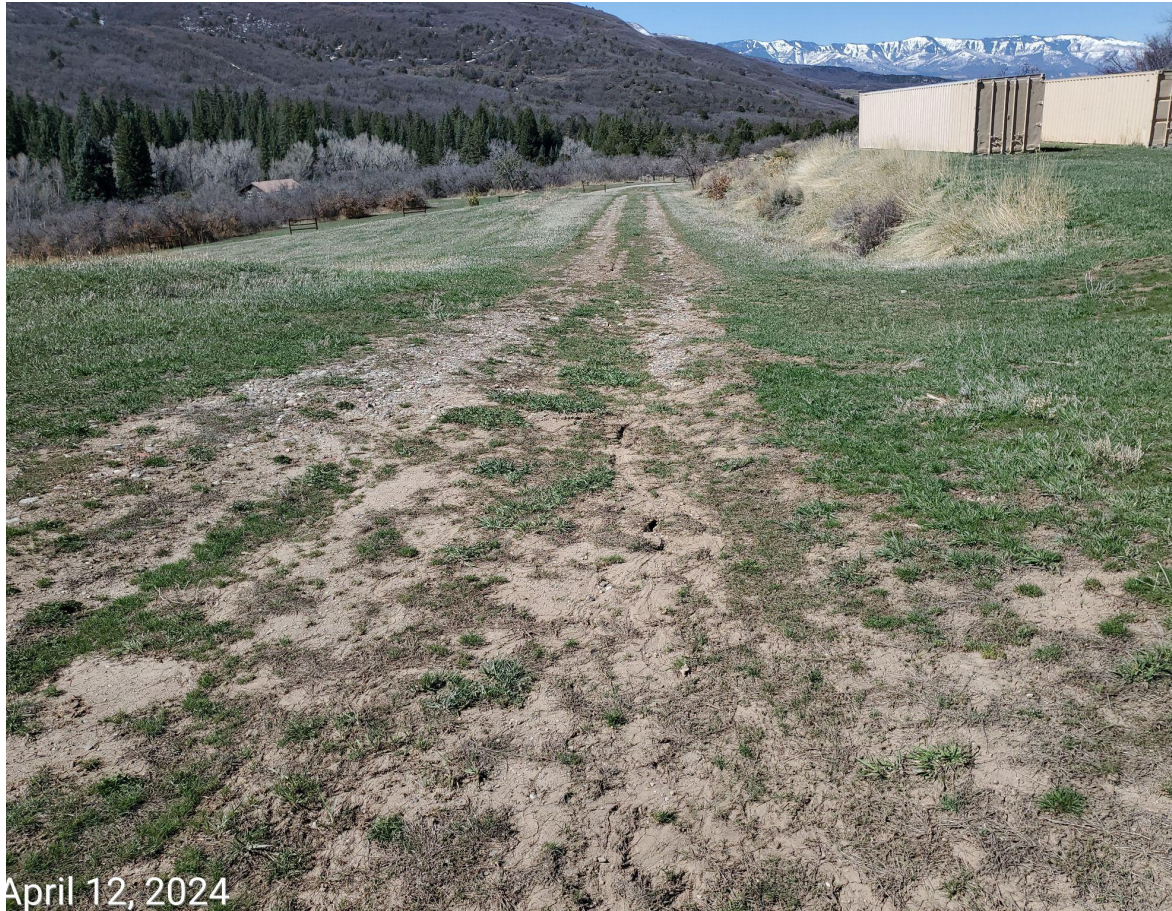
Photo 8: Photo shows access road leading to location. Access road requires reclamation.

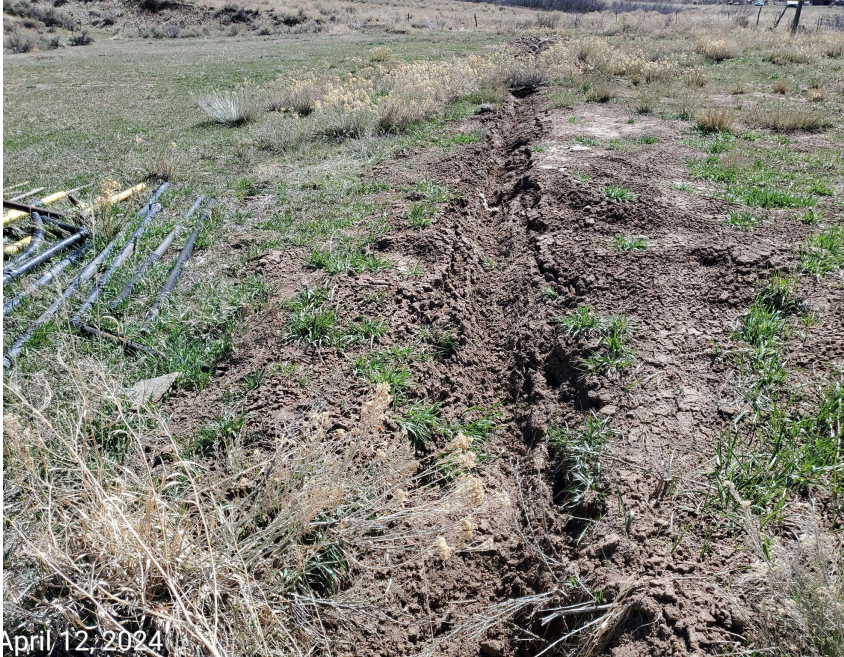
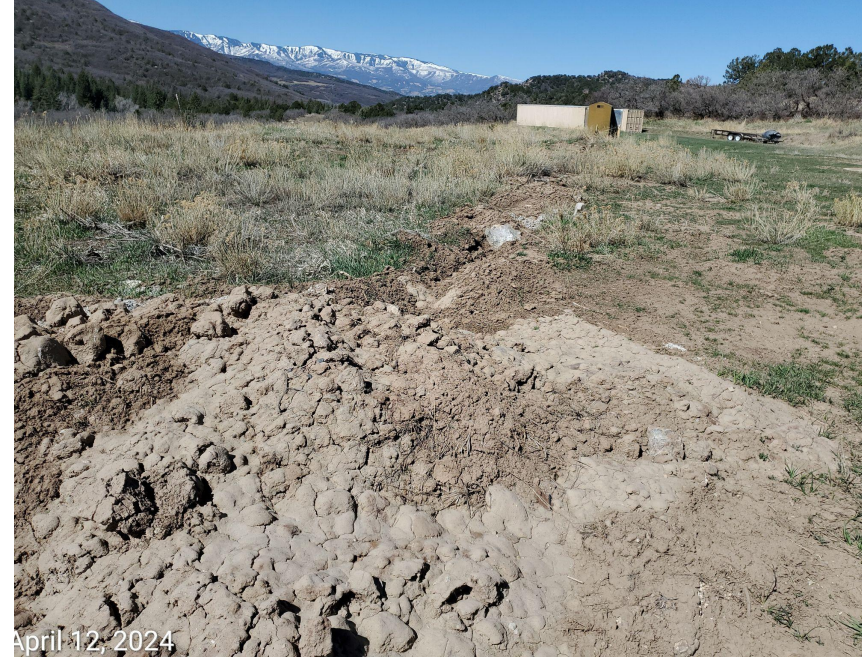
Photo 9: Photos taken from the south end of the Location, facing west. Photo examples showing areas of excavation along the flowline, and where separator equipment was located.

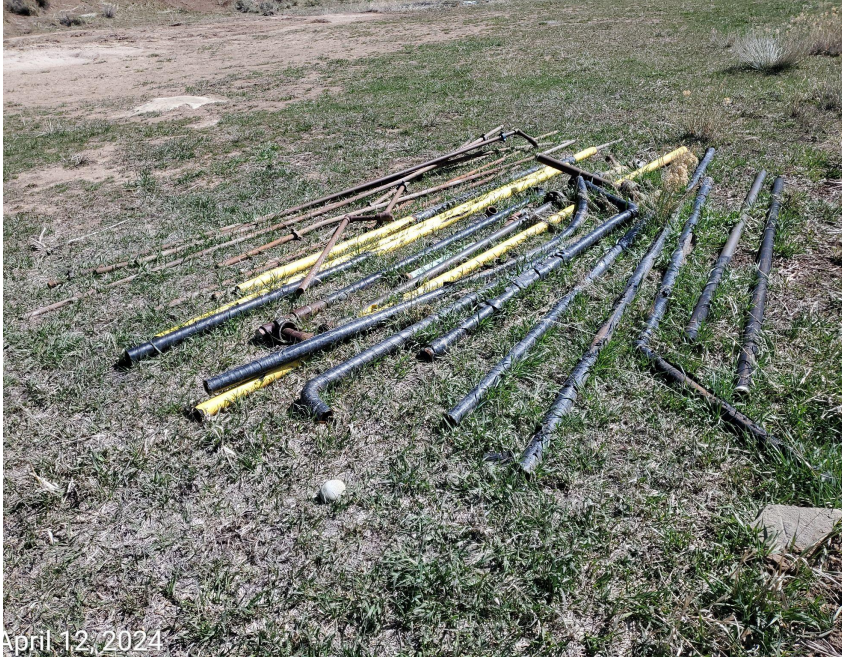
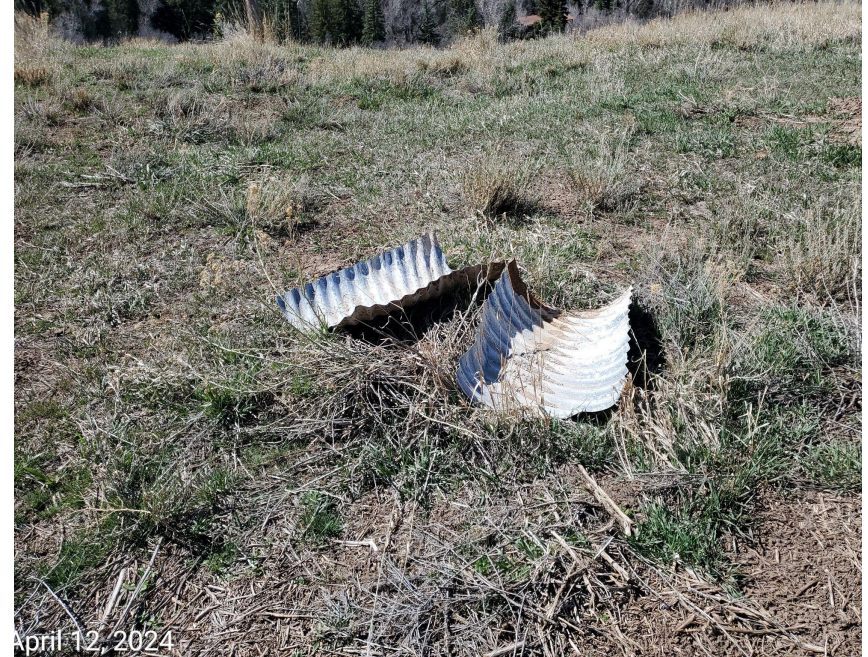
Photo 10: Photos 10-12 examples showing various equipment/trash/debris/rubbish on the Location. Materials/items require removal.

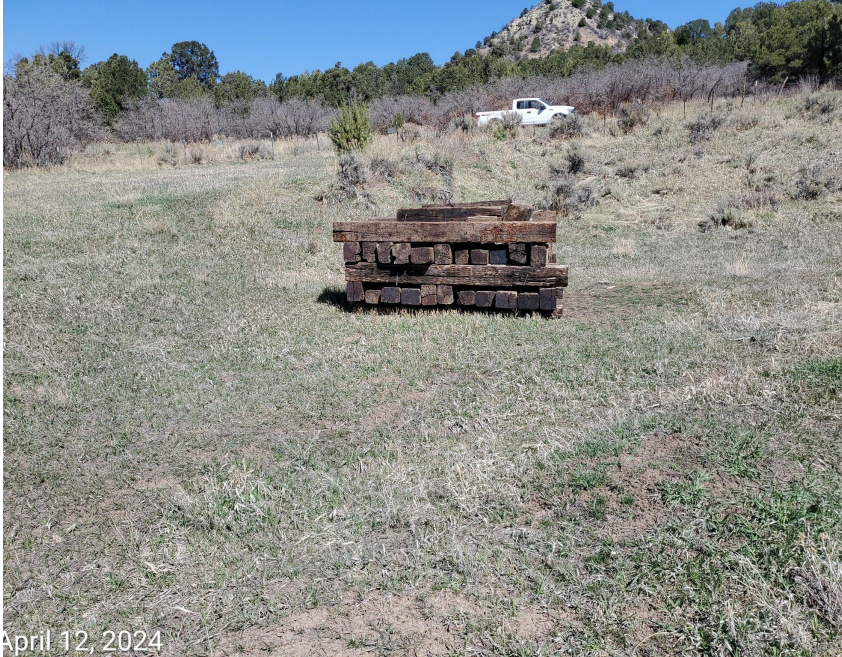
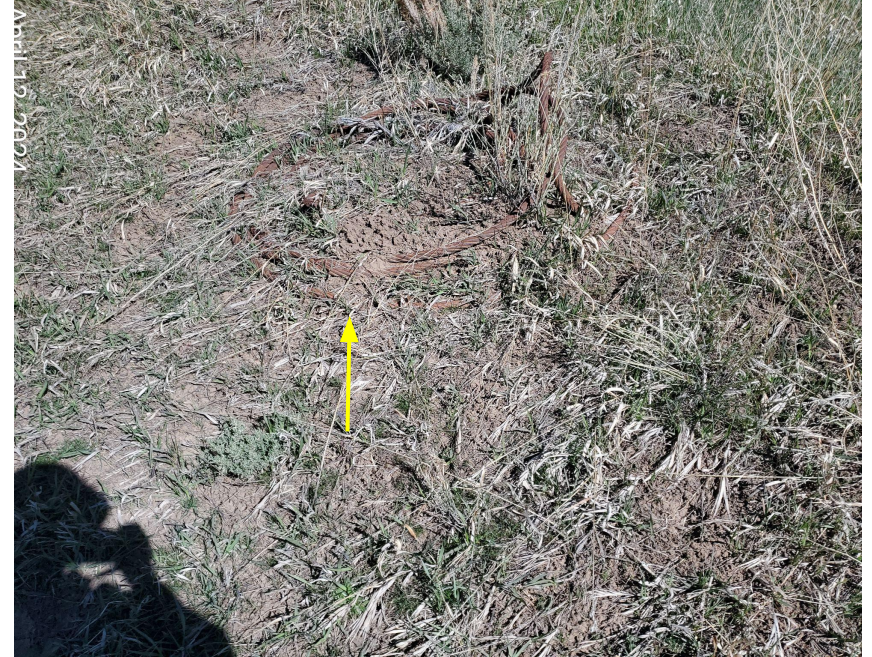
Photo 11: See comments under photo 10.

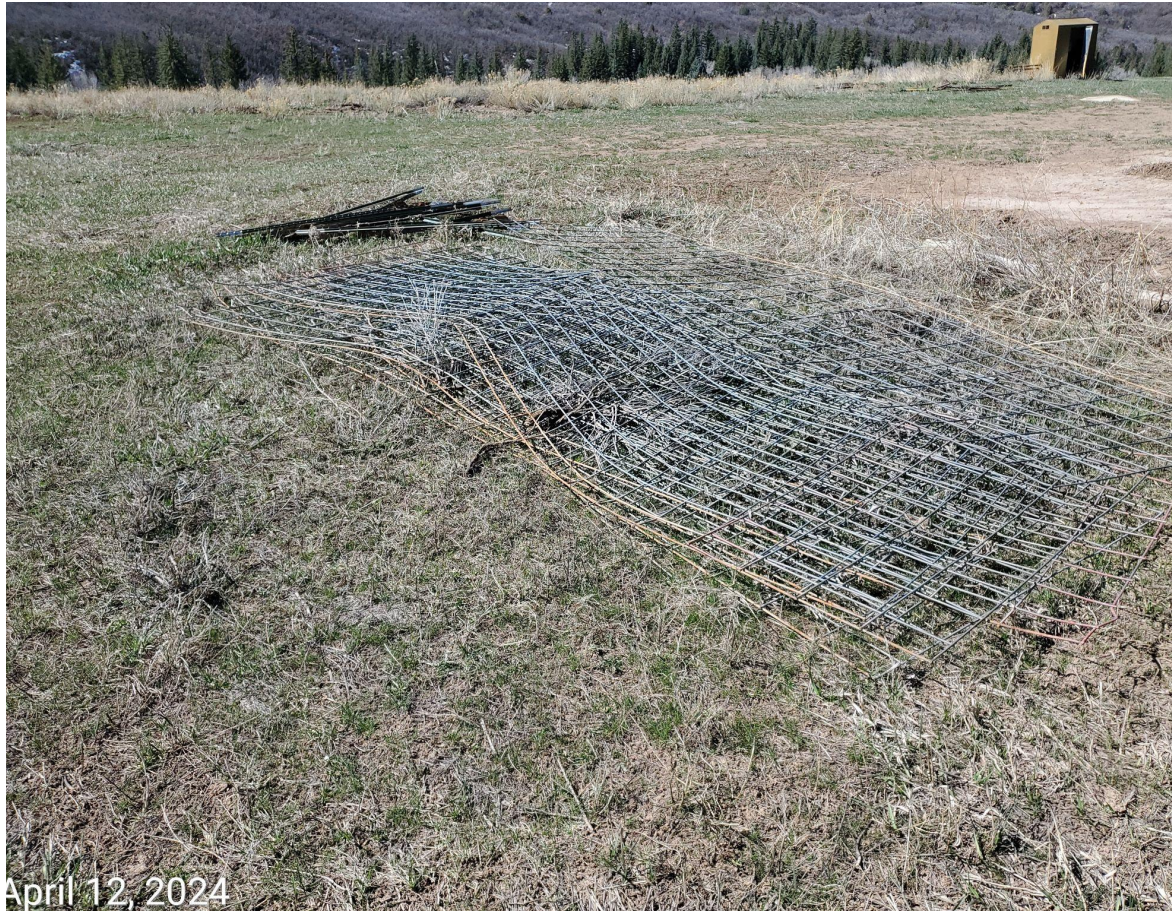
Photo 12: See comments under photo 10.

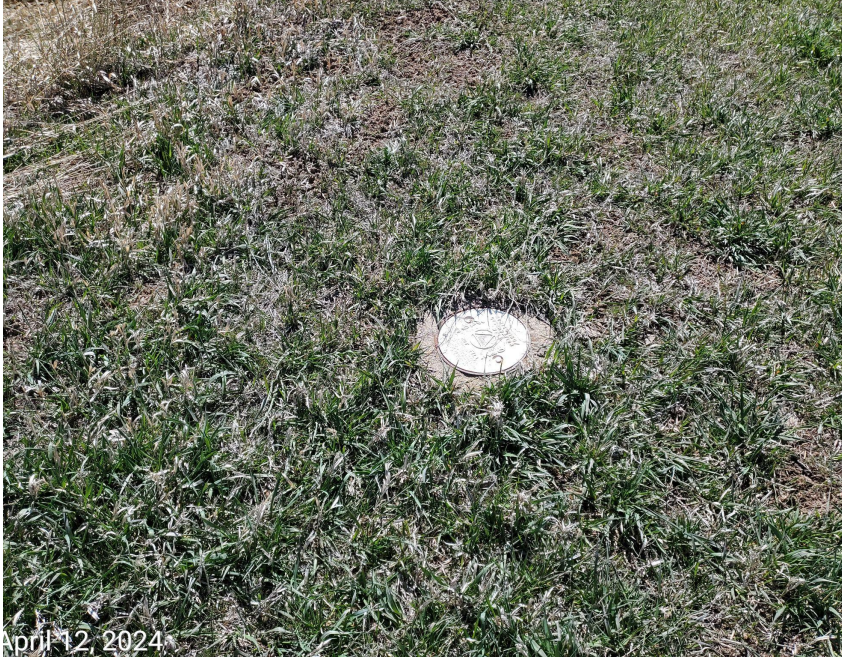
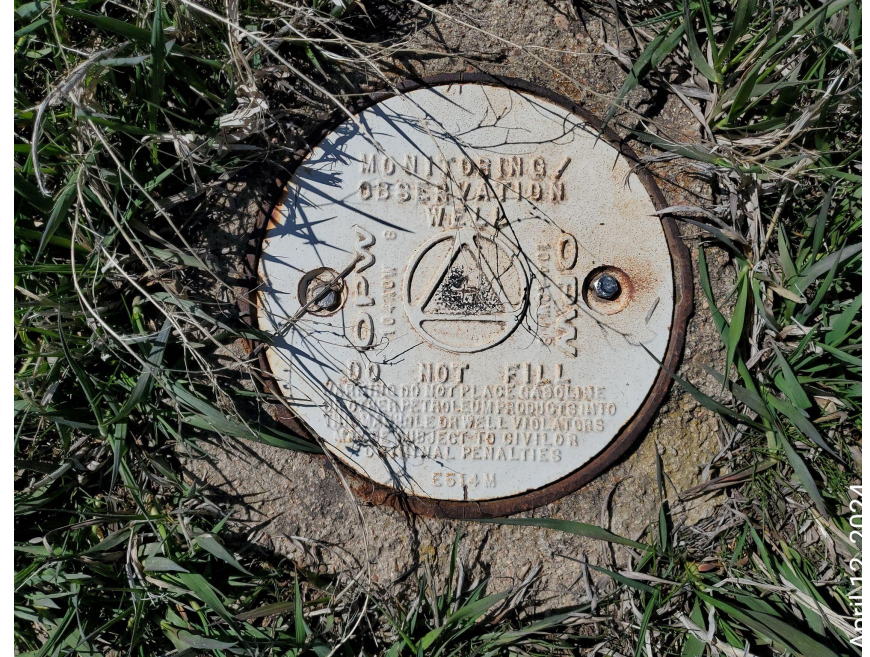
Photo 13: Photos taken from behind the meter shed equipment, on the southwest end of the Location. Photo shows monitoring well on Location.
