Final Reclamation and Stormwater Inspection

Operator: SAND HILLS SOCIETY - 76120

Location ID: 403660

Inspection Photos
Location Name: Strickler 1-31
Location ID: 403660

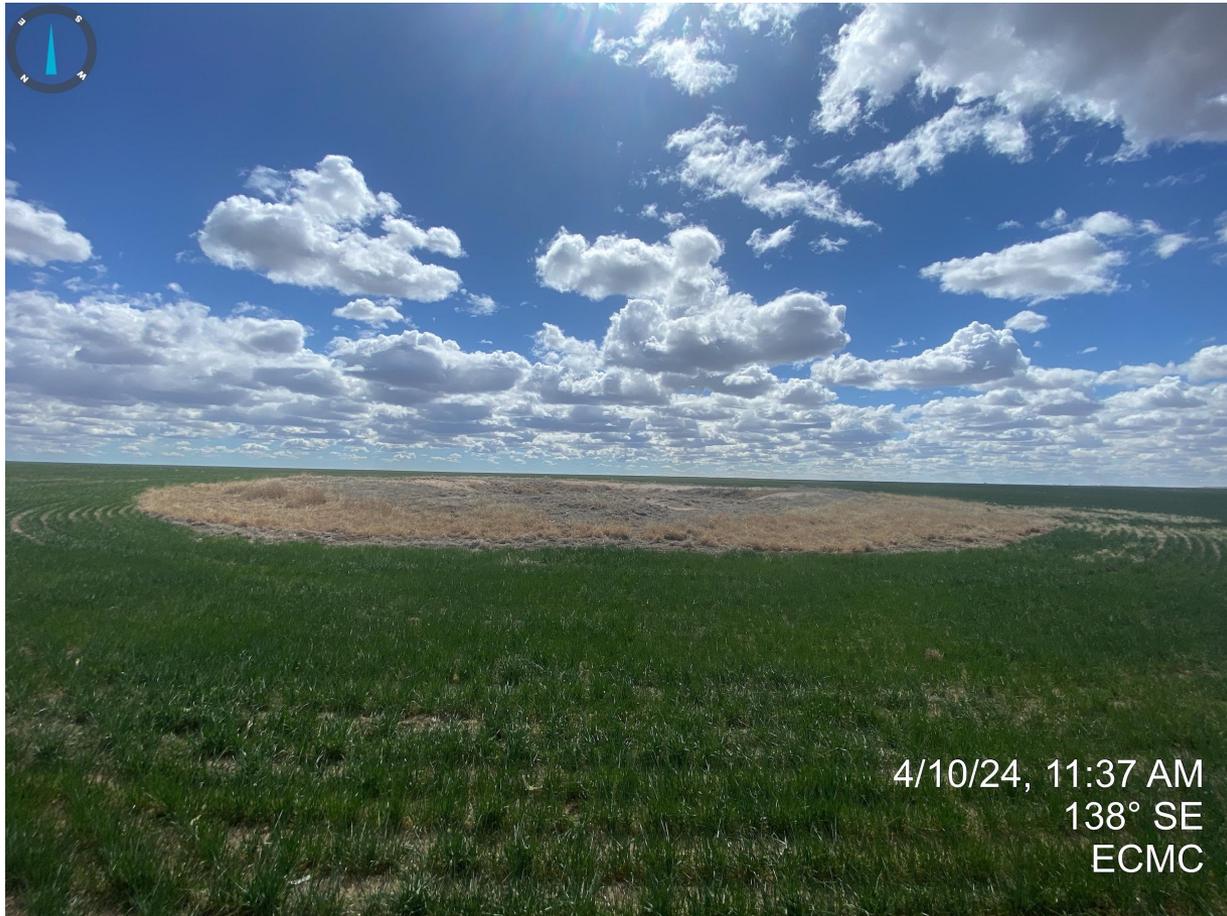
Photo 1. Taken north of the pit and well location. It does not appear that any additional reclamation work has been conducted since the previous inspections. The pit remains open and requires additional reclamation work to comply with Rule 1004.

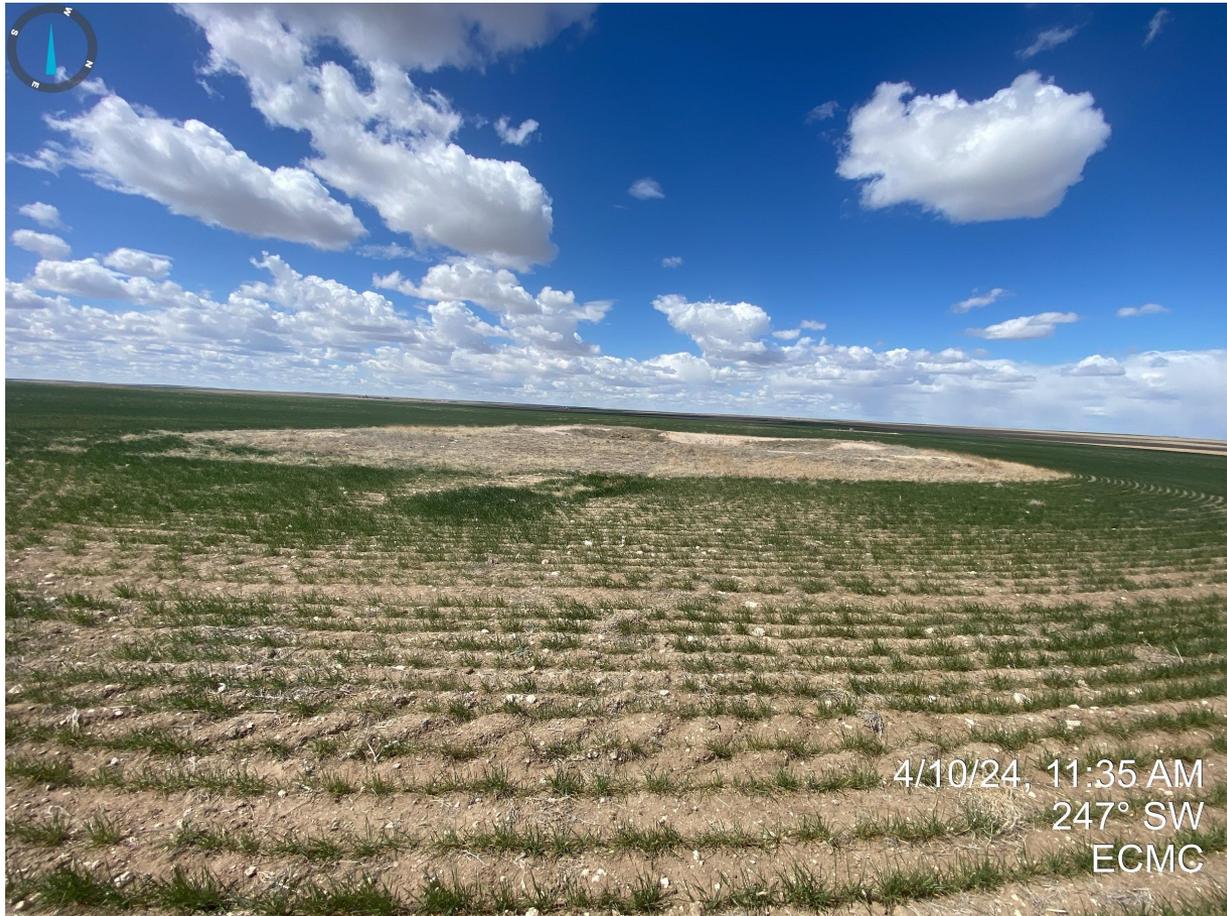
Photo 2. Taken near the east side of the former pit and well location; see comments in Photo 1.

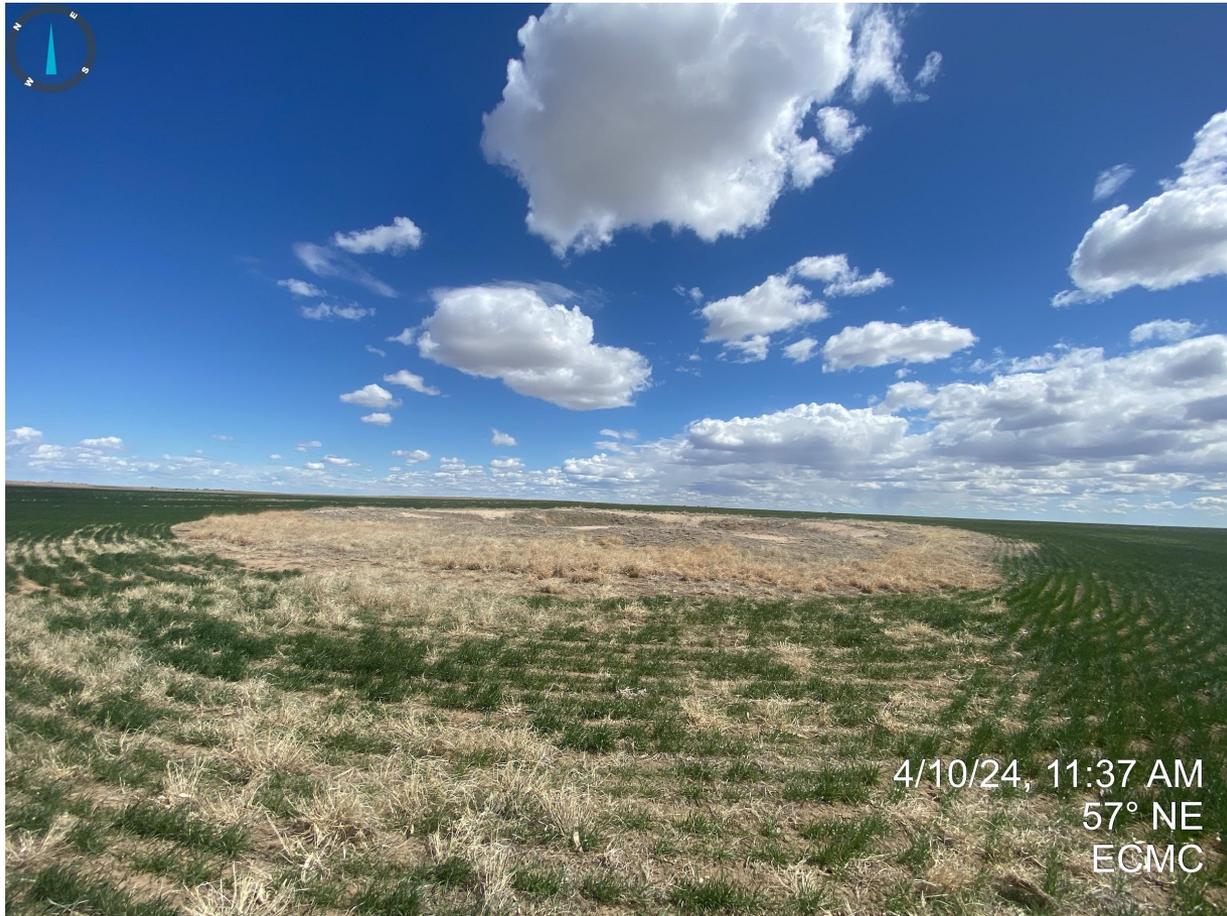
Photo 3. Taken near the west side of the former pit and well location; see comments in Photo 1.

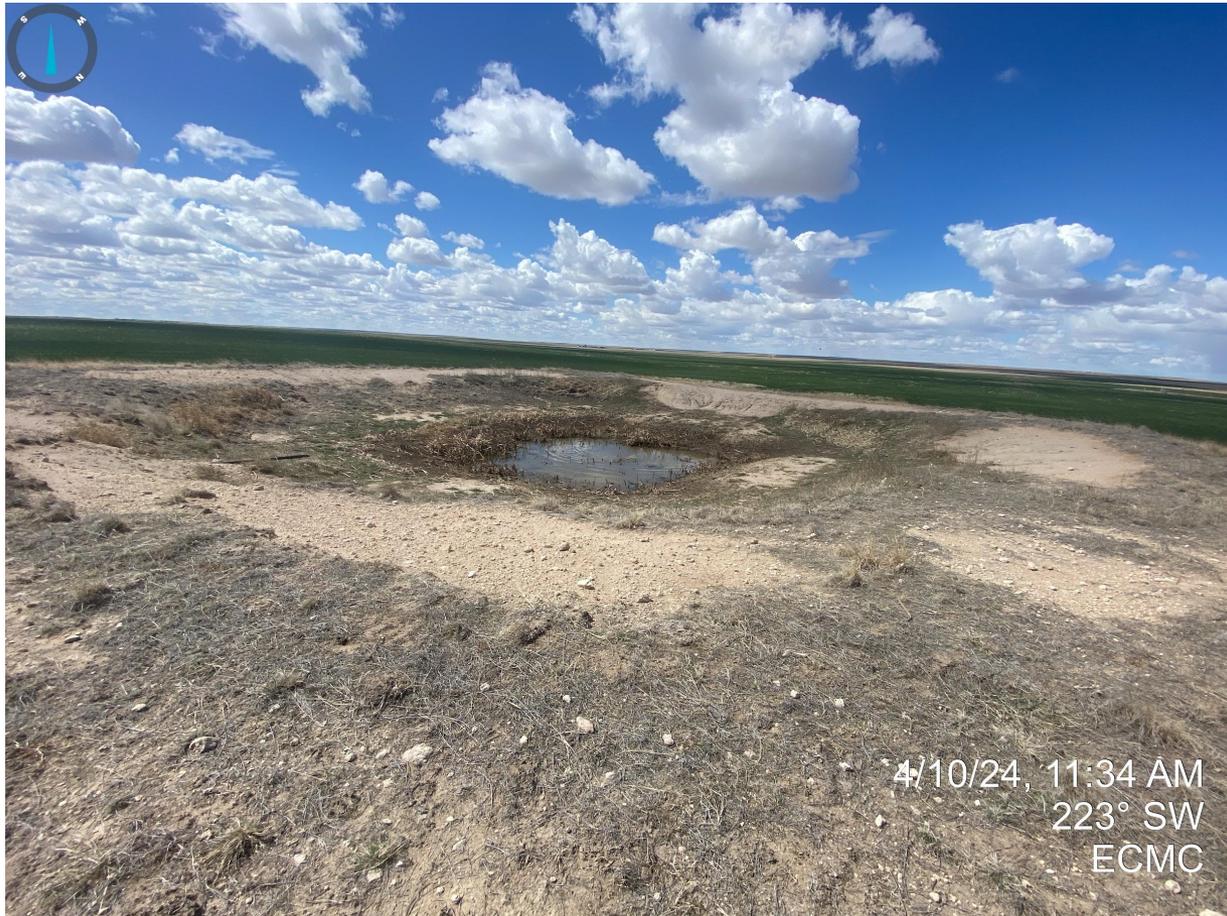
Photo 4. Taken from the northeast corner of the pit. No evidence of reclamation activities observed at the time of this inspection.

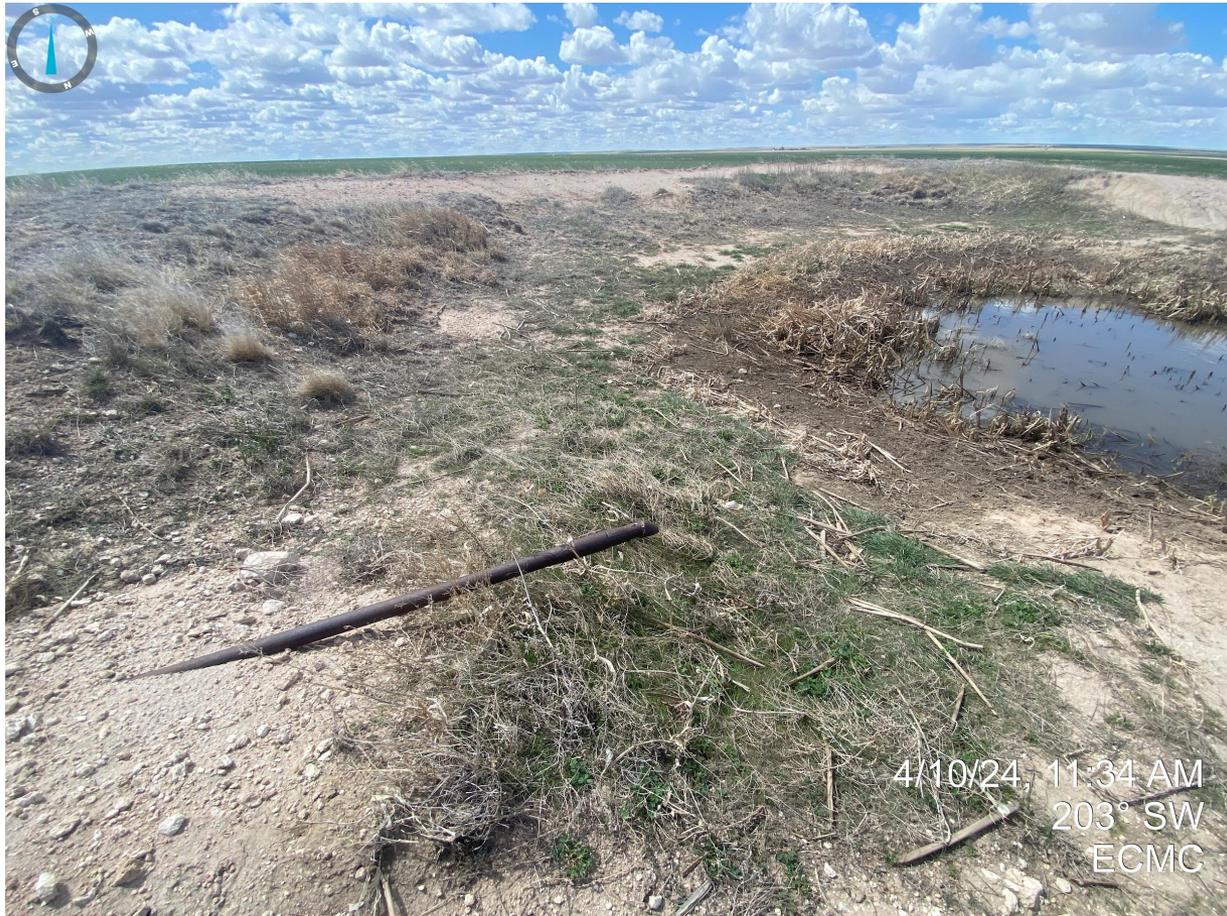
Photo 5. Pipe remains within pit area.

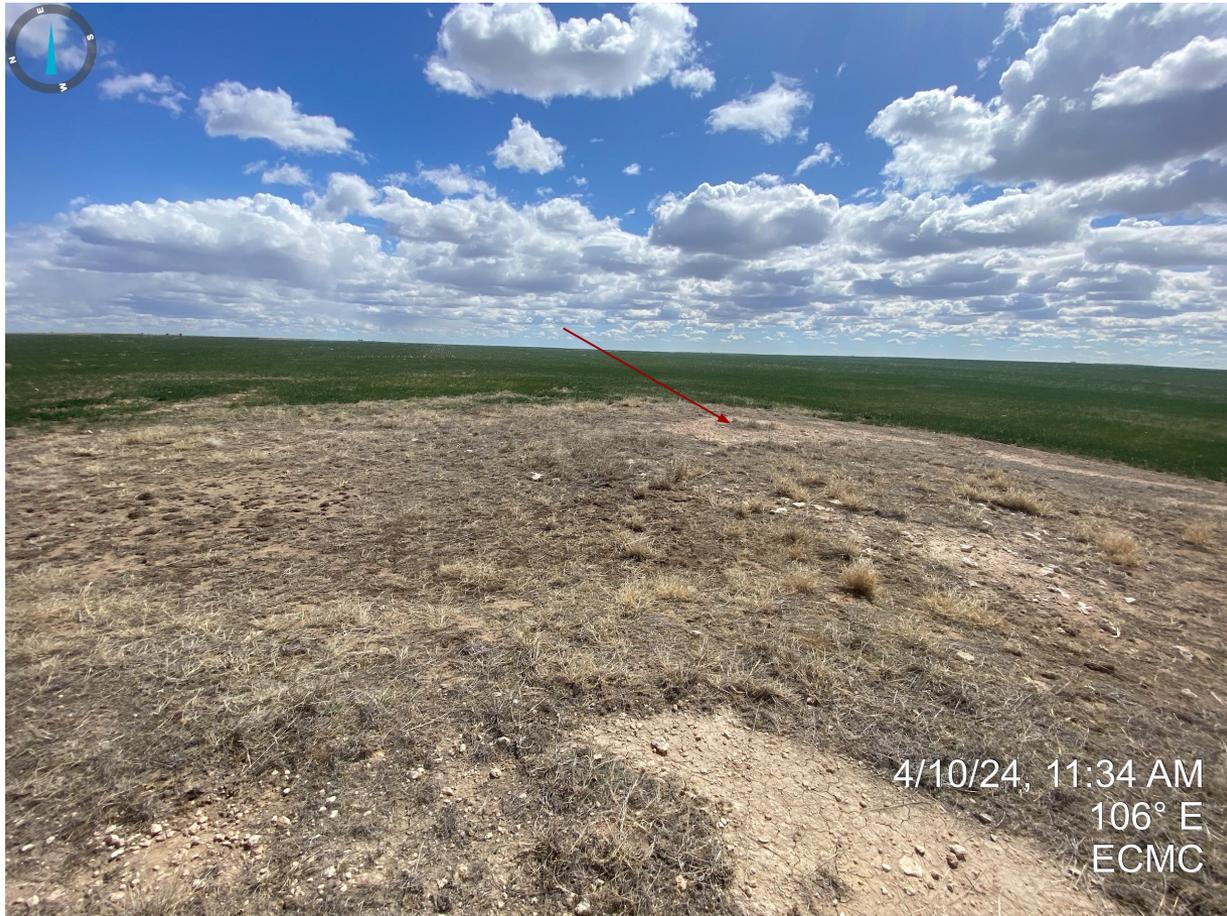
Photo 6. The former well location (approximated by red arrow) does not appear to have been reclaimed and is not reflective of the adjacent reference area.

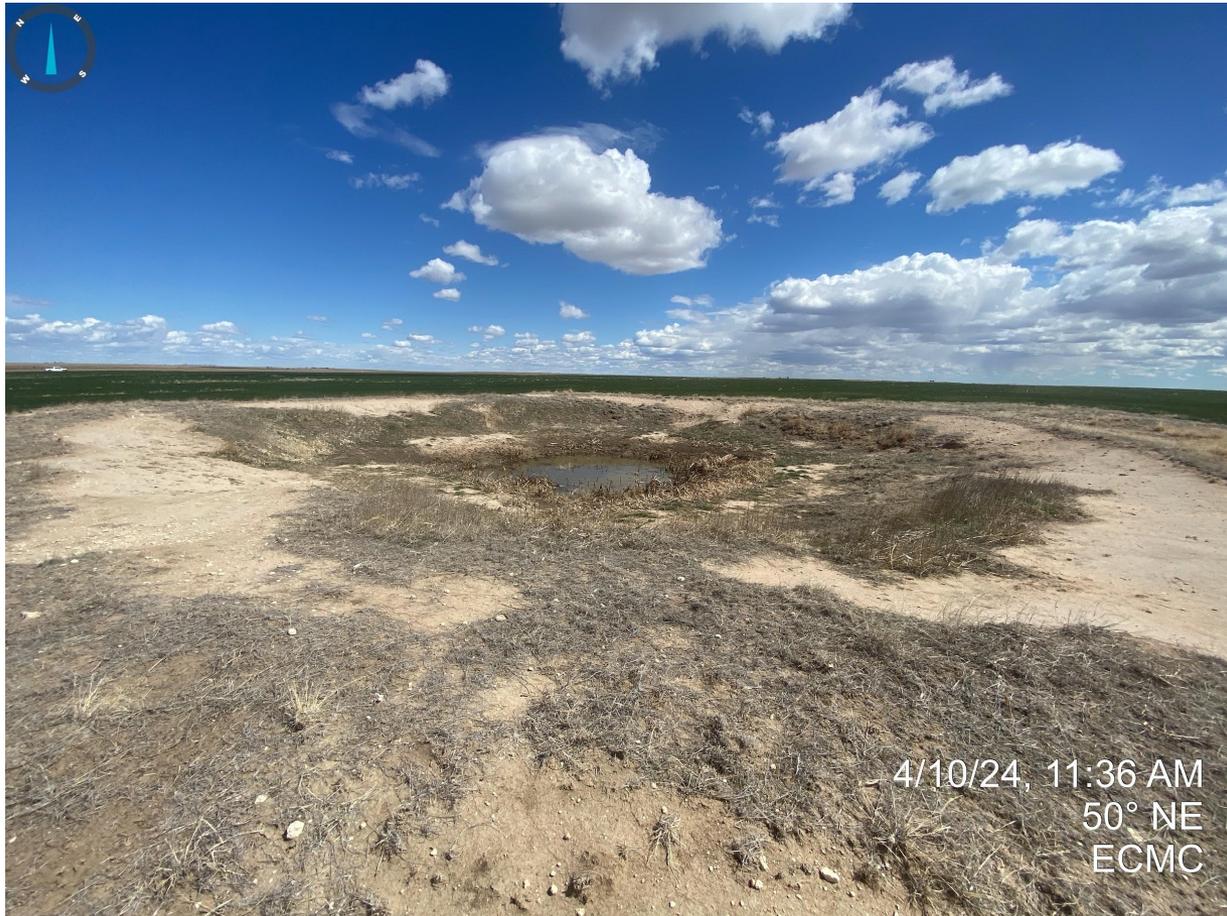
Photo 7. Taken from the southwest corner of the pit. No evidence of reclamation activities observed at the time of this inspection.

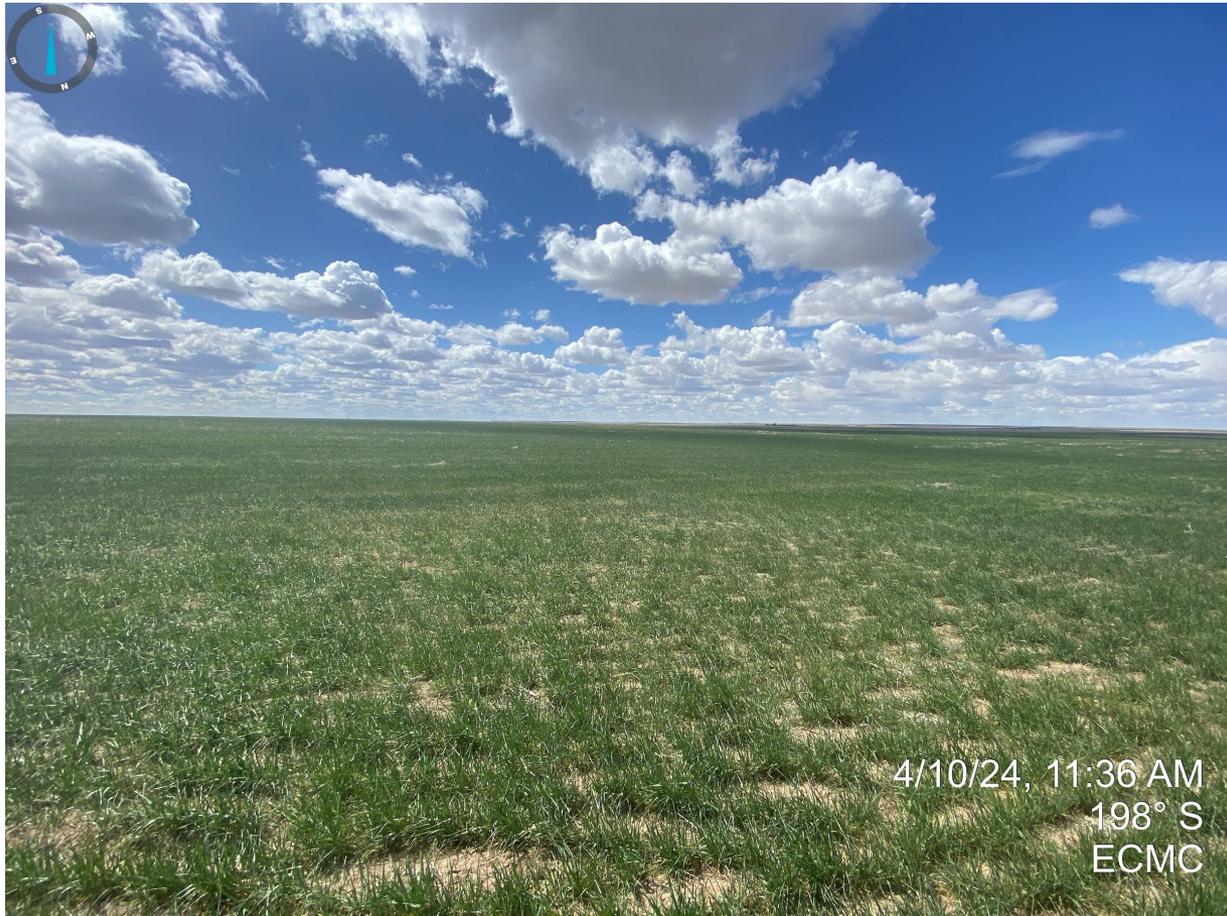
Photo 8. Adjacent reference area photo (cropland) taken south of the pit/well location.
