# Inspection Photos

Operator: MorningStar Operating LLC - 10755

Inspection Document #: 714000665

Inspection Photos  
Location Name: Chapin 32-06 23-3, 4  
Location ID: 333334

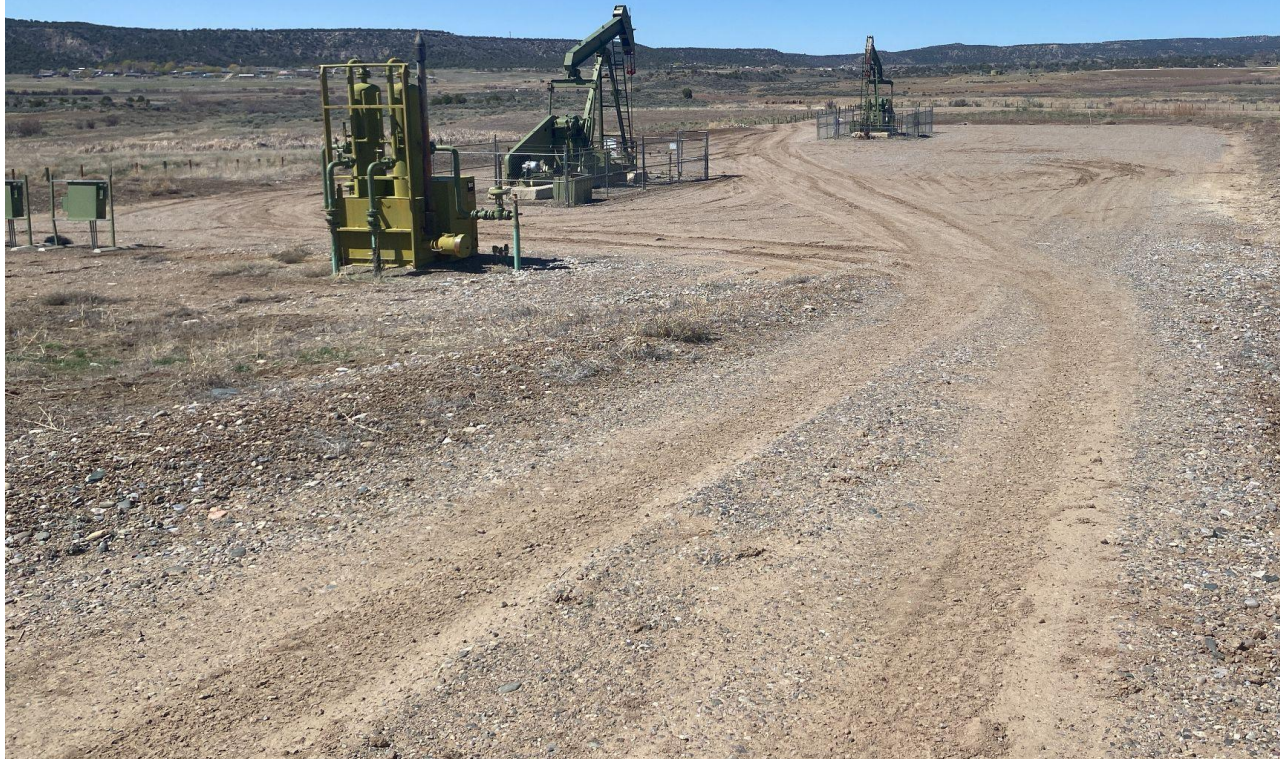
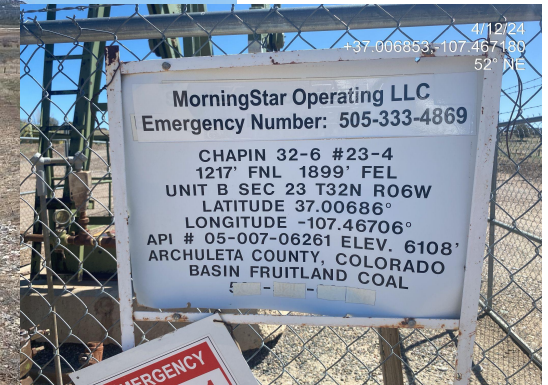
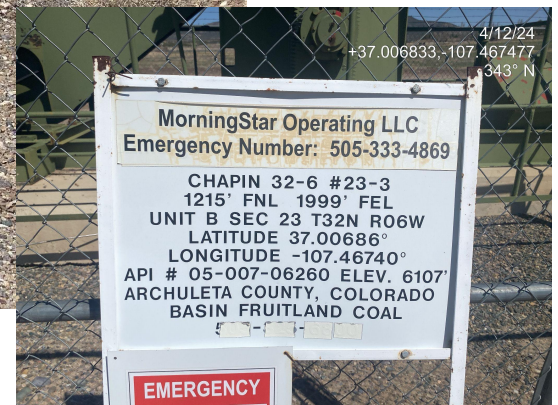
**Photo 1.** View of the well disturbance from the access point facing center.

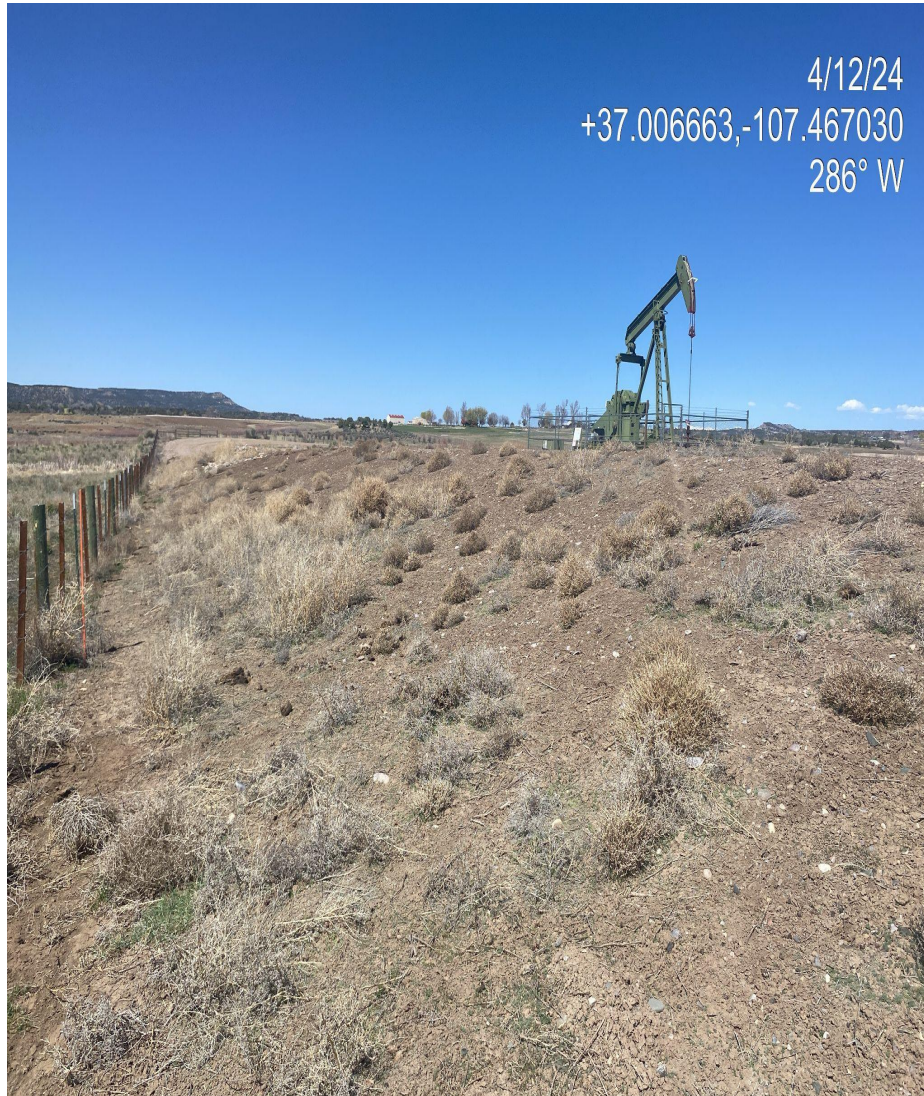
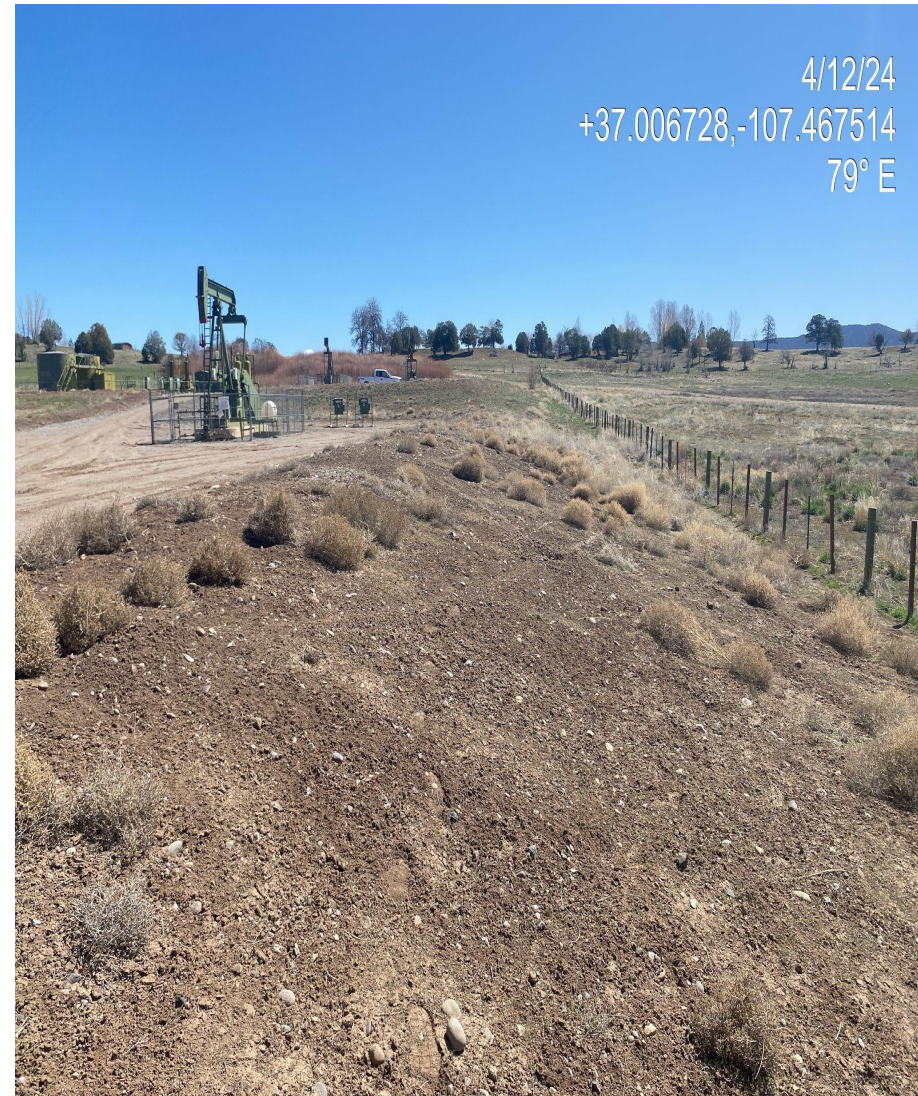
**Photo 2.** View of southern fill slope/interim reclamation areas dominated by kochia/russian thistle debris and lacking vegetation. Stormwater BMPs/soil stabilization is needed until long term stabilization is achieved with perennial vegetation.

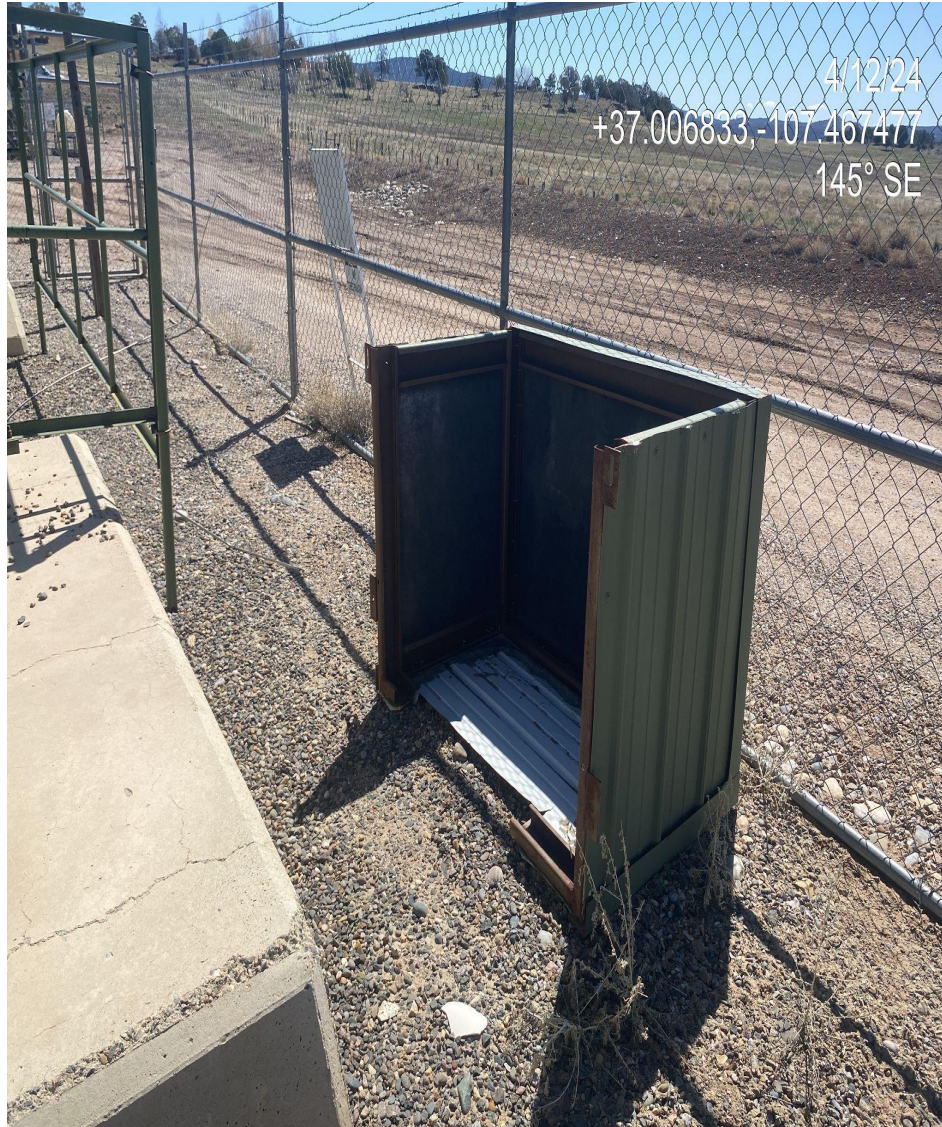
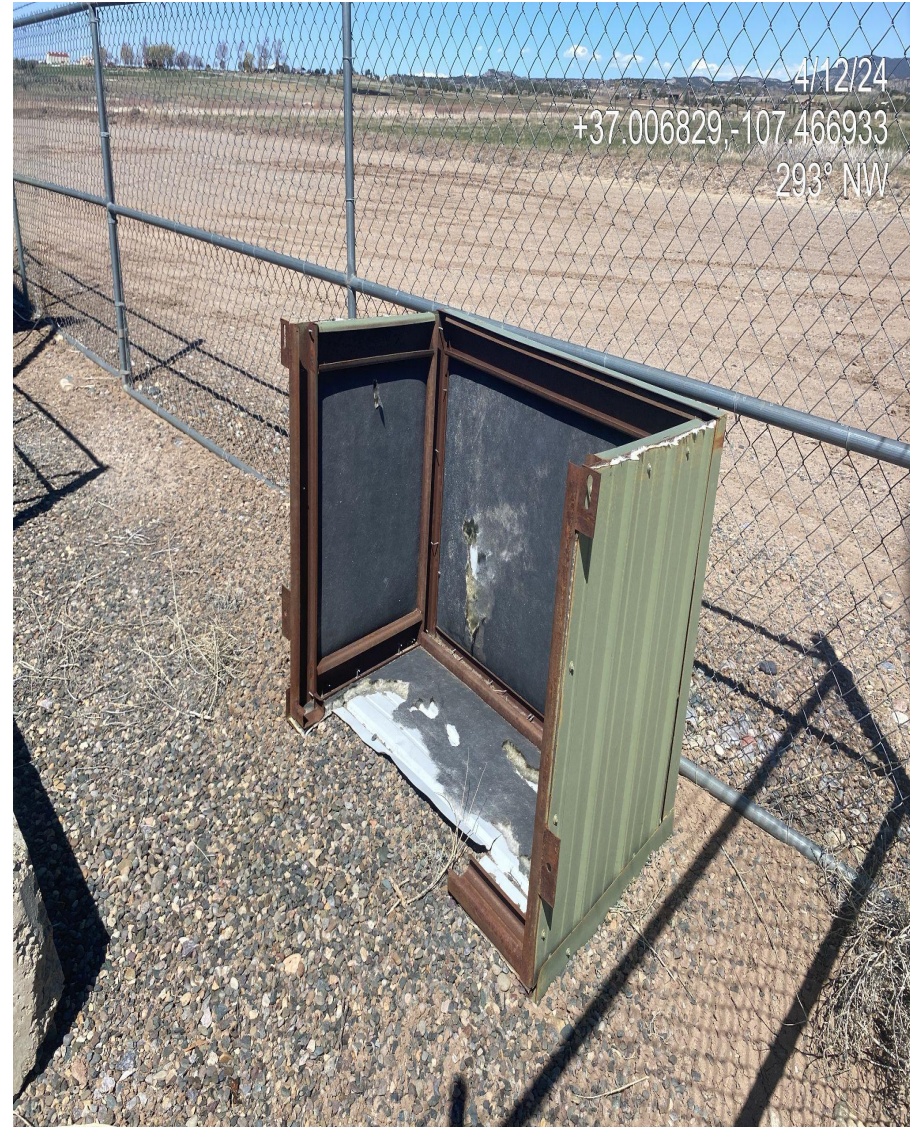
**Photo 3.** Unused oil and gas equipment observed at both pump jacks.

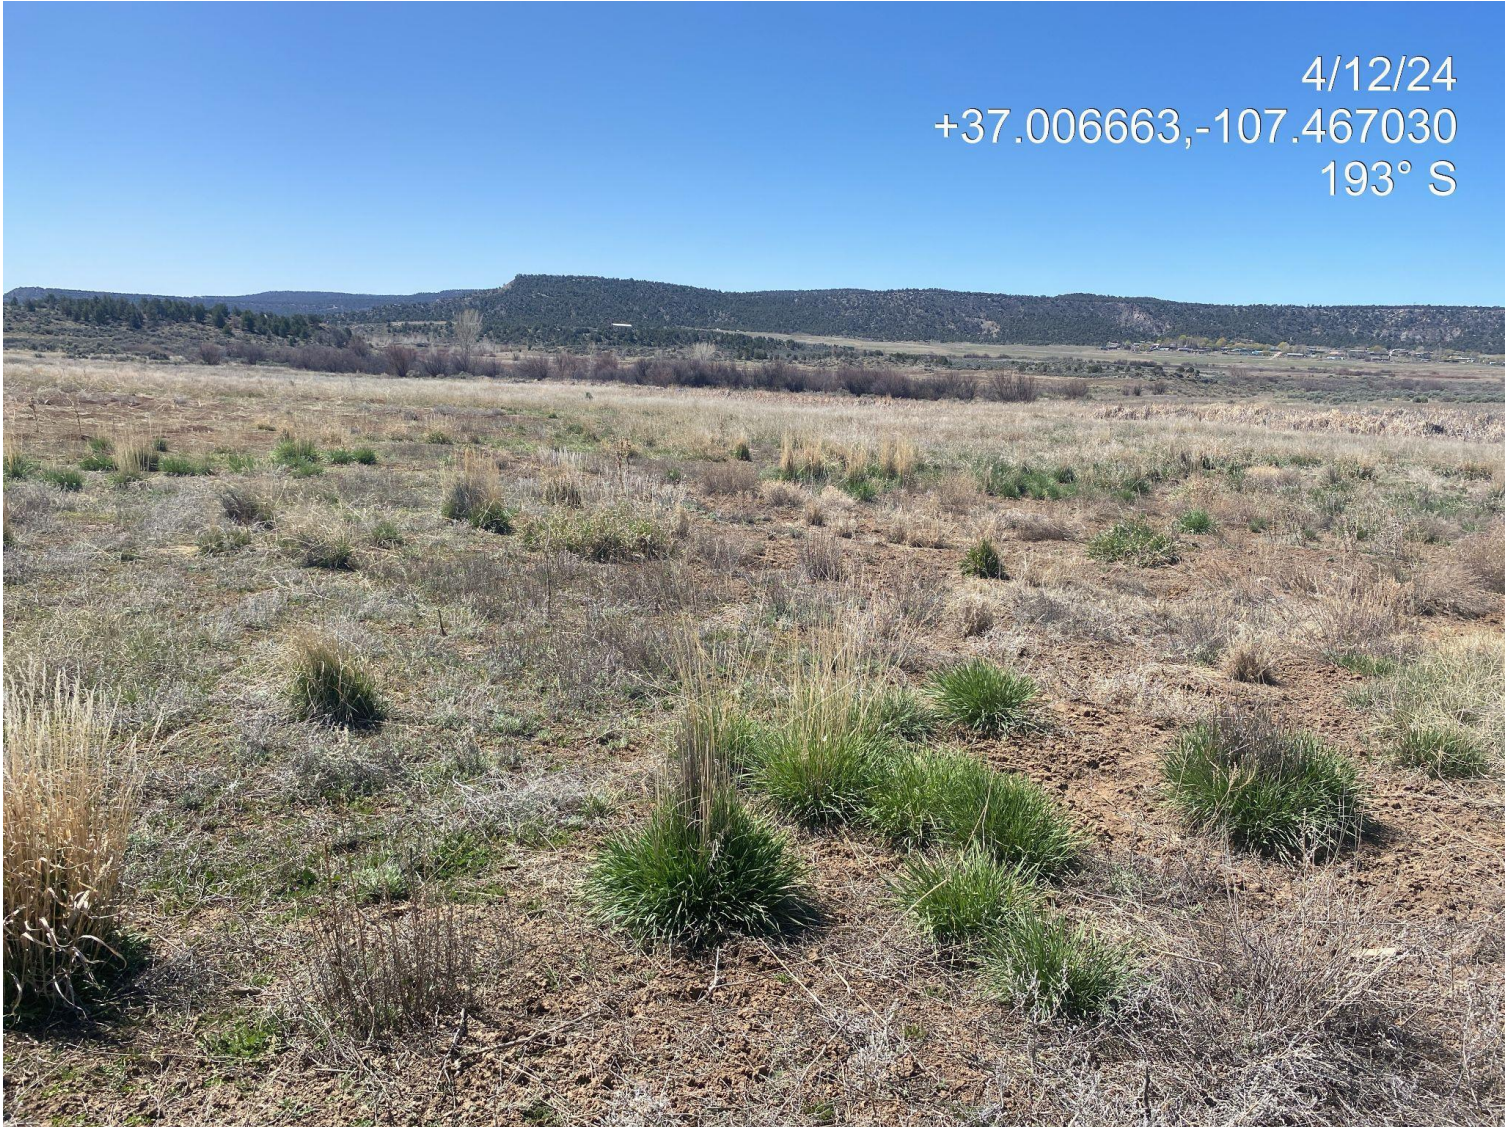
**Photo 4.** Reference area comprised of smooth brome and intermediate wheatgrass.
