Inspection Photos

Operator: Catamount Energy Partners LLC - 10464

Location ID: 320847

Inspection Photos
Location Name: Cox 2
Location ID: 320847

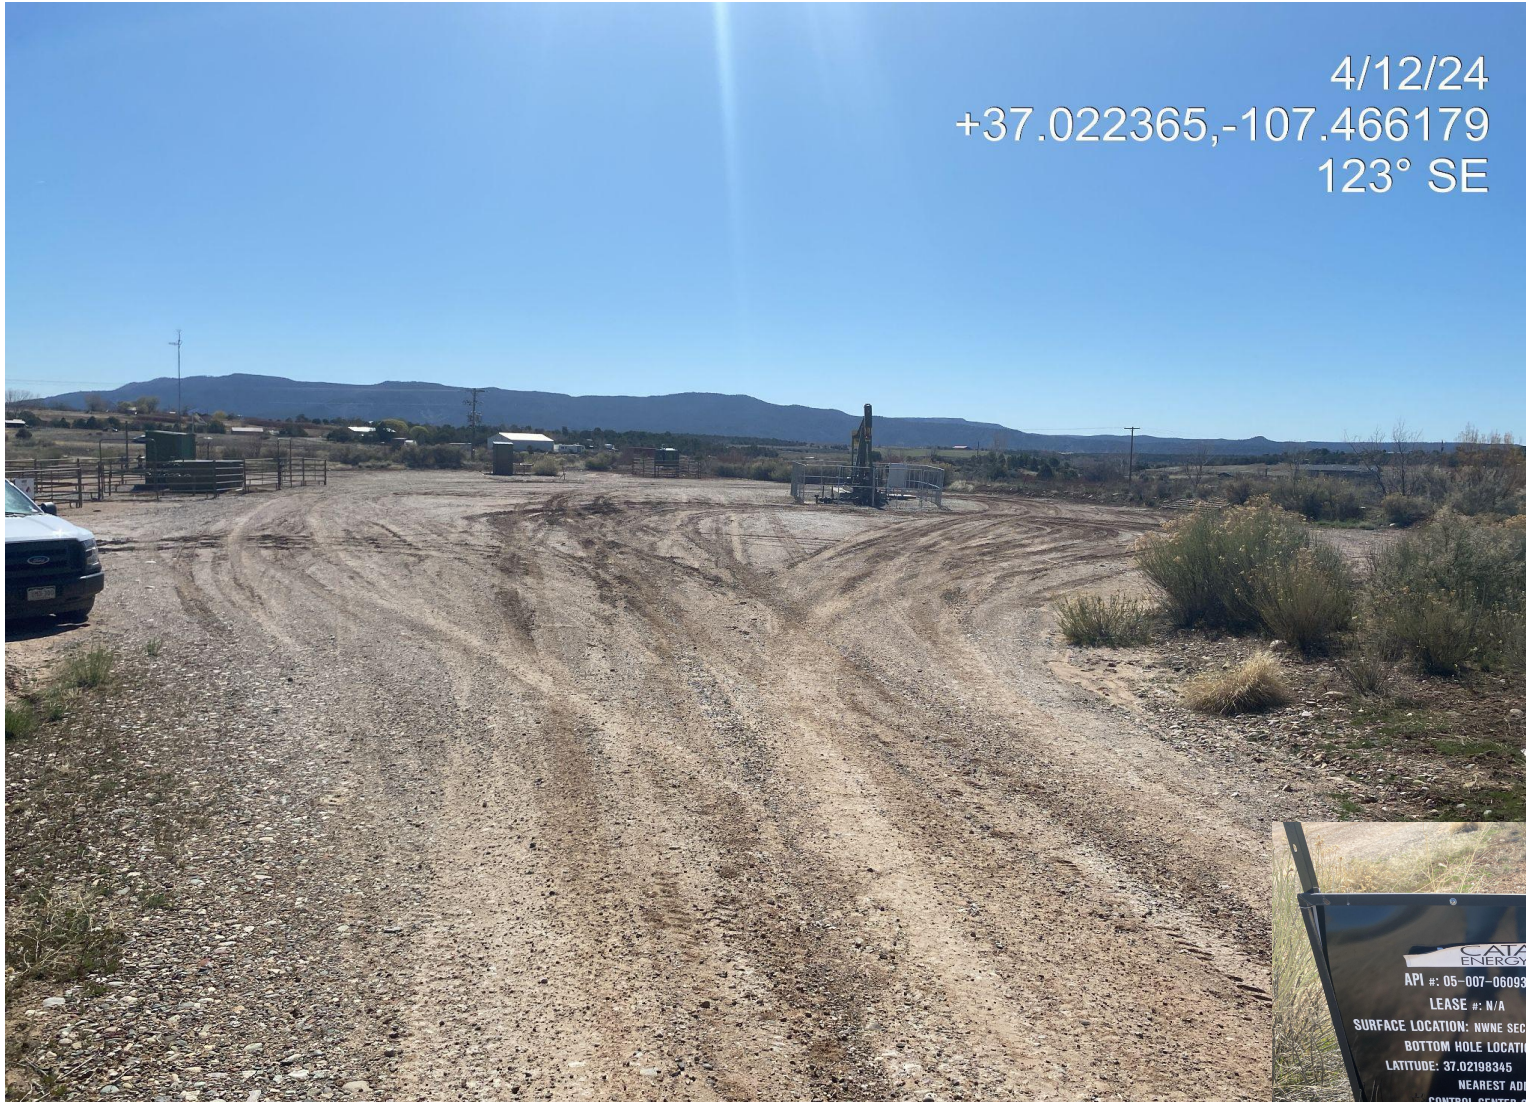
4/12/24
+37.022365,-107.466179
123° SE

Photo 1. View of the well disturbance from the access point facing center.

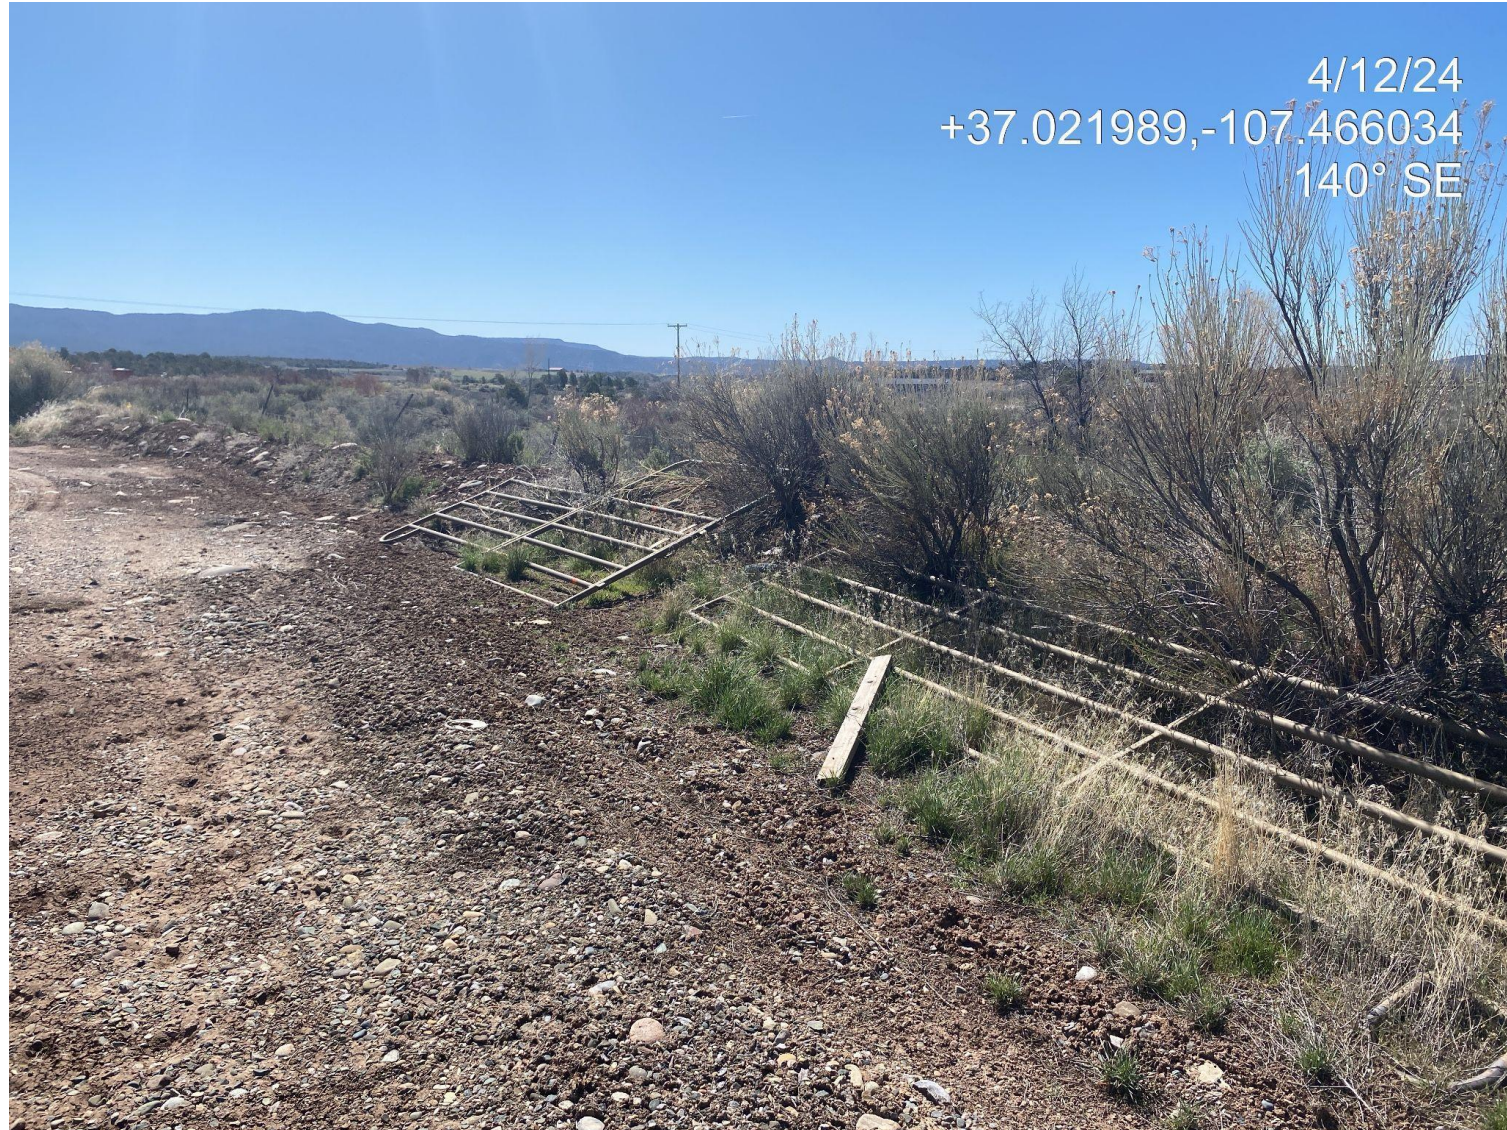
4/12/24
+37.021989,-107.466034
140° SE

Photo 2. View of unused oil and gas fencing stored along the southern edge of the disturbance.

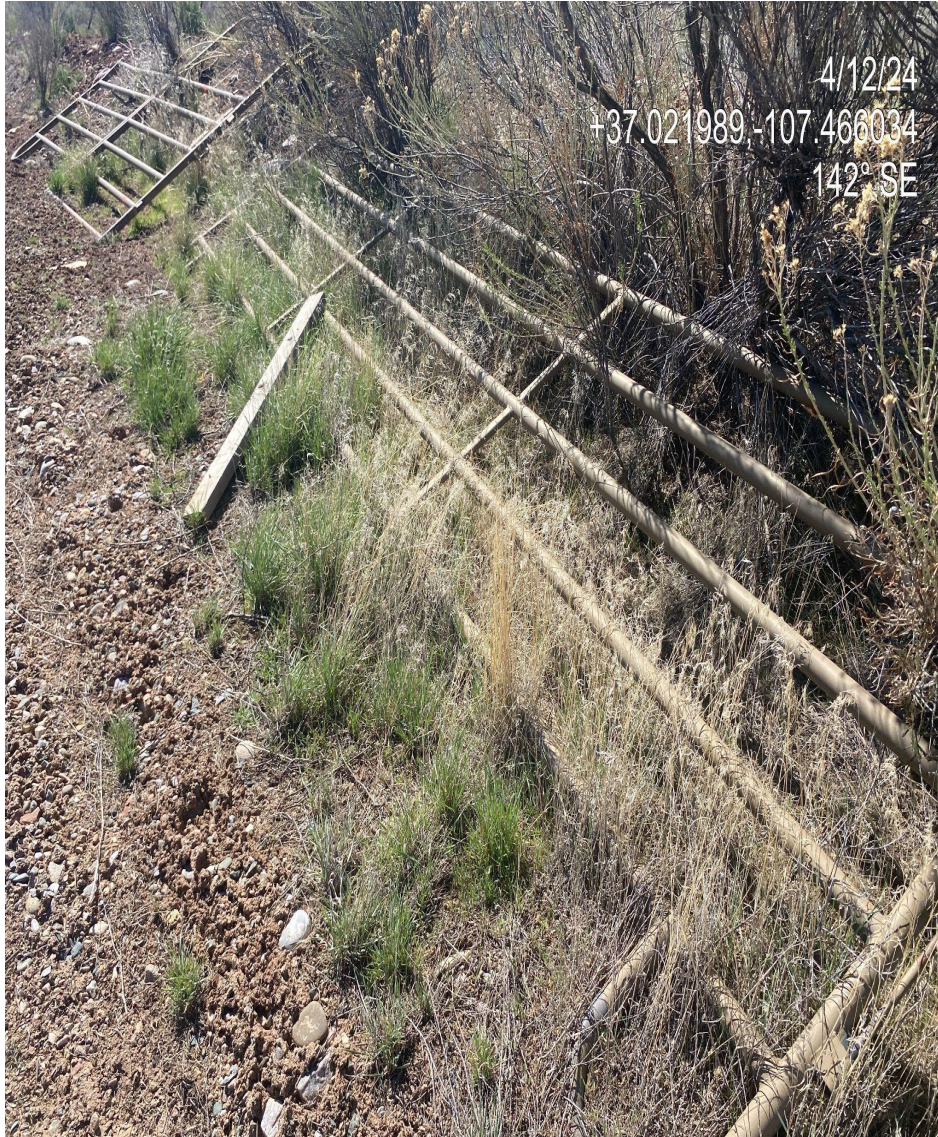
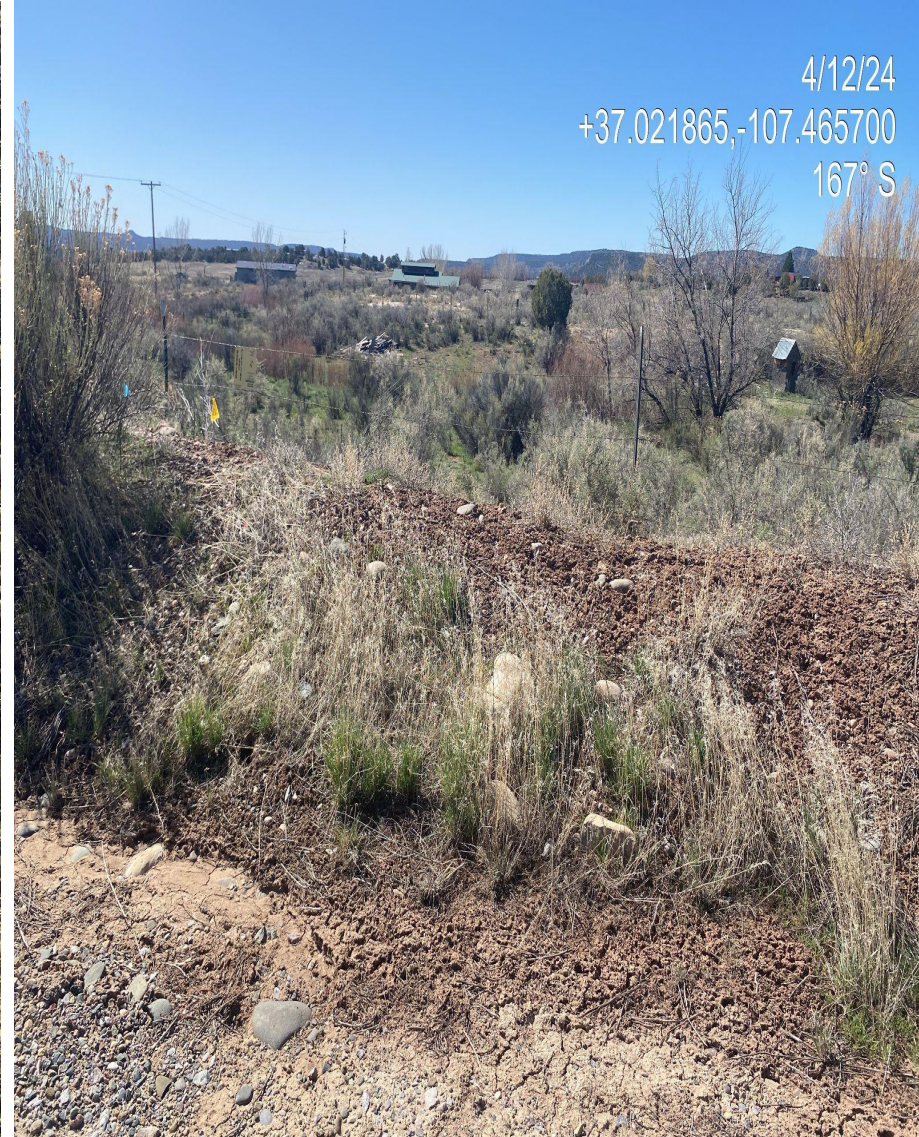
Photo 3. Patches of cheatgrass (*Bromus tectorum*) observed along the southern edge of the disturbance.

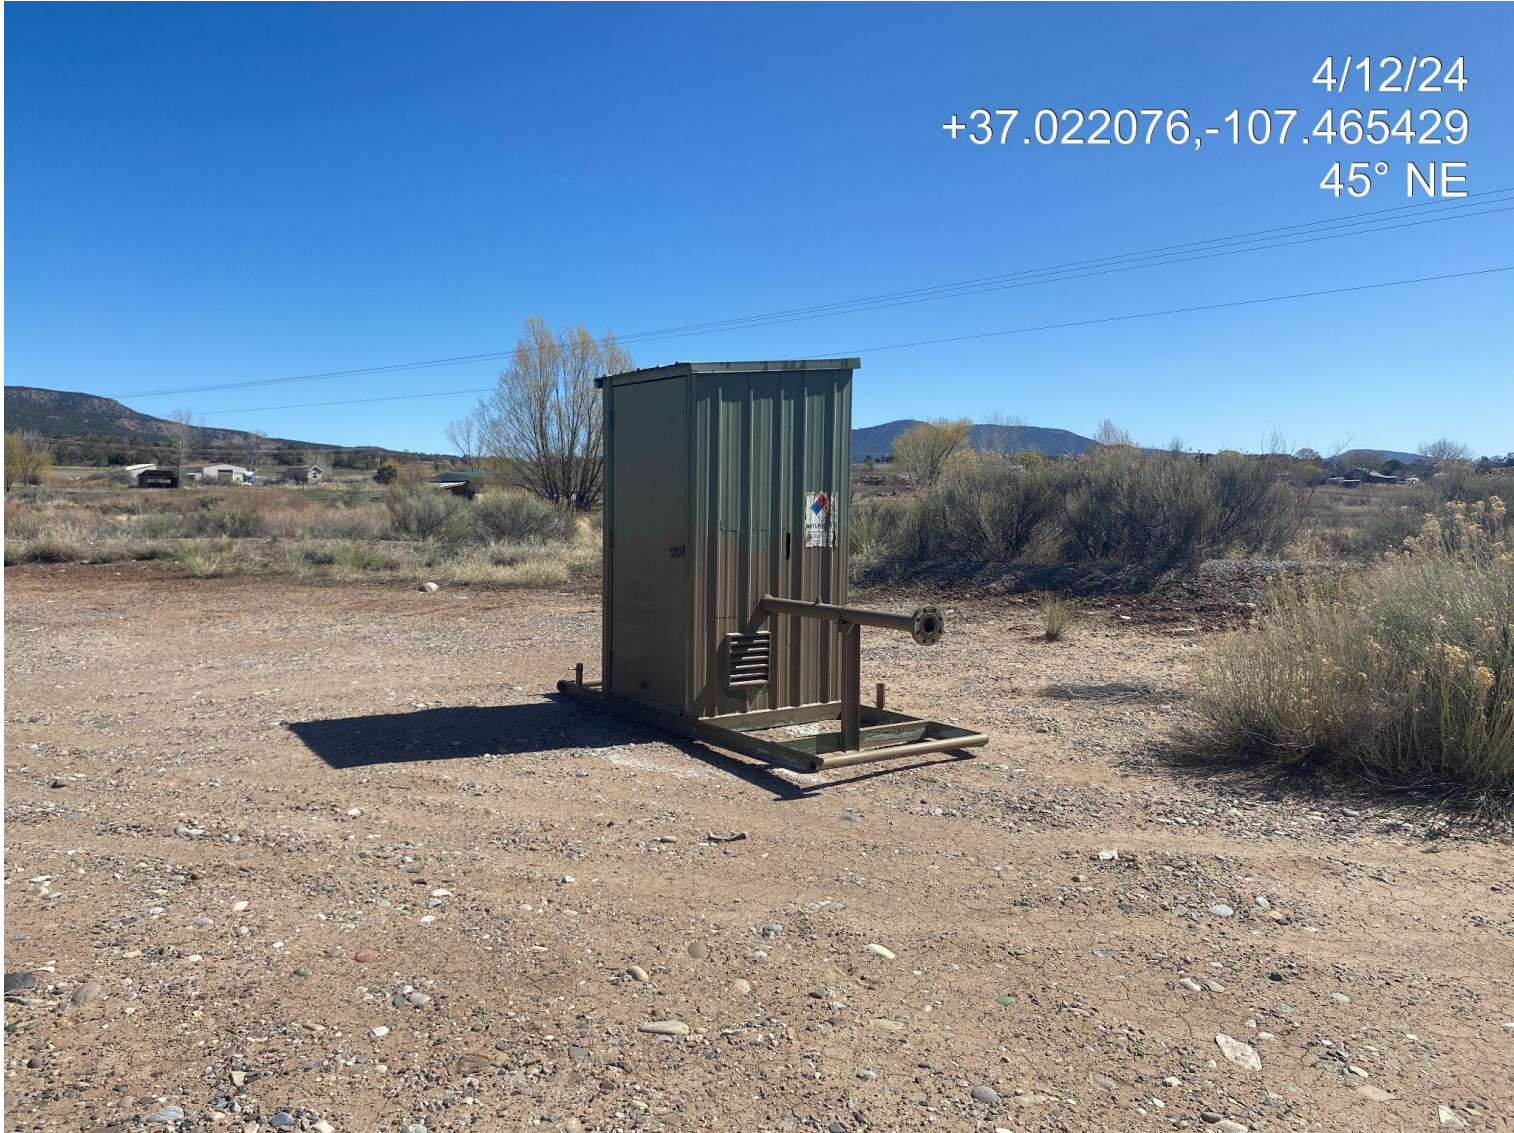
4/12/24
+37.022076,-107.465429
45° NE

Photo 4. View of unused meter shed stored in the eastern side of the disturbance.

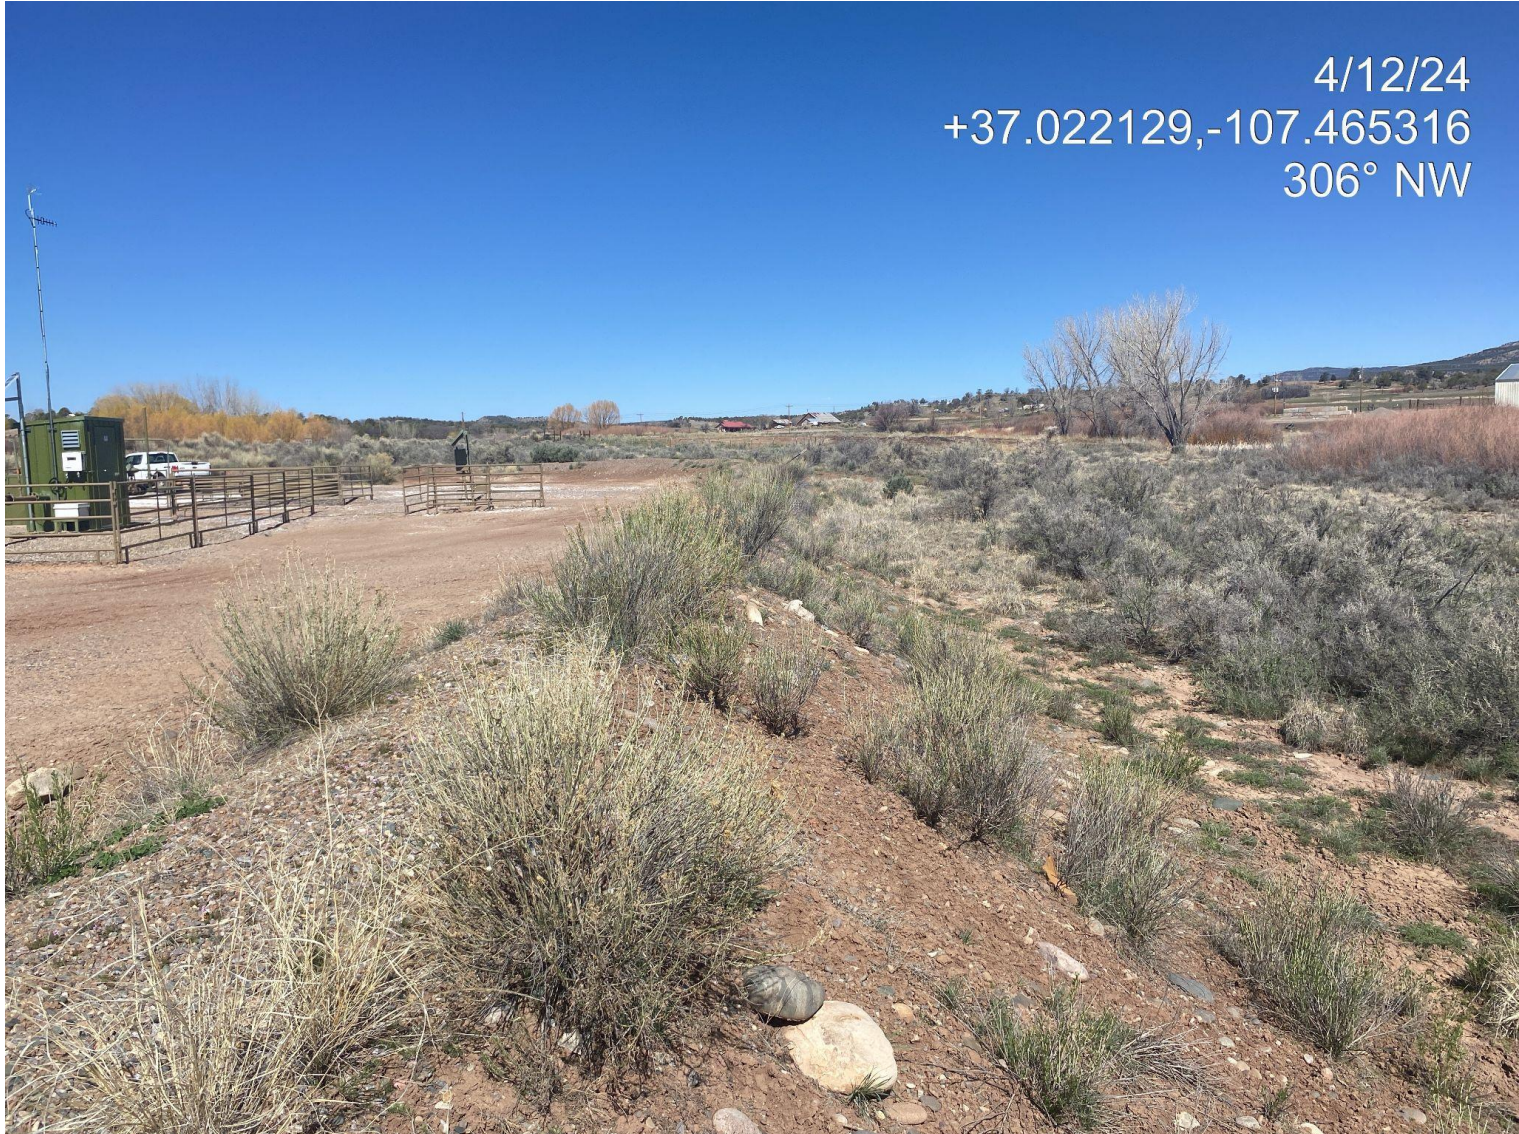
4/12/24
+37.022129,-107.465316
306° NW

Photo 5. View of the northern interim reclamation area facing north west.
Vegetation comprised of smooth brome and rabbit brush.

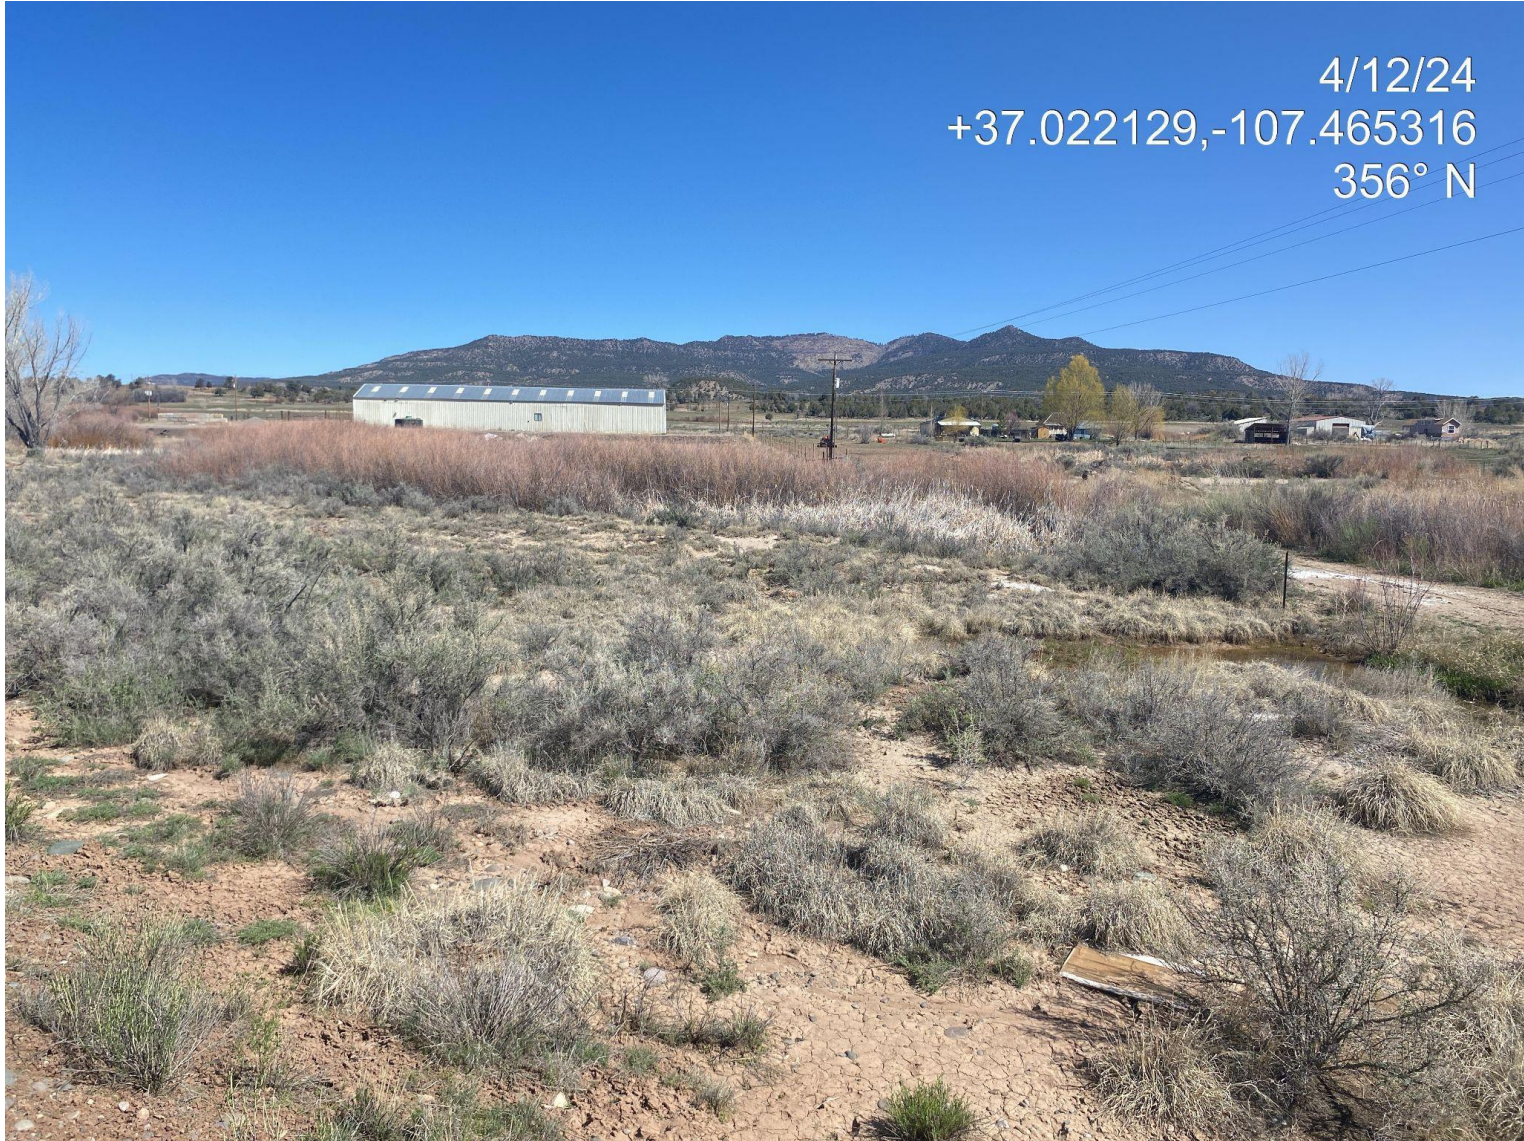
4/12/24
+37.022129,-107.465316
356° N

Photo 6. View of the reference area comprised of sage brush, rabbit brush, smooth brome and squirrel tail.
