# Inspection Photos

**Operator:** TEP ROCKY MOUNTAIN LLC - 96850

**Location ID:** 418828

**Inspection Doc:** 696205757

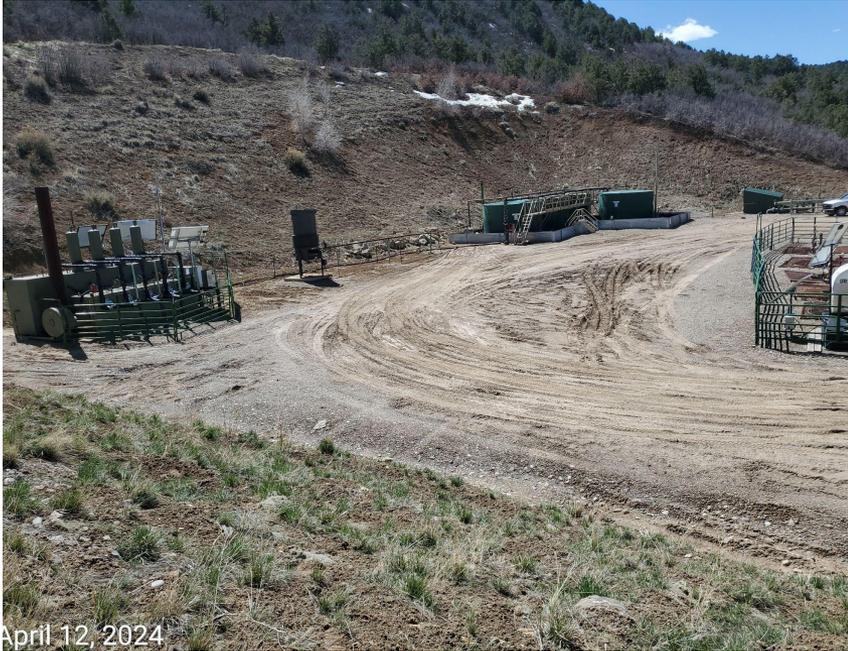
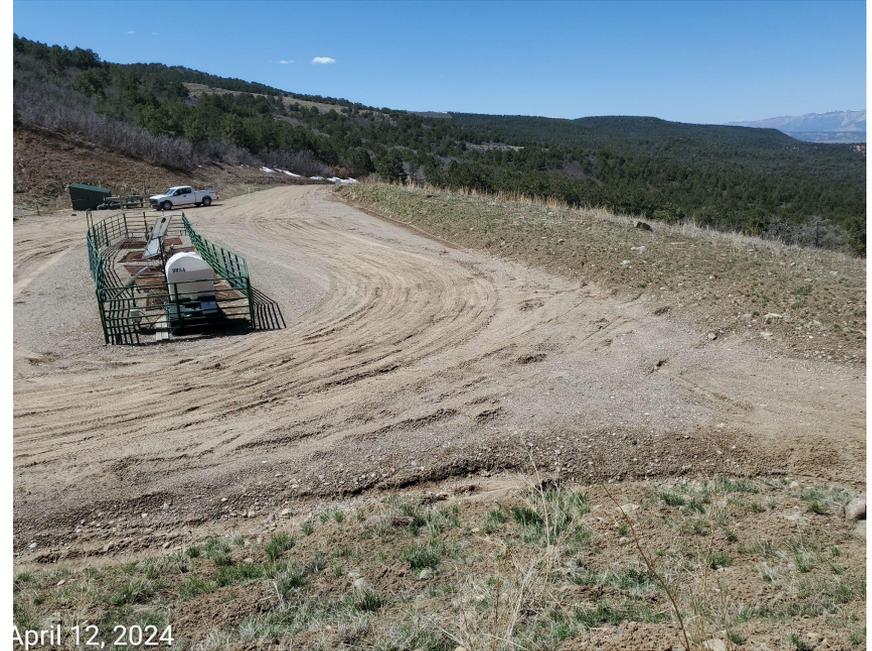
**Photo 1:** Photos taken from the east end of the Location, facing southwest and west. Photo provides an overview of the working pad surface and Location.

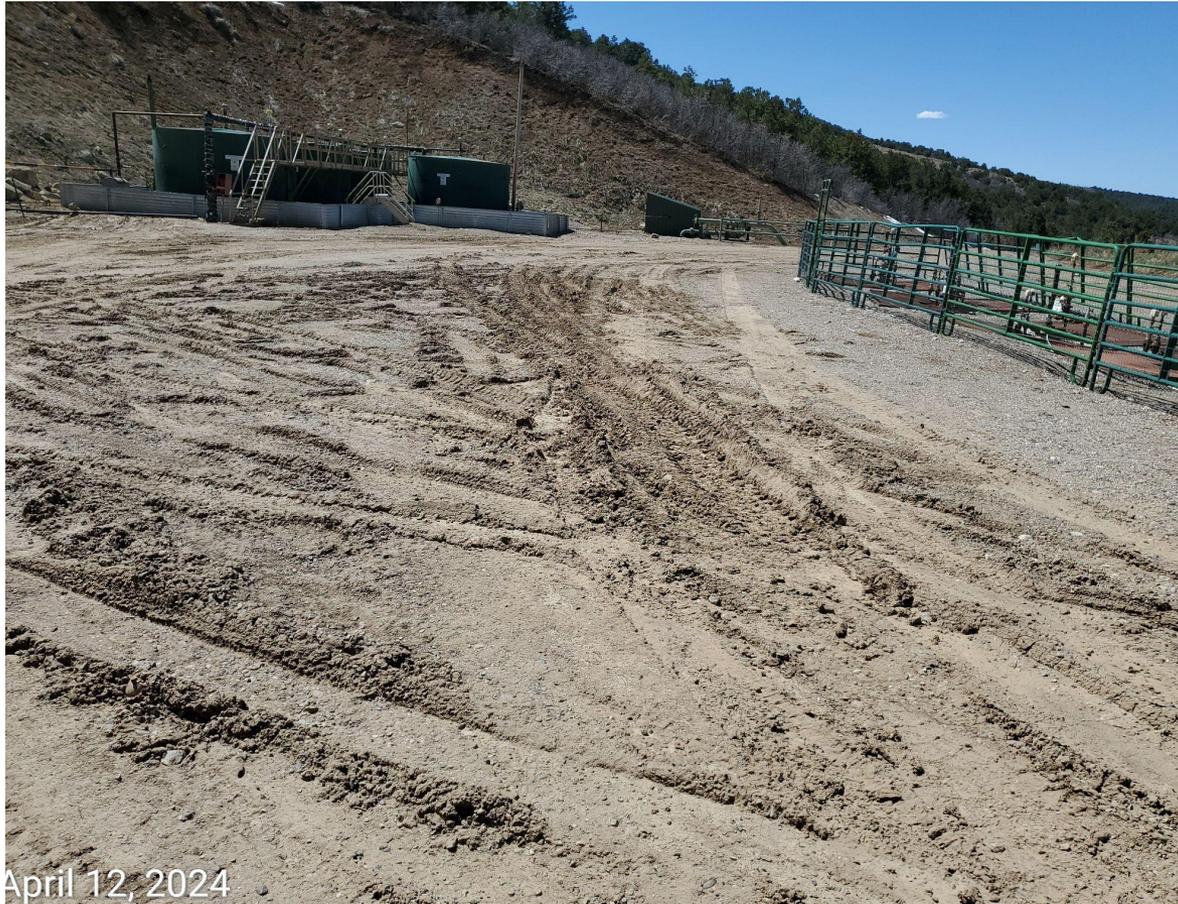
**Photo 2:** Photo taken from the east end of the working pad surface, facing west. Photo shows pad lacks stabilization; BMPs to stabilize, as well as to minimize tracking and degradation during wet conditions have not been maintained on Location. Grading along will be insufficient.

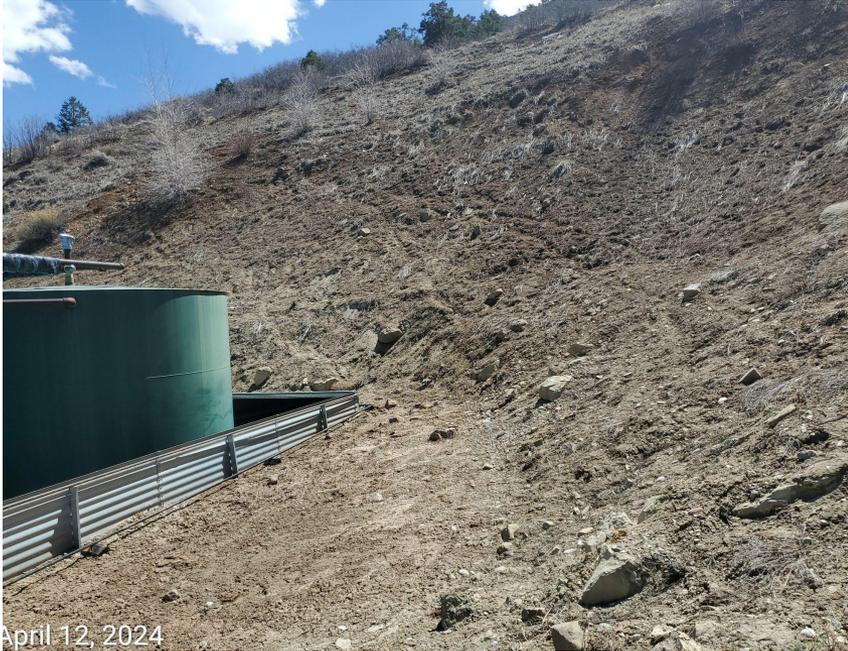
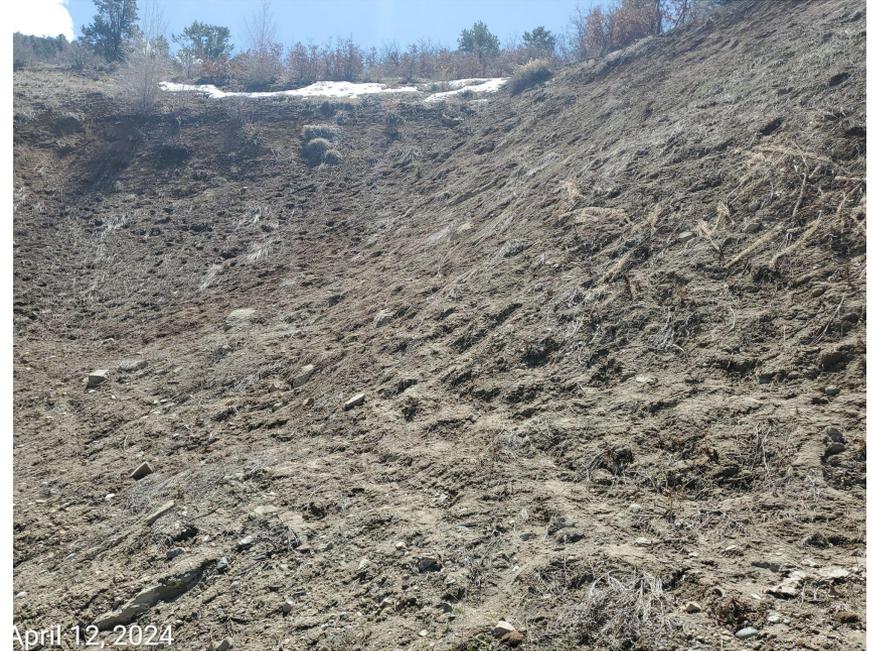
**Photo 3:** Photos taken from the south end of the Location, facing south/southeast. Southern areas of the Location are predominantly bare and unstabilize soils. Erosion degradation evident. BMPs to stabilize slopes, and to minimize erosion, degradation and sediment transport inadequate. Additional reclamation required.

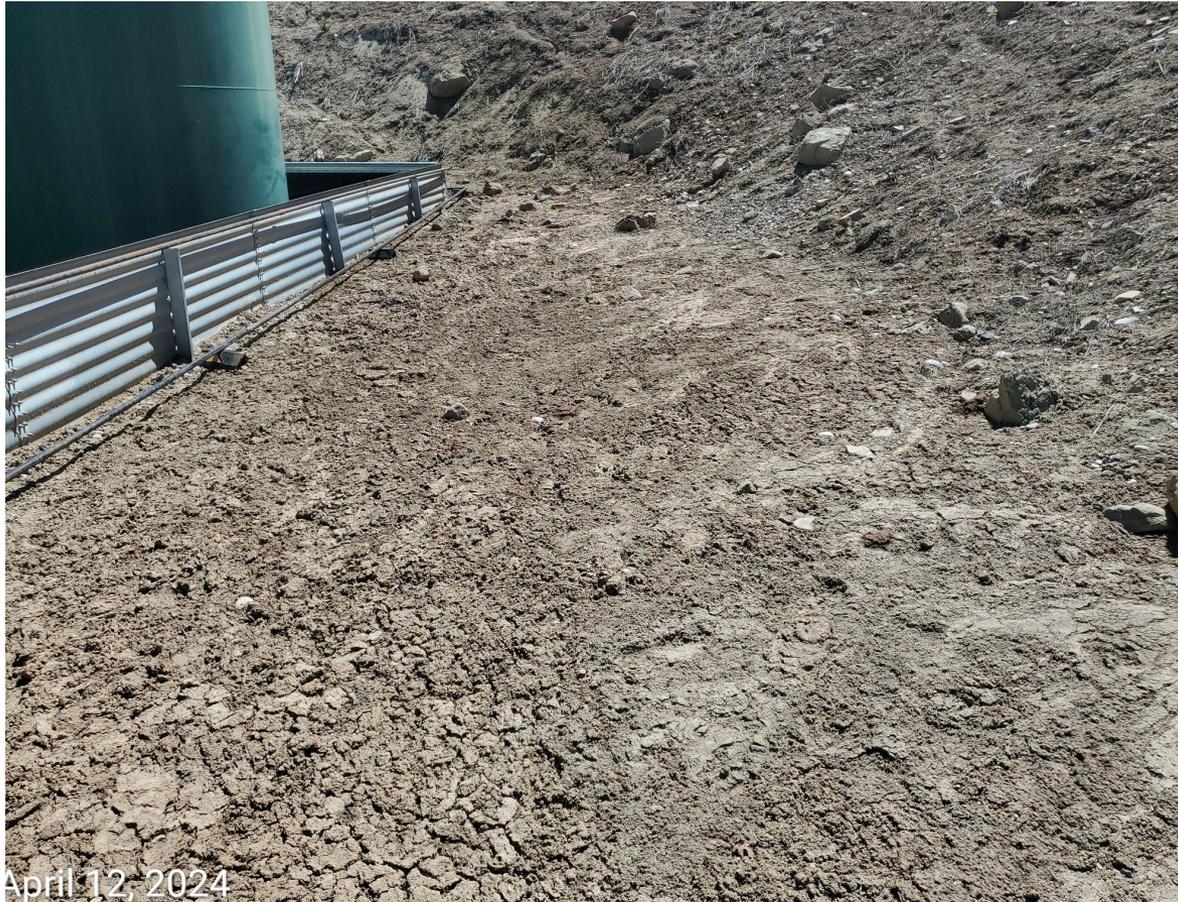
**Photo 4:** Continued from photo 3. Photo shows sediment deposition due to unstabilized slopes on the southern interim areas.

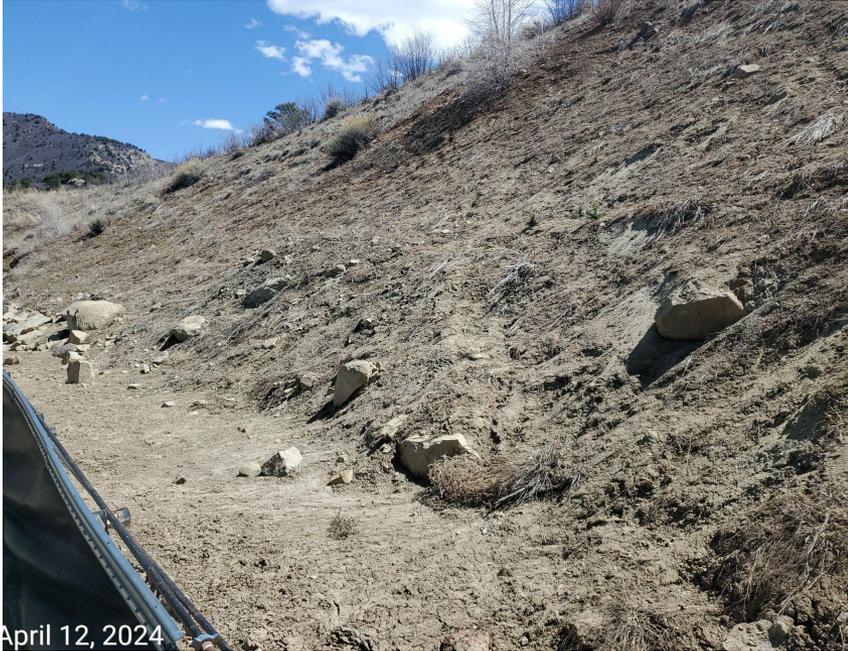
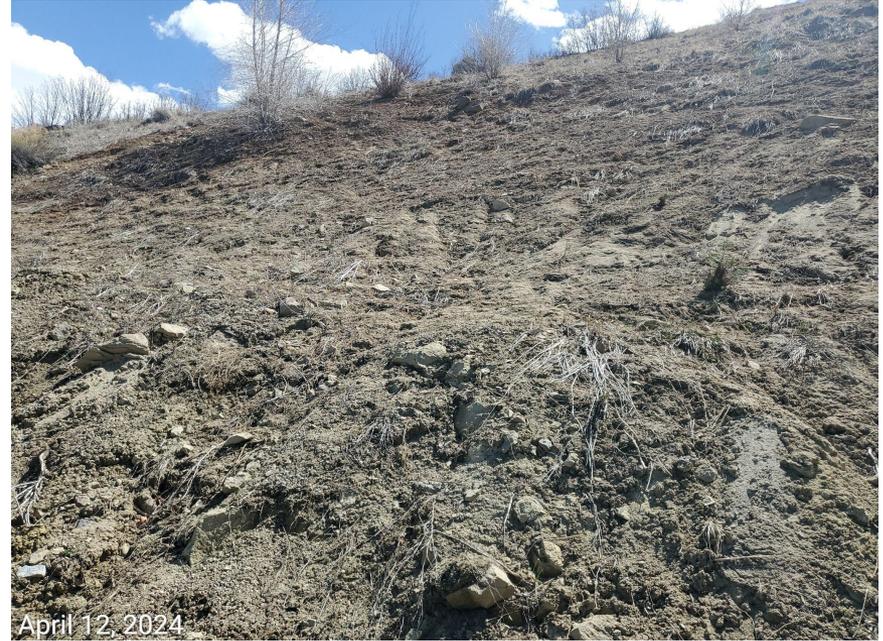
**Photo 5:** Photos taken from the south end of the Location, facing east/southeast. Southern areas of the Location are predominantly bare and unstabilize soils. Erosion degradation evident. BMPs to stabilize slopes, and to minimize erosion, degradation and sediment transport inadequate. Additional reclamation required.

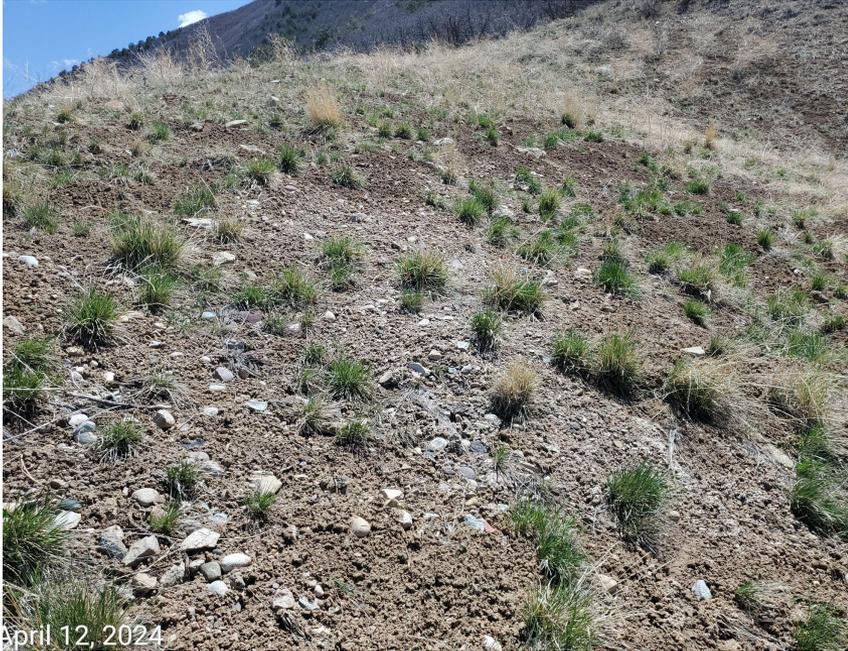
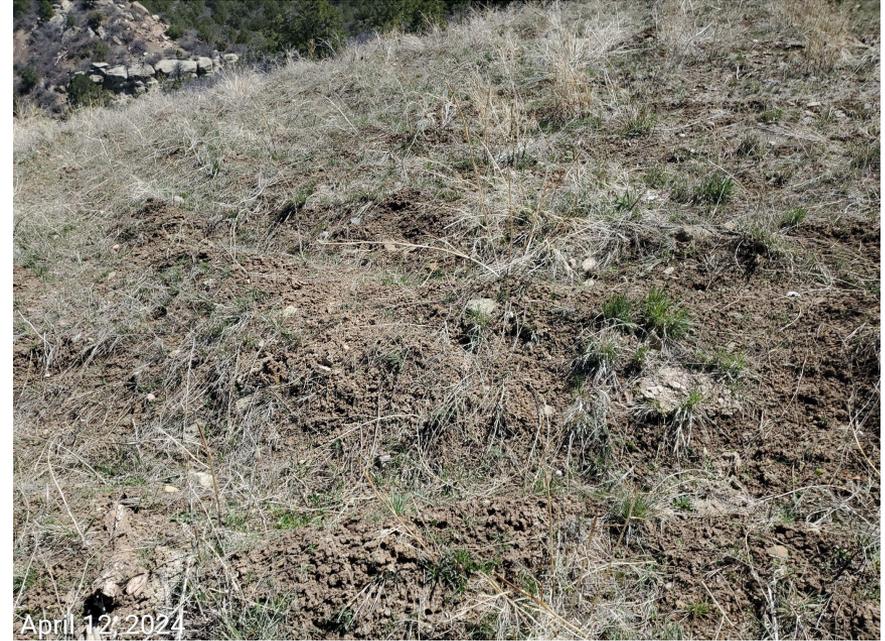
**Photo 6:** Photos taken from the eastern and southern interim areas of the Location. Reclamation appears to be progressing towards 1003 standards within these areas.

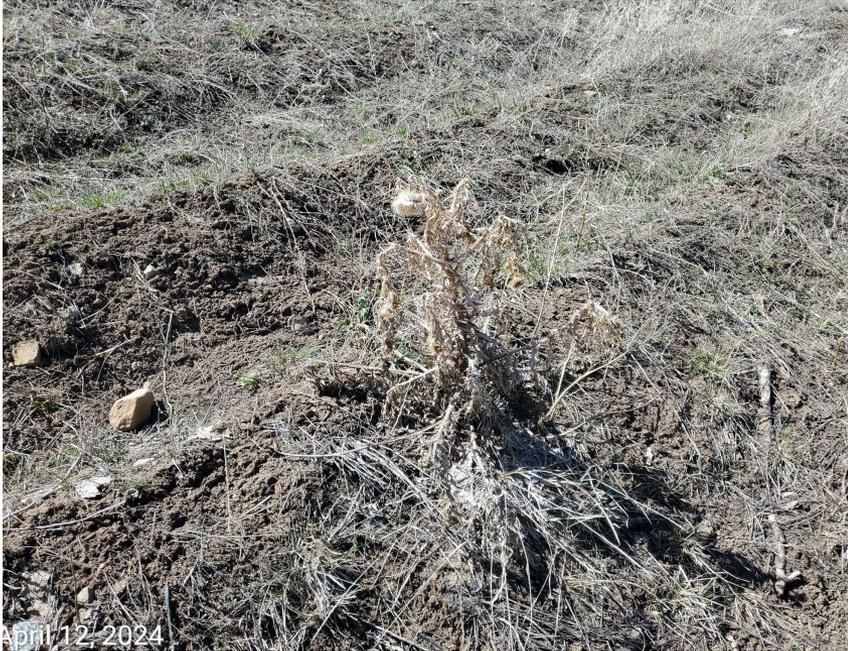
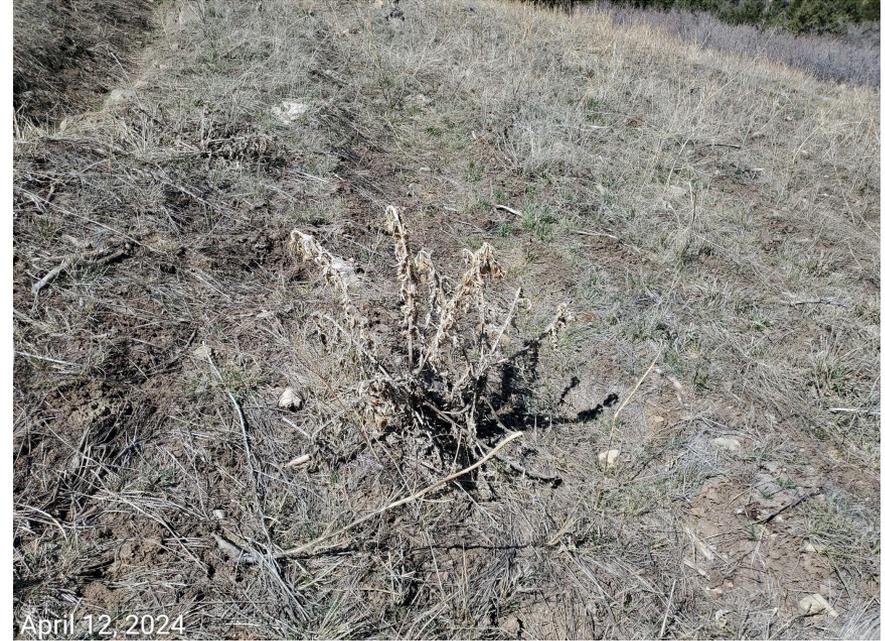
**Photo 7:** Photos examples showing noxious weeds (Musk thistle) observed on the interim areas of the Location; weeds reached maturity during the 2023 growing season.

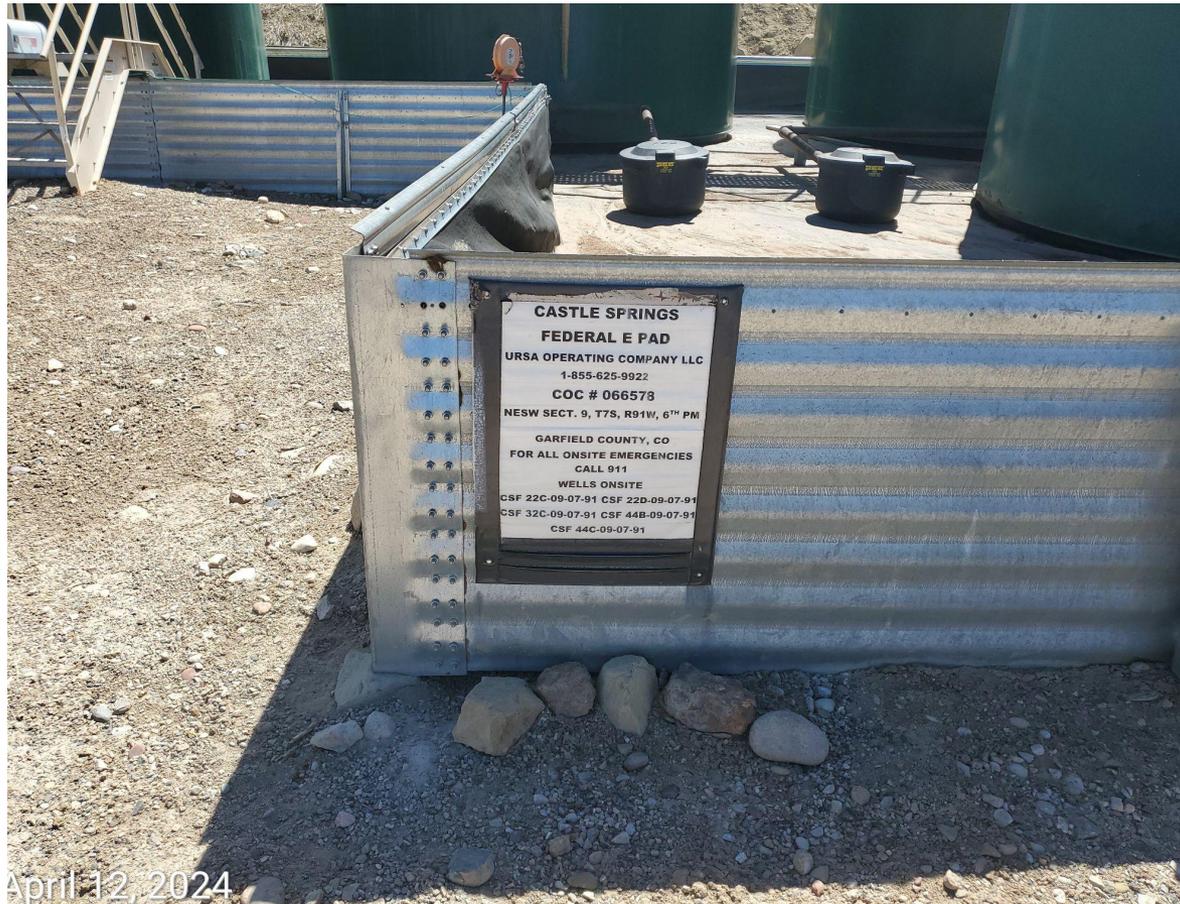
**Photo 8:** Photo shows tank battery signage with missing and inaccurate information.

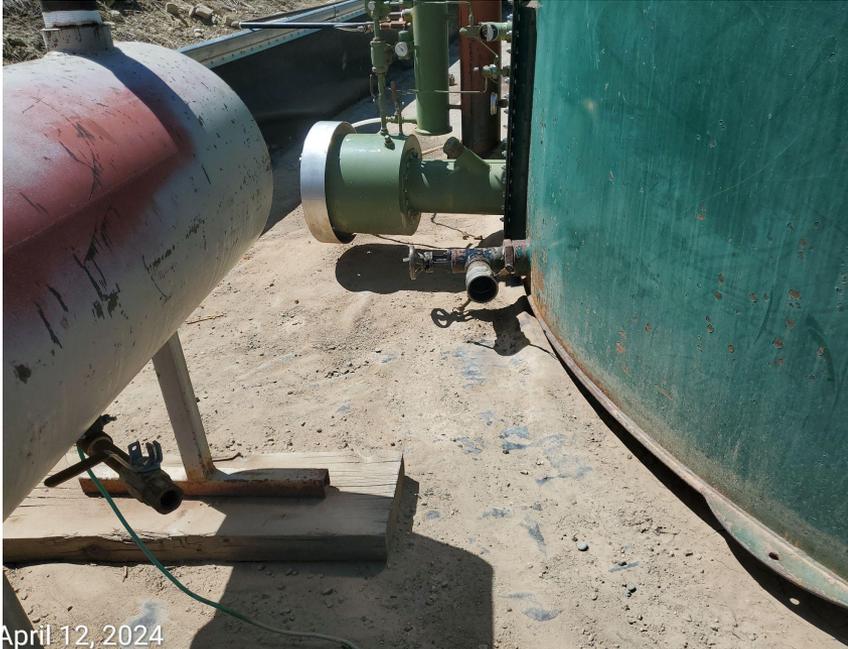
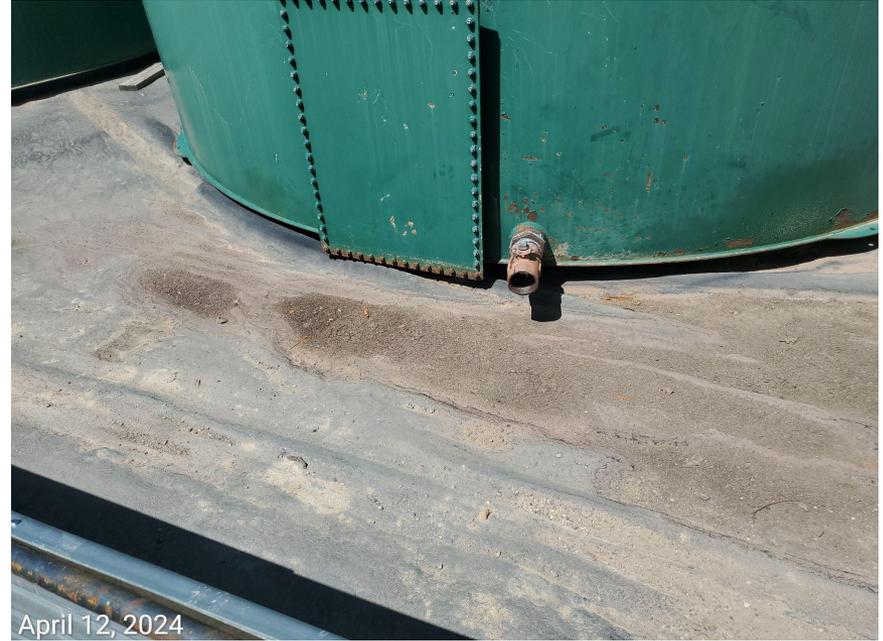
**Photo 9:** Photos show lines at tanks missing required cap/pug.
