Inspection Photos

Loc: 334553

Operator: OXY USA INC

Inspection Date: 4/16/2024

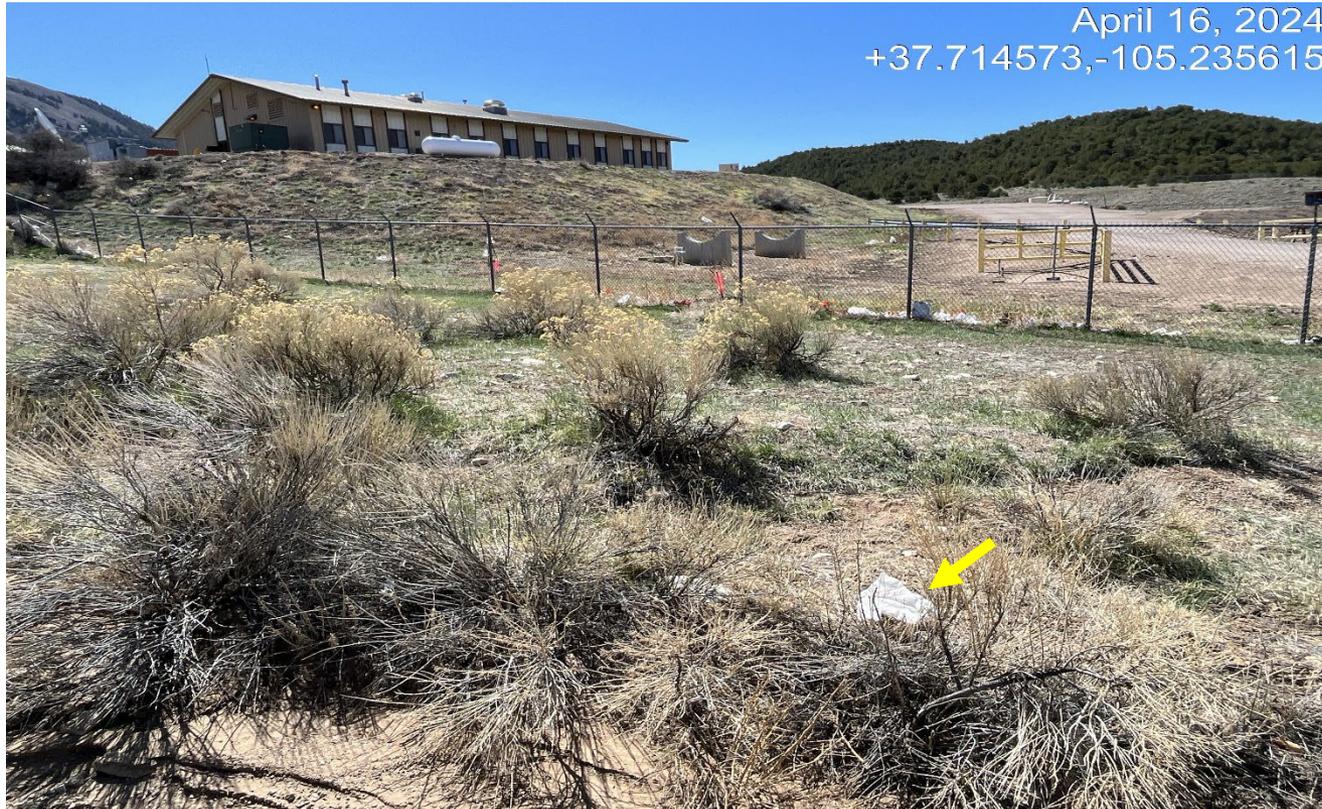
Photo 1. Facing southwest toward the Oxy yard. There is trash along the fence line that is also blowing over the fence. Trash needs to be picked ASAP.

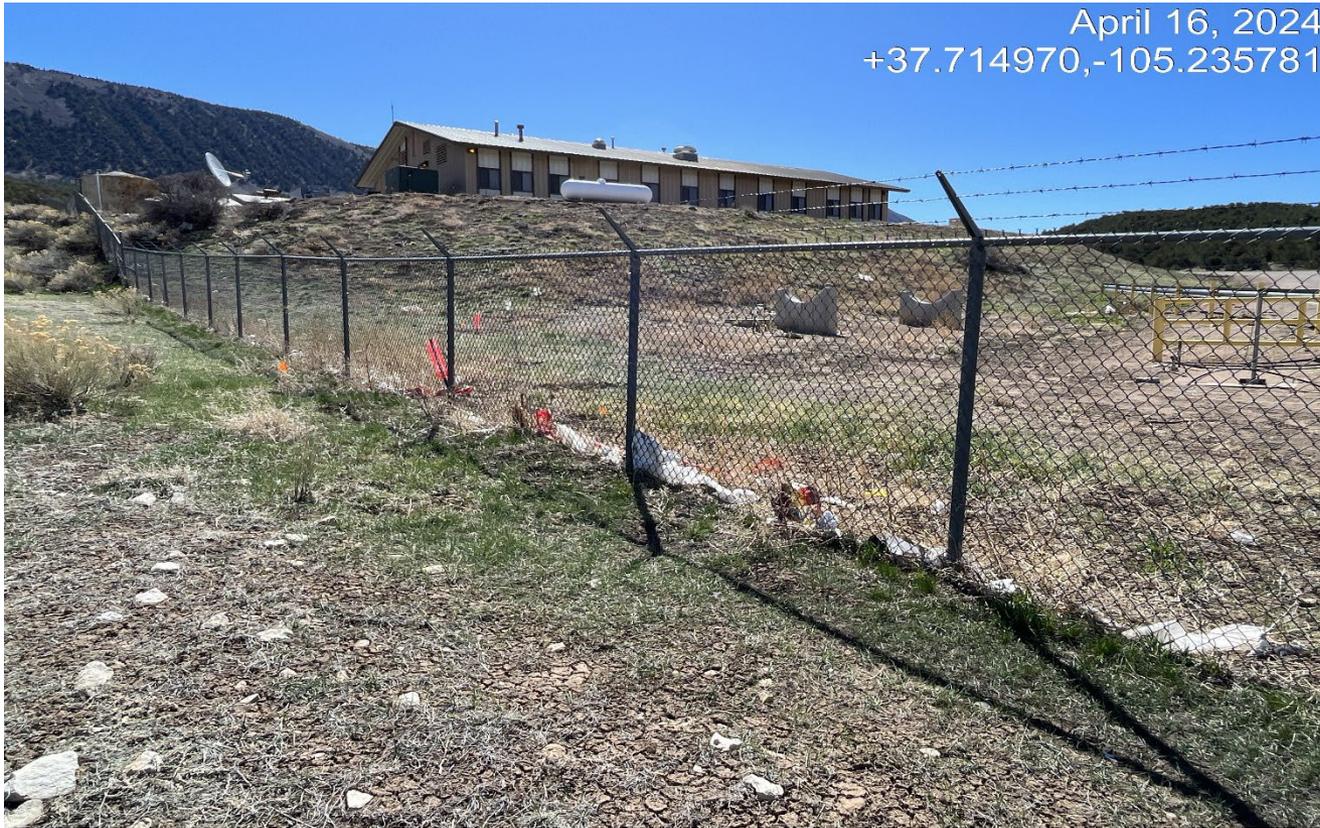
Photo 2. There is trash inside the fenced in Oxy yard that which should be picked up.

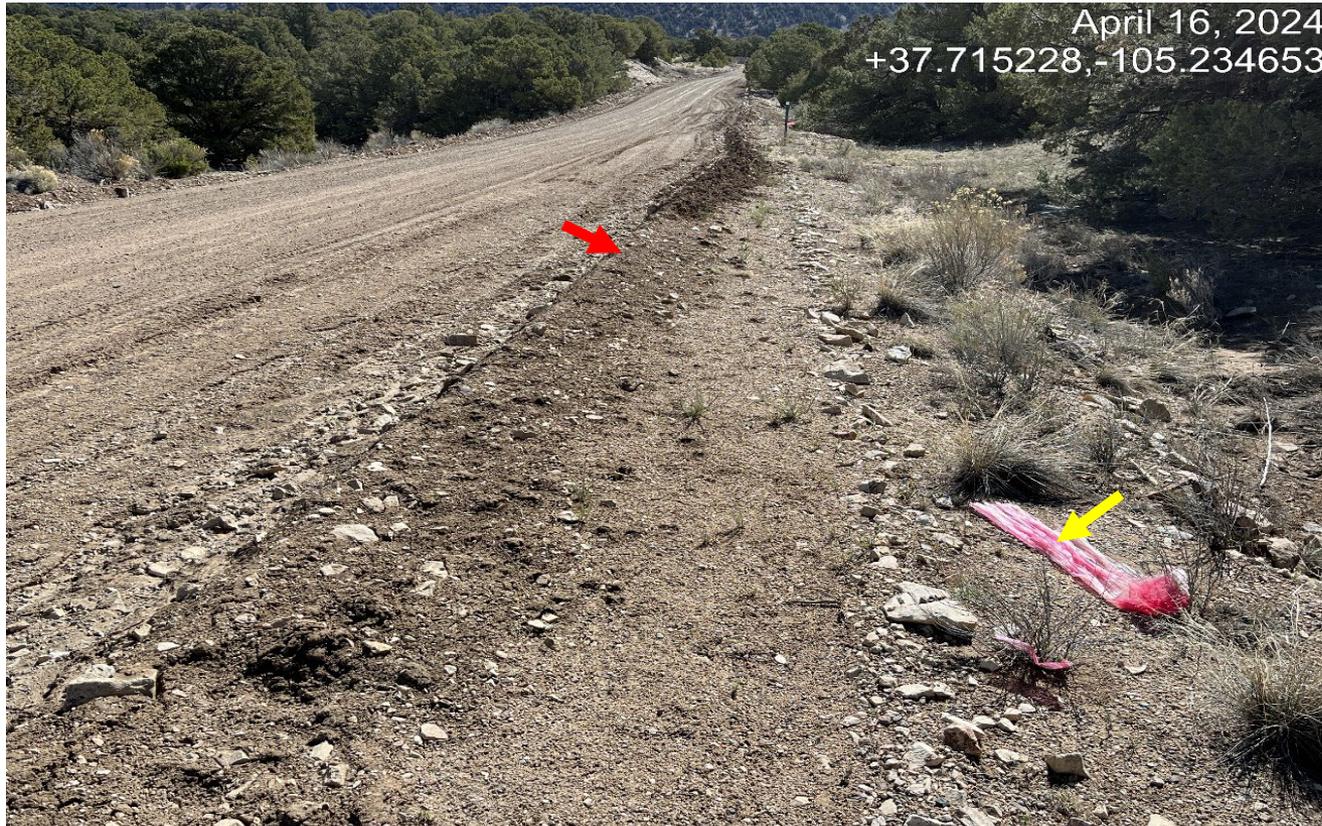
Photo 3. Facing east along the access road. Grading of the road has pushed a row of gravel along the side shown at red arrow which interferes which stormwater drainage off the road to prevent erosion. There is trash at yellow arrow that needs to be pick up.

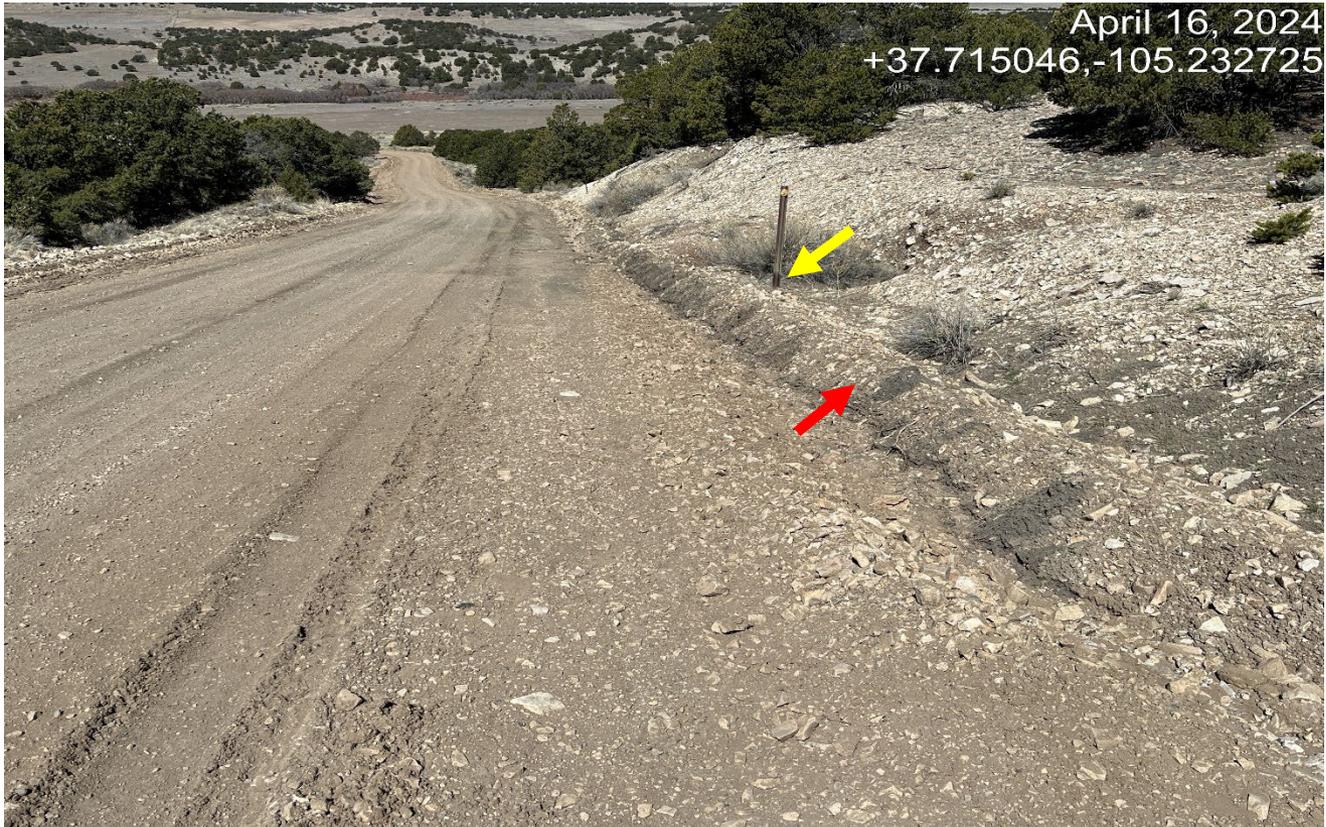
Photo 4. Facing back west down the access road. Grading of the road has pushed a row of gravel along the side shown at red arrow which is blocking drainage toward the culvert at the yellow arrow.

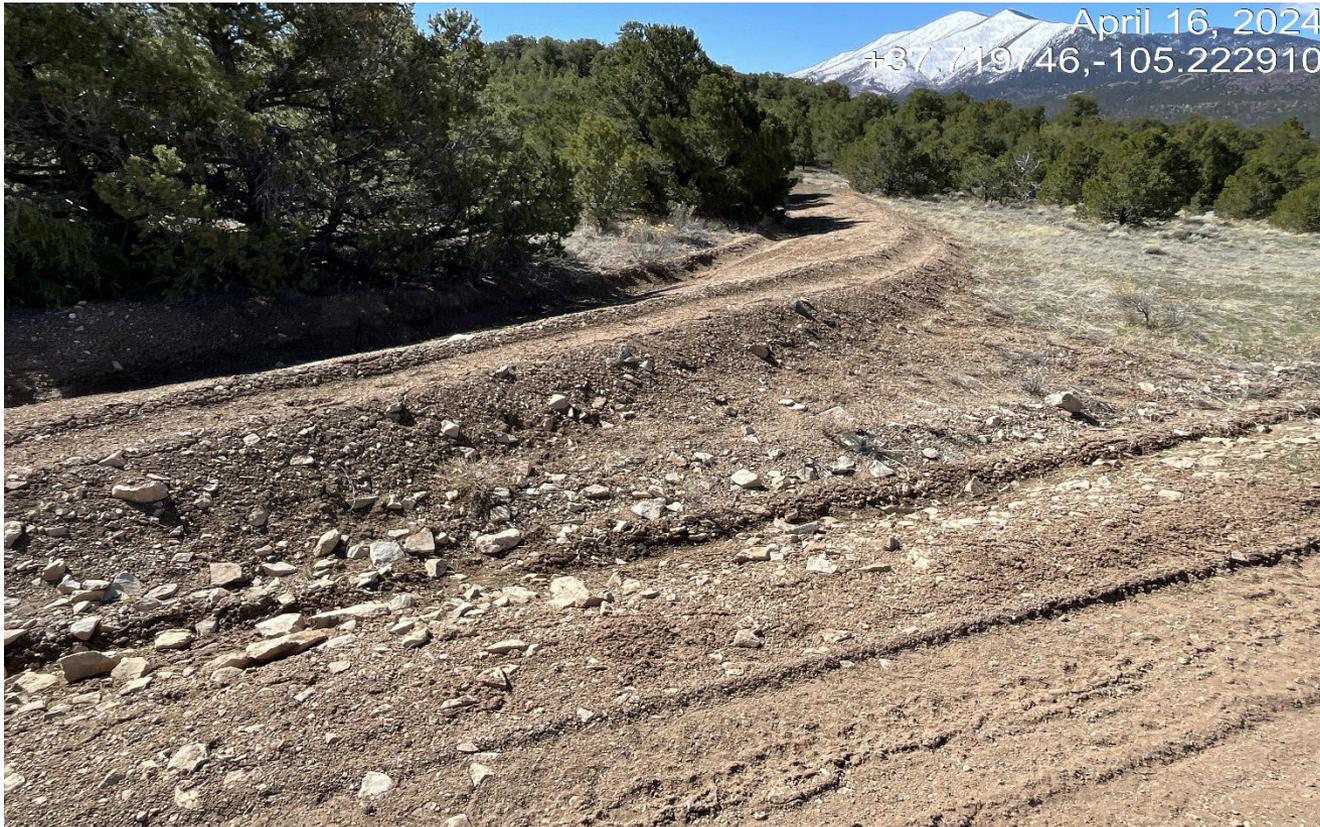
Photo 5. There are several drainage diversion along the road that need to be seeded and stabilized. Also make sure grading has not blocked these drainage ditches for stormwater diversion..

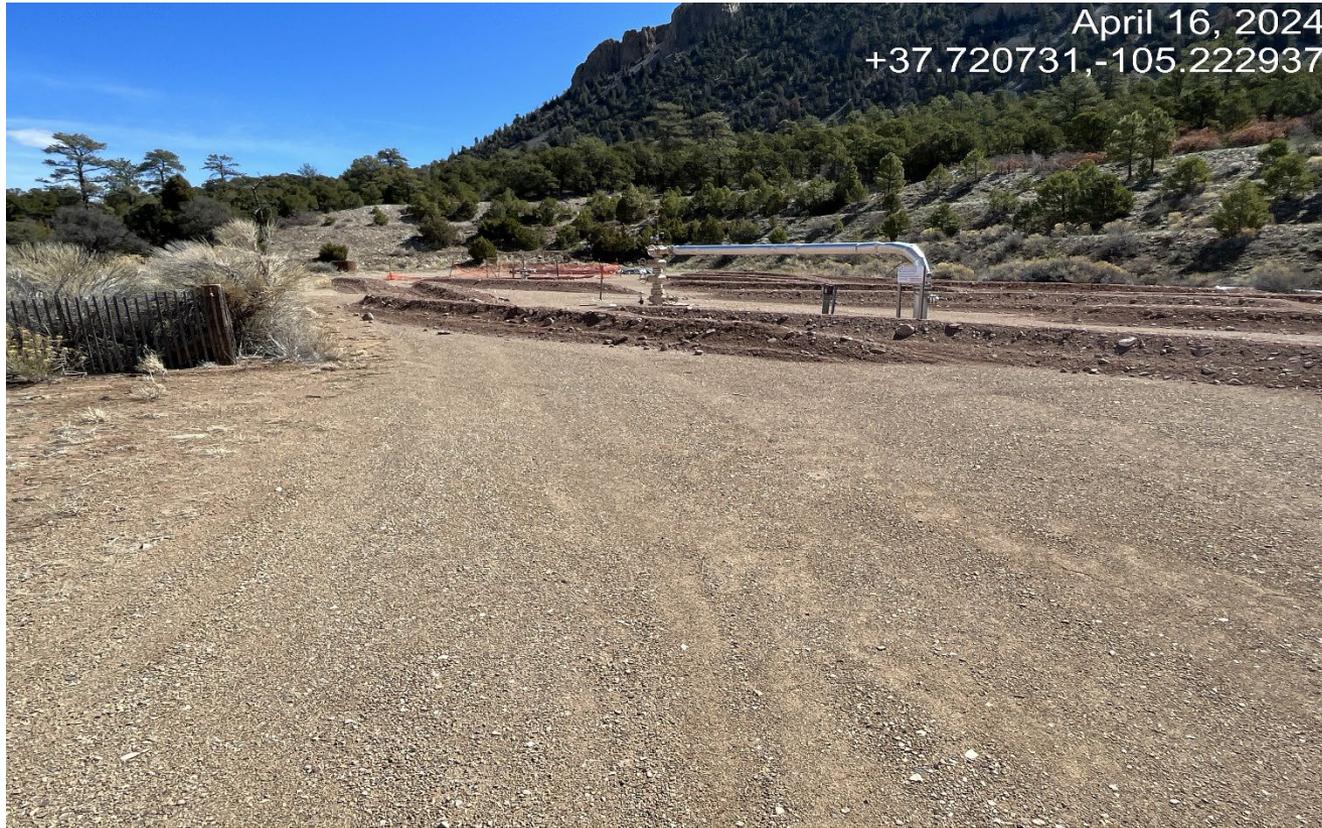
Photo 7. Facing northeast toward the wellsite. Fill material has been brought in to backfill the open excavation..

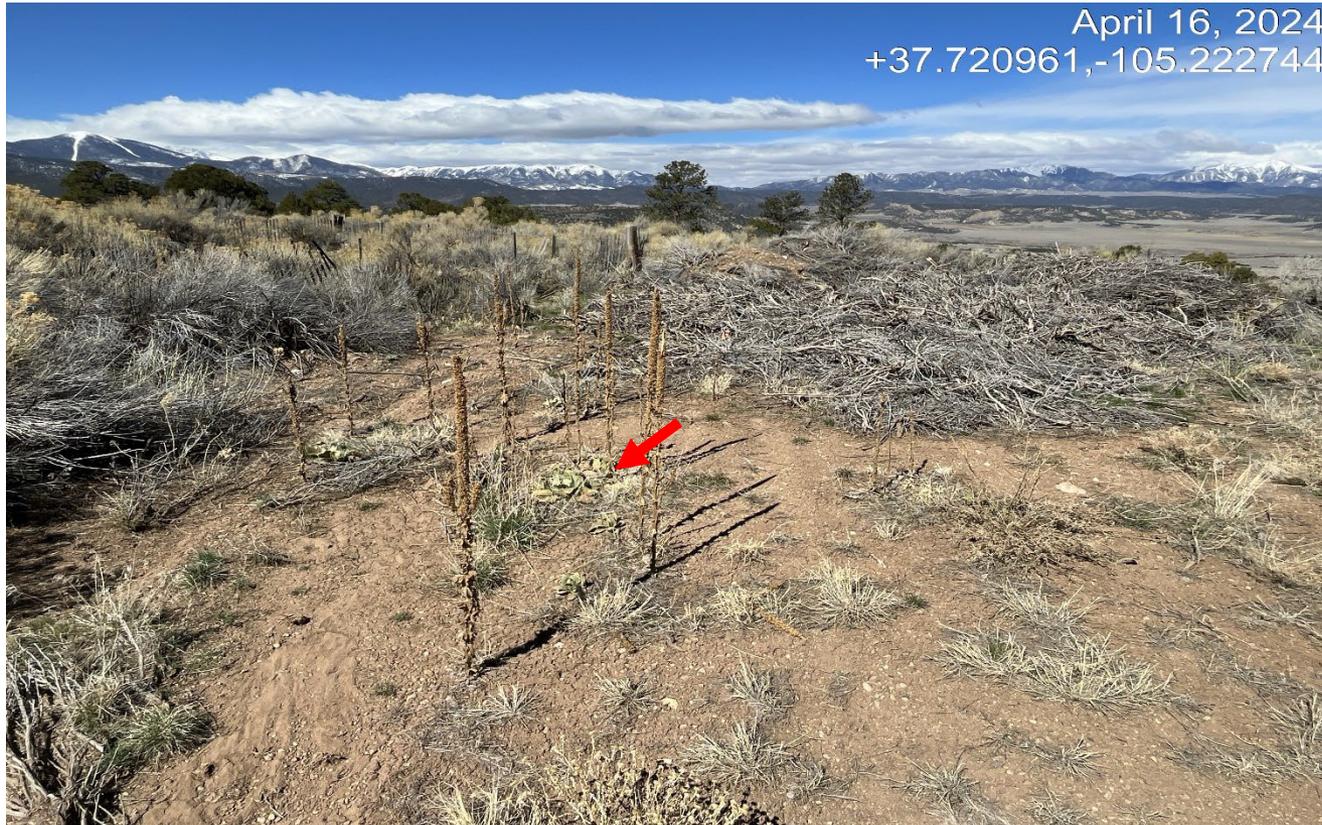
Photo 8. Facing northwest at the location. There is a pile of brush debris that was pushed to this area that must be removed. There are also noxious weeds in this area (Mullein). Previous corrective action was not completed.

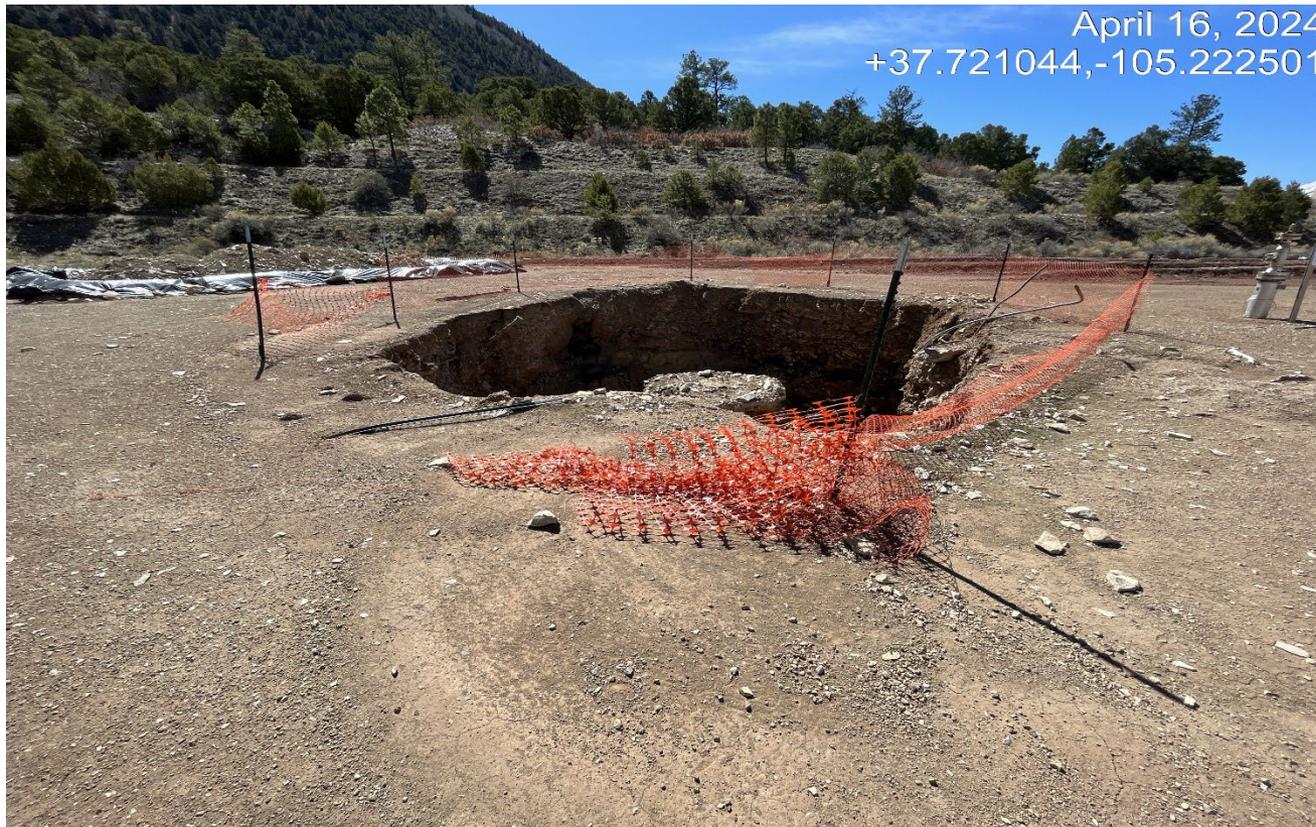
Photo 9. Facing toward the open excavation which the fence has fall apart. This must be fenced immediately to prevent wildlife of livestock from falling in.

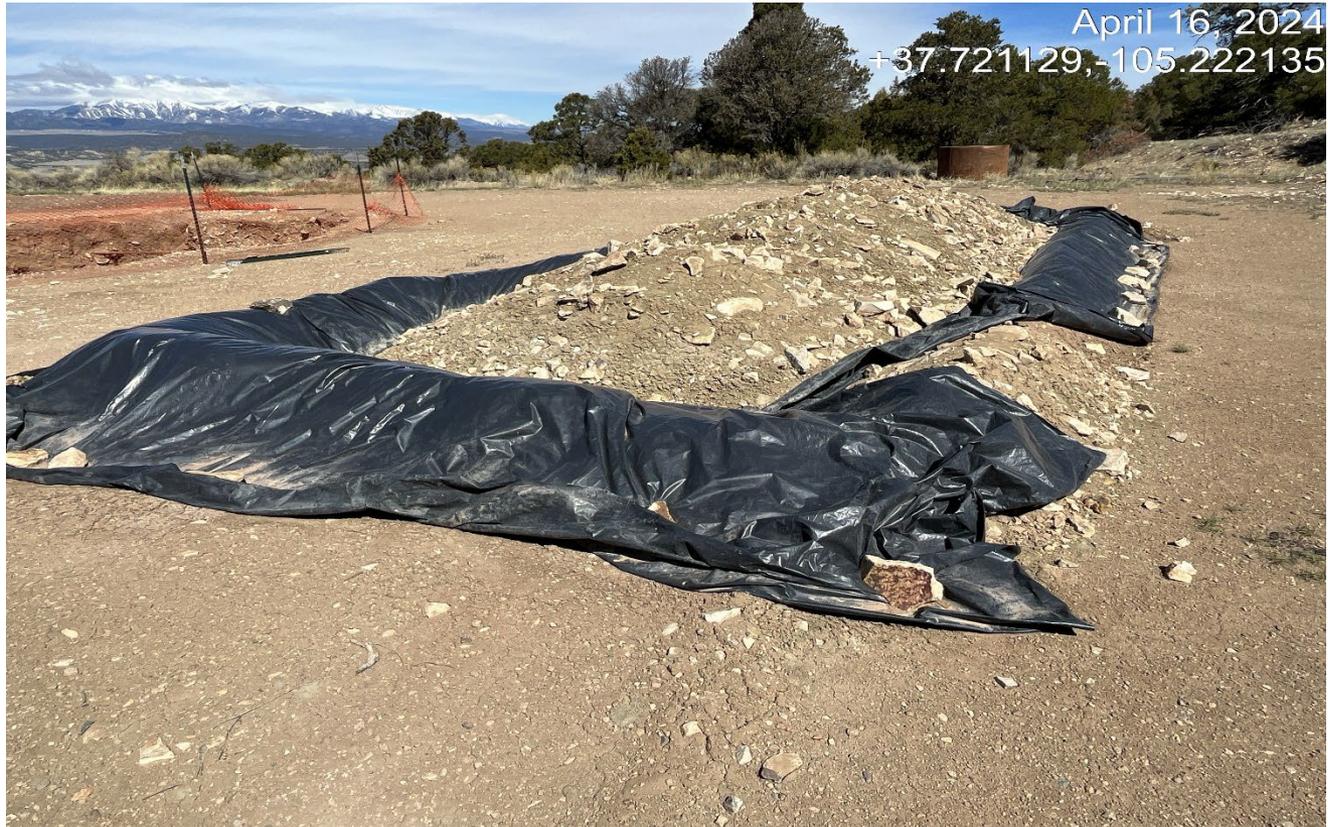
Photo 10. The plastic liner is compromised and impacted soil needs to be removed.

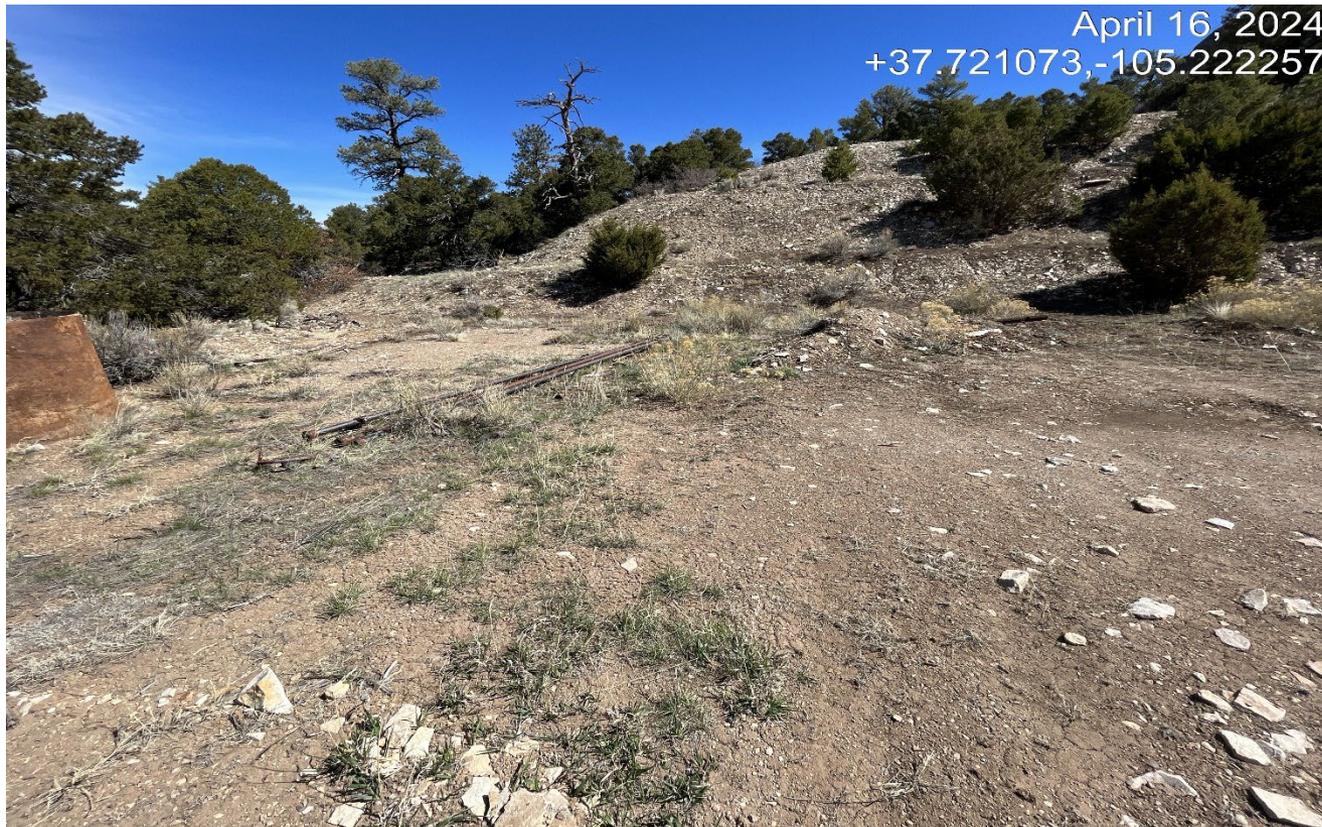
Photo 11. Facing toward northeast side of the location. There is unused pipe and steel ring that needs to be removed. Disturbed area needs to be reclaimed at right side of the photo.
