# Interim Reclamation and Stormwater Inspection

April 11, 2024

Operator: NGL WATER SOLUTIONS DJ LLC- 10373

Location ID: 443339

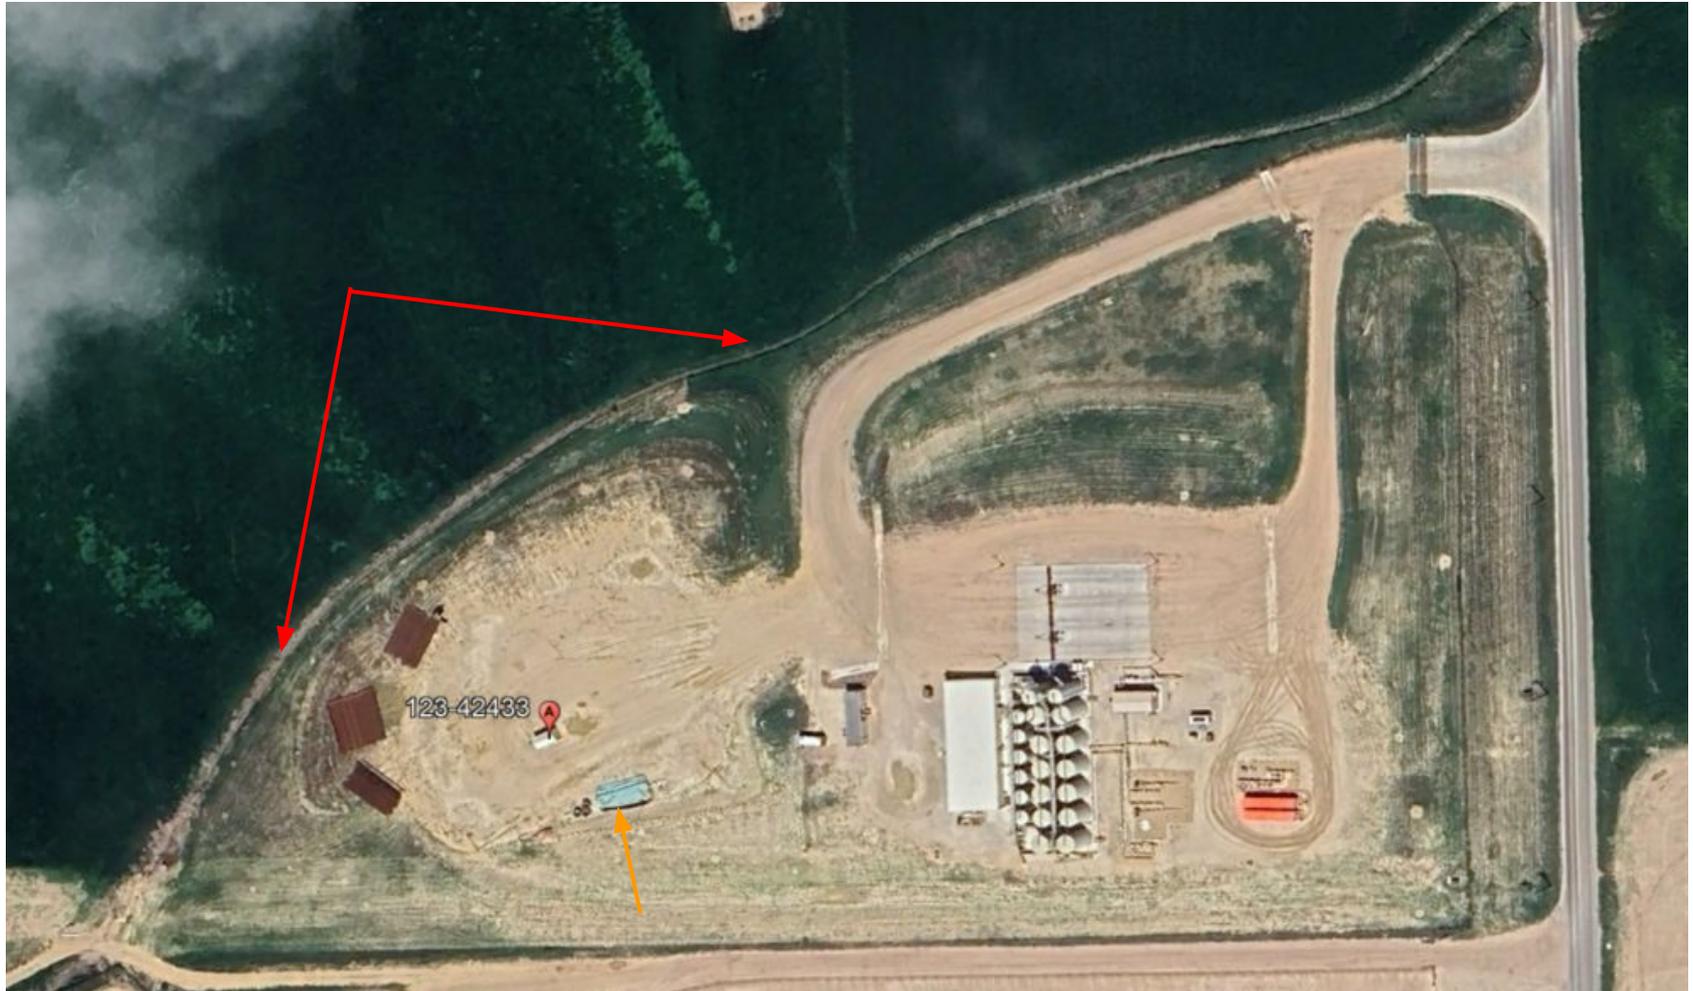
**Photo 1.** Google Earth aerial imagery from 5/24/2023 illustrating the location. Operator has failed to install perimeter stormwater BMPs while conducting interim reclamation activities.

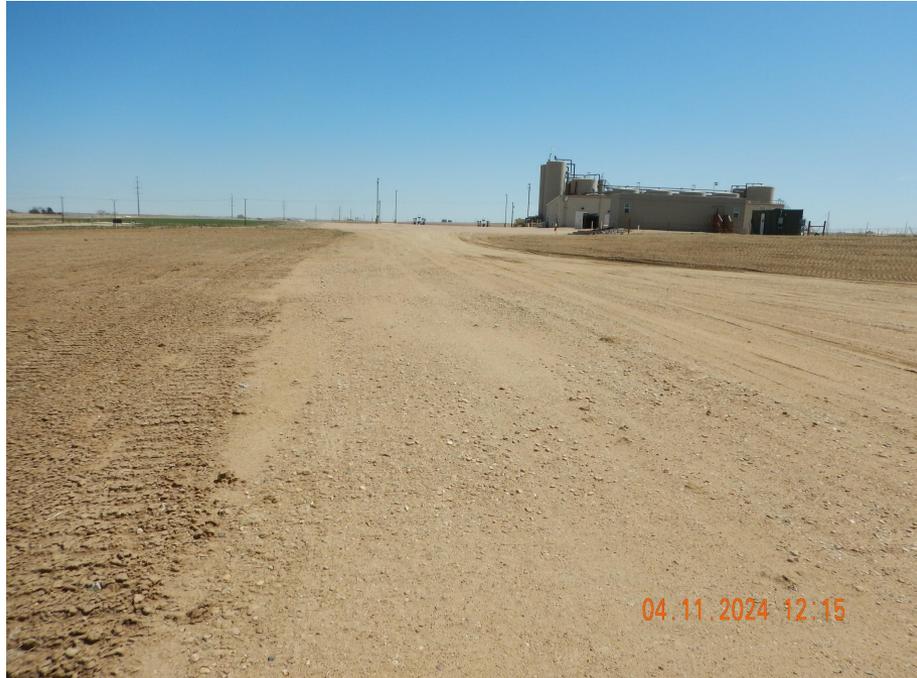
**Photo 2.** Photo taken from the well location, facing East. Photo illustrates the Operator has initiated interim reclamation activities.

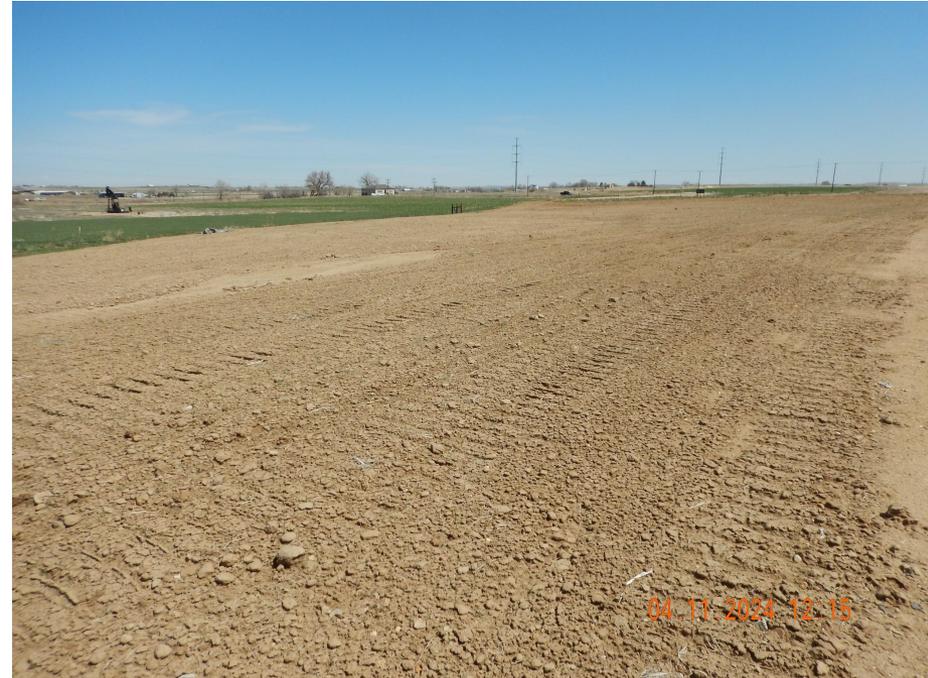
**Photo 3.** Photo taken from the well location, facing Northeast. See comments under Photo 2.

Also, if the Operator has already seeded the interim area, the interim area has not been stabilized.

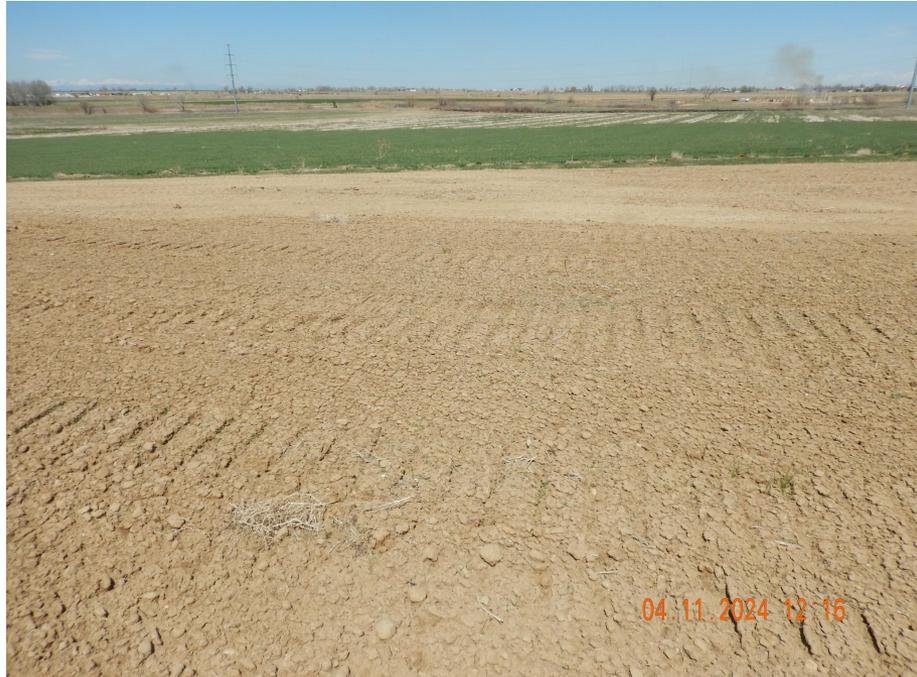
**Photo 4.** Photo taken from the well location, facing North. See comments under Photo 2.

Note- Operator has not properly tracked the fill slope, which is only aiding stormwater erosion towards an irrigation ditch.

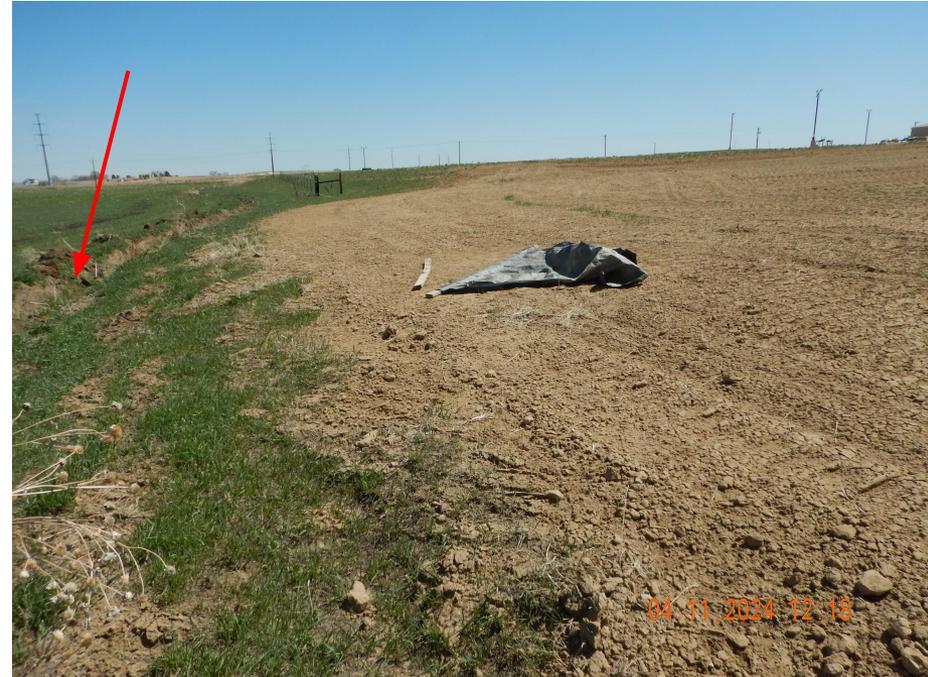
**Photo 5.** Photo taken from the northern interim reclamation area, facing East. Photo illustrates there is no perimeter stormwater BMP, only a remnant insufficient ditch area along small portions of the perimeter. Red arrow illustrates the irrigation ditch.

Also, there is trash observed within the interim reclamation area.

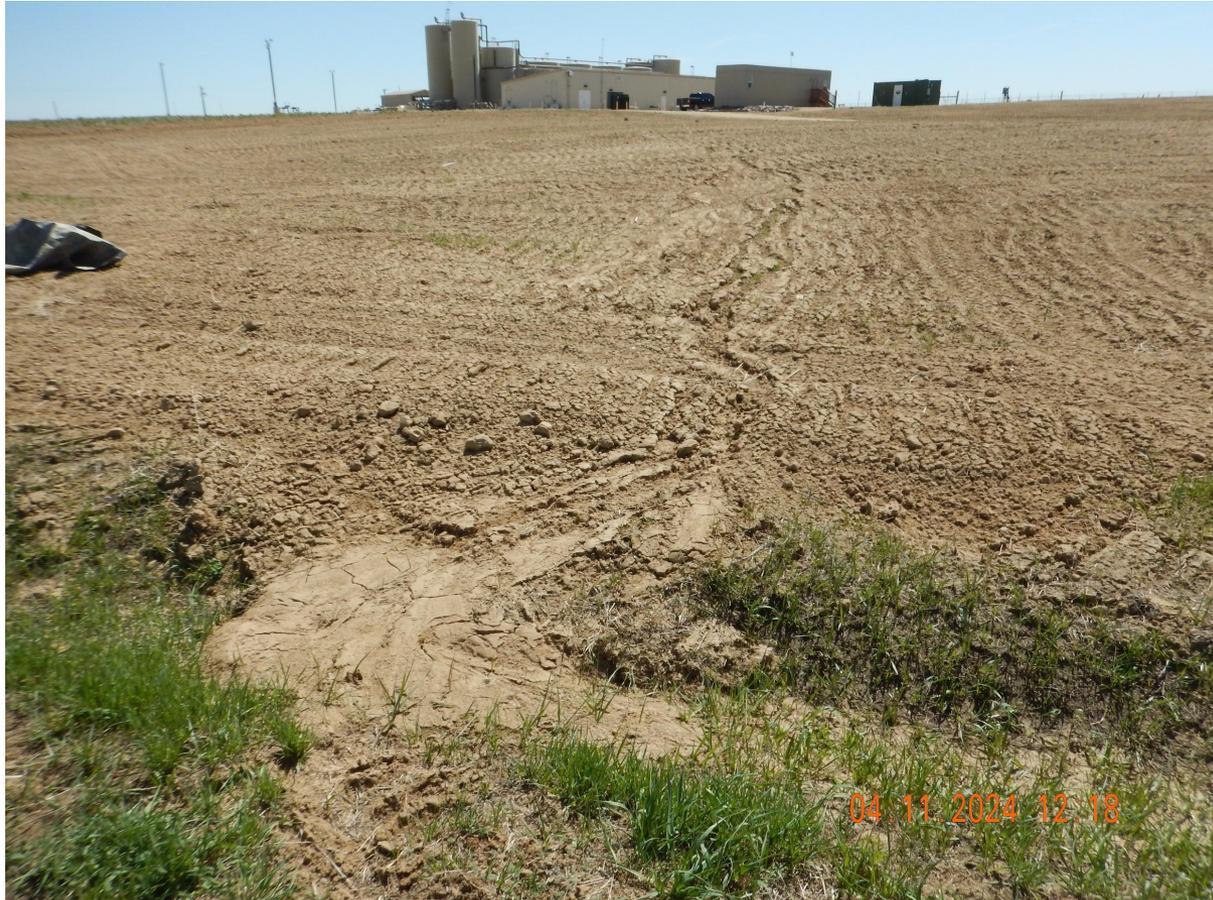
**Photo 6.** Photo taken from the northern interim reclamation area, facing South. Photo illustrates Operator has not properly tracked the fill slope, which is only aiding stormwater erosion towards an irrigation ditch.
