Inspection Photos

API: 055-06012

Operator: OXY USA INC

Inspection Date: 4/16/2024

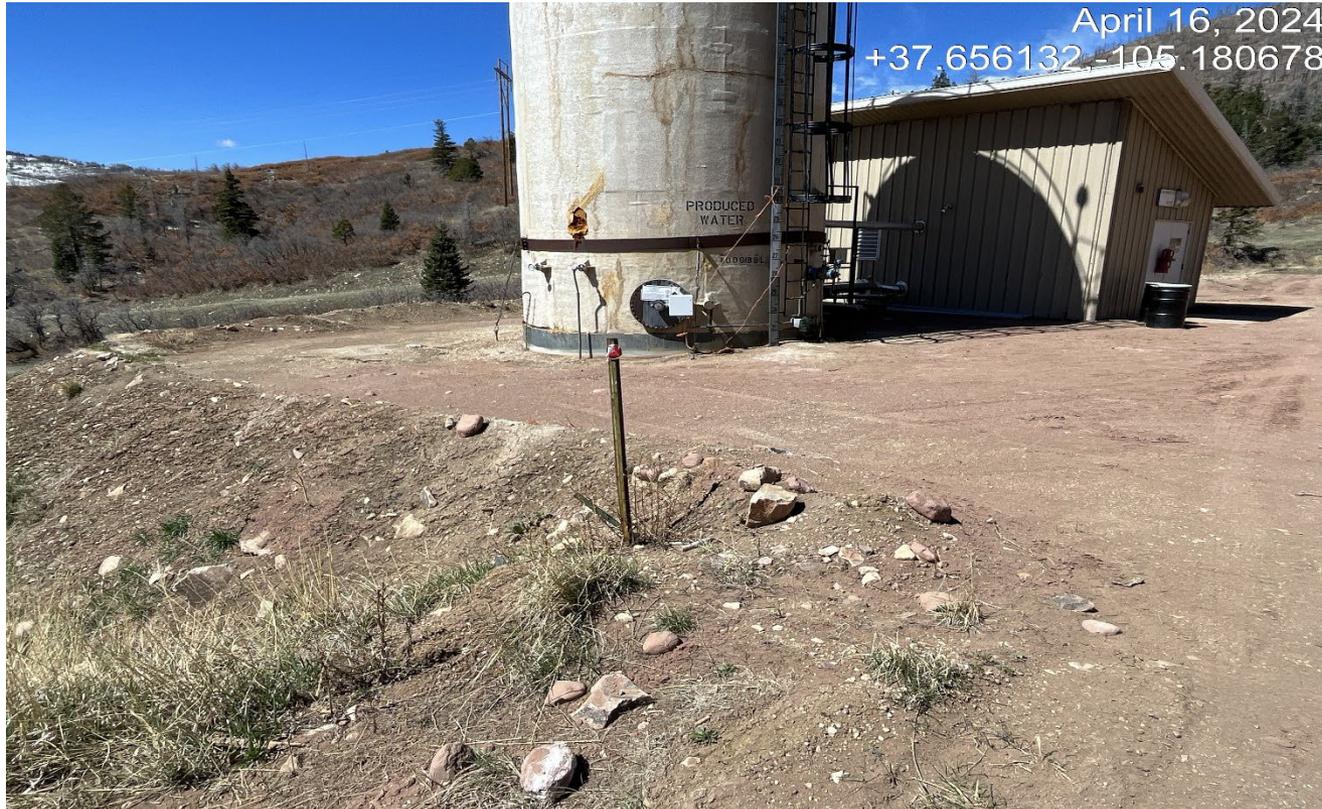
Photo 1. Facing toward the produced water tank. The secondary berm around the tank is insufficient to contain a spill. Red arrow points to small berm which could easily be overtopped by a leak. Previous corrective action was not completed.

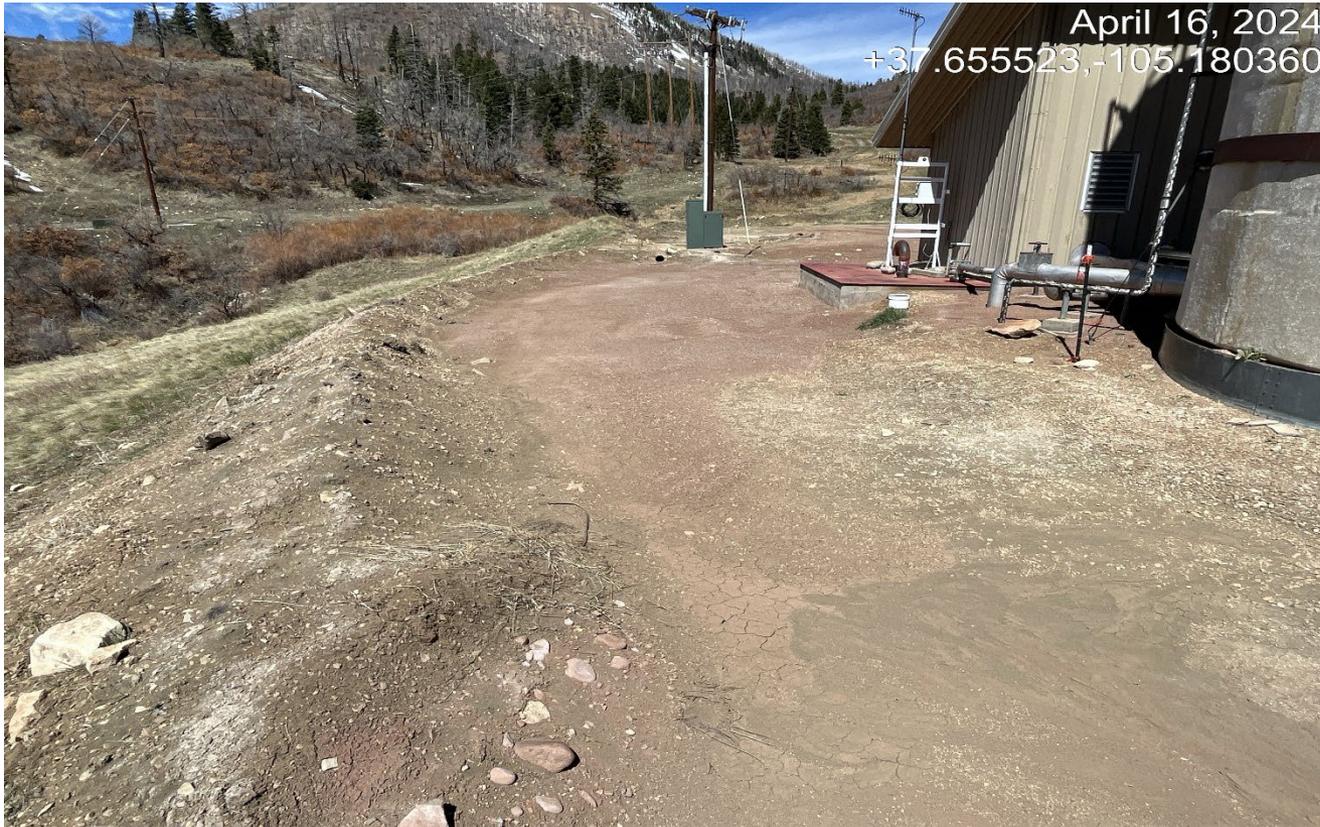
Photo 2. Facing northwest at the backside of the tank. The secondary containment at the tank is insufficient to contain a spill..

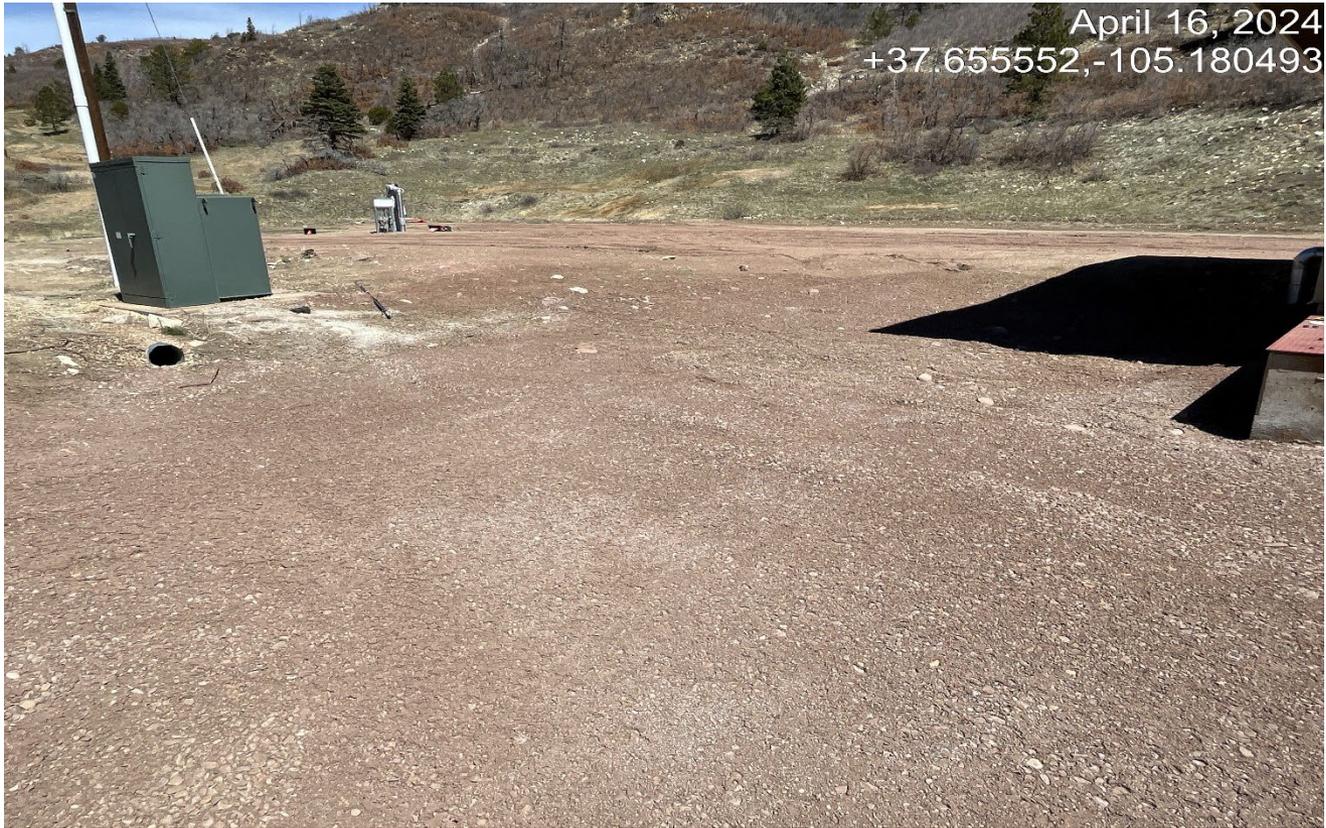
Photo 3. The remediation area where tank was located has been backfilled with sand and gravel.

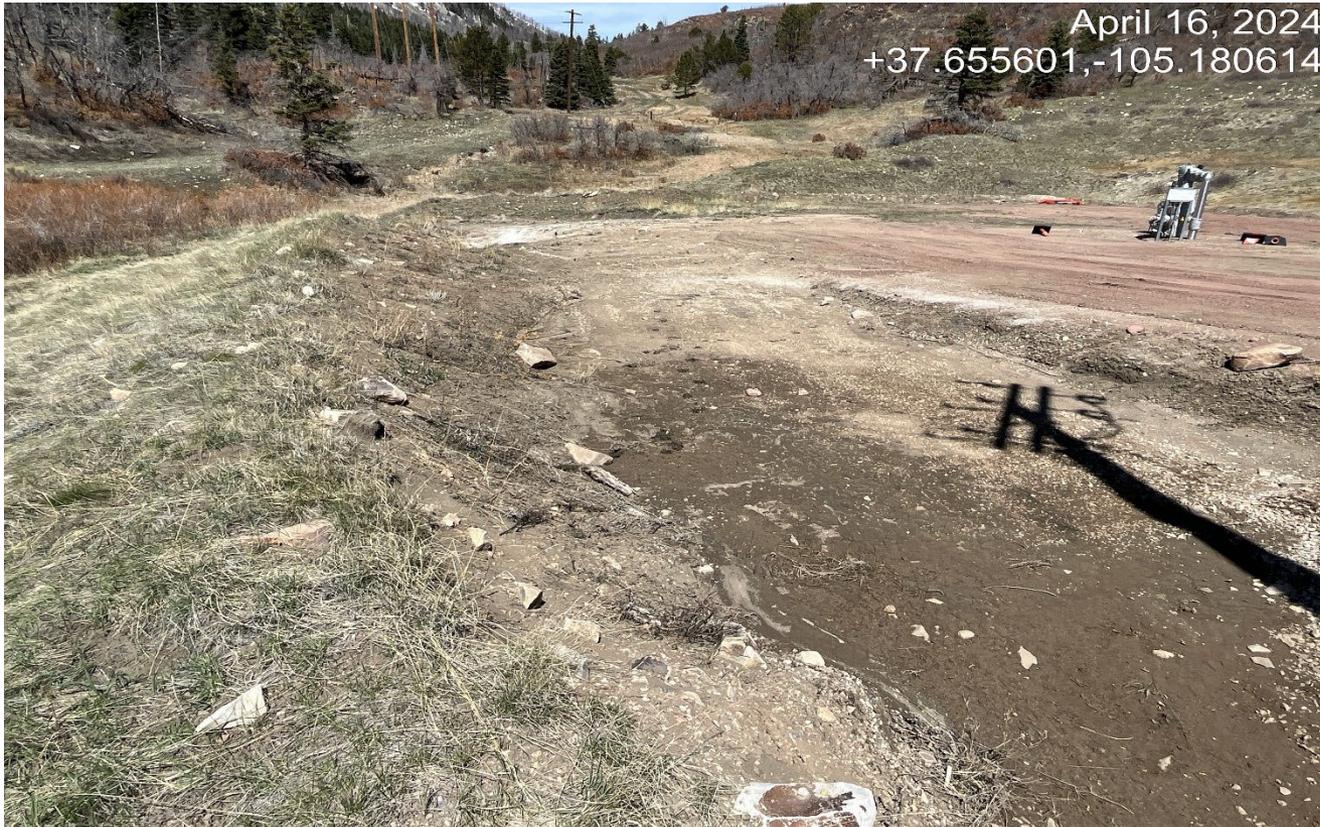
Photo 4. Facing northwest toward the retention pond are where remediation remains ongoing.

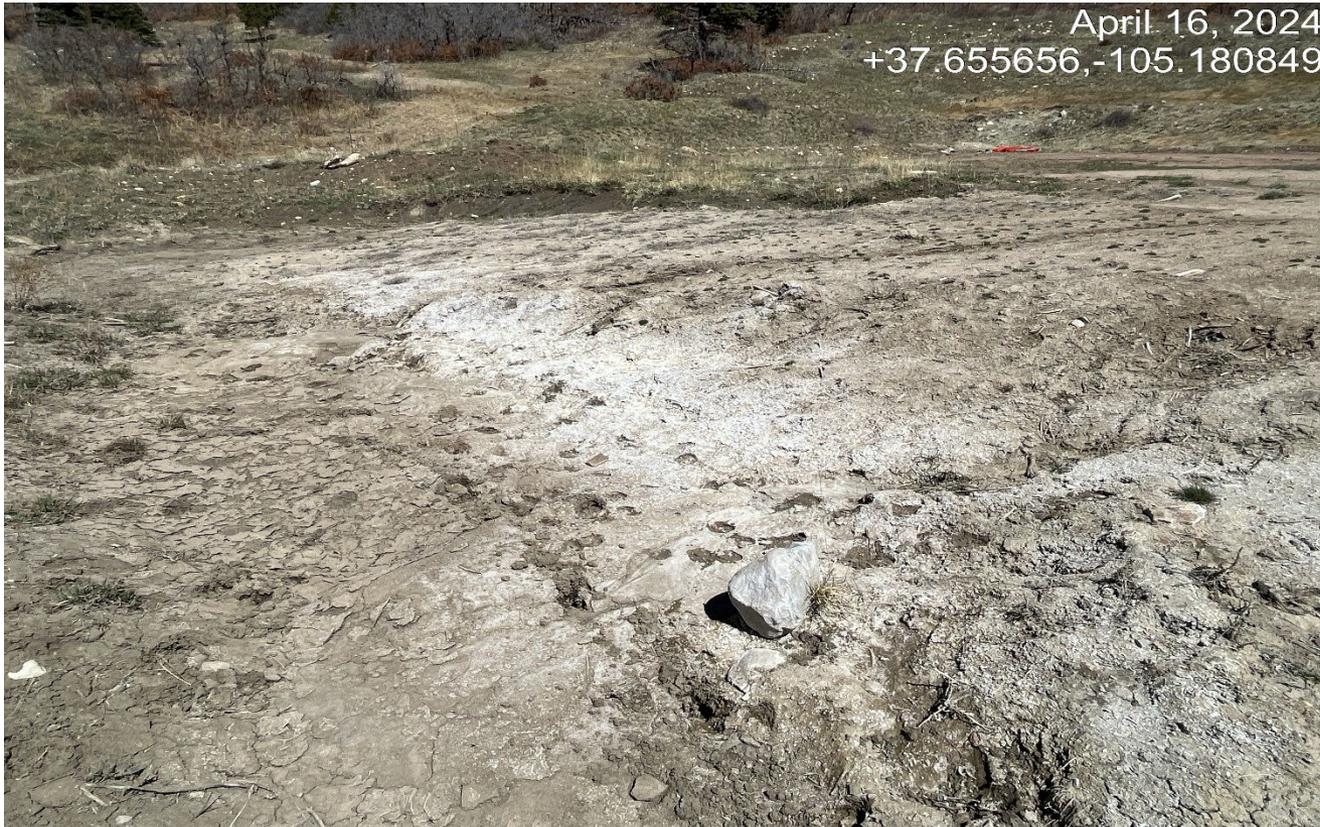
Photo 5. There is a white material used to backfill the excavated retention pond area and there are concerns this material may not be suitable for reclamation. Operator will need to sample this area for soil suitability.

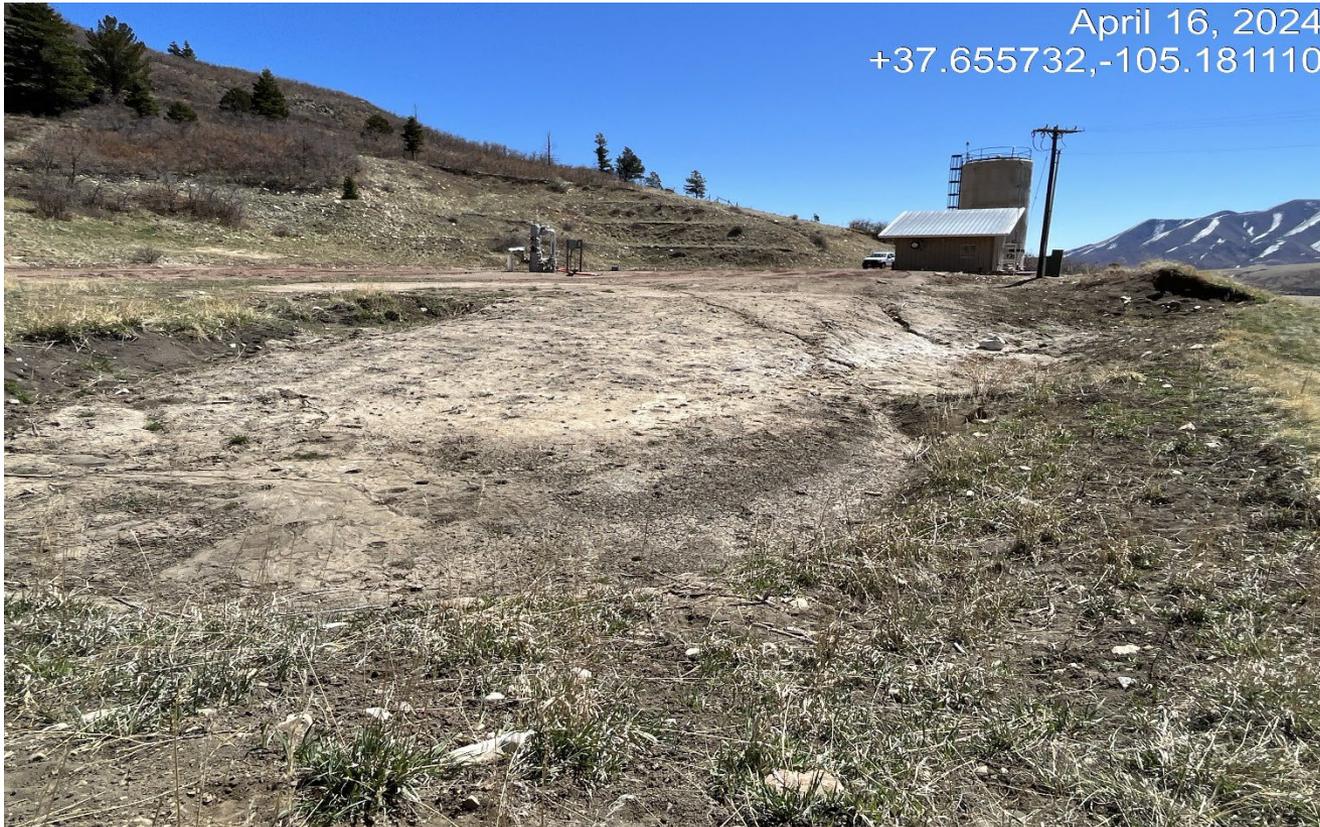
Photo 6. Facing southeast at the down gradient portion of the location. The degraded perimeter wattles were removed however, no new BMP's were installed and there is a creek approximately 10ft' from the edge of the location. Previous corrective action has not been completed.

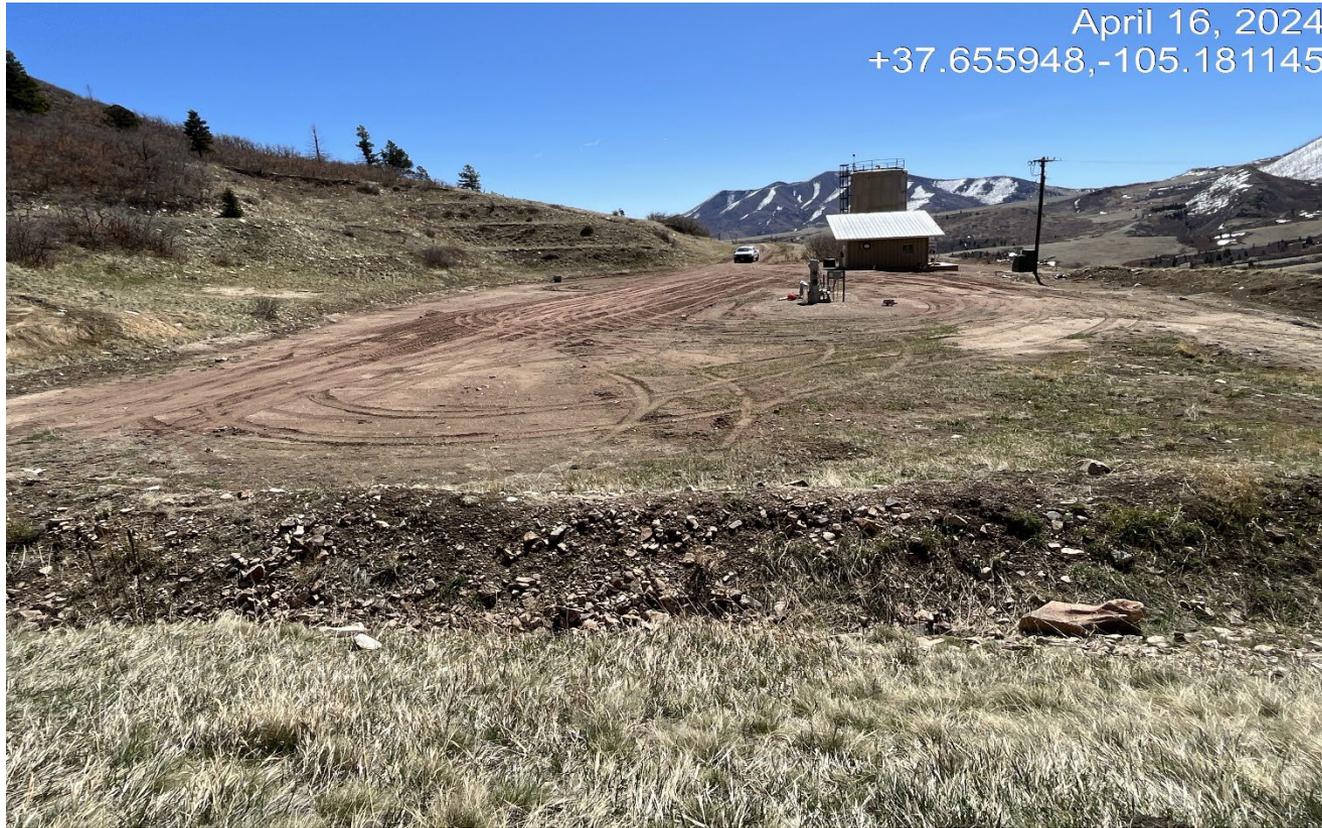
Photo 7. Facing southwest at the location. .

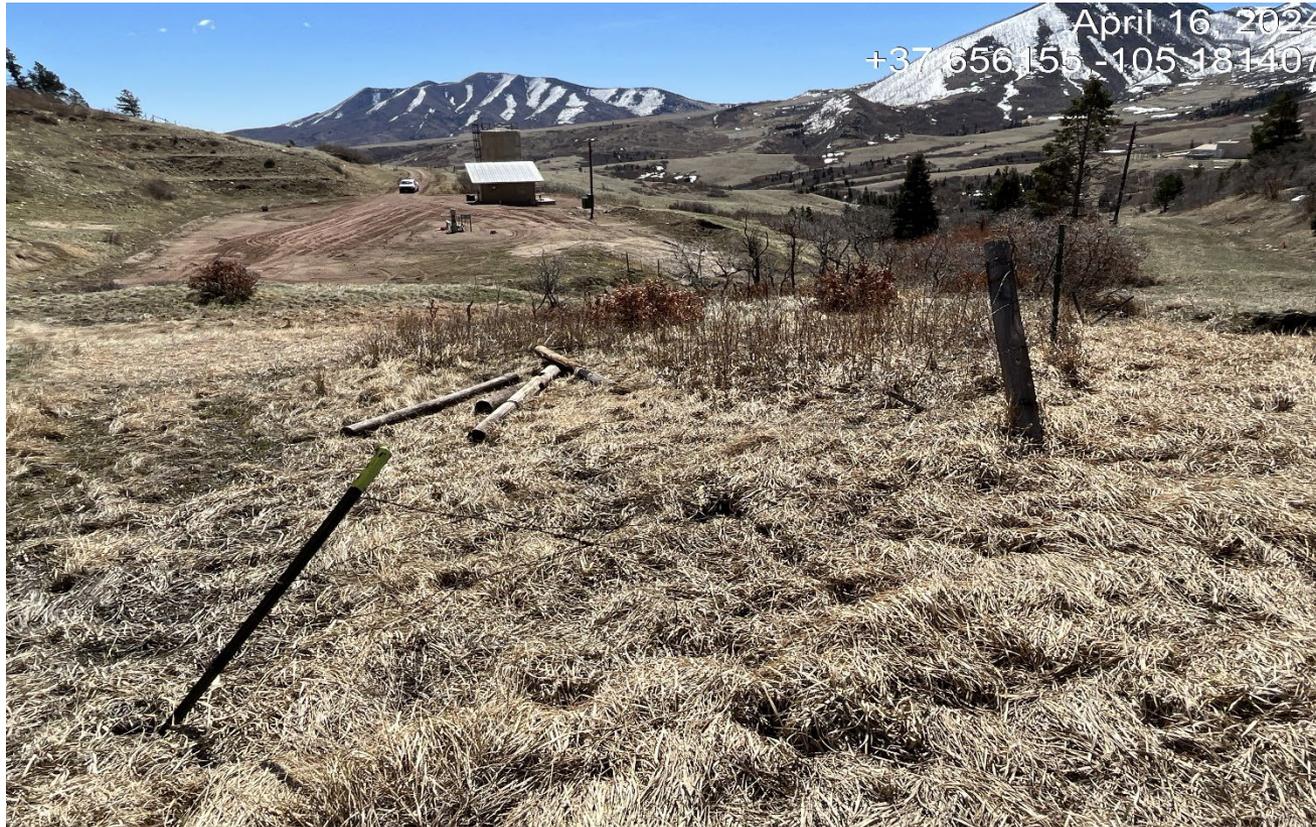
Photo 8. Facing southeast further away from the location. There is a degraded perimeter fence that needs to be maintained. Previous corrective action was not completed.

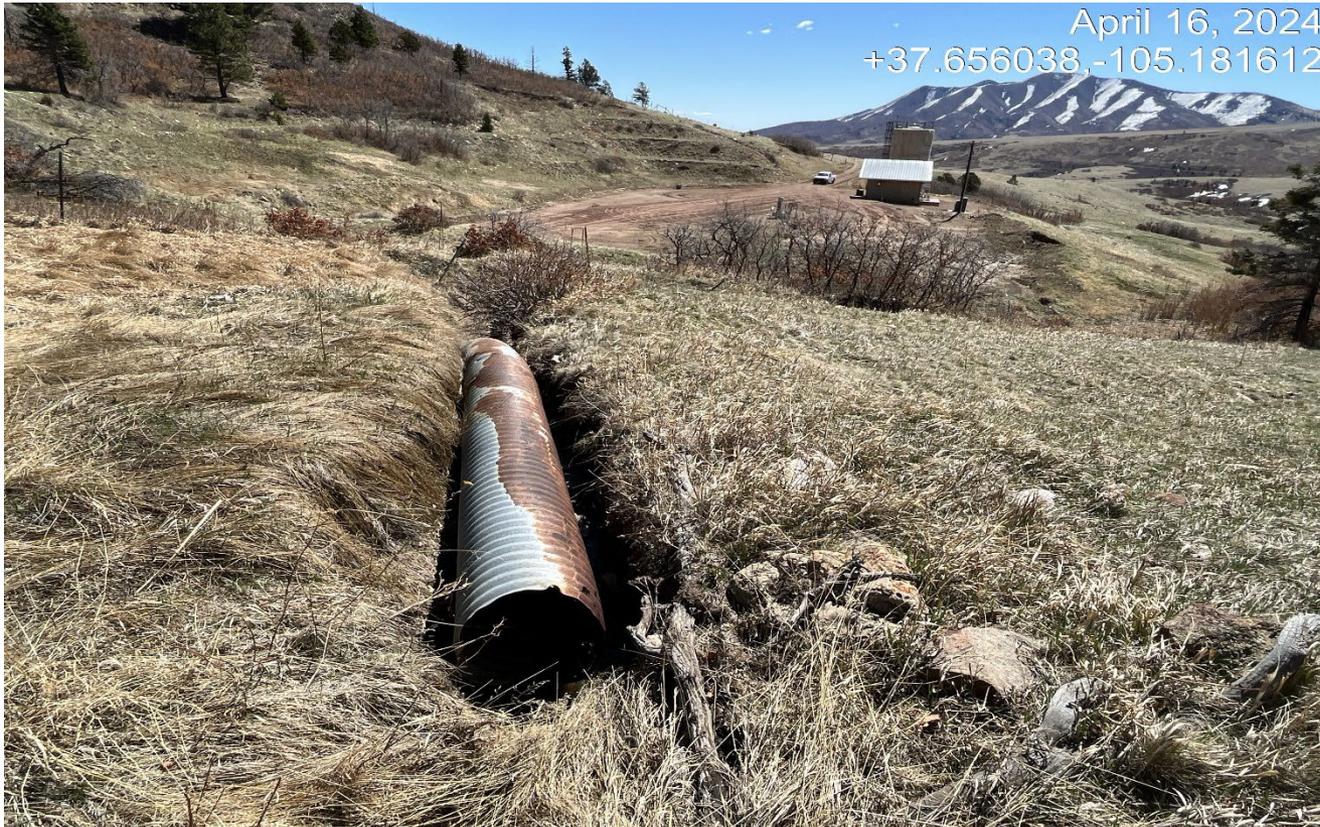
Photo 9. Standing approximately 125' northwest of the location along the flowline area is an eroded out culvert where the creek flows. The culvert needs repaired or removed. Previous corrective action was not completed.

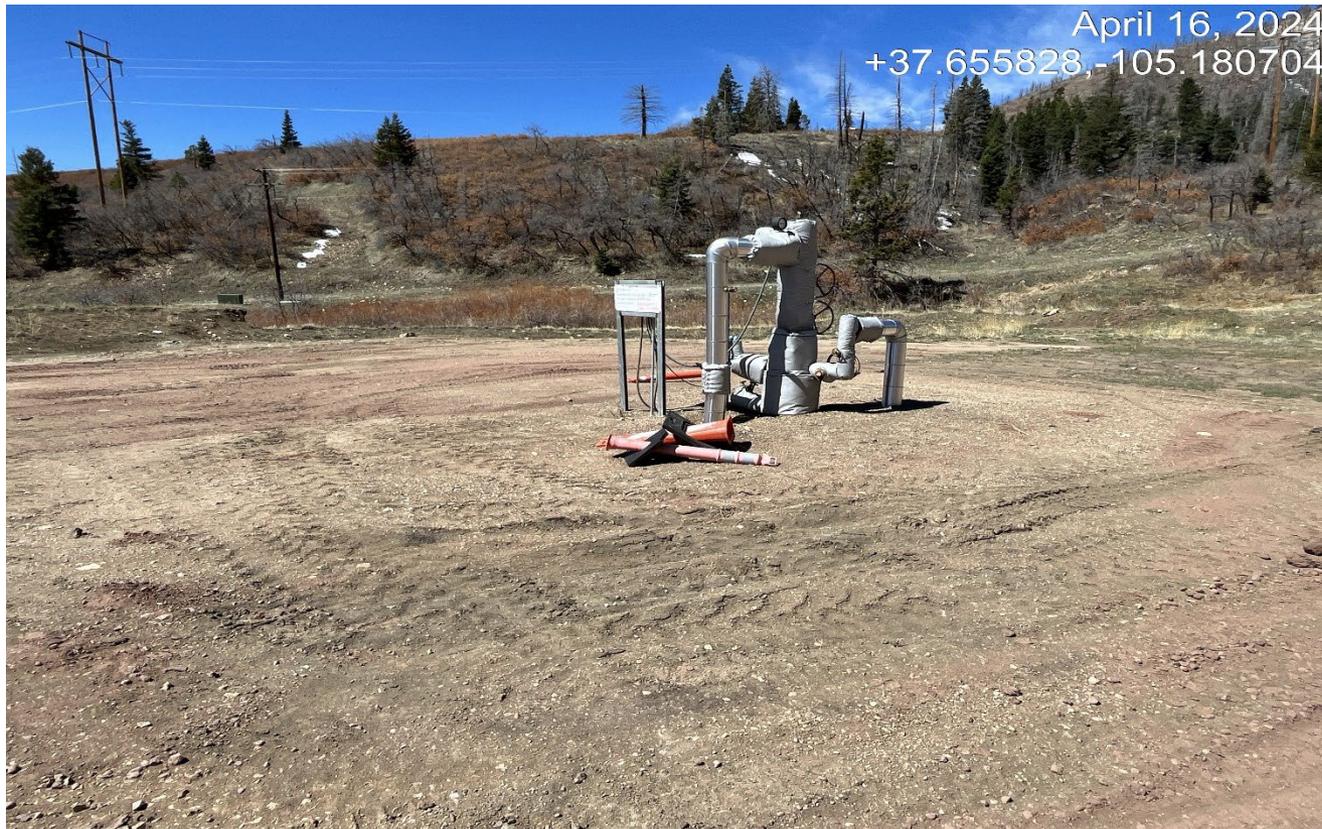
Photo 10. Facing toward the injection wellhead.

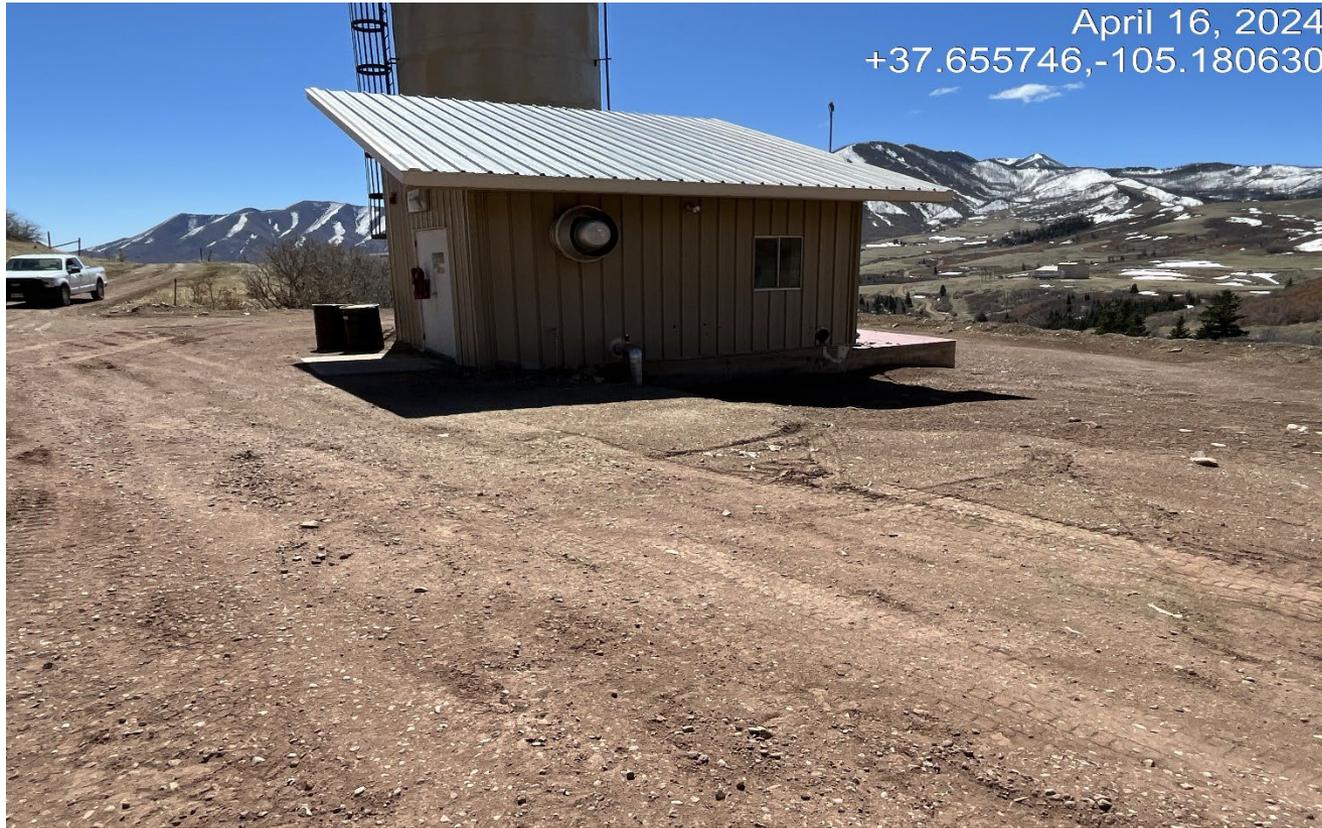
Photo 11. Facing northeast along the fill slope.

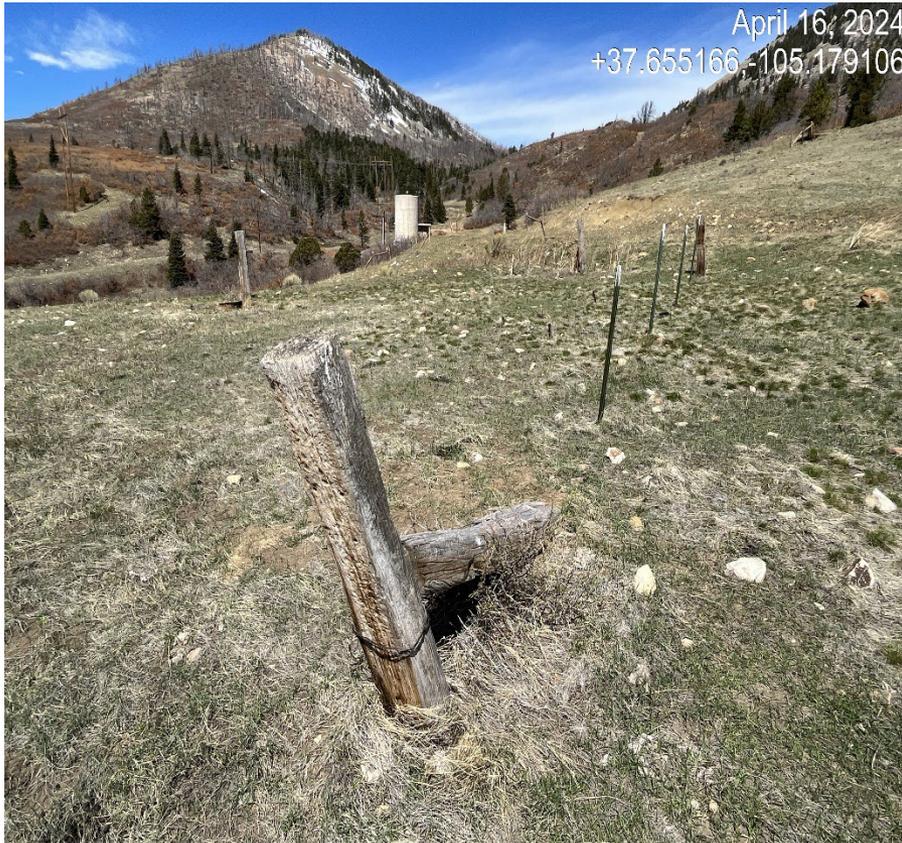
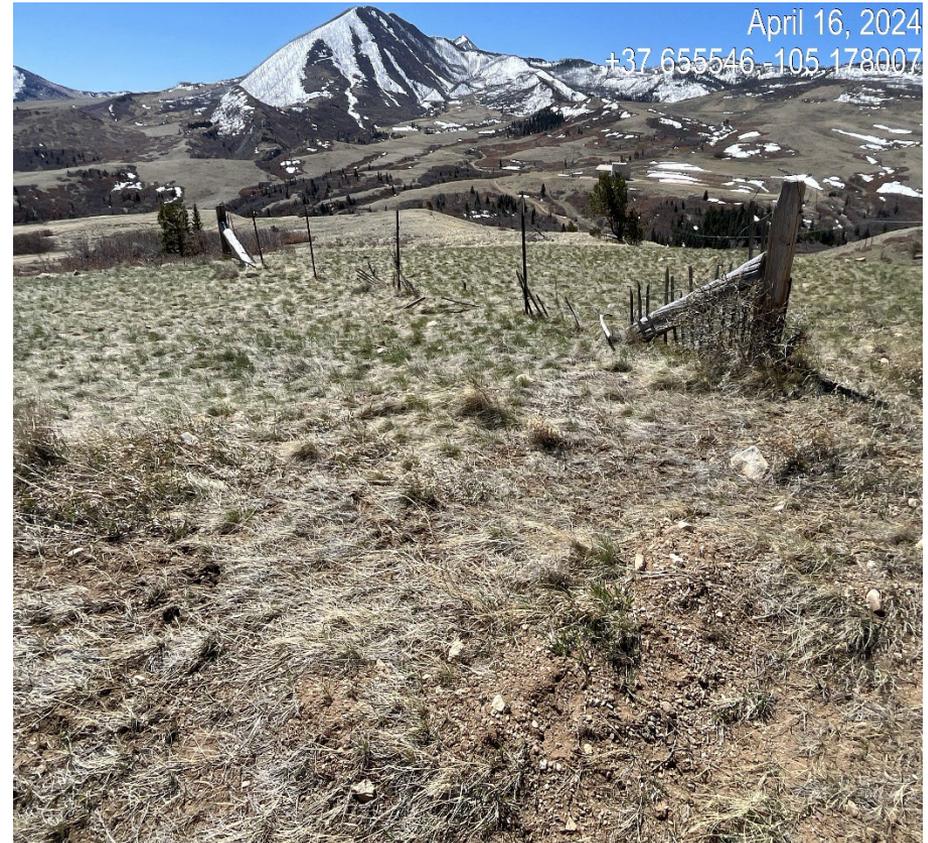
Photo 12. Observed along the access road were several dilapidated snow fences which need to be removed or repaired. Previous corrective action was not completed.
