# Interim Reclamation and Stormwater Inspection

Date: 4/4/24

Operator: Highpoint Operating Corporation - 10071

Location Name: Anschutz Equus Farms 4-62-28

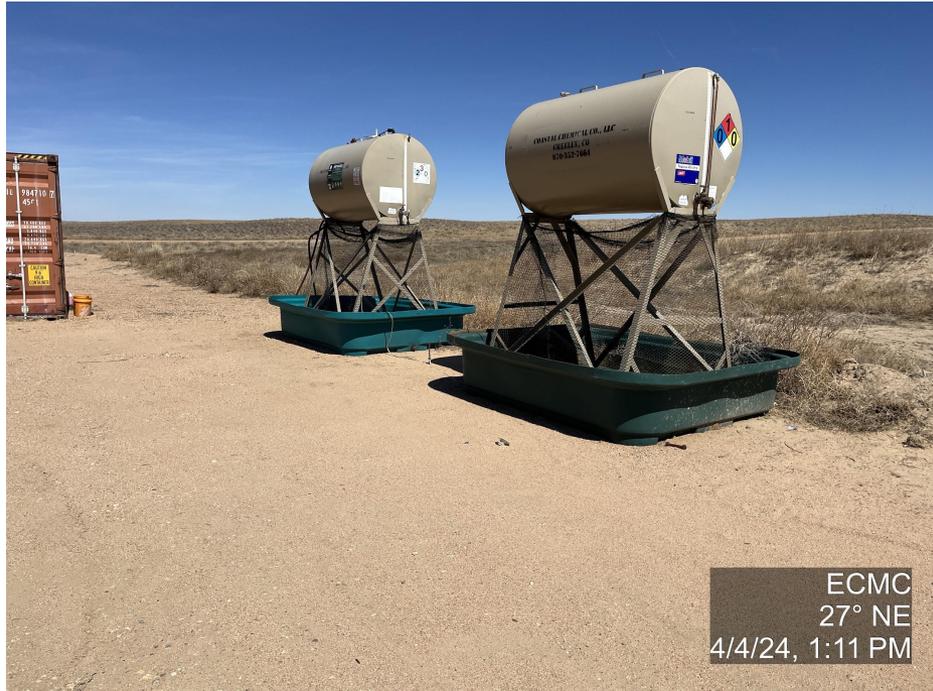
**Photo 1.** The photo was taken at the well location facing Northeast. The photo illustrates secondary contaminants with improper wildlife netting.

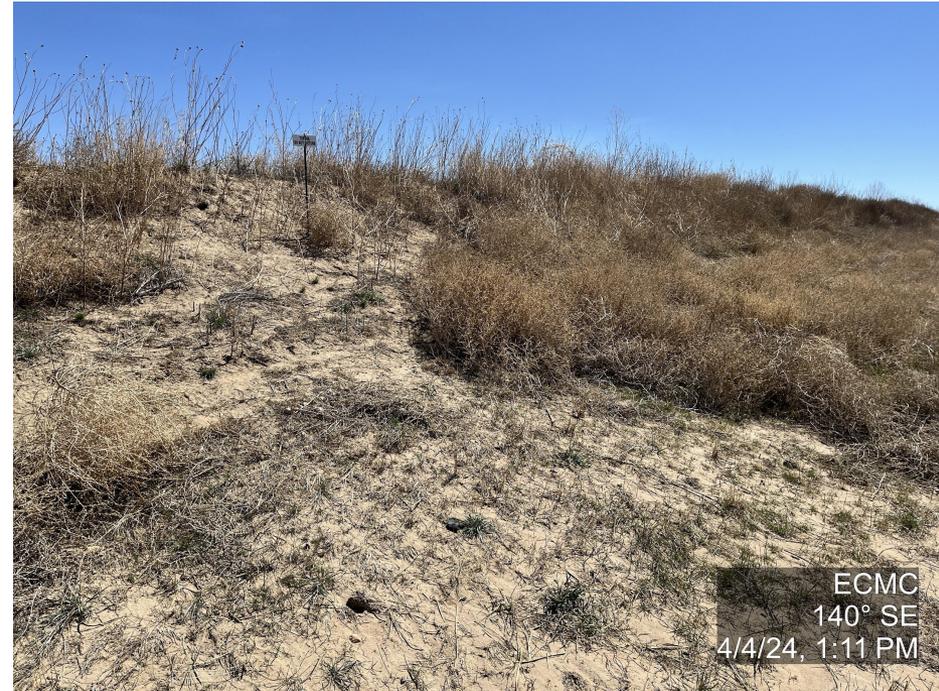
**Photo 2.** The photo was taken at the well location facing Southeast. The photo illustrates the topsoil stockpile is dominated by bare soil and Russian thistle.

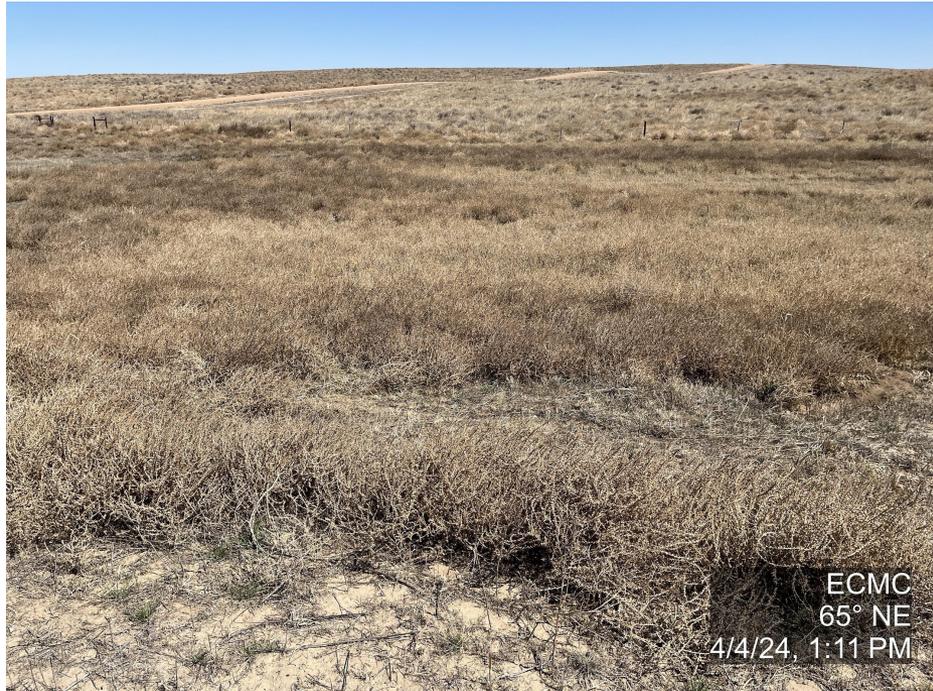
**Photo 3.** The photo was taken at the well location facing Northeast. The photo illustrates interim areas in the Northeast corner are dominated by Russian thistle.

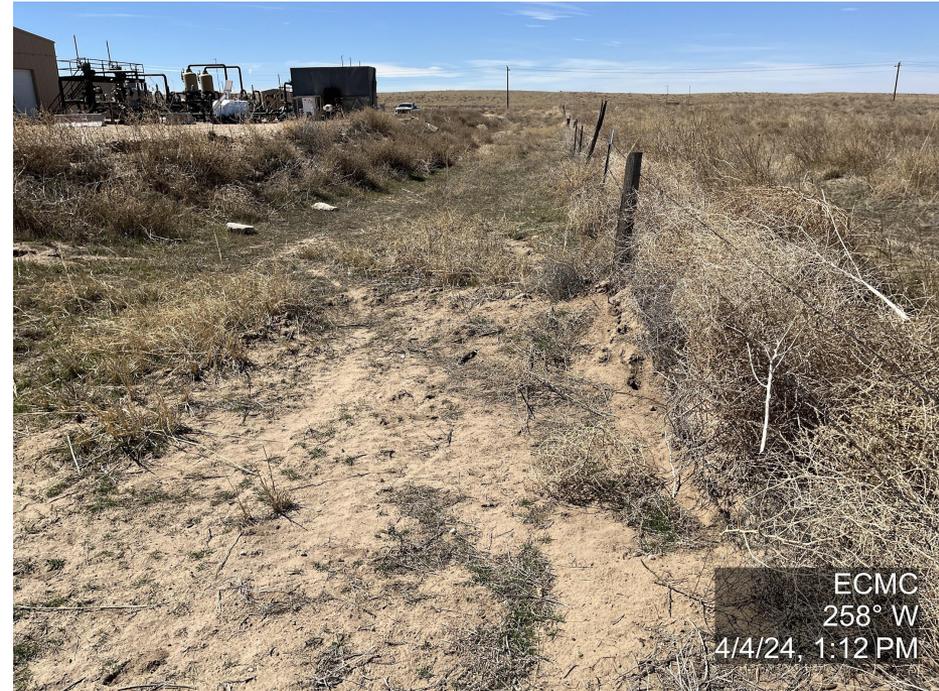
**Photo 4.** The photo was taken at the well location facing West. The photo illustrates the Northern disturbance boundary fence with tumbleweeds throughout.

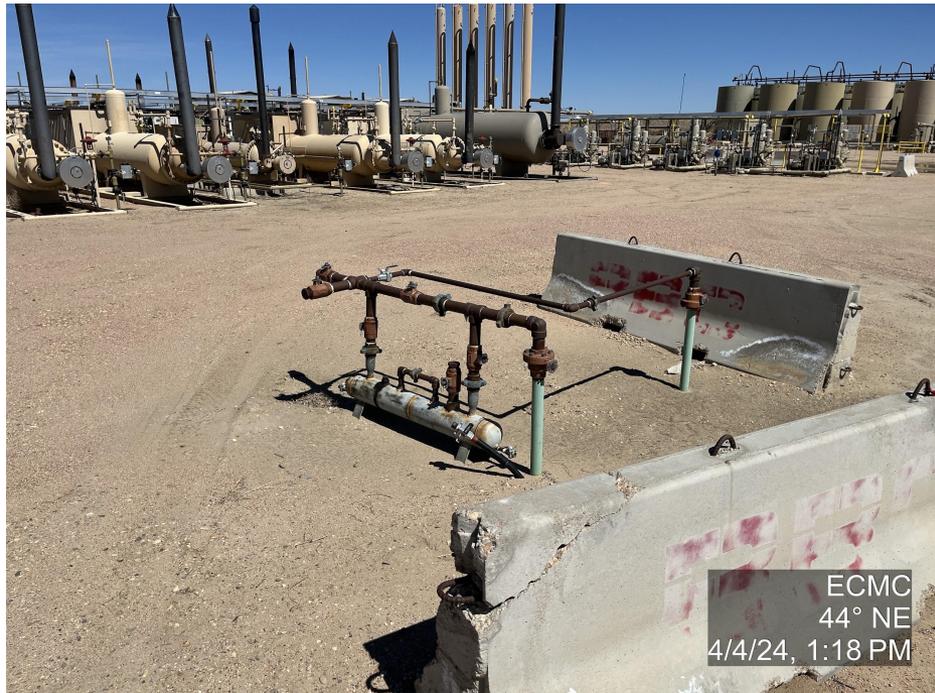
**Photo 5.** The photo was taken at the well location facing Northeast. The photo illustrates unmarked risers.

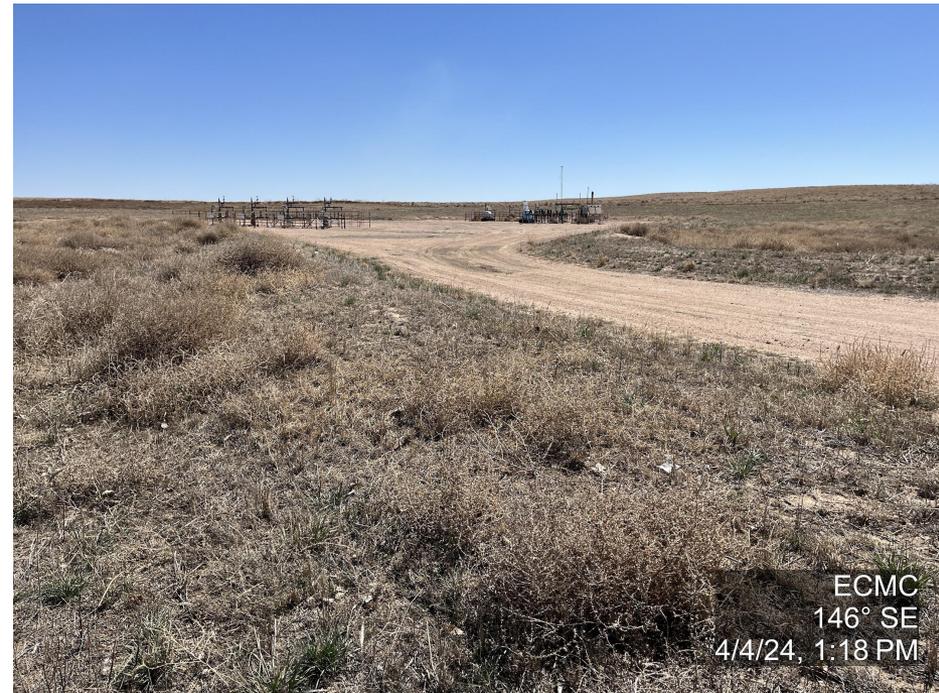
**Photo 6.** The photo was taken at the well location facing Southeast. The photo illustrates the wellhead footprint on the location.

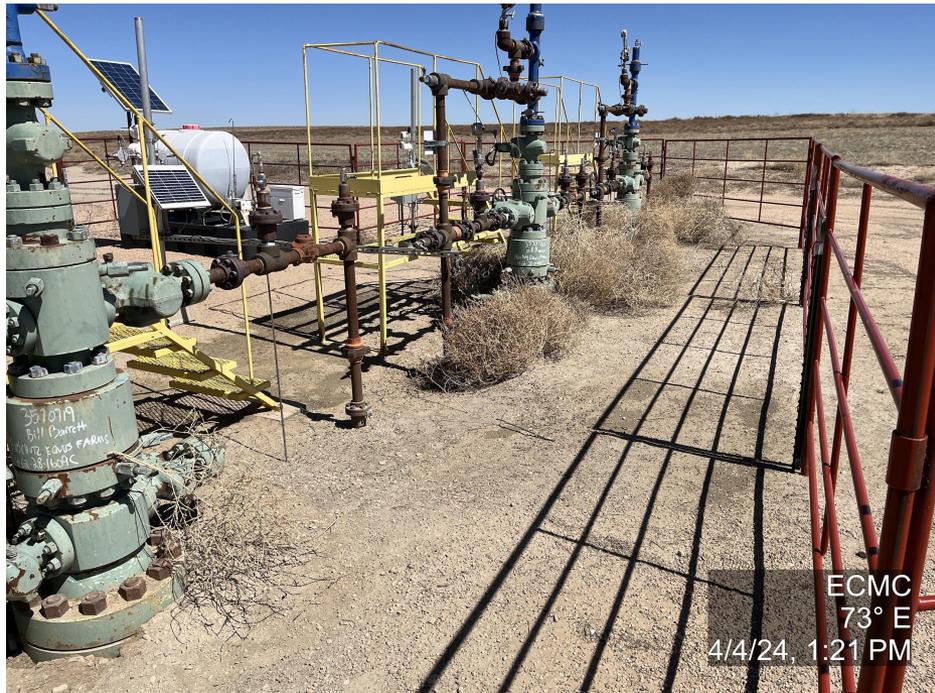
**Photo 7.** The photo was taken at the well location facing East. The photo illustrates tumbleweeds piled around the wellheads.

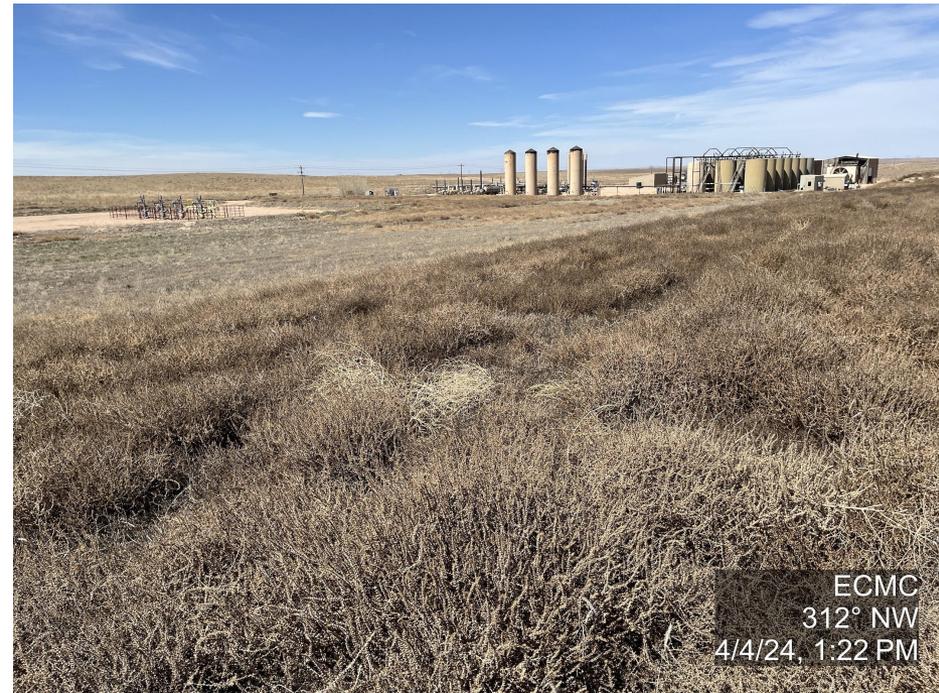
**Photo 6.** The photo was taken at the well location facing Northwest. The photo illustrates portions of the interim areas appear to be being unmanaged being dominated by tall stands of Russian thistle.

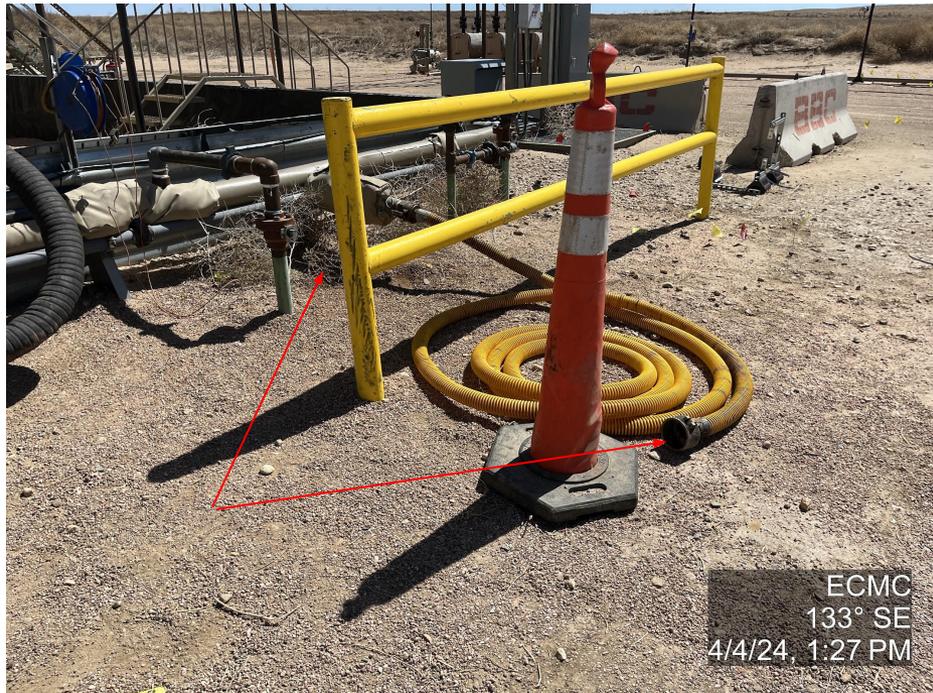
**Photo 9.** The photo was taken at the well location facing Southeast. The photo illustrates tumbleweeds piled around equipment and a hose without a bullplug left outside of secondary containment.

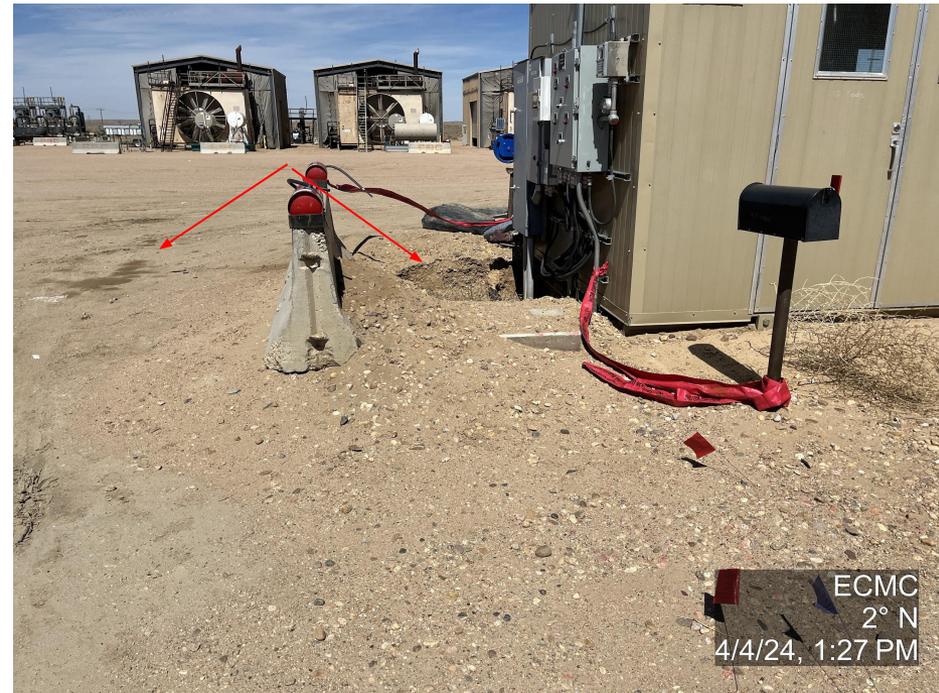
**Photo 10.** The photo was taken at the well location facing North. The photo illustrates soil staining as well as some small excavation around electrical panels.

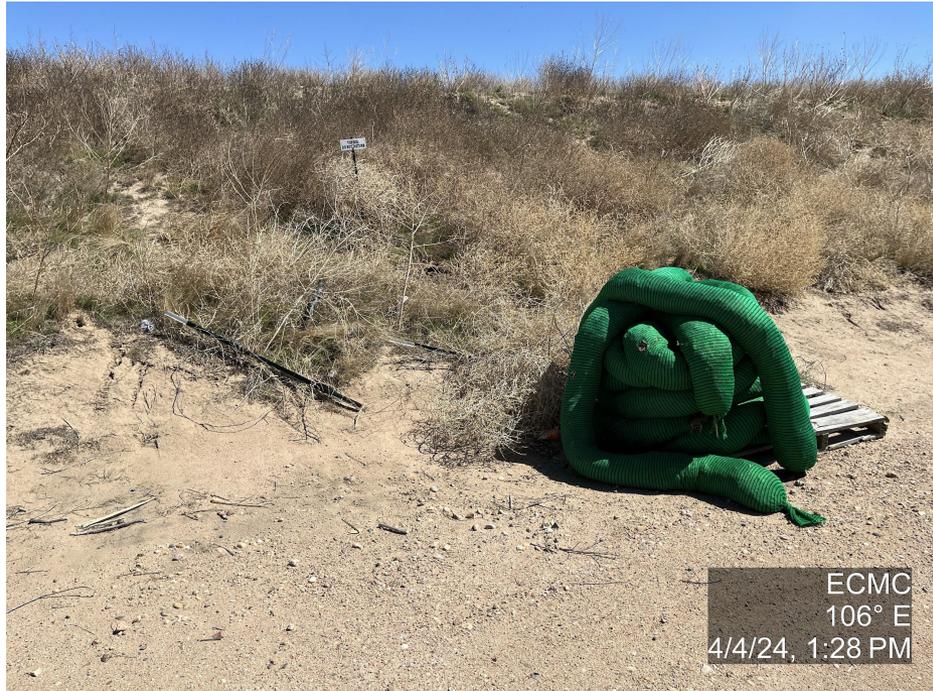
**Photo 11.** The photo was taken at the well location facing East. The photo illustrates equipment being stored on the production pad.

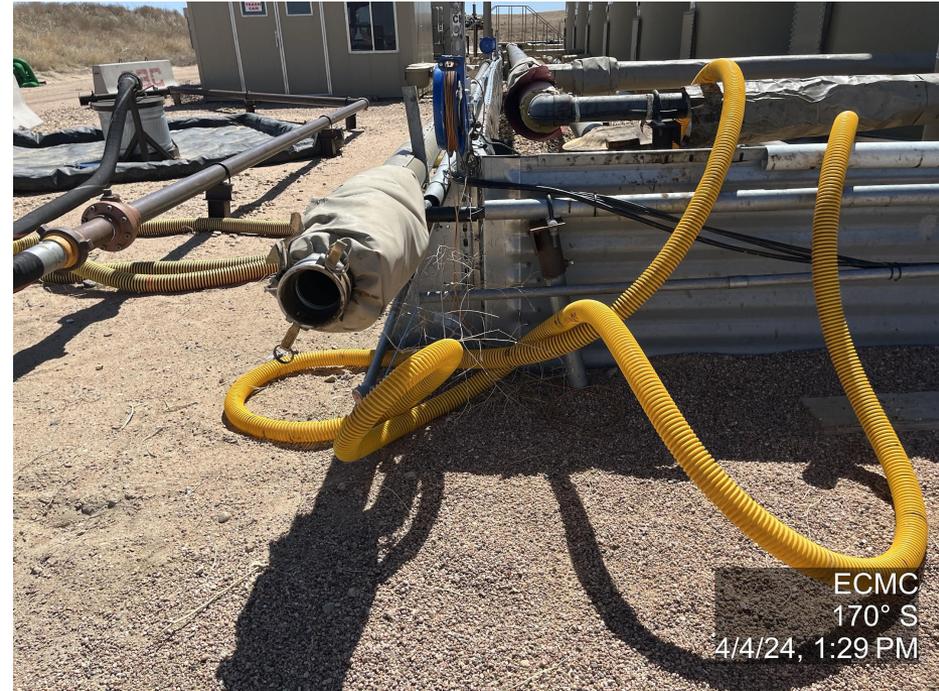
**Photo 12.** The photo was taken at the well location facing South. The photo illustrates another line without a plug of any kind.

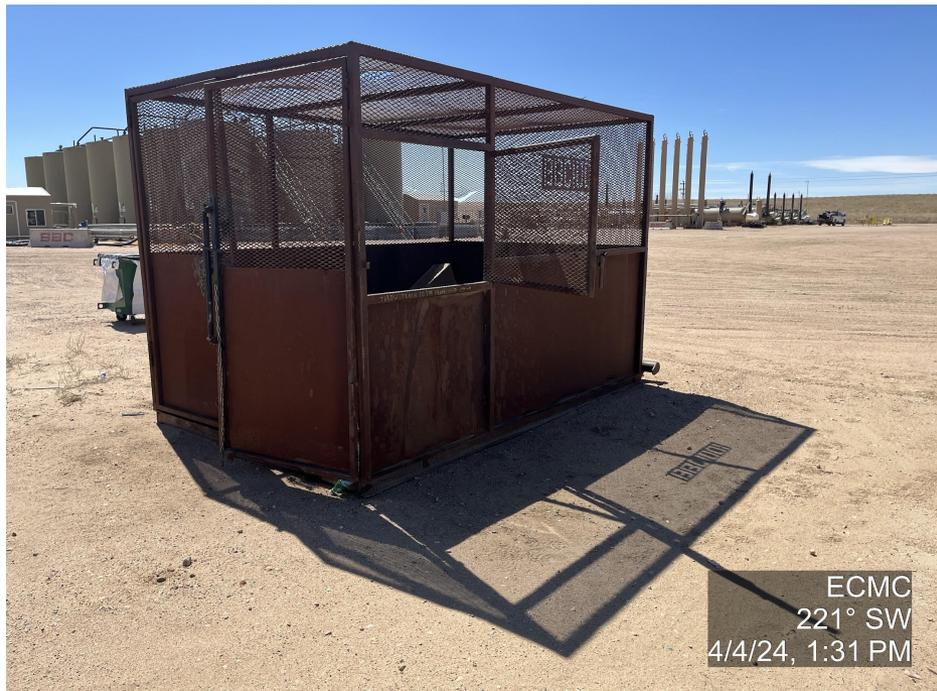
**Photo 12.** The photo was taken at the well location facing Southwest. The photo illustrates a trash receptacle is being left open and allowing trash to distribute around the location.

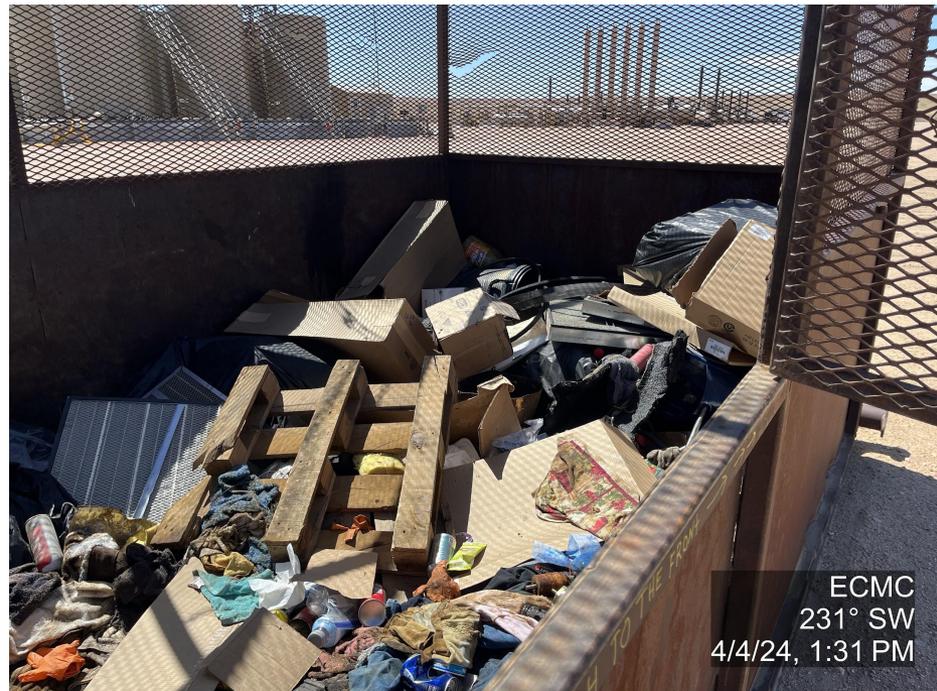
**Photo 13.** The photo was taken at the well location facing Southwest. Refer to the comment for photo 12.

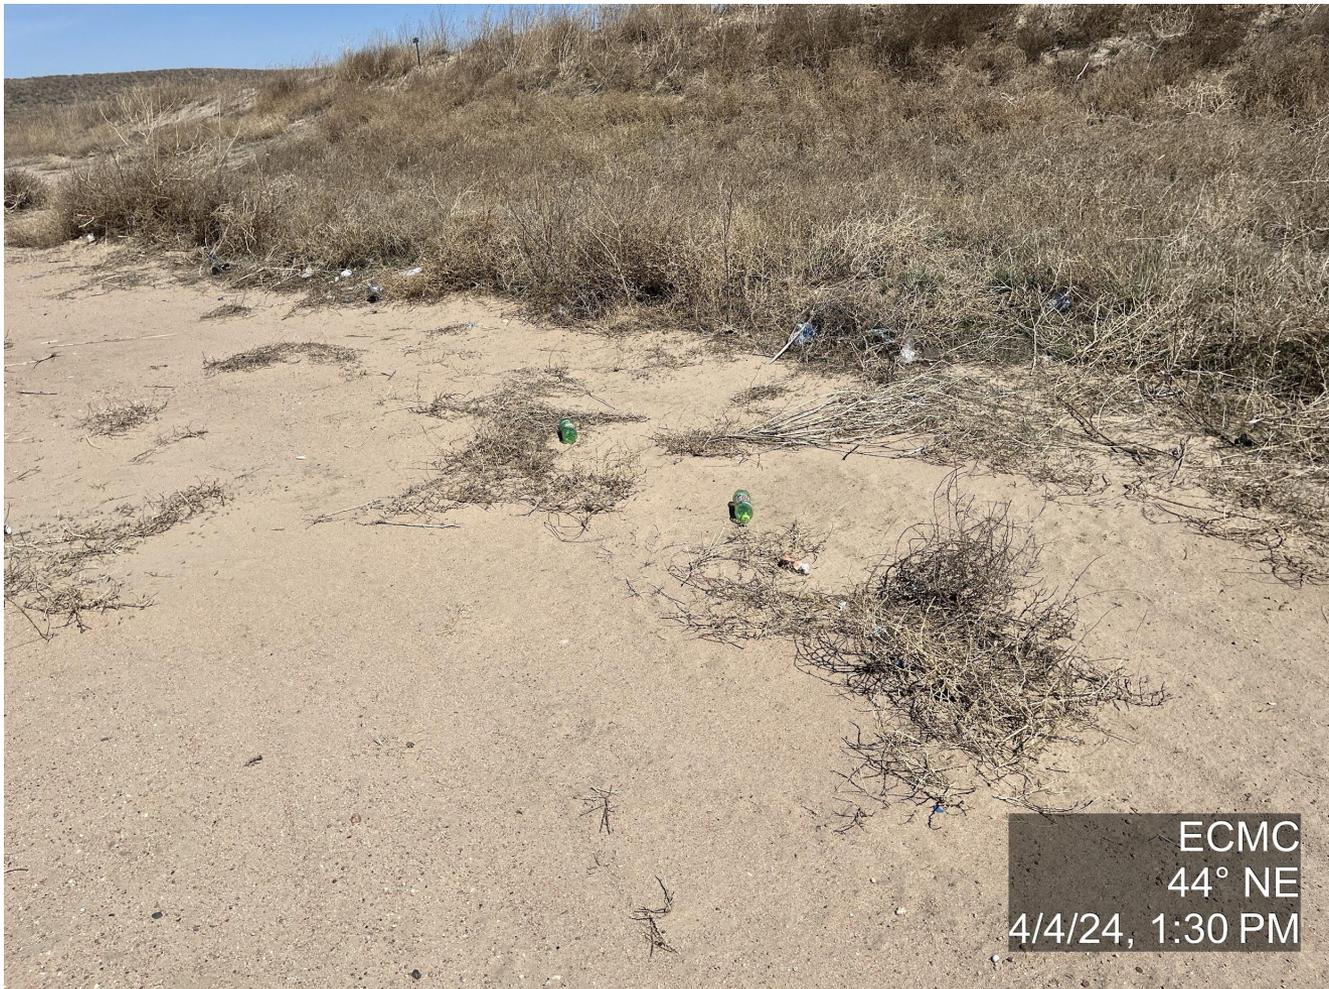
**Photo 14.** The photo was taken at the well location facing Northeast. The photo illustrates trash blowing out of the receptacle noted in photo 12.
