# Interim Reclamation and Stormwater Inspection

Date: 04/17/2024

Operator: HIGHPOINT OPERATING CORPORATION -  
10071

Location ID: 439471

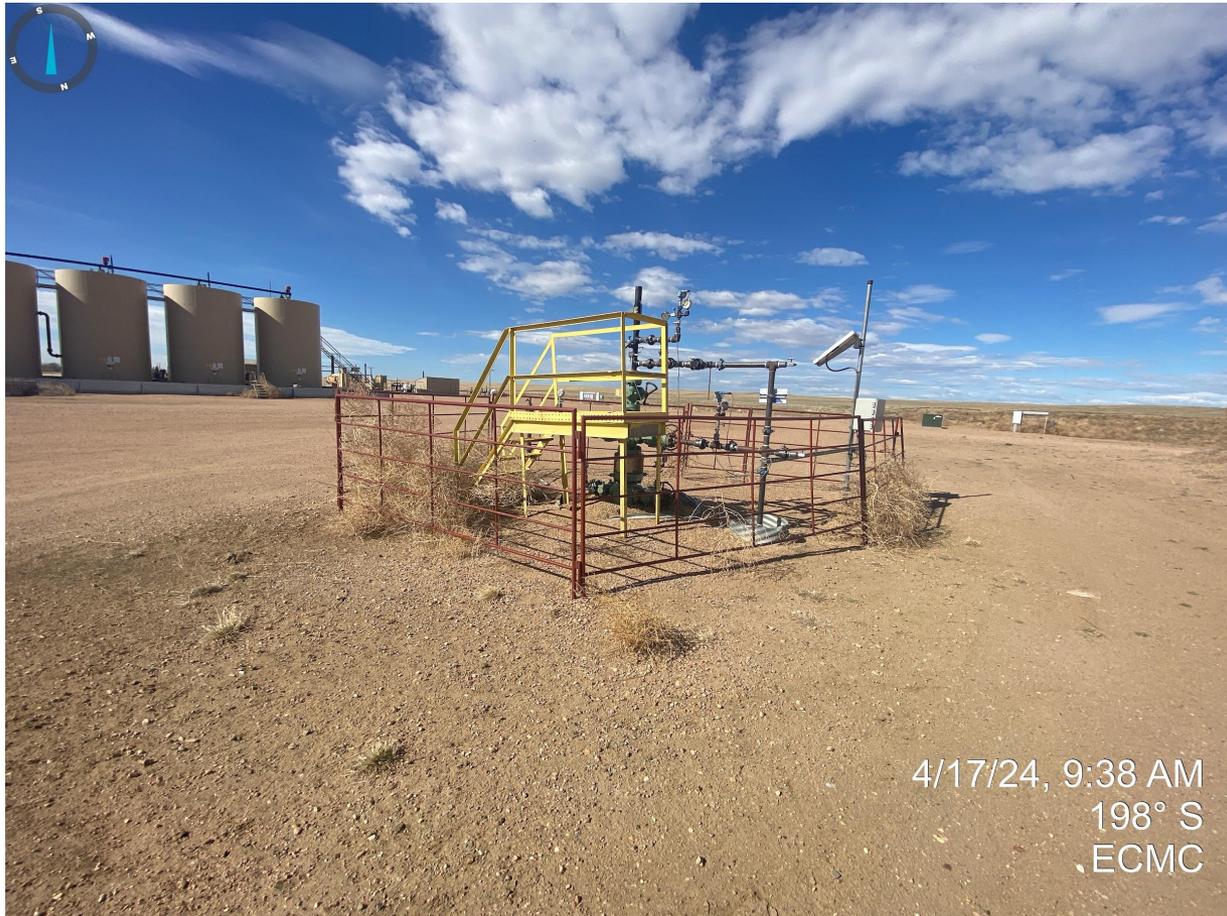
**Photo 1.** Tumbleweed accumulations around equipment need to be removed.

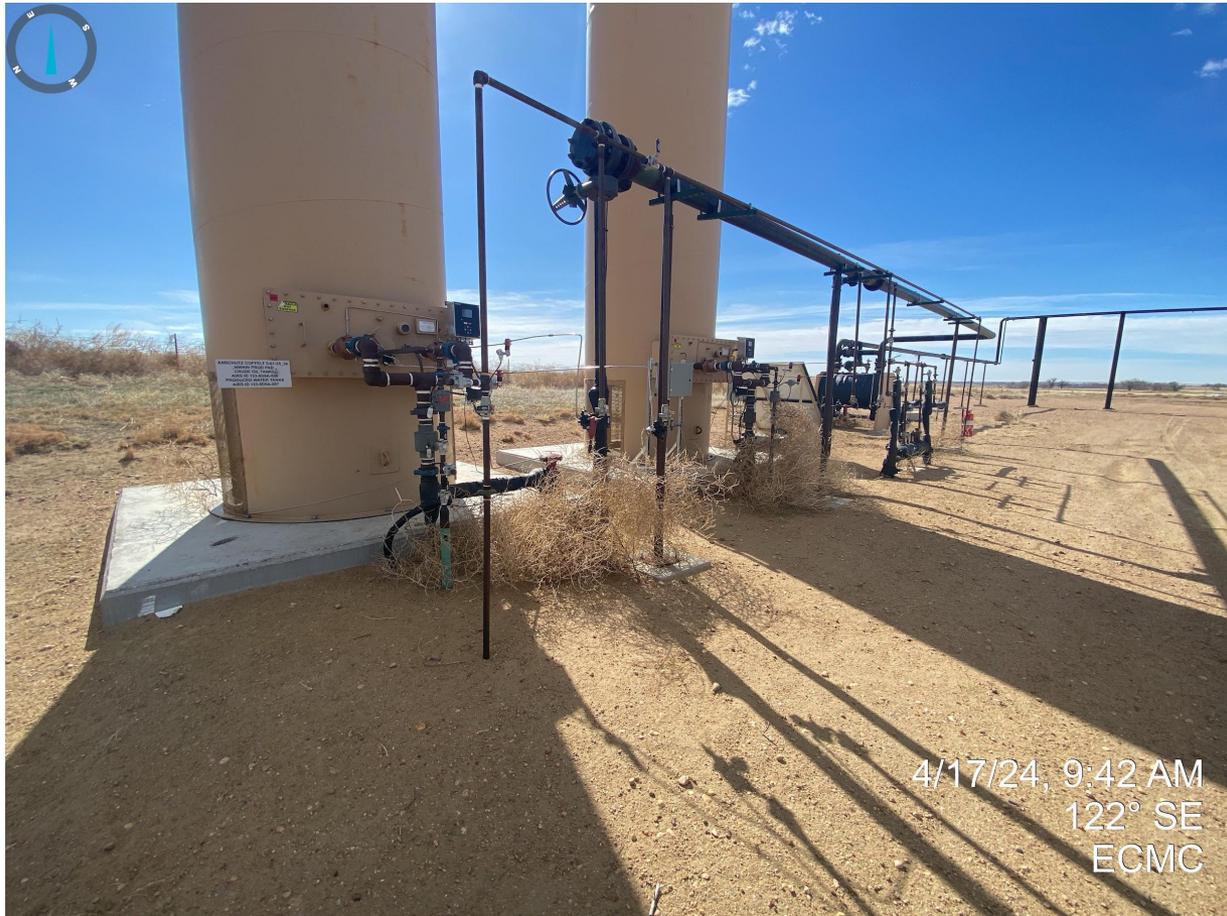
**Photo 2.** Tumbleweed accumulations around equipment need to be removed.

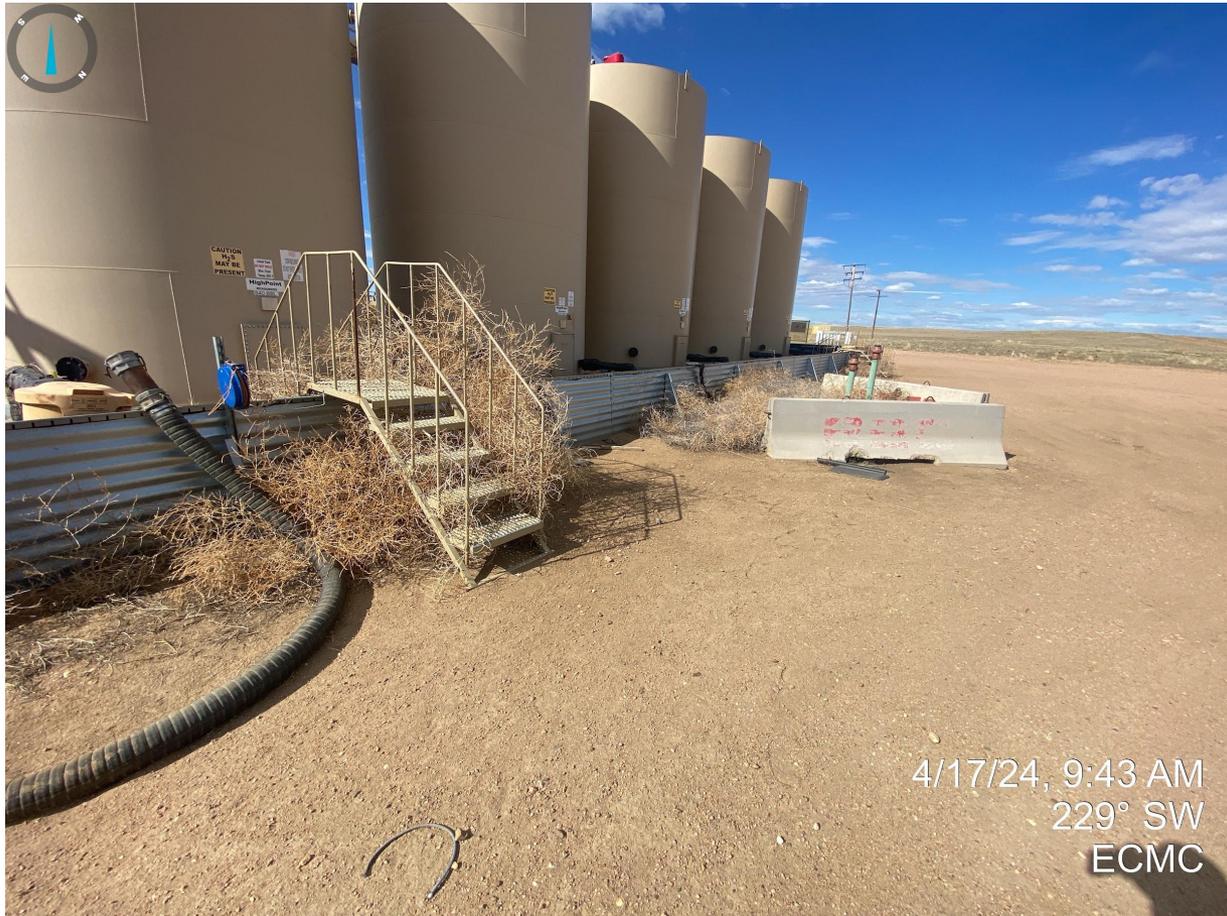
**Photo 3.** Tumbleweed accumulations around equipment need to be removed.

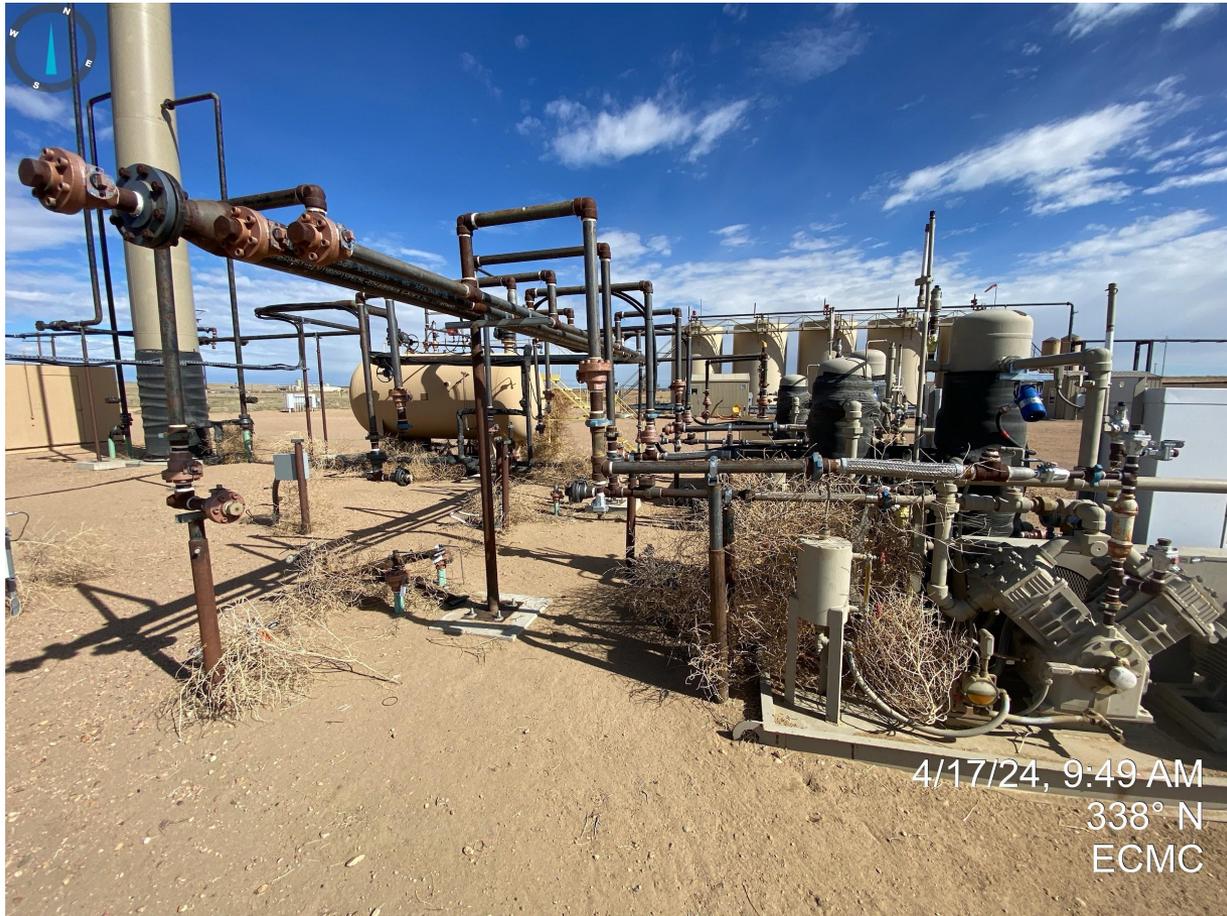
**Photo 4.** Tumbleweed accumulations around equipment need to be removed.

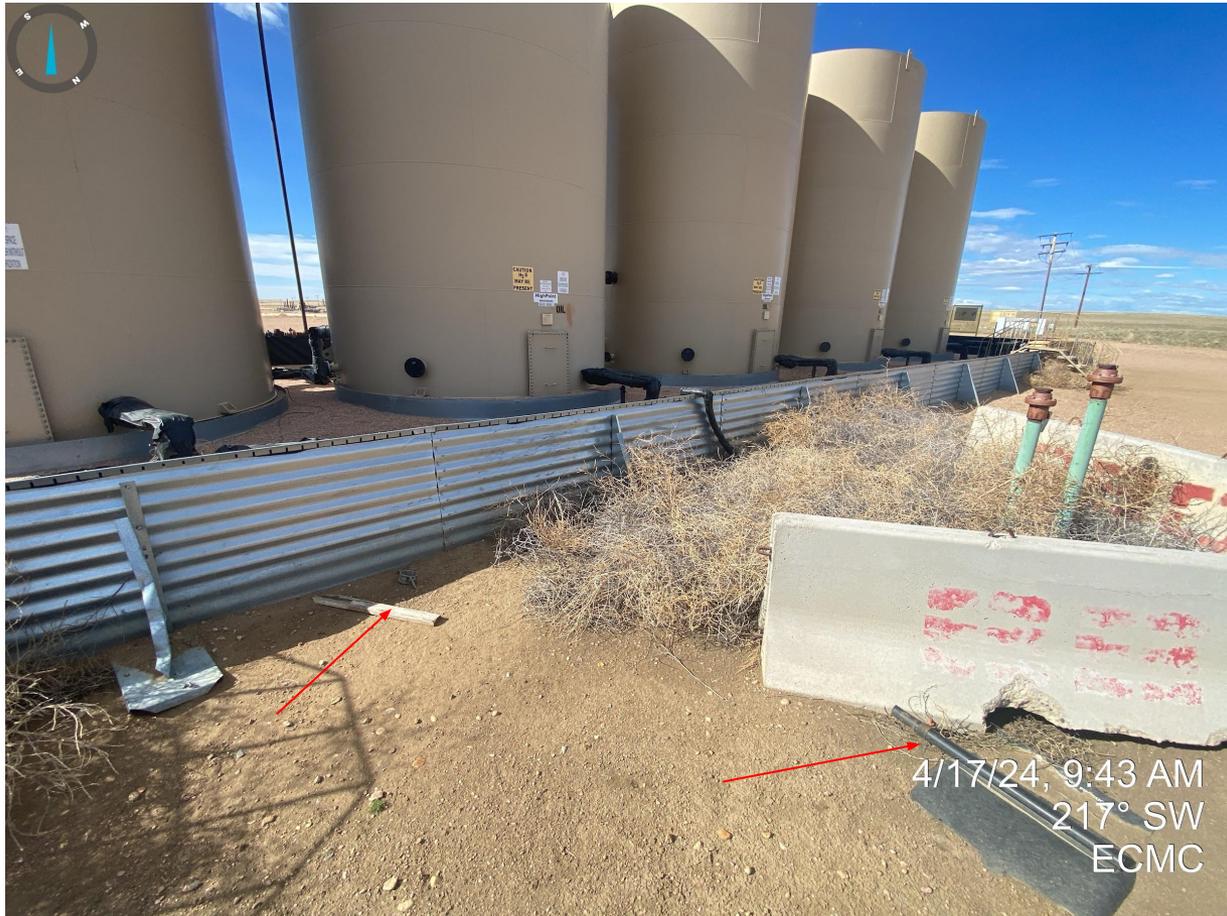
**Photo 5.** Tumbleweed accumulations and debris/trash need to be removed.

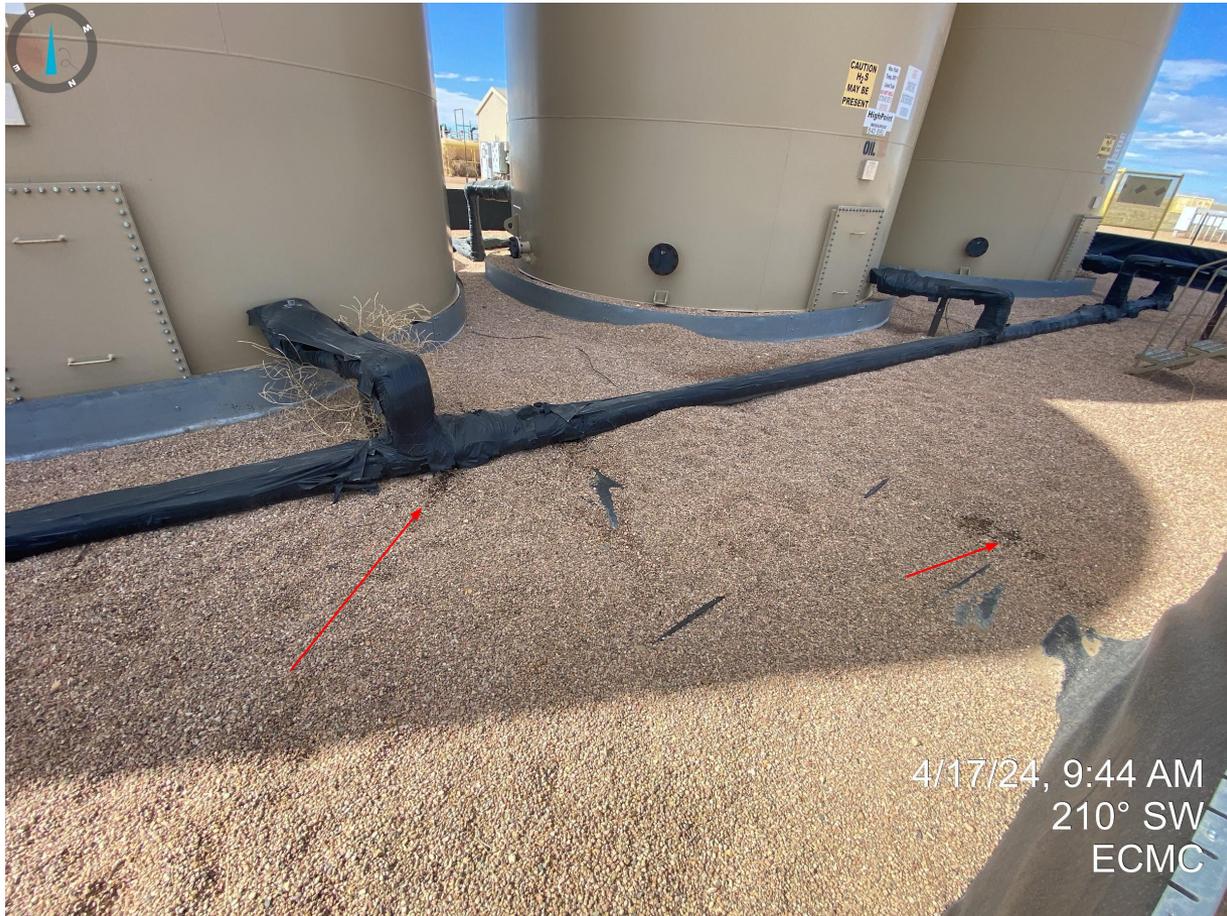
**Photo 6.** Stained soil within secondary containment needs to be properly cleaned up and removed.

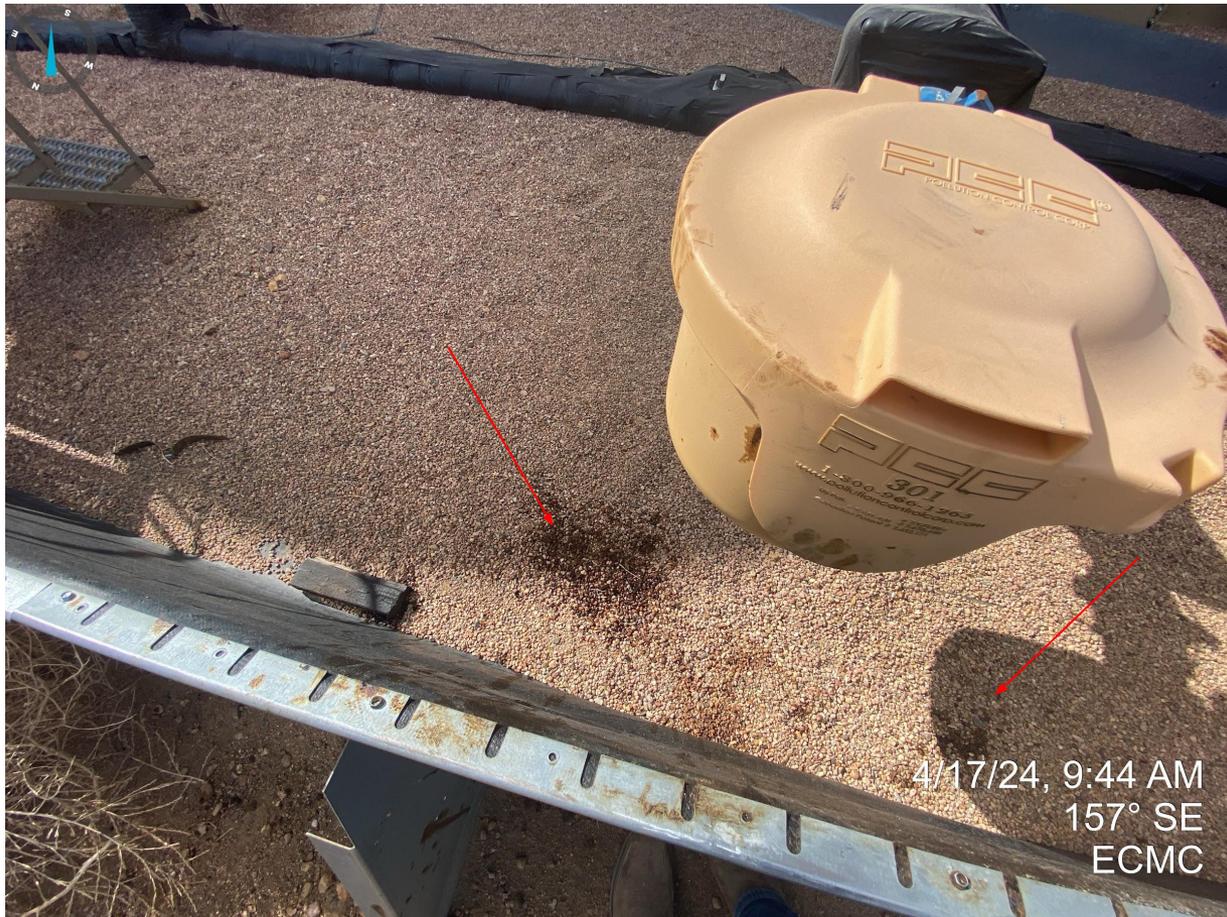
**Photo 7.** Stained soil within secondary containment needs to be properly cleaned up and removed.

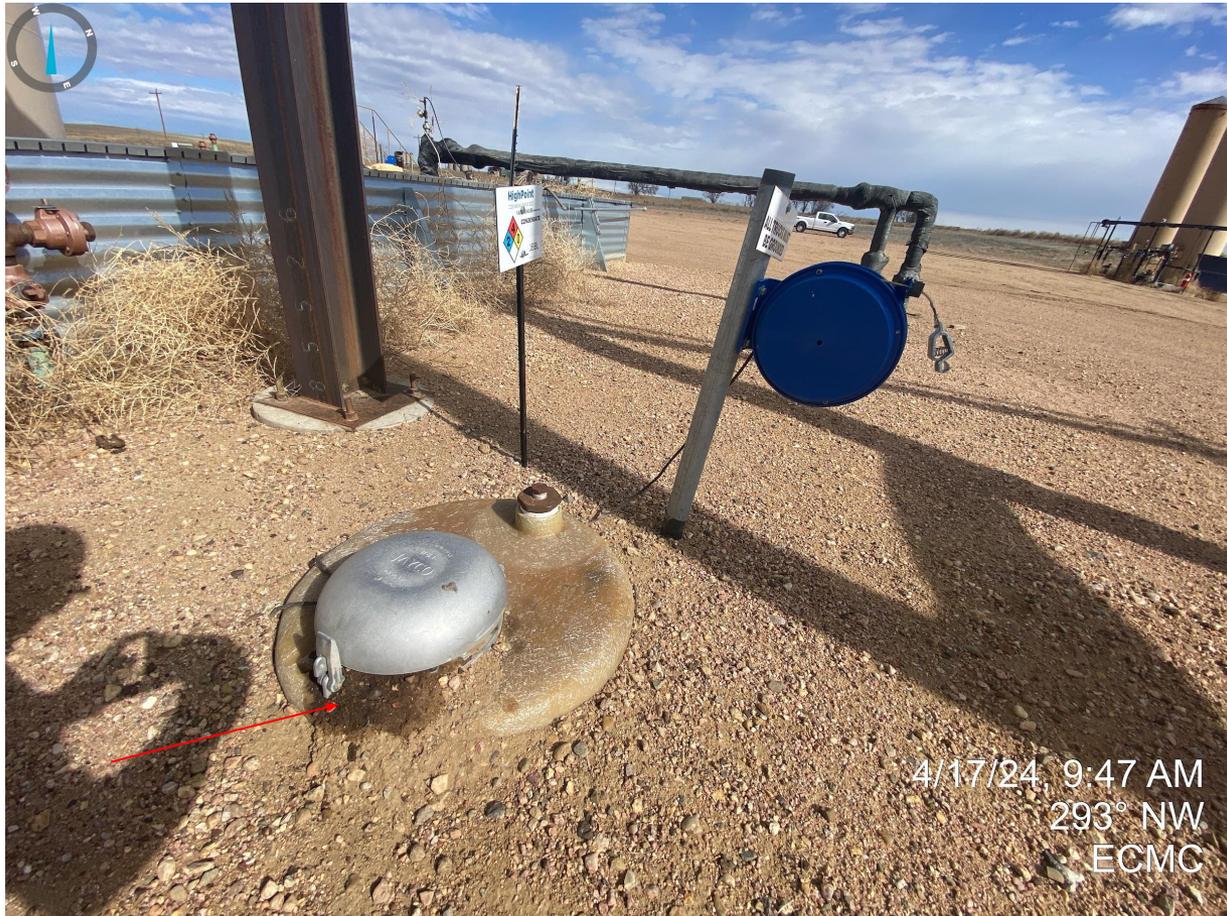
**Photo 8.** Stained soil around buried vessel needs to be cleaned up and properly disposed of.

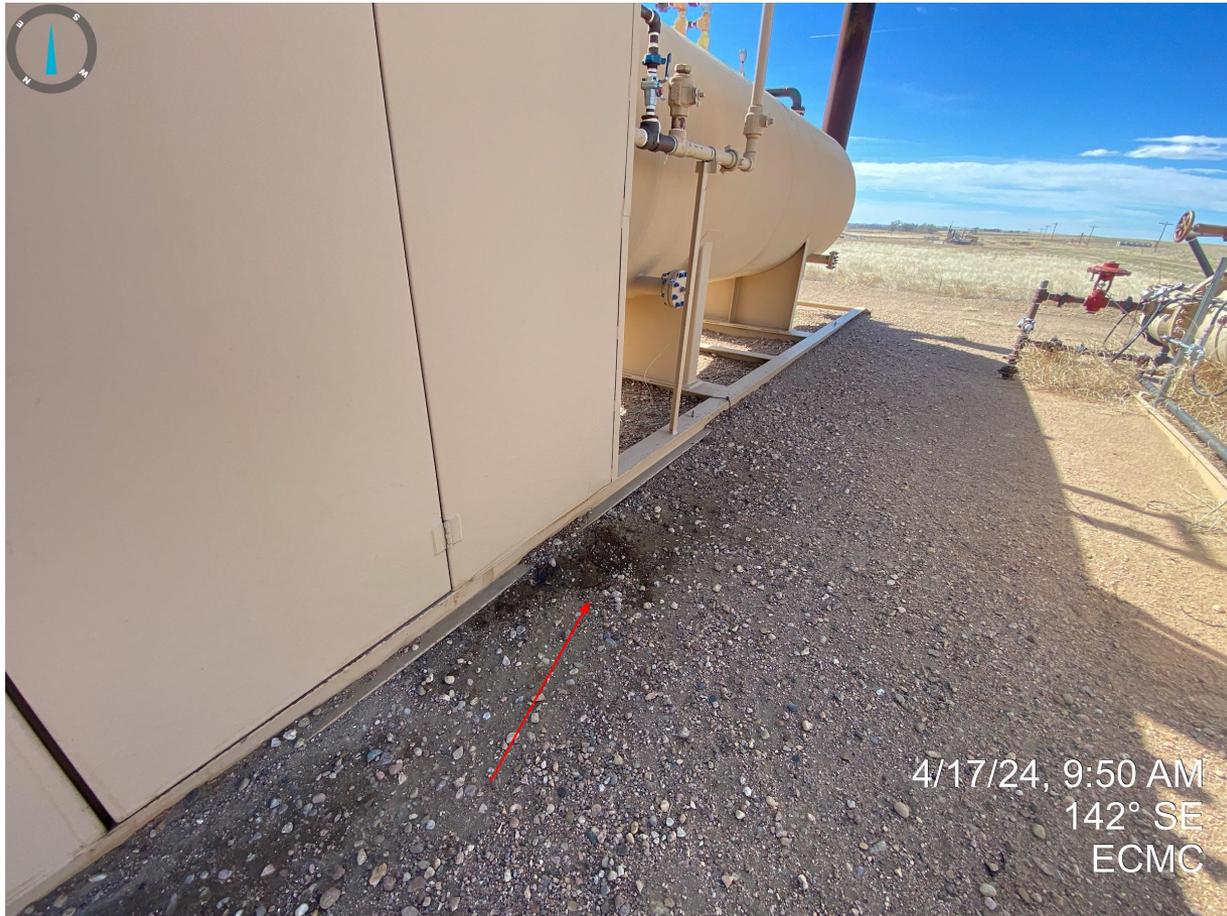
**Photo 9.** Stained soil around equipment needs to be properly cleaned up and disposed of.

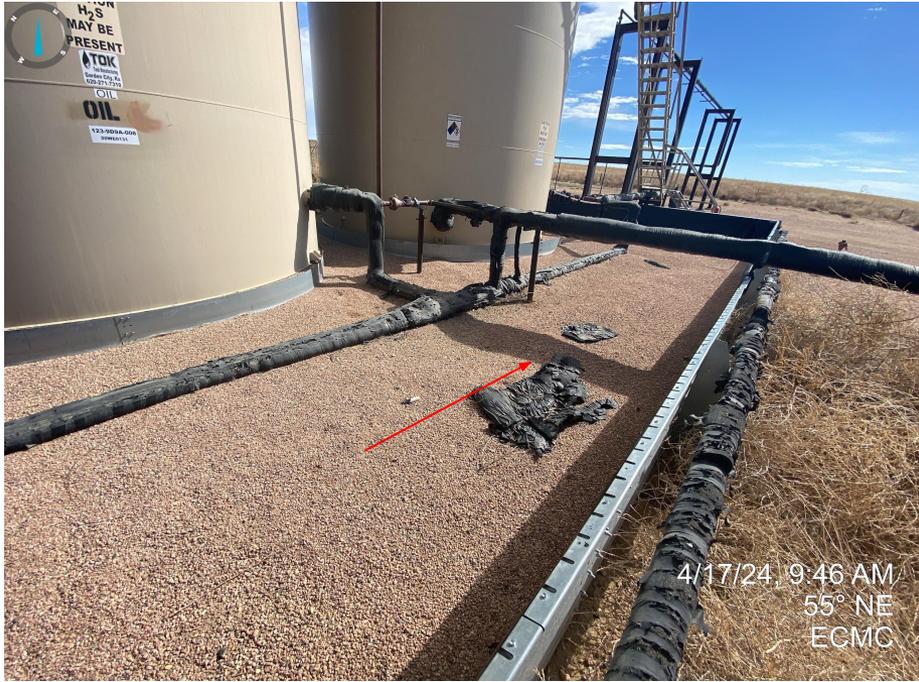
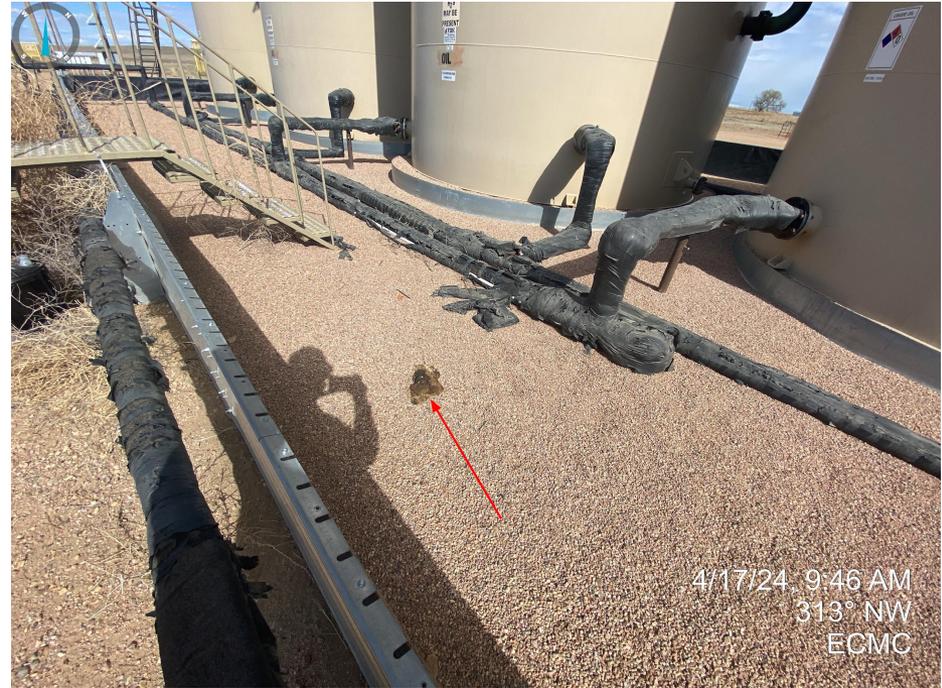
**Photo 10.** Debris/trash within secondary containment needs to be removed.

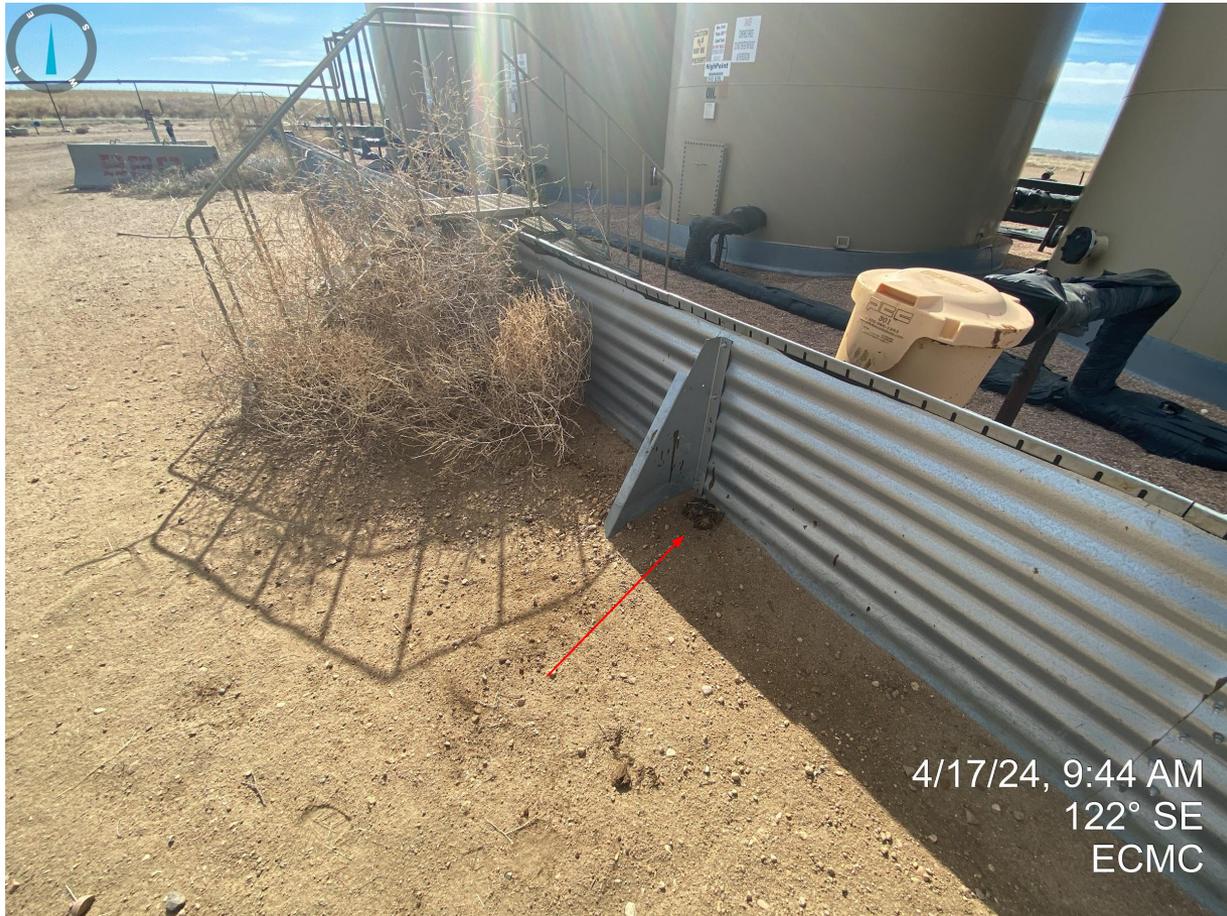
**Photo 11.** Stained soil outside of secondary equipment needs to be removed and properly disposed of.

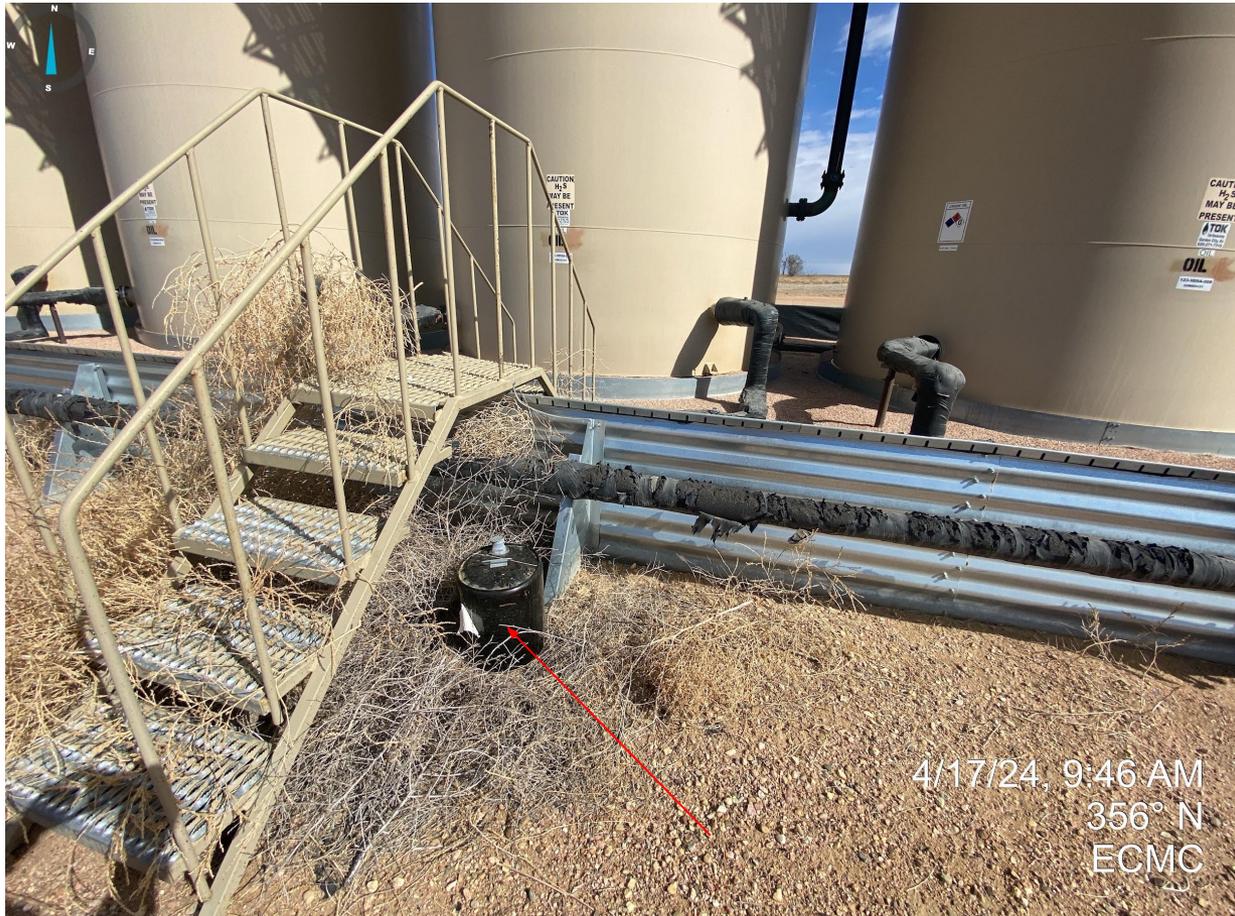
**Photo 12.** Container outside of secondary containment needs to be removed or placed inside of secondary containment.

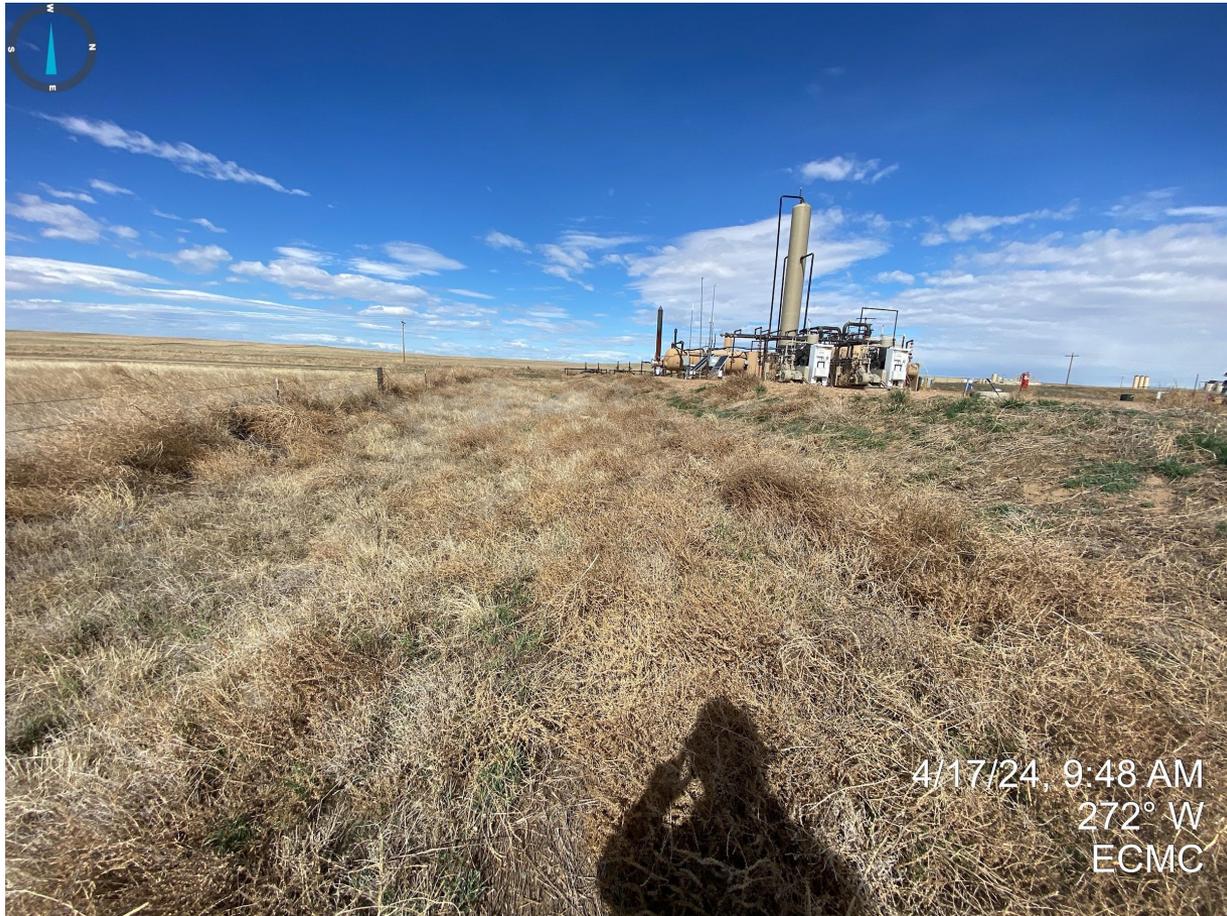
**Photo 13.** Southern interim areas consist primarily of russian thistle.

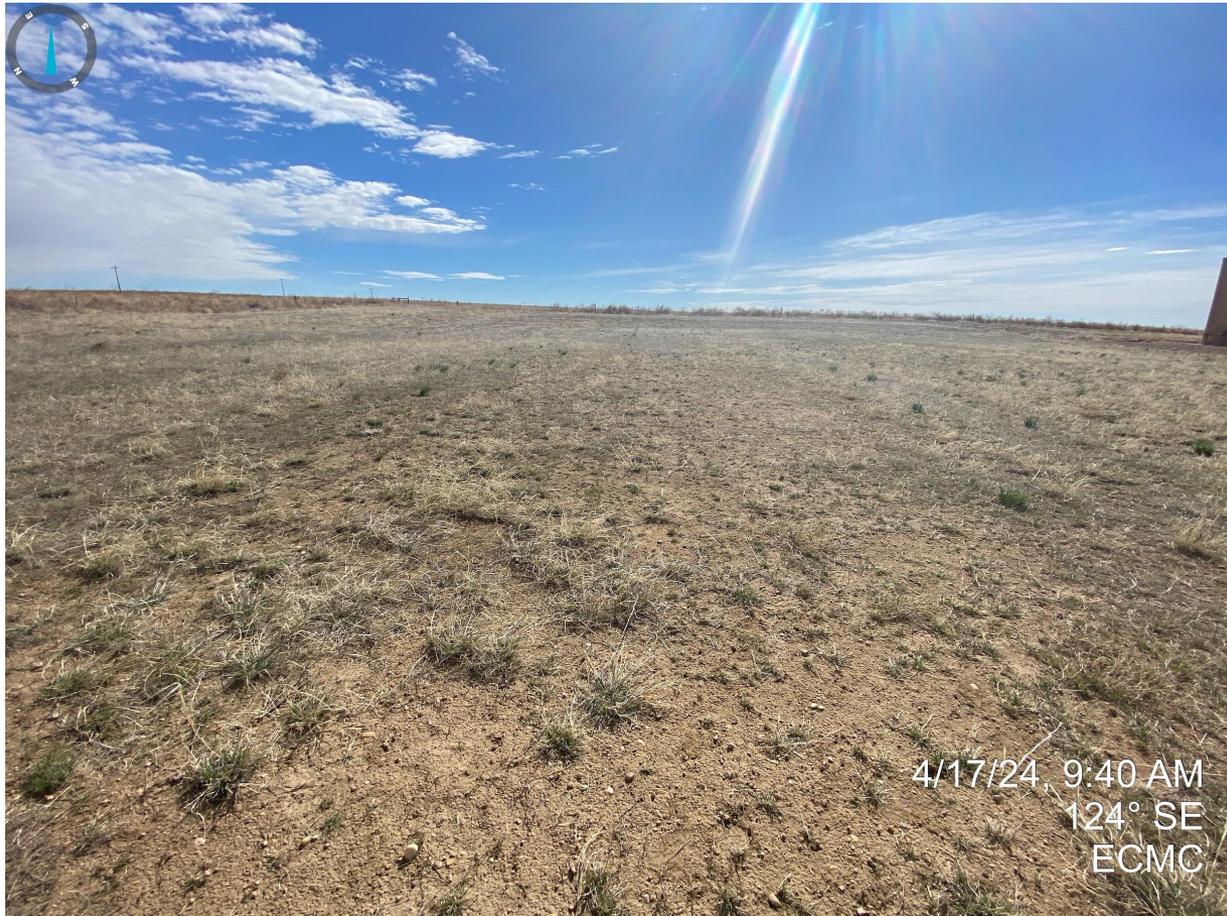
**Photo 14.** Northern interim areas have some desirable vegetation however, some areas do not have uniform vegetation cover and there is evidence of kochia and russian thistle in the early growth stages that will need to be properly managed for.

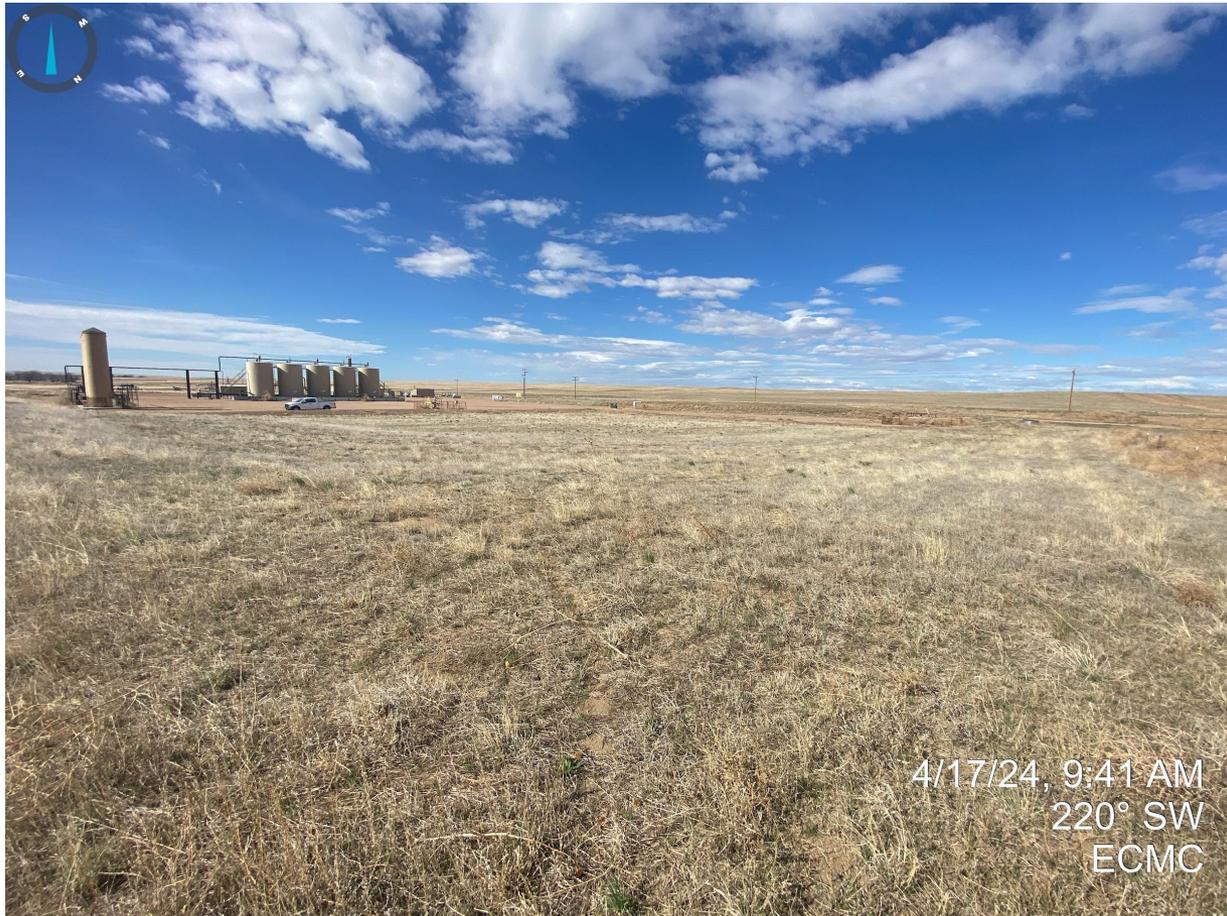
**Photo 15.** Northern interim areas, facing southwest; see comments in Photo 14.

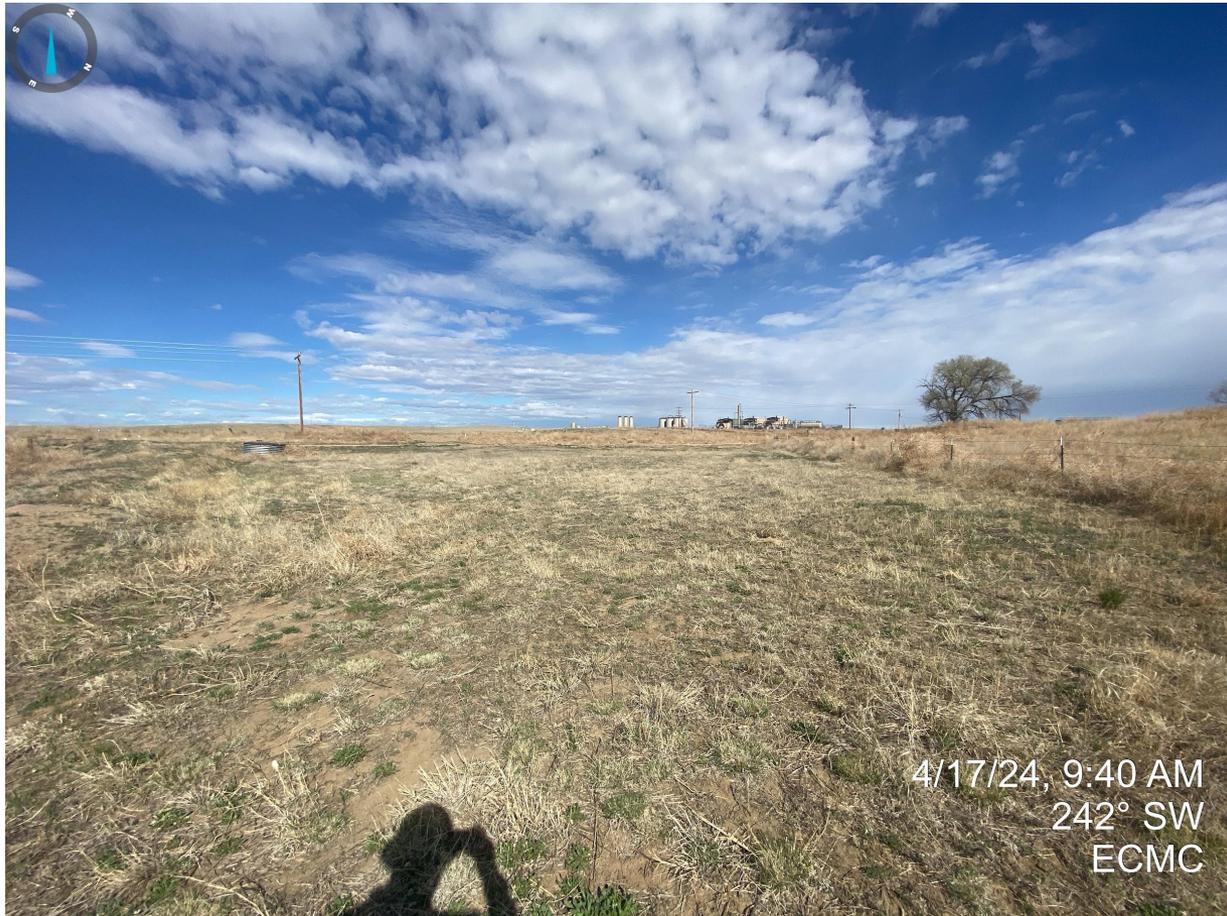
**Photo 16.** Northern interim areas, facing southwest; see comments in Photo 14.

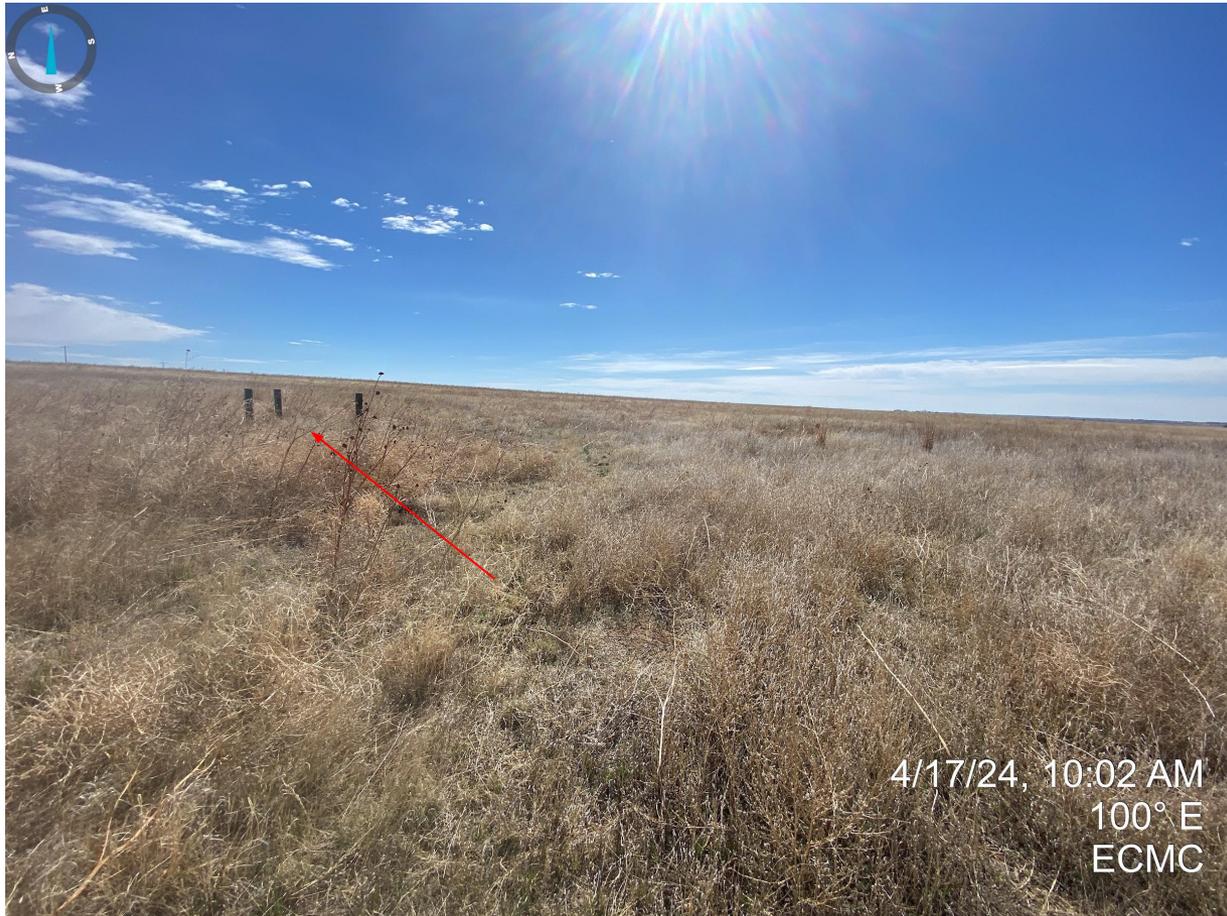
**Photo 17.** Fence posts from the initial location construction do not appear to be in use and need to be removed. Located on the northeast corner of the location.
