# Interim Reclamation and Stormwater Inspection

Operator: BONANZA CREEK ENERGY OPERATING  
COMPANY LLC - 8960

Location ID: 441005

Inspection Document #: 708201158

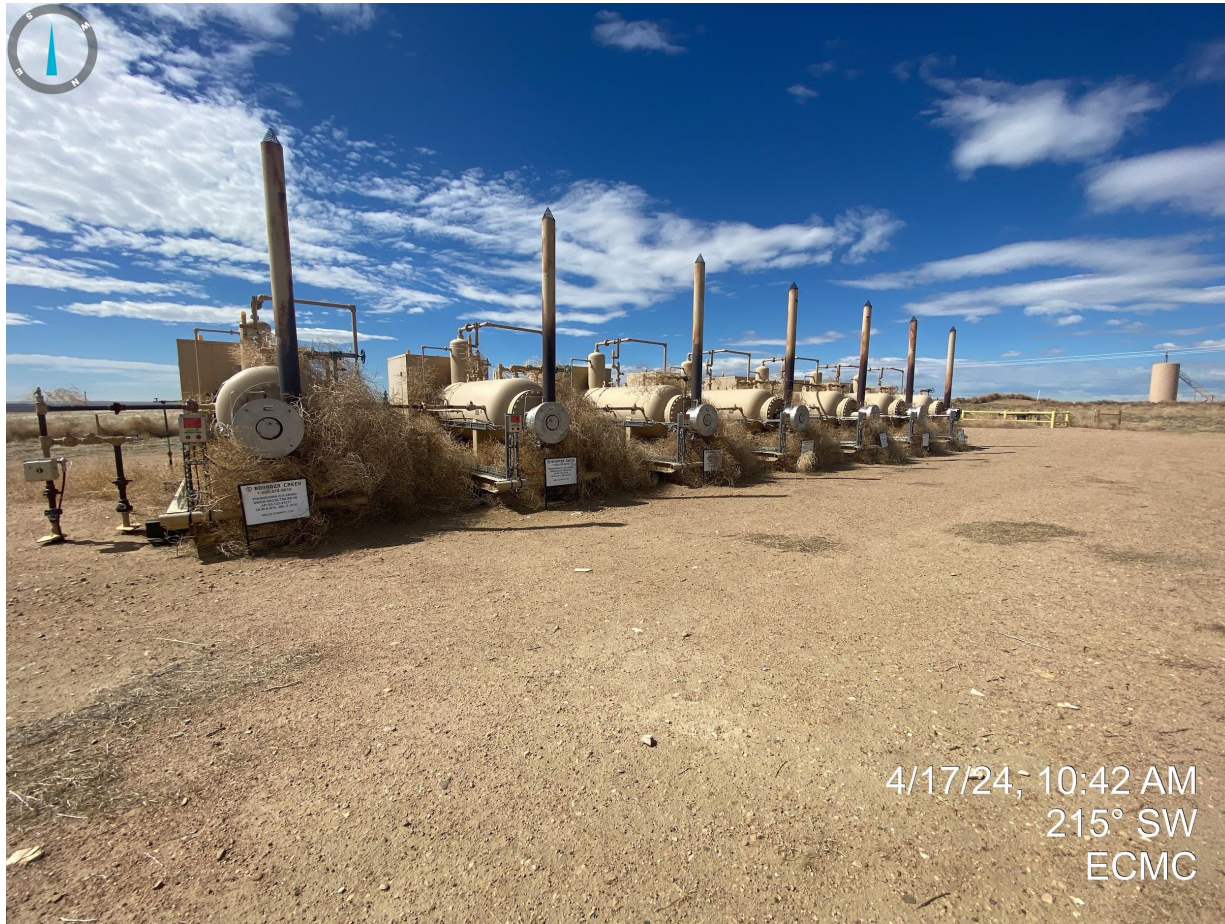
**Photo 1.** Tumbleweed accumulations within equipment.

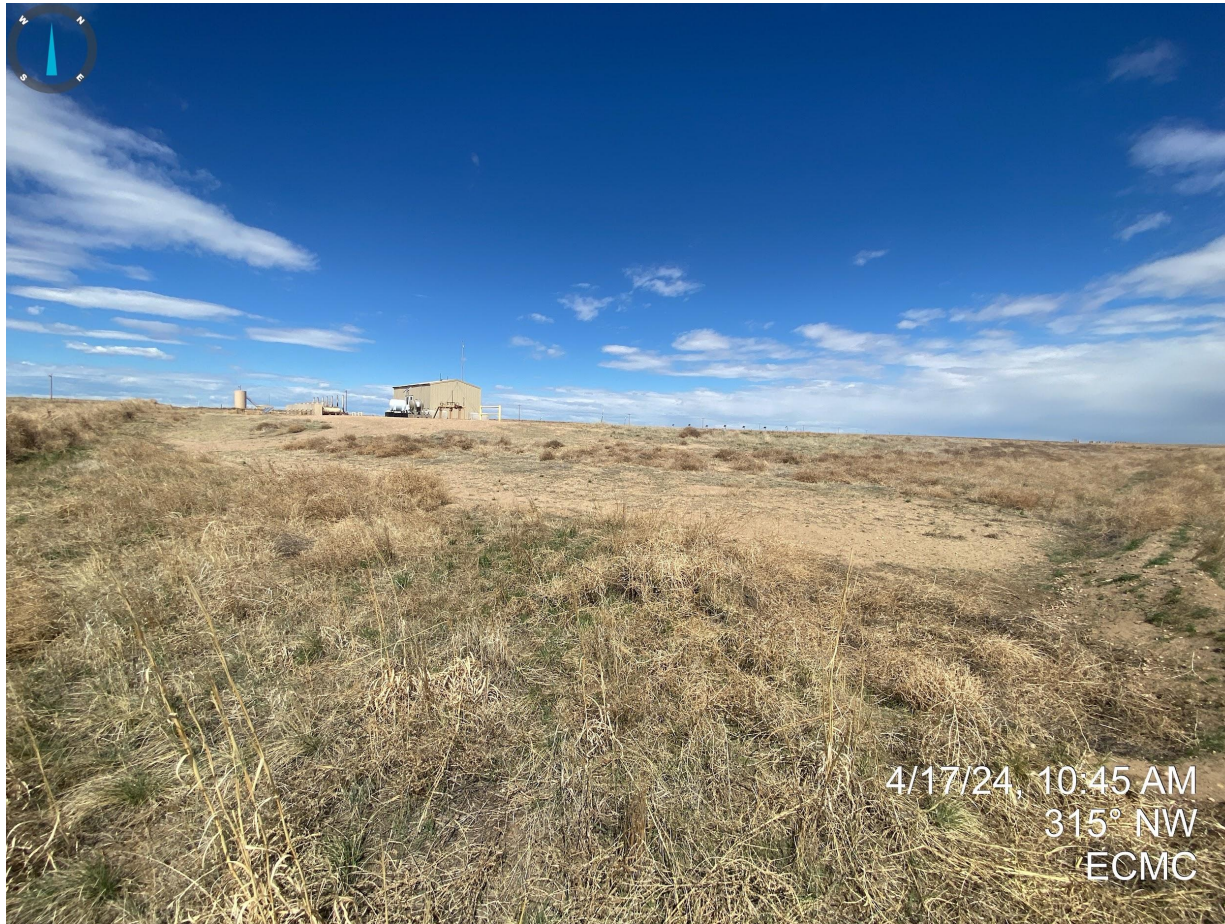
**Photo 2.** Southern interim areas consist mainly of undesirable vegetations and bare/exposed soils.

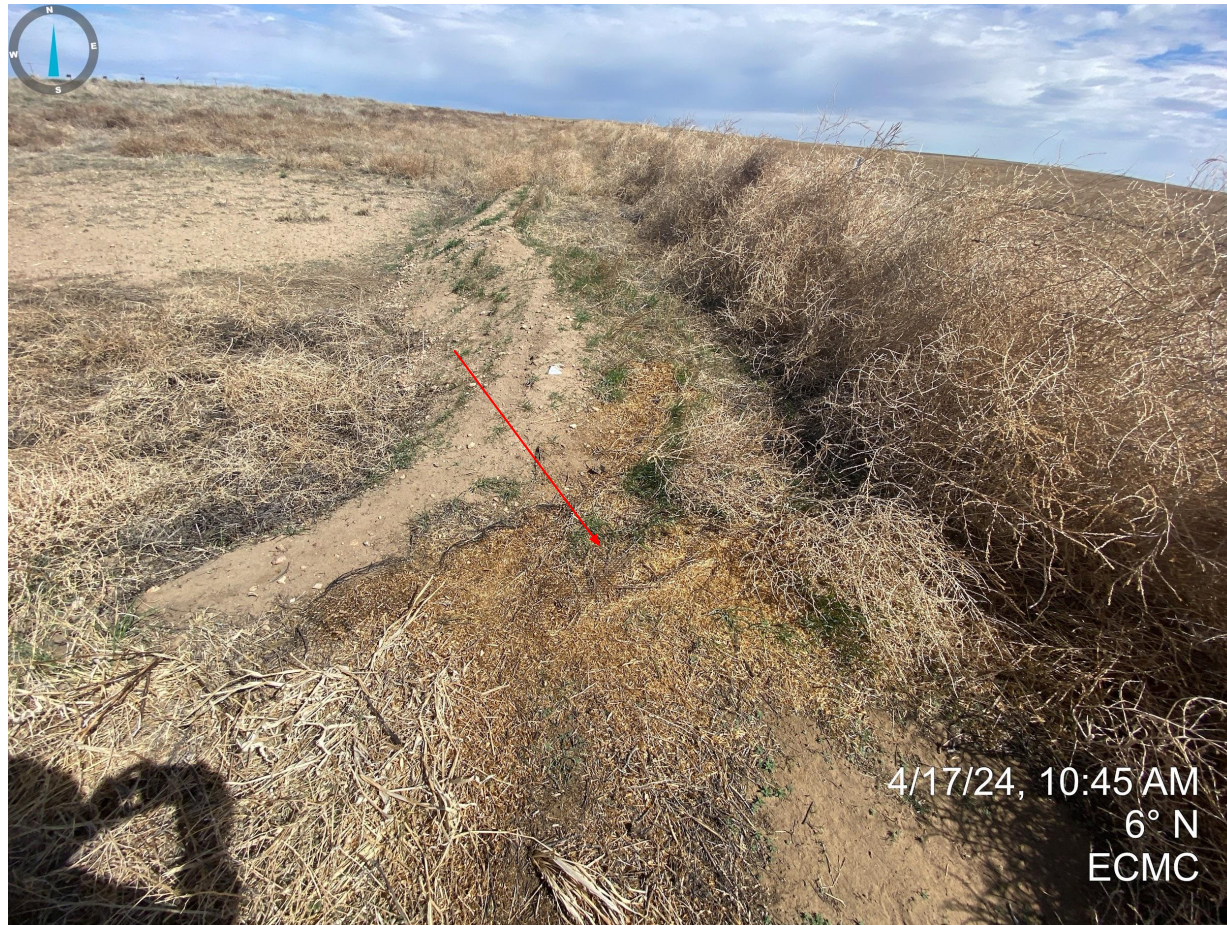
**Photo 3.** Degraded straw wattle at the SE corner of the location (sediment trap) is now considered debris.

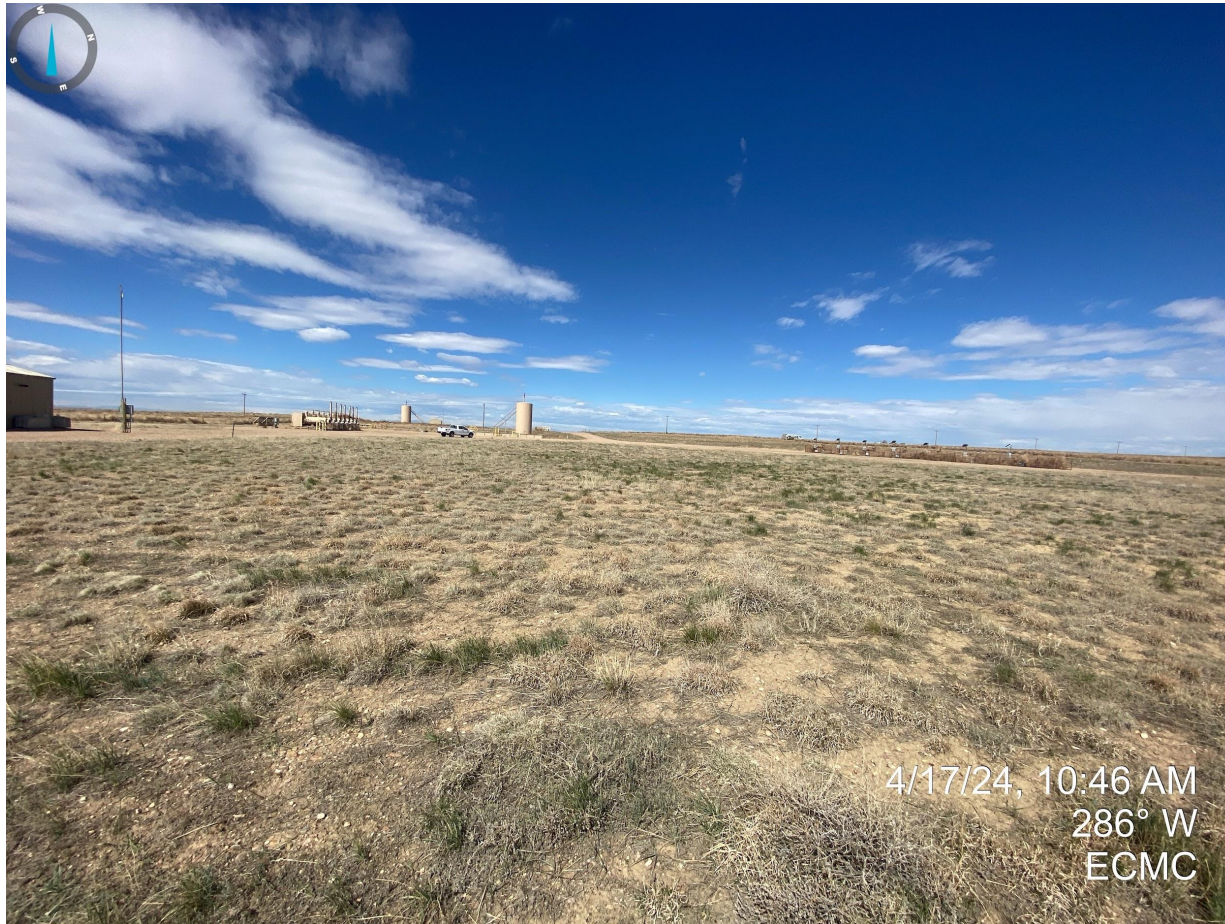
**Photo 4.** Center interim areas are not progressing towards Rule 1003 standards with areas of non-uniform vegetation cover.

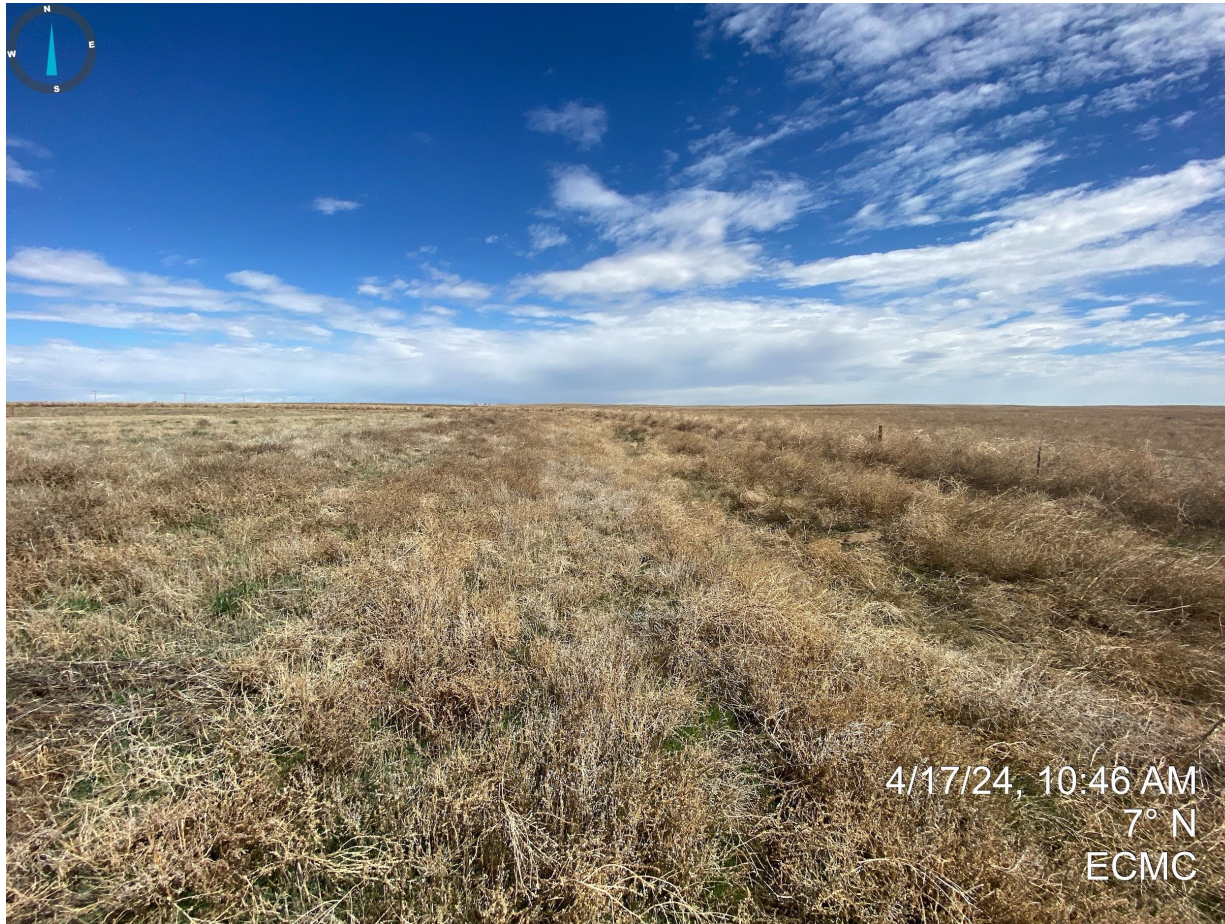
**Photo 5.** Eastern interim areas are primarily undesirable vegetation (russian thistle and kochia).

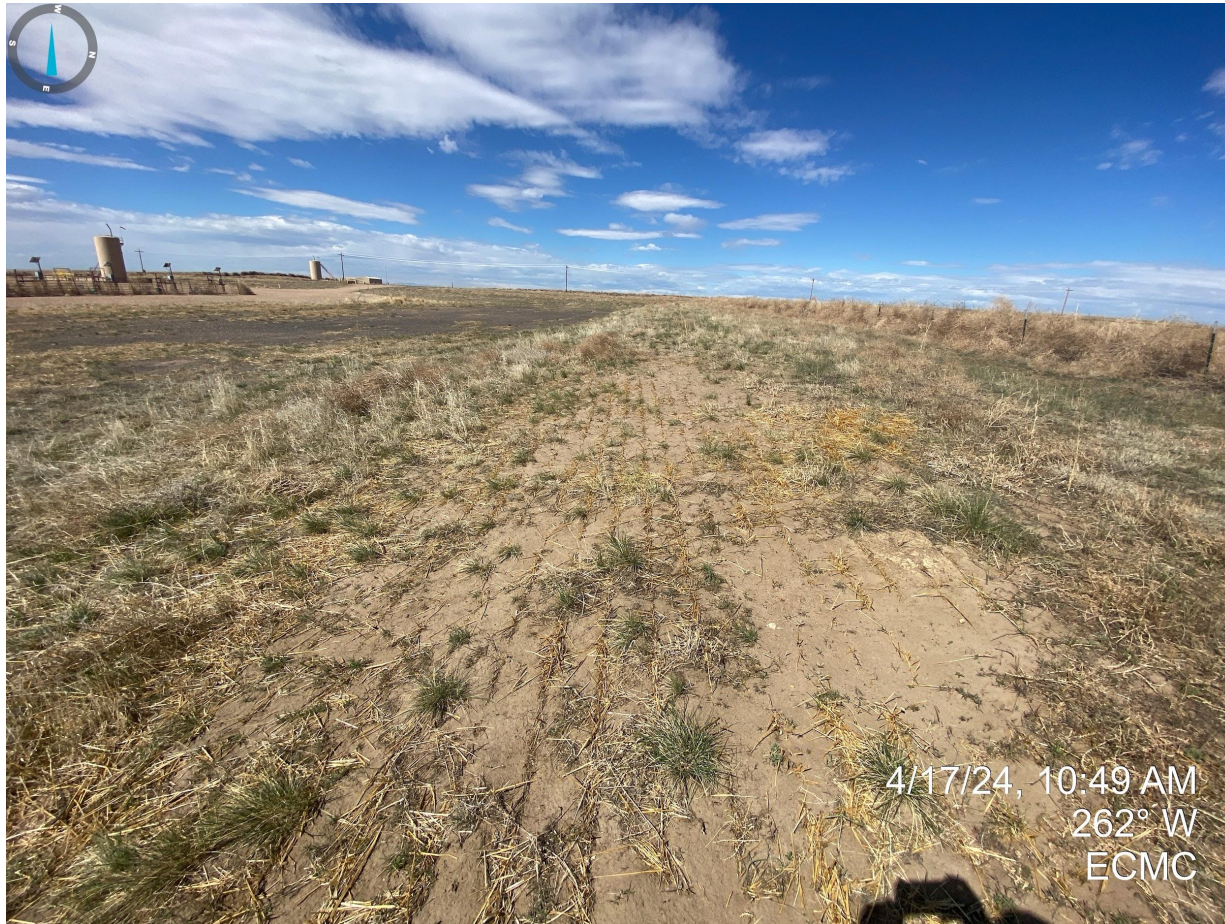
**Photo 6.** Northern interim areas appear to have been recently drill seeded. Some desirable germination was observed.

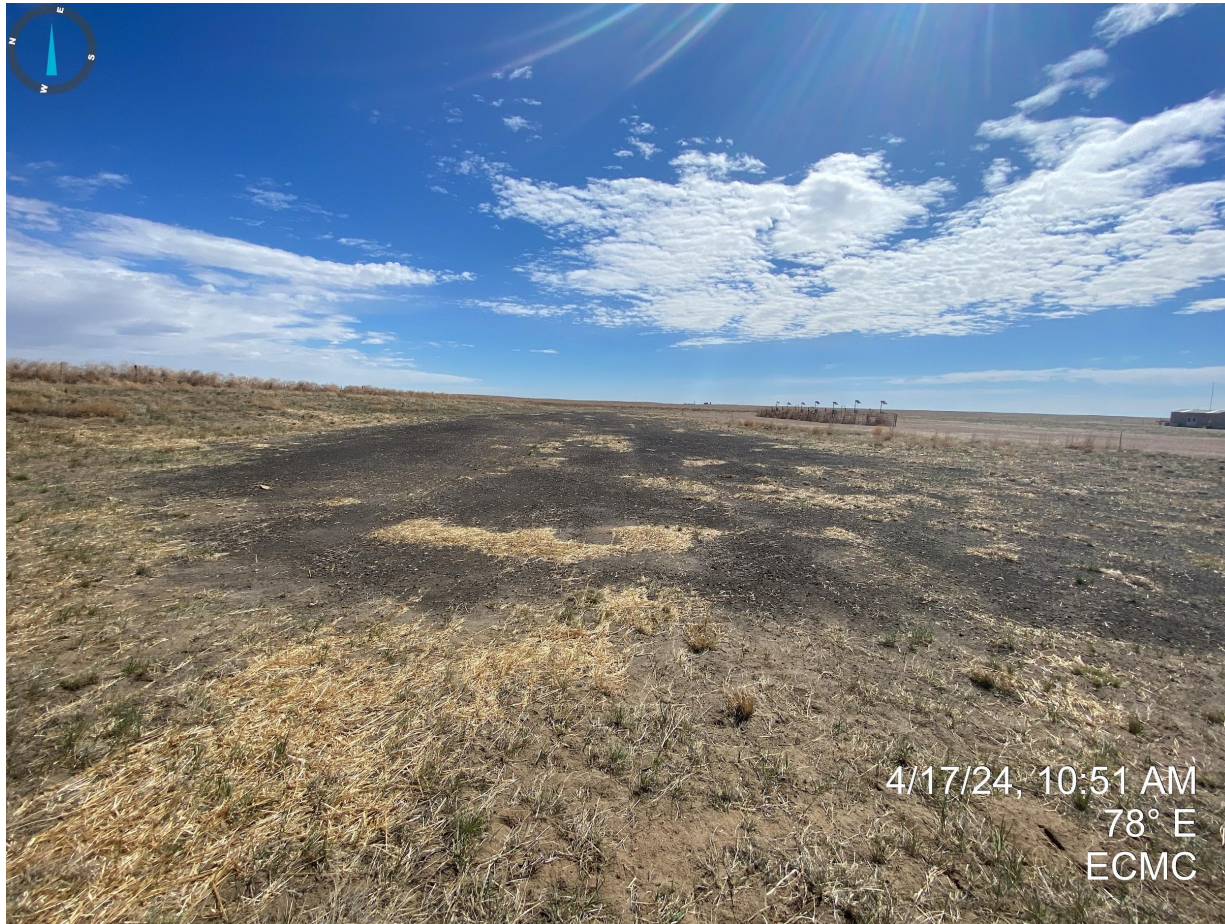
**Photo 7.** Northern interim area with drill cuttings incorporation; it appears this area has been recently drill seeded, however, no germination was observed. Soils are bare and unstabilized.

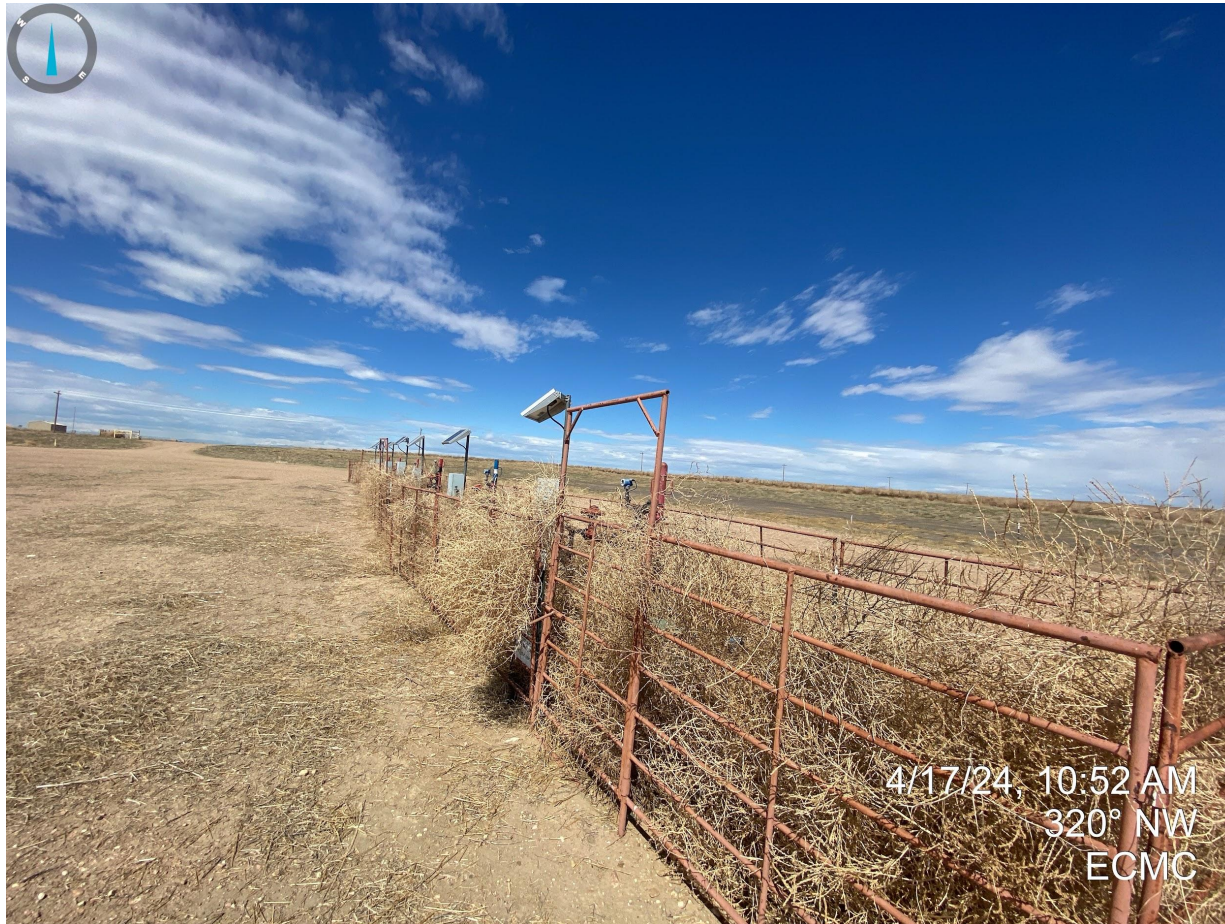
**Photo 8.** Tumbleweed accumulations within equipment (wellheads).
