Final Reclamation and Stormwater Inspection

Operator: BONANZA CREEK OPERATING COMPANY
LLC - 8960

Location ID: 305298

Inspection Photos
Location Name: Pronghorn 41-16
Location ID: 305298

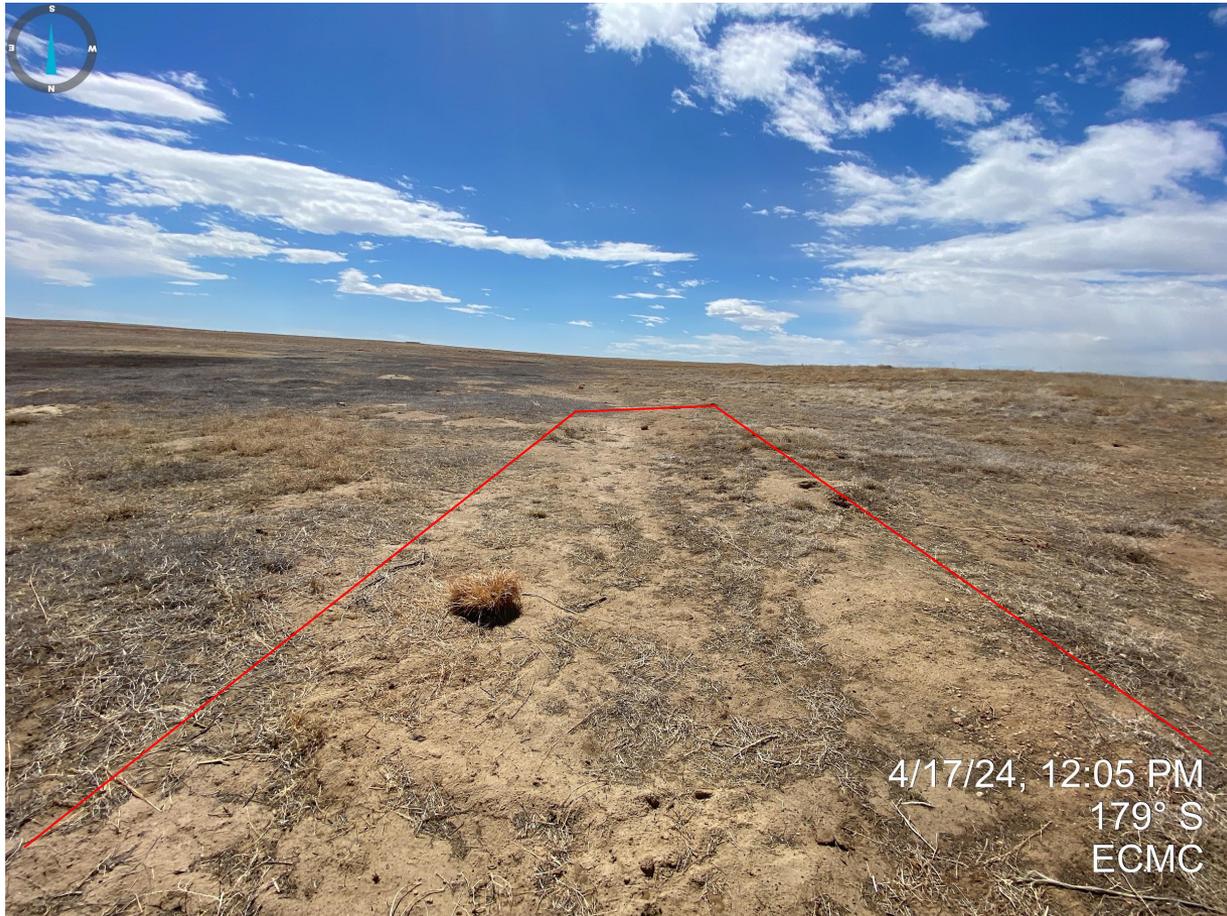
Photo 1. Access road does not appear to be properly stabilized as the road is primarily bare/exposed soil.

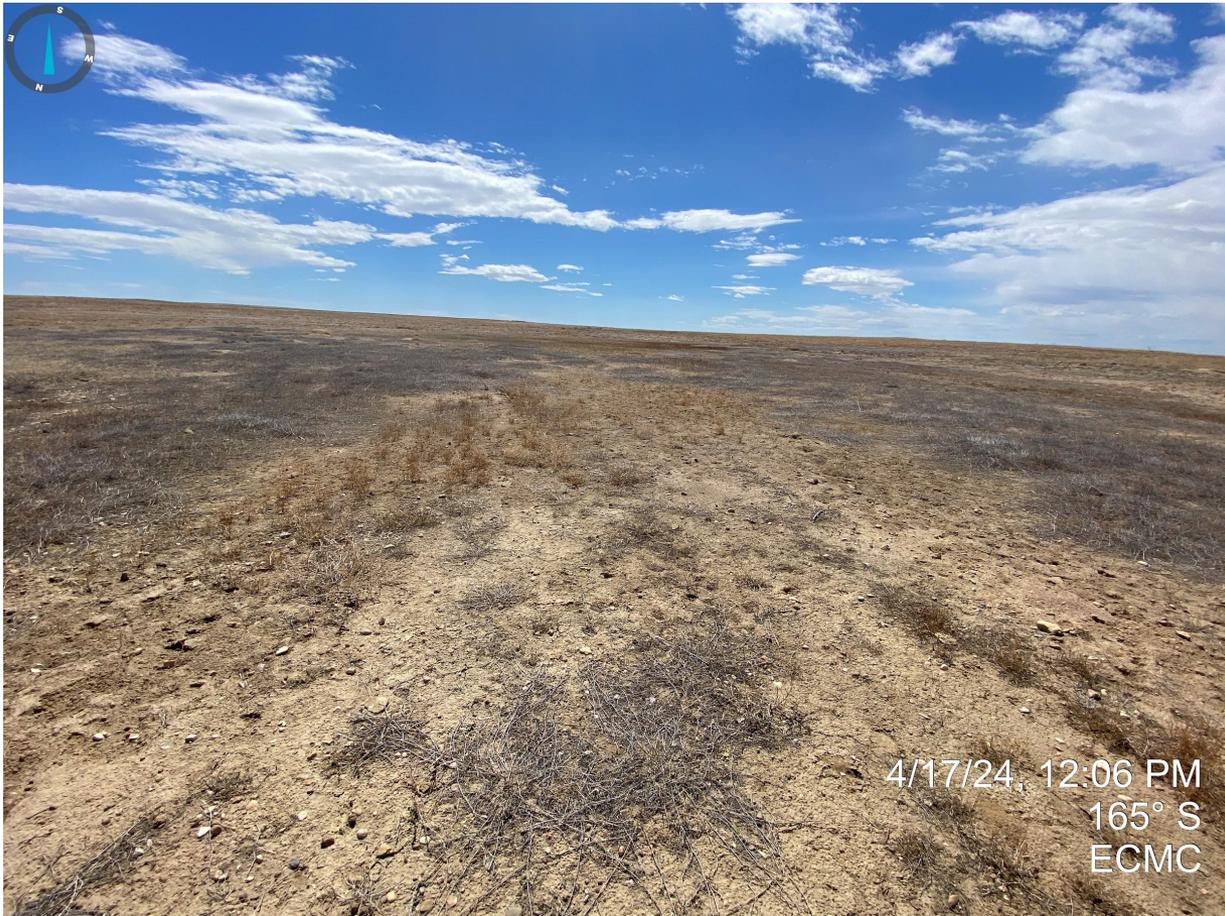
Photo 2. The former wellhead/pumpjack area does not appear to be properly stabilized as it is primarily bare/exposed soil.

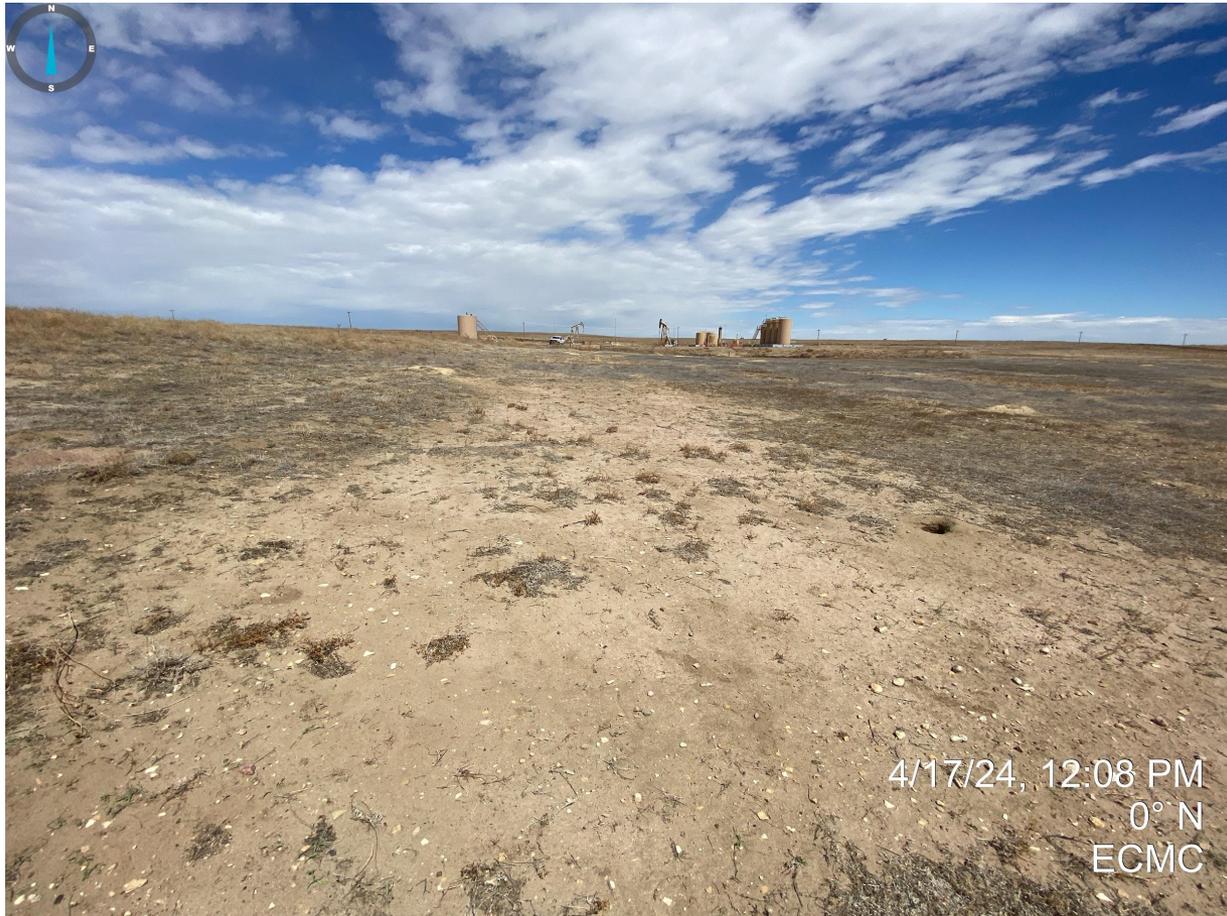
Photo 3. The former tank battery area does not appear to be properly stabilized as it is primarily bare/exposed soil.

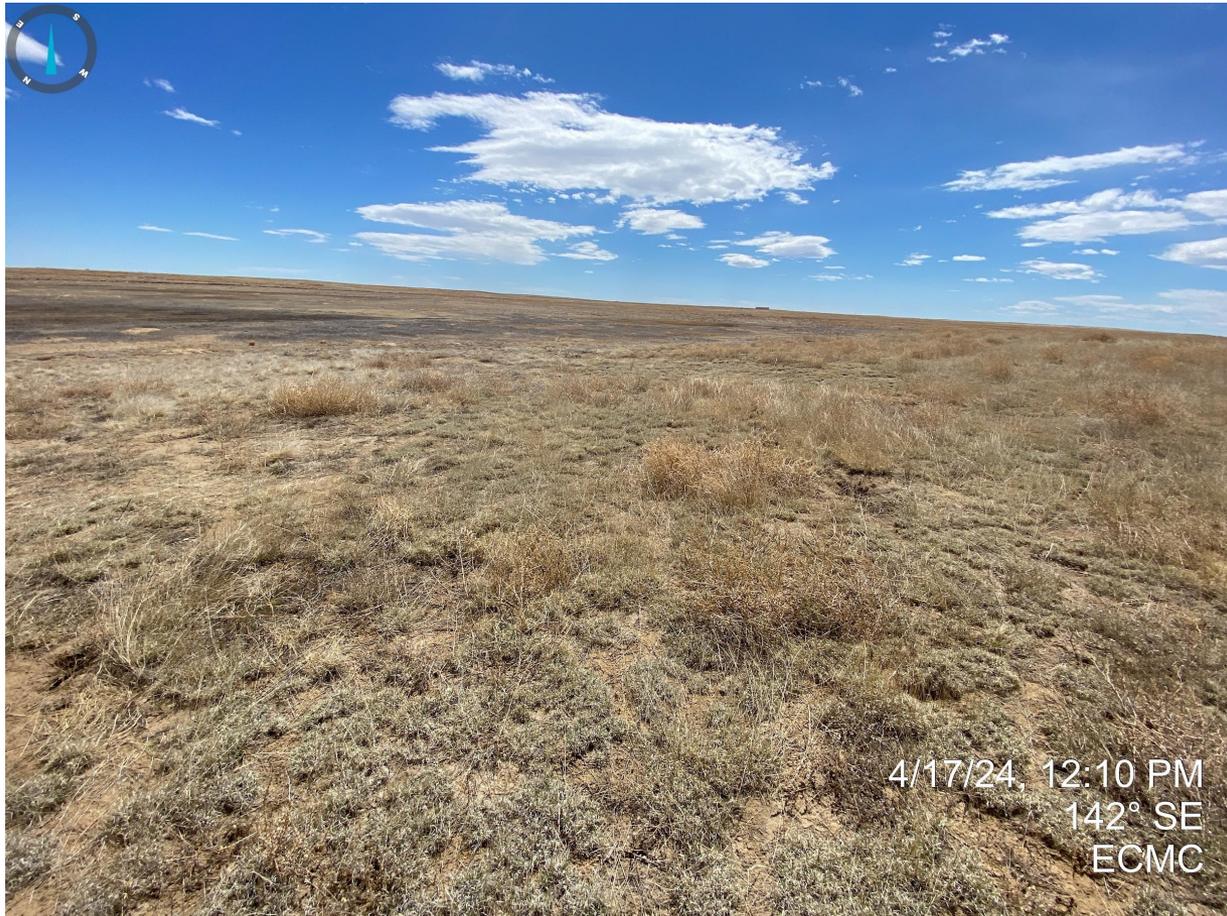
Photo 4. Reference area photo taken northwest of the former location. Desirable species observed is primarily blue grama.
