Interim Reclamation and Stormwater Inspection

Date: 04/17/2024

Operator: BONANZA CREEK OPERATING COMPANY
LLC - 8960

Location ID: 428090

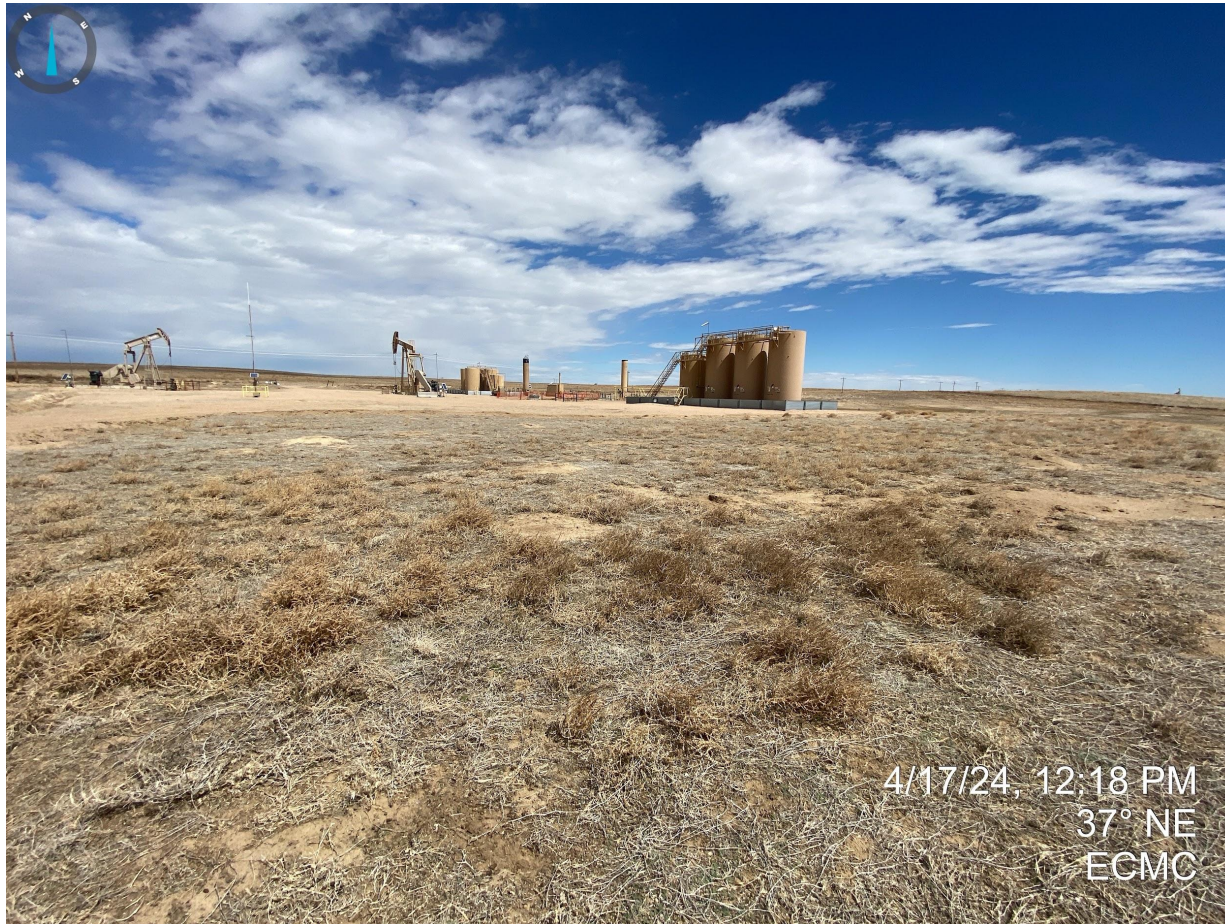
Photo 1. Southern interim areas are primarily undesirable vegetation (e.g. russian thistle).

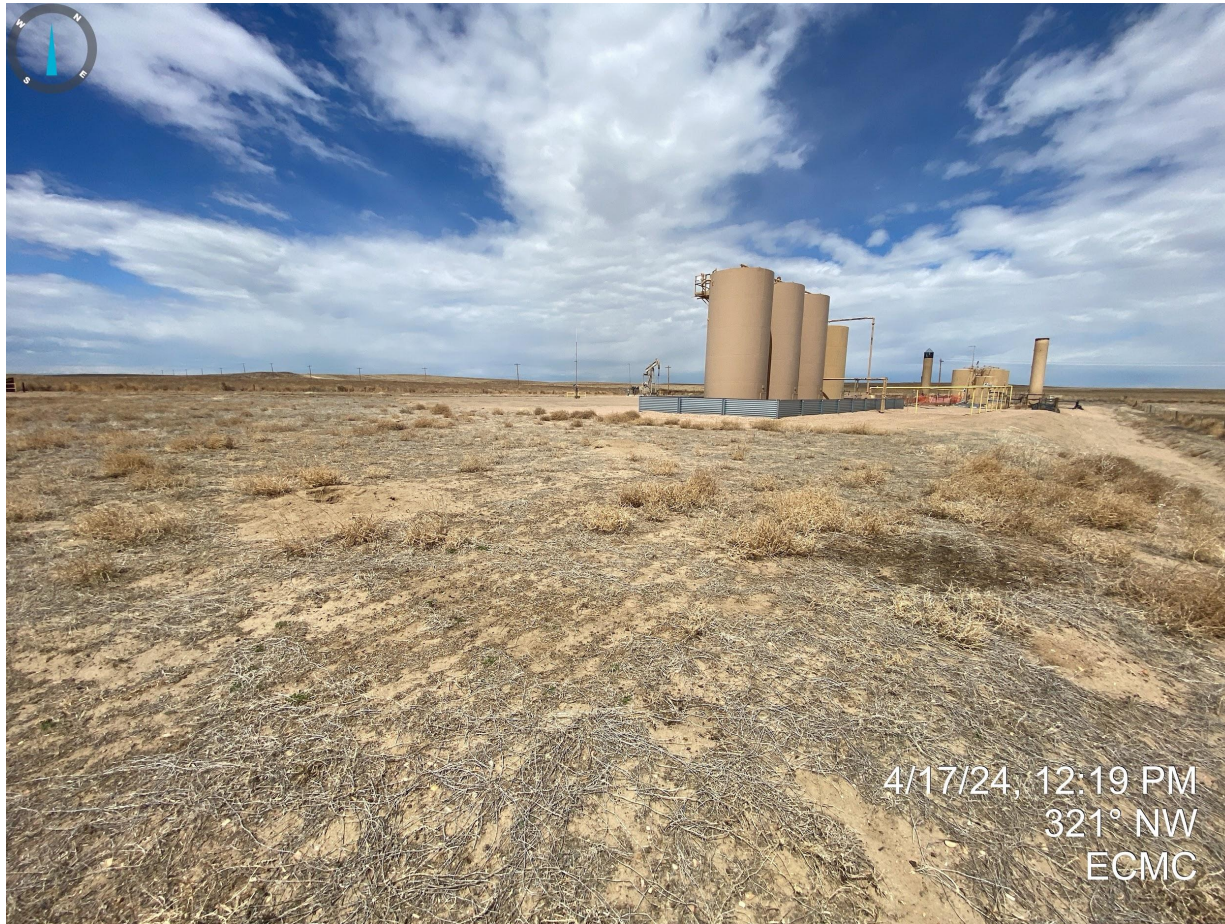
Photo 2. Southern interim areas are primarily undesirable vegetation (e.g. russian thistle).

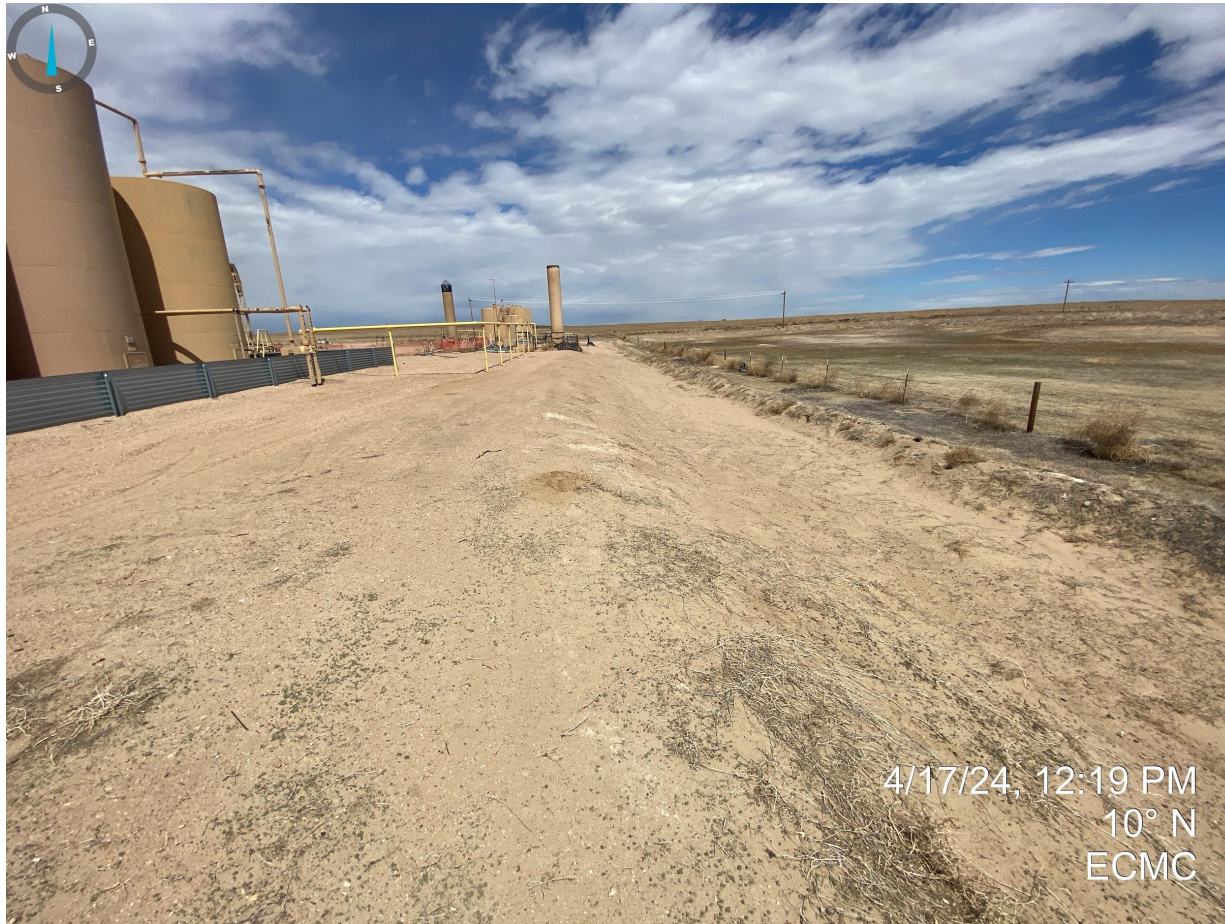
Photo 3. Production areas are not properly stabilized as they are primarily exposed soils.

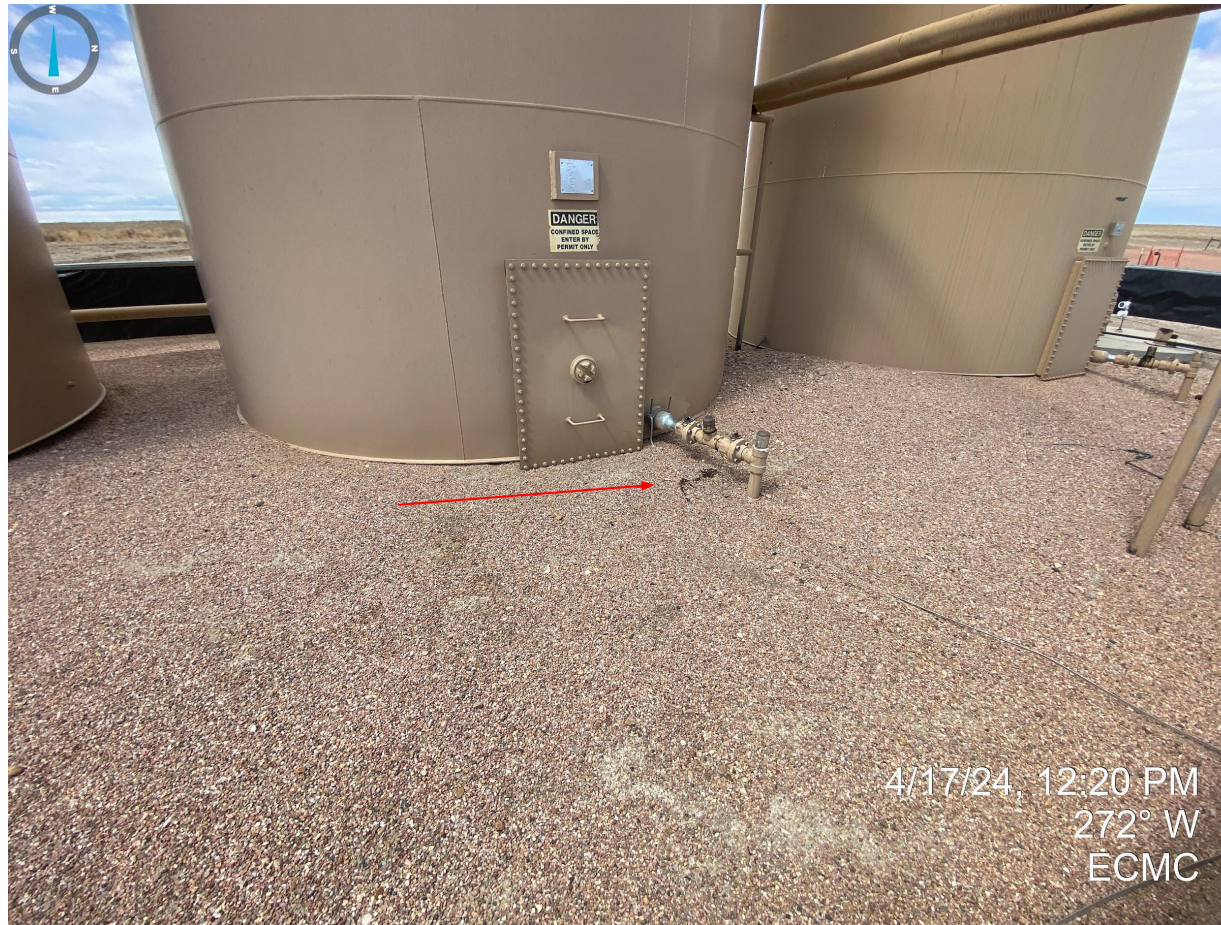
Photo 4. Stained soils on the east side of the tank battery.

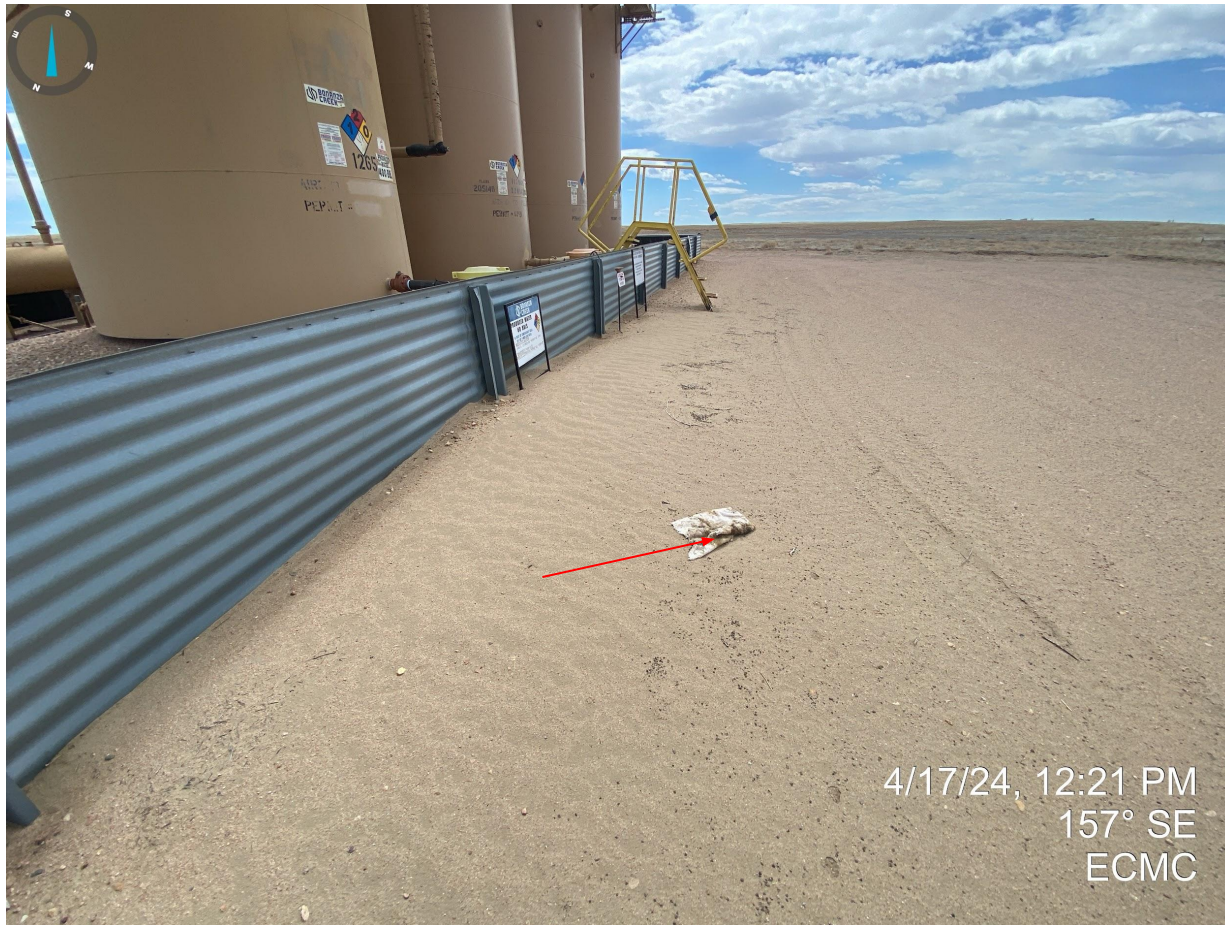
Photo 5. Debris near tank battery.

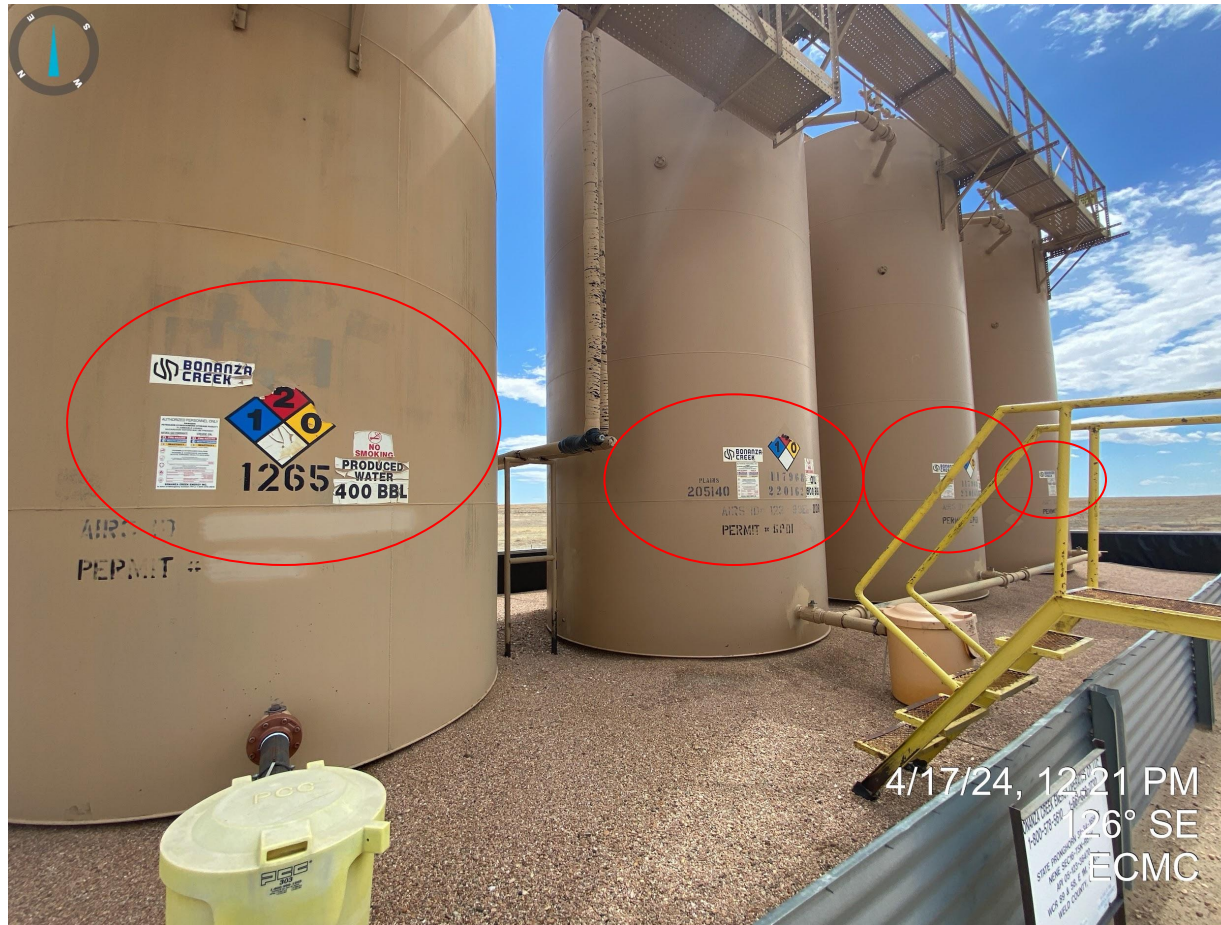
Photo 6. Tank labels are peeling/faded/cracked.

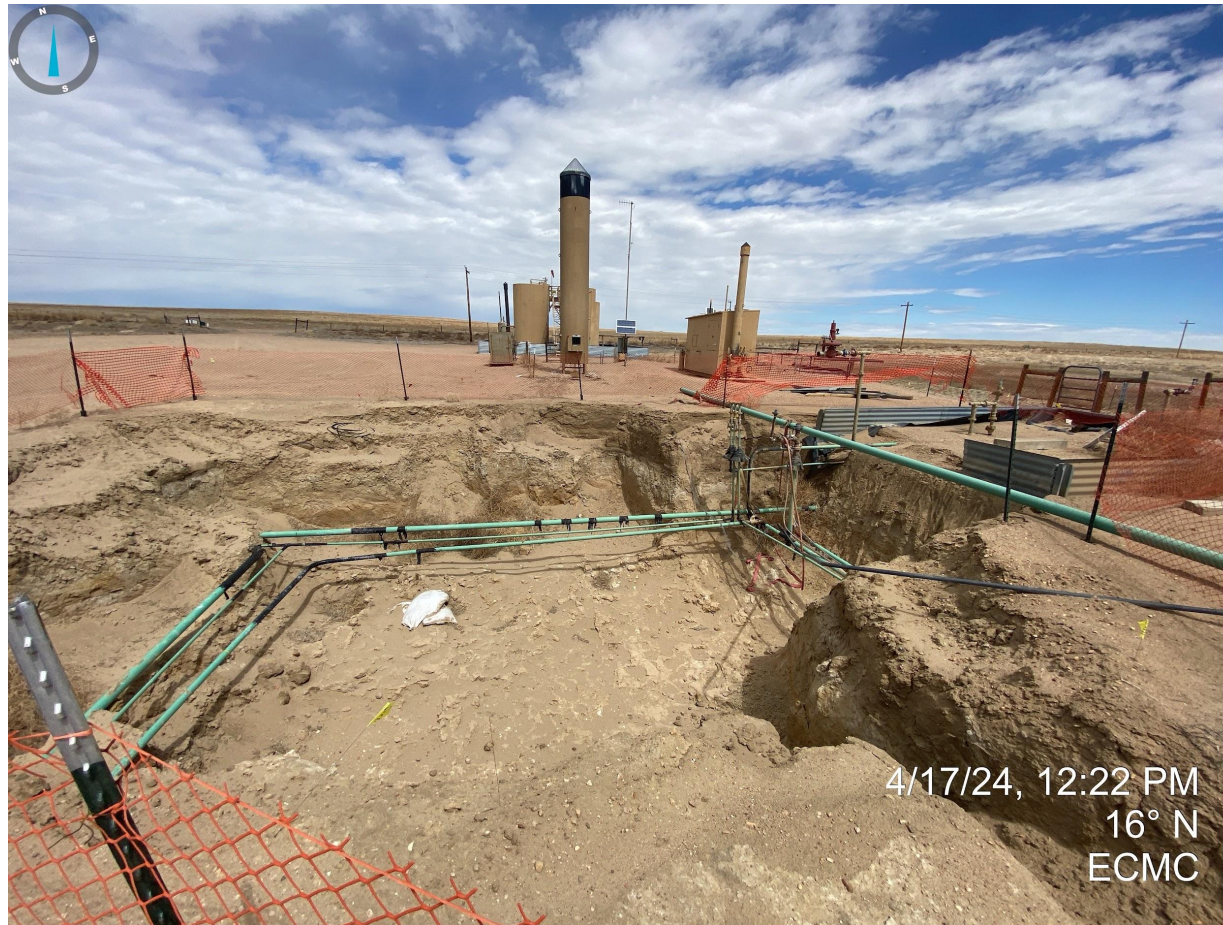
Photo 7. Open excavation in relation to remediation project #33589. Operator shall continue to follow 900 series rules for project closure and maintain fencing around all open excavations.

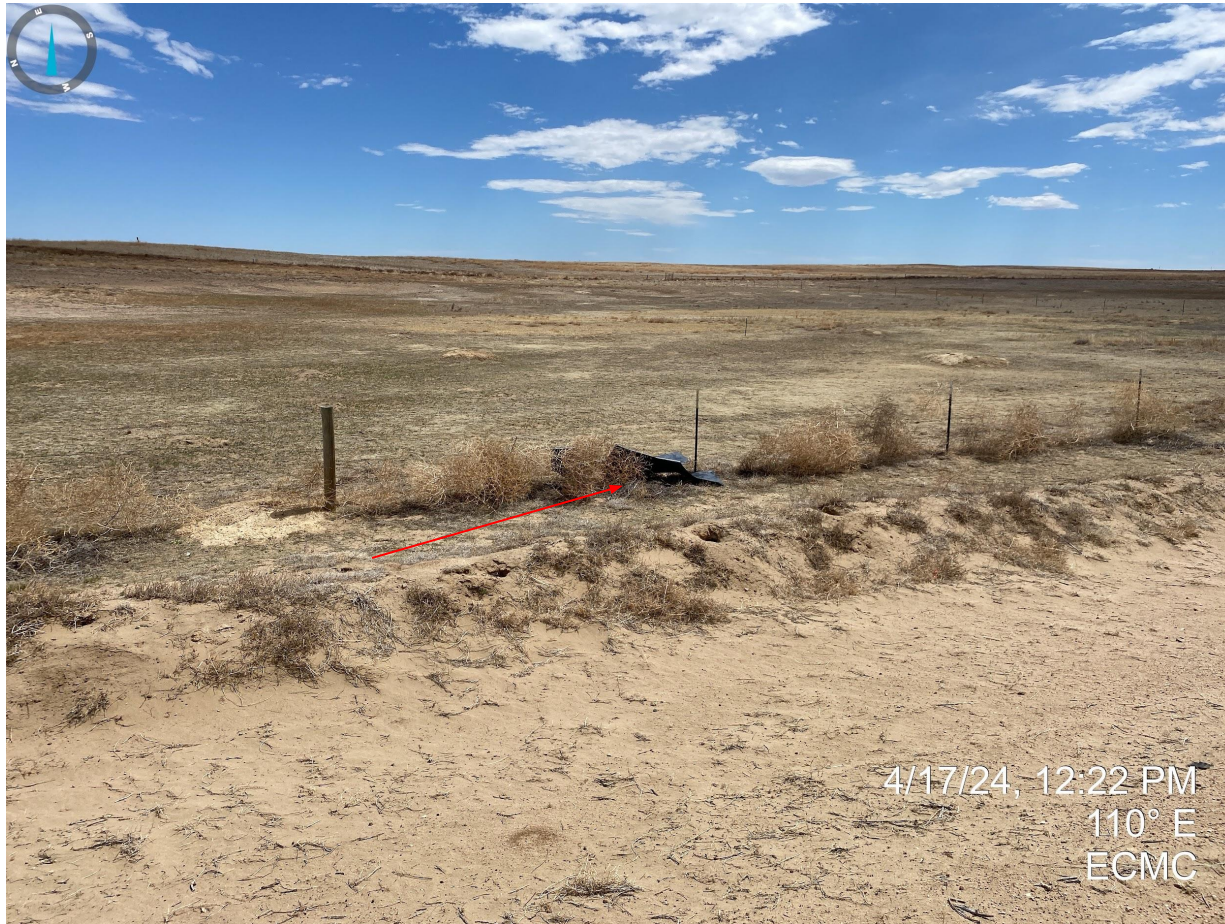
Photo 8. Debris observed on the east side of the location.

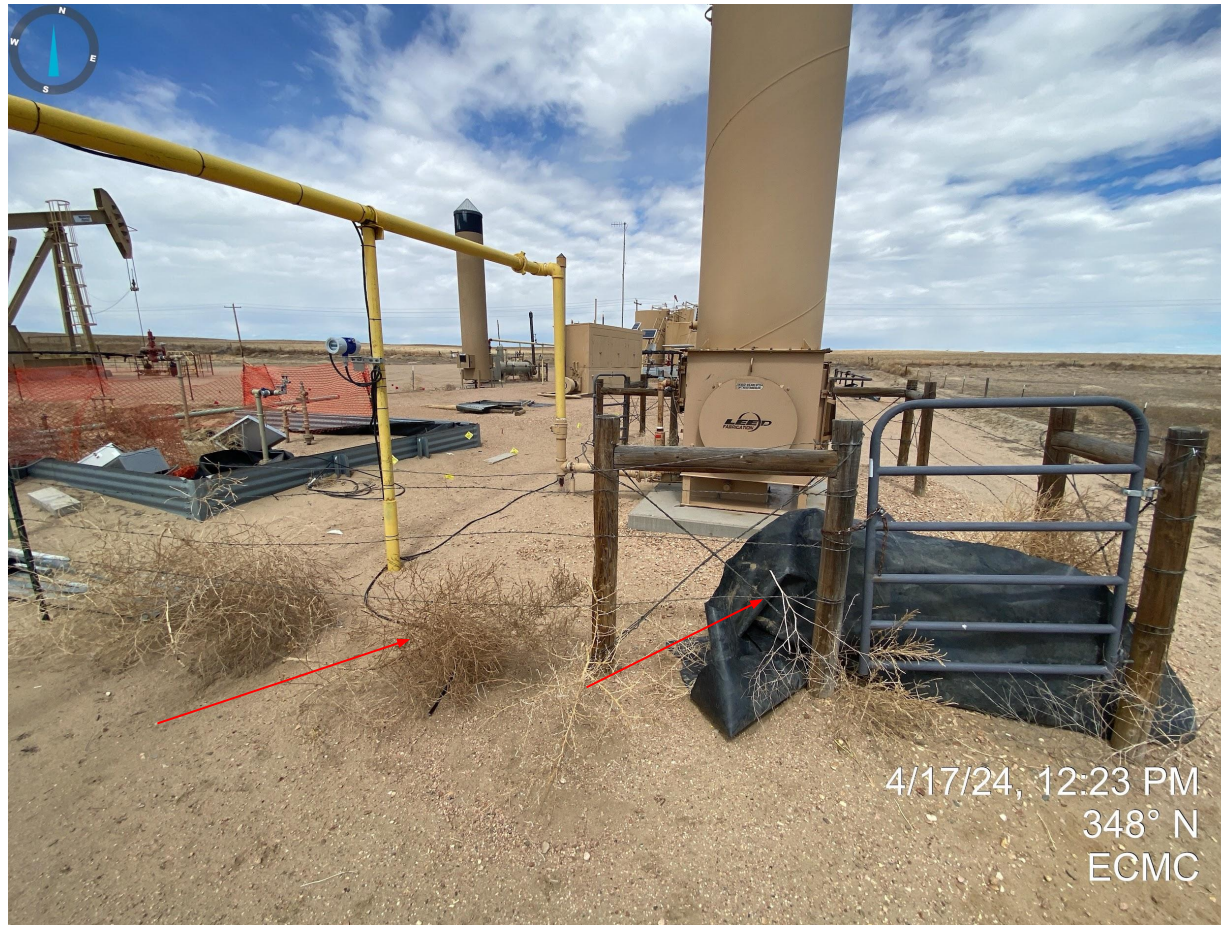
Photo 9. Debris, including tumbleweed accumulations around equipment, on east side of the location.

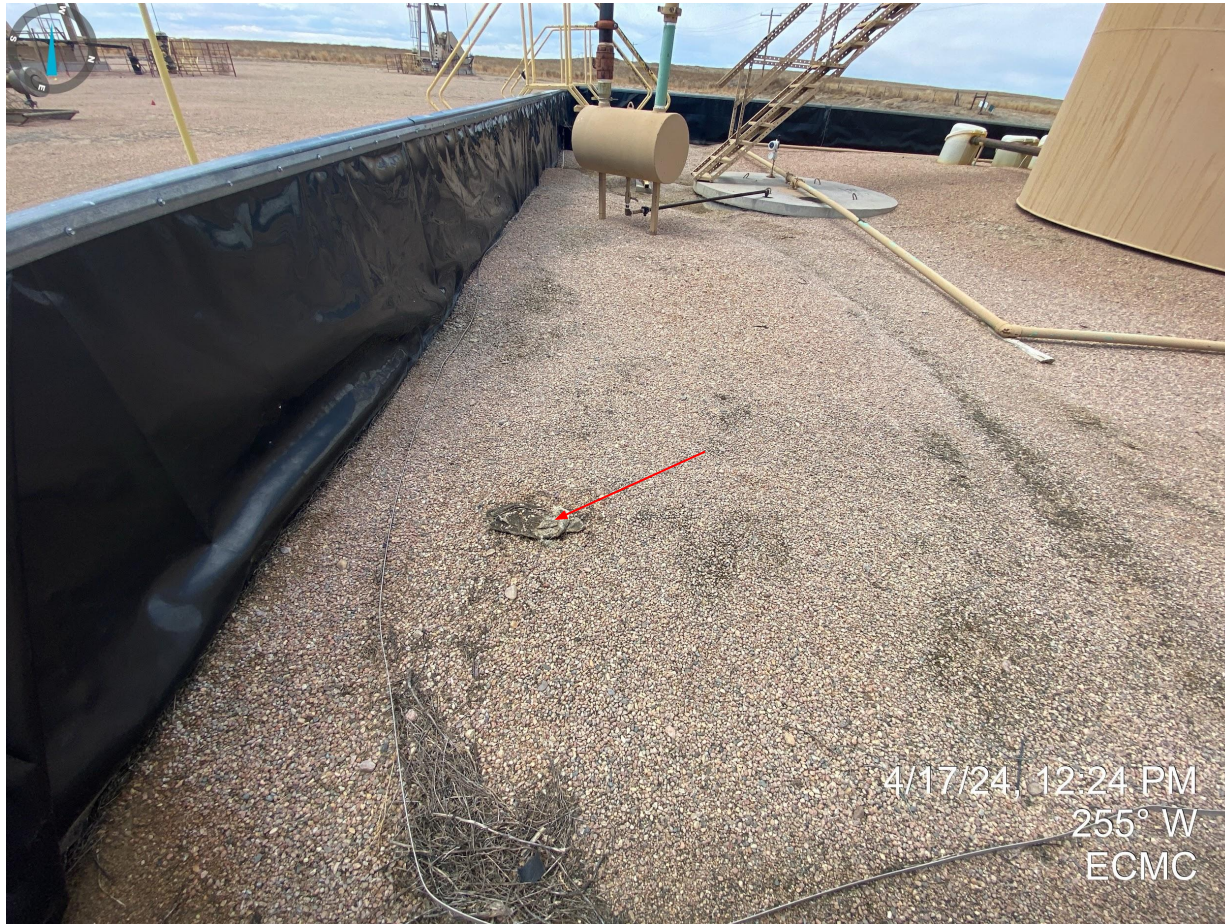
Photo 10. Debris/trash within tank battery secondary containment.

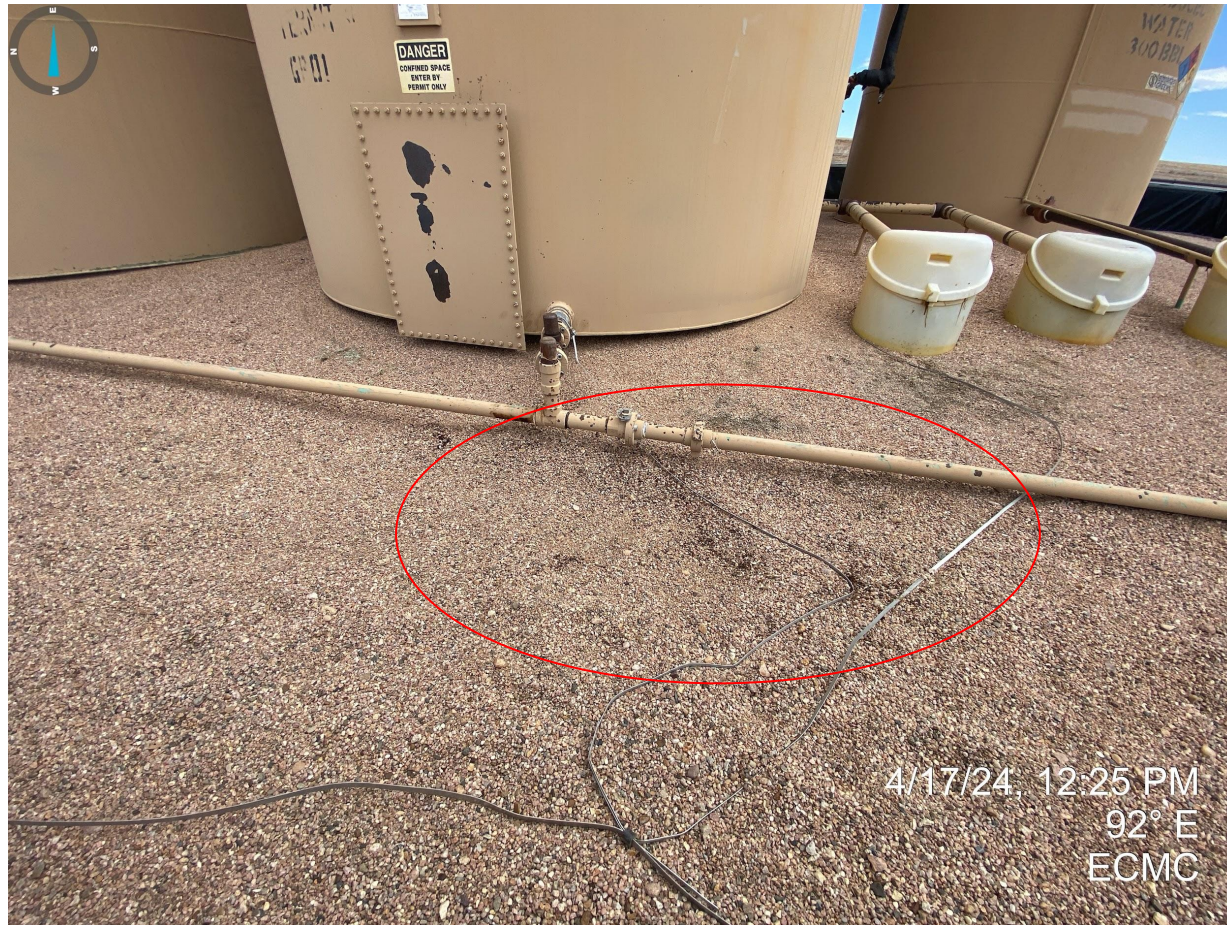
Photo 11. Stained soil at tank battery.

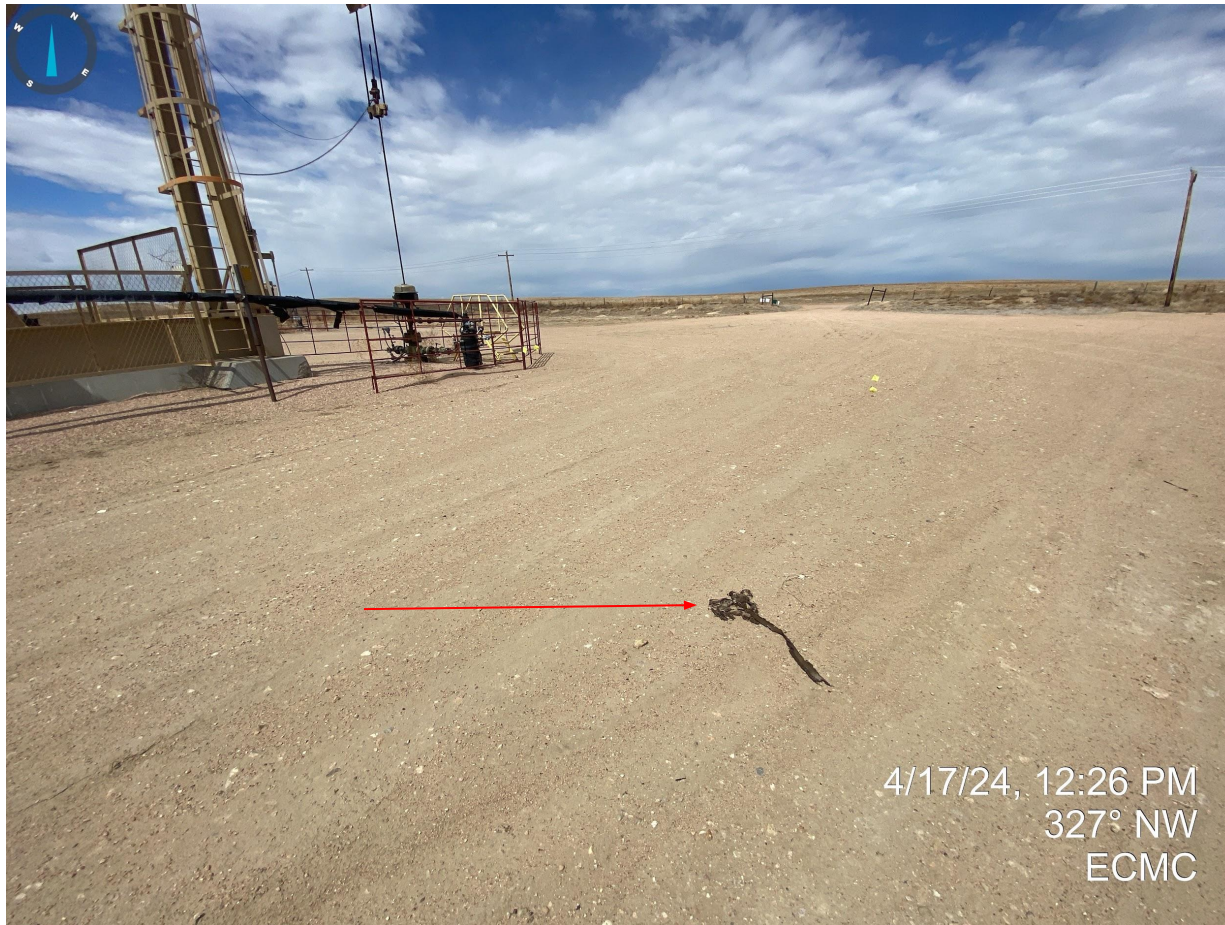
Photo 12. Debris near pumpjack.

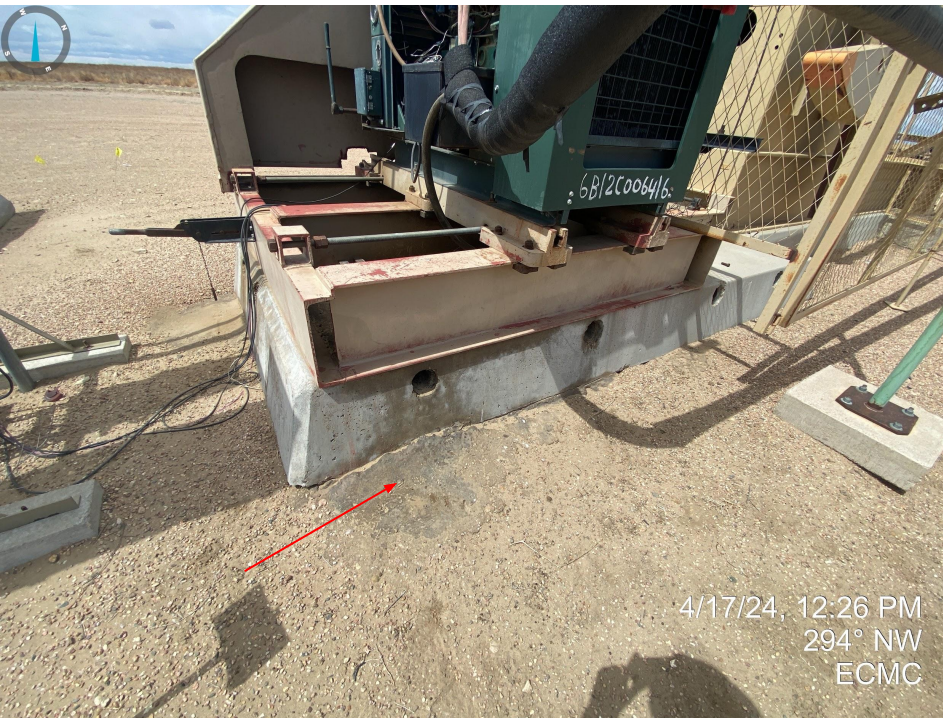
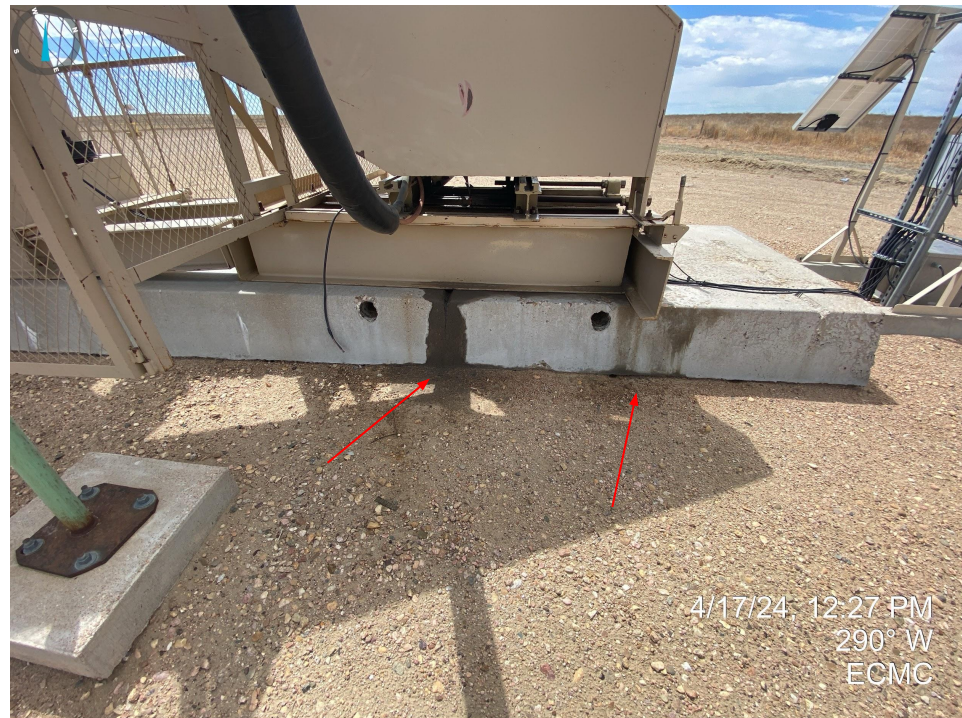
Photo 13. Stained soil at pumpjack well API 123- 35220 (left) and well API 123-36470 (right).

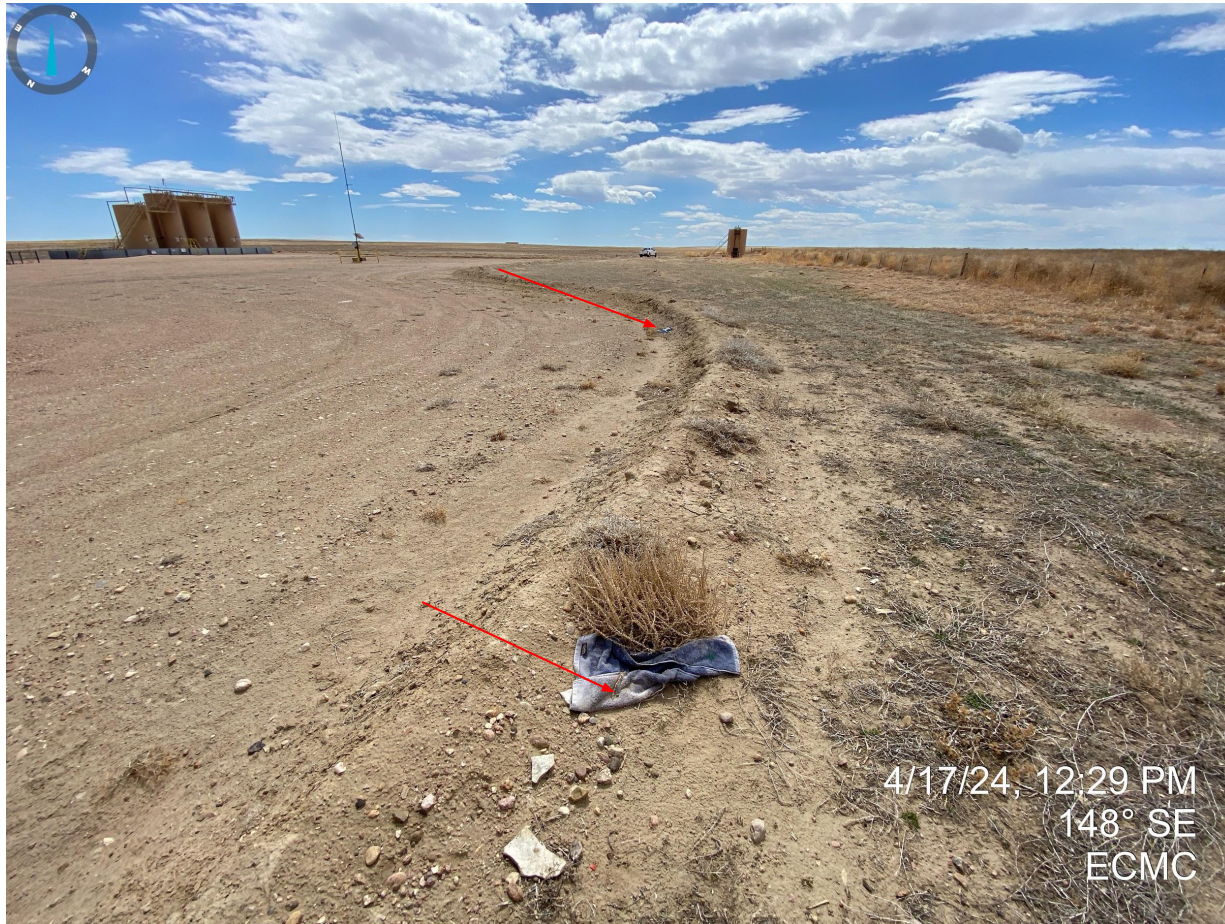
Photo 14. Debris/trash observed on the west side of the location.

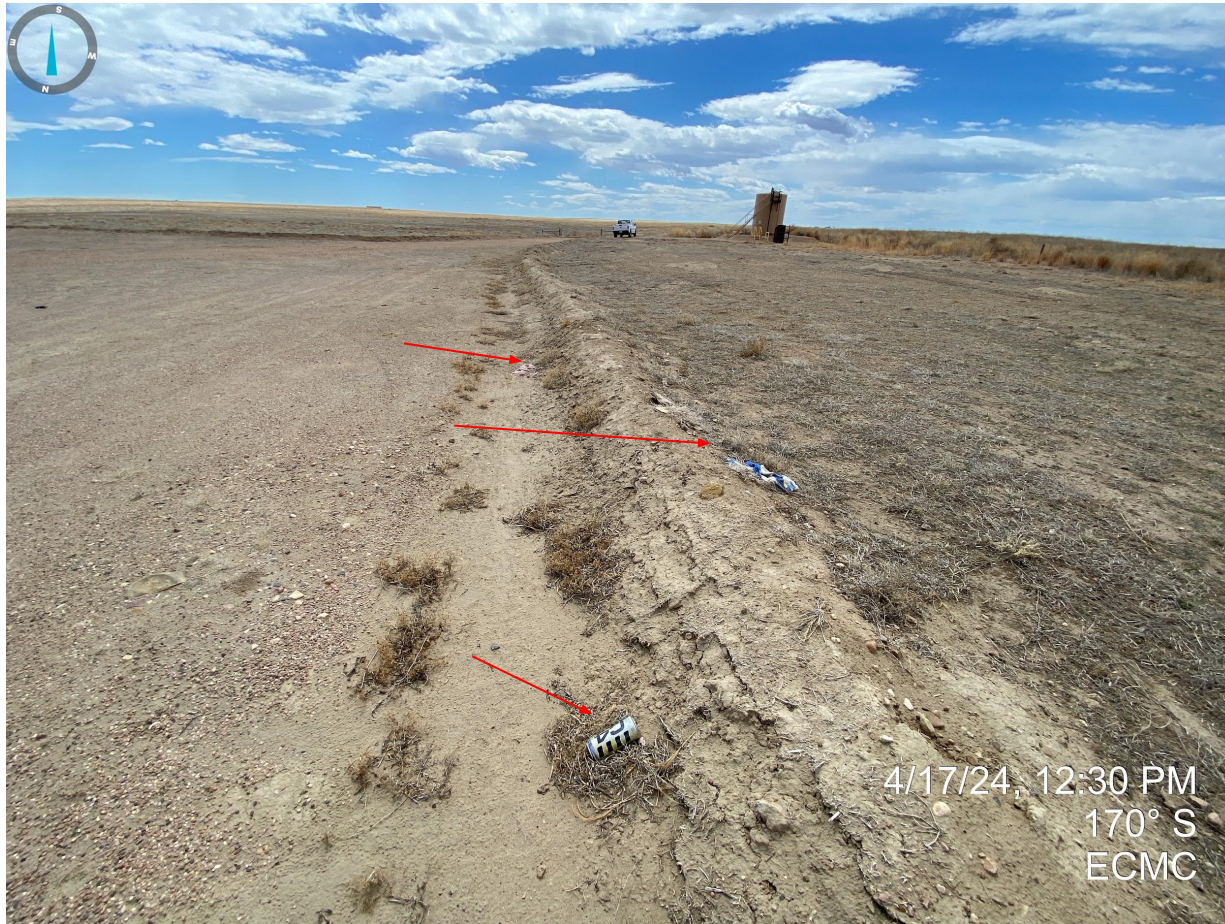
Photo 15. Debris/trash observed on the west side of the location.

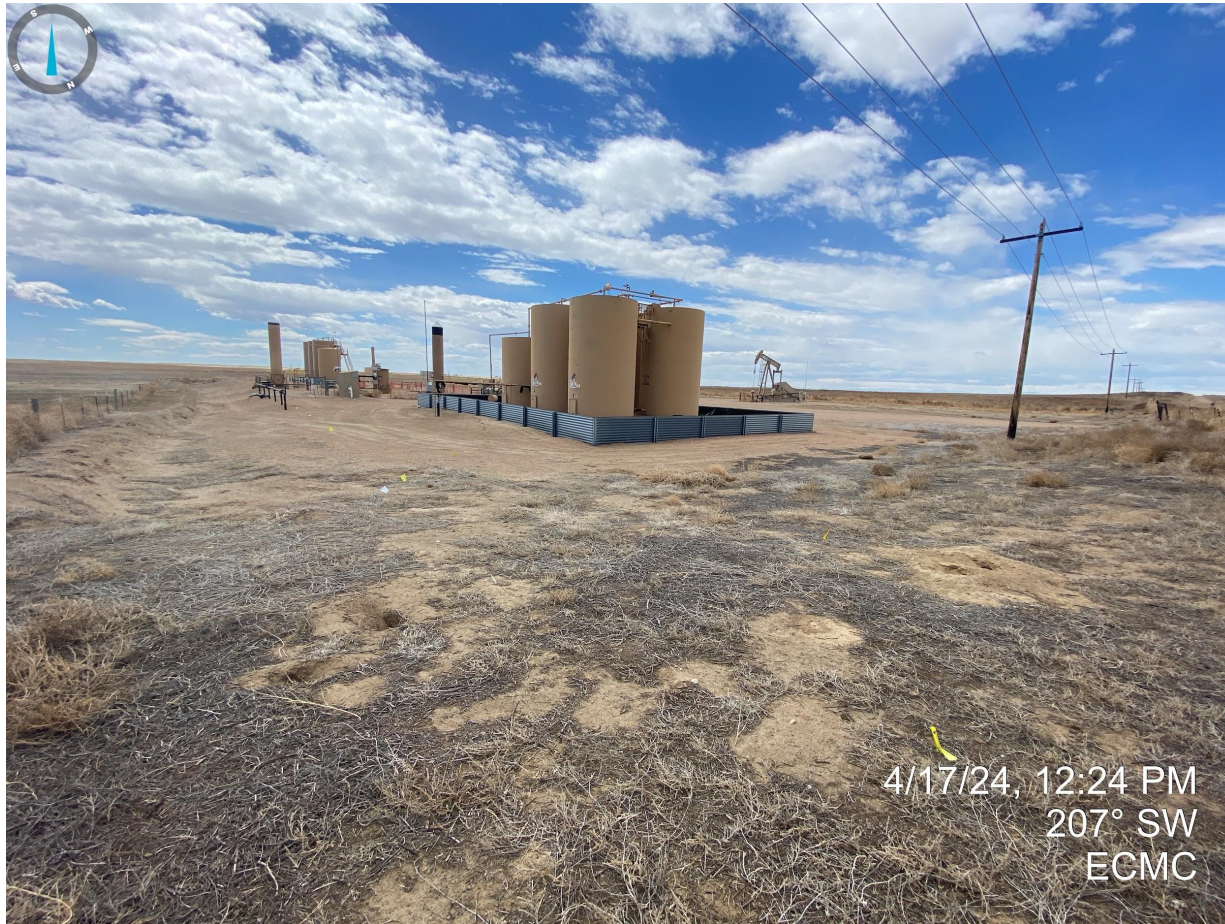
Photo 16. Northern interim areas are primarily undesirable vegetation (e.g. russian thistle) and weed debris.

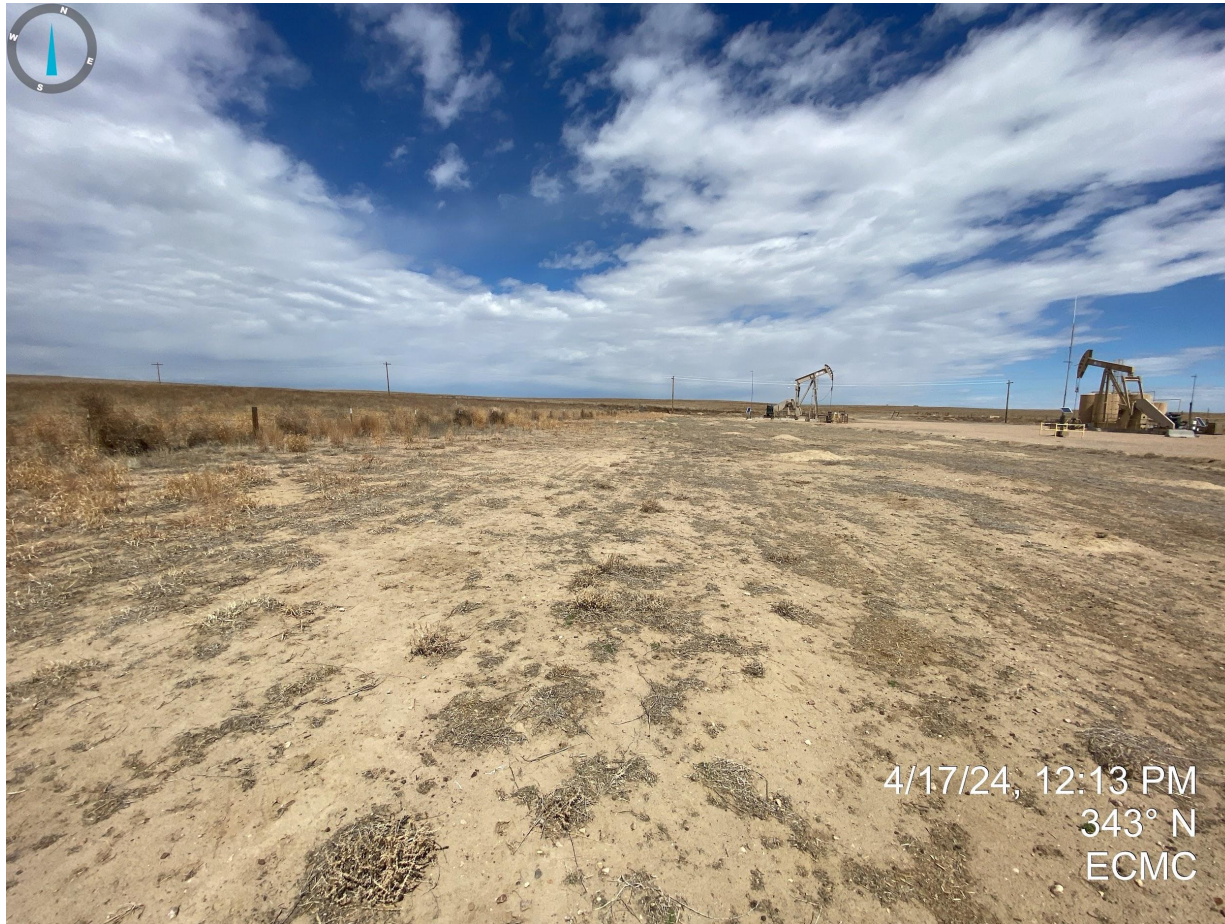
Photo 17. Western interim areas are primarily exposed soils.
