Inspection Photos

Location Name: Story Gulch Unit H34 496 Pad

Location ID: #335941

Inspection Date: April 18, 2024

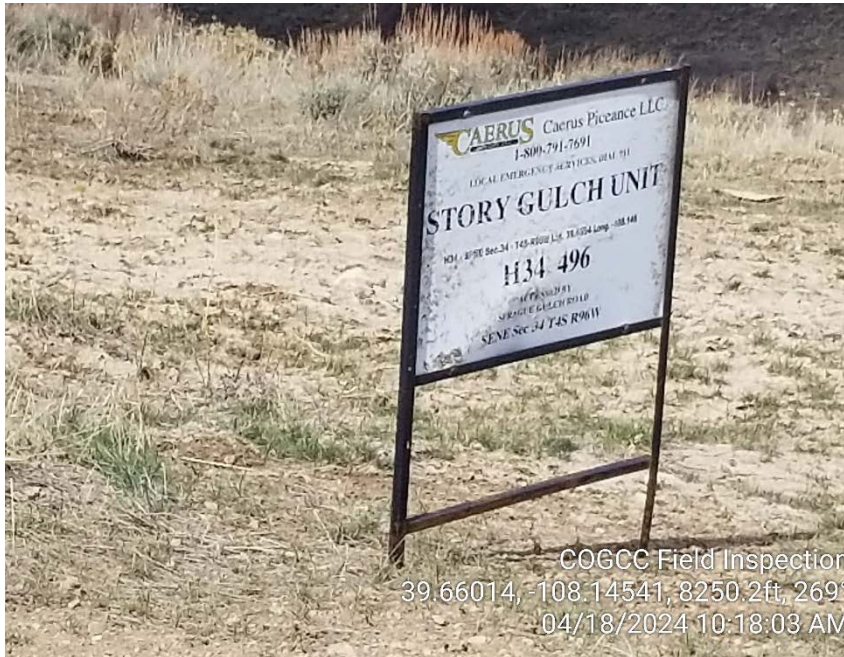
Photo #1 – Sign at entrance to pad.

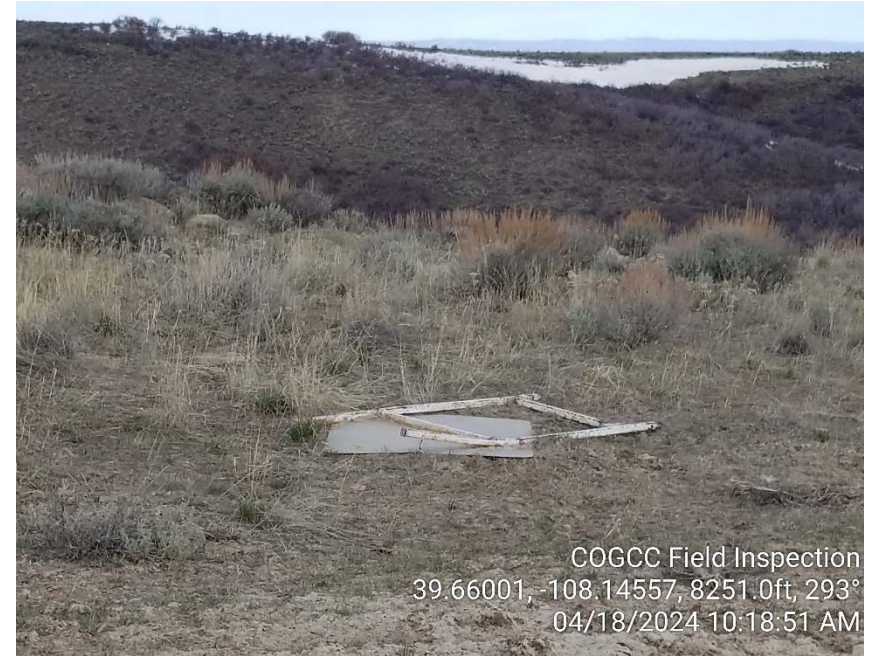
Photo #2 – Unused sign/debris located at NW corner of pad.

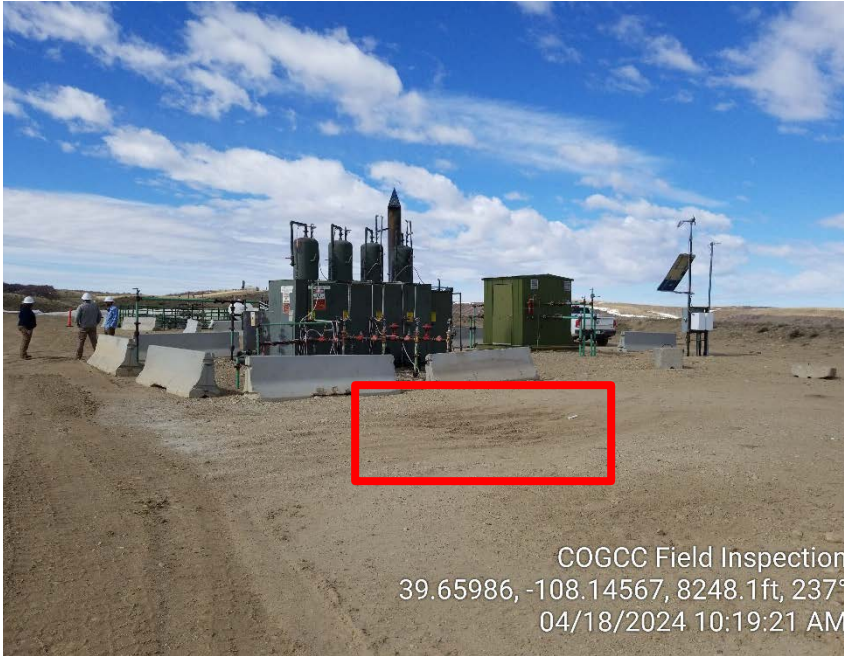
Photo #3 – Rutted area north of separators.

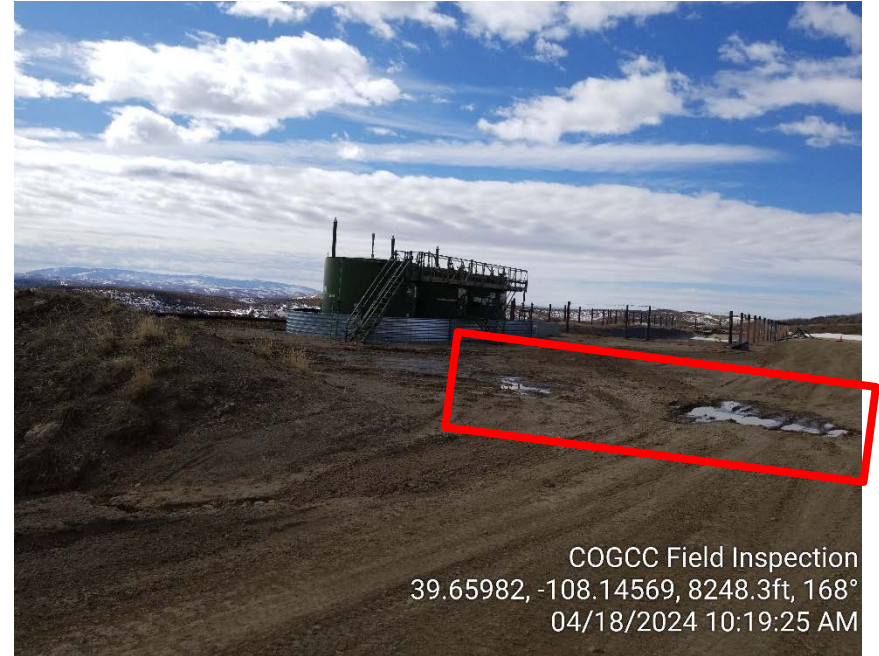
Photo #4 – Rutted area at pad entrance and north of tank battery.

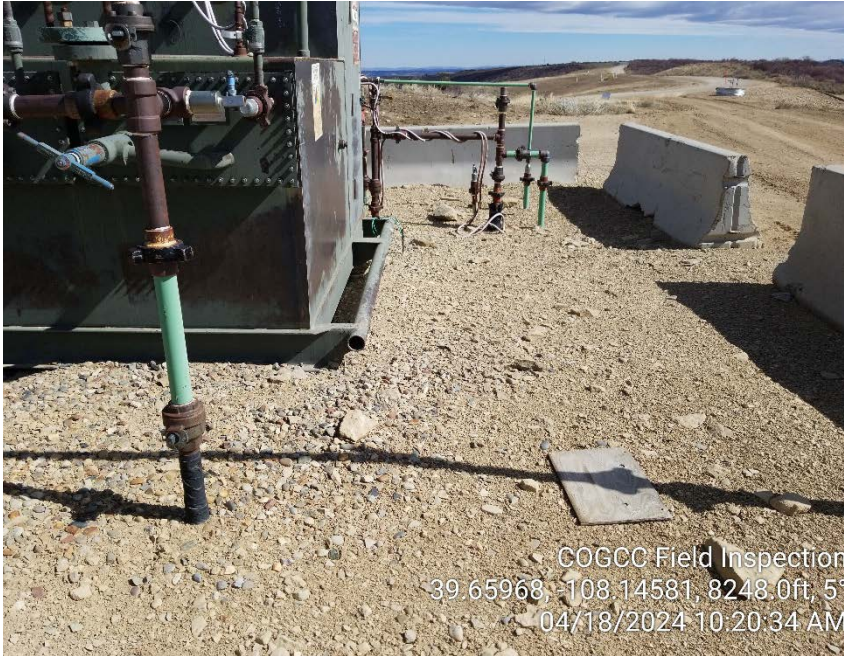
Photo #5 – Trash and debris in separator area.

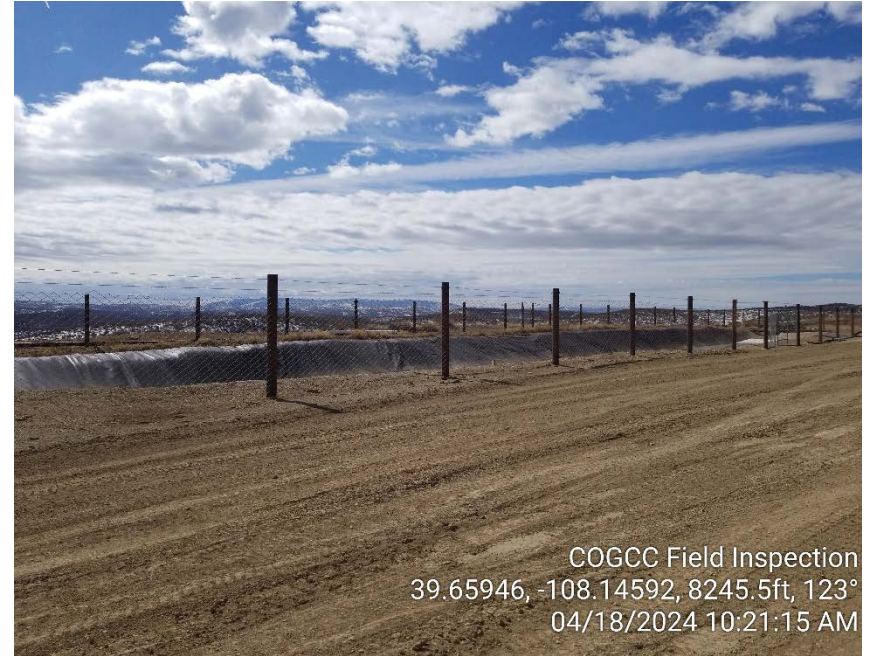
Photo #6 – View of freshwater pit from northwest.

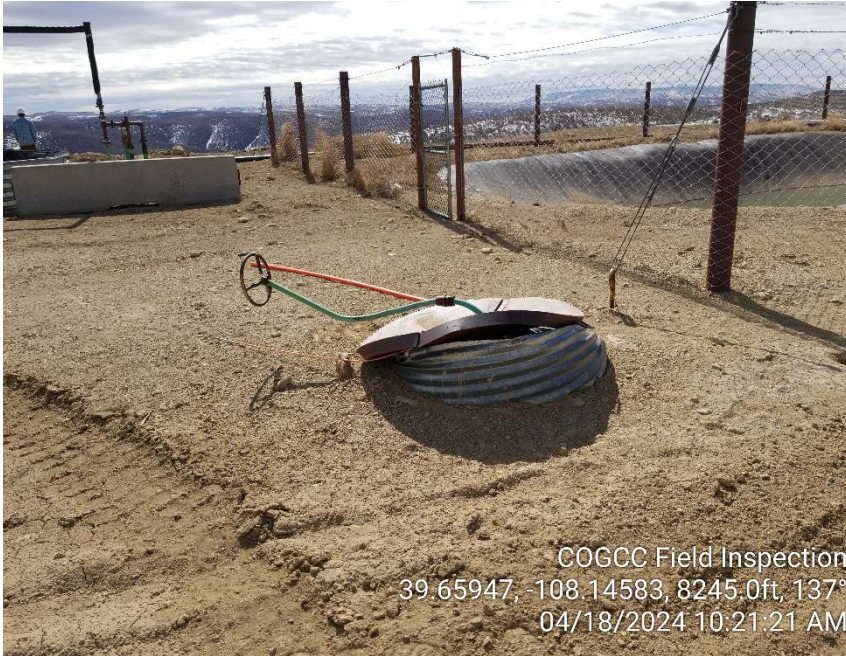
Photo #7 – Damaged valve can at NW corner of pit.

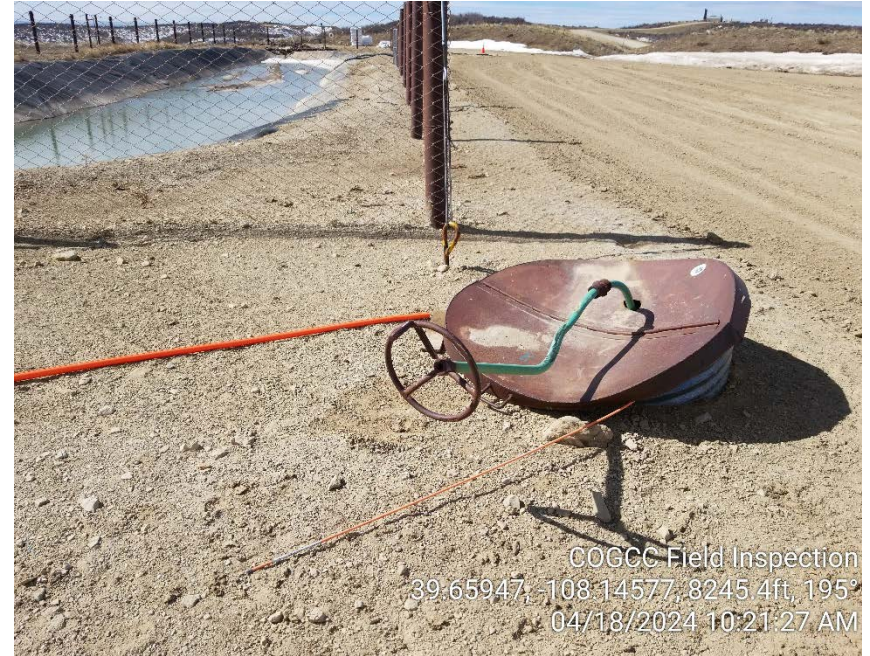
Photo #8 - Damaged valve can at NW corner of pit (2).

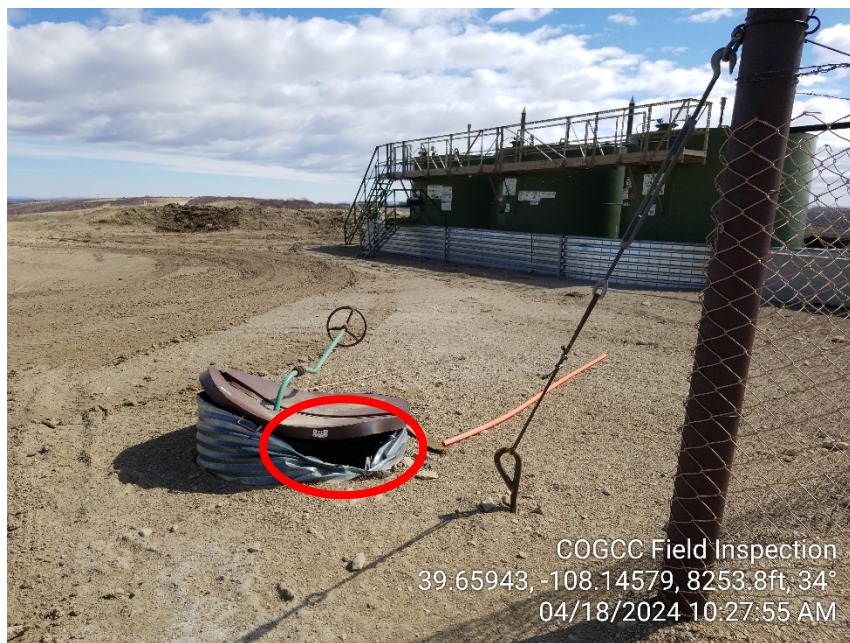
Photo #9 - Damaged valve can at NW corner of pit (3).

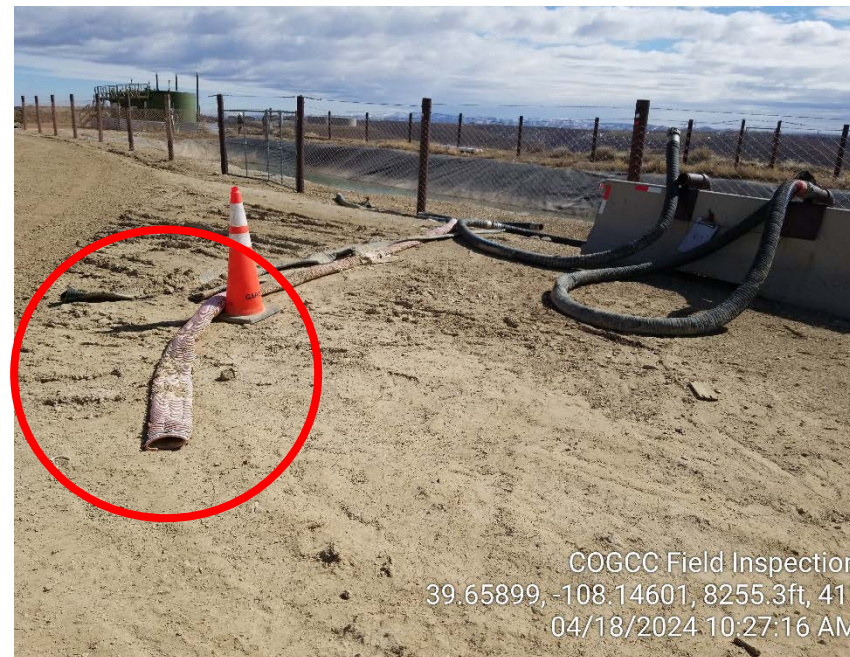
Photo #10 – Hose storage on west side of pit.

Note: hoses in high traffic area appeared to have been damaged by vehicle traffic.

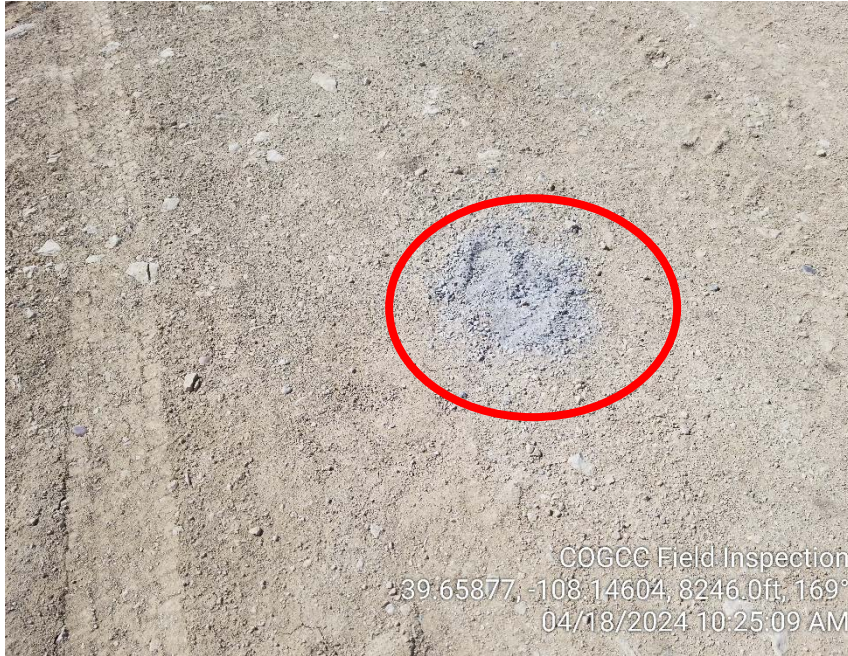
Photo #11 – Unidentified, gray material on pad surface toward south end of pad.

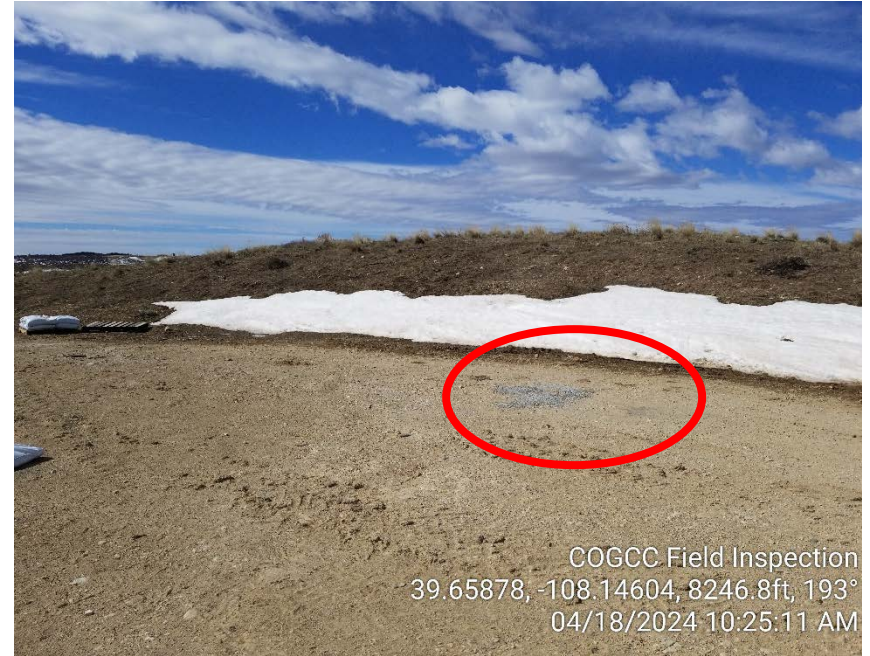
Photo #12 – Larger accumulation of unidentified, gray material on pad surface toward southwest end of pad.

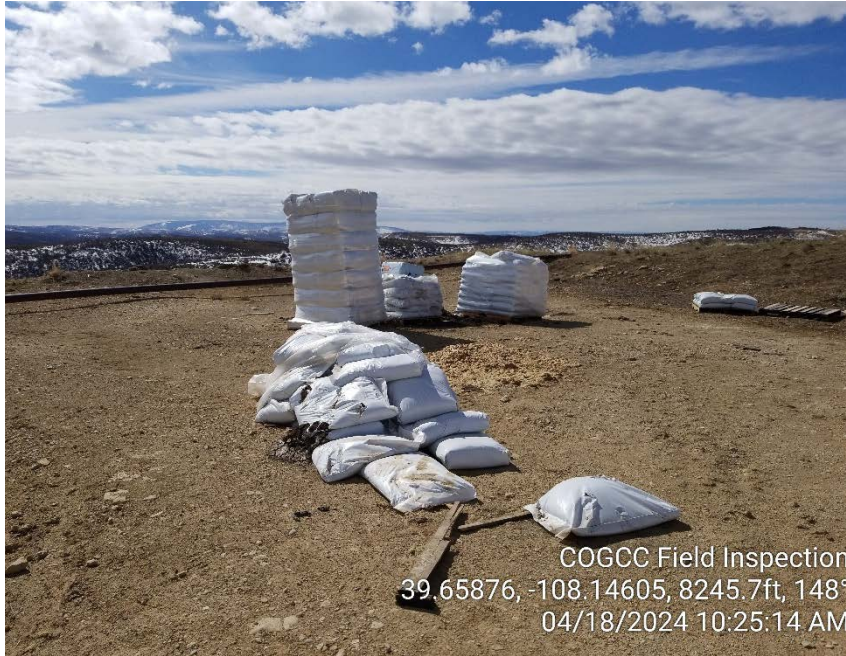
Photo #13 – Materials storage south of pit (Richlawn turf food).

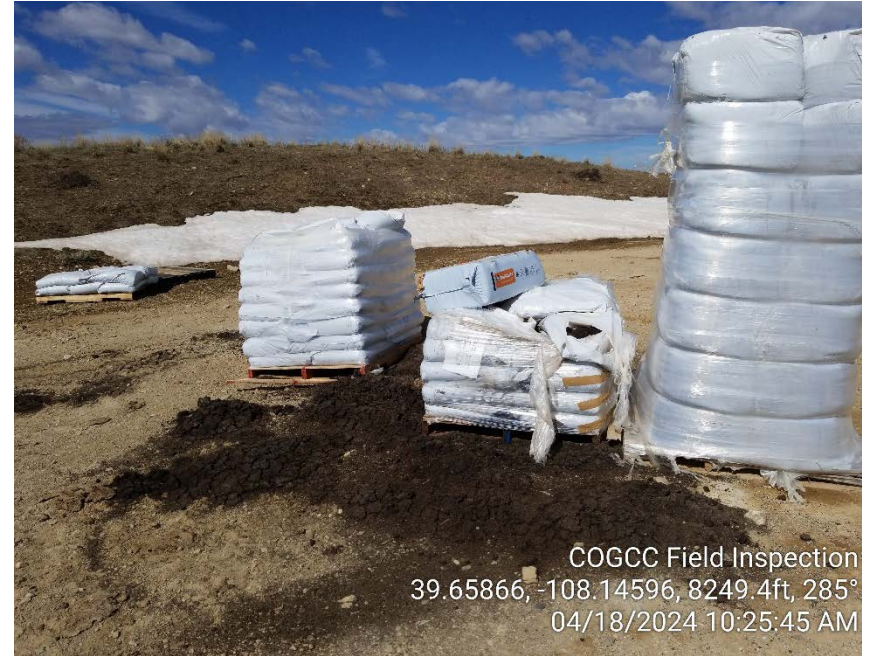
Photo #14 – Damaged containers of soil amendments.

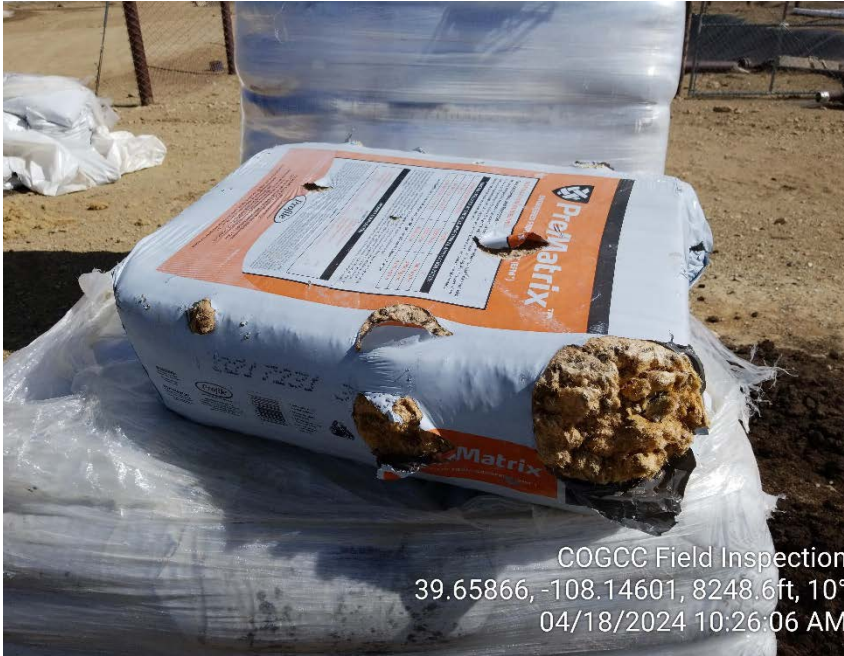
Photo #15 – Damaged container of Profile ProMatrix Engineered Bonded Fiber Matrix in storage area.

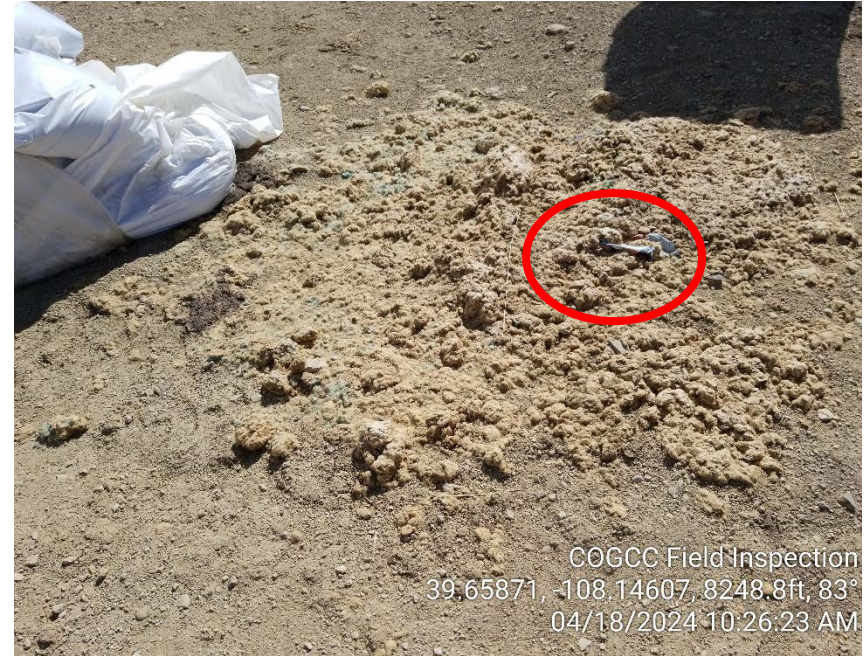
Photo #16 - Former container of Profile ProMatrix Engineered Bonded Fiber Matrix in storage area.

Note: this material still contained portions of the wrapping (circled in red).

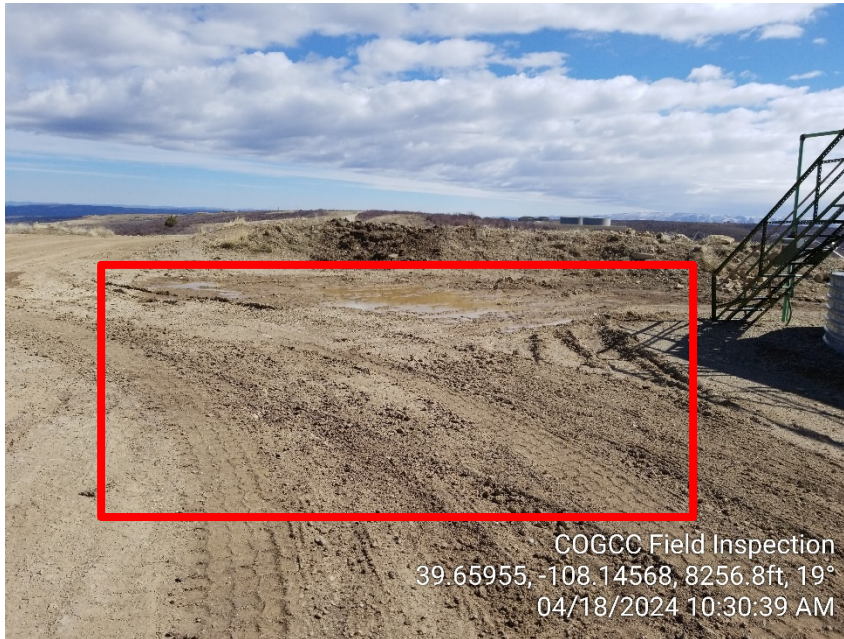
Photo #17 – Rutted area north of tank battery (view from SW).

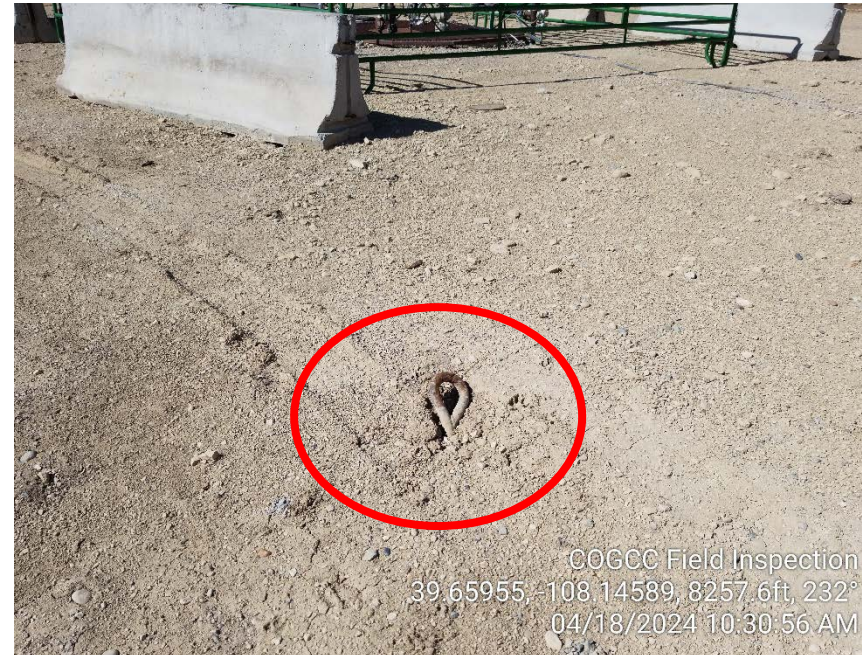
Photo #18 – Unmarked rig anchor located northeast of wellheads.

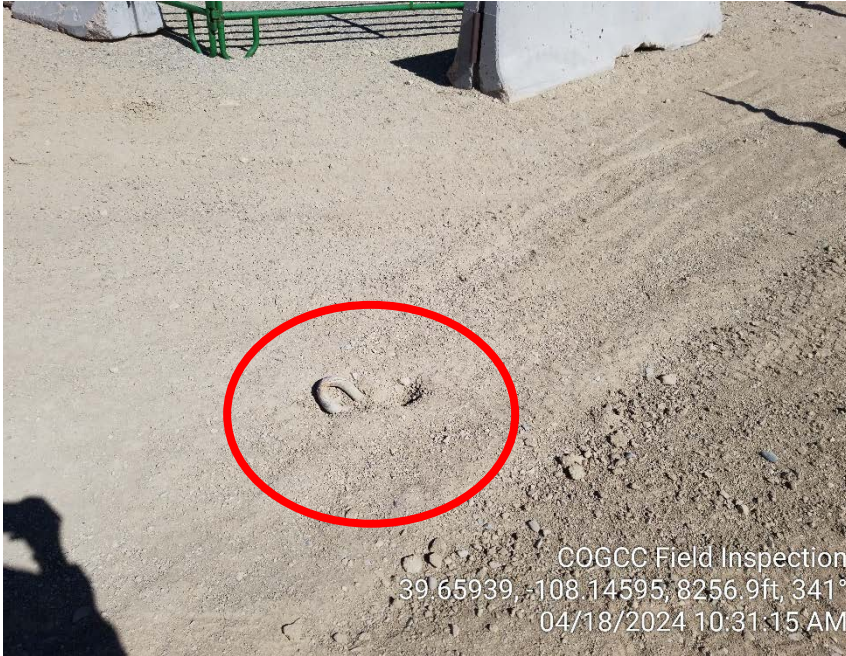
Photo #19 - Unmarked rig anchor located southeast of wellheads.

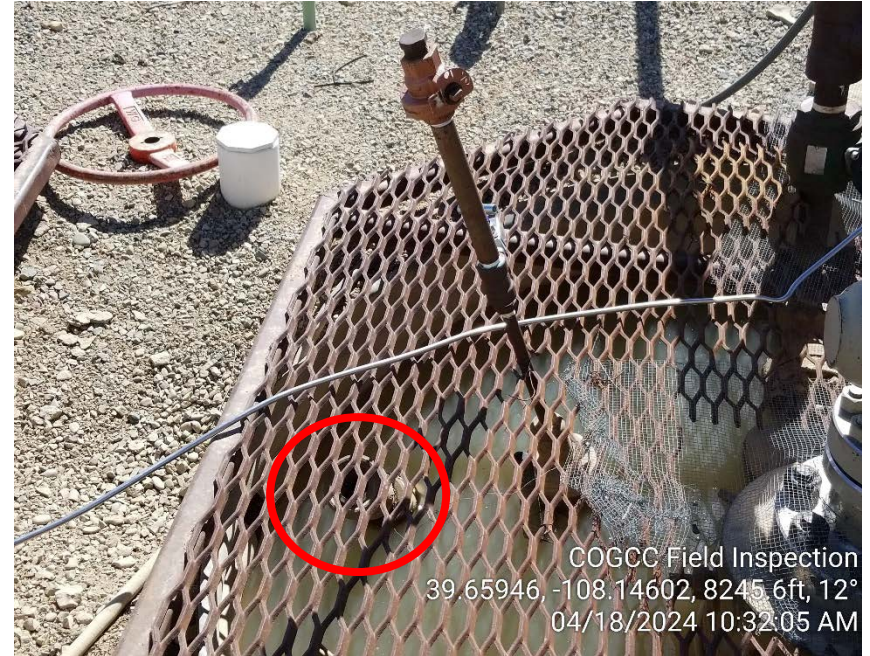
Photo #20 – Uncapped wellhead equipment in well cellar.

Note: Well cellar contained unidentified fluid on inspection date. No hydrocarbon odors or sheen were observed in this area during inspection.

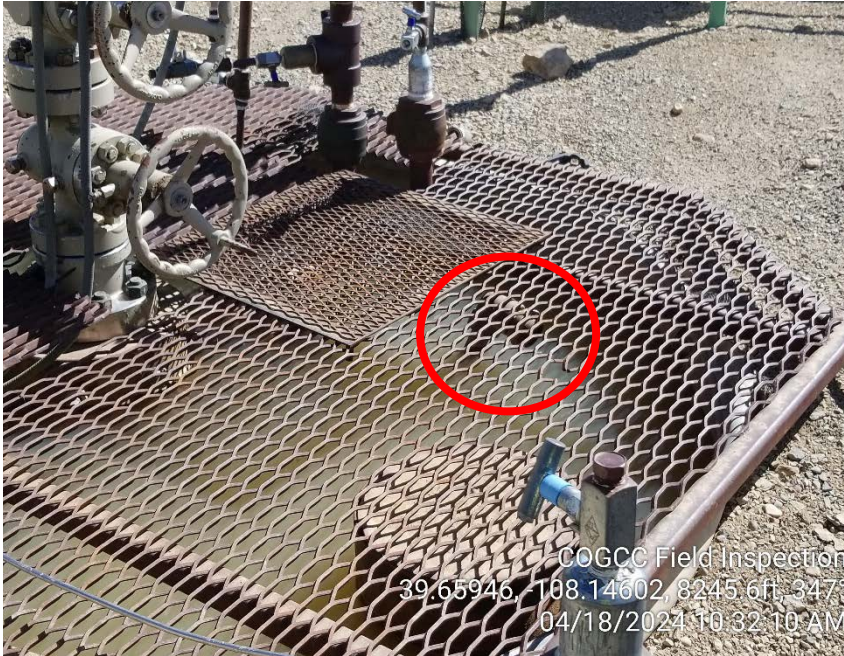
Photo #21 - Uncapped wellhead equipment in well cellar.

Note: Well cellar contained unidentified fluid on inspection date. No hydrocarbon odors or sheen were observed in this area during inspection.

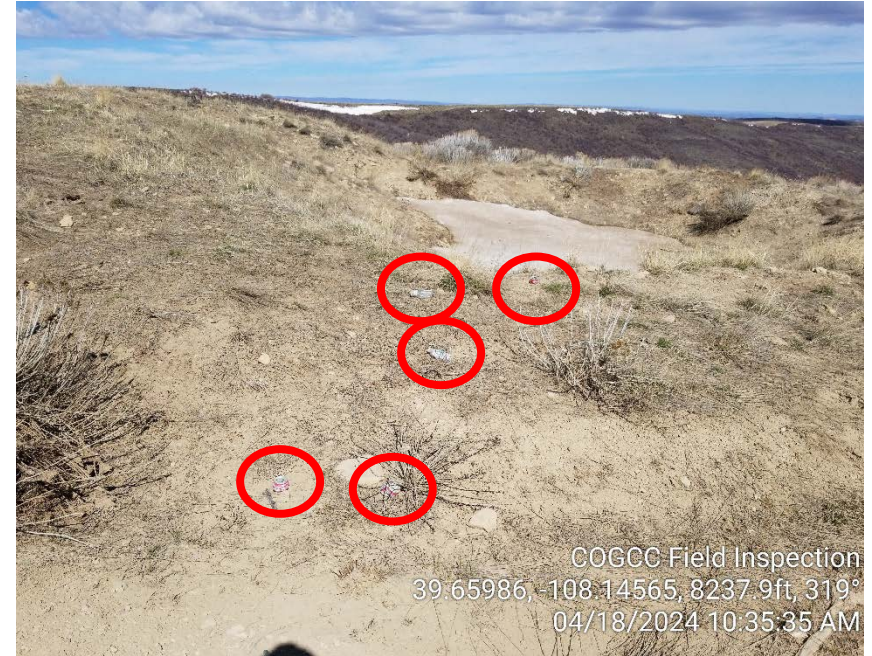
Photo #22 – Trash observed at entrance to pad, looking NW.

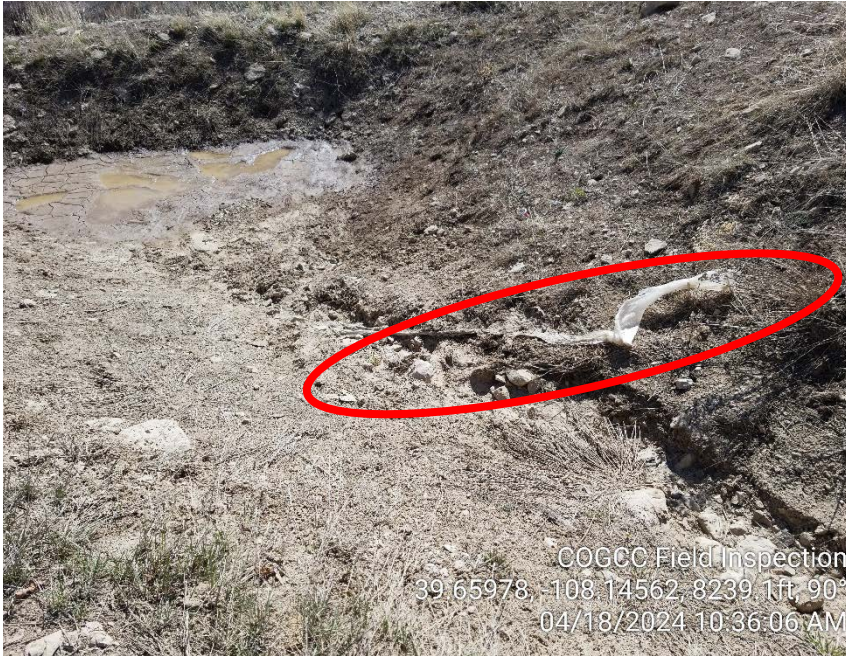
Photo #23 – Trash inside of retention pond located at NE corner of pad.
