# Inspection Photos

API: 055-06316

Operator: OXY USA INC

Inspection Date: 4/16/2024

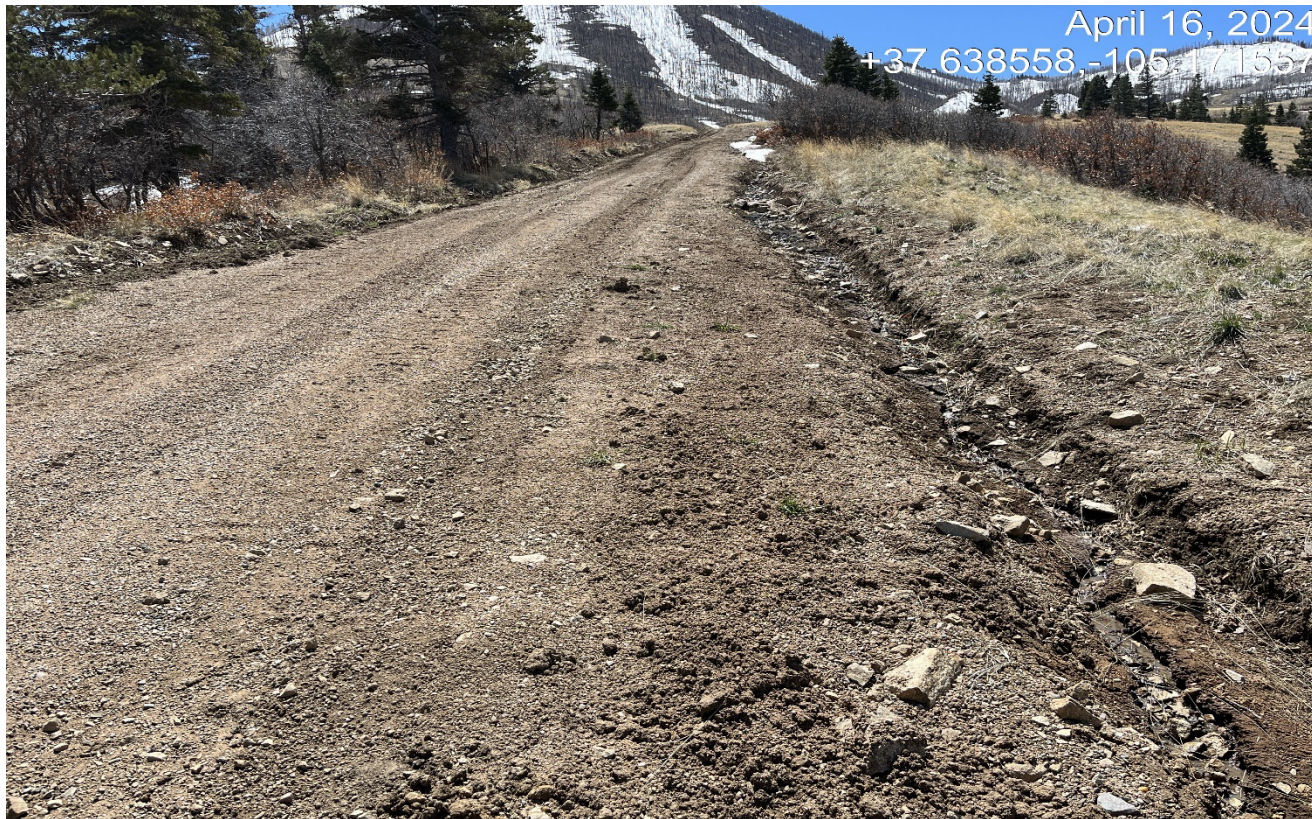
**Photo 1.** Facing south along the access road. There is erosion along the roadside that has not been repaired and BMP's have not been installed. Previous corrective action has not been completed.

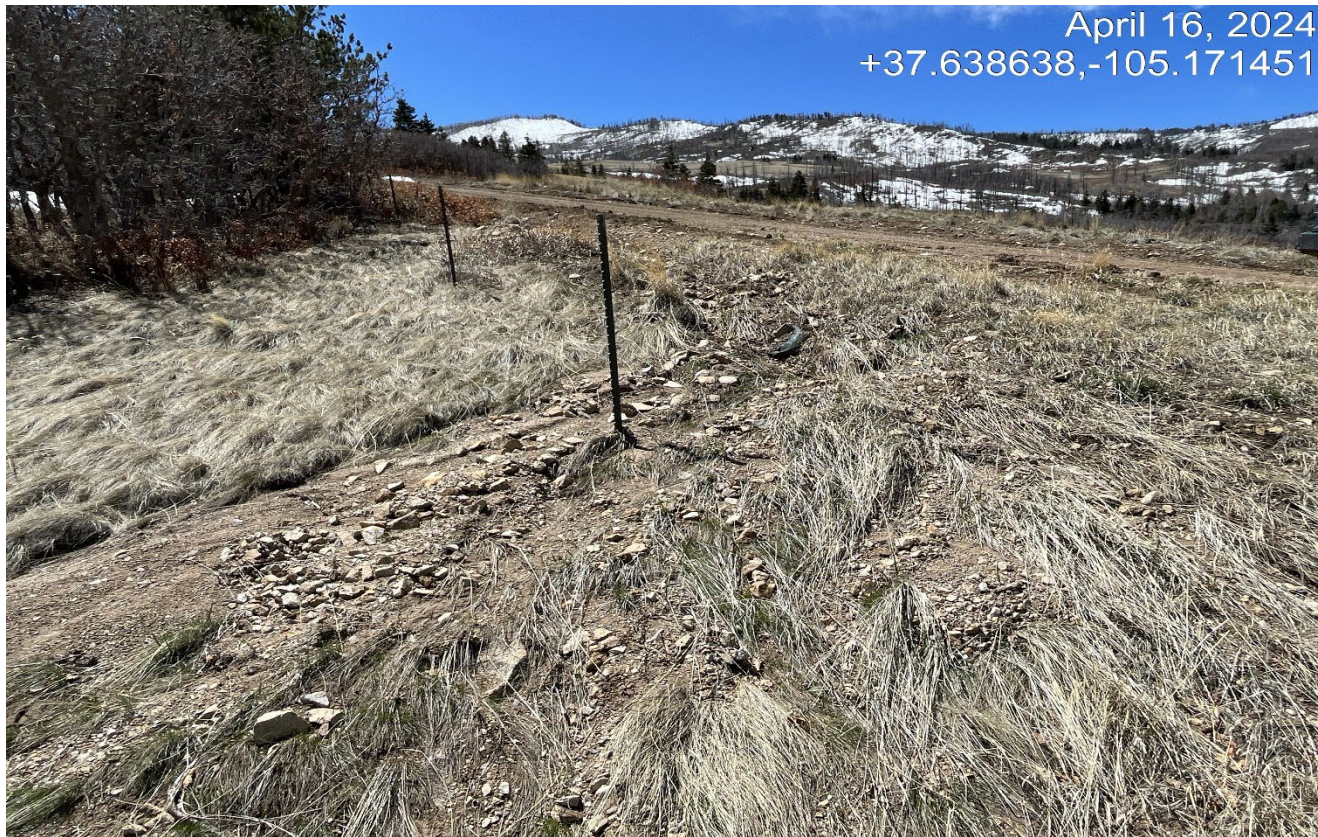
**Photo 2.** There is sediment that has been transported offsite along the road.

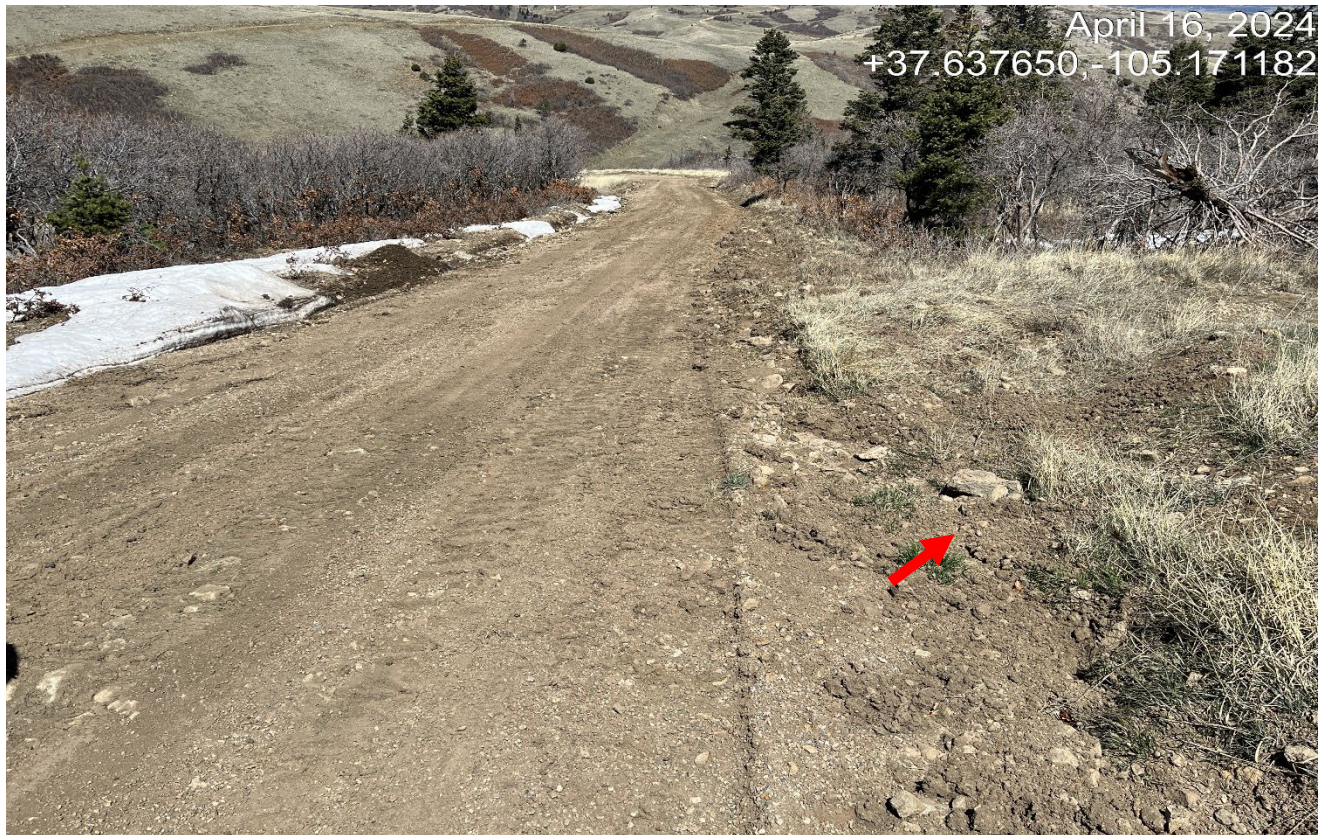
**Photo 3.** Facing back north the steep grade of access road. Stormwater is not being diverted off the road which is causing erosion of the road. Stormwater should be divert toward red arrow and into a sediment trap.

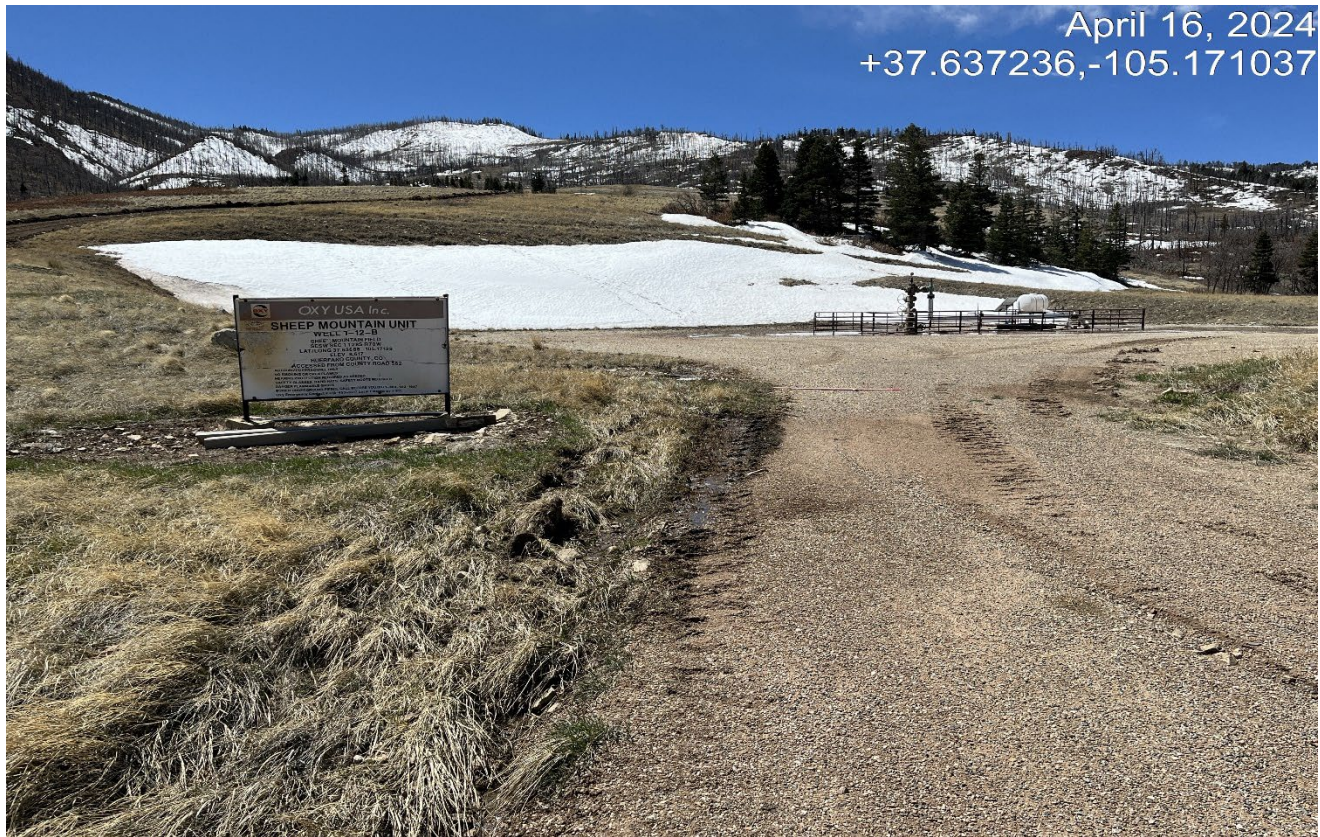
**Photo 4.** Facing southwest toward the wellsite.
