Construction and Stormwater Inspection

Date: 04/19/2024

Operator: PDC ENERGY INC - 69175

Inspection Photos
Location Name: Denali State 5N67W13 1-23
Location ID: 485098

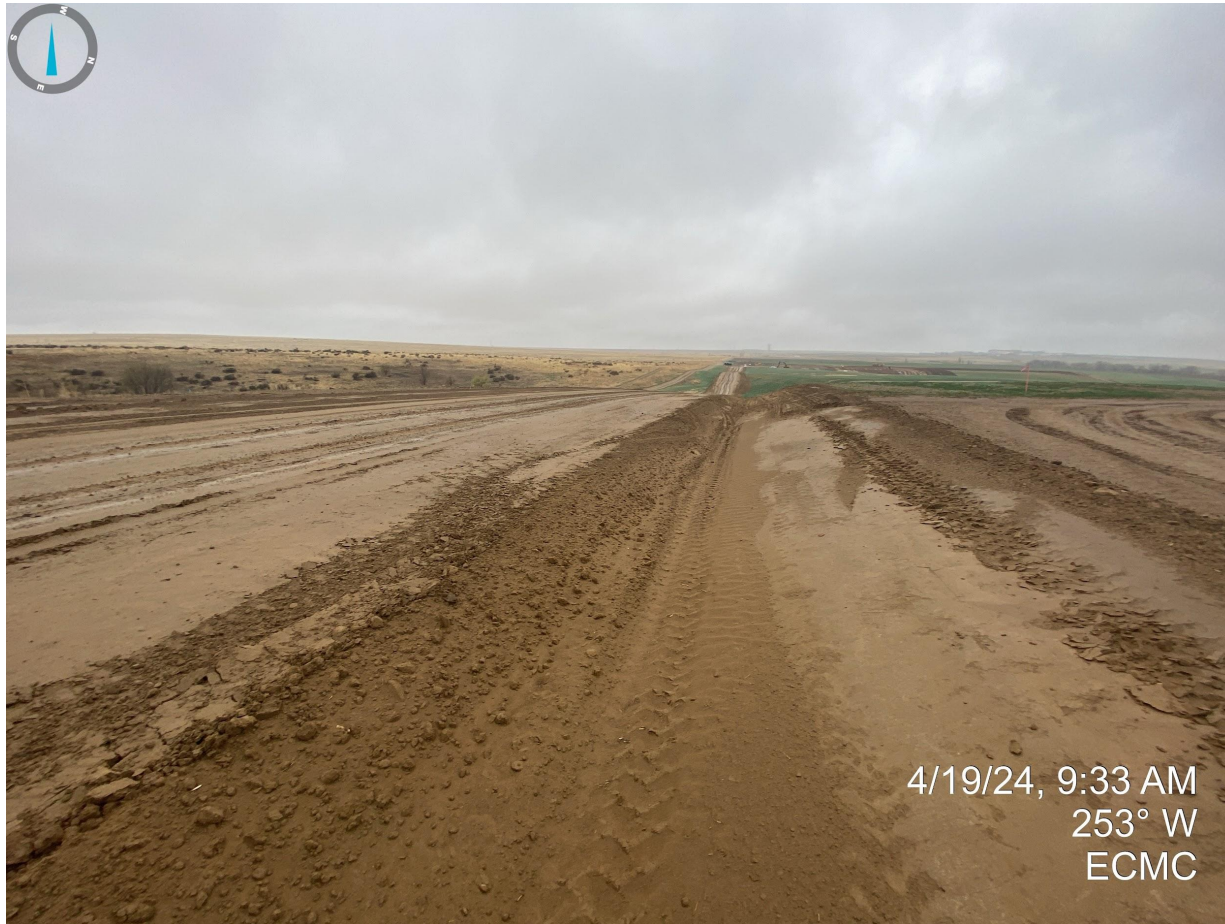
Photo 1. Taken near the start of the access road, facing west. It appears that topsoil has been salvaged and a stormwater ditch has been constructed.

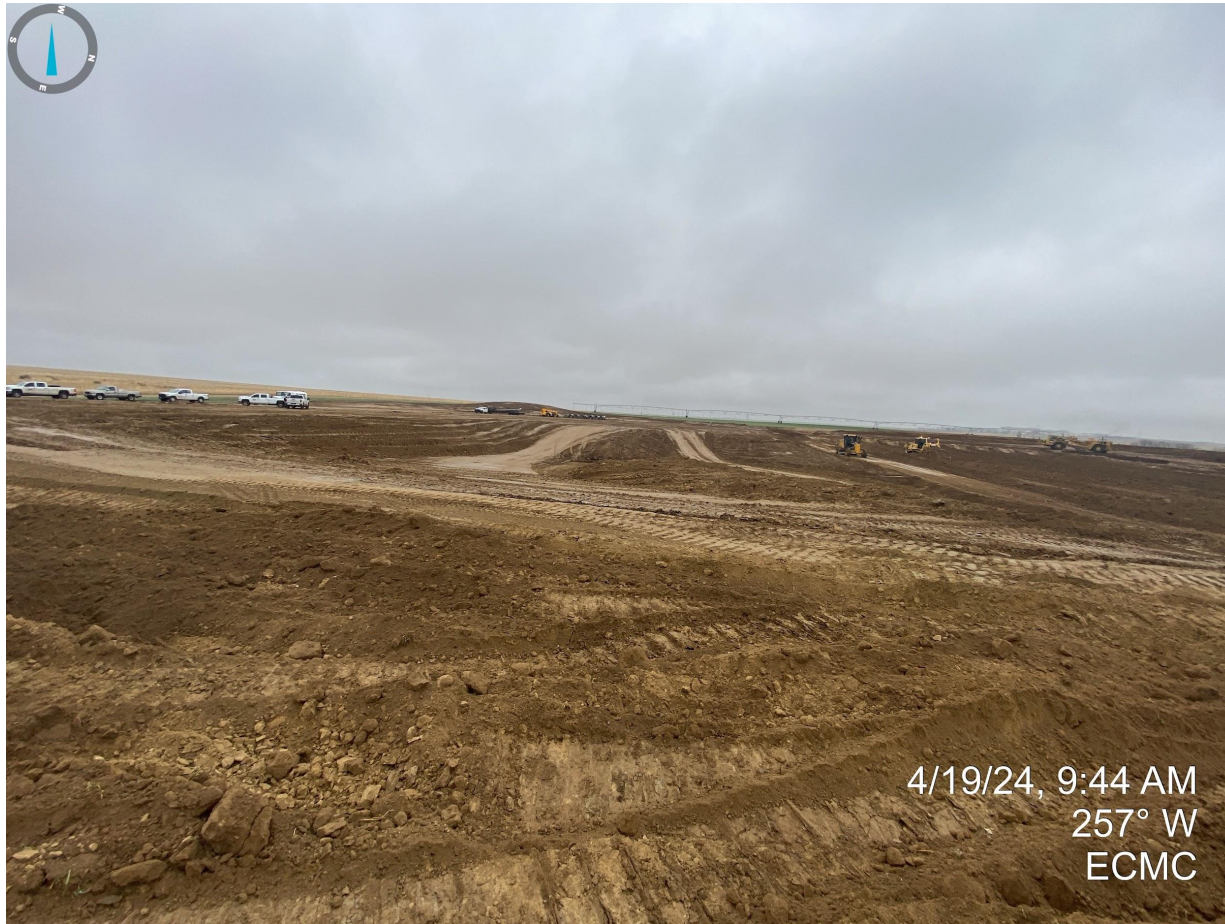
Photo 2. Taken near the east side of the disturbance area. Photo illustrates topsoil salvage activities and cut/fill operations.

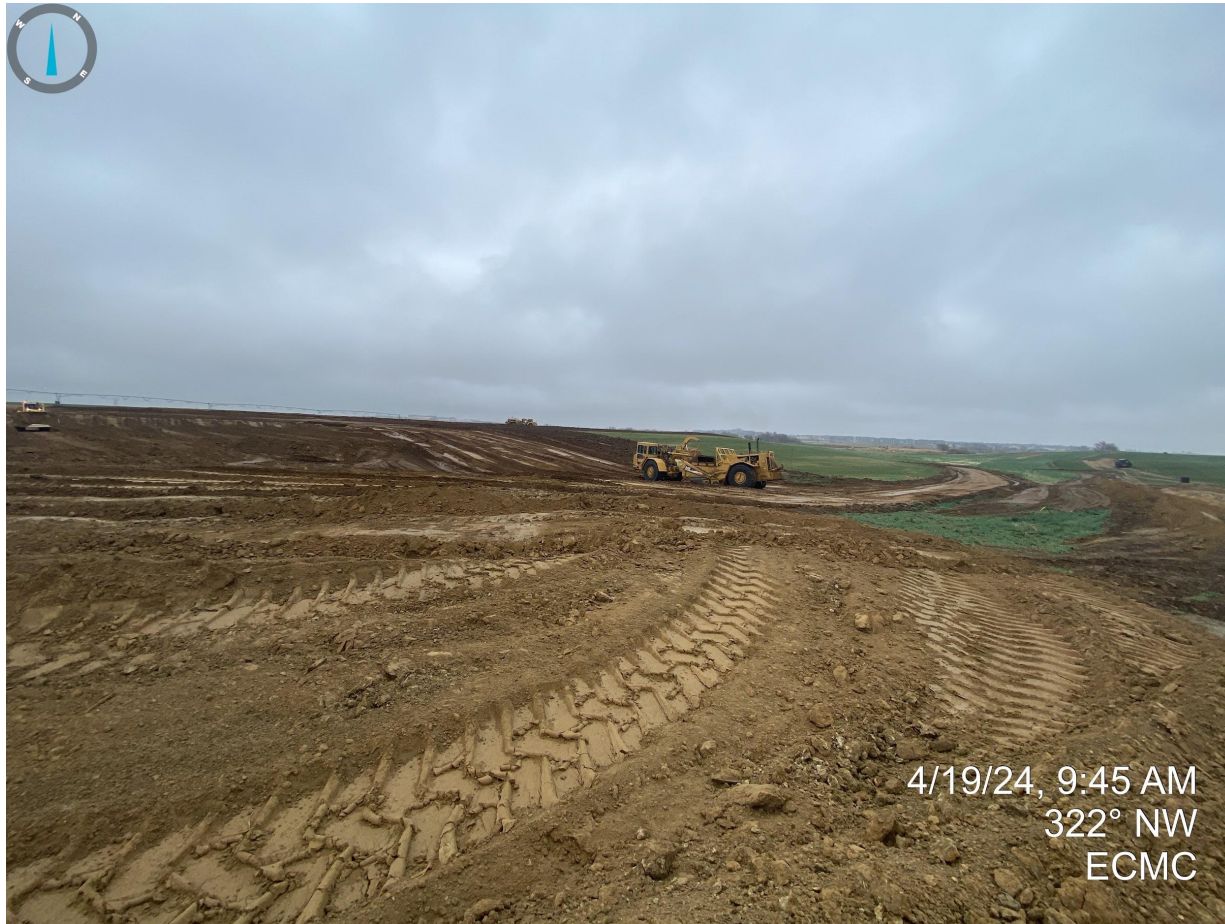
Photo 3. Taken near the east side of the disturbance area. Photo illustrates topsoil salvage activities and cut/fill operations.

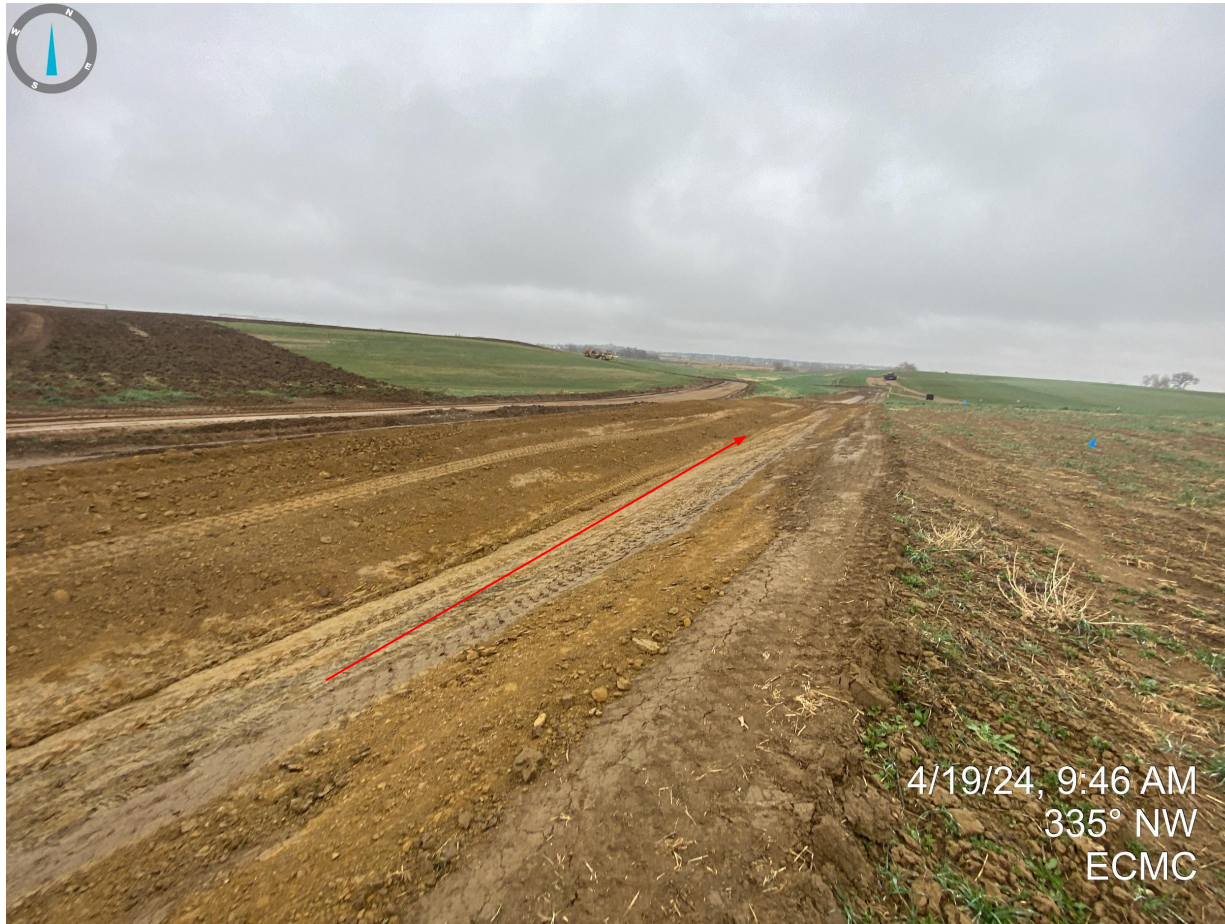
Photo 4. Stormwater ditch constructed along the east side of the disturbance area.

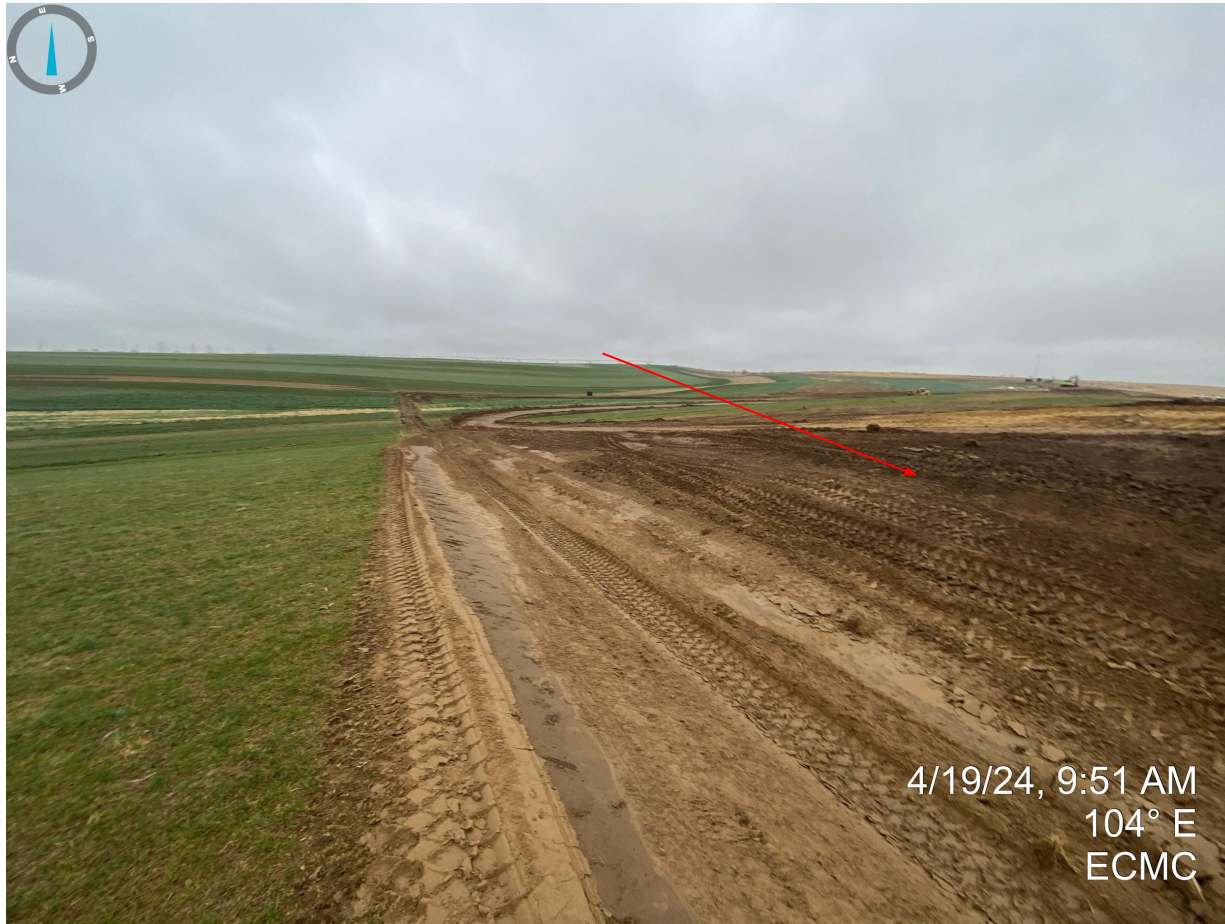
Photo 5. Stormwater ditch constructed along the north side of the disturbance area. Topsoil stockpile illustrated by red arrow.

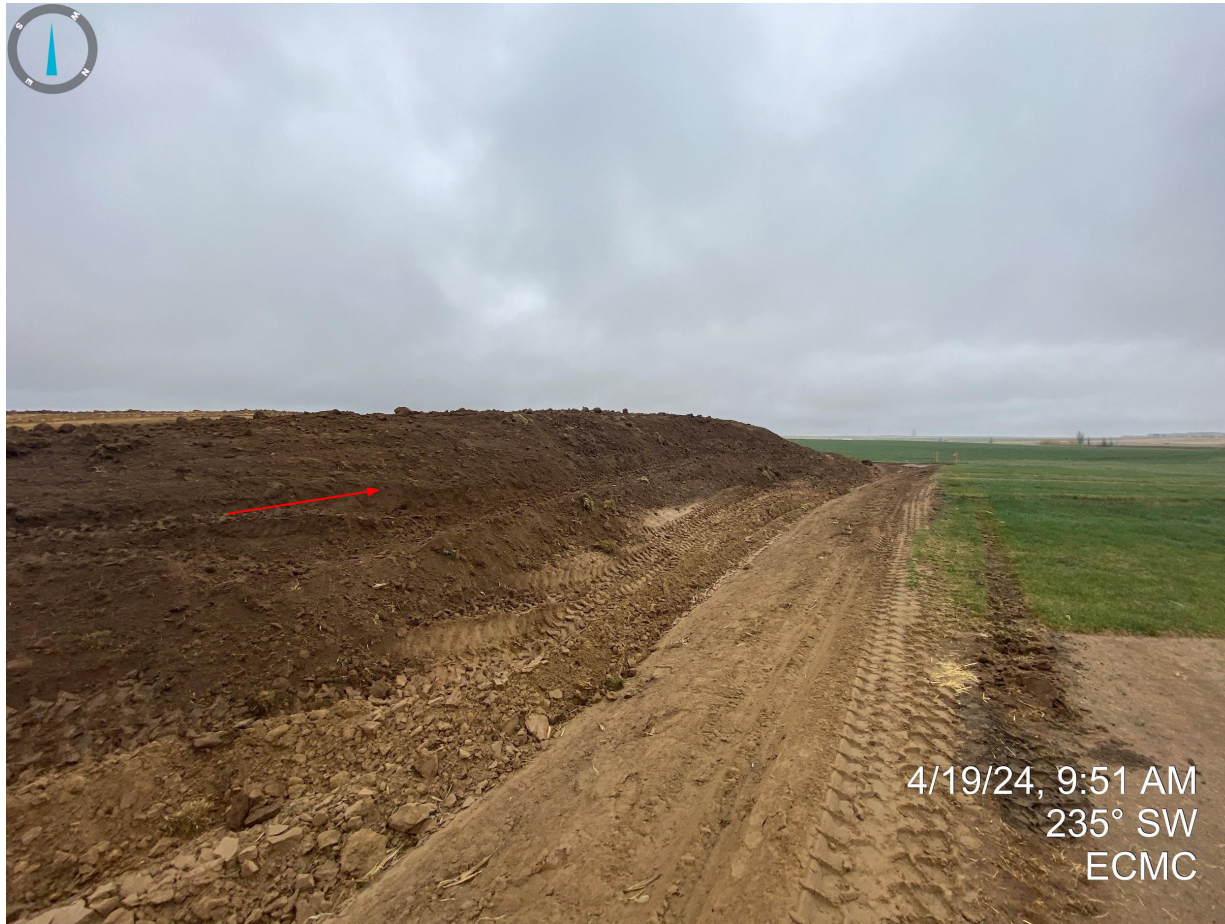
Photo 6. Stormwater ditch constructed along the north side of the disturbance area. Topsoil stockpile illustrated by red arrow.

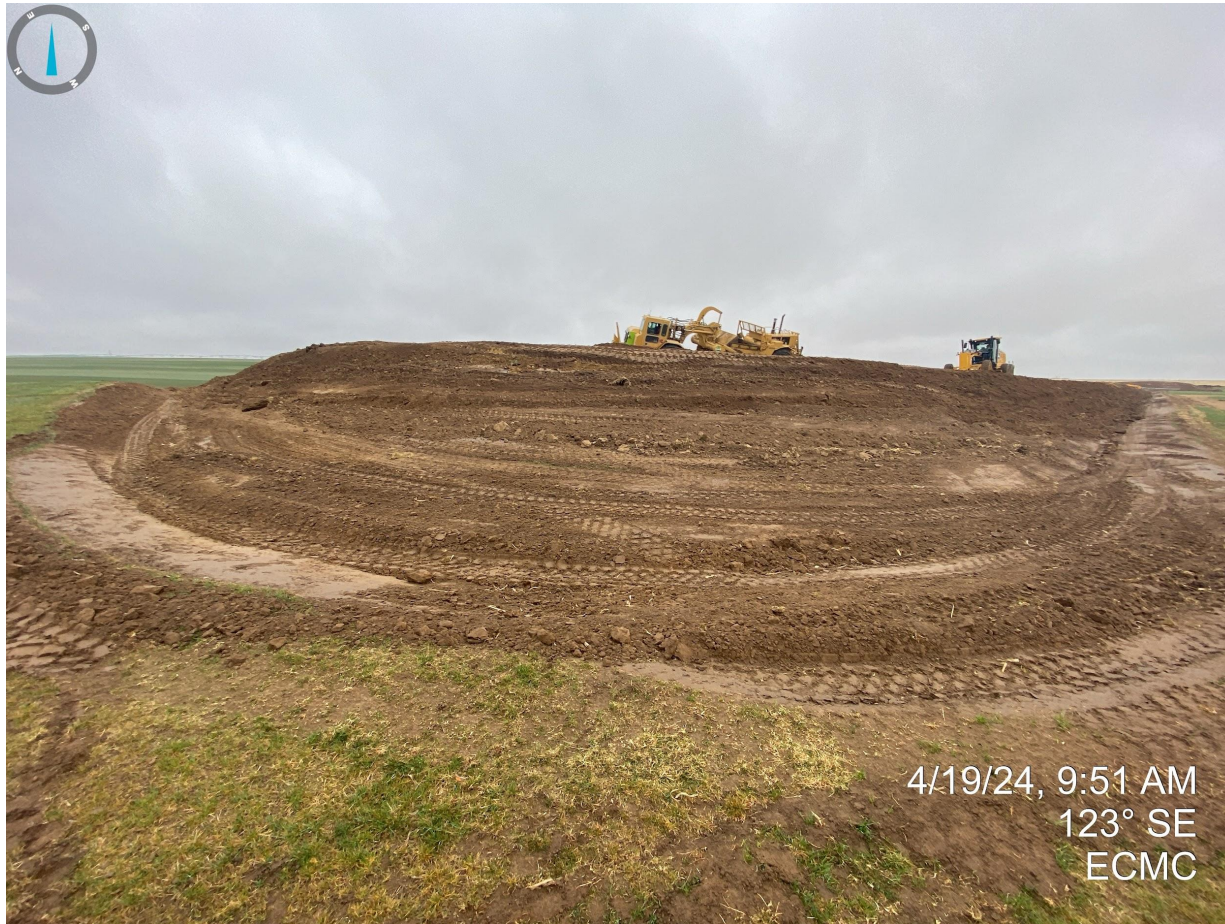
Photo 7. Taken near the northwest corner of the disturbance area. Topsoil salvage activities were ongoing at the time of this inspection.

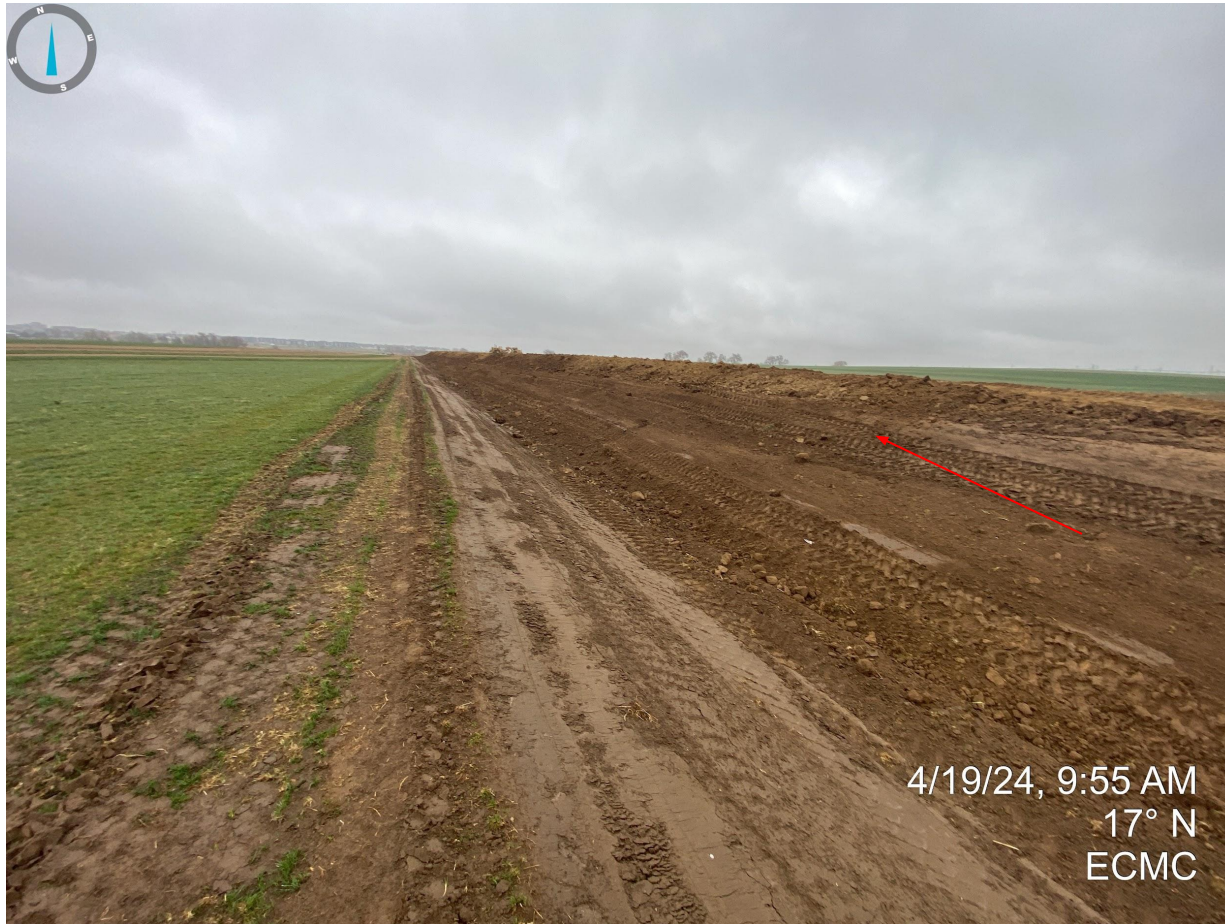
Photo 8. Stormwater ditch constructed along the west side of the disturbance area. Topsoil stockpile illustrated by red arrow.

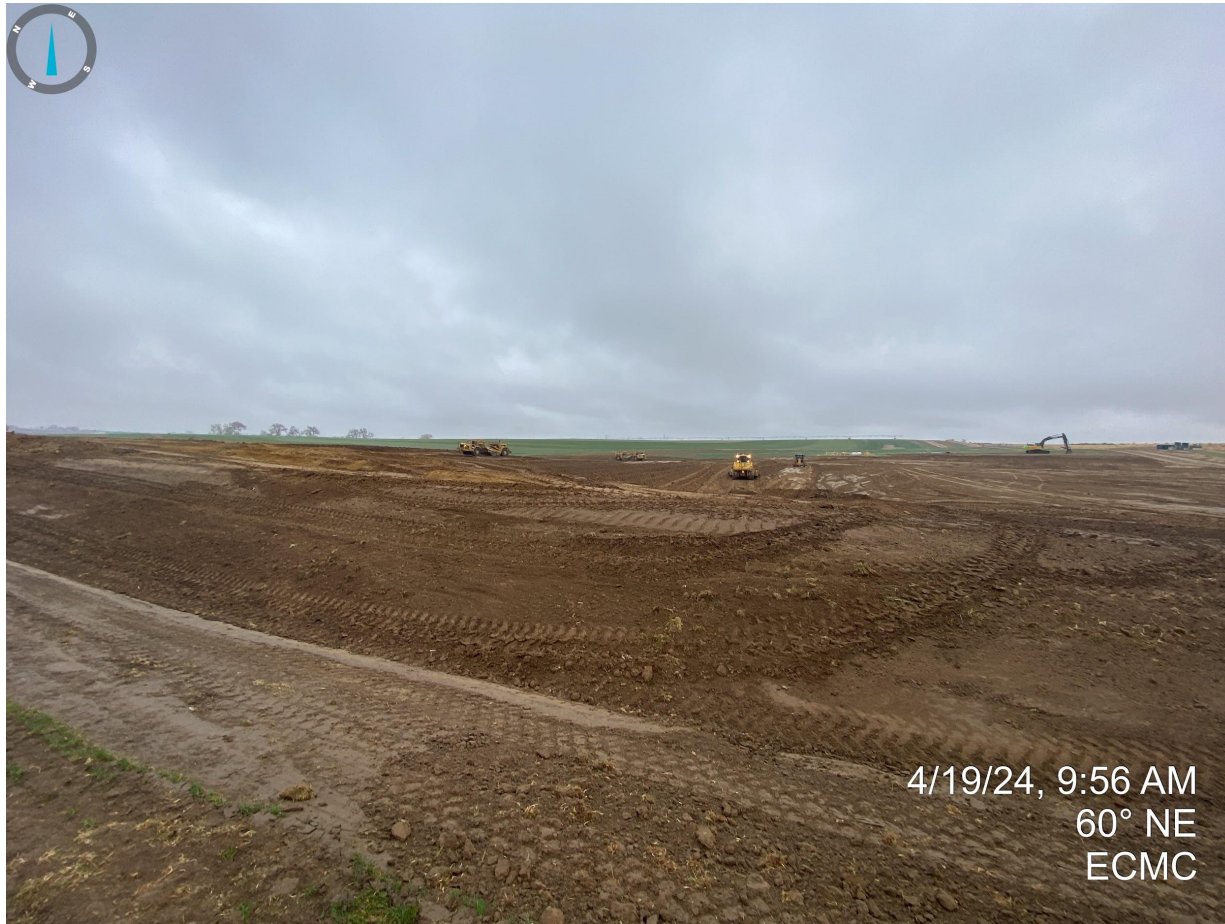
Photo 9. Taken near the west side of the disturbance area. Photo illustrates topsoil salvage activities and cut/fill operations are ongoing.

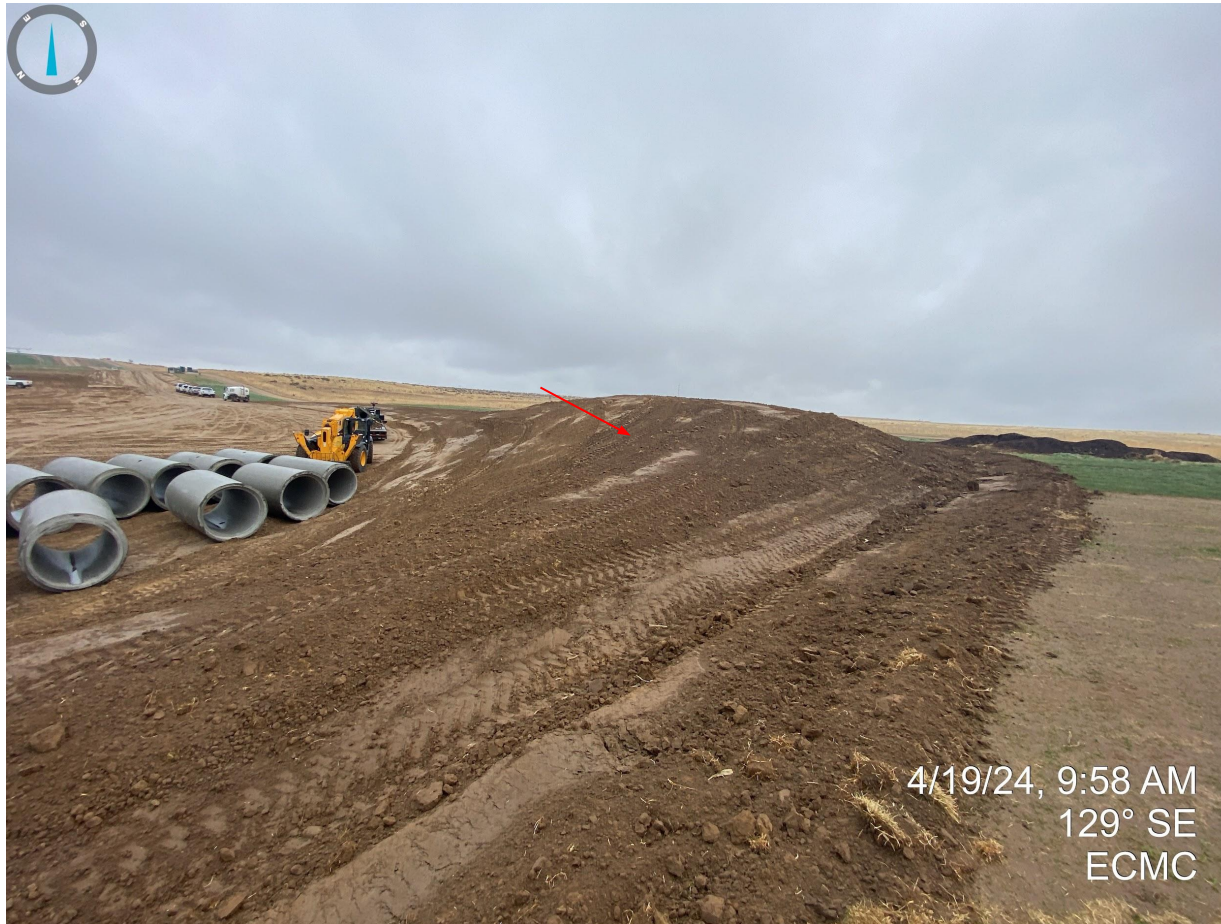
Photo 10. Topsoil stockpile located in the southwest corner of the disturbance area where the future production facility will be located. Operator shall ensure that all topsoil is stabilized in compliance with Rule 1002.c.

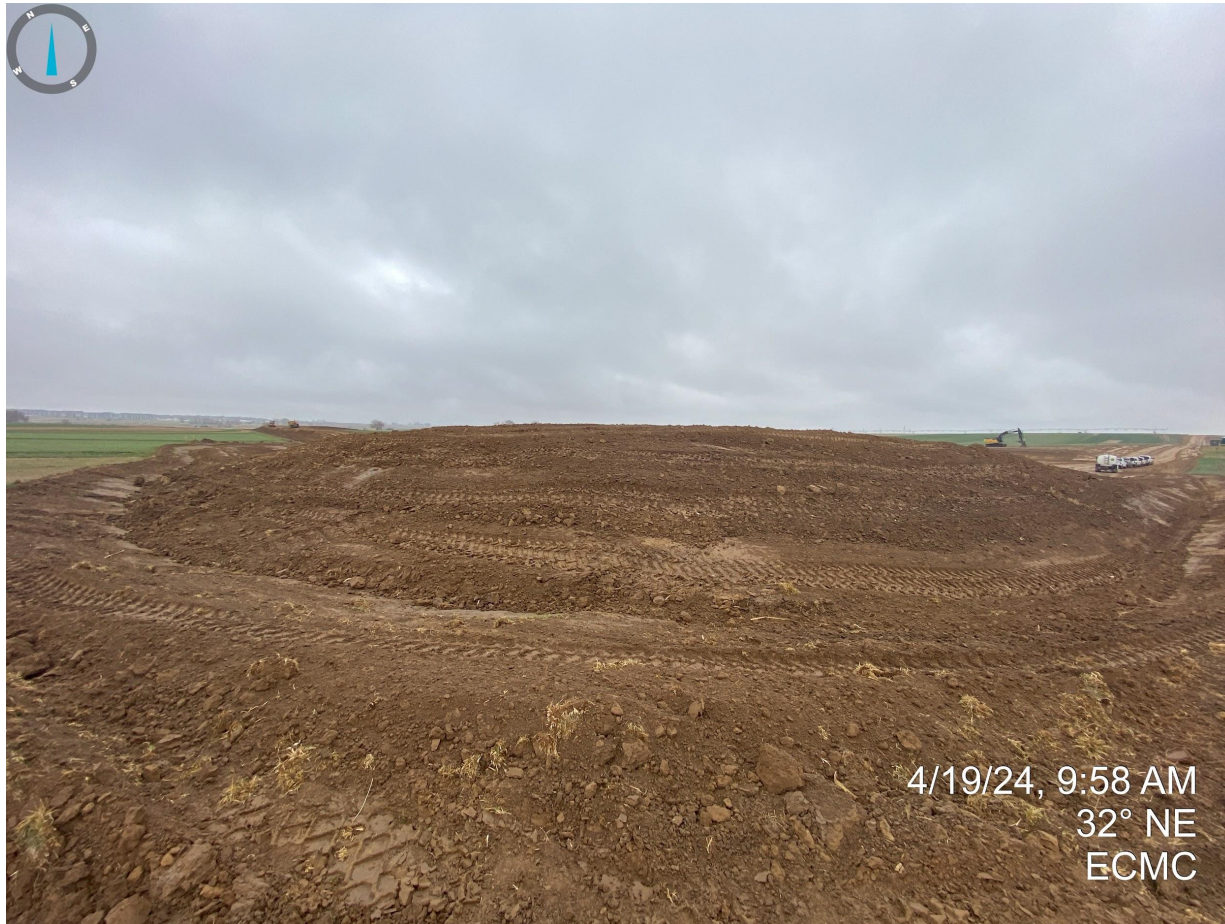
Photo 11. Taken near the southwest corner of the disturbance area. See comments in Photo 10.

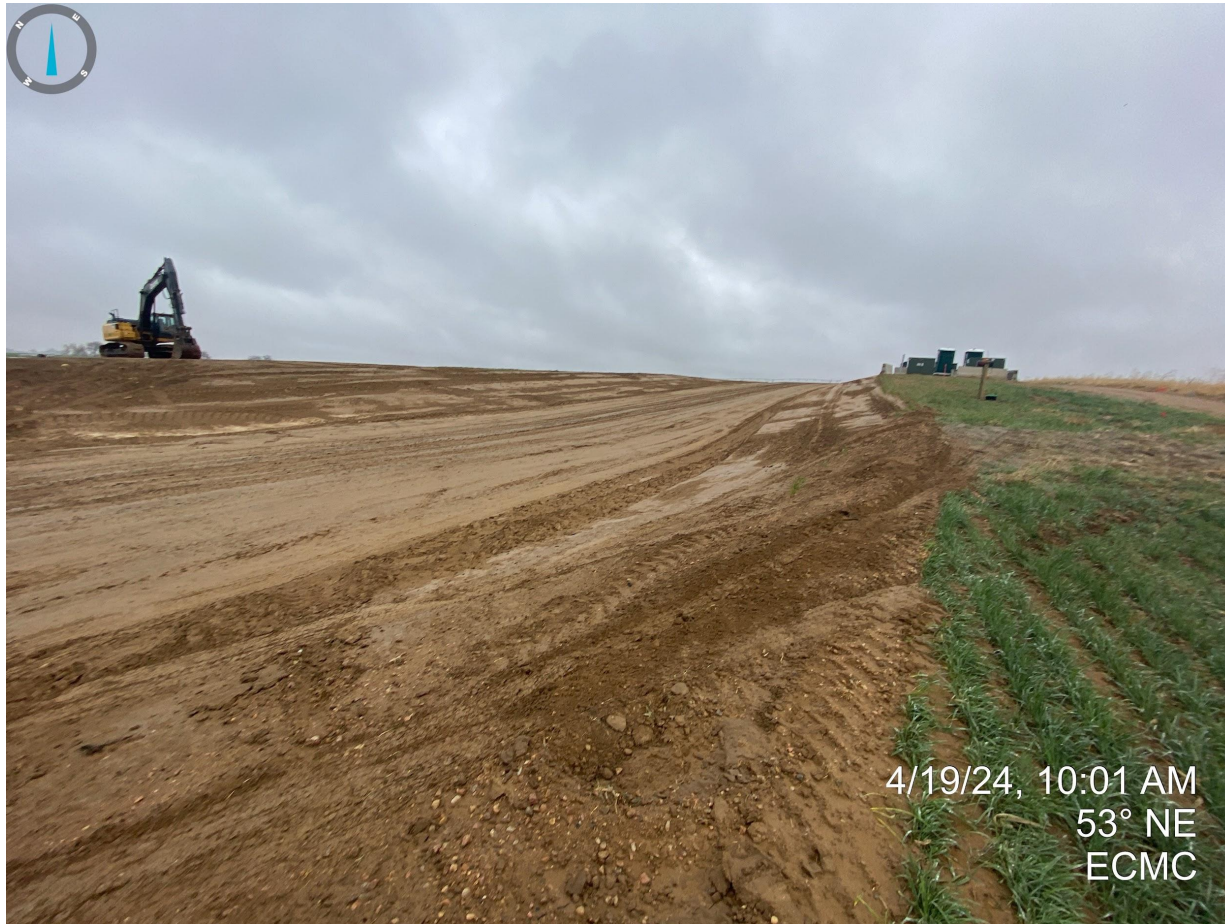
Photo 12. Looking northeast along the access road start from the disturbance area. It appears that topsoil has been salvaged and a stormwater ditch has been constructed.

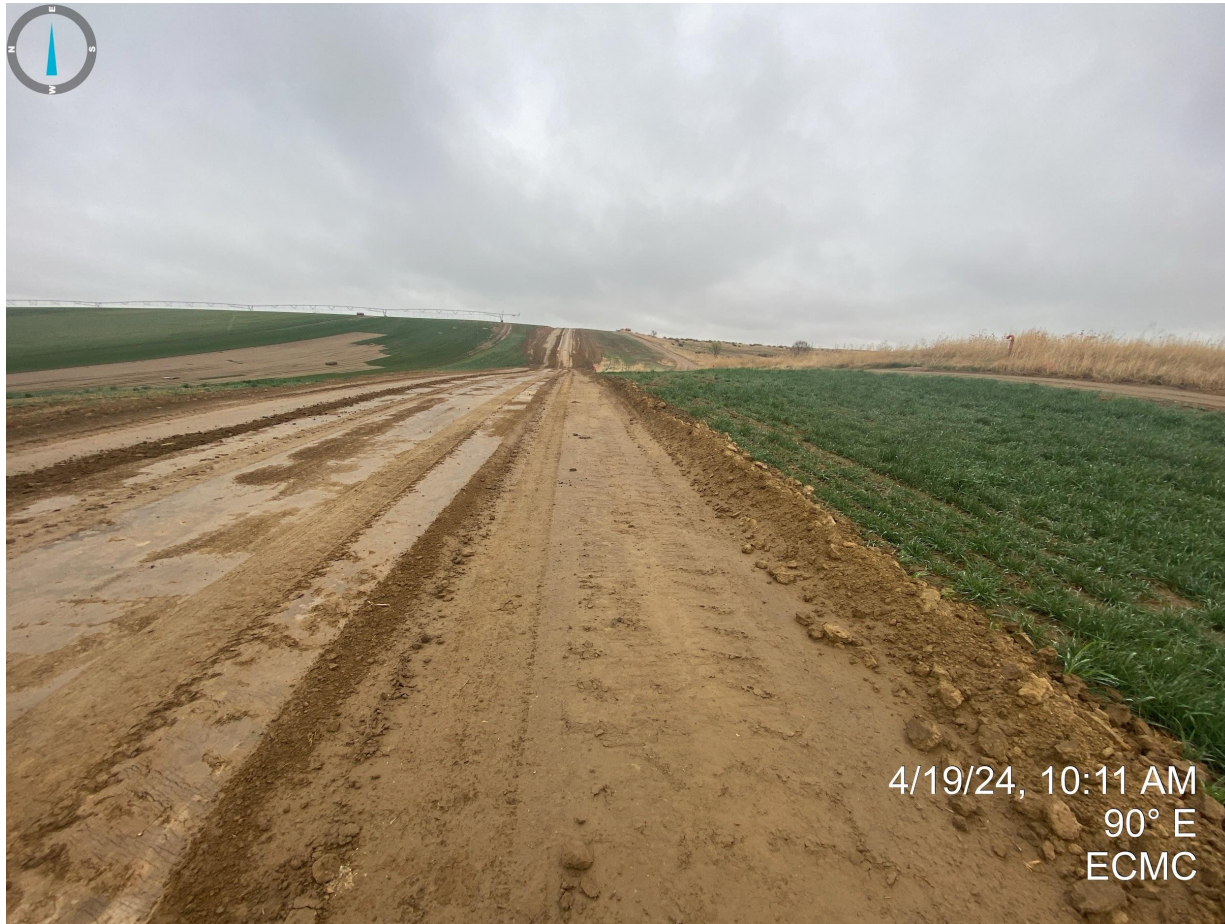
Photo 13. Taken near the center portion of the access road, facing east. See comments in Photo 12.

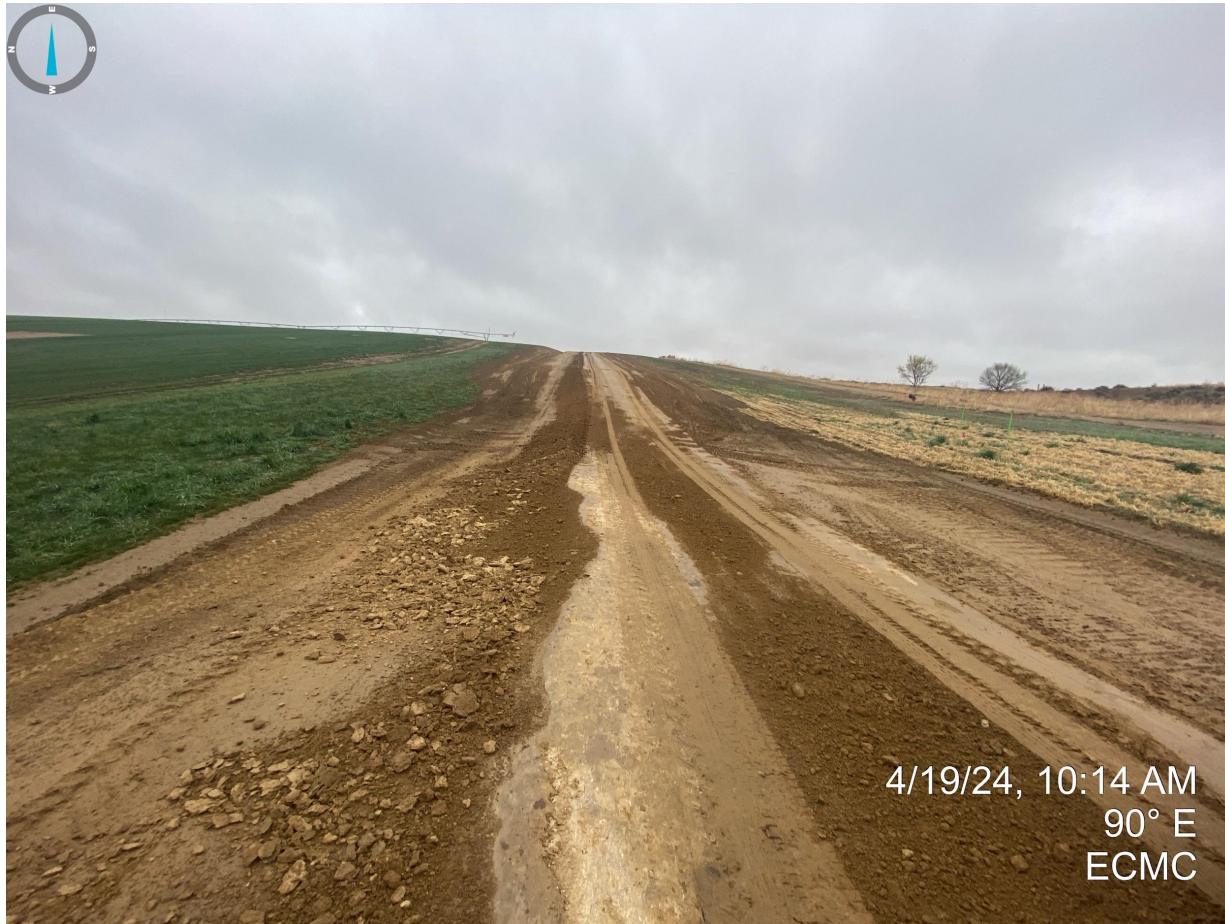
Photo 14. Taken near the center portion of the access road, facing east. See comments in Photo 12. It appears that stormwater BMPs are planned for the low point of the access road.

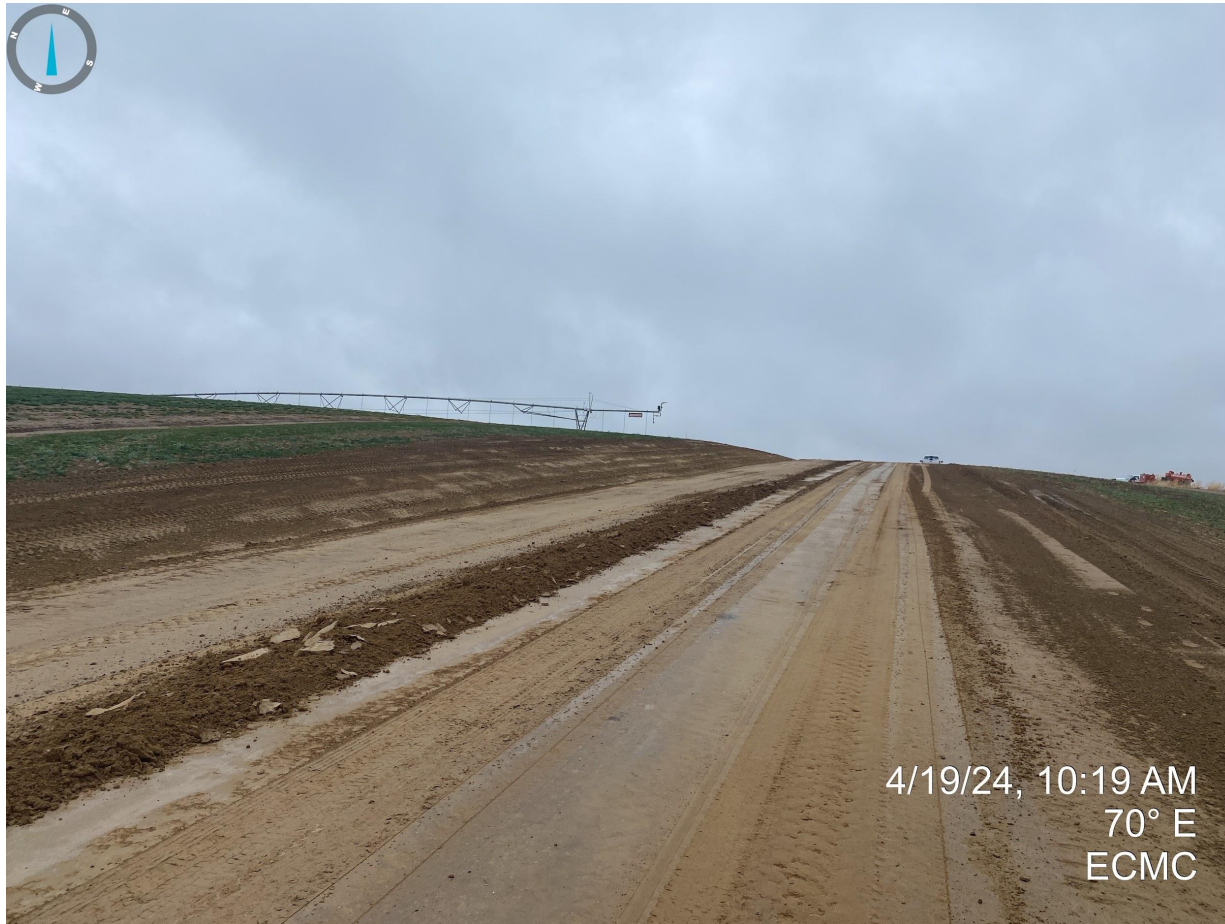
Photo 15. Taken near the eastern portion of the access road, facing east. See comments in Photo 12.

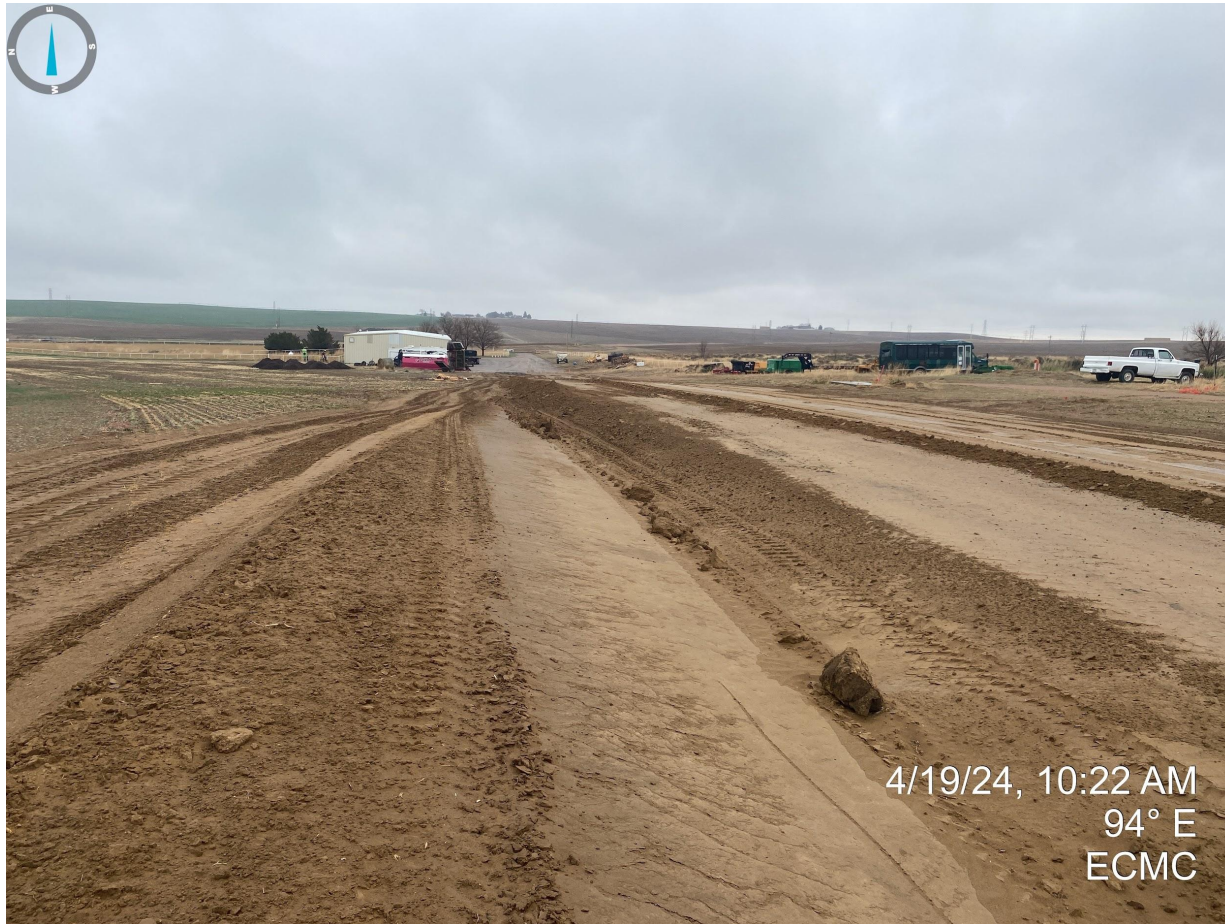
Photo 16. Taken near the eastern portion (start) of the access road, facing east. See comments in Photo 12.
