WELL NAME: HILL RANCH 15-09, API #: 071-08474, INSP. # 695109504

COLORADO
Energy & Carbon Management
Commission
Department of Natural Resources

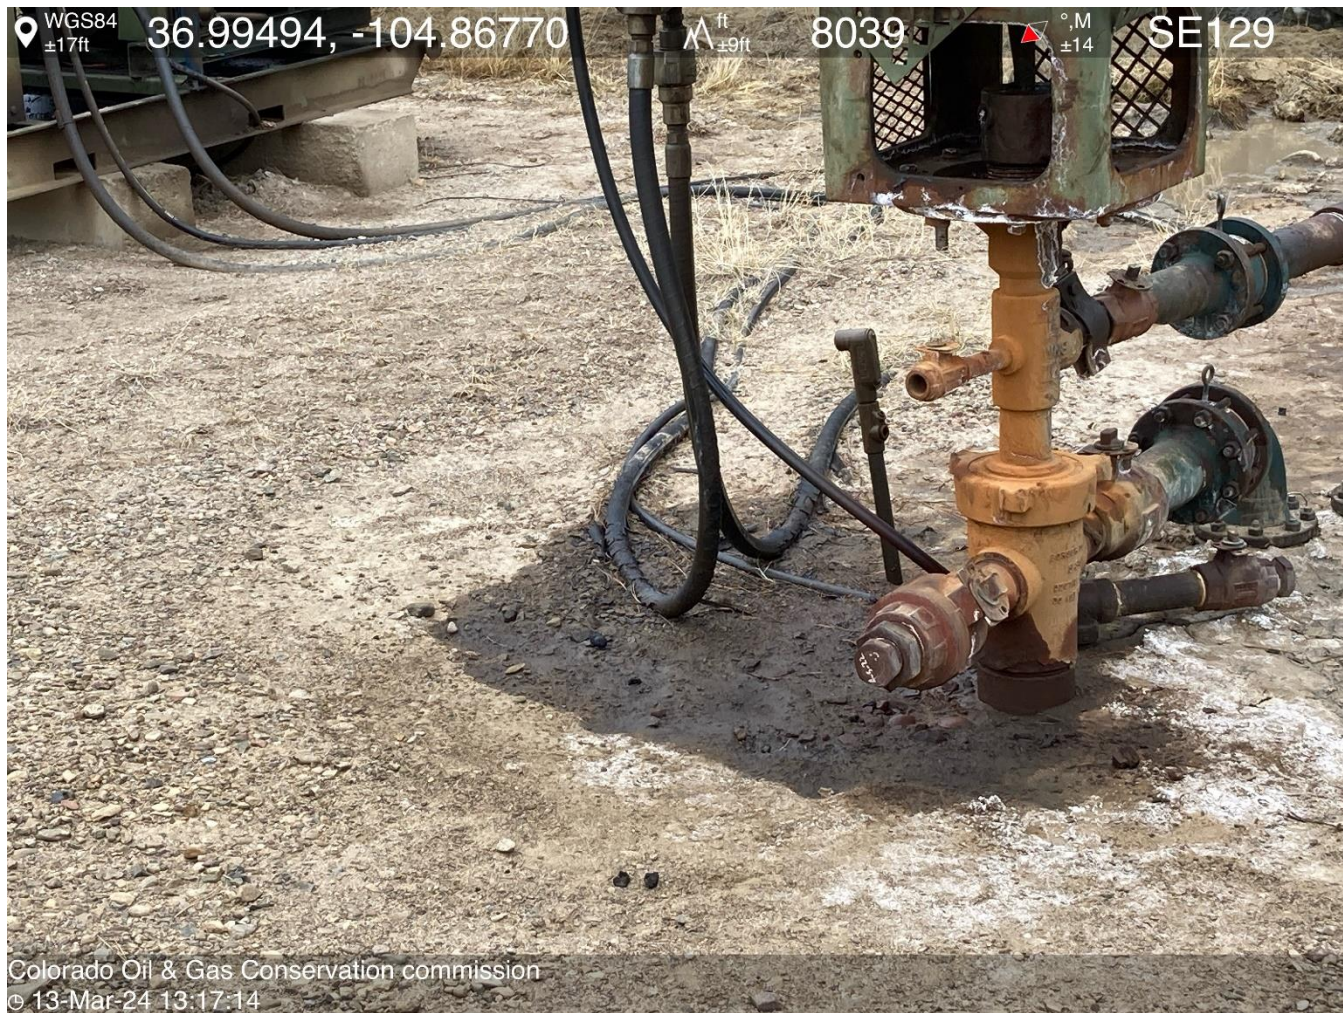
PHOTO 4: AREA OF IMPACTED SOIL UNDER DRIVE HEAD. Conduct maintenance on equipment, cleanup stained material and review self inspection processes. COMPLY WITH RULE 1002,.(2).D. CA DATE 5-22-2024.

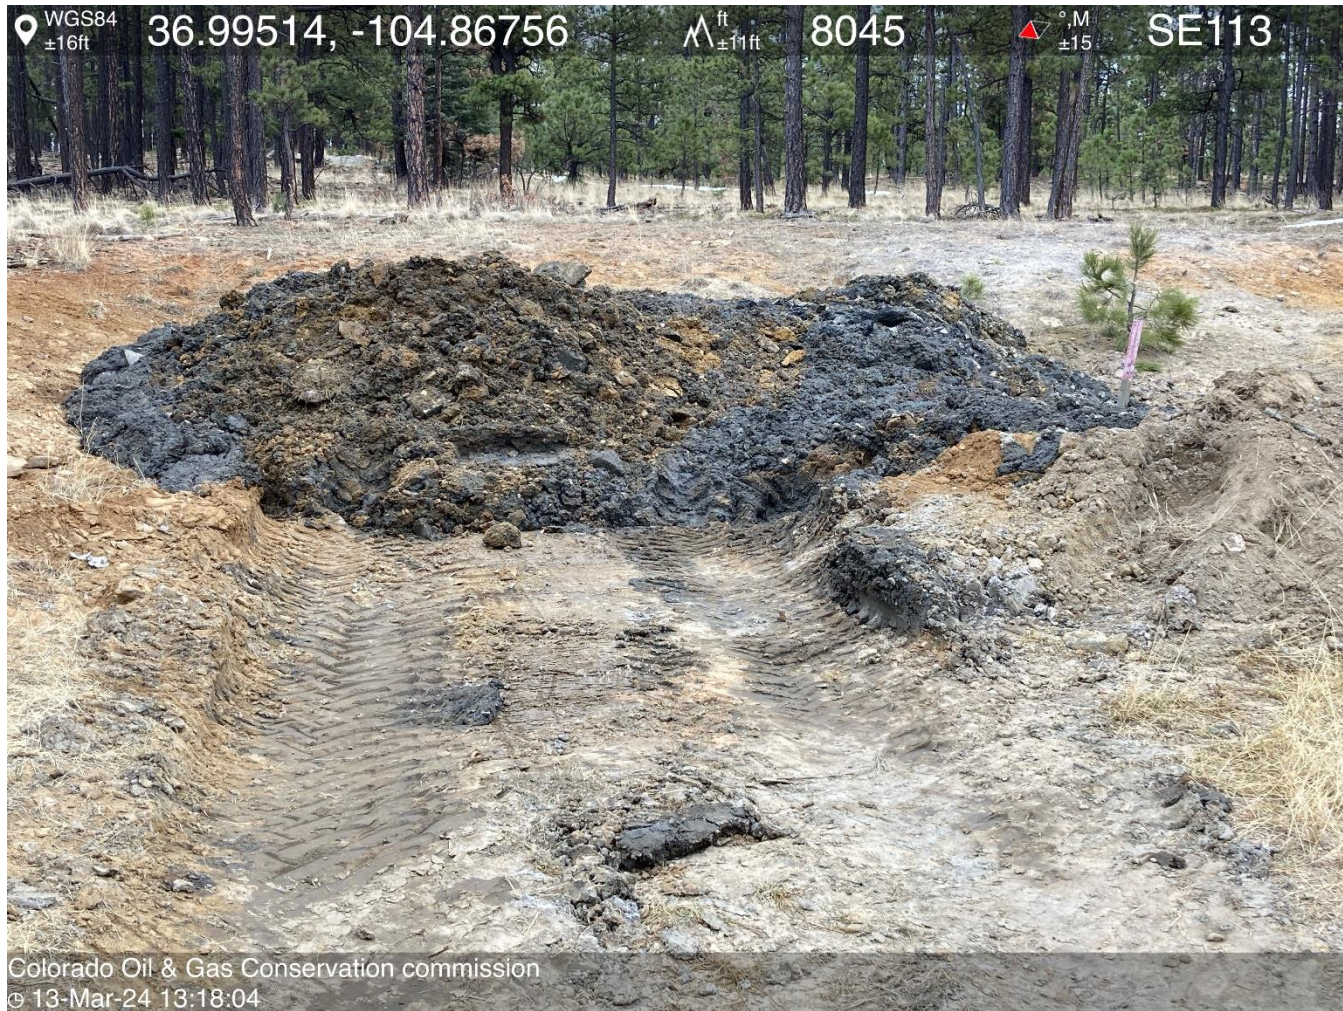
PHOTO 5: IT APPEARS THAT THE PRODUCED WATER PIT HAS BEEN CLEANED AND THE SECONDARY CONTAINMENT FOR THE PIT MATERIAL STORED ON LOCATION HAS BEEN COMPROMIZED AND THERE IS NO RUN ON PROTECTION IN PLACE TO PREVENT STORM WATER FROM MIXING WITH PIT MATERIAL. INTALL AND REPAIR BERMS PER 1002 SERIES RULES. CA DATE 5-22-2024.

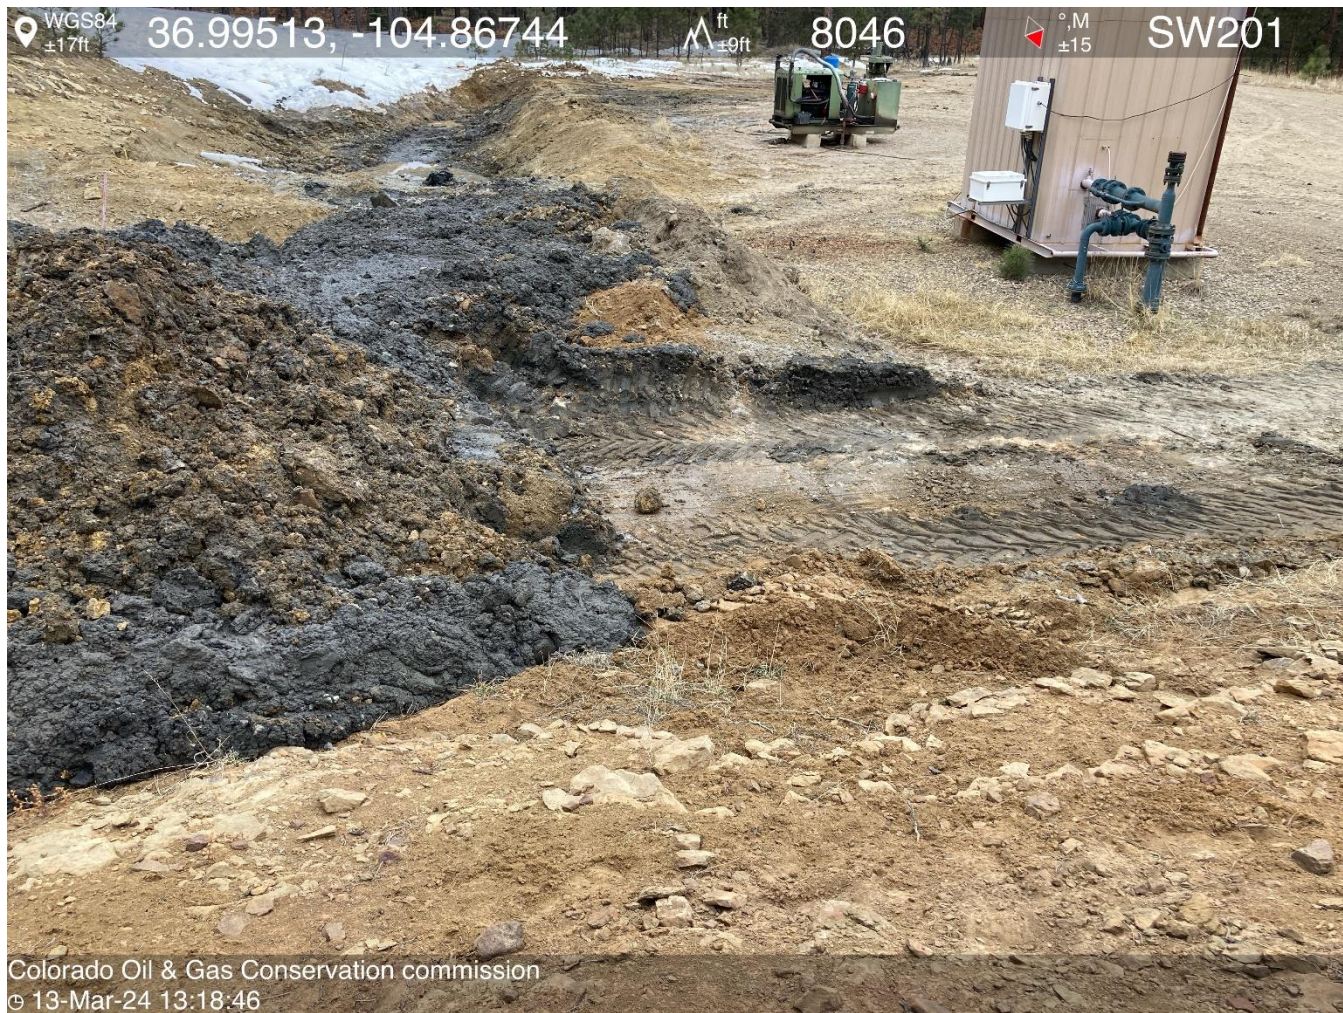
PHOTO 5: IMAGE OF THE COMPROMISED BERM FROM A DIFFERENT ANGLEL.
