Construction and Stormwater Inspection

Date: 04/19/2024

Operator: KERR MCGEE OIL & GAS ONSHORE LP -
47120

Location ID: 485057

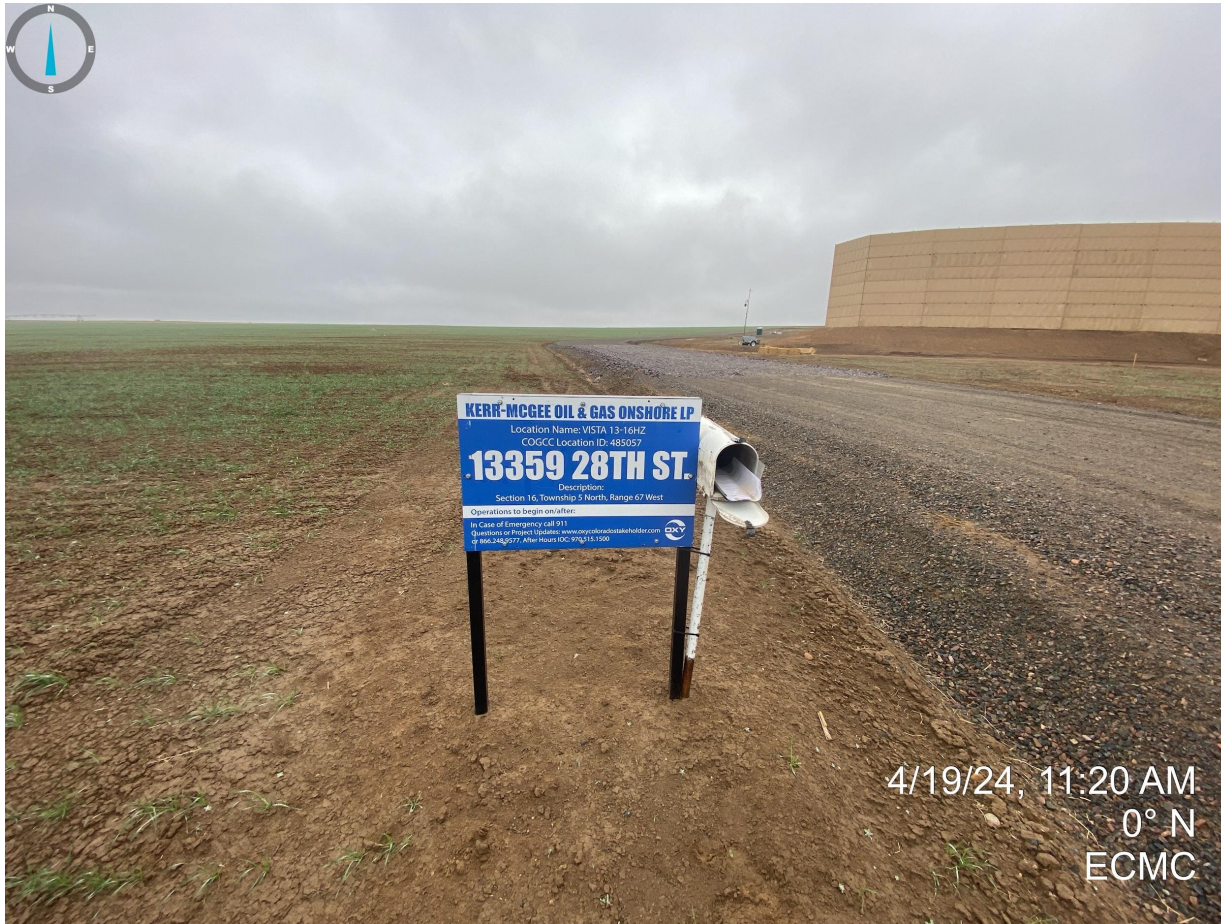
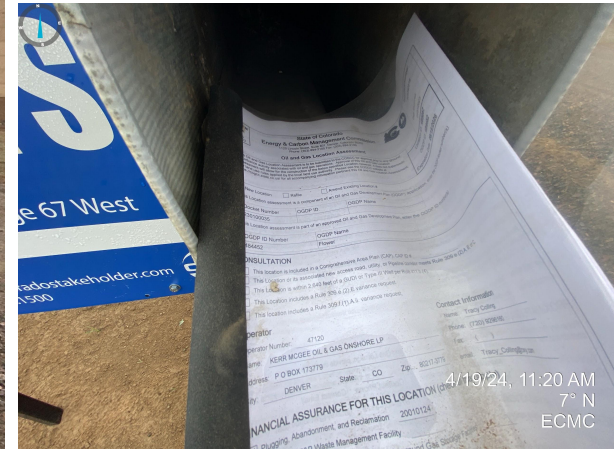
Photo 1. Form 2A was posted on location at the time of this inspection.

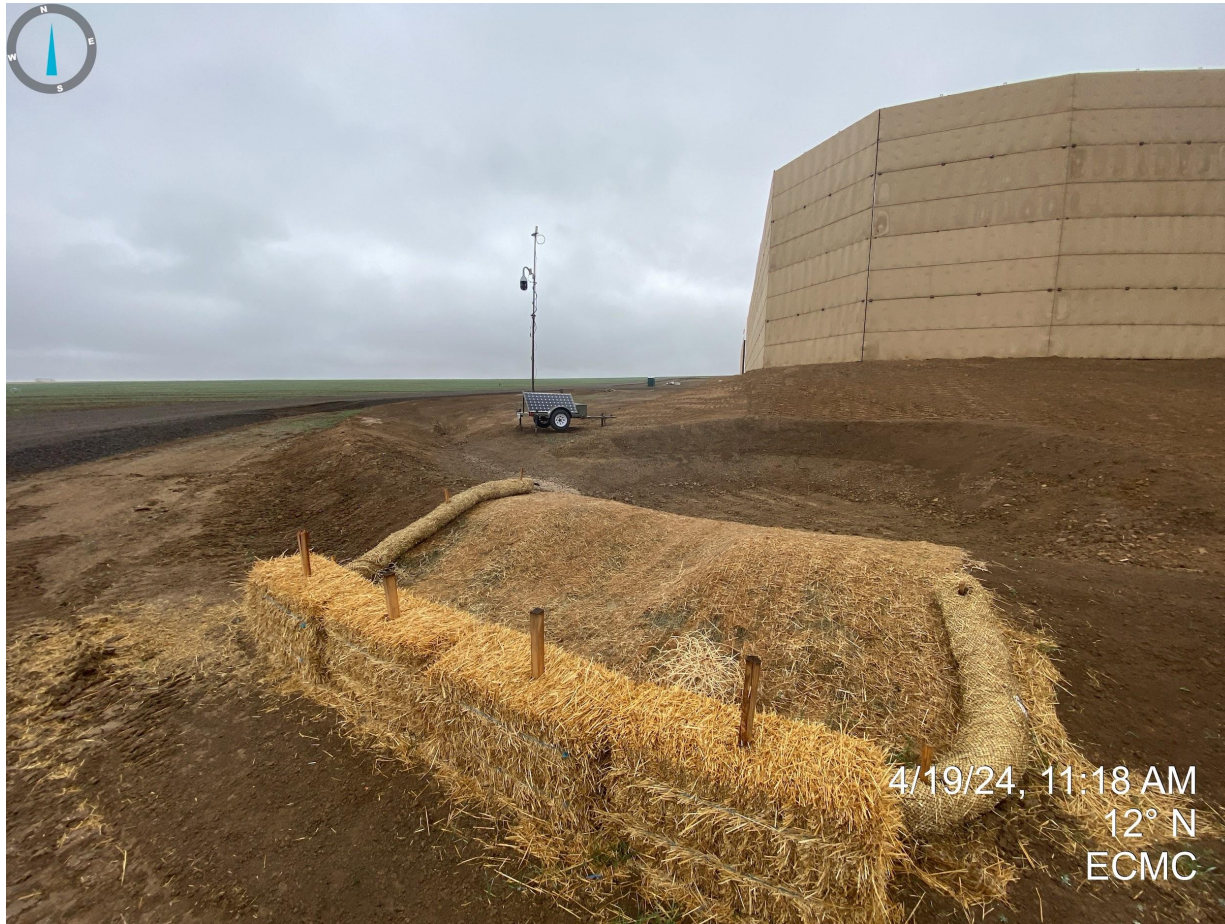
Photo 2. Taken from the southern portion of the disturbance area. Stormwater control measures have been installed during the construction phase of the location. Temporarily stabilized outlets, ditch and berm and sediment traps pictured.

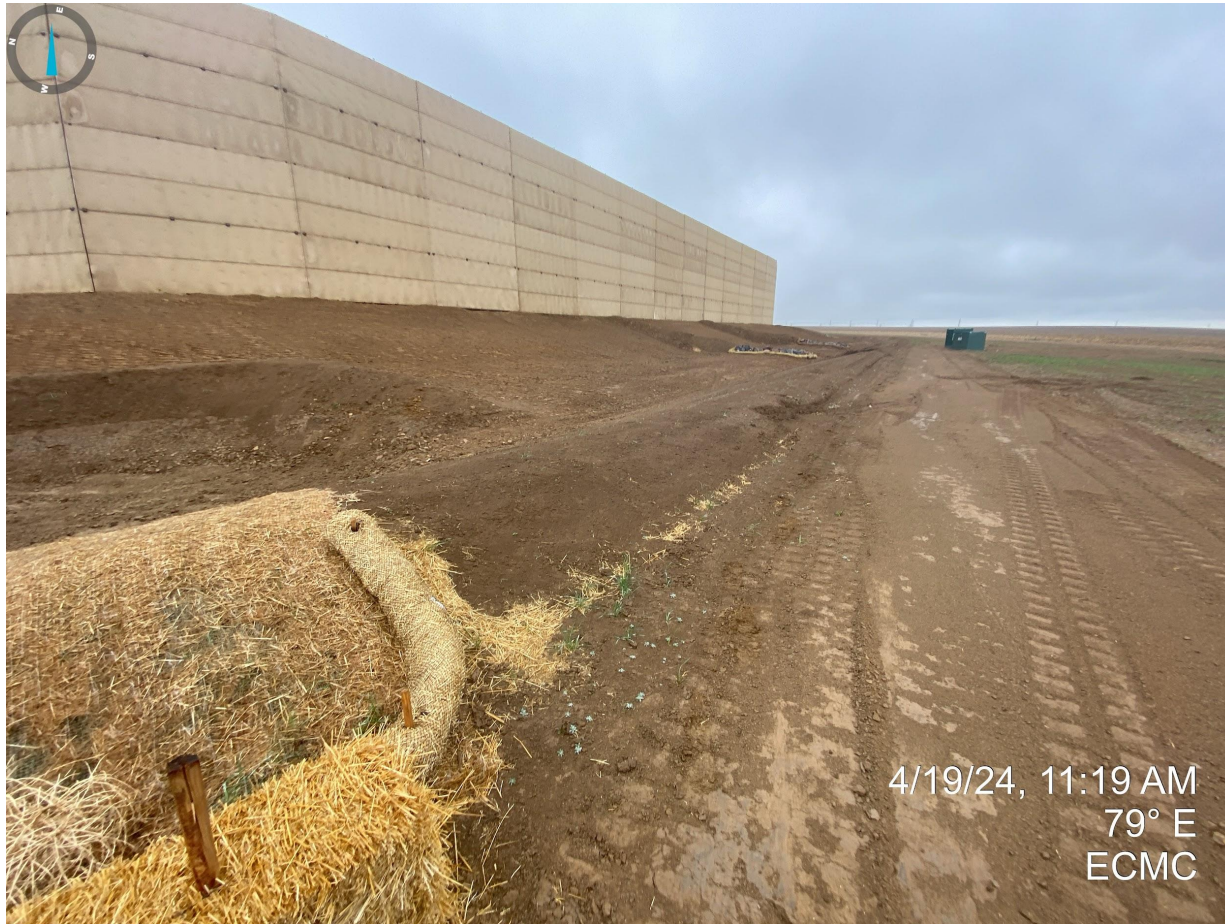
Photo 2. Taken near the southern portion of the disturbance area; see comments in Photo 1.

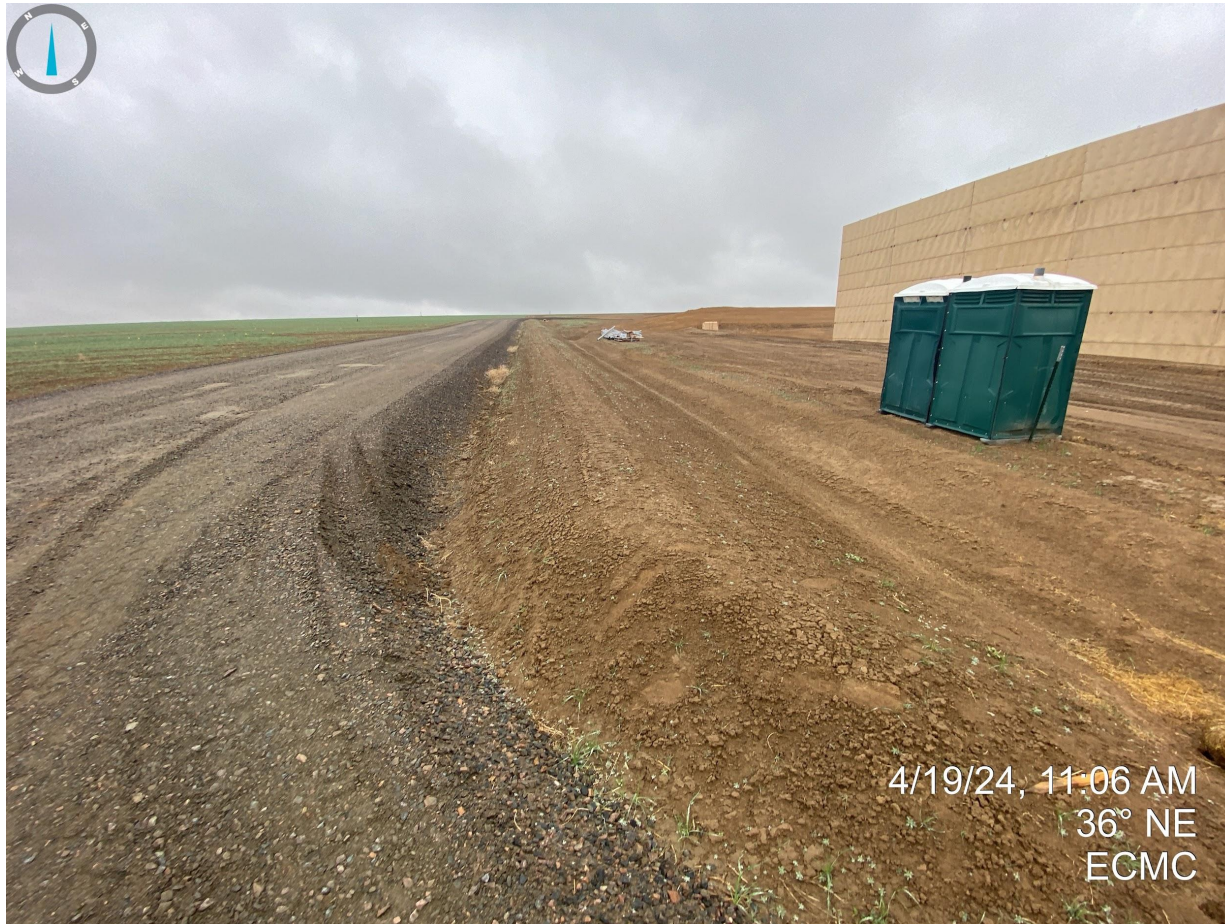
Photo 4. Taken from the western portion of the disturbance area. Stormwater ditch and berm installed along the temporary access road to the working pad surface.

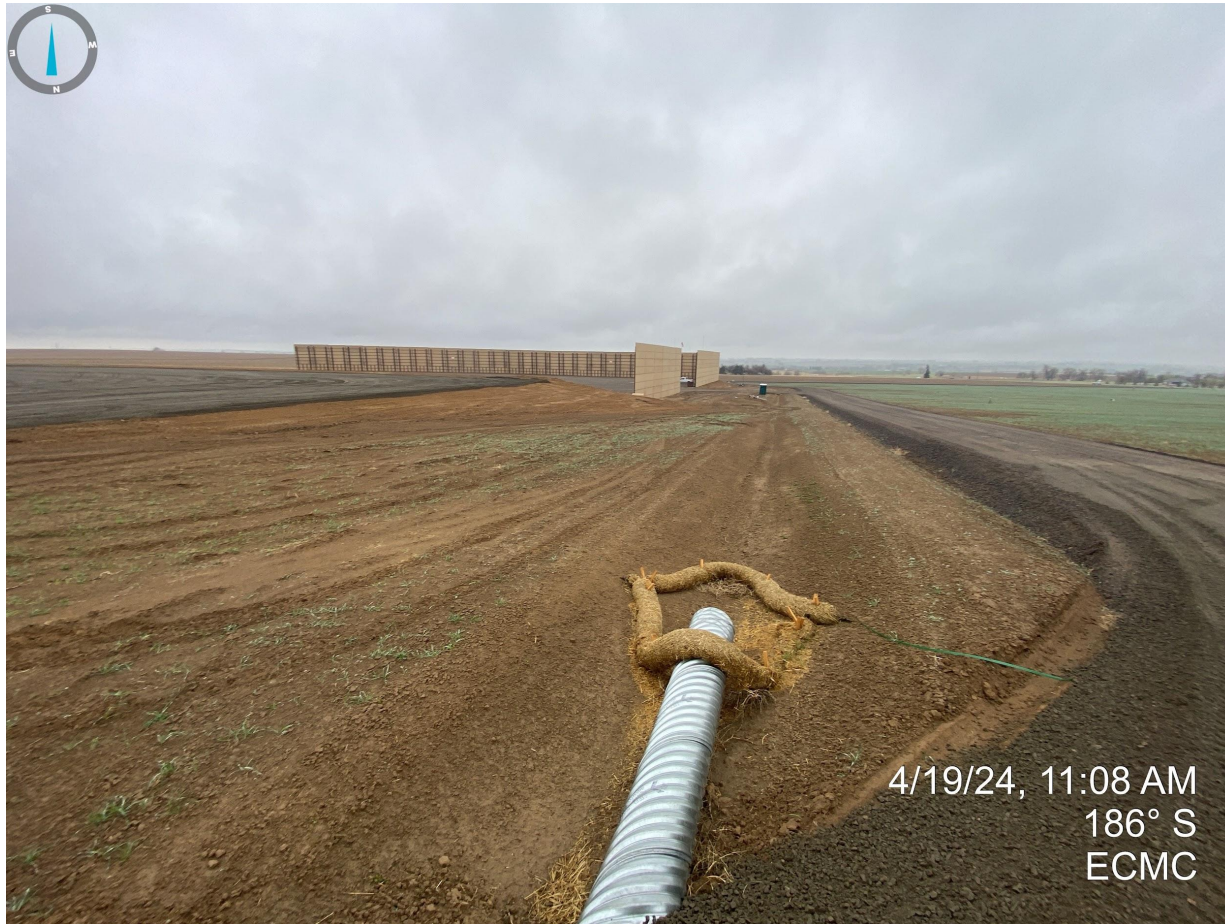
Photo 5. Taken from the western portion of the disturbance area. Stormwater ditch and berm and culvert with temporarily stabilized outlets.

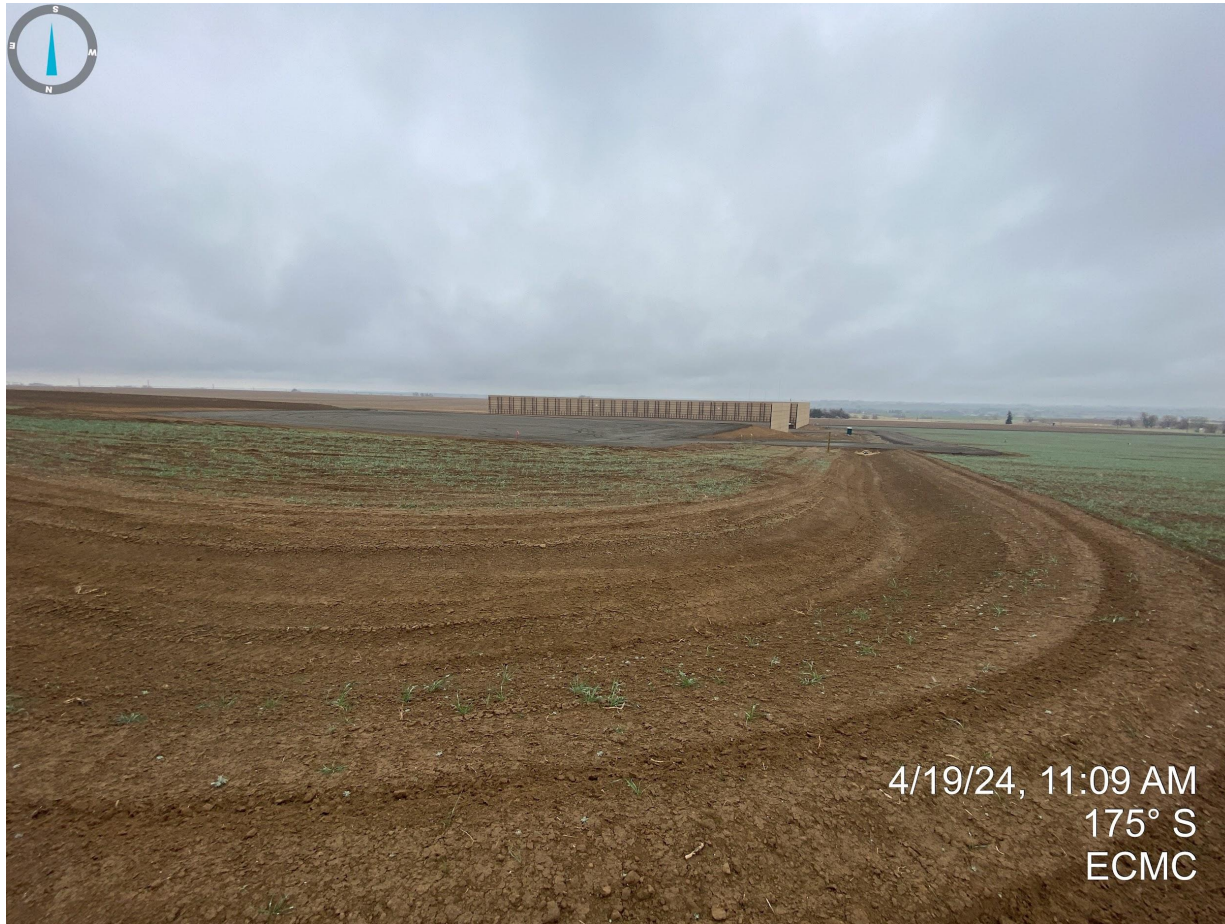
Photo 6. Taken from the northwestern portion of the disturbance area. Perimeter ditch and berm do not appear to be properly stabilized as evidenced by bare/exposed soils.

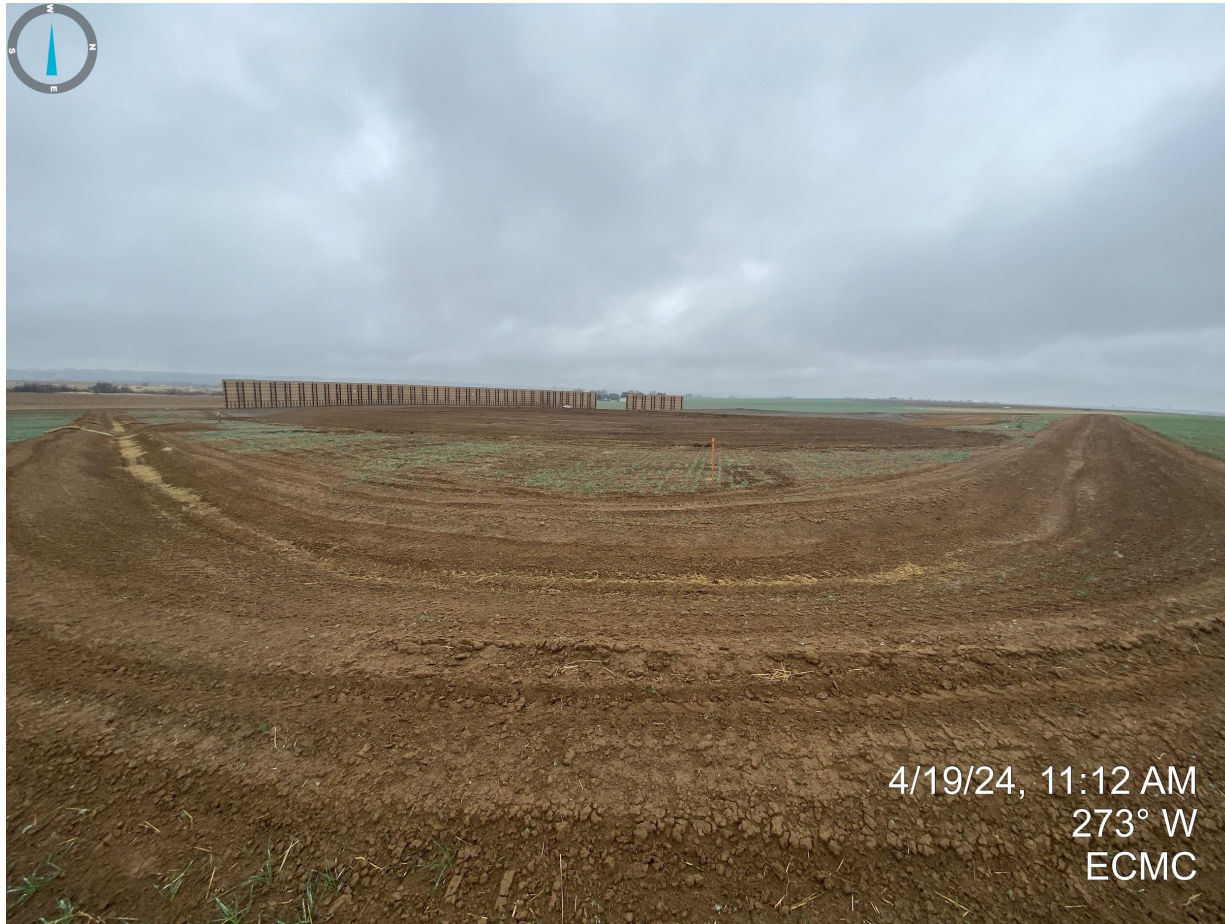
Photo 7. Taken from the northeastern portion of the disturbance area. Perimeter ditch and berm do not appear to be properly stabilized as evidenced by bare/exposed soils.

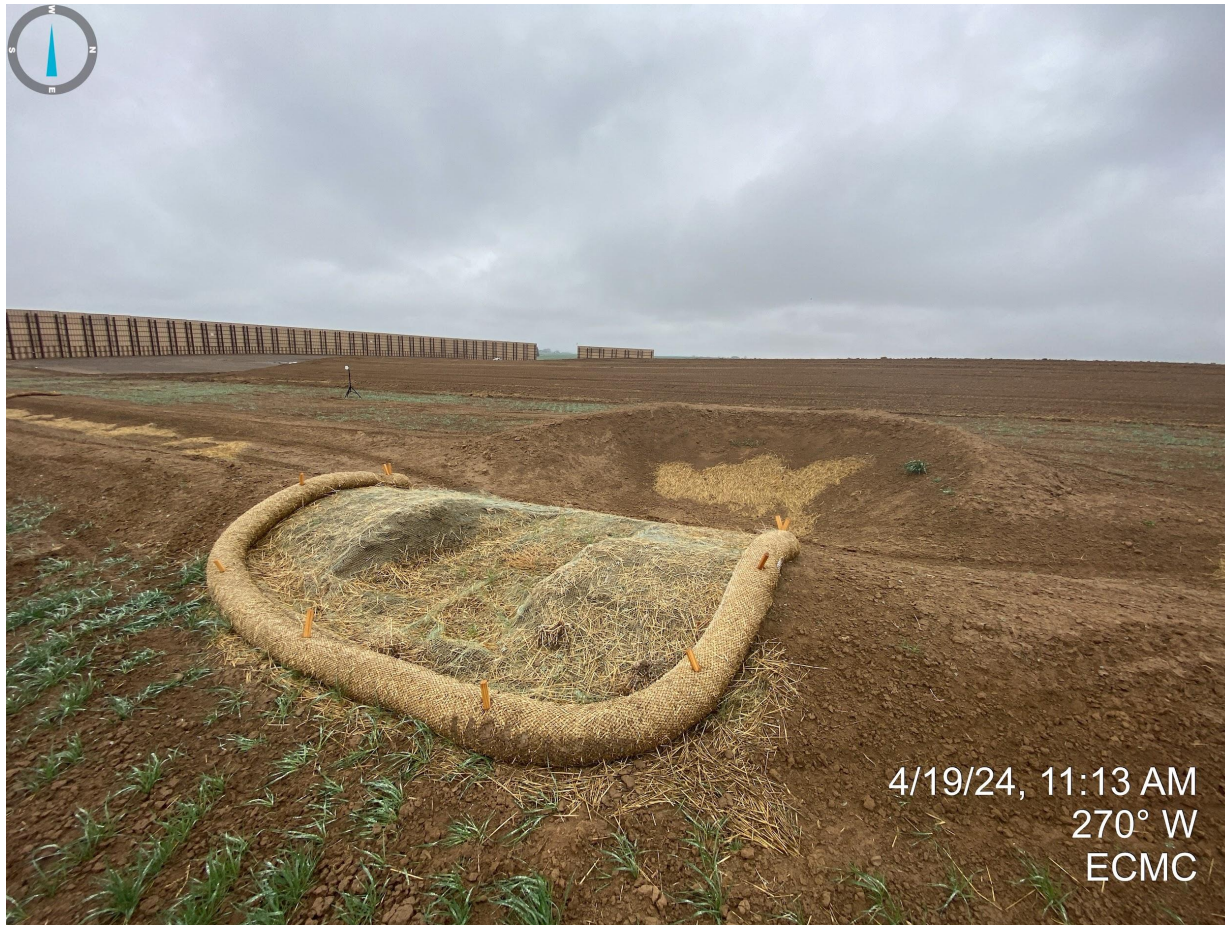
Photo 8. Taken along the east side of the disturbance area. Photo illustrates a sediment trap and temporarily stabilized outlets.

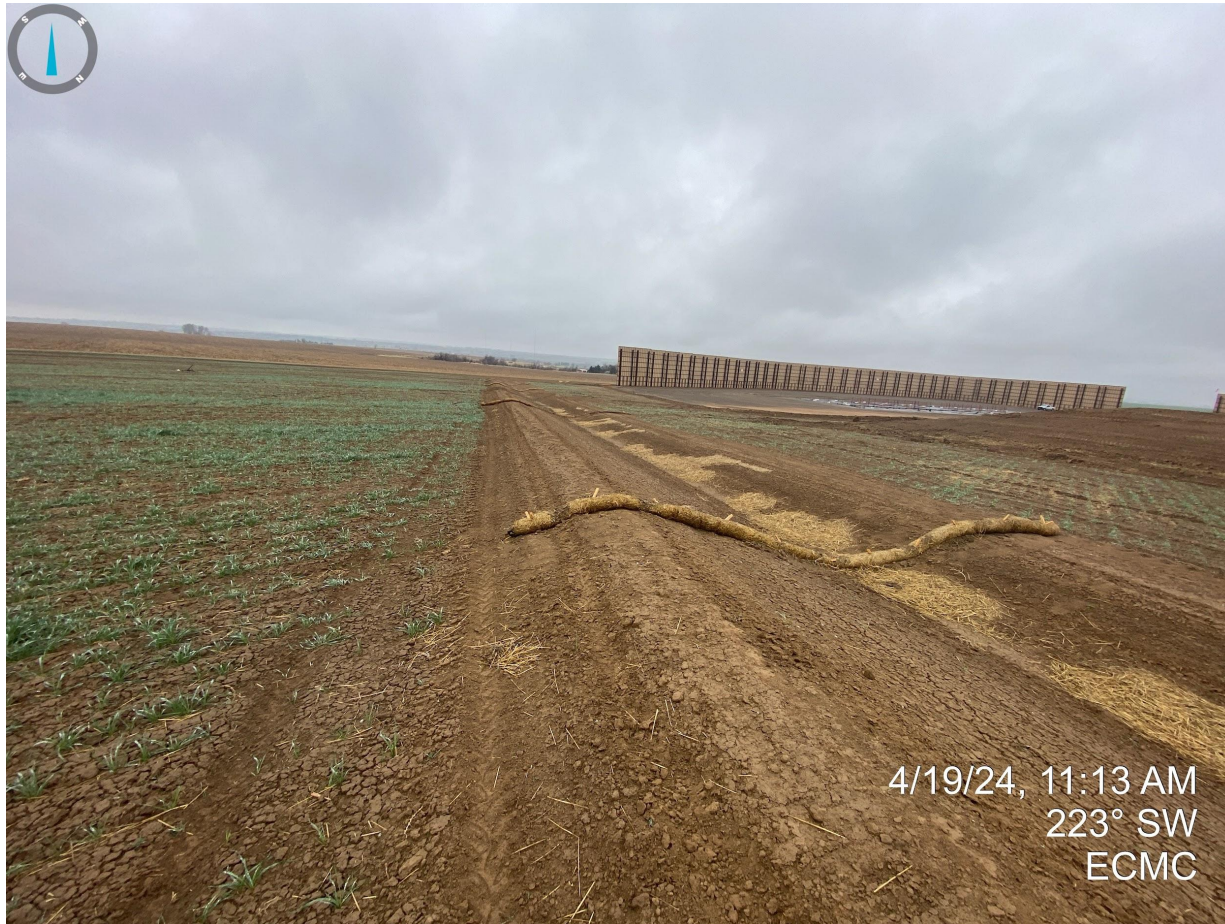
Photo 9. Taken along the eastern side of the disturbance area. erosion control logs installed in the perimeter stormwater ditch. Perimeter ditch and berm do not appear to be properly stabilized as evidenced by bare/exposed soils

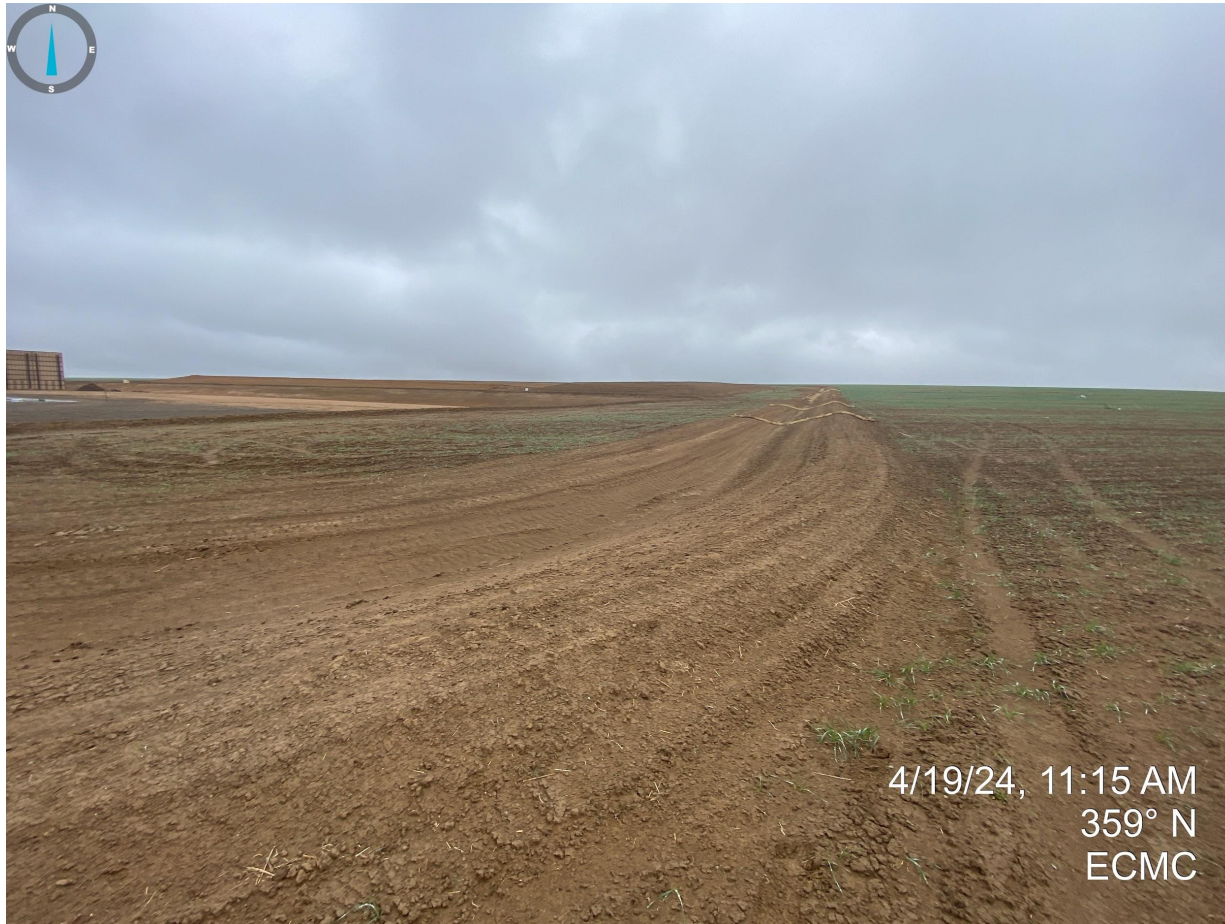
Photo 10. Taken near the eastern/southeastern portion of the disturbance area; see comments in Photo 9.

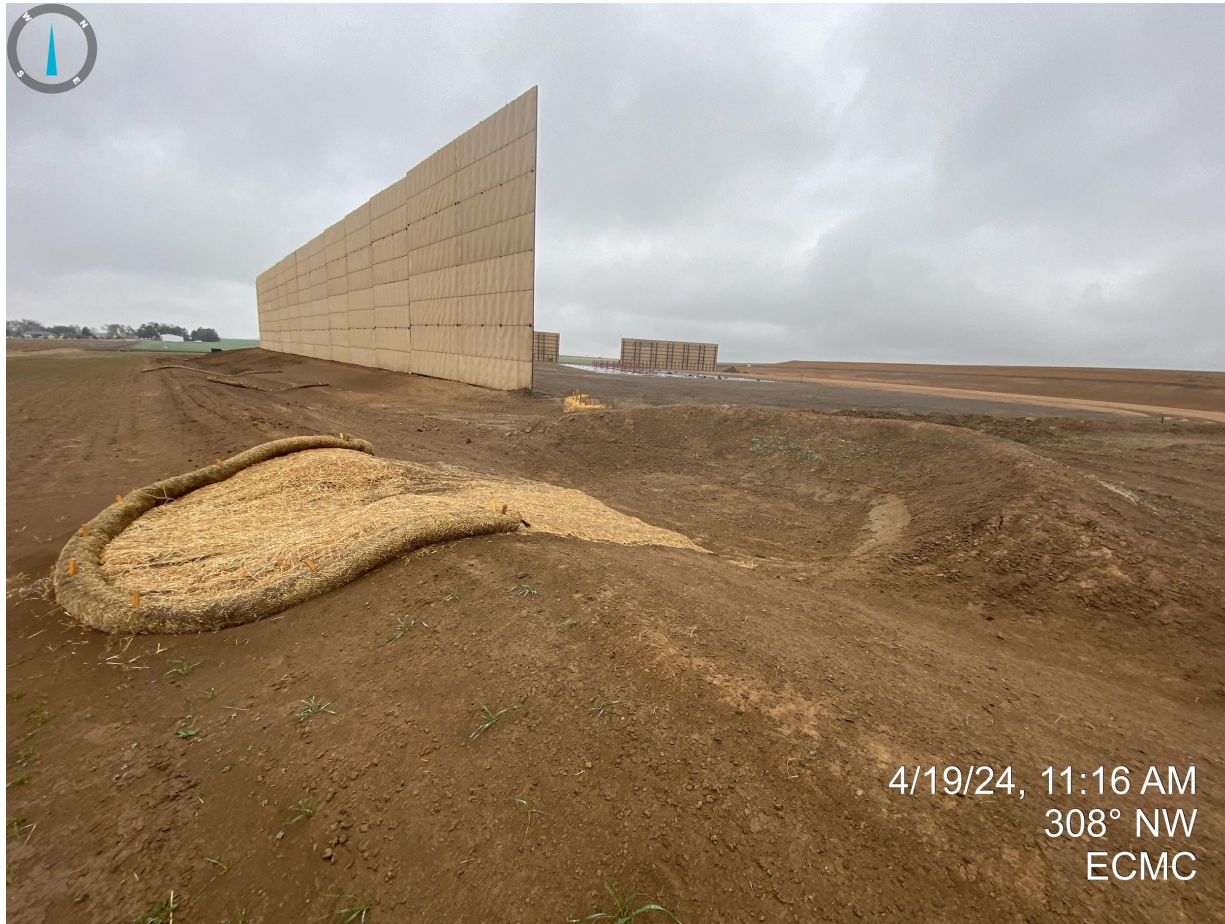
Photo 11. Taken near the eastern/southeastern portion of the disturbance area; see comments in Photo 8.

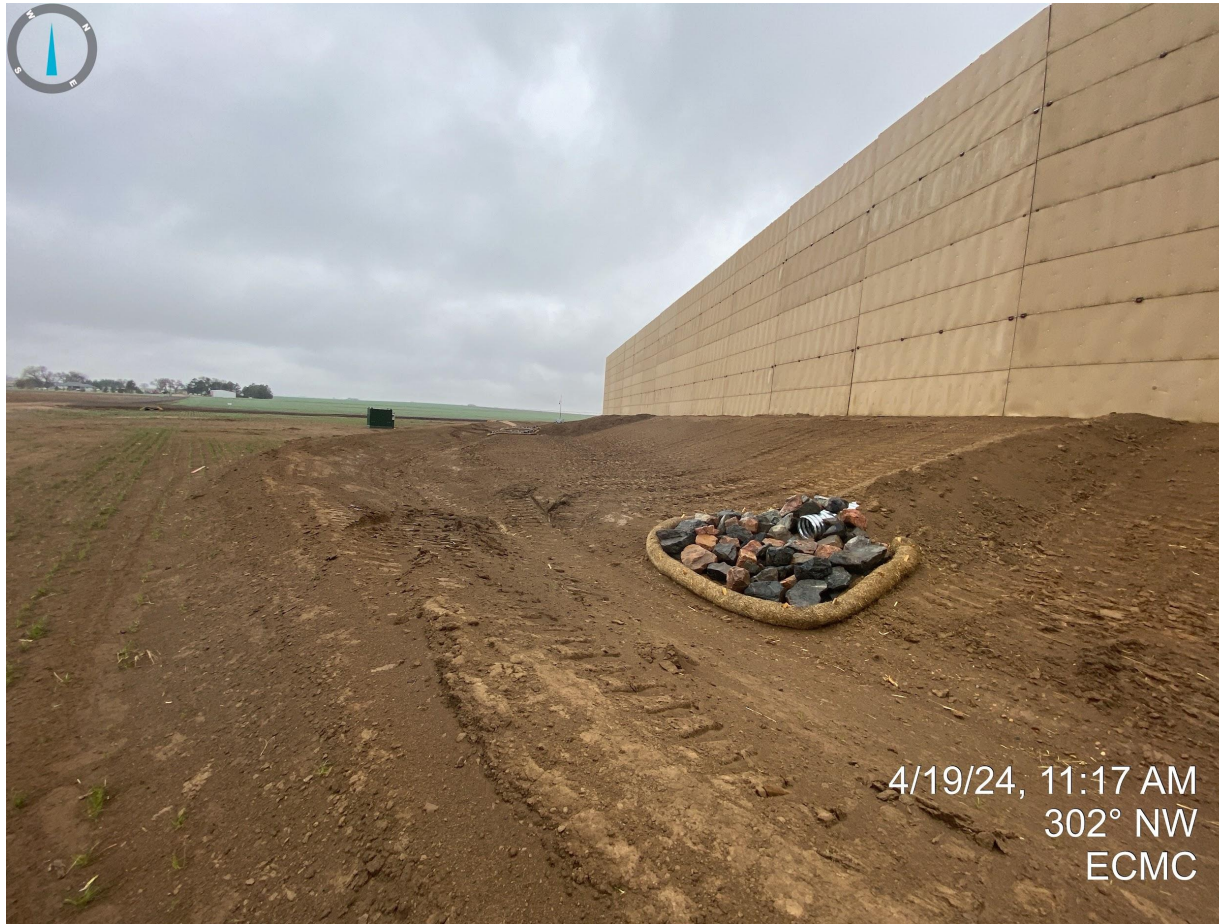
Photo 12. Taken near the southern/southeastern portion of the disturbance area. Photo illustrates outlet protections and unstabilized soils within the ditch and berm and slopes. Additional stabilization BMPs are required on the bare/exposed soils.

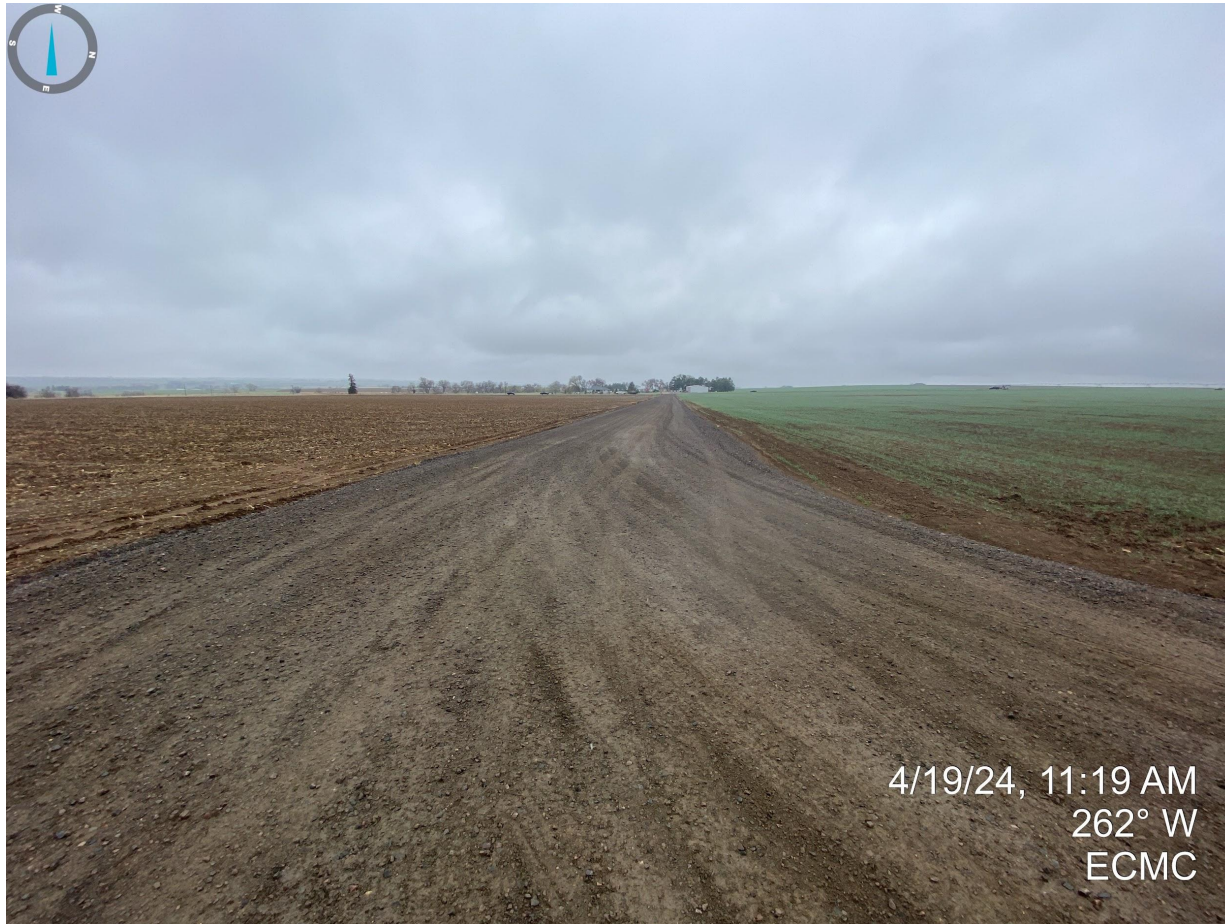
Photo 13. Facing west near the construction area. Photo illustrates that the existing county road has been improved and stabilized.

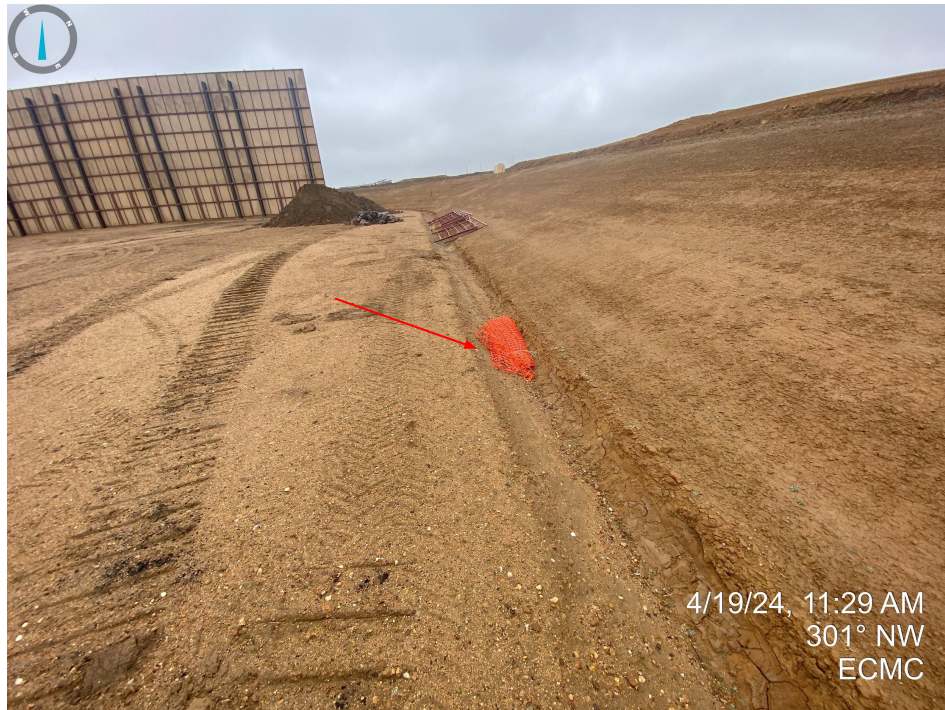
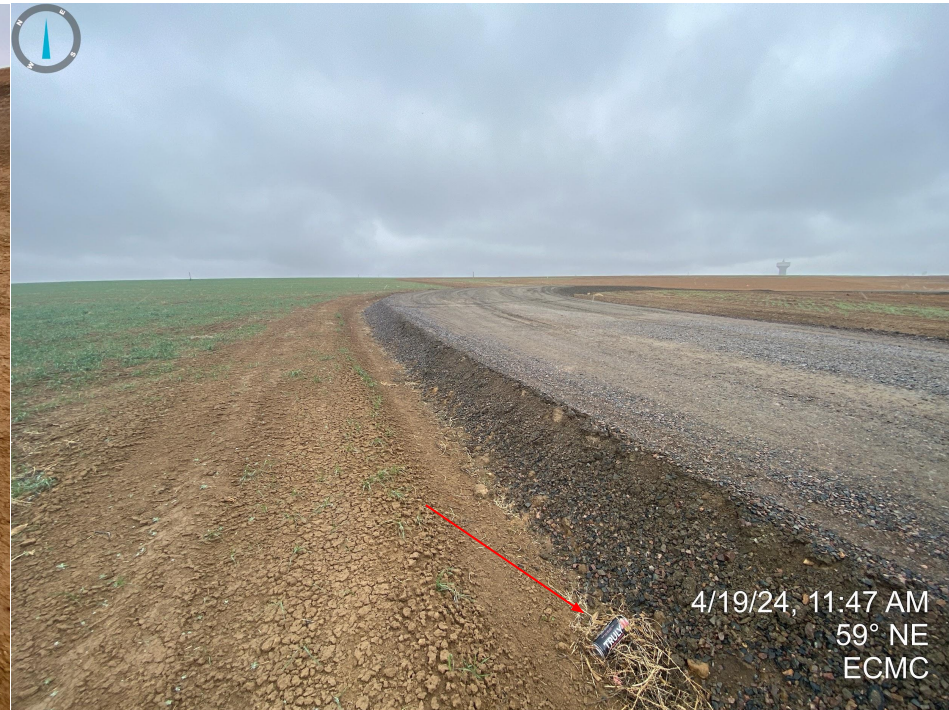
Photos 14 & 15. Examples of debris and trash observed throughout the location; Operator shall self inspect the entire location and remove all debris and trash.

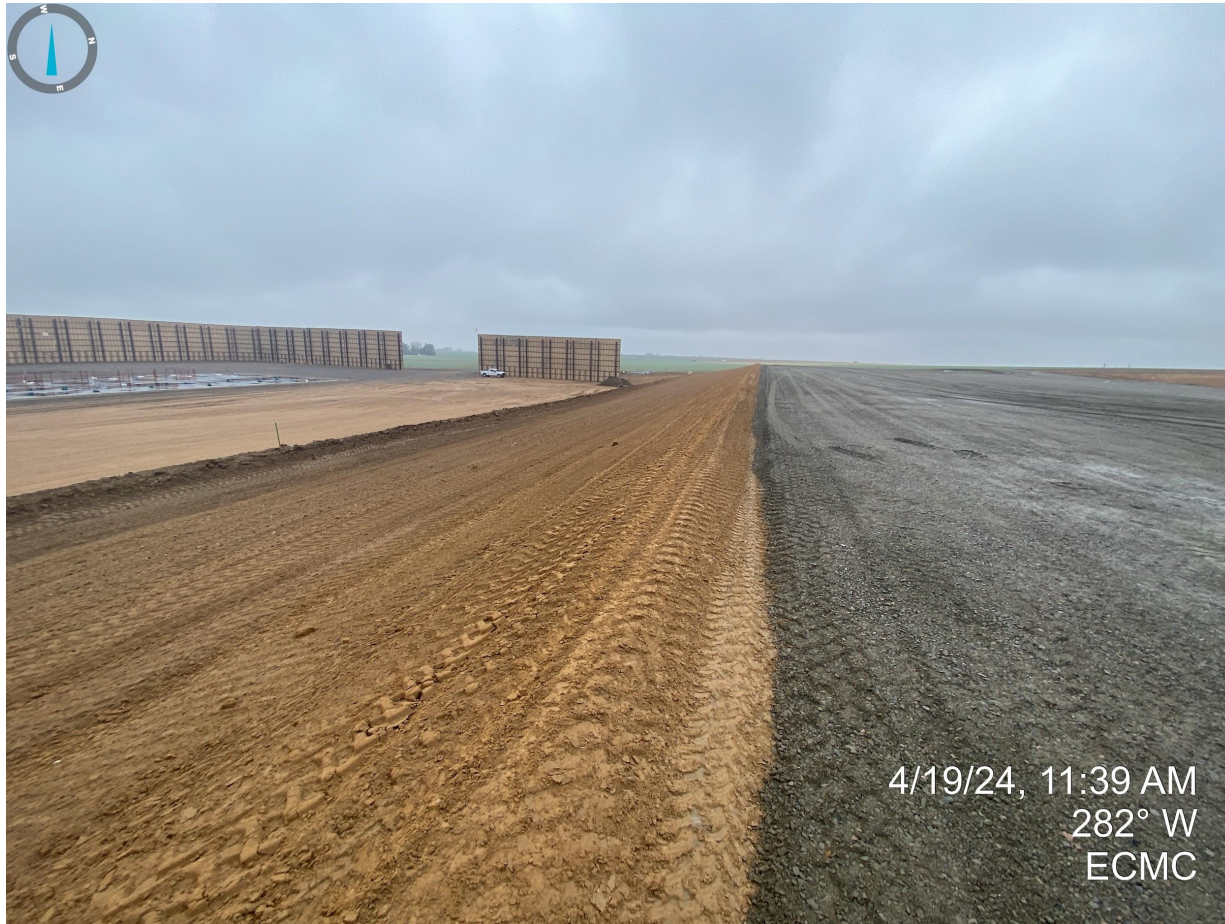
Photo 16. Taken from the cut/fill transition near the proposed production facility location. Photo illustrates that cut/fill slopes require additional stabilization BMPs.

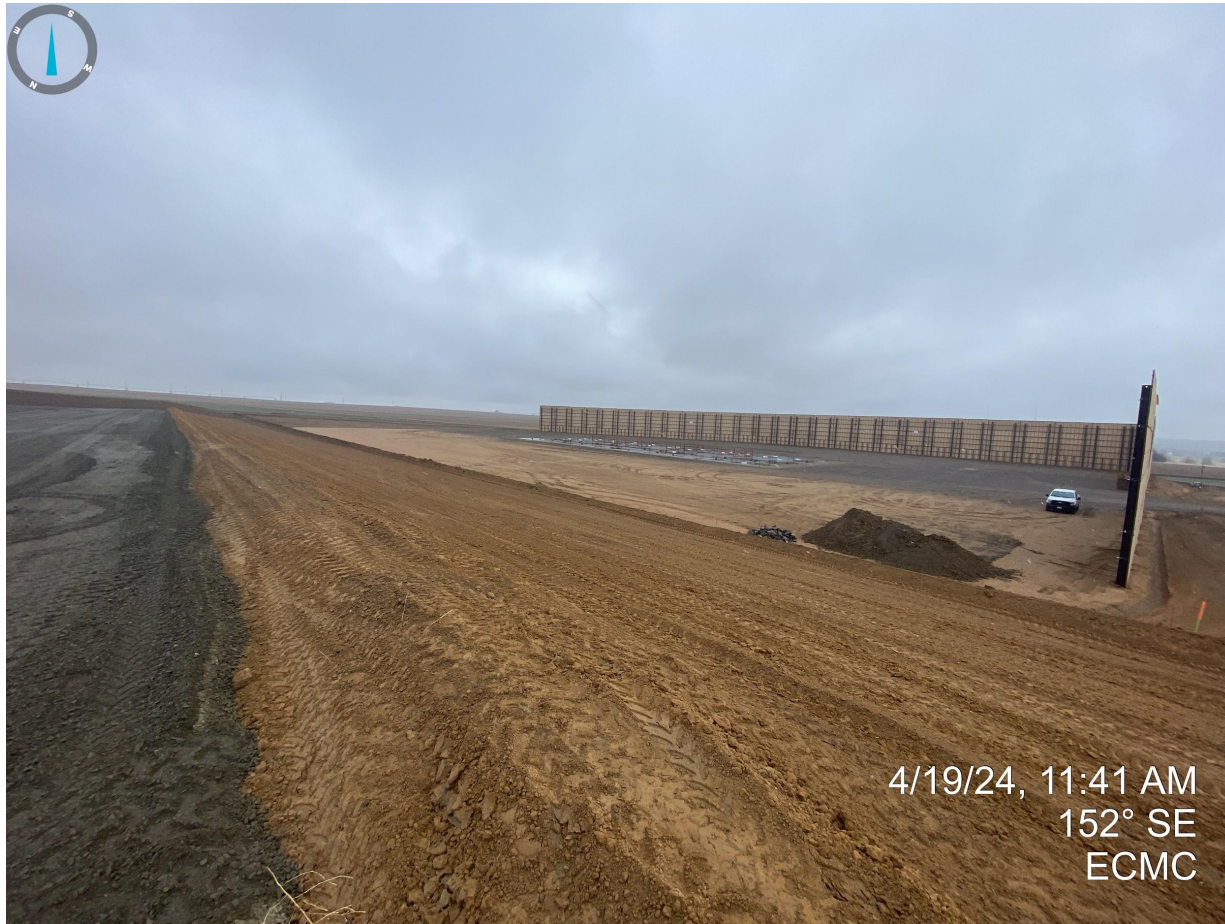
Photo 17. See comments in Photo 16.

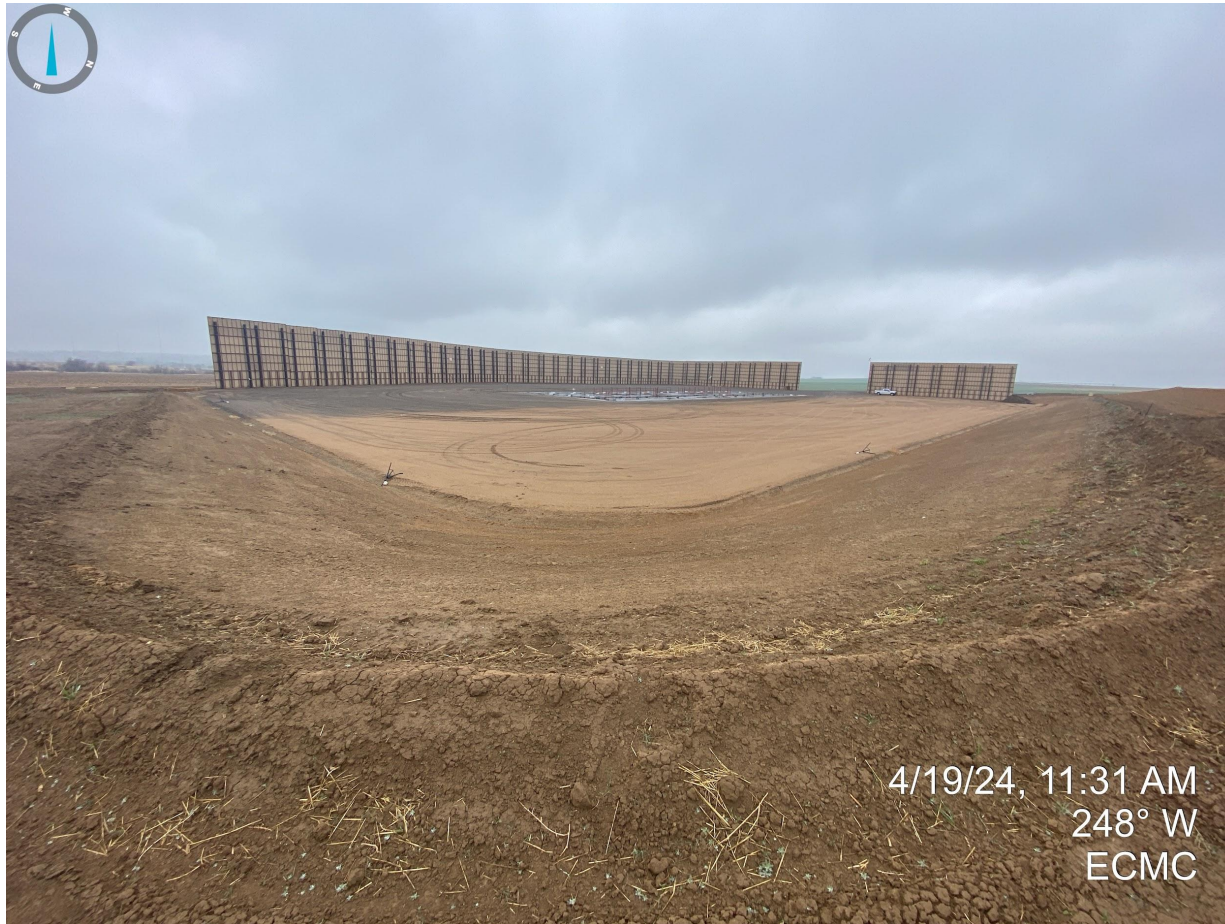
Photo 18. Taken from the cut/fill transition near the proposed well locations. Photo illustrates that cut/fill slopes require additional stabilization BMPs.

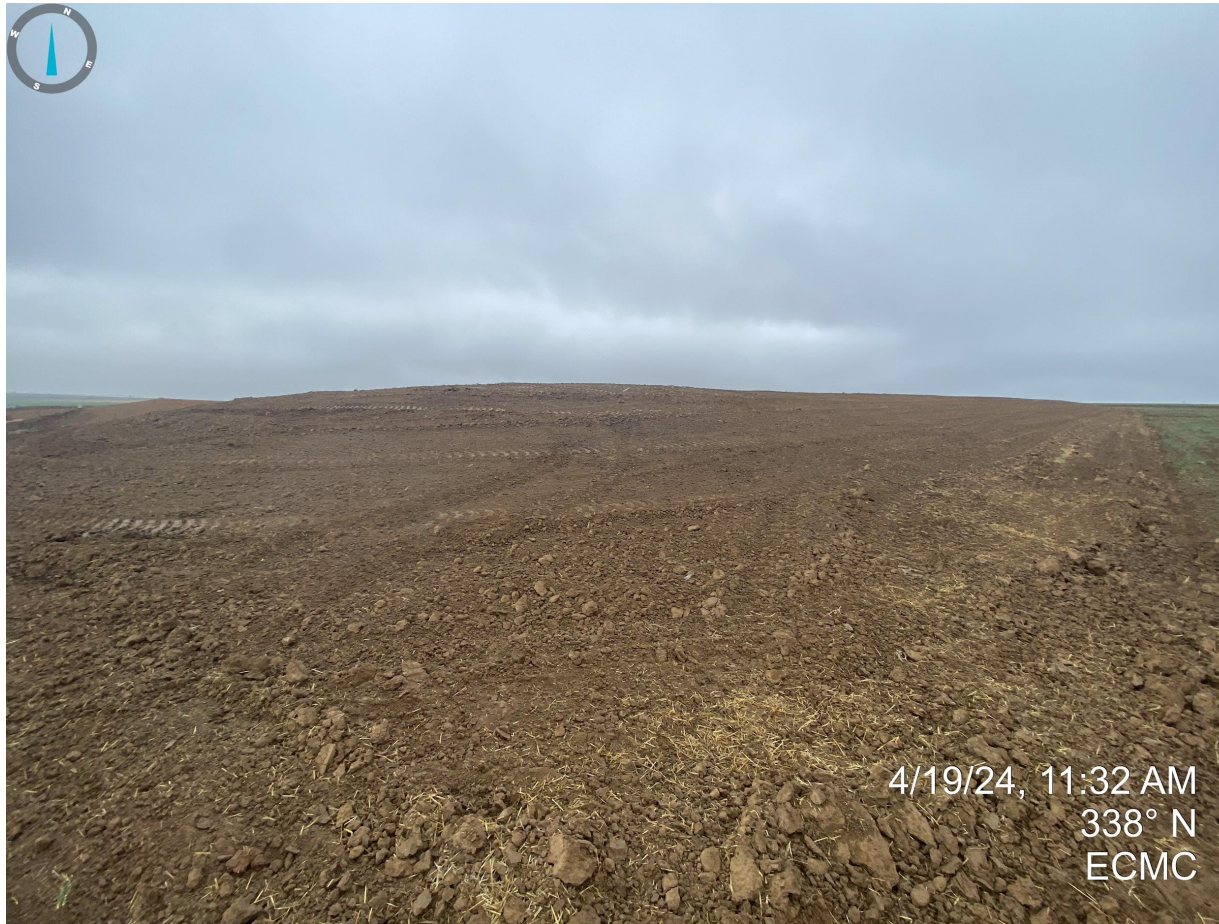
Photo 19. Taken from the southeast corner of the topsoil stockpile. Photo illustrates that the stockpile requires additional temporary stabilization BMPs.

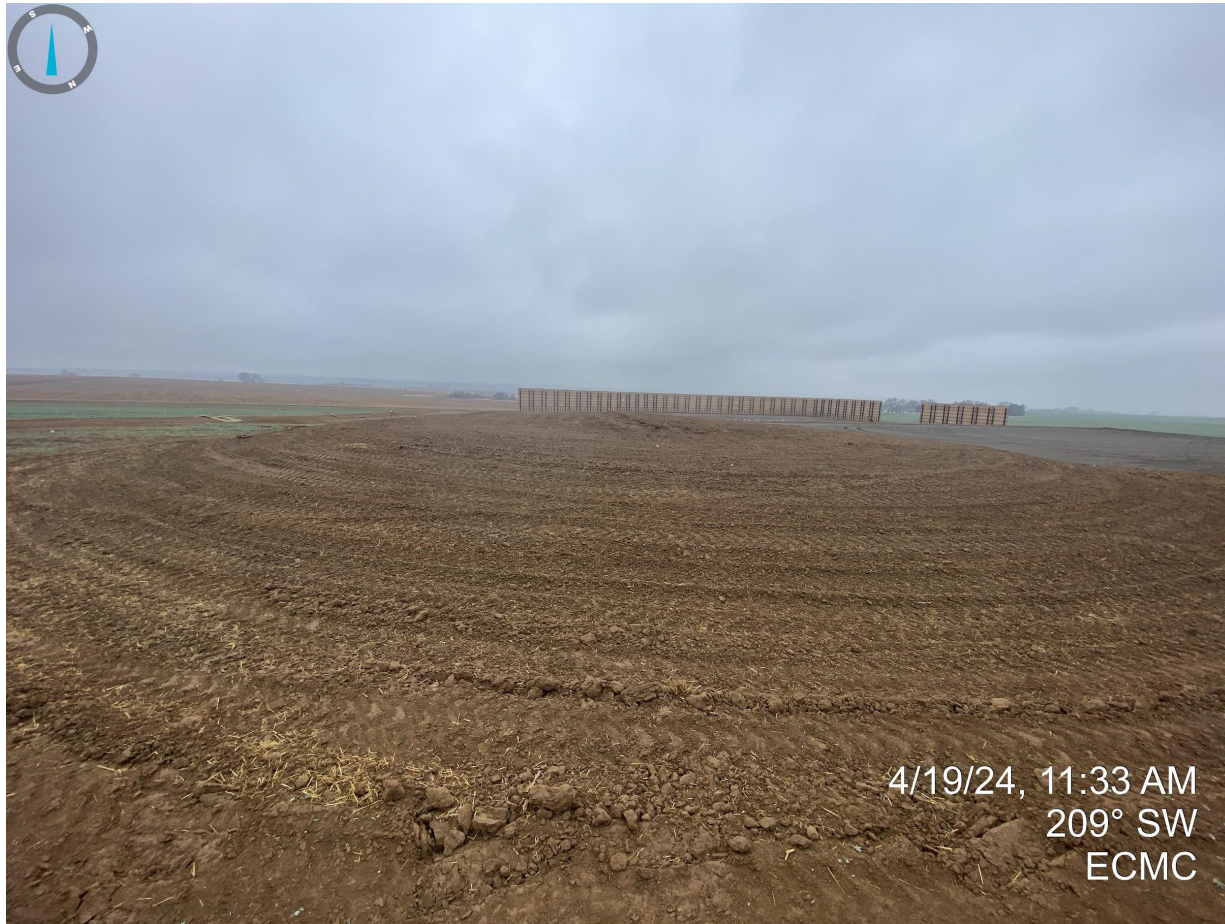
Photo 20. Taken from the northern portion of the topsoil stockpile; see comments in Photo 19.
