Construction and Stormwater Inspection

Date: 04/19/2024

Operator: KERR MCGEE OIL & GAS ONSHORE LP -
47120

Location ID: 485057

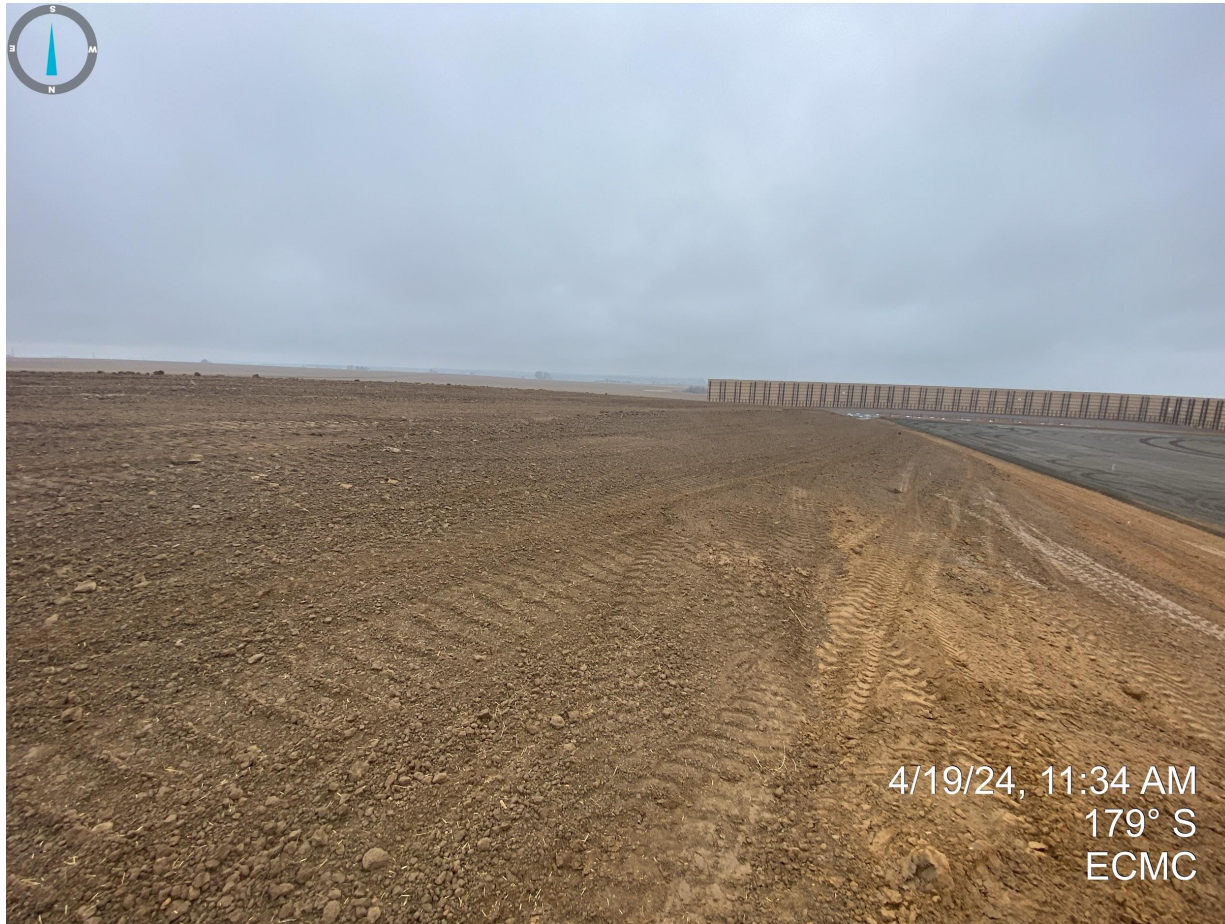
Photo 19. Taken from the southeast corner of the topsoil stockpile. Photo illustrates that the stockpile requires additional temporary stabilization BMPs.

Photo 21. Taken from the eastern side of the topsoil stockpile; see comments in Photo 19.

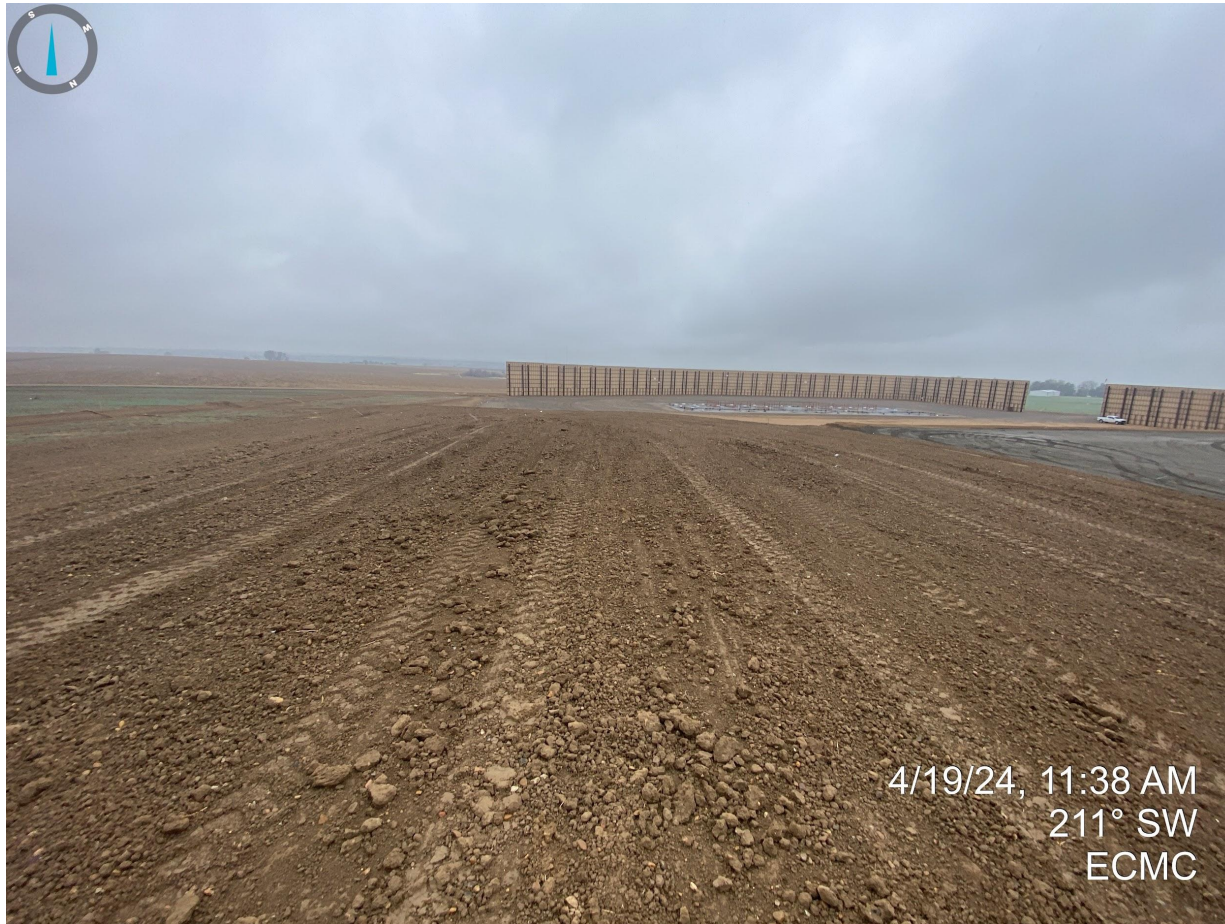
Photo 22. Taken from the top/center portion of the topsoil stockpile; see comments in Photo 19.
