Construction and Stormwater Inspection

Date: 4/12/24

Operator: PDC Energy Inc - 69175

Inspection Photos
Location Name: Trippett 3N66W3 1-48
Location ID: 484682

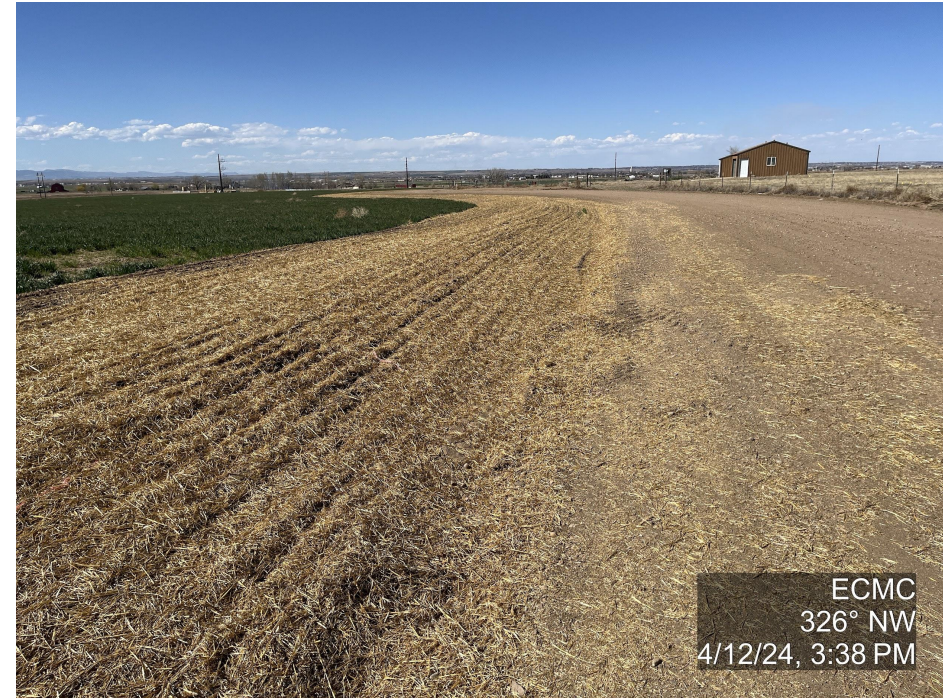
Photo 2. The photo was taken at the entrance to the well location facing Northwest. The photo illustrates stored topsoil along the access road edge has been roughed, crimped and seeded.

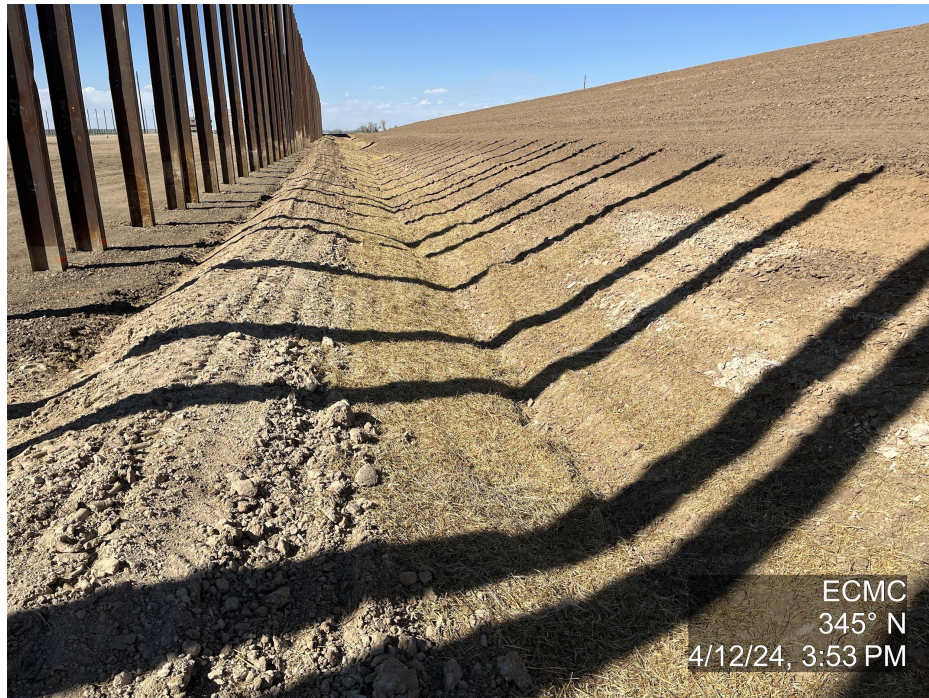
Photo 3. The photo was taken at the well location facing North. The photo illustrates the an erosion control ditch at the foot of the topsoil stockpile and edge of production pad has been crimped.

Note - The topsoil stockpile has not been crimped or seeded.

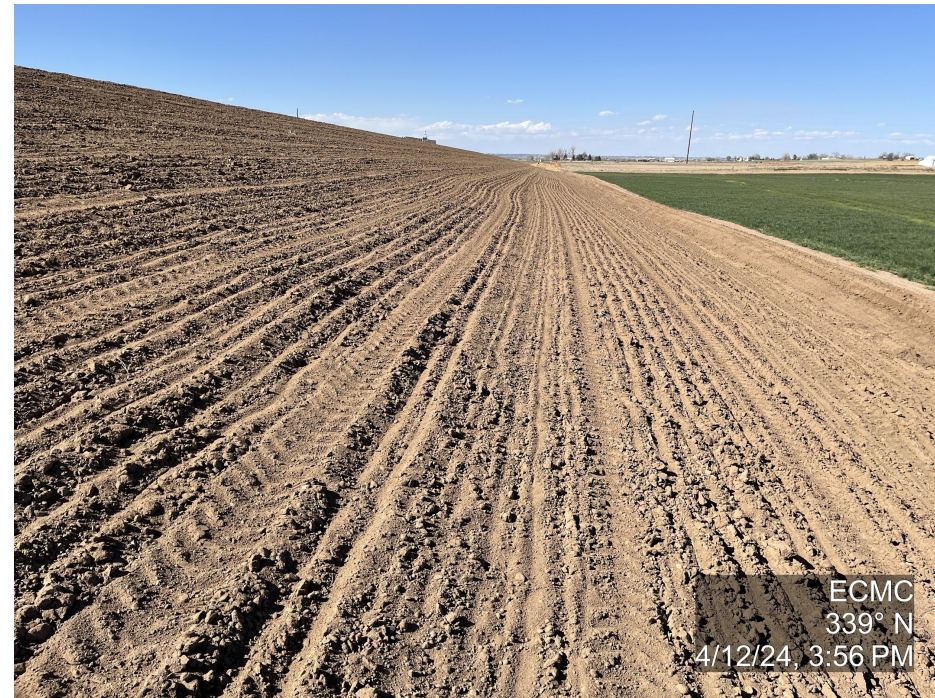
Photo 4. The photo was taken at the well location facing North. The photo illustrates the topsoil stockpile has been roughed but has no crimping or seeding applied to it.

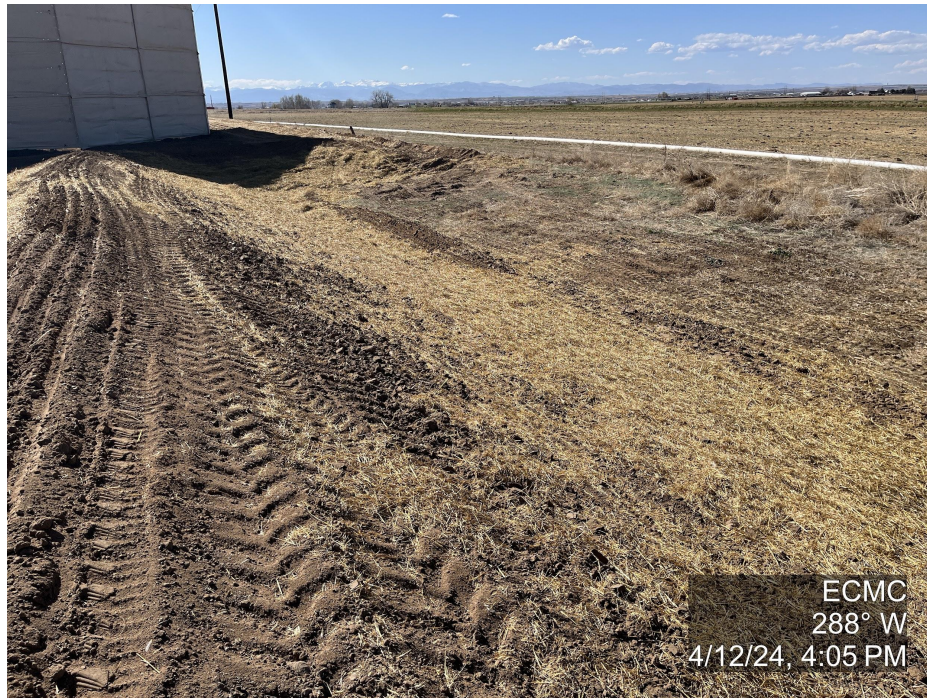
Photo 5. The photo was taken at the well location facing West. The photo illustrates the northern ditch and berm have been flattened during construction of the detention area.

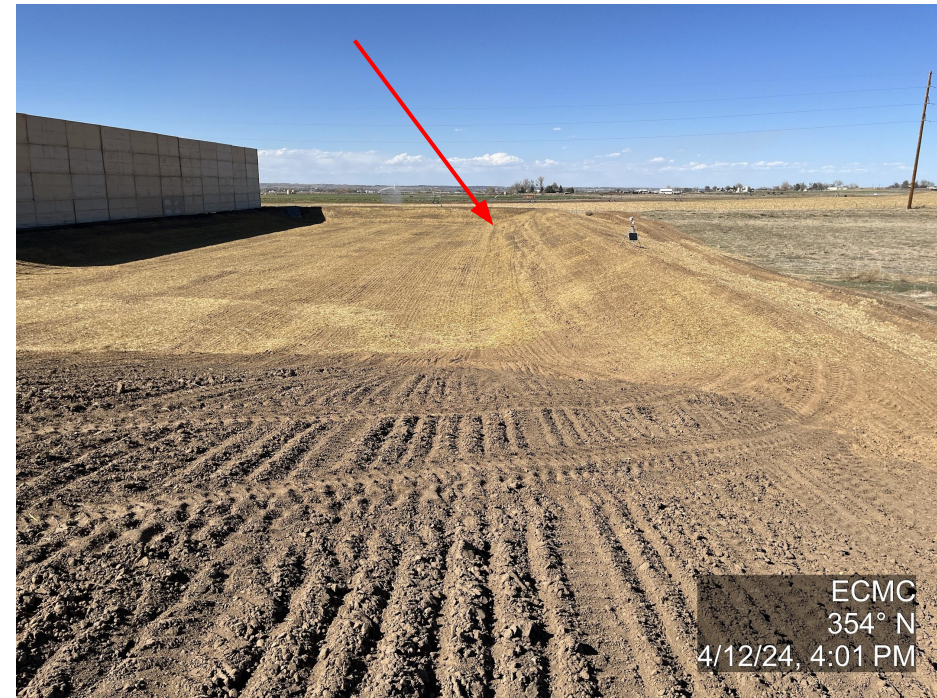
Photo 6. The photo was taken at the well location facing North. The photo illustrates the temporary detention area on the Northeast side of the location has been straw crimped.

Note - In Operator provided stormwater, interim and topsoil designs an outfall was to be located where the red arrow is indicating, but it was not present at the time of inspection. The same can be said for the detention area in the Northwest corner.

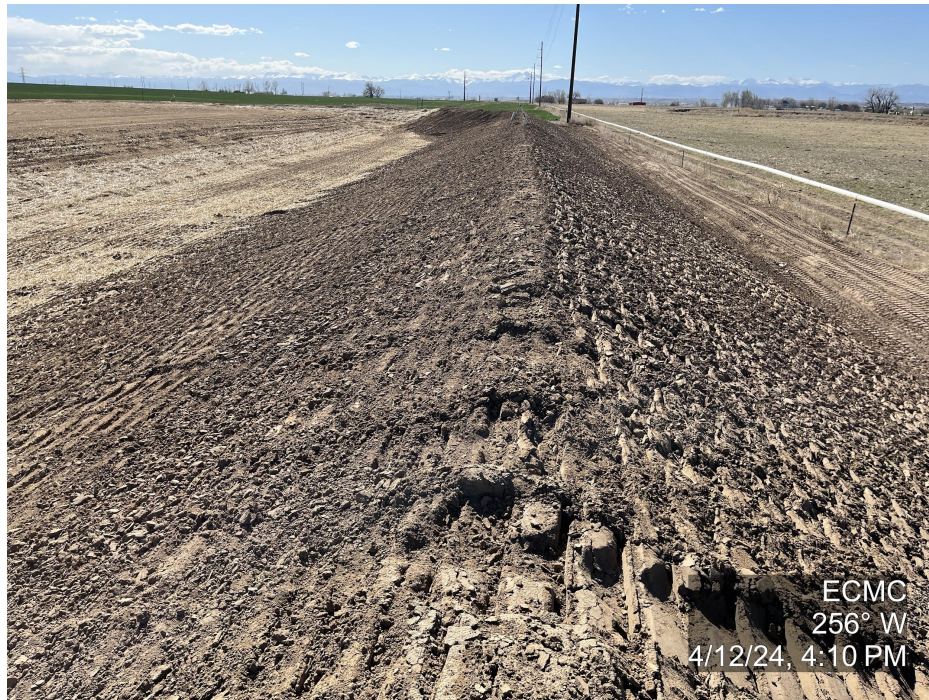
Photo 9. The photo was taken at the well location facing West. The photo illustrates the earthen berm has been tracked around the western retention area.

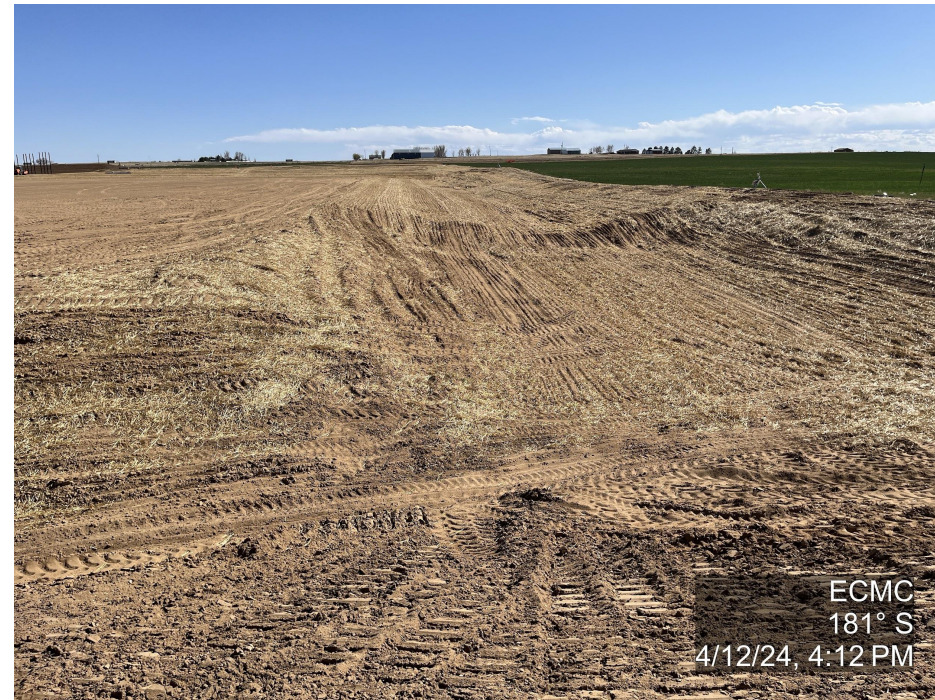
Photo 10. The photo was taken at the well location facing South. The photo illustrates the inflow to the retention area has been crimped with straw.

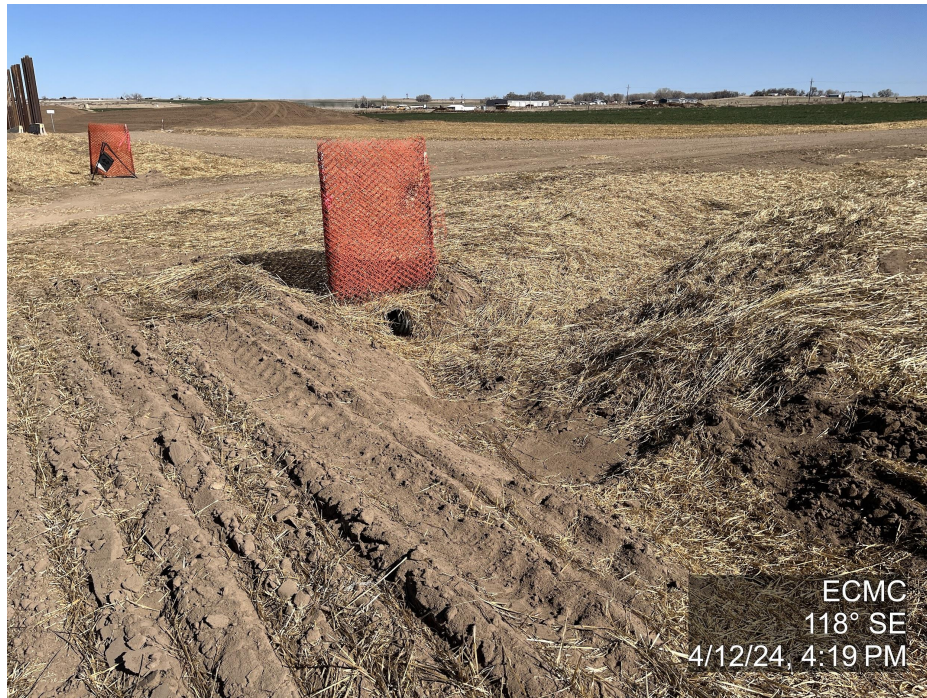
Photo 11. The photo was taken at the well location facing Southeast. The photo illustrates the culvert under the access road to the facility do not have inflow or outflow protection.

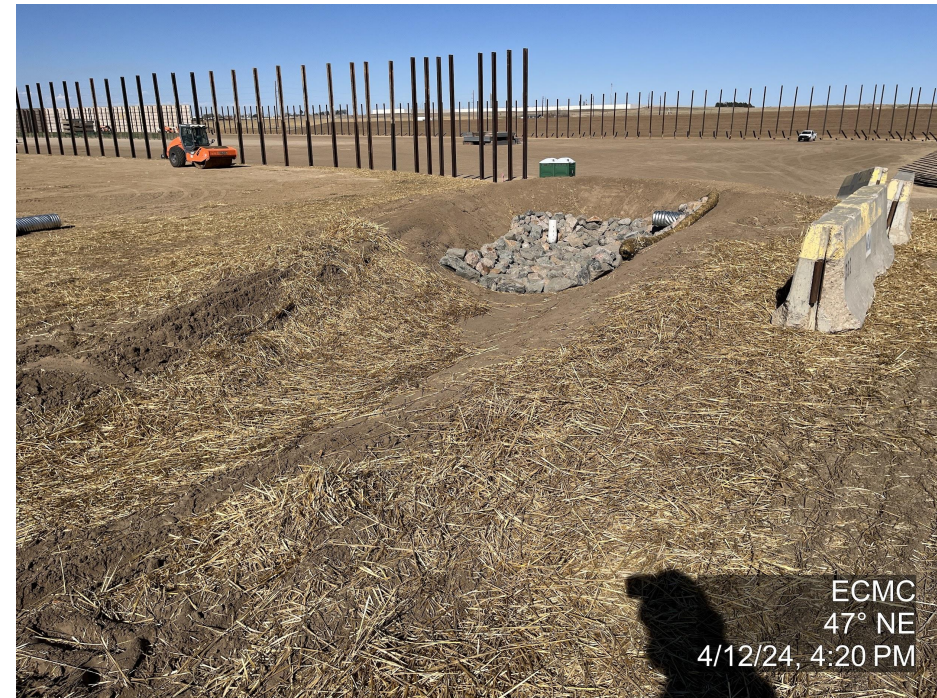
Photo 12. The photo was taken at the well location facing Northeast. The photo illustrates a small sediment trap constructed in the central area of the facility.

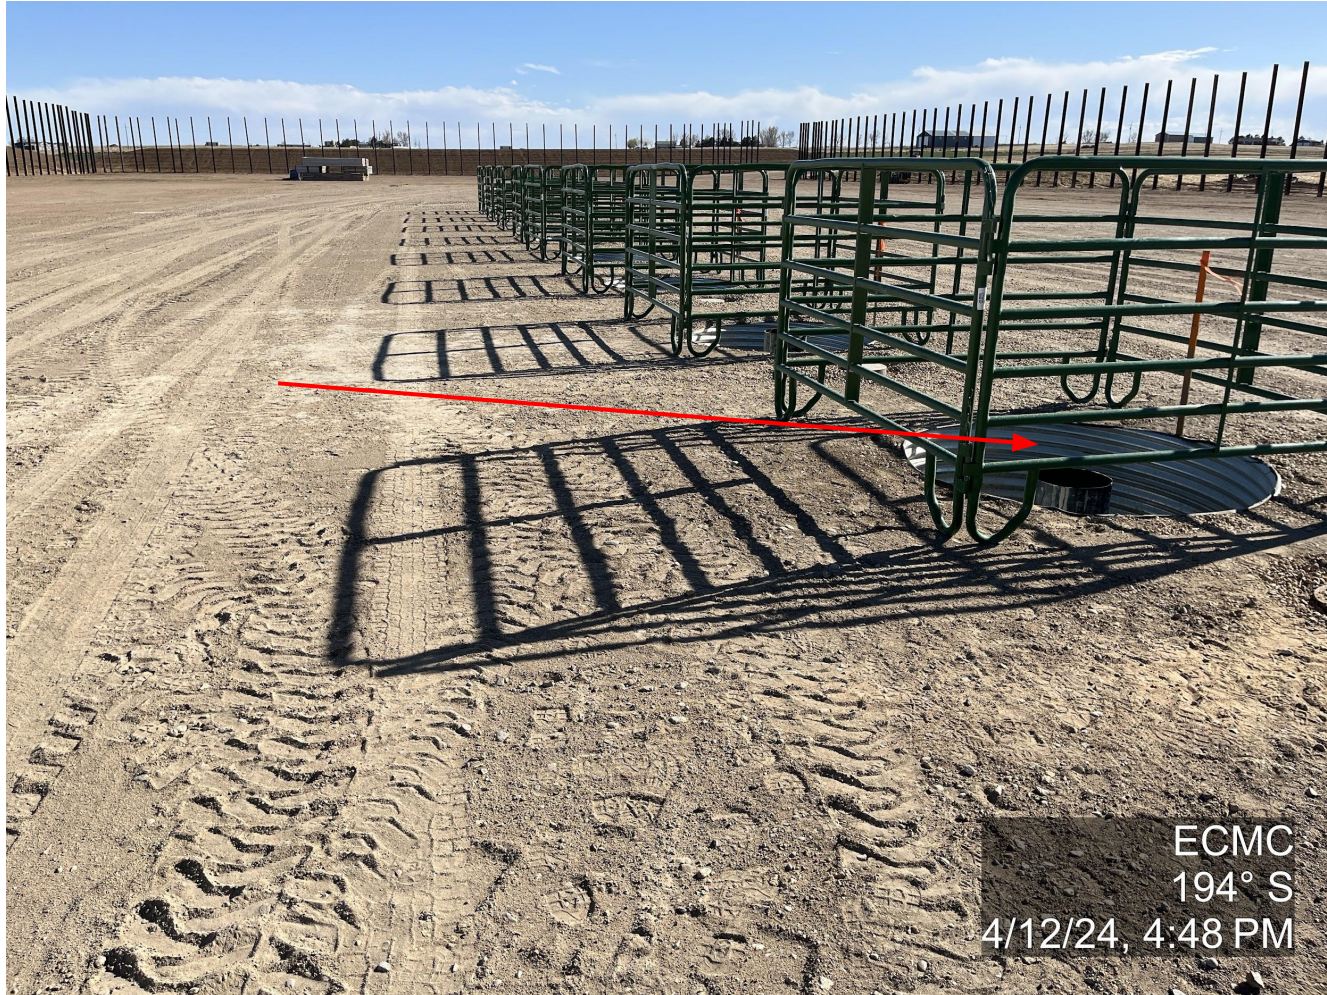
Photo 13. The photo was taken at the well location facing South. The photo illustrates that the operator has failed to install night caps on the surface casings.
