Inspection Photos

Loc: 484358

Operator: DESERT EAGLE OPERATING LLC

Inspection Date: 4/22/2024

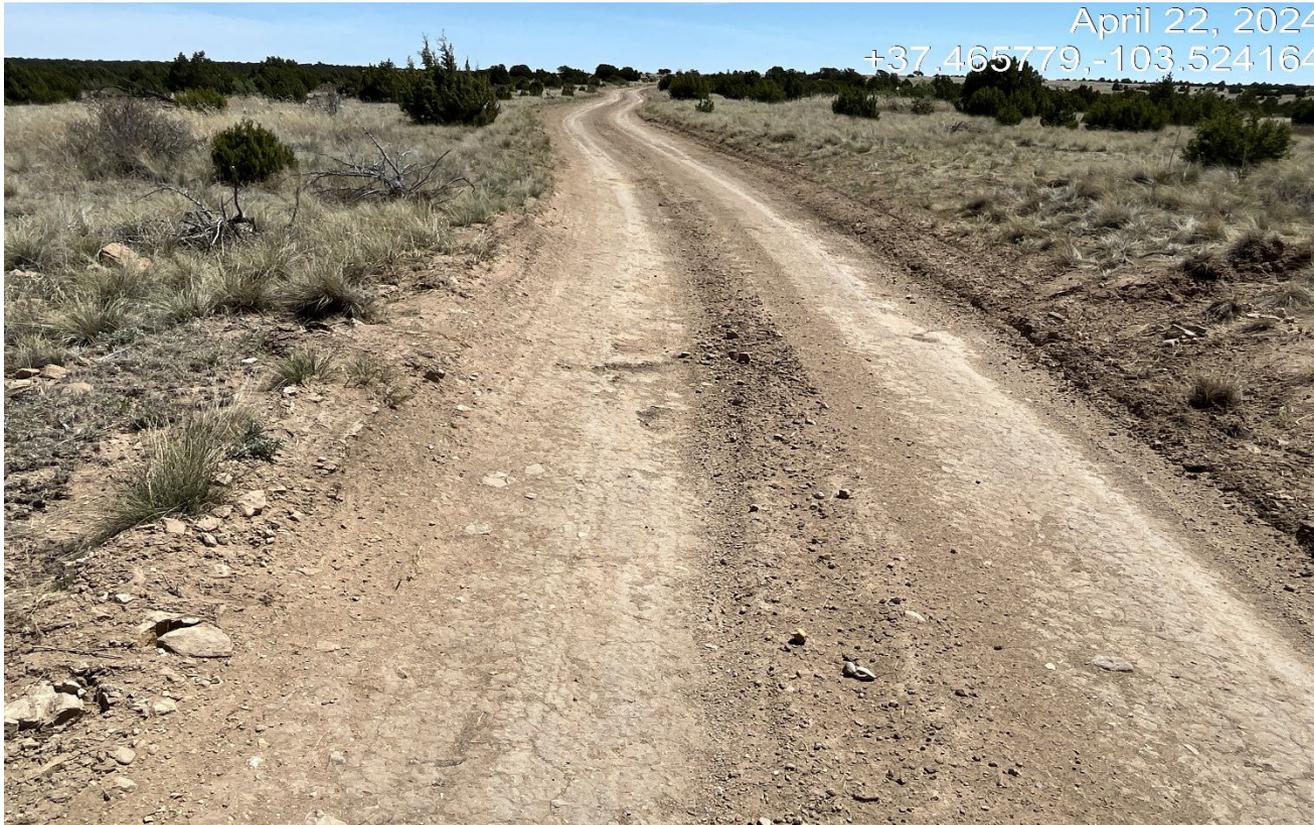
Photo 1. Facing east along the access road.

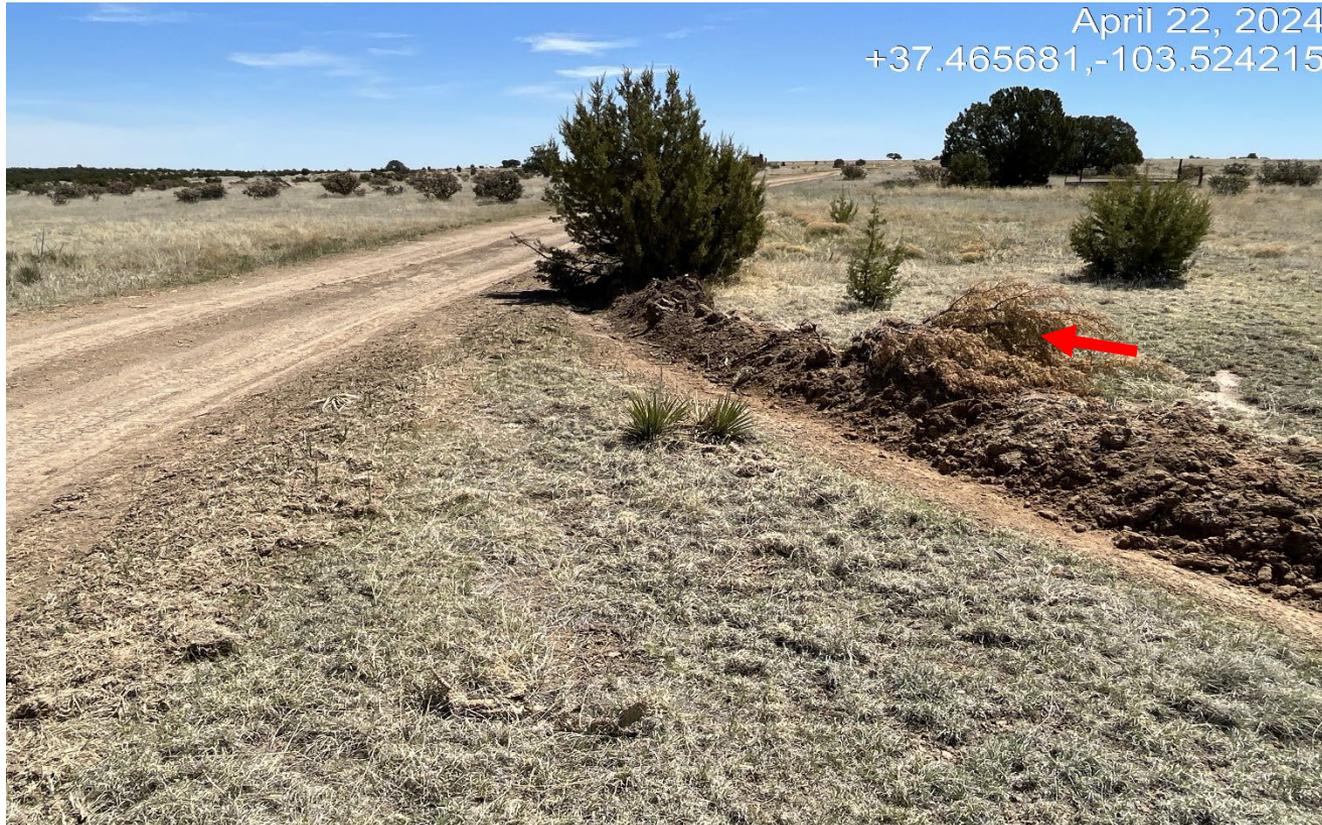
Photo 2. There are cuts installed for stormwater diversion however the loose soil berms need to be stabilized and tree debris must be removed. Previous CA was not completed.

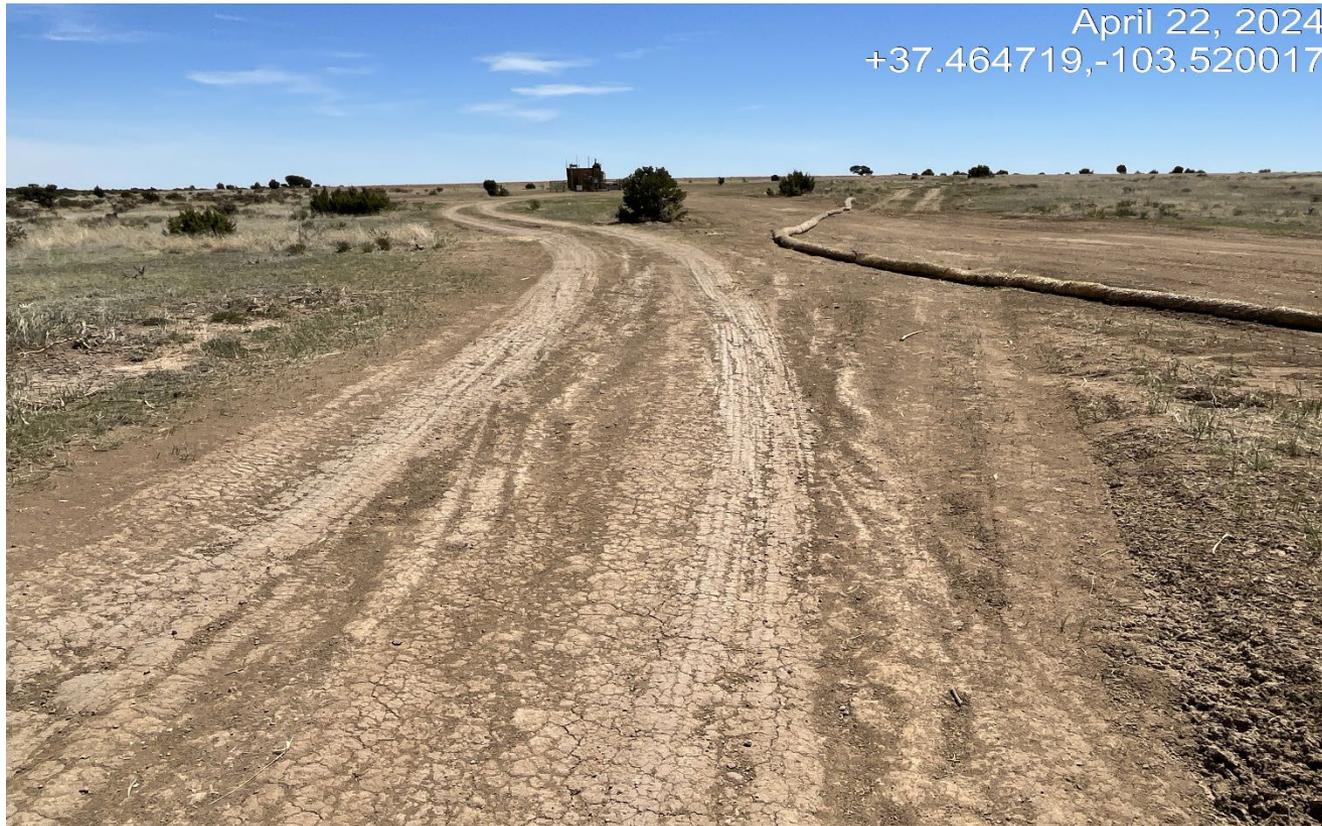
Photo 3. Facing east toward along the access road near the location. Topsoil was not salvaged along the road and is not very compacted.

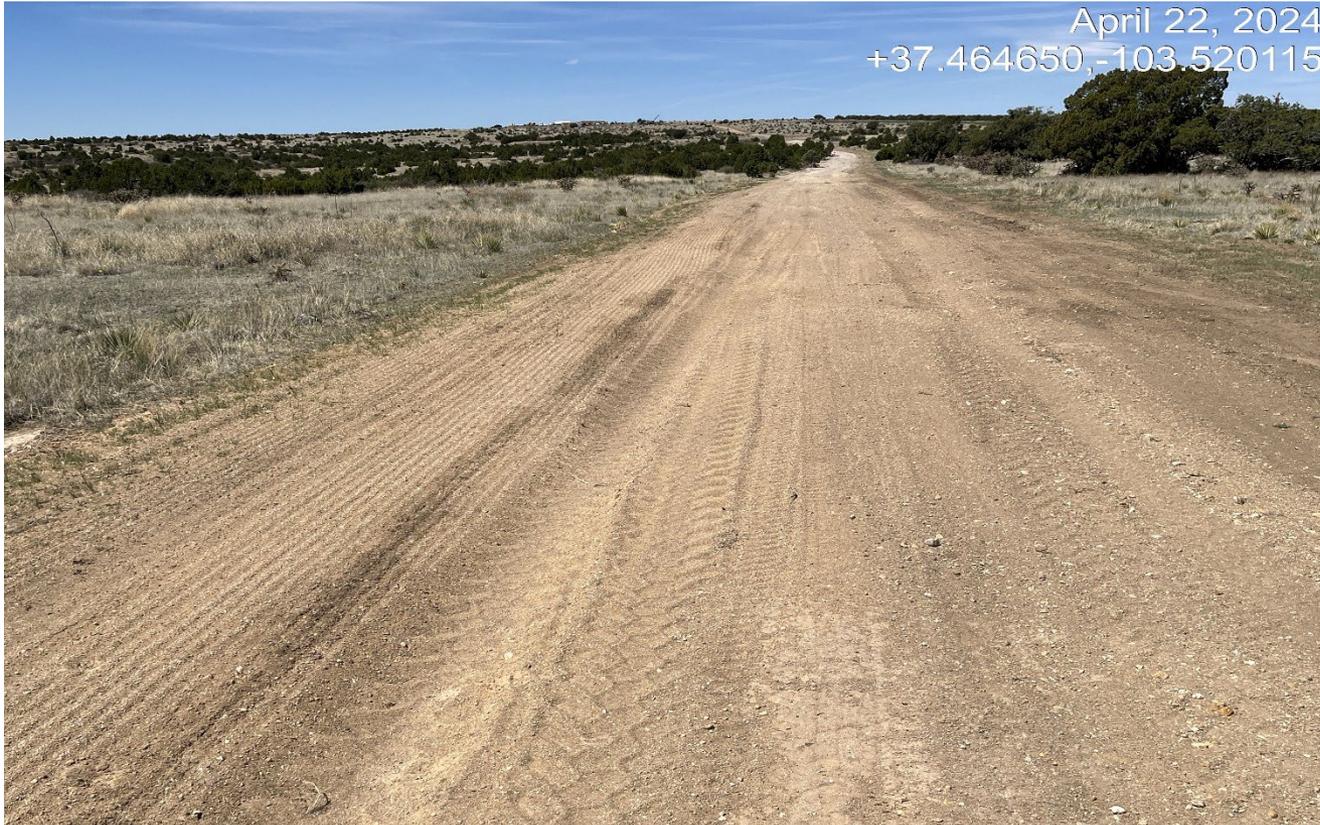
Photo 4. Facing back west toward the flowline disturbance. It appears seeding was performed however loose soils are not stabilized. This area needs to be monitored and additional BMP's may need to be installed.

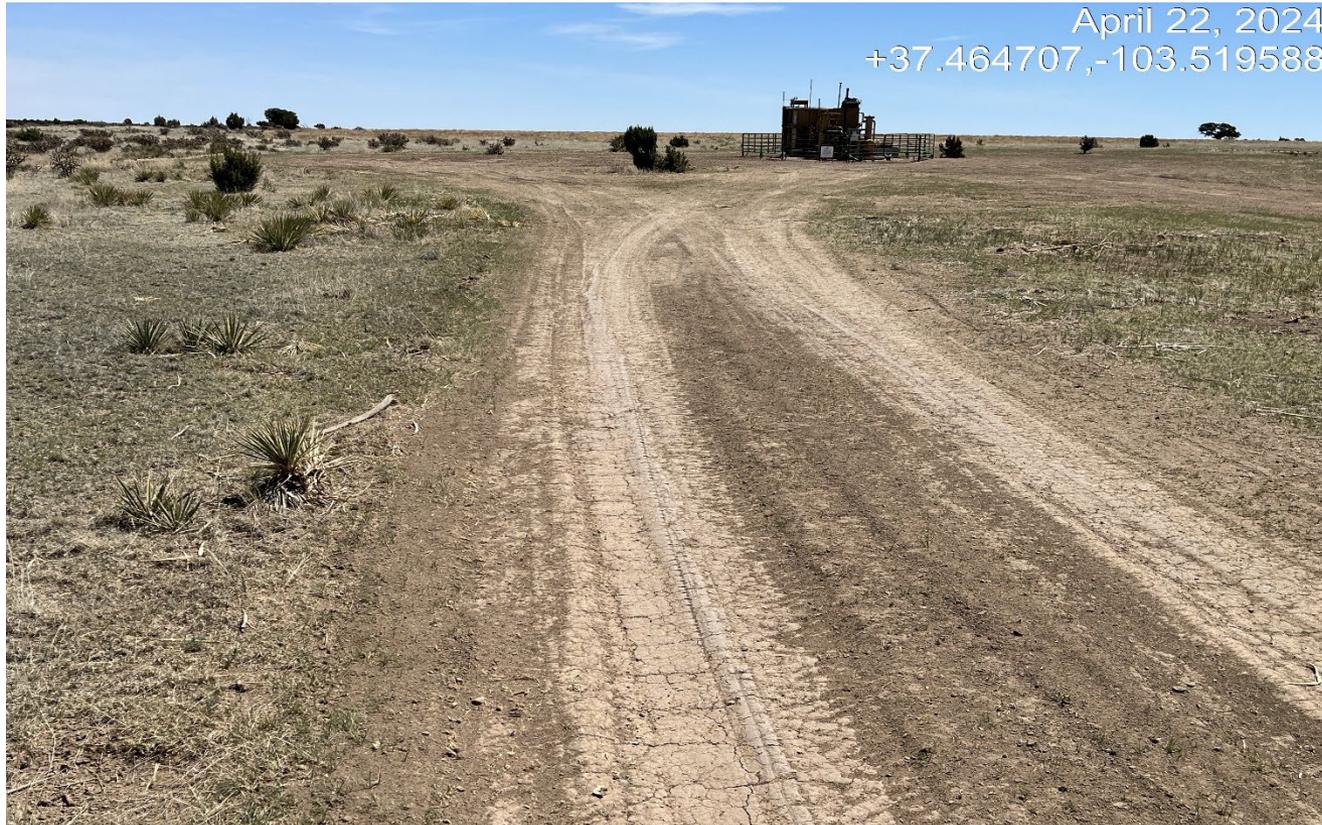
Photo 5. Facing east toward the wellsite. Topsoil was not salvaged along the road and is not very compacted.

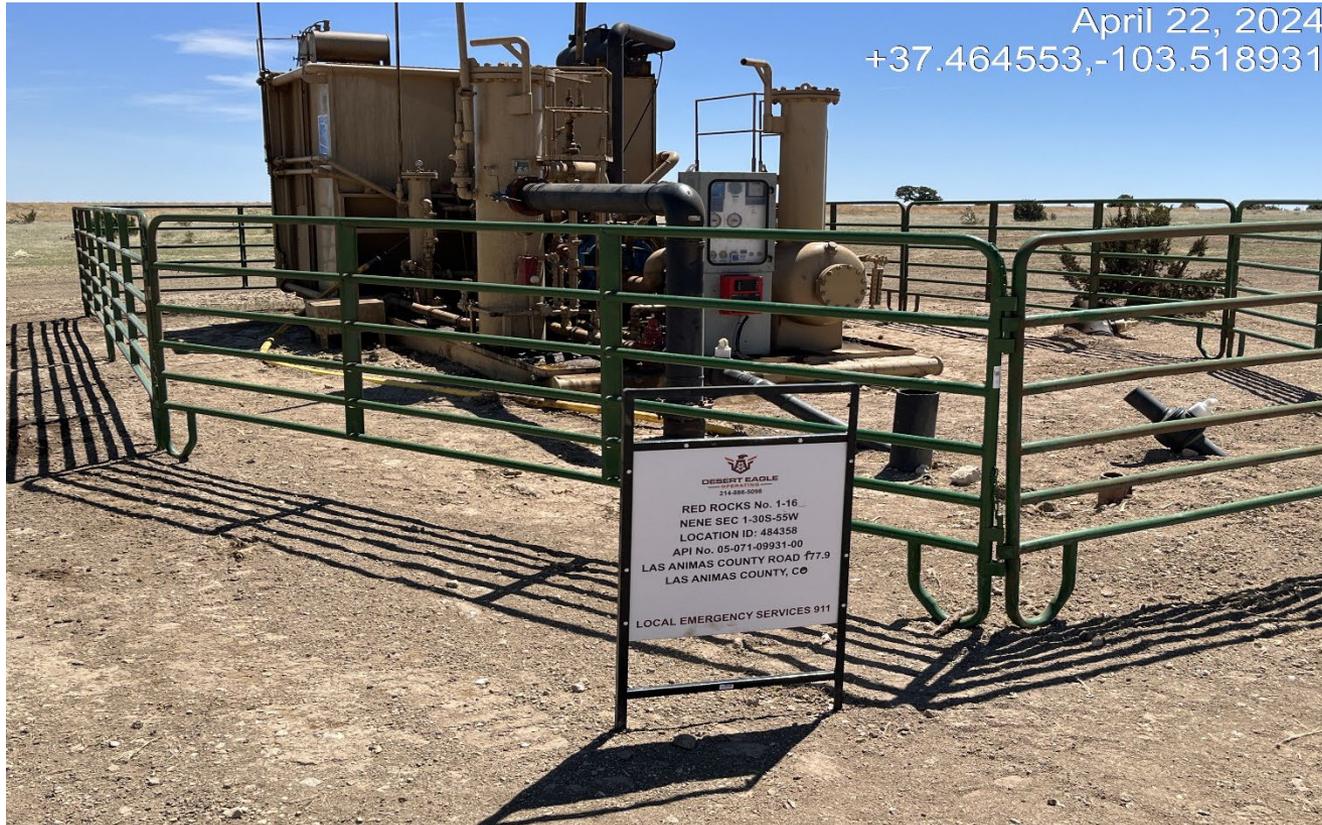
Photo 6. There is compressor engine installed b the wellhead.

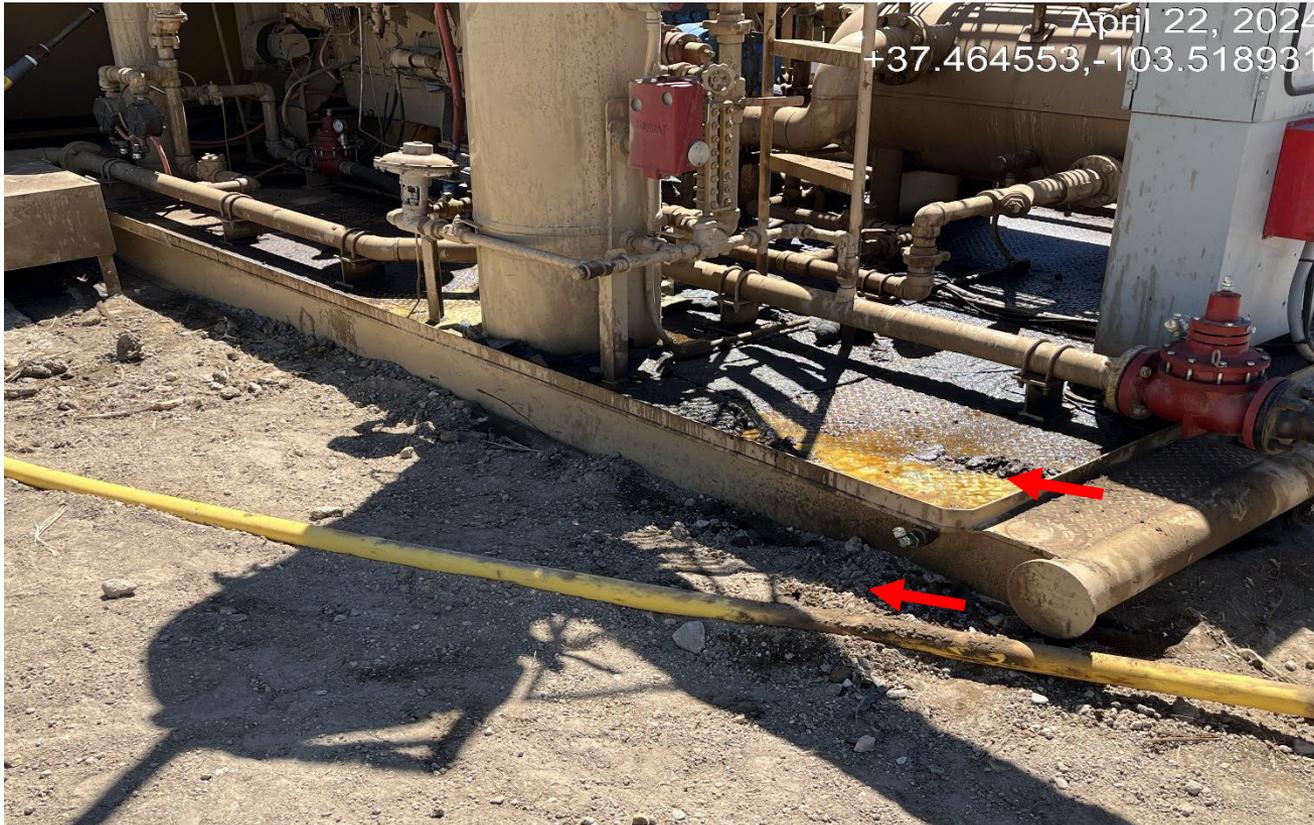
Photo 7. There is oily fluids in the engine skid that has spilled onto the ground. This must be cleaned up.

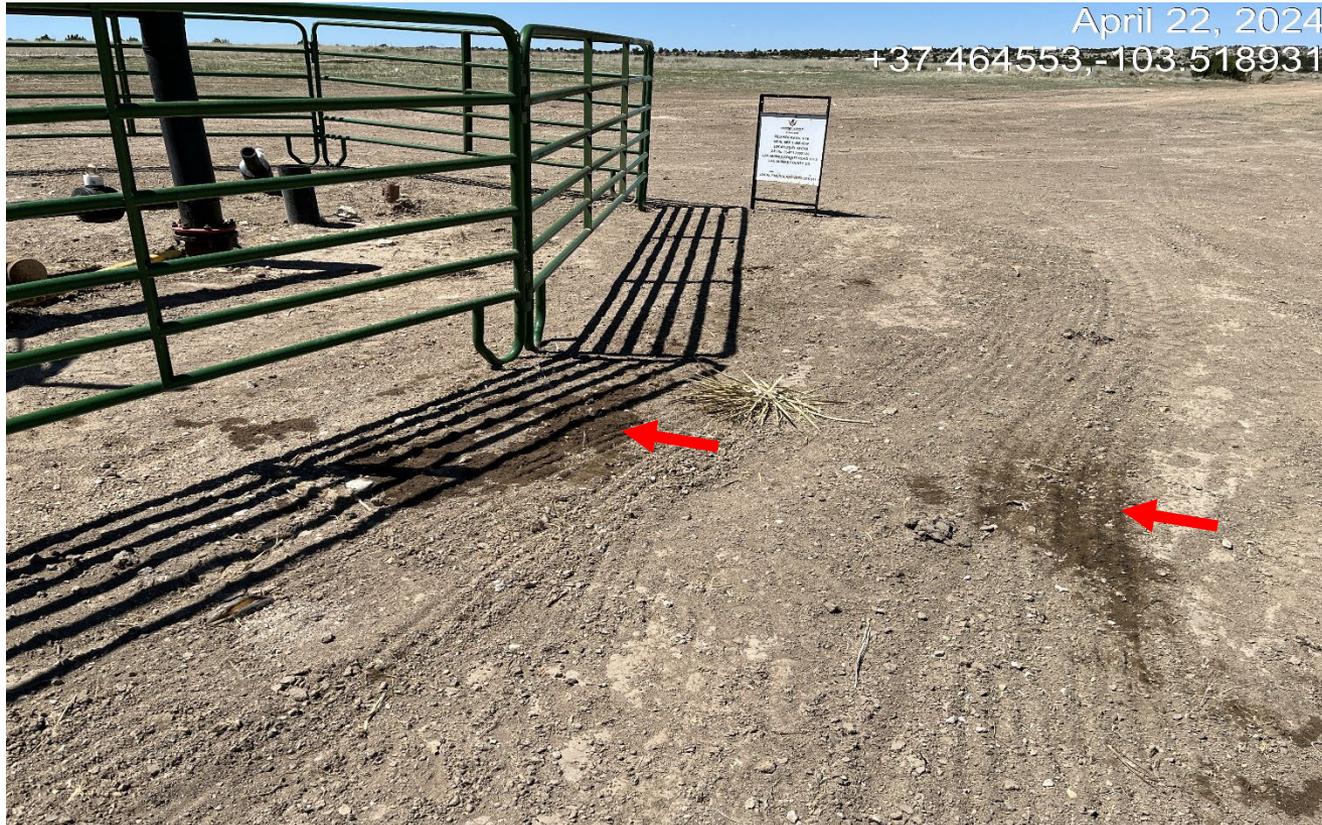
Photo 8. There is stained soil outside fenced area that must be cleaned up.

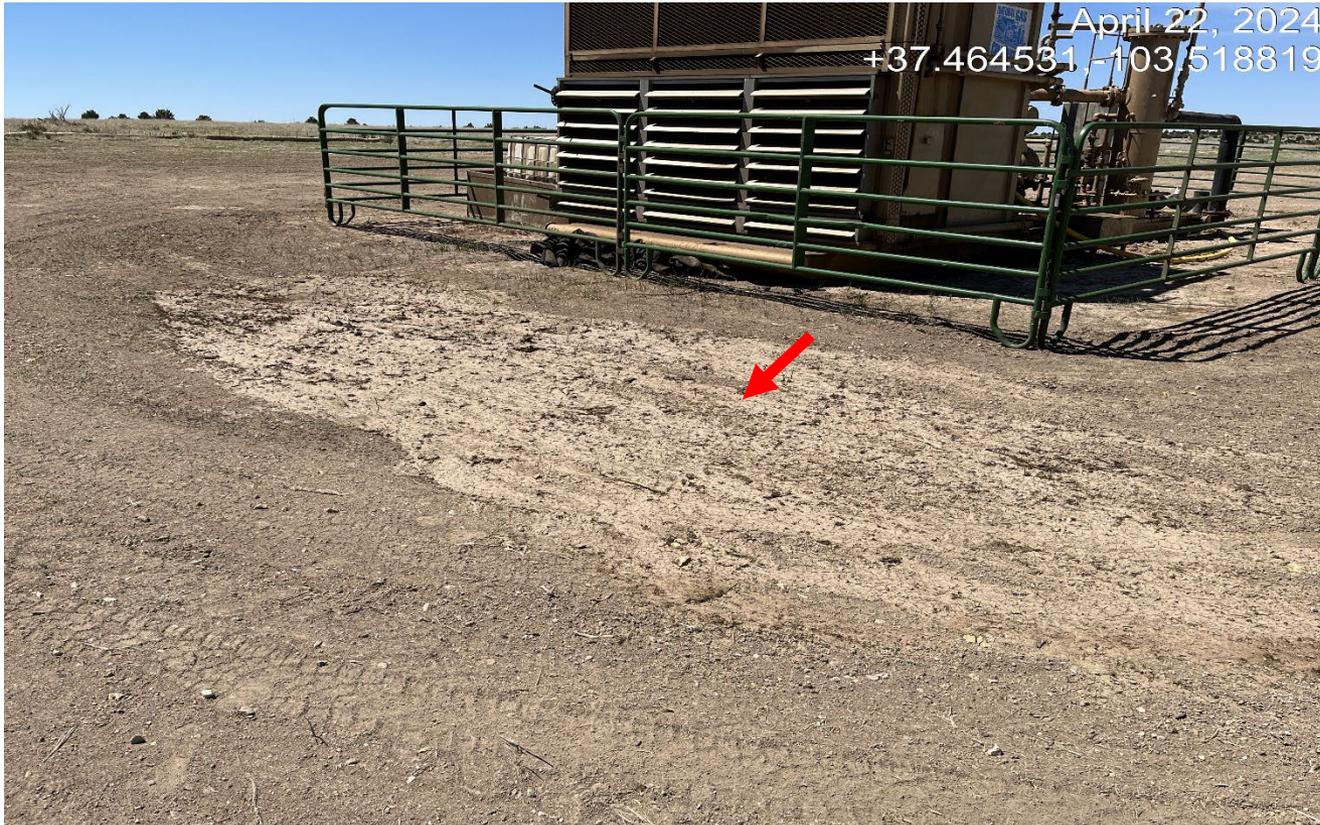
Photo 9. It appears there was a leak at the backside of the engine compressor.

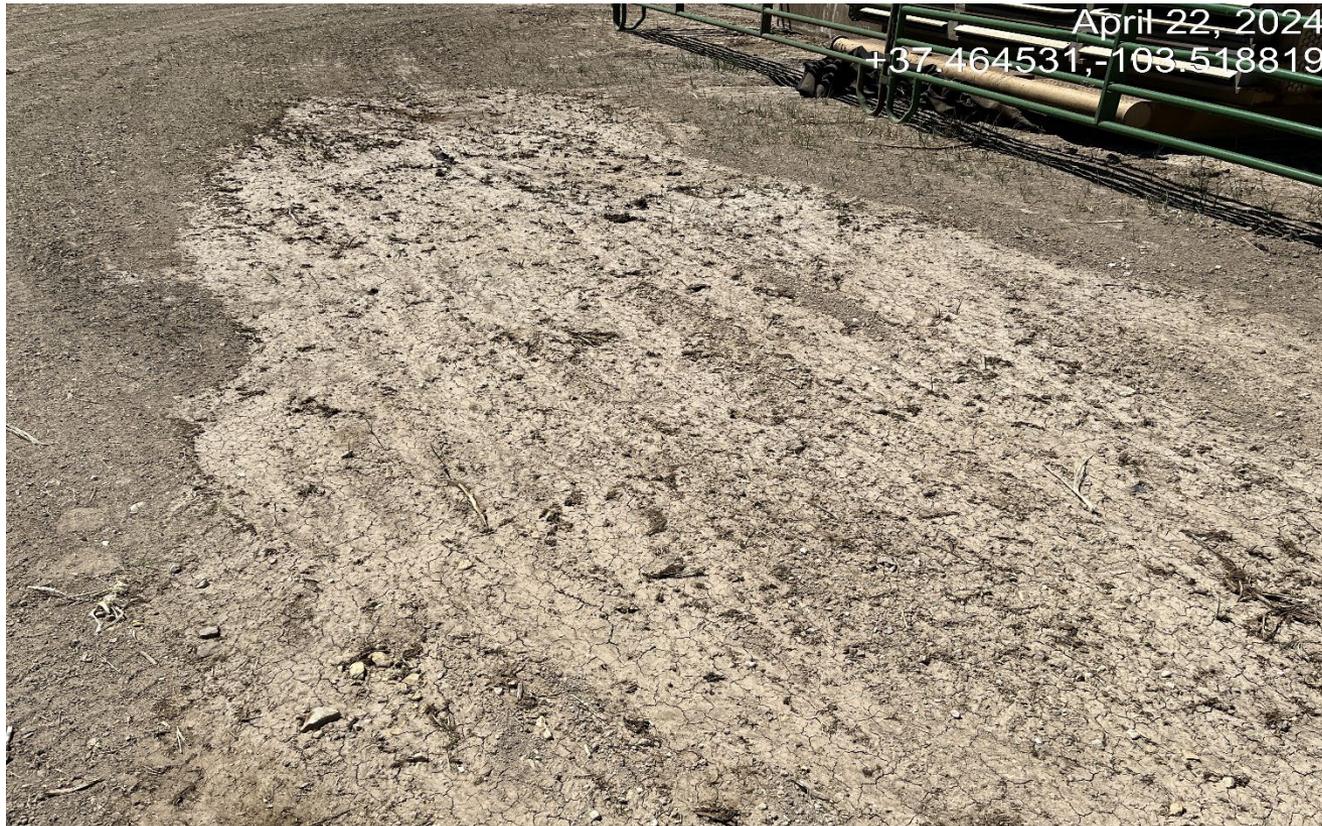
Photo 10. View of stained soil at the back side of the compressor about 6'x5'.

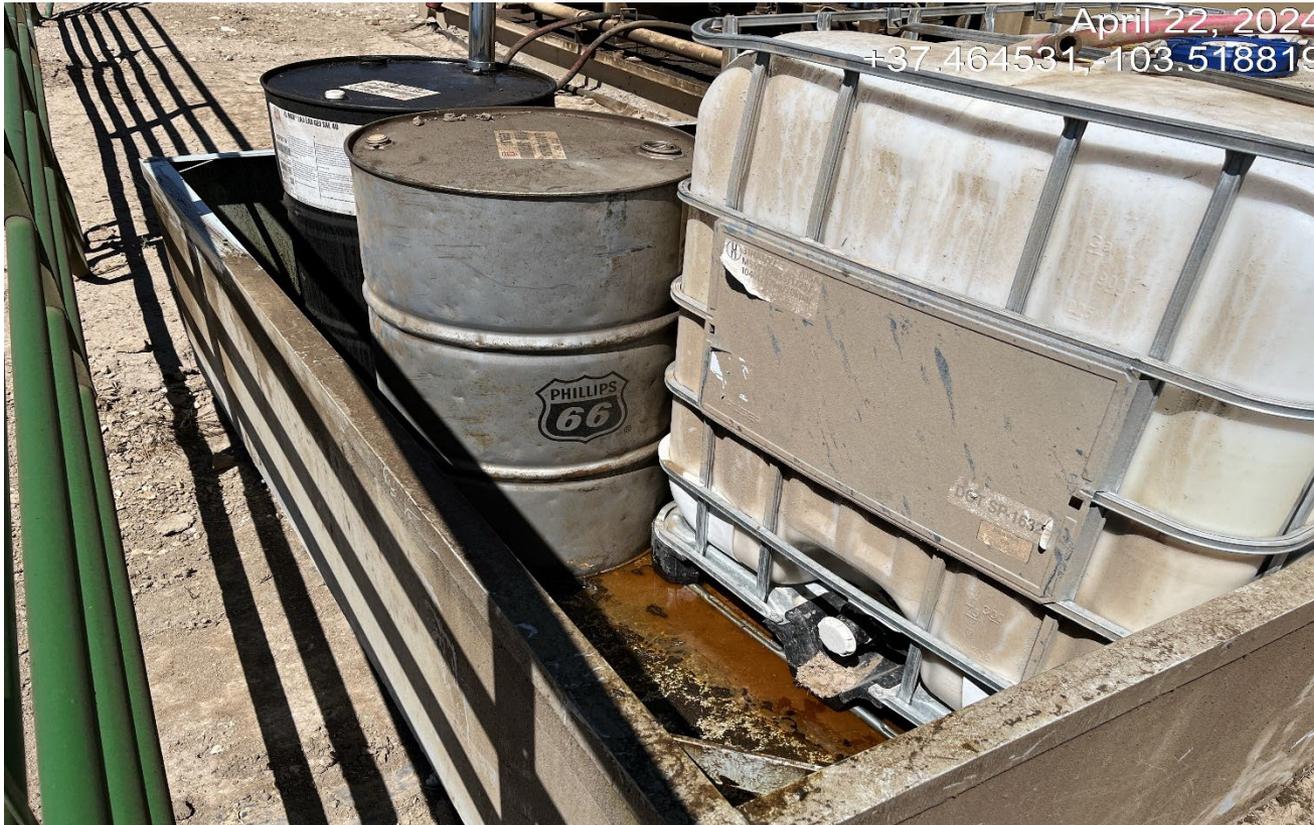
Photo 11. There are fuel containers stored inside of secondary containment but have leaked. This needs to be cleaned up and netting needs to be installed over the top of this area to prevent wildlife entry.

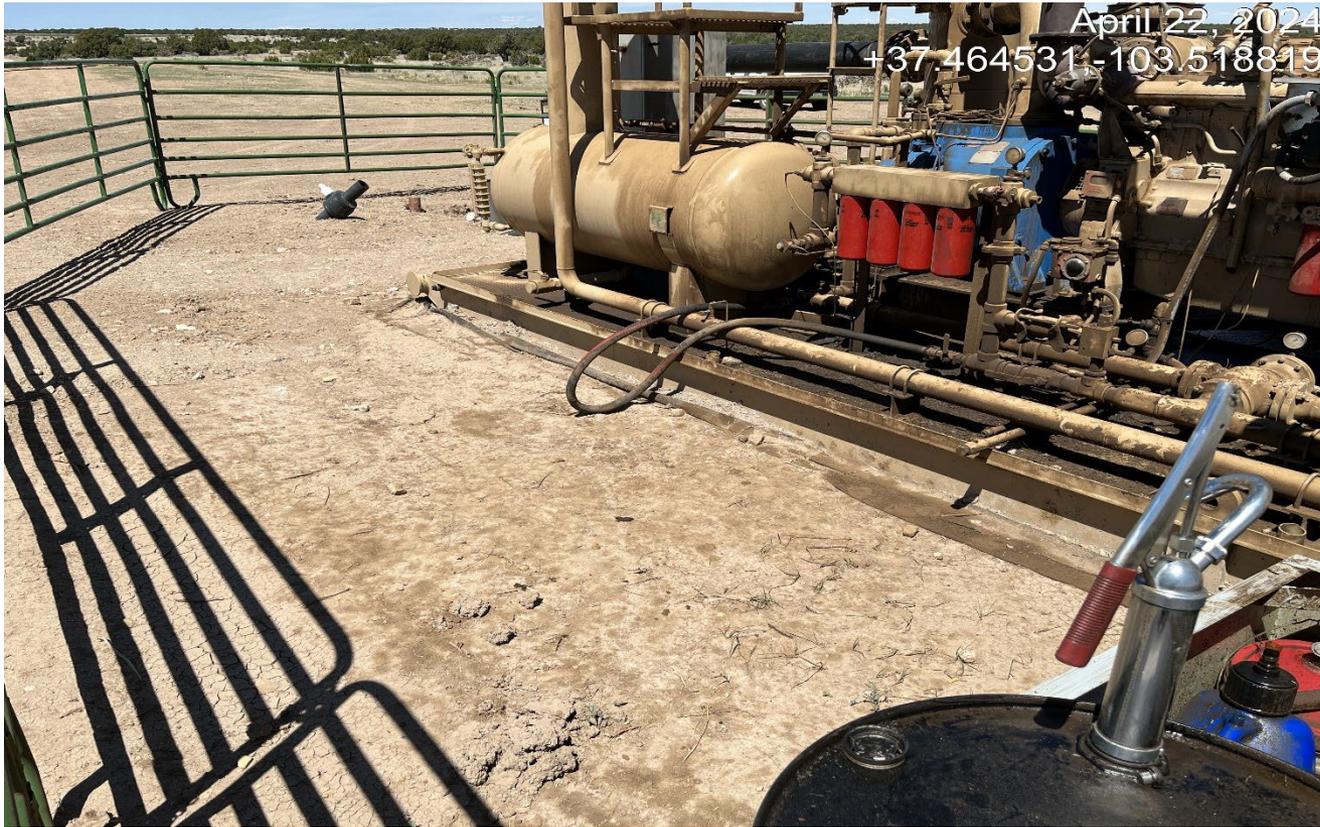
Photo 12. It appears there is more stained soil at around the engine compressor.

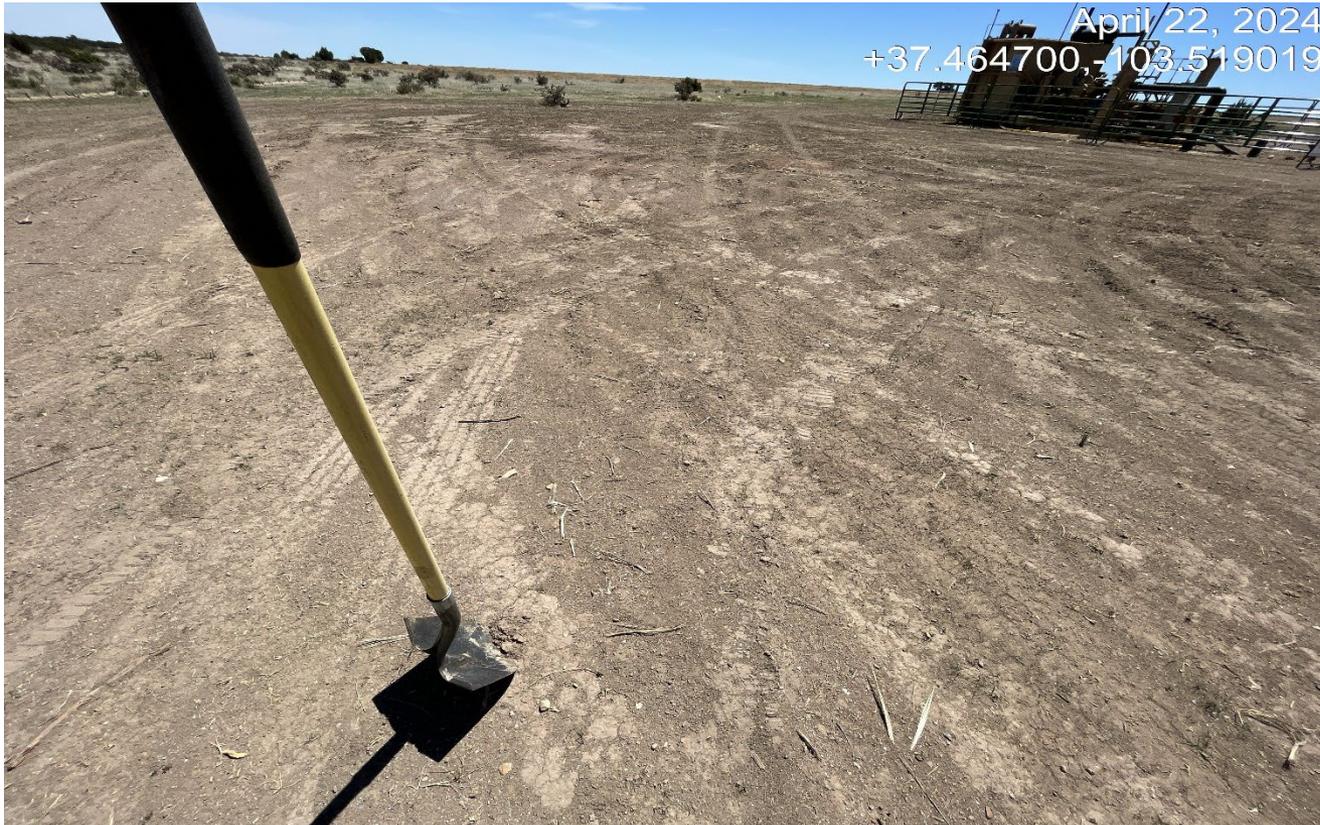
Photo 13. North side of the location facing southwest. There are area where soils are very compacted. Seeding was performed in this area however vegetation will not grow well in compacted soils.

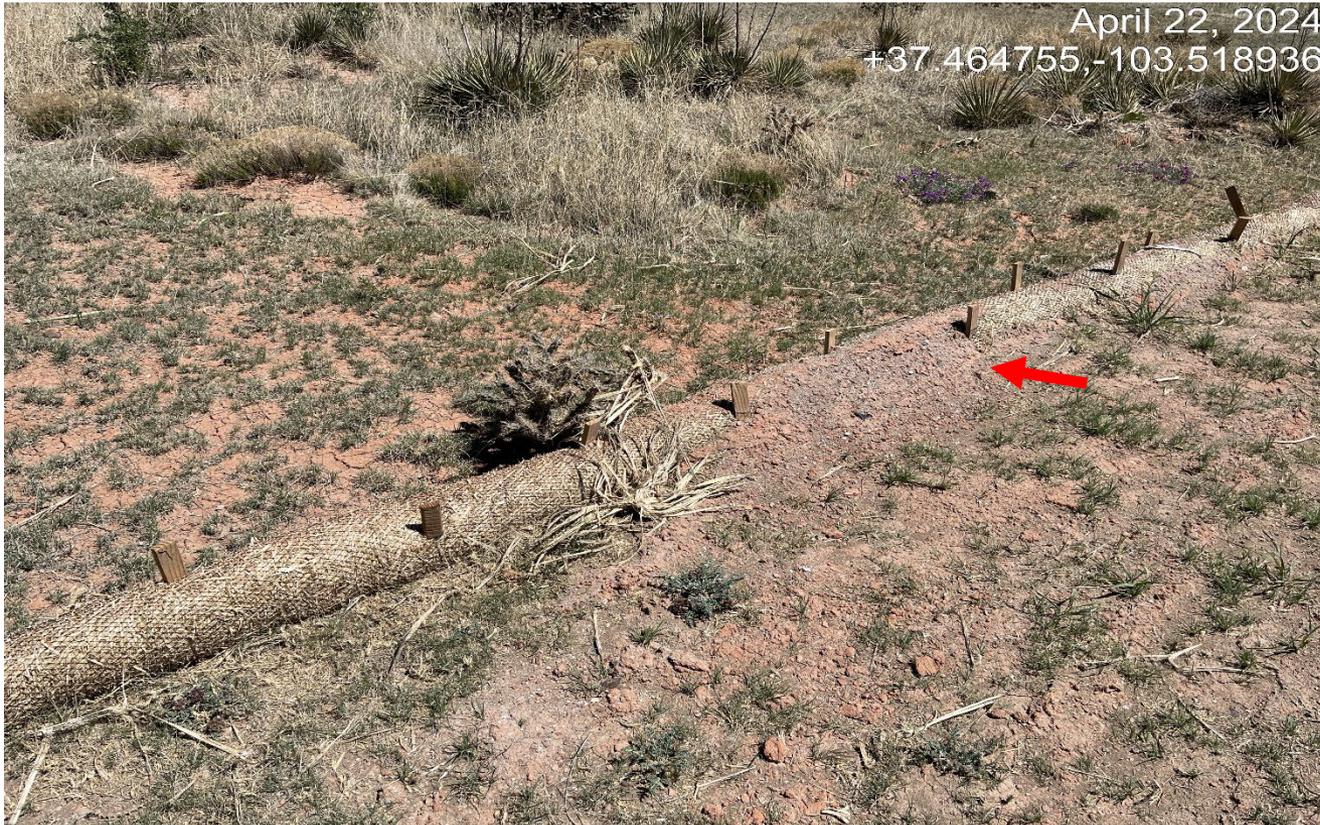
Photo 14. North side of the location are perimeter wattles. There are still red cutting by the wattles.

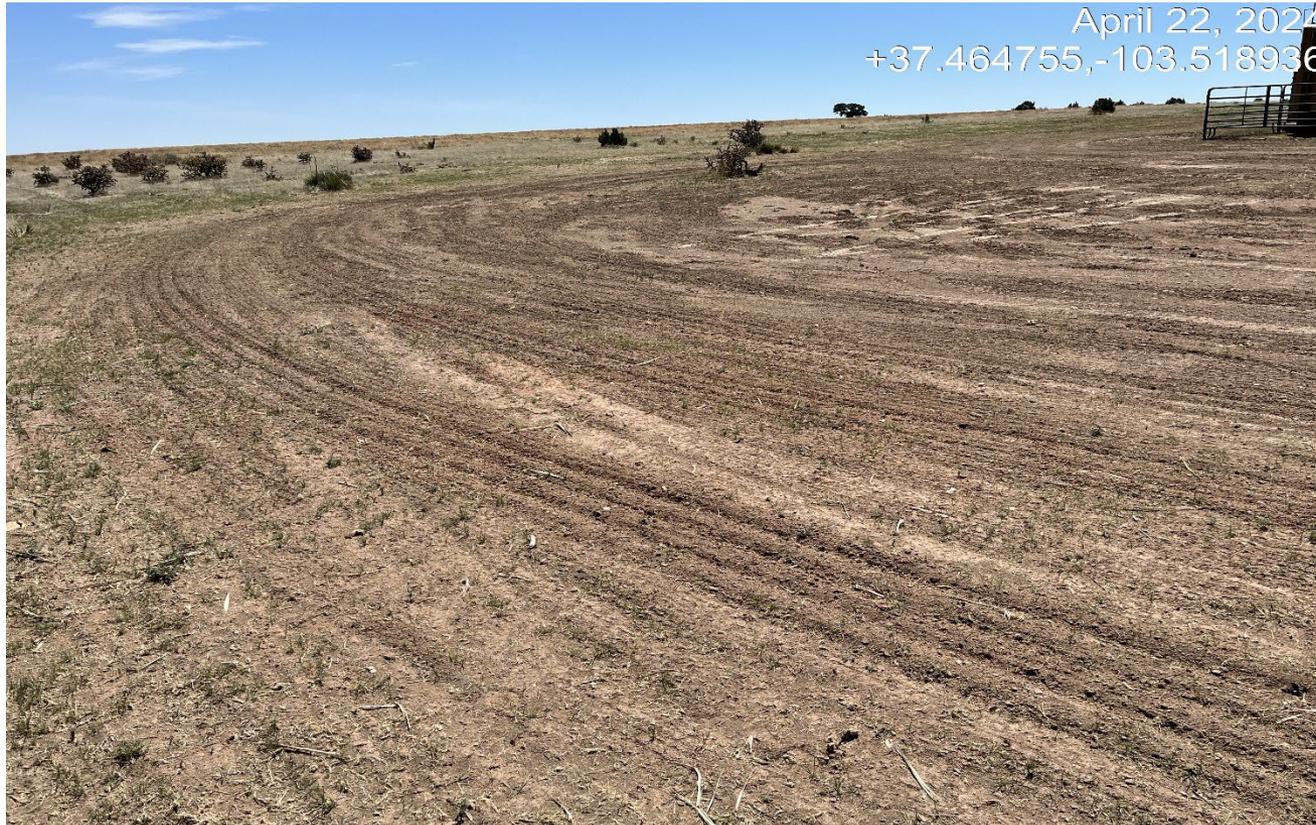
Photo 15. North side of the location facing west. Disturbed areas have been seeded. .
