# Environmental Inspection

Operator: Woodbury Resources LLC

Location ID: 324766

API: 057-06483 Fuqua 19-02-10-H

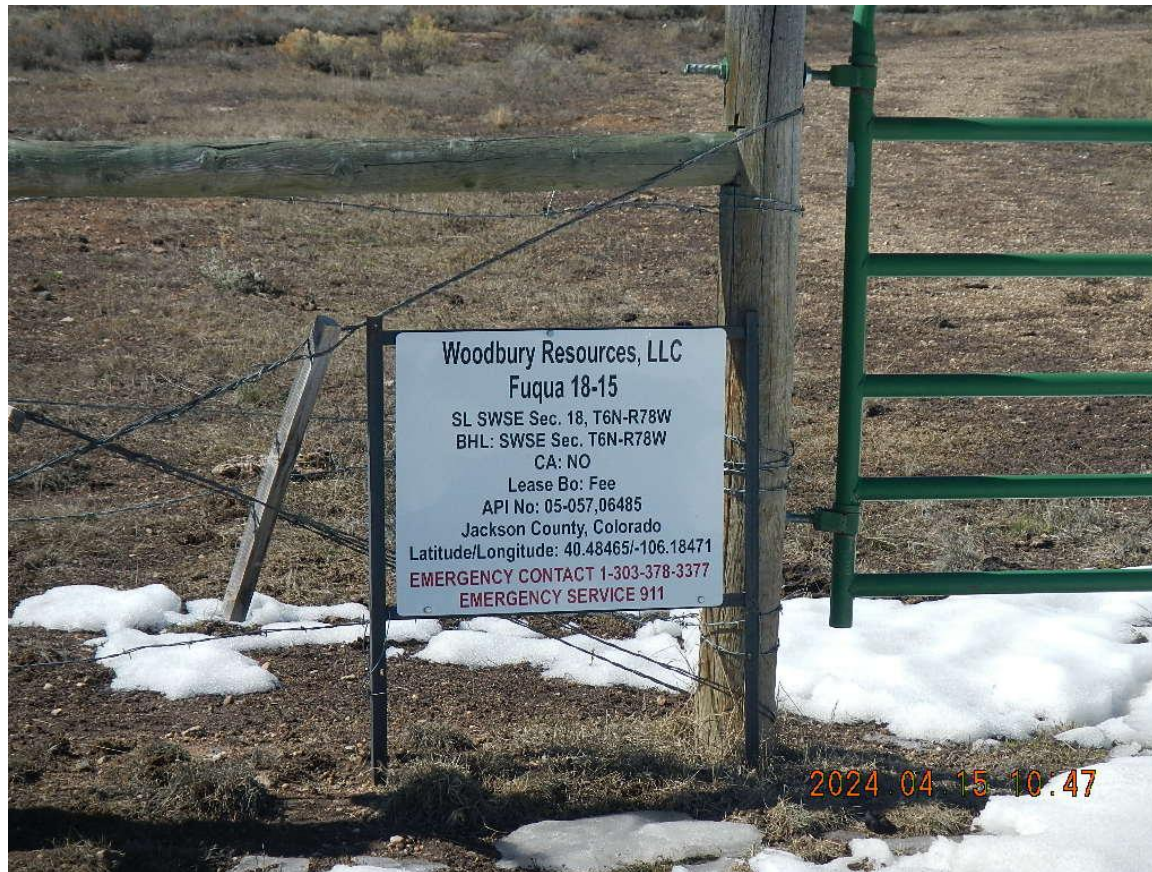
**Photo 1.** Entrance signage. NOTE: API shown is 05-057-06485, CORRECT API should read 05-057-06483.

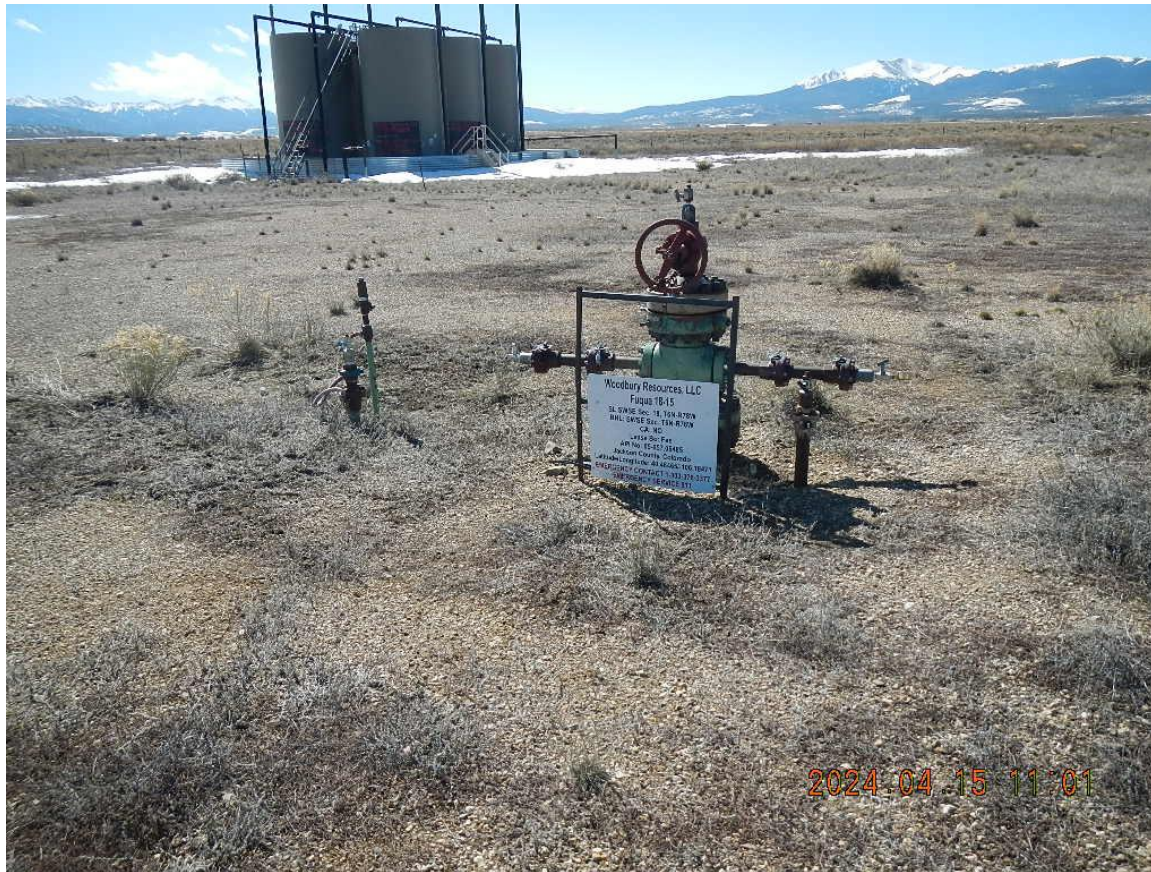
**Photo 2.** Well signage. NOTE: API shown is 05-057-06485, CORRECT API should read 05-057-06483.

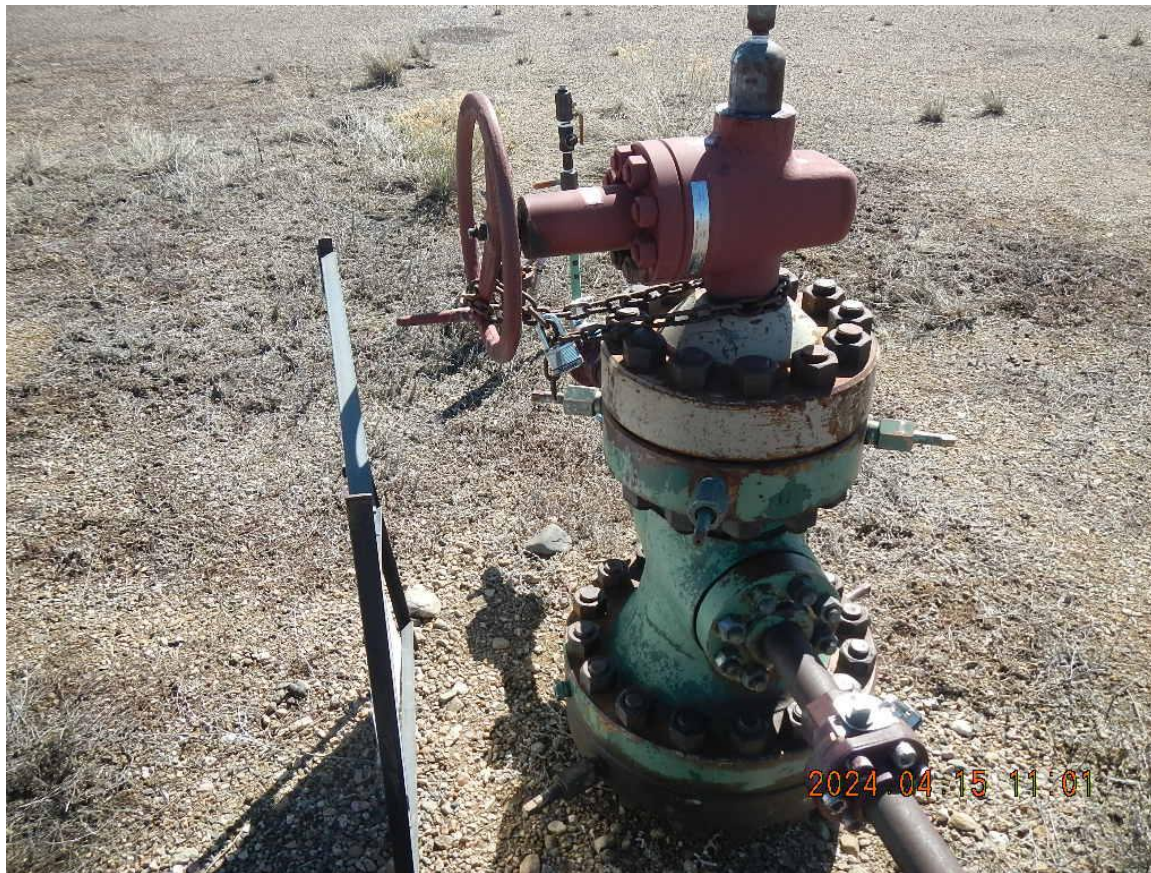
**Photo 3.** Well is locked out.

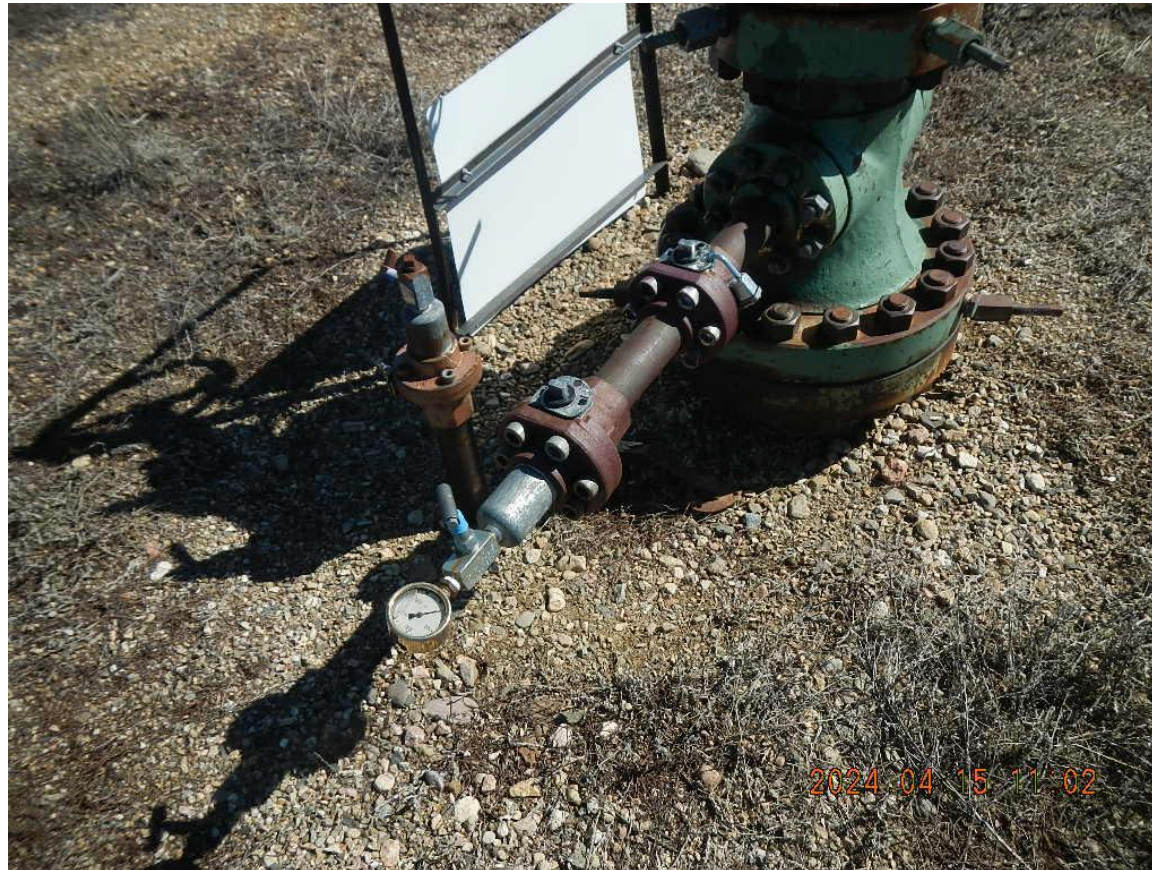
**Photo 4.** Well is locked out.

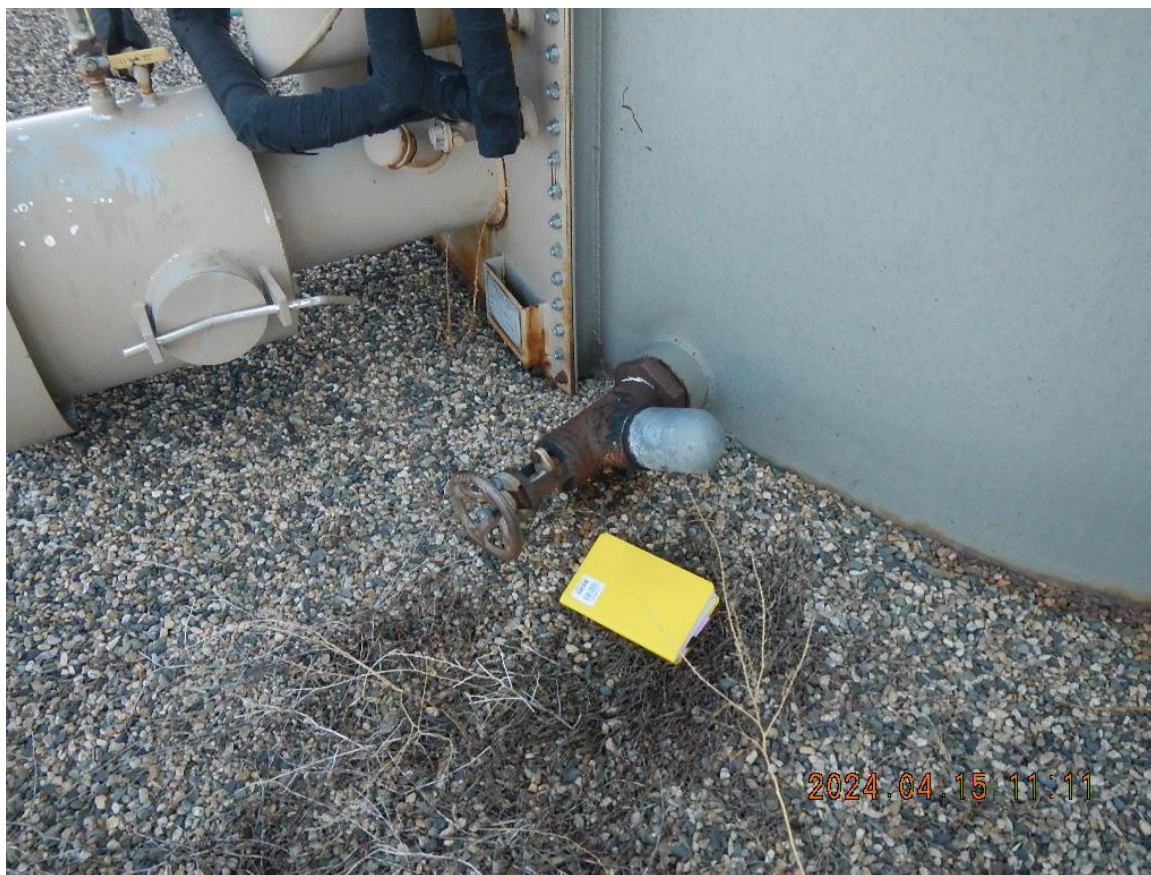
**Photo 5.** Tank 00163 indicates signs of hydrocarbon staining.

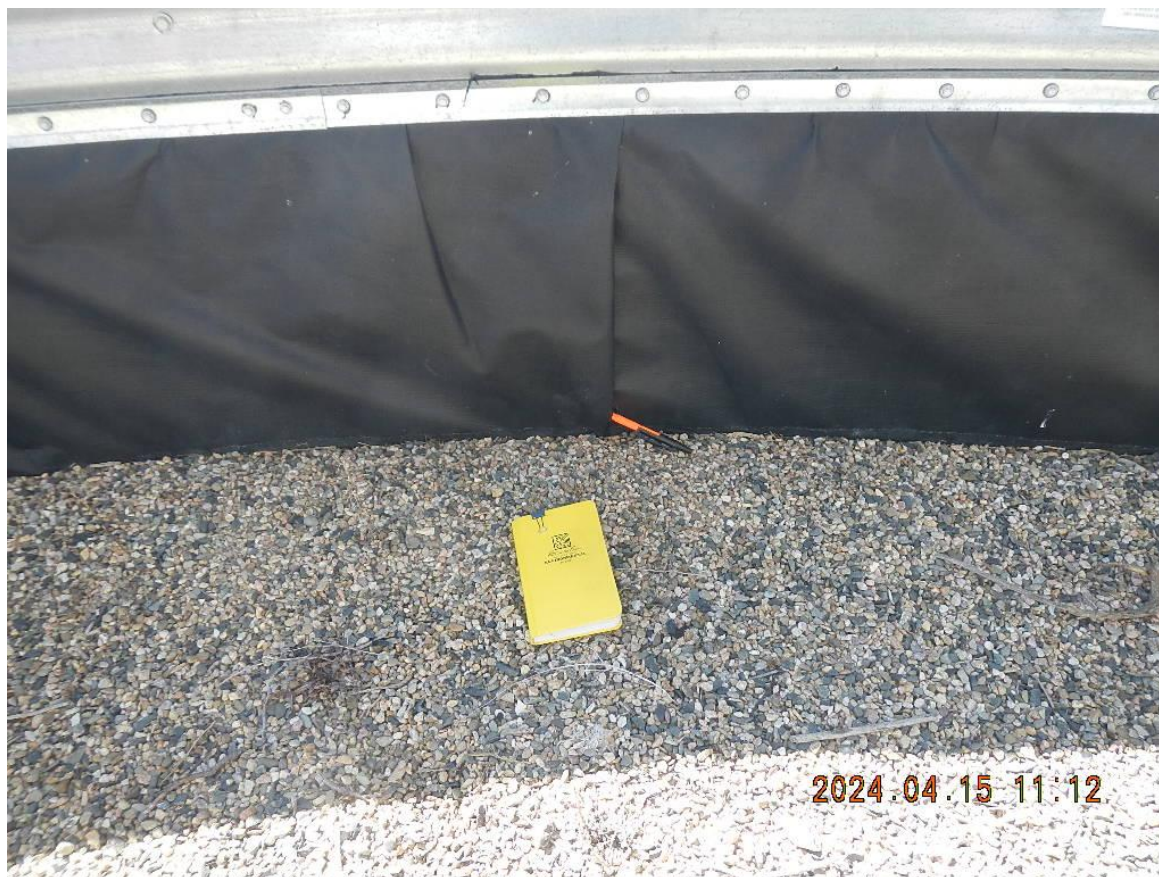
**Photo 6.** Secondary containment liner compromised.

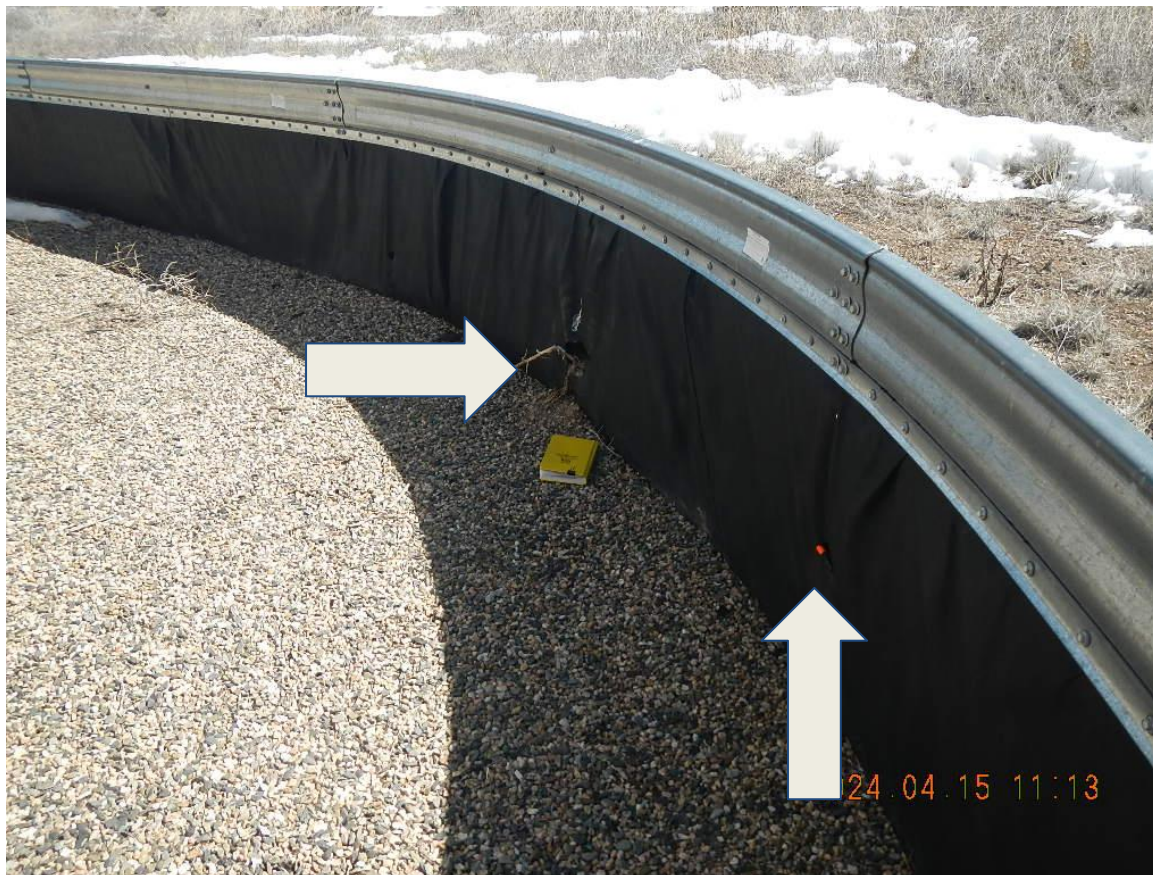
**Photo 7.** Secondary containment liner compromised with vegetation growth though liner.

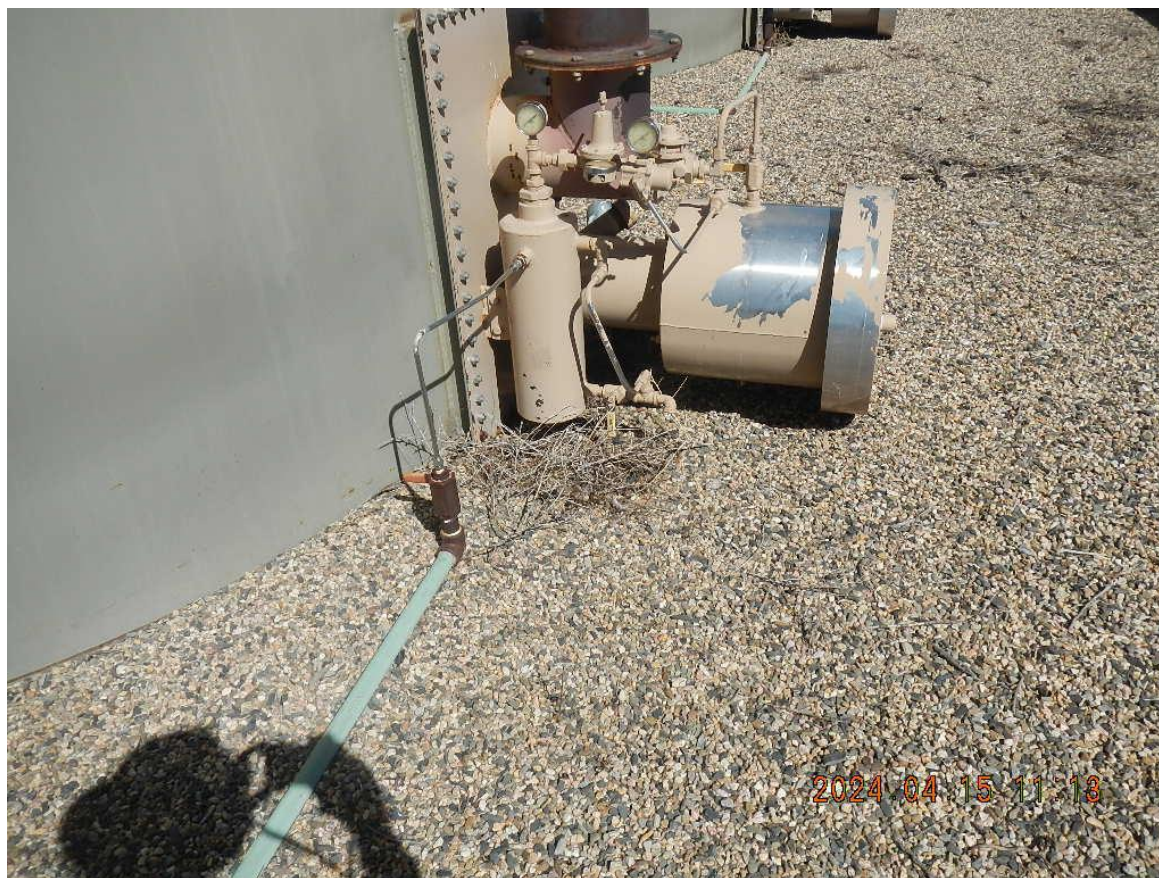
**Photo 8.** Weeds/Debris near fire tube.

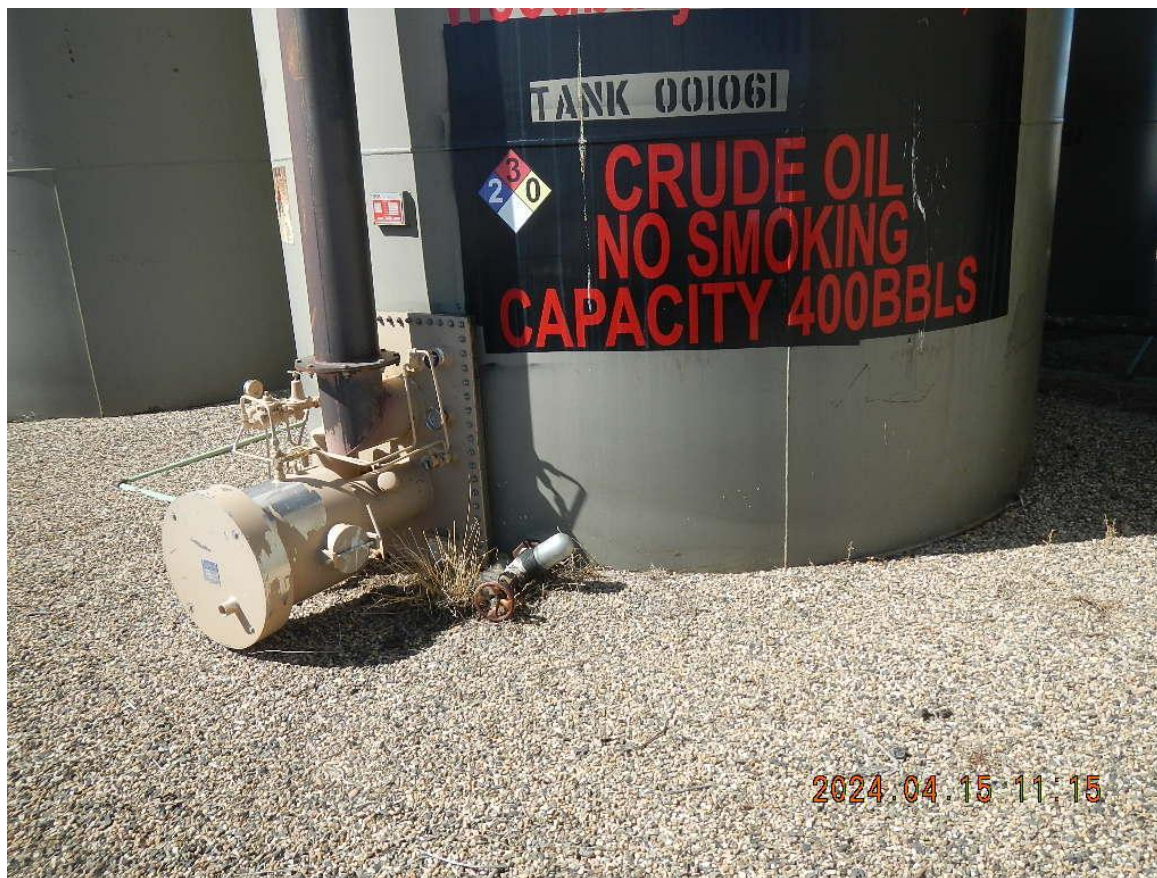
**Photo 9.** Weeds/Debris near fire tube.

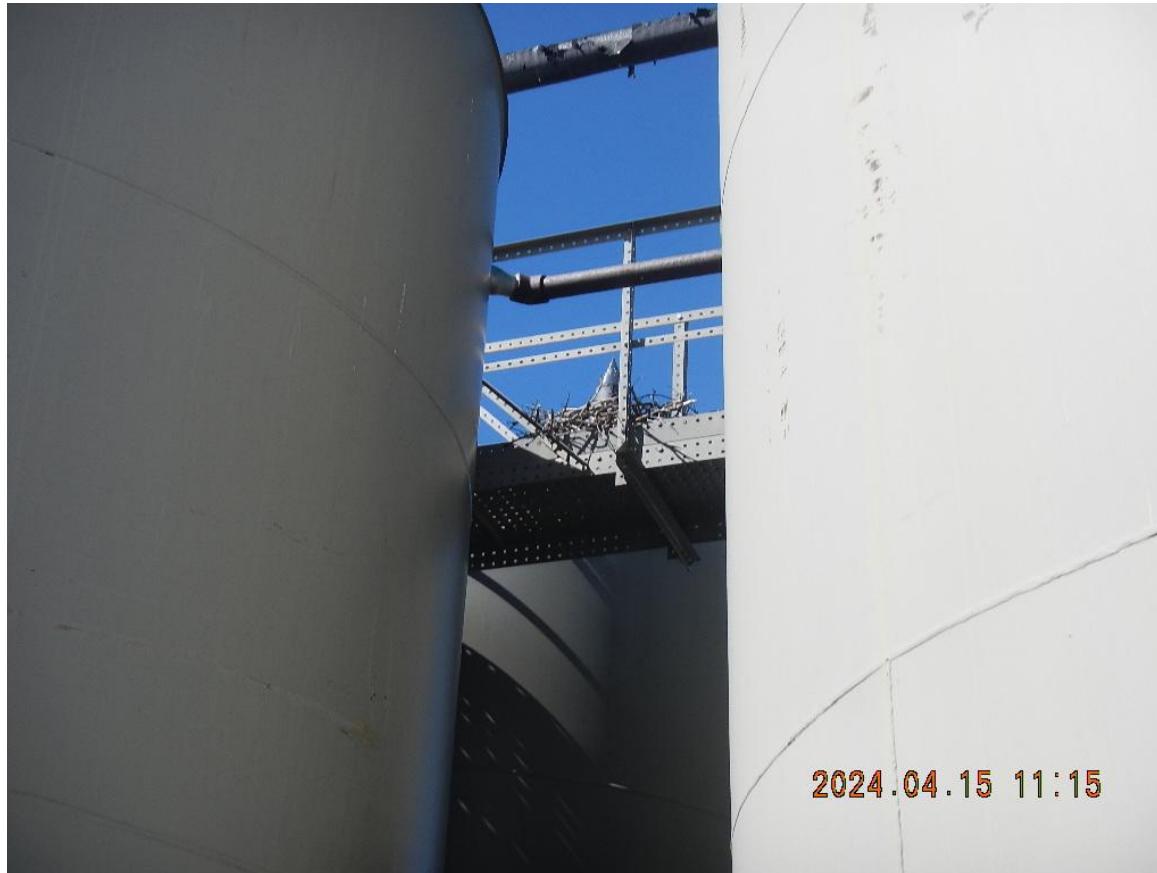
**Photo 10.** Nest on catwalk.

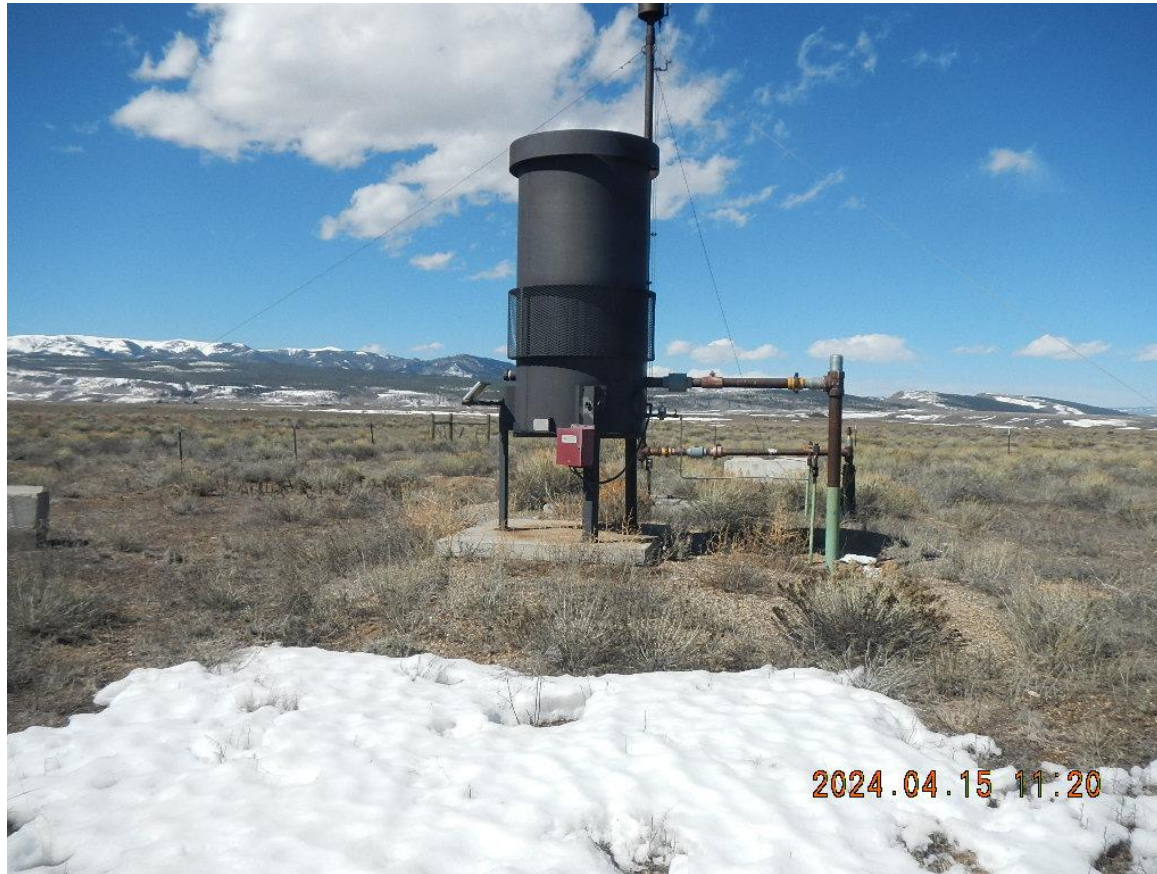
**Photo 11.** Flare.

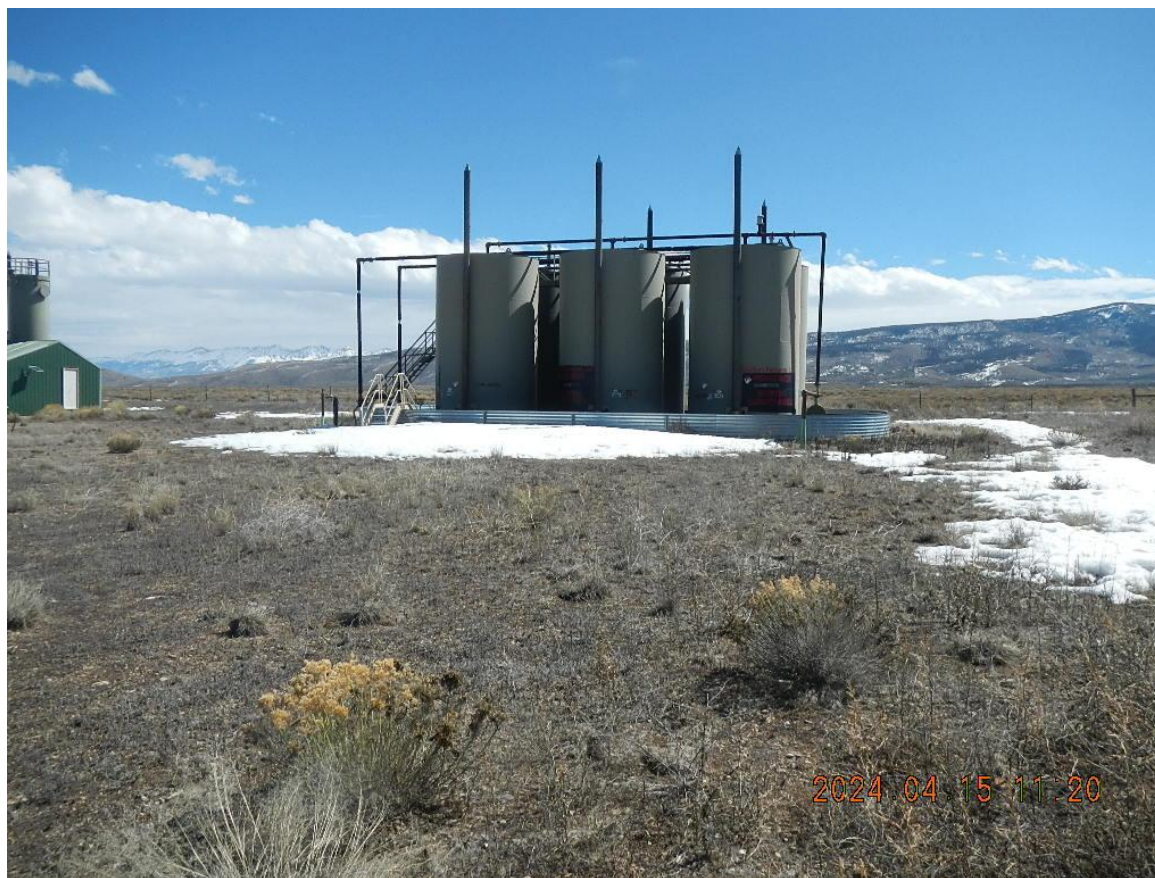
**Photo 12.** Looking east toward tank battery.

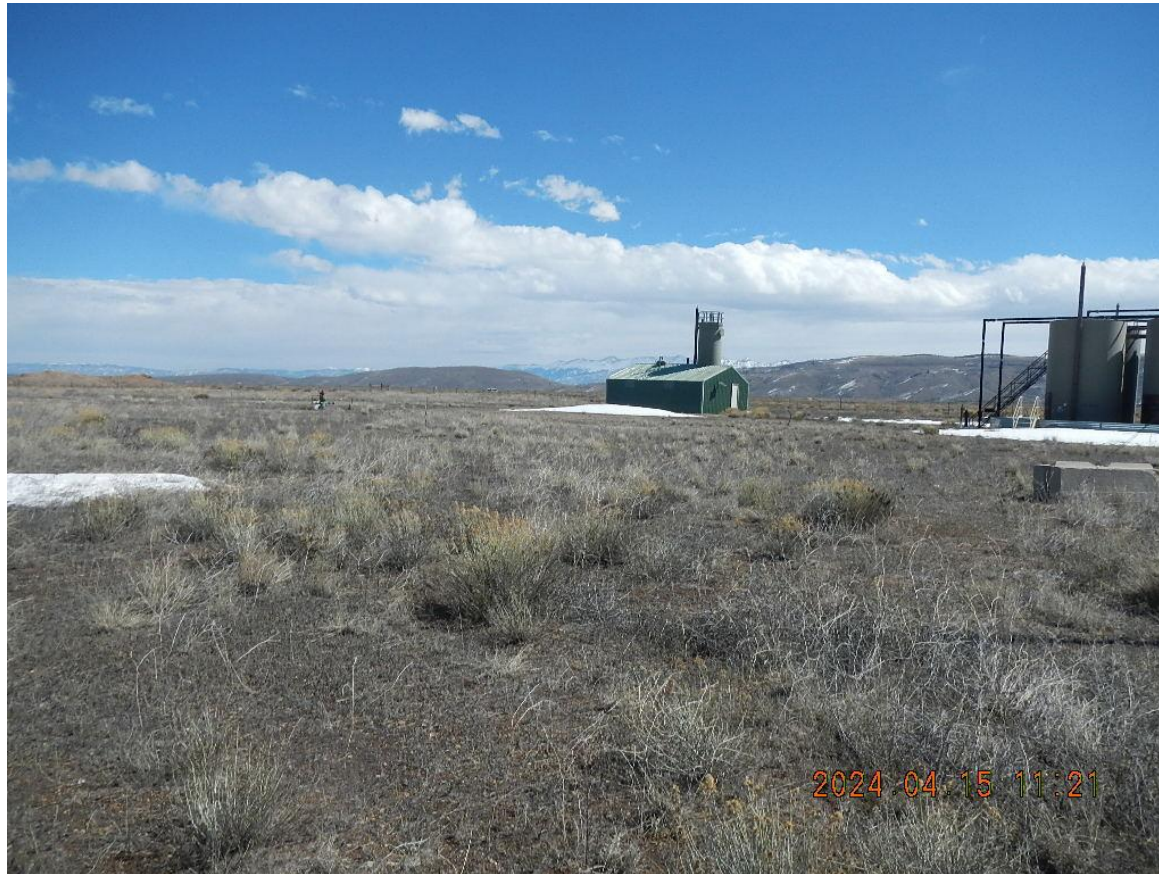
**Photo 13.** Weeds across location.

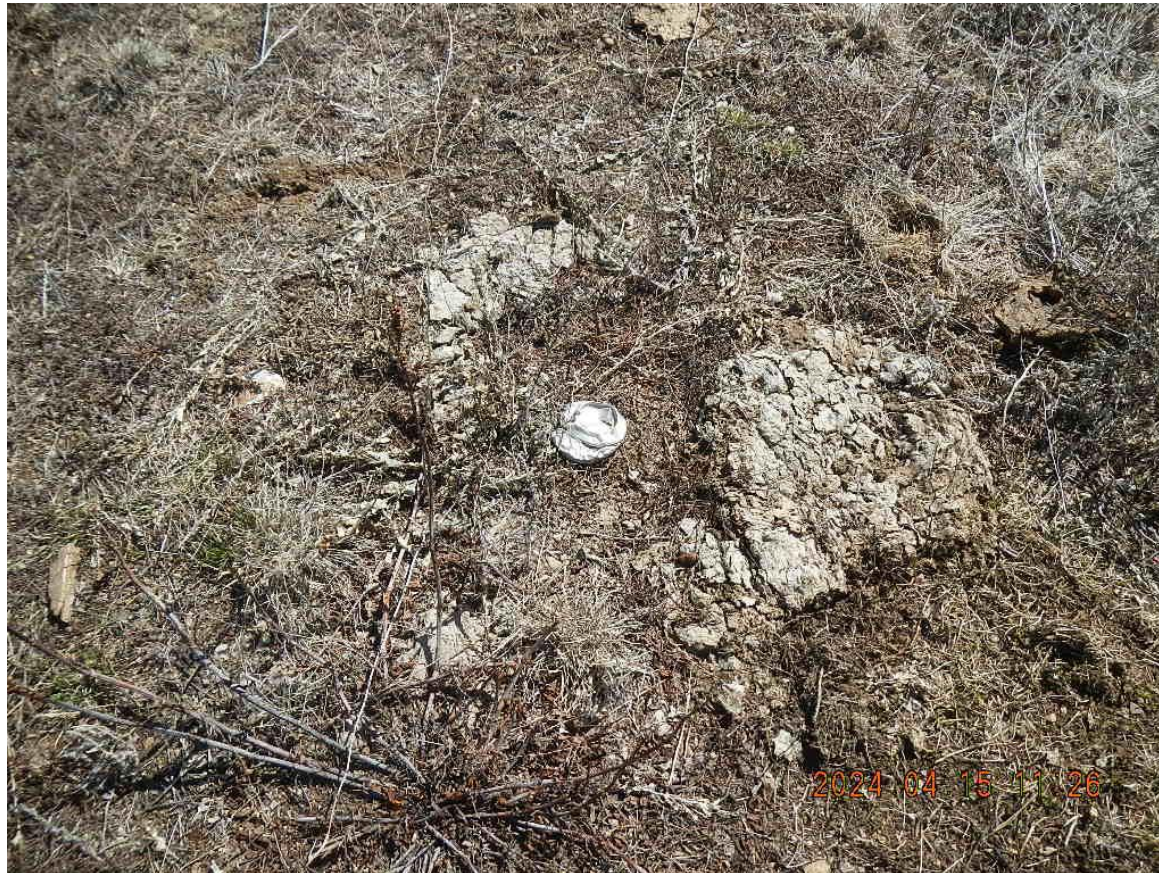
**Photo 14.** Trash/debris.

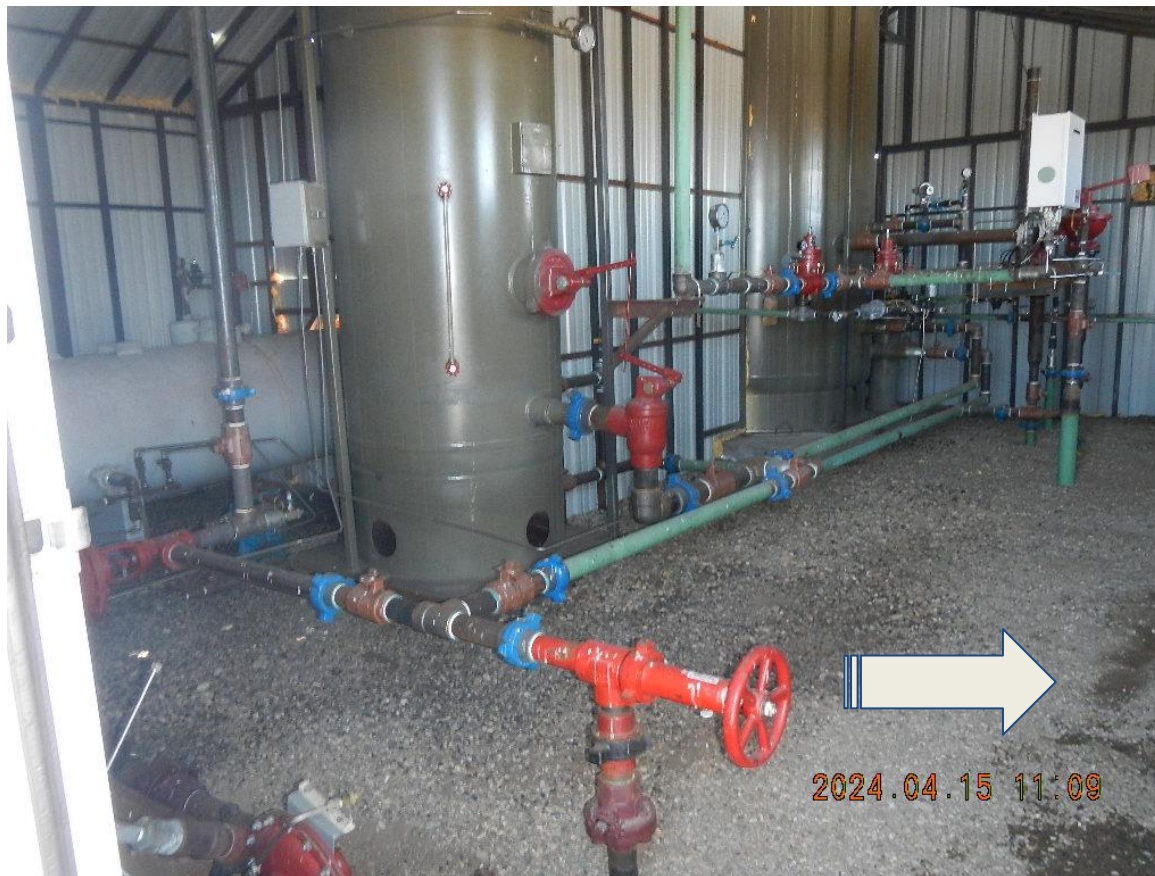
**Photo 15.** Apparent gravel placed on hydrocarbon stained surface (See Inspection 690900189).

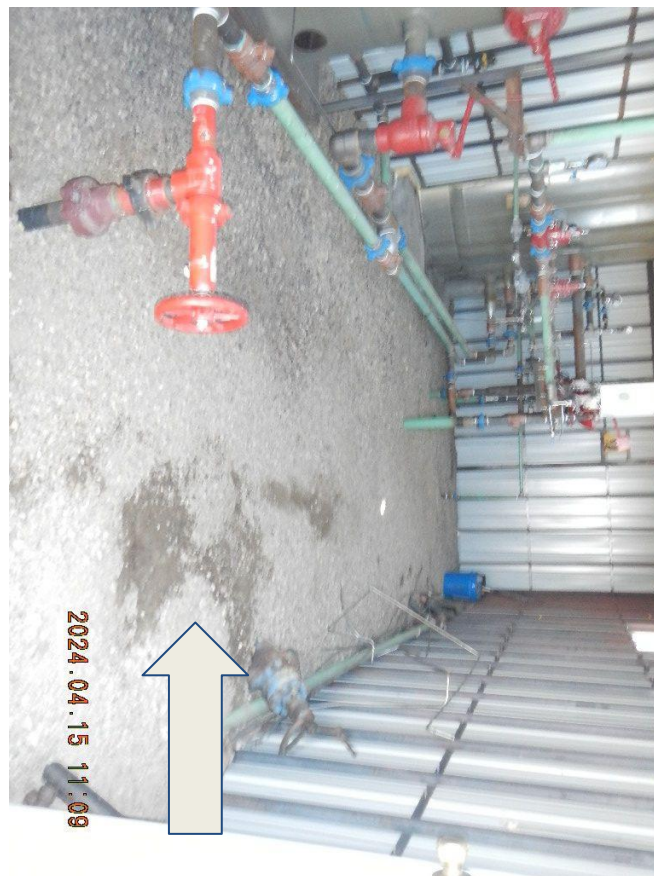
**Photo 16.** Apparent gravel placed on hydrocarbon stained surface (See Inspection 690900189).
