Catamount Energy Partners
Cox 2
Inspection 714000667 Remedial Report

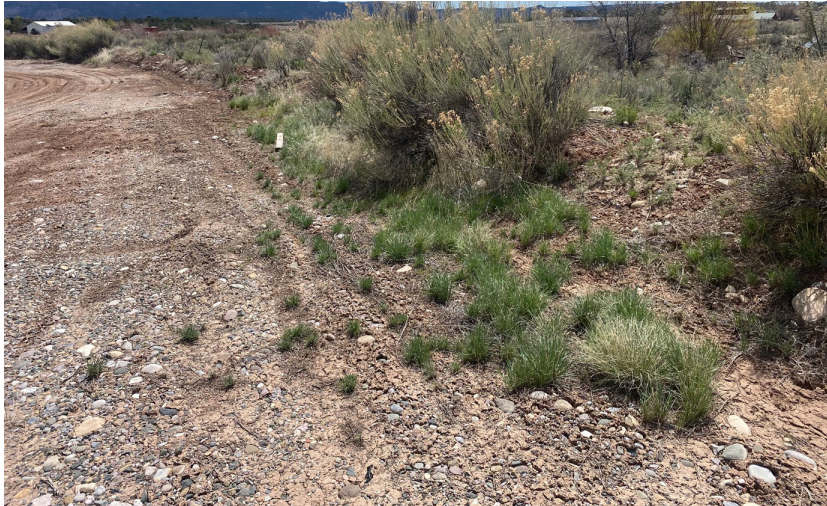
Comment: Unused fencing and meter house equipment observed on location.

Removed unused equipment

Corrective Action: **Comply with rule 606. Remove and properly store unused equipment.**

Action Taken: Removed fencing and meter house from location

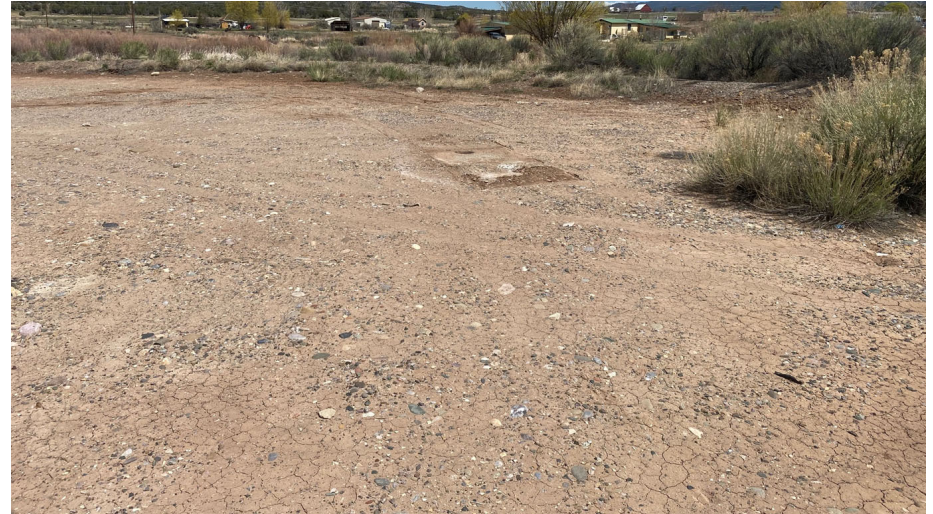
Removed unused equipment

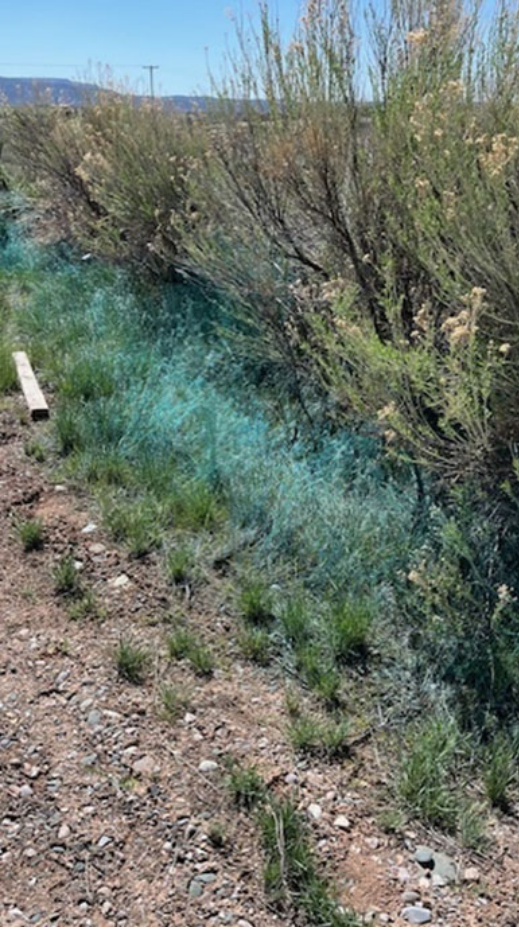
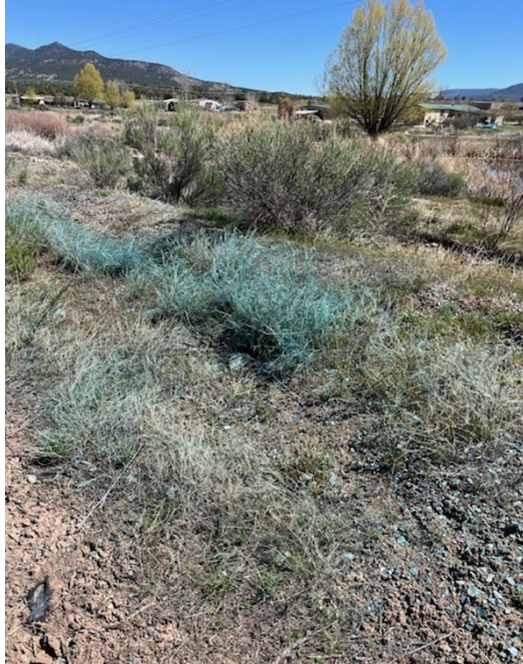
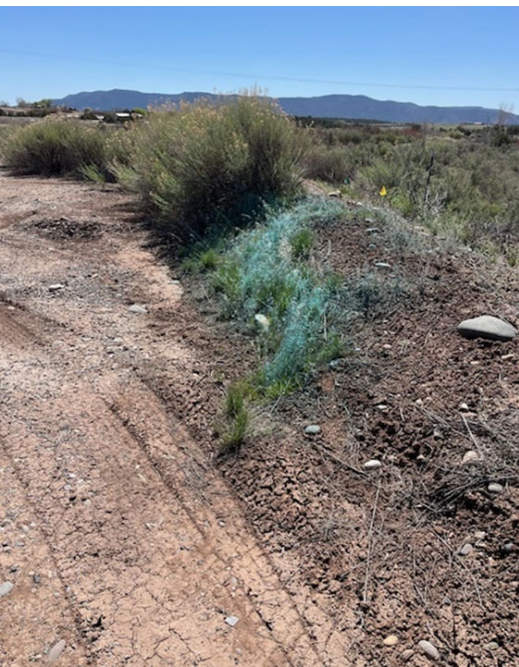
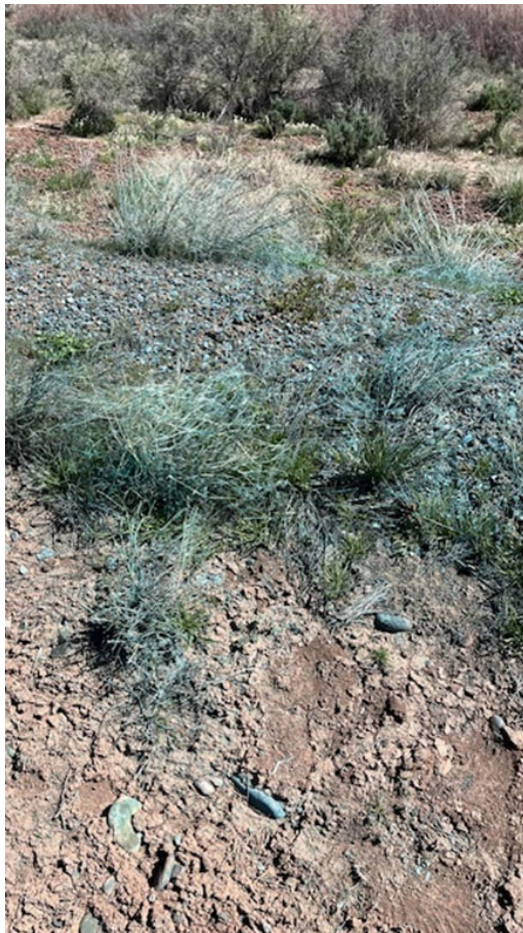
Comment Cheatgrass observed along the southern edge of the disturbance.

- Chemically treated weeds

Corrective Action **Comply with rule 1003.f**

Action Taken: Chemically treated weeds on location
