# Inspection Photos

Operator: Simcoe LLC - 10749

Location ID: 320857

Inspection Document #: 714000707

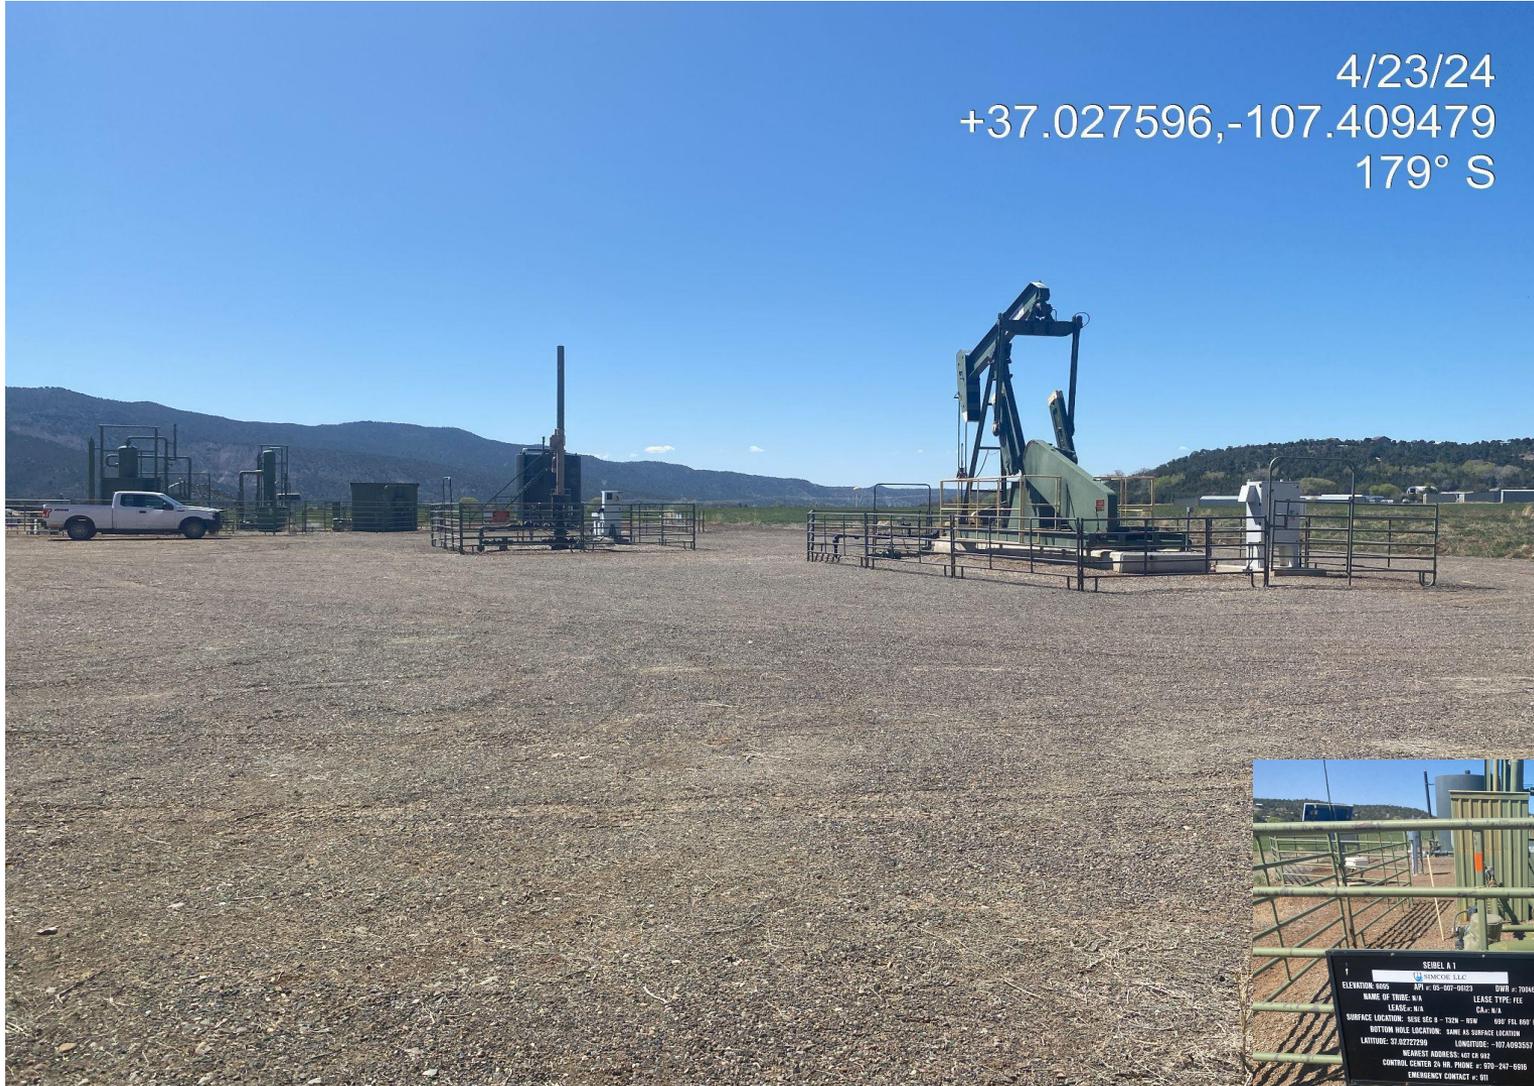
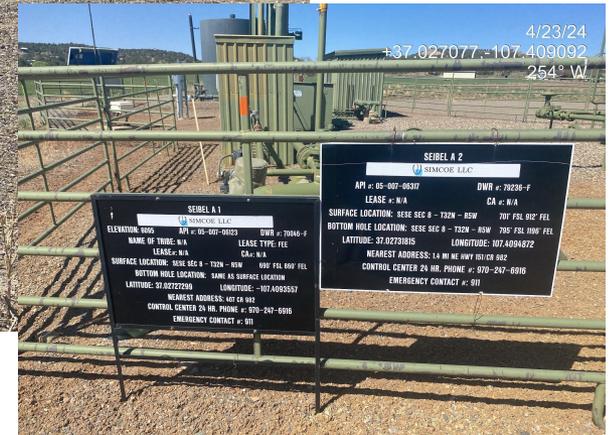
Photo 1. View of the disturbance taken from the access point facing center.

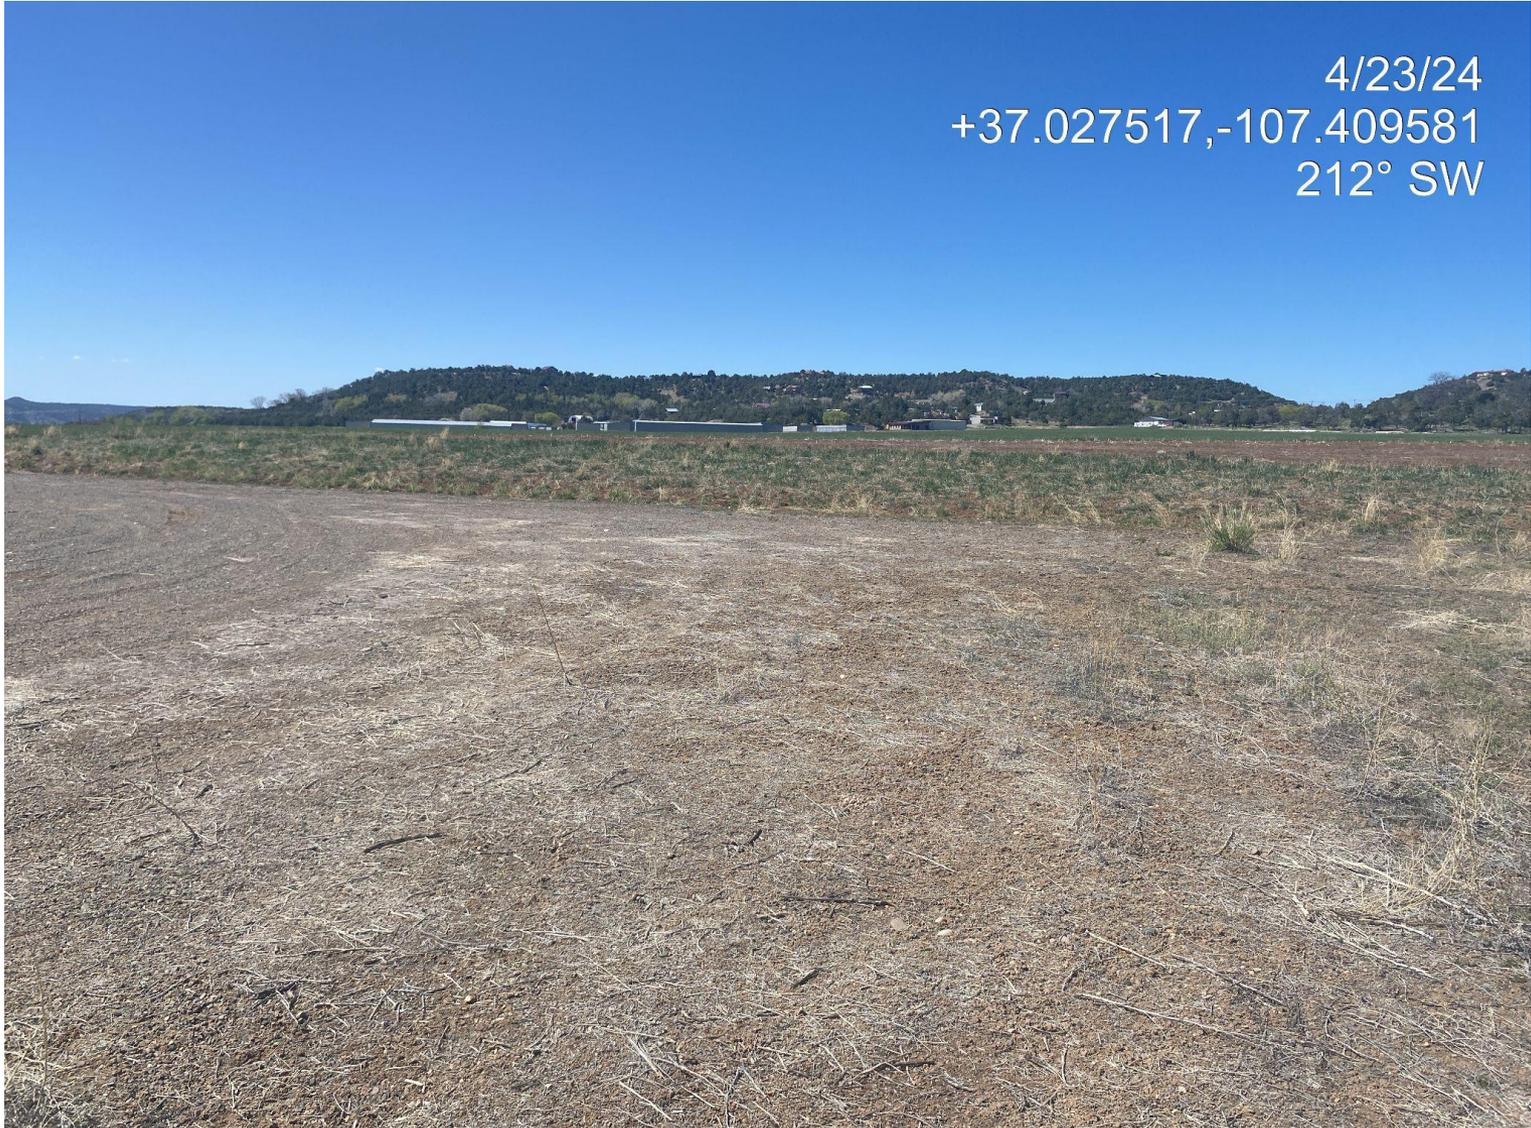
**Photo 2.** Weedy debris corrective action identified in the previous inspection doc #693903984 has been addressed/resolved.

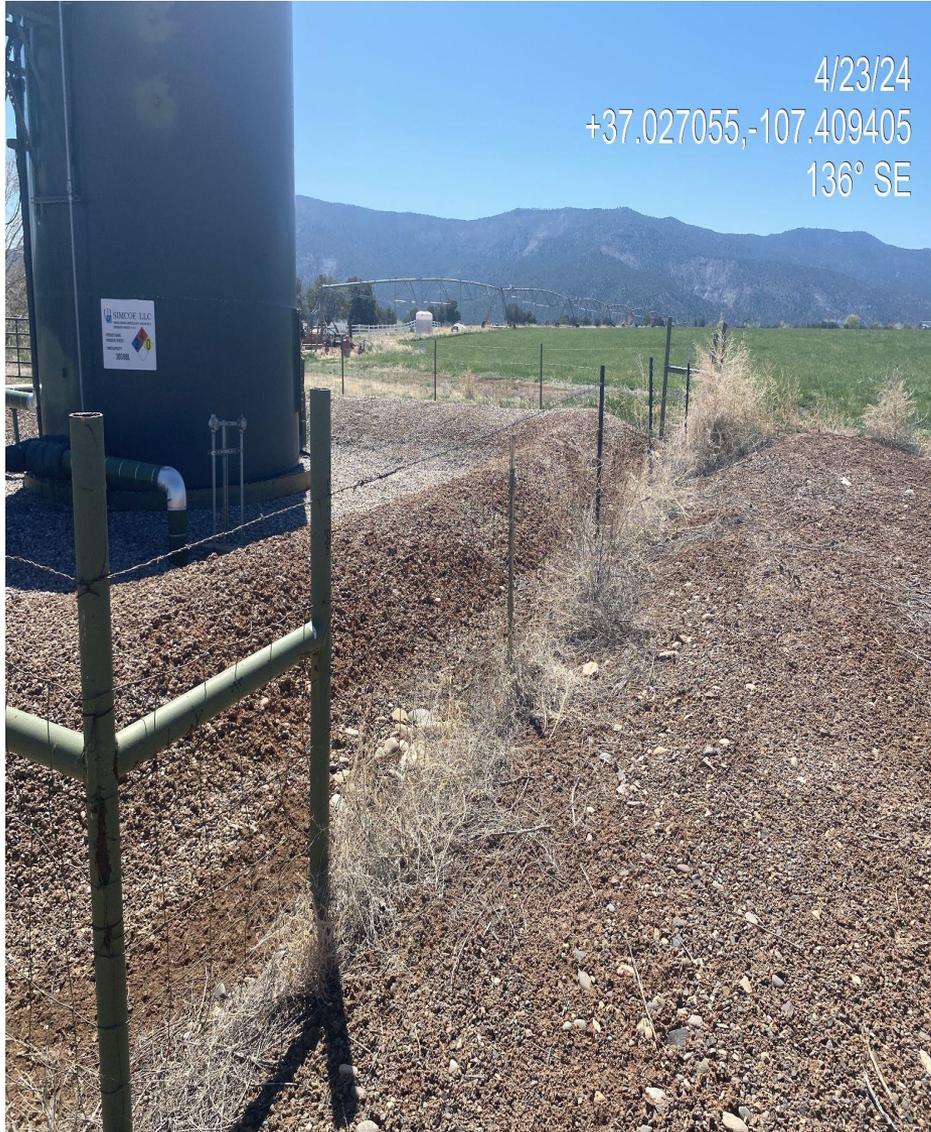
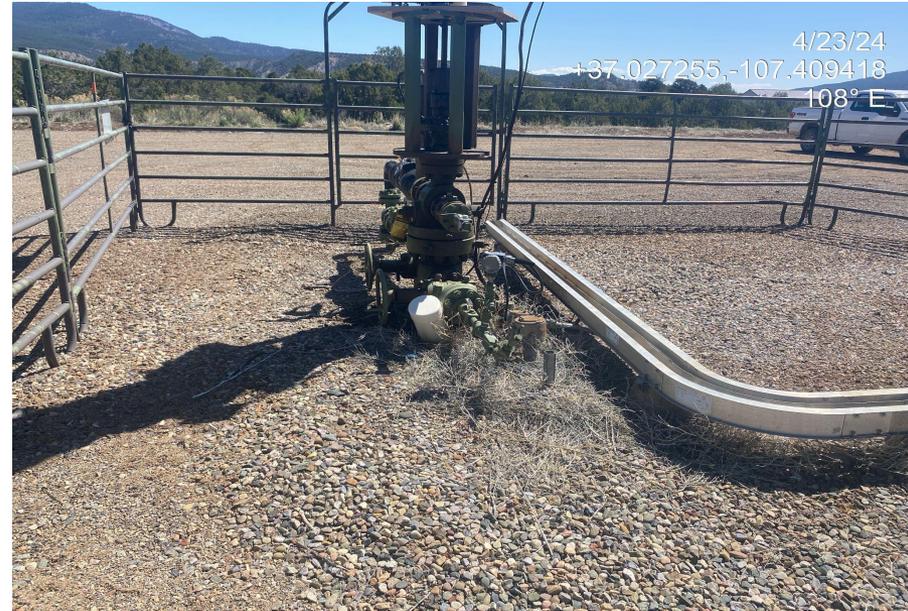
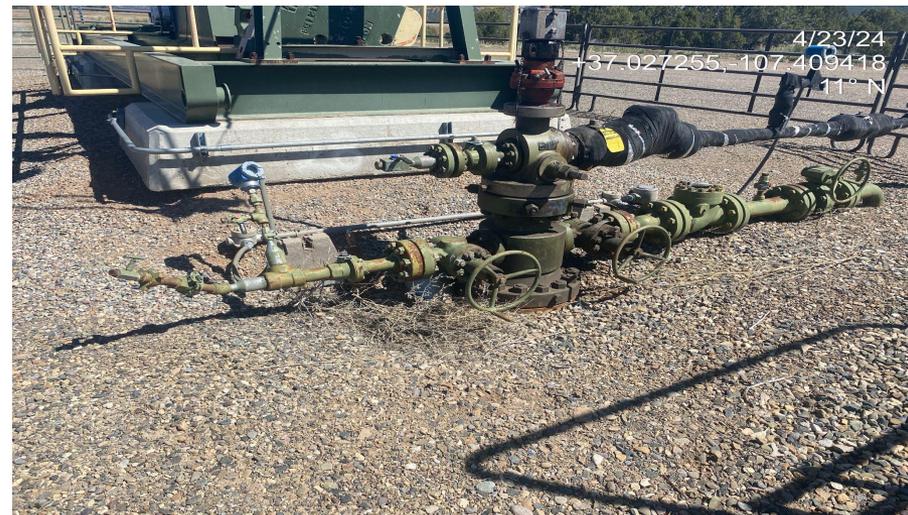
**Photo 3.** Weedy debris observed along the tank berm fence line and at both well heads.

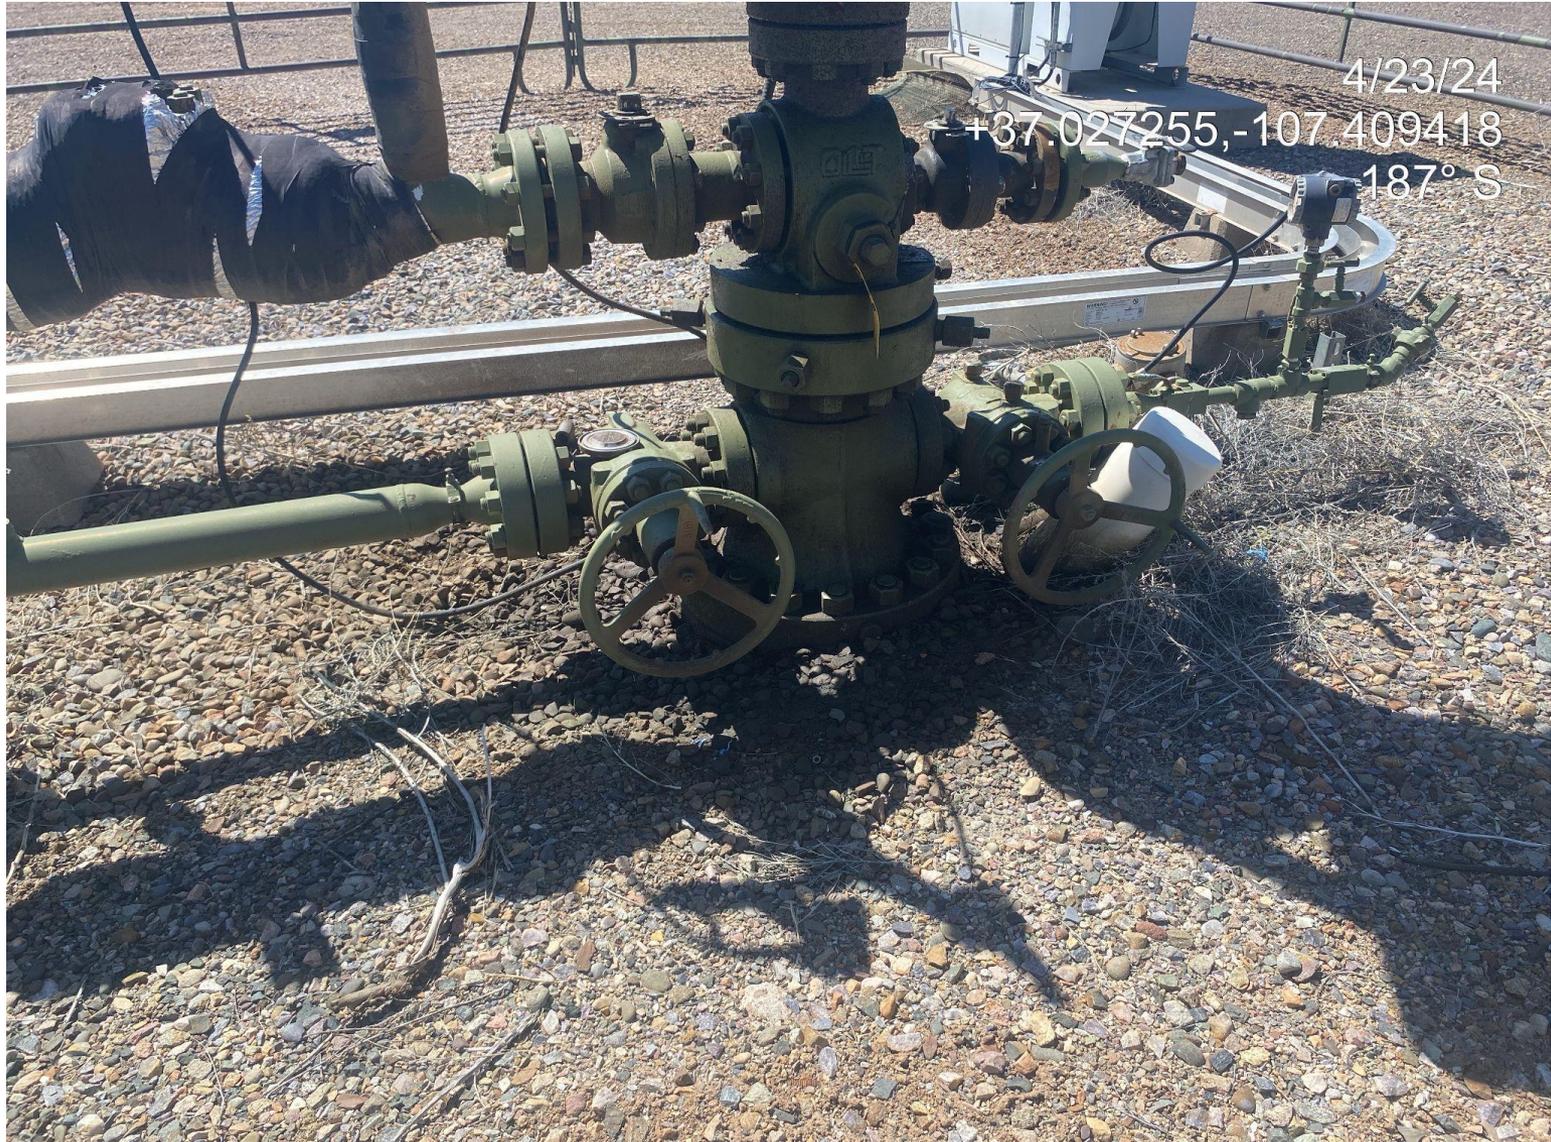
**Photo 4.** Impacted surface material observed at the A1 well head.

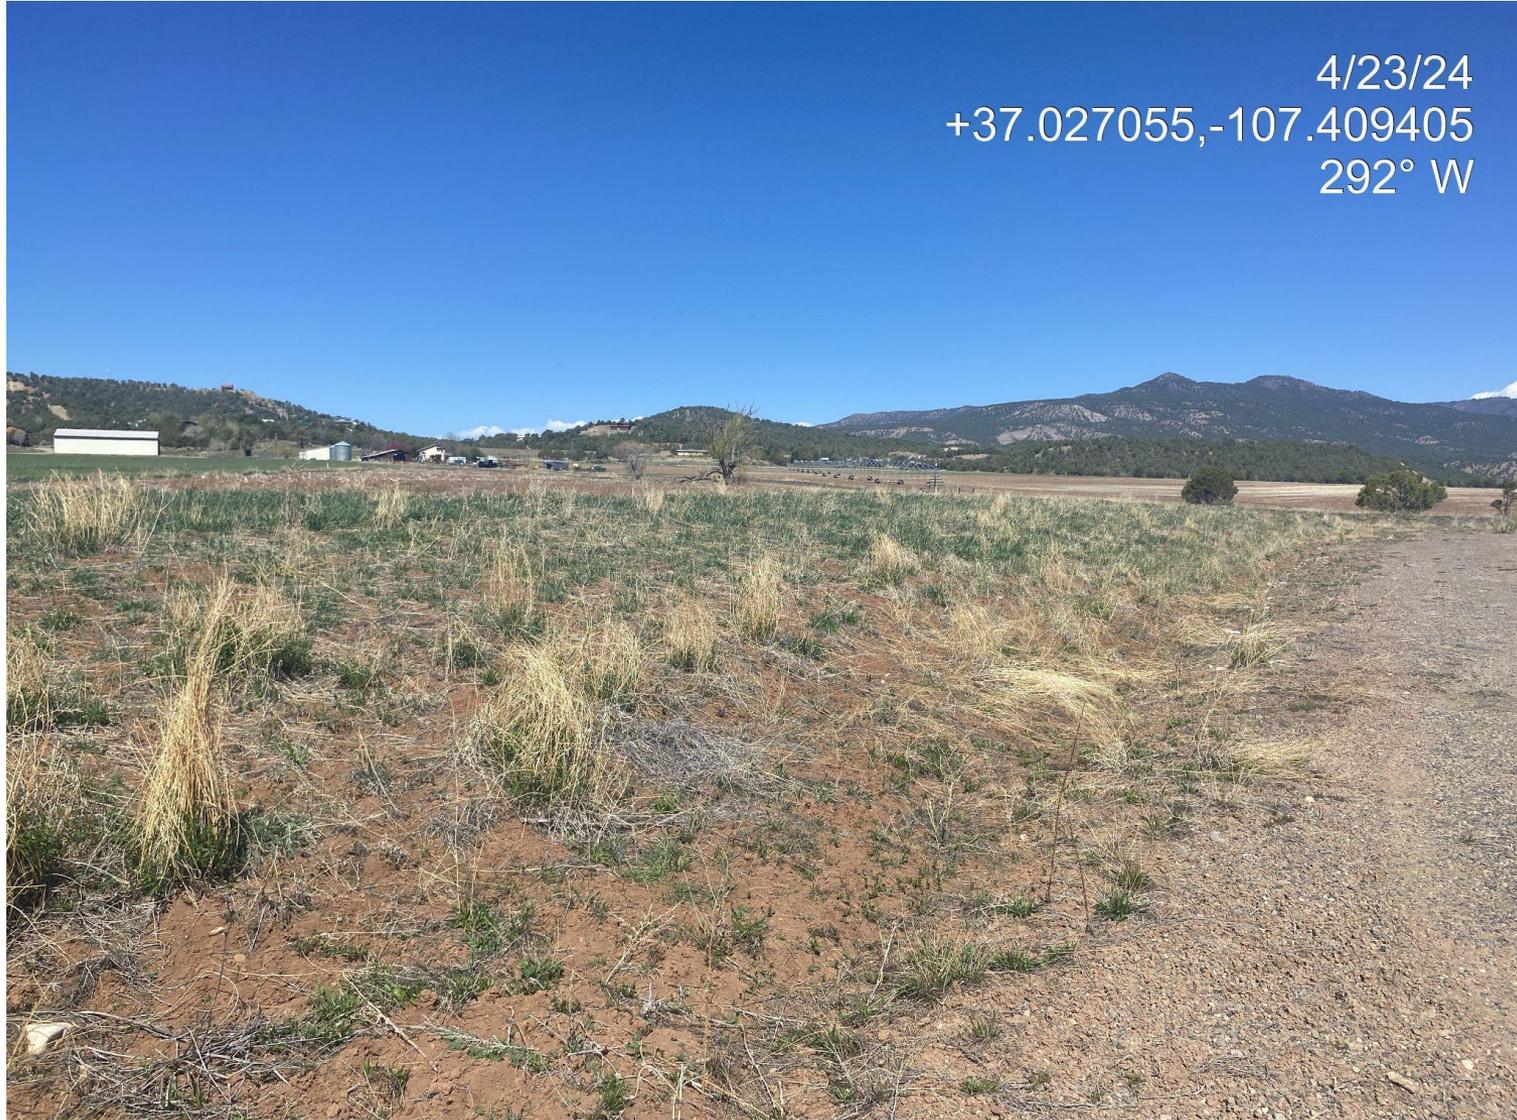
**Photo 5.** View of southern interim reclamation area facing west. Vegetation comprised of crested wheatgrass and alfalfa.

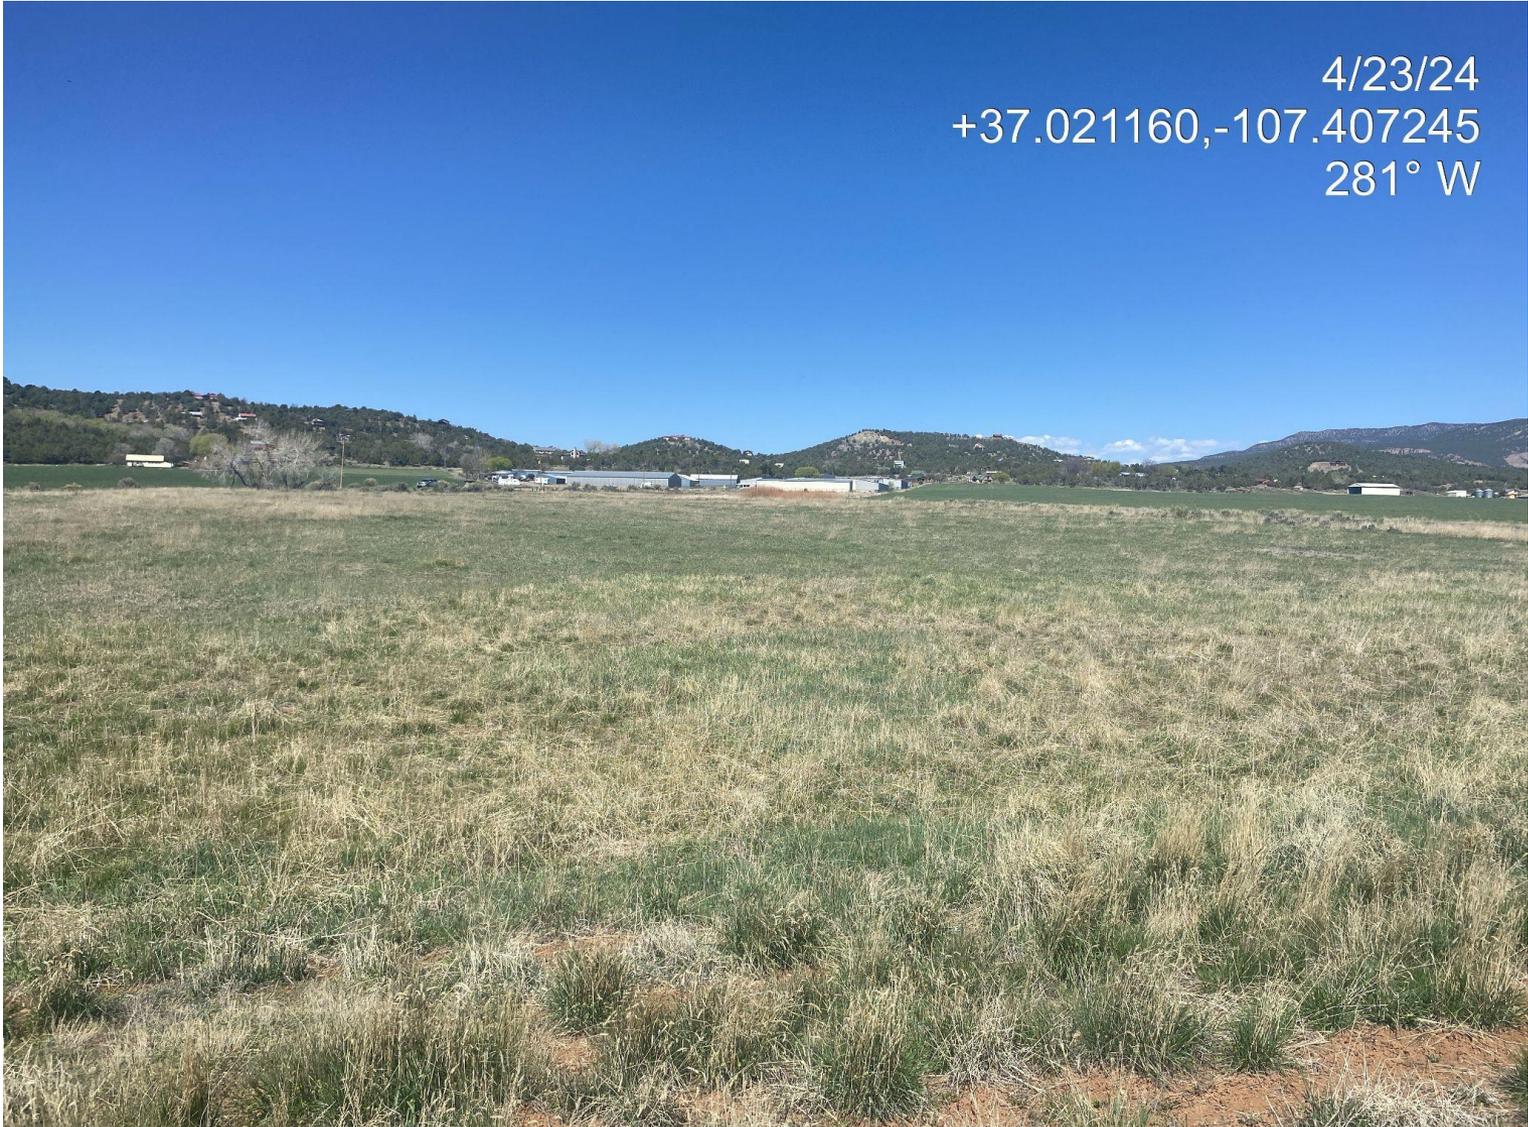
**Photo 6.** Reference area comprised of crested and intermediate wheatgrass.
