Inspection Photos

Operator: Simcoe LLC - 10749

Location ID: 320869

Inspection Document #: 714000708

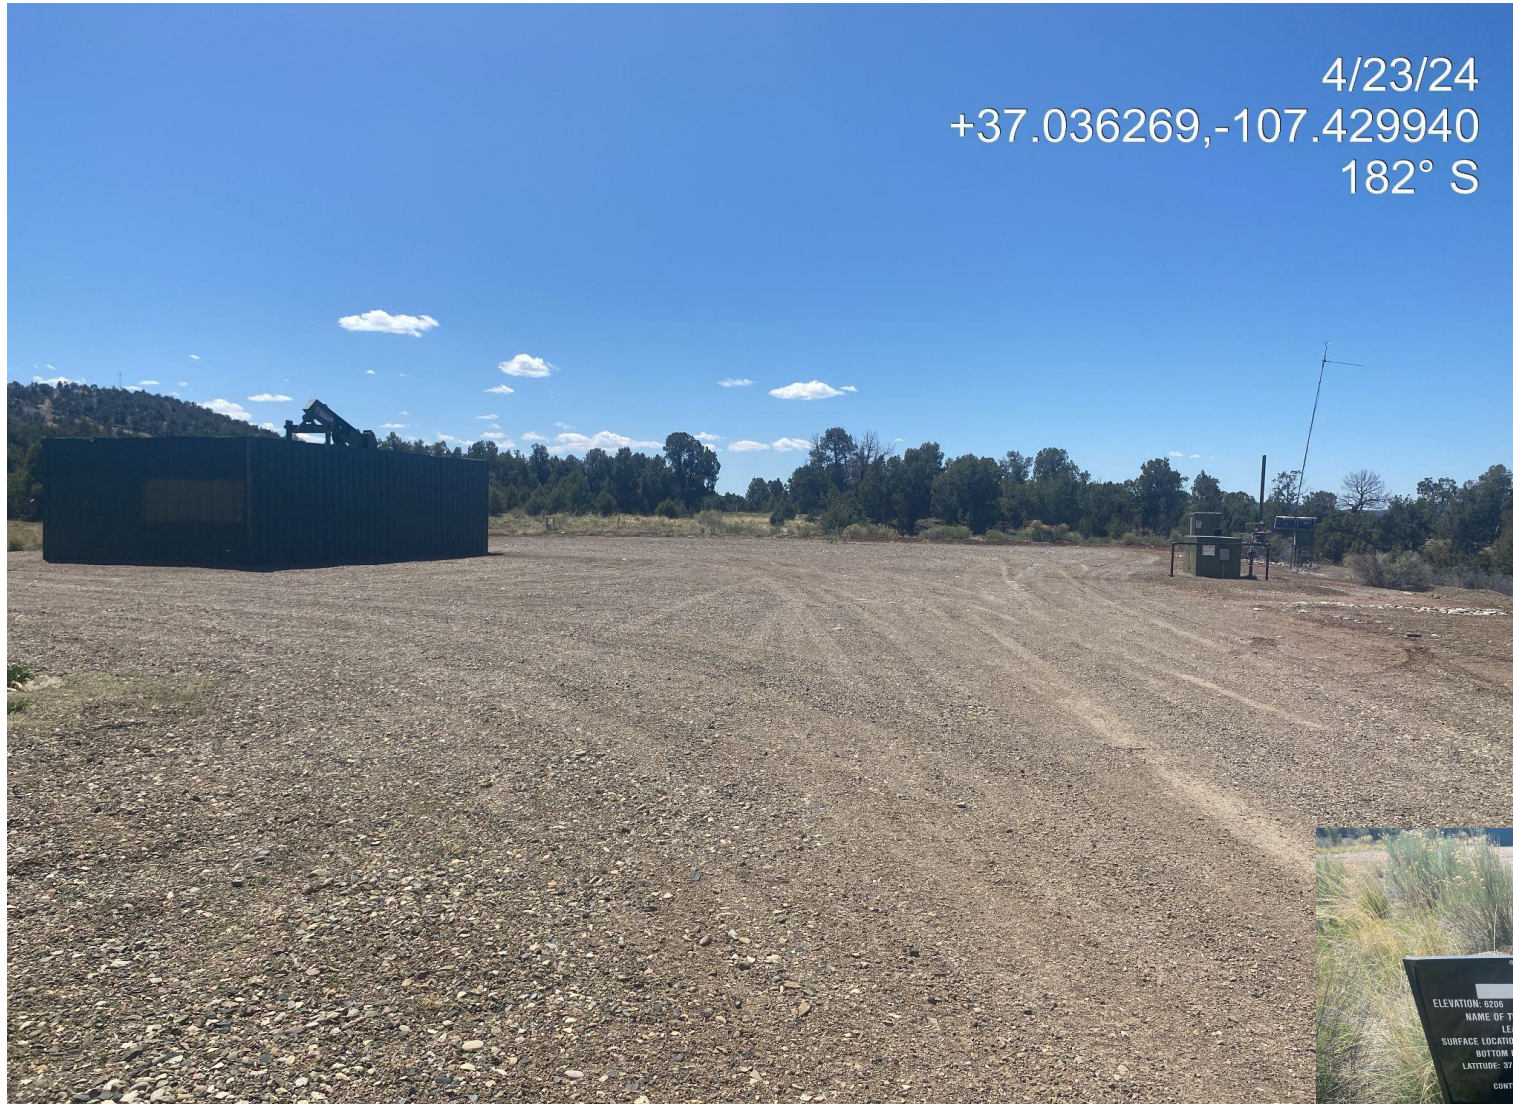
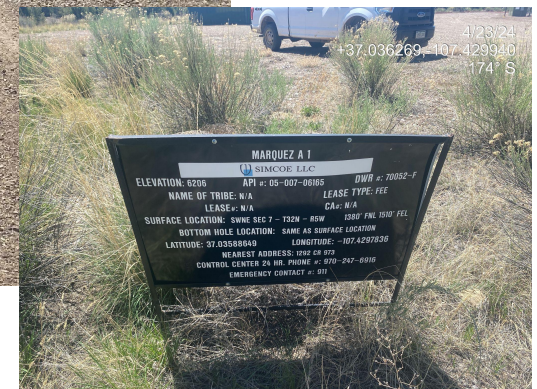
Photo 1. View of the disturbance taken from the access point facing center.

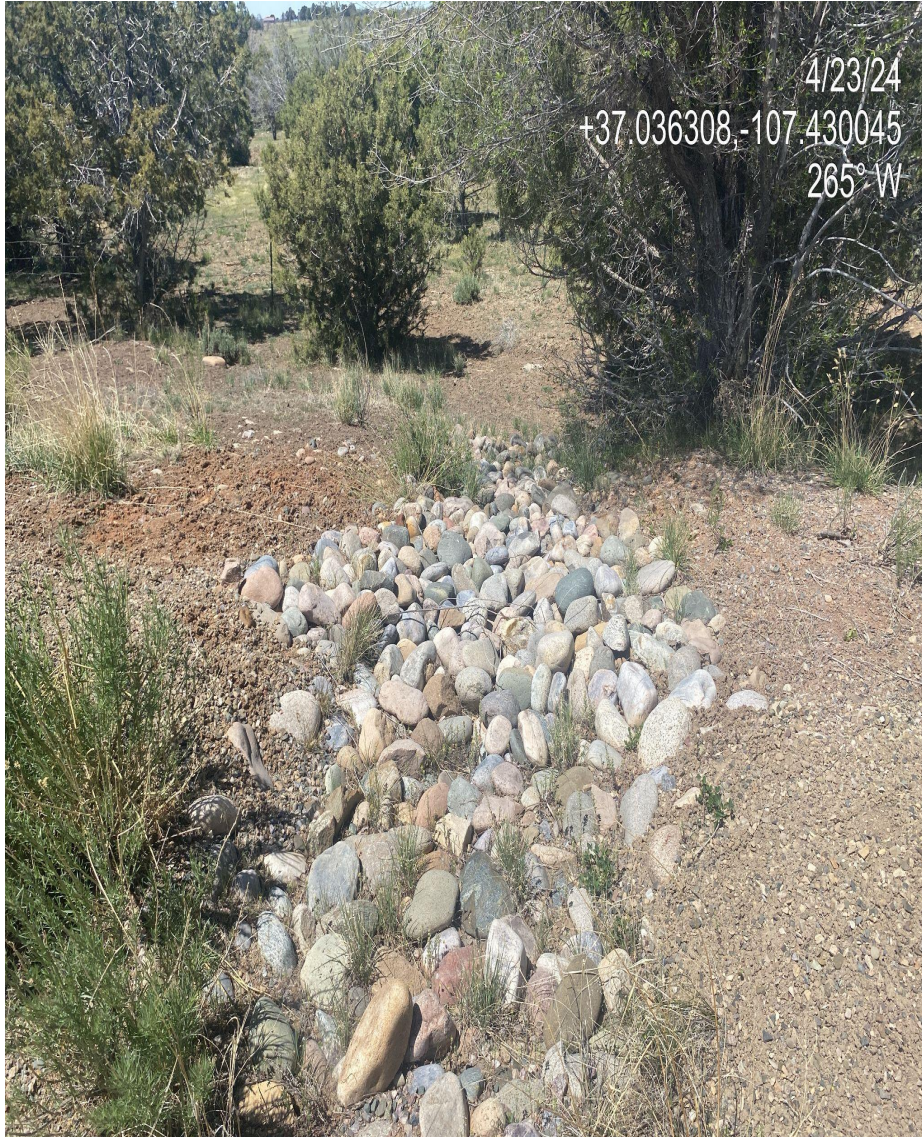
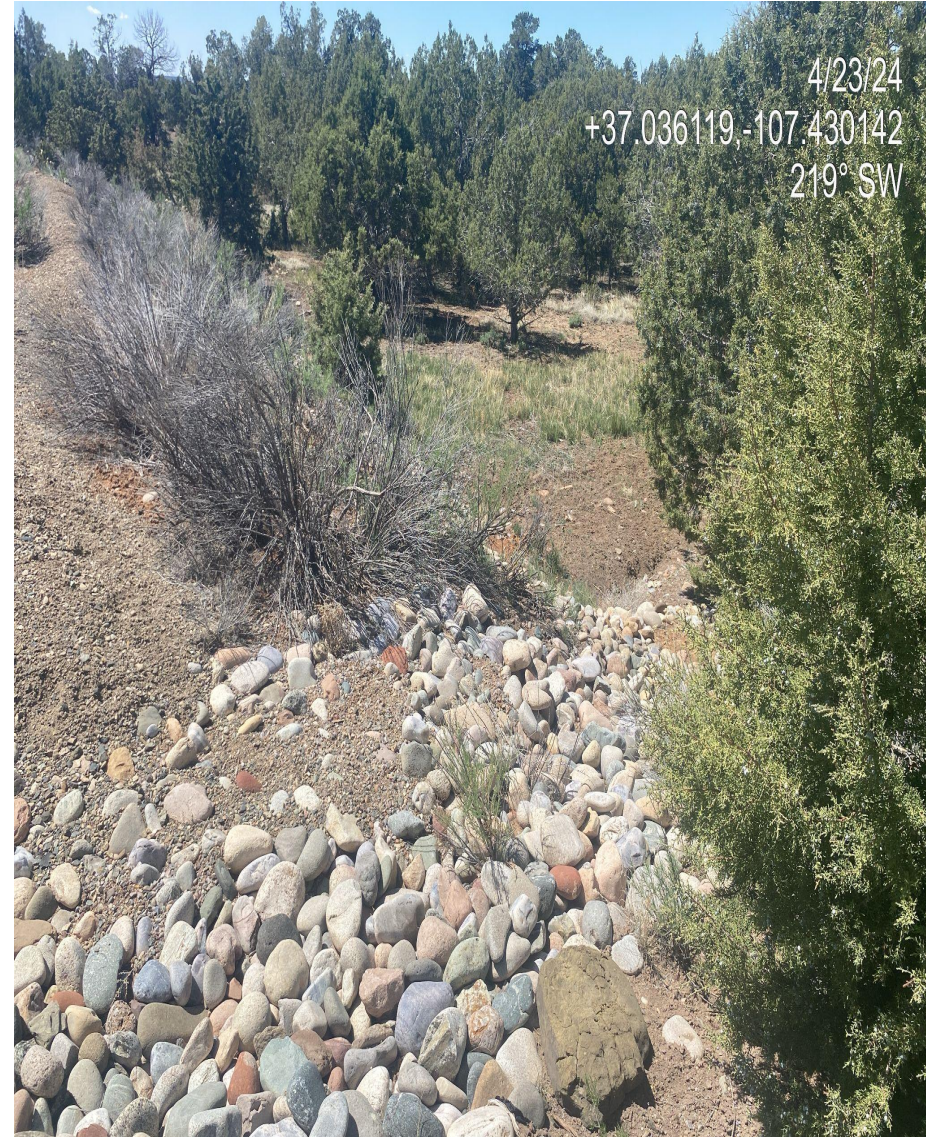
Photo 2. Storm water corrective action identified in the previous inspection doc #693904254 has been addressed/resolved.

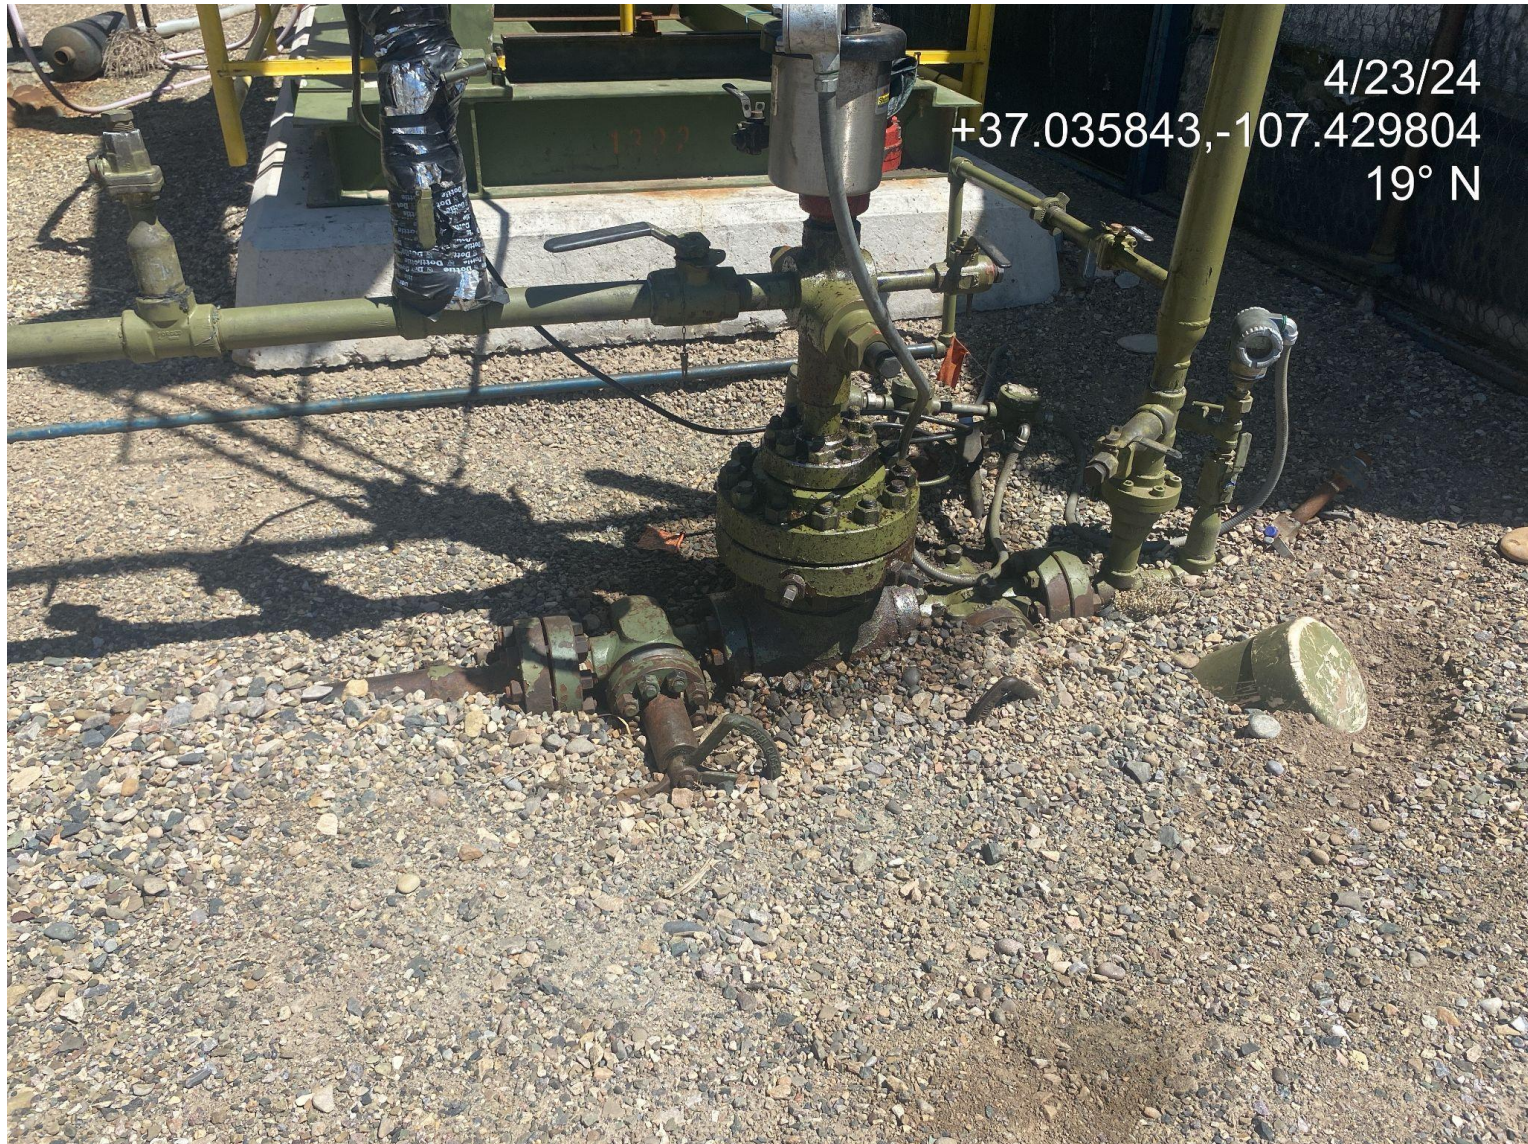
Photo 3. Impacted surface material observed at the well head.

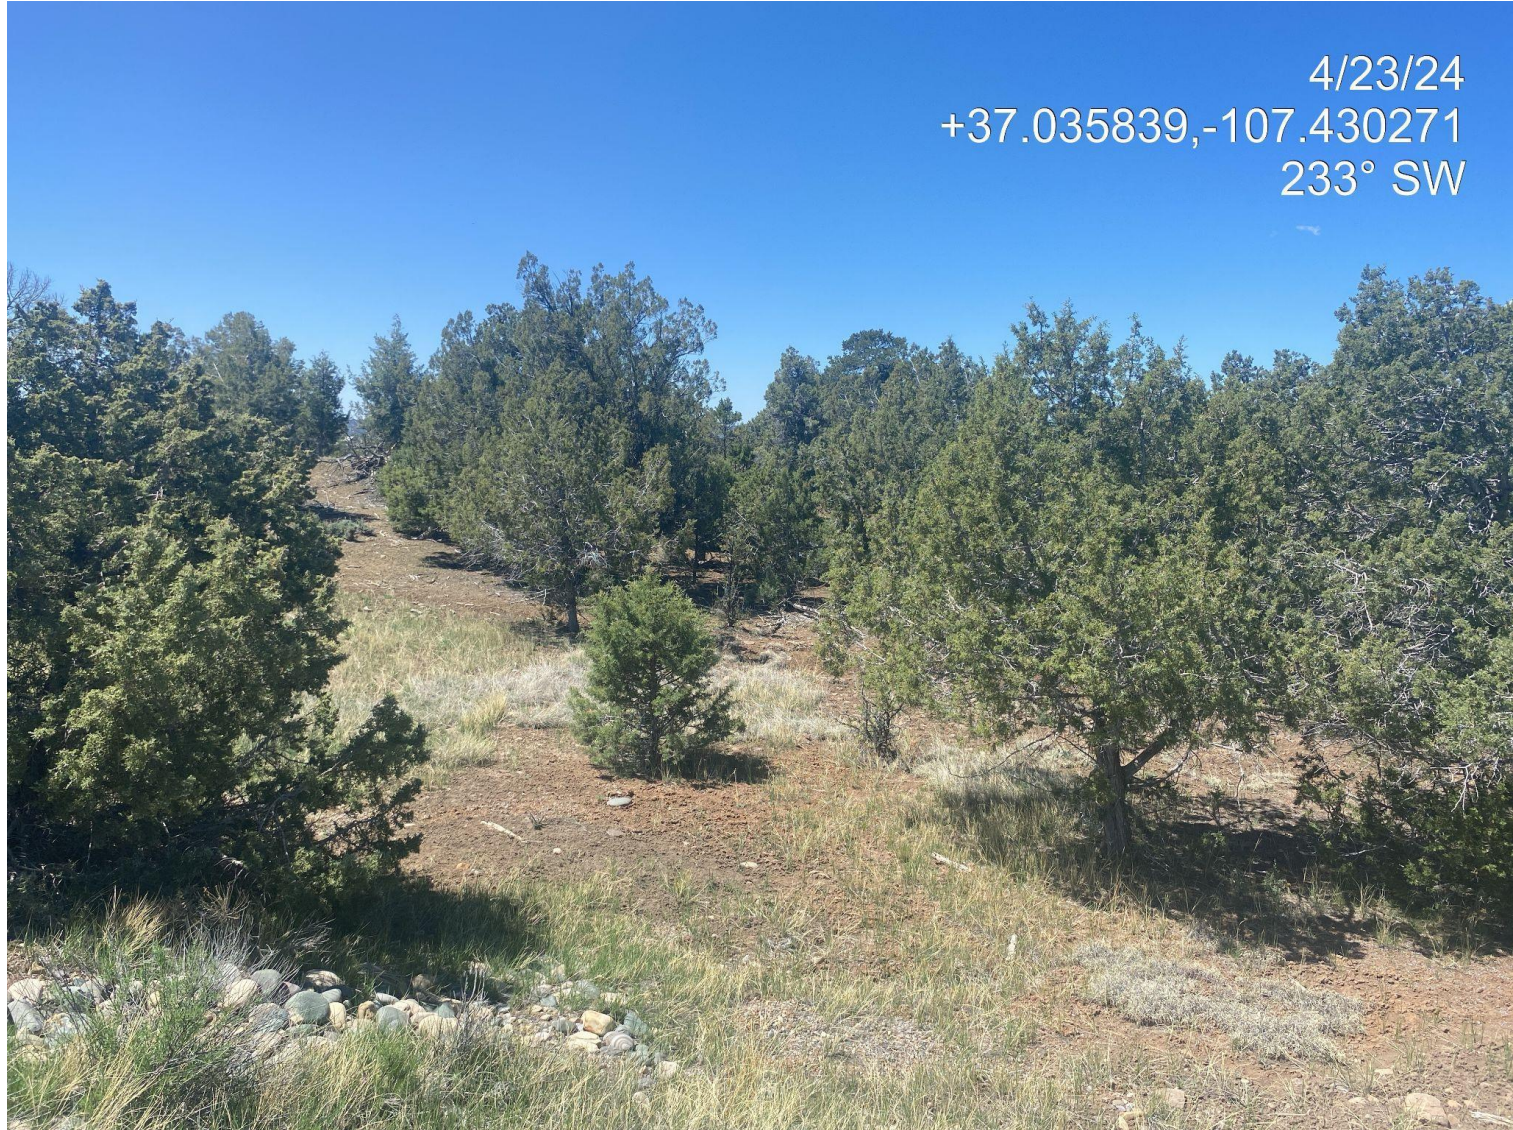
Photo 5. Reference area comprised of smooth brome, rabbit brush and juniper.
