# Inspection Photos

Operator: Simcoe LLC - 10749

Location ID: 453717

Inspection Document #: 714000709

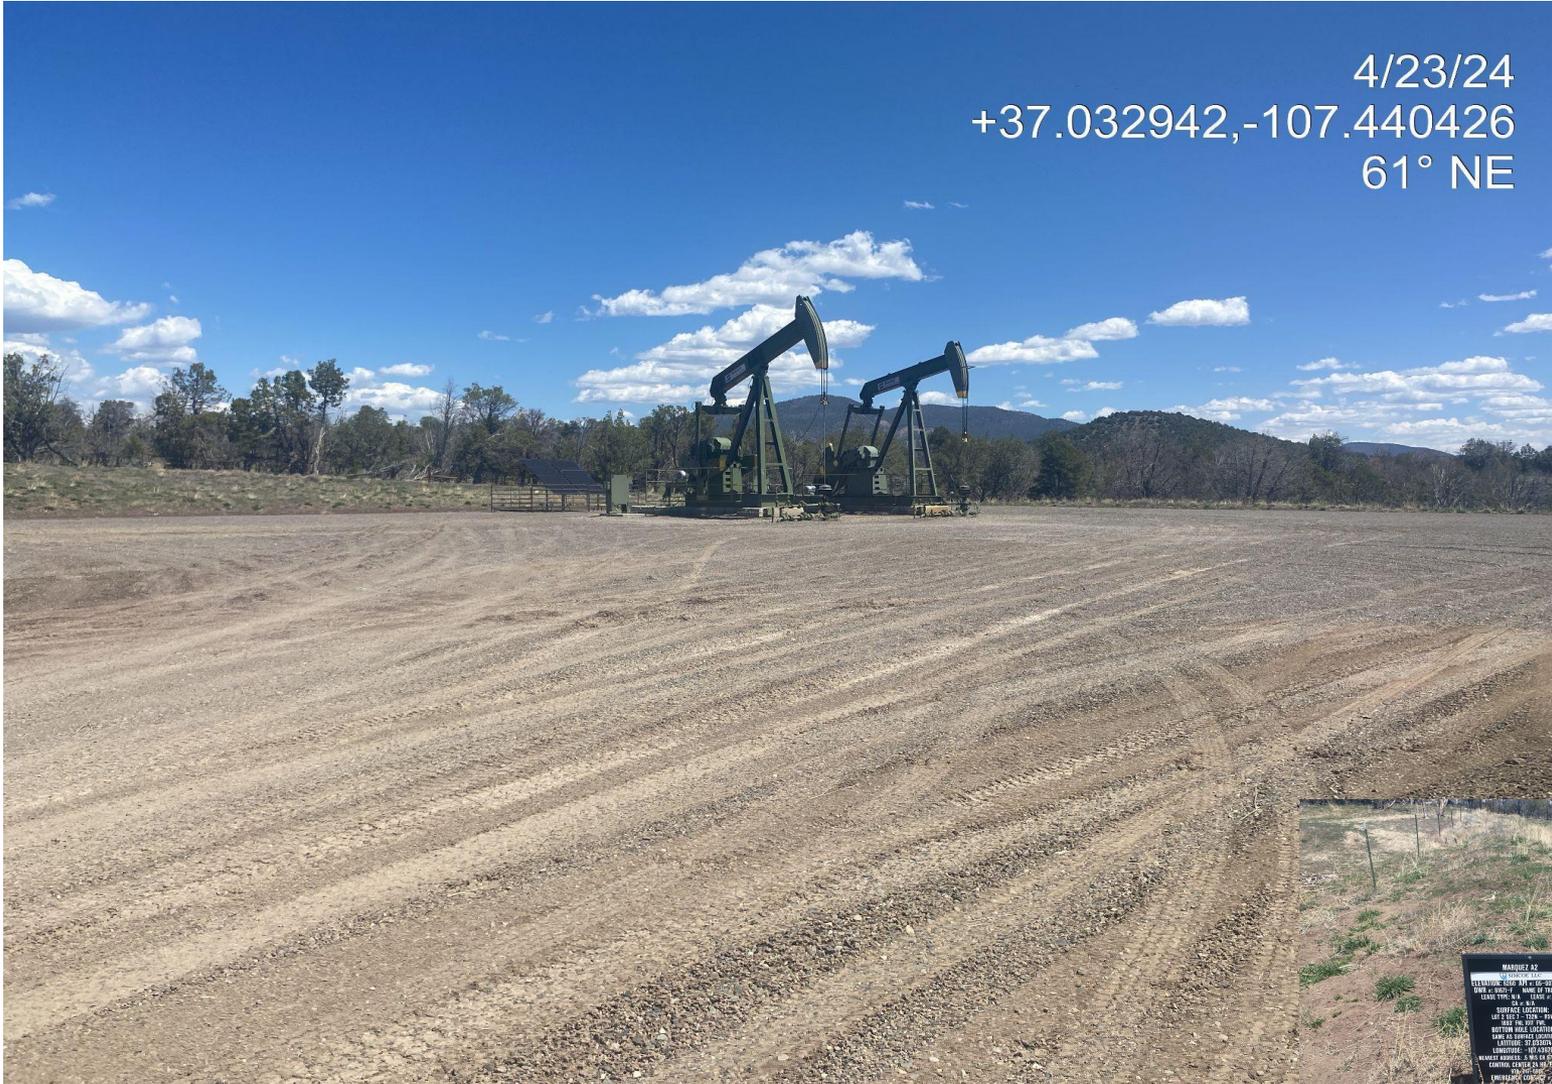
Photo 1. View of the disturbance taken from the access point facing center.

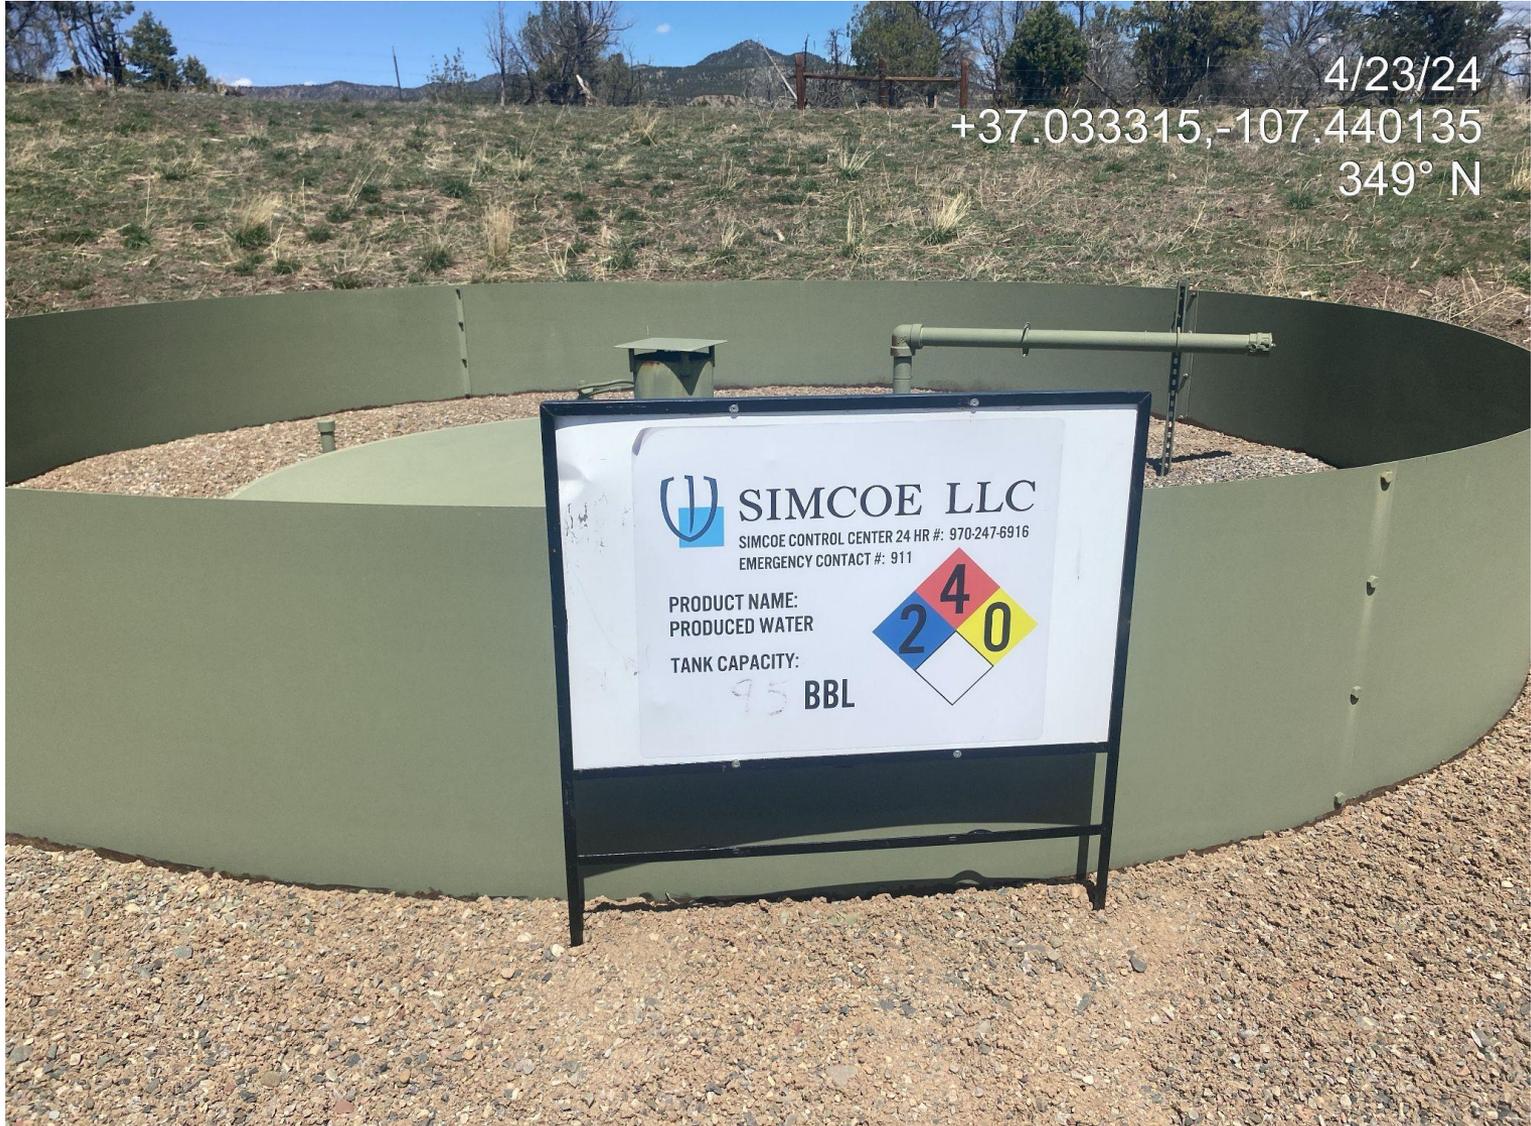
**Photo 2.** Produced water sign/placard corrective action identified in the previous inspection doc #702500393 has been addressed/resolved.

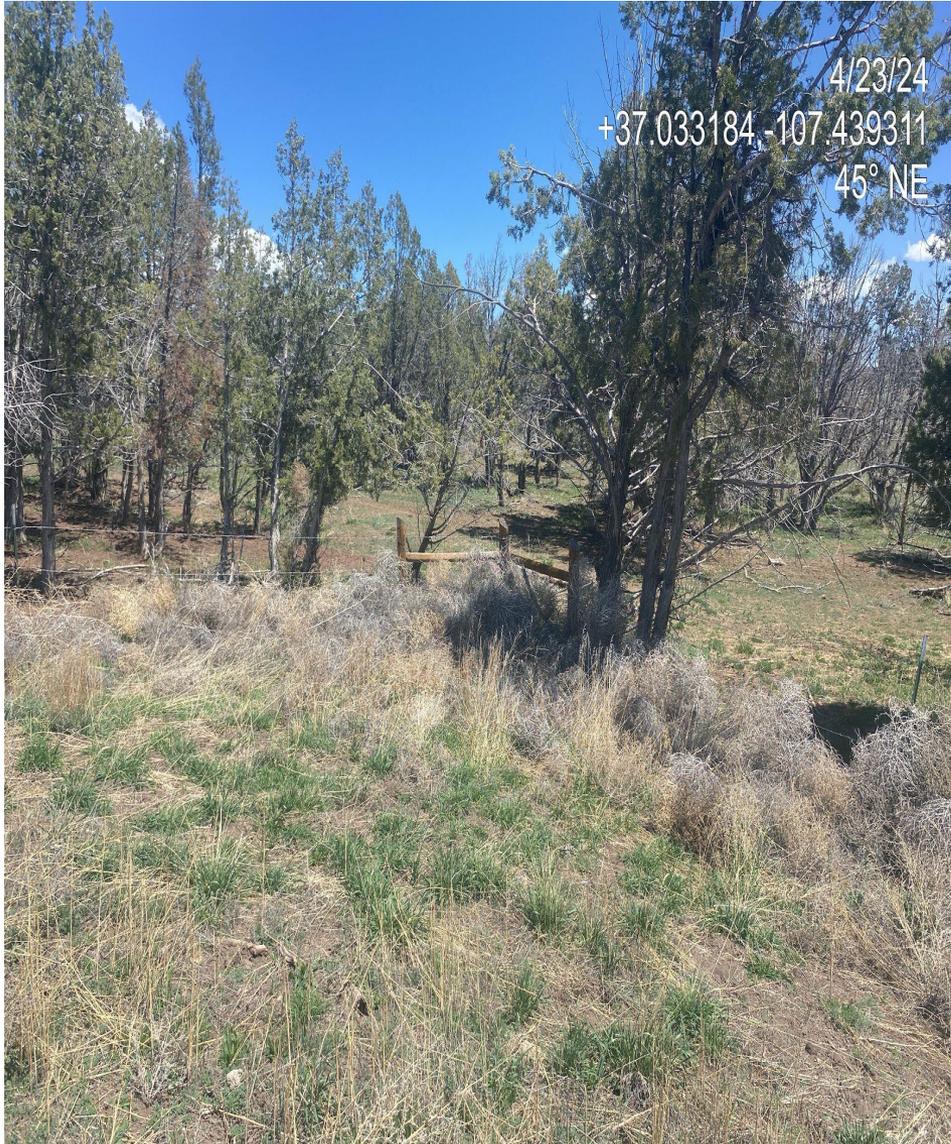
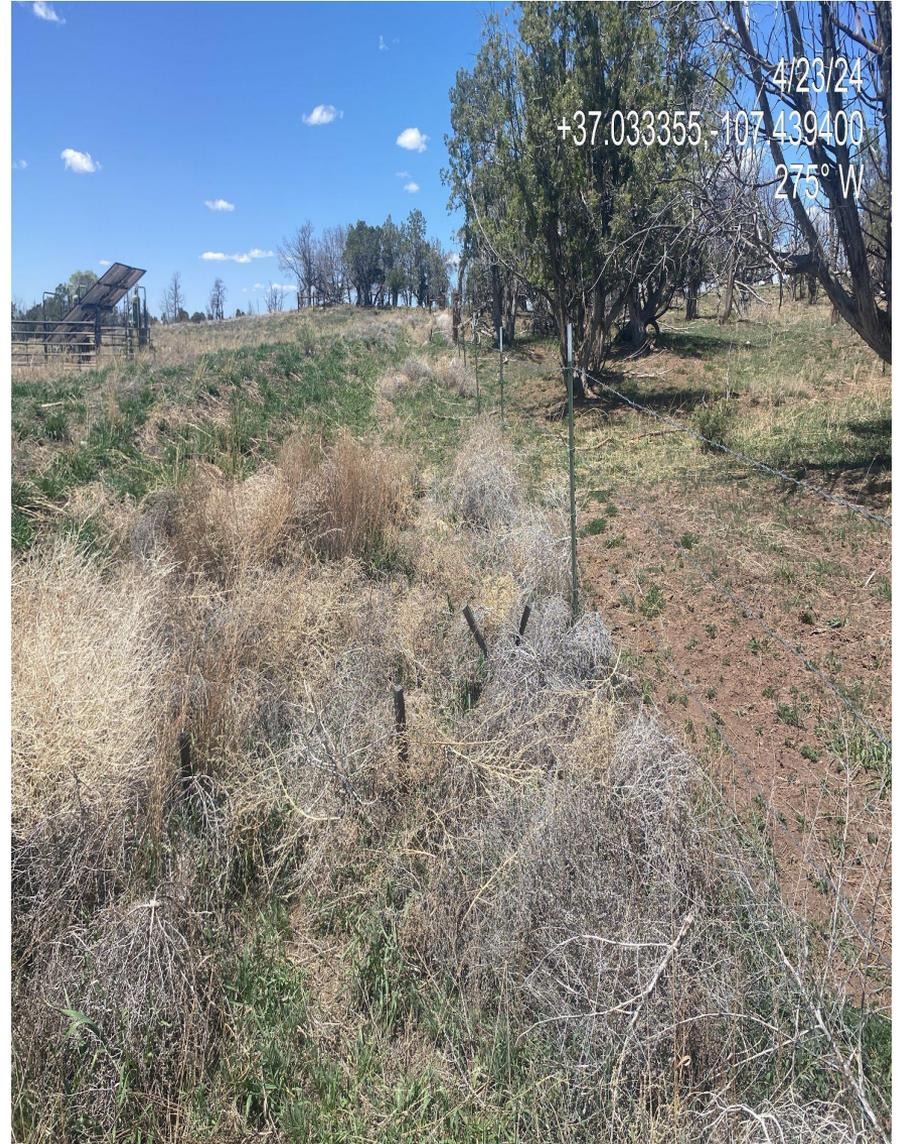
**Photo 3.** View of weedy russian thistle debris piling up along the northern fence line and in the northeast corner of the disturbance.

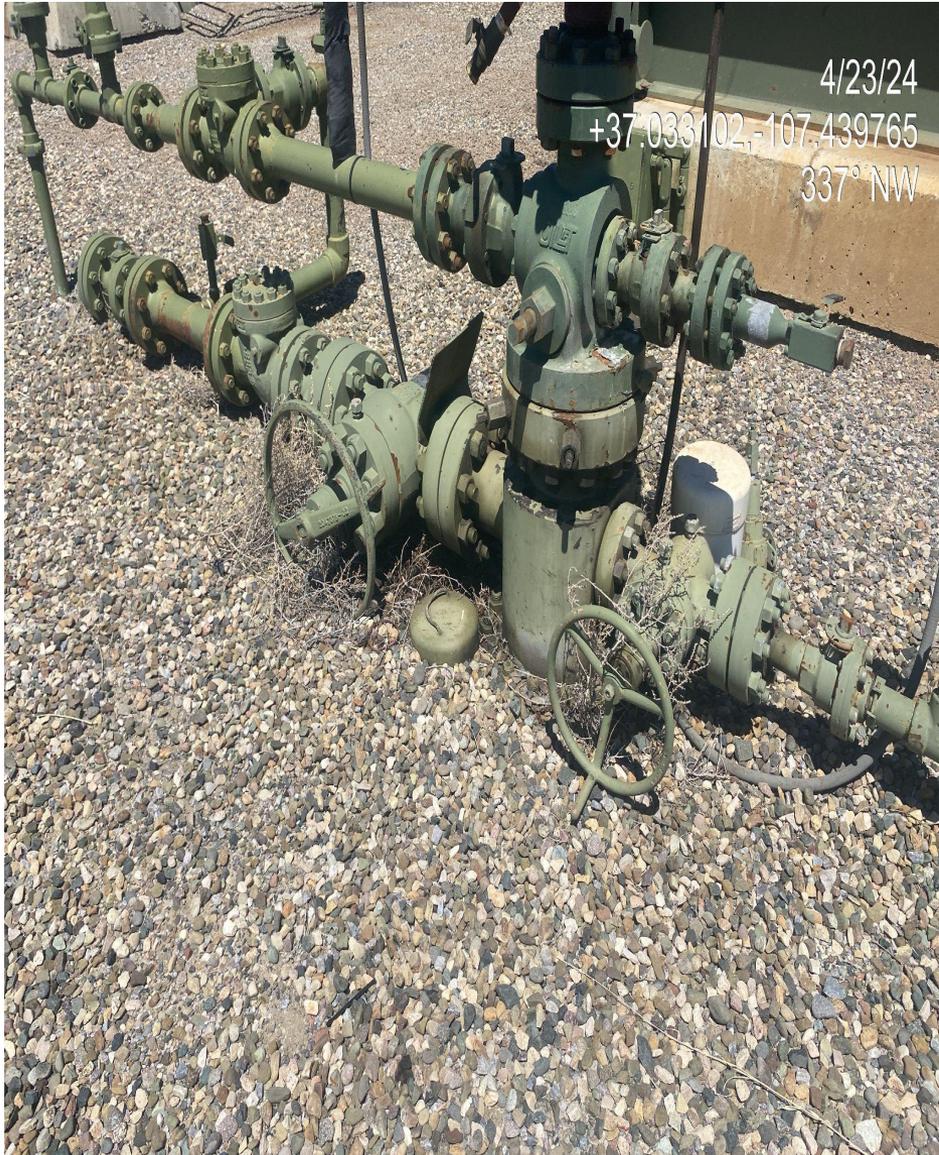
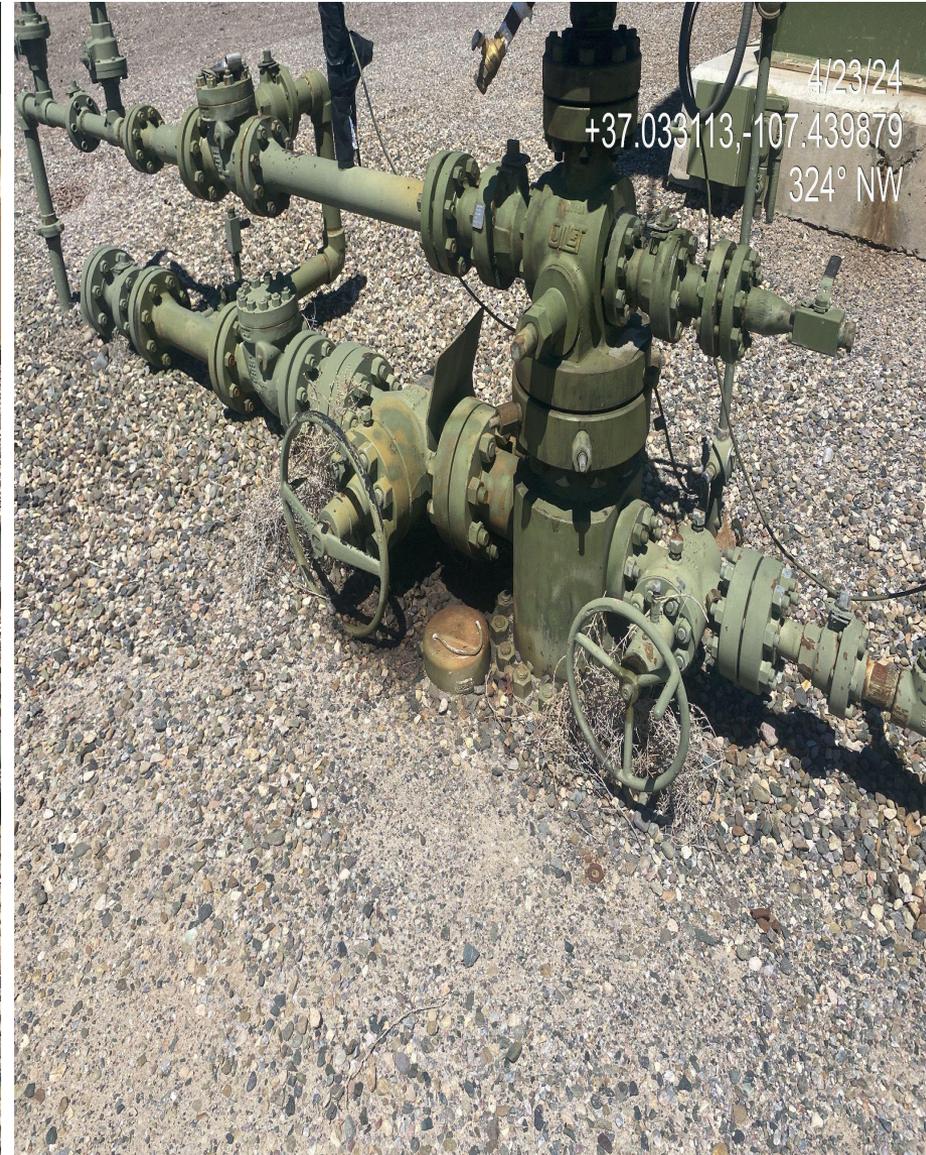
**Photo 4.** Weedy russian thistle debris and impacted surface material observed at both well heads.

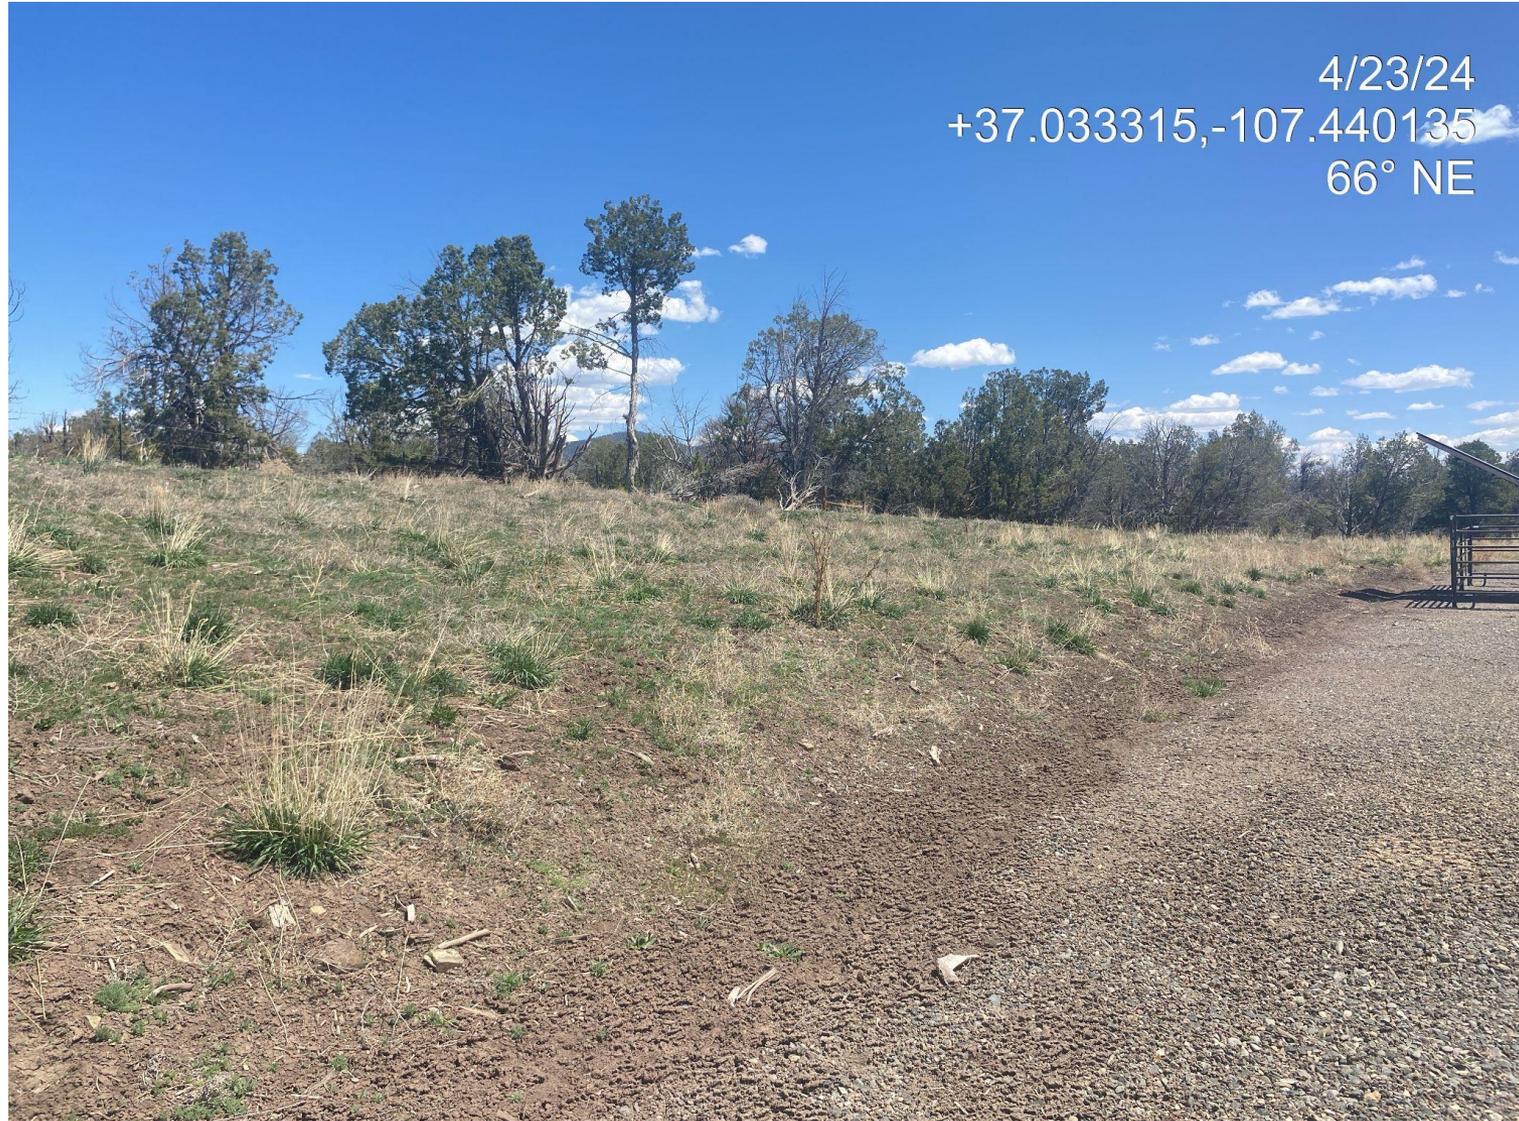
**Photo 5.** View of northern interim reclamation area facing north east. Vegetation comprised of intermediate and crested wheatgrass.

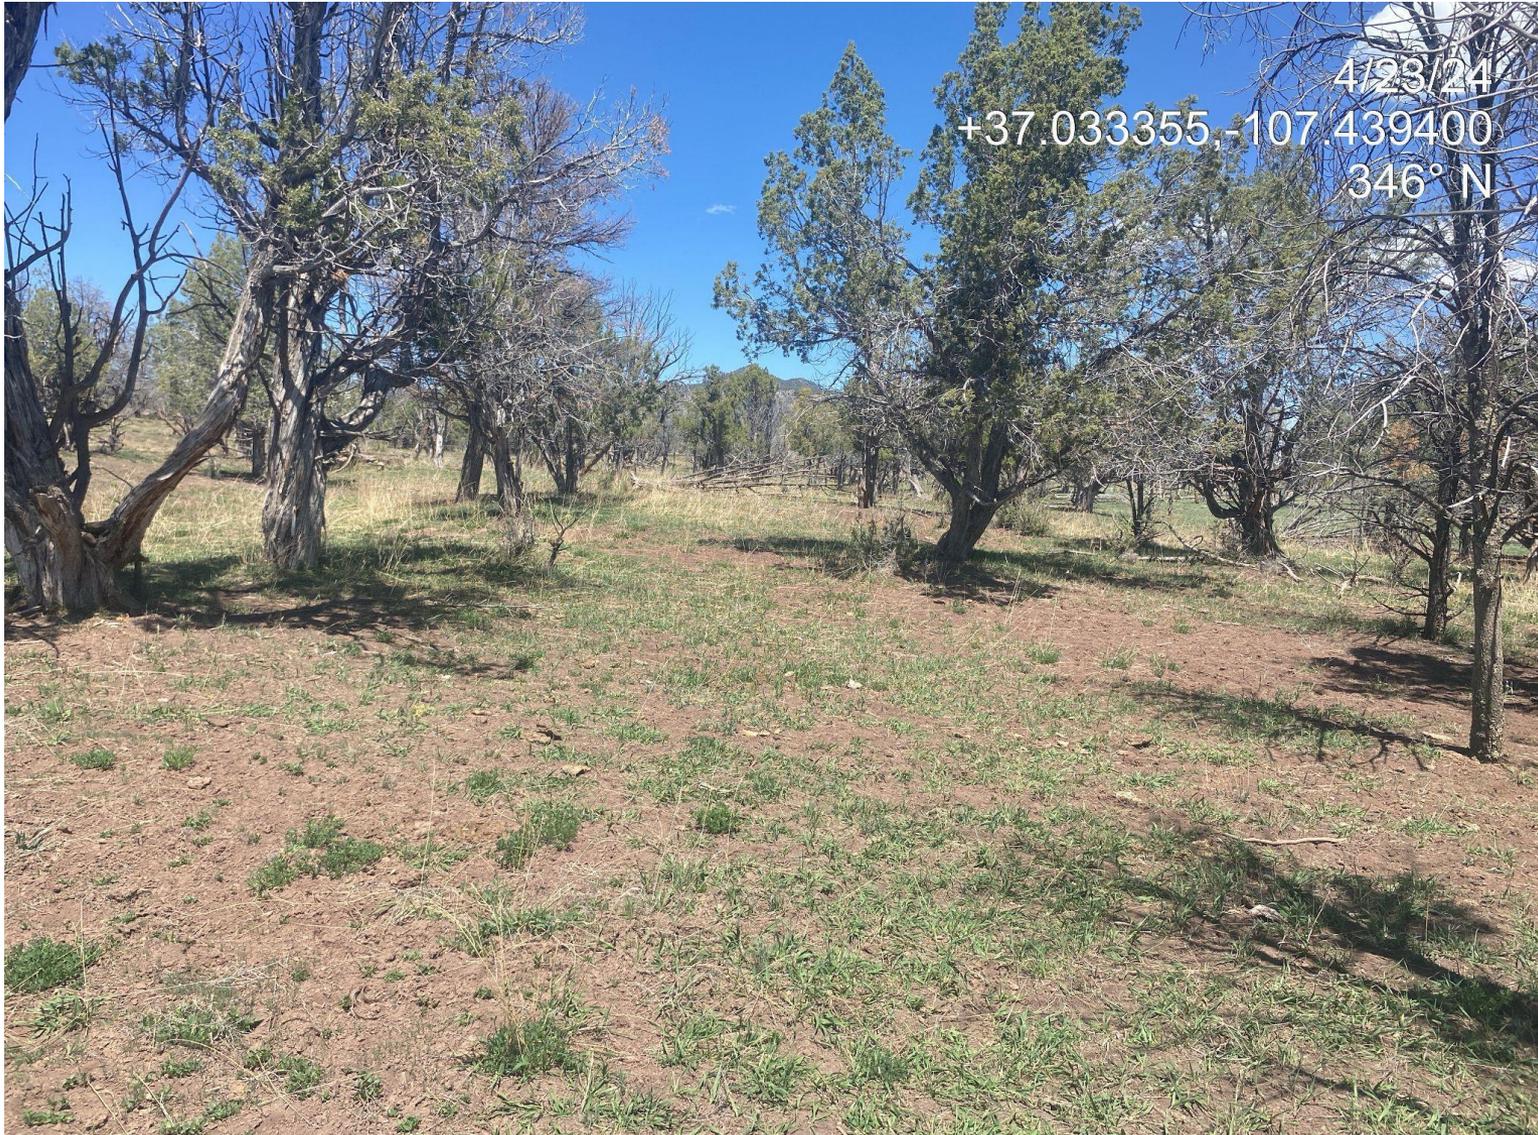
**Photo 6.** Reference area comprised of juniper and grazed grasses in the under story.
