Inspection Photos

Operator: MorningStar Operating LLC - 10755

Location ID: 320880

Inspection Photos
Location Name: Quintana 32-5 7-2
Location ID: 320880

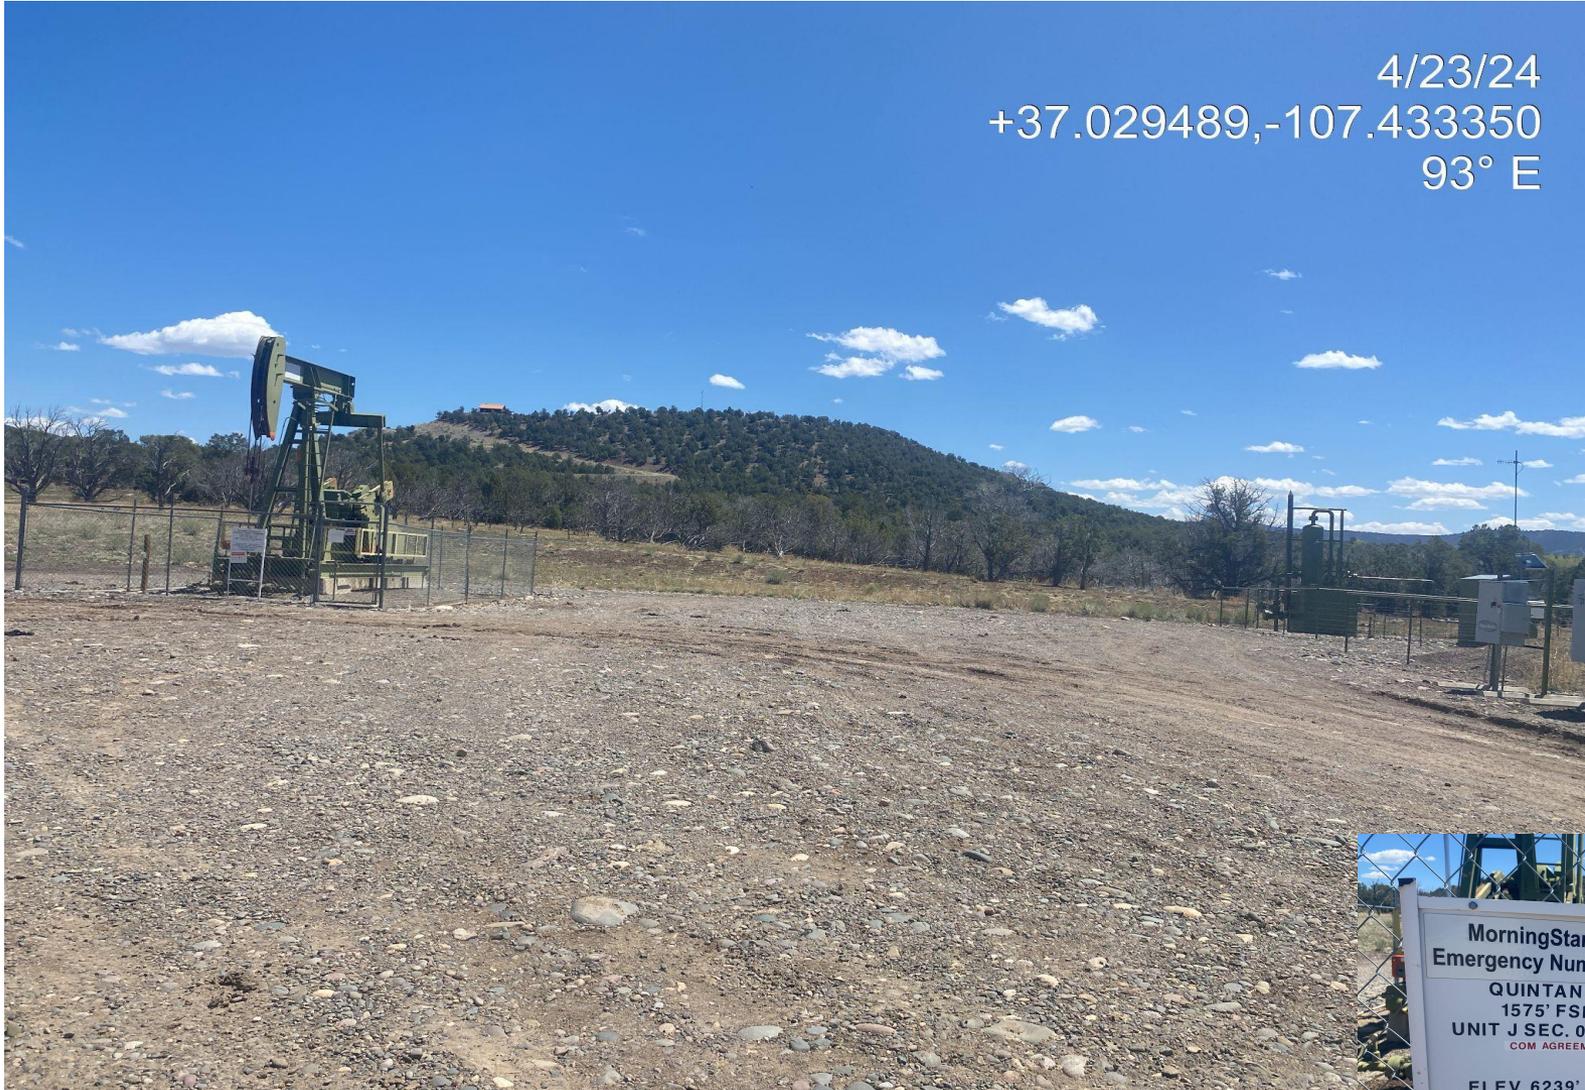
Photo 1. View of the disturbance taken from the access point facing center.

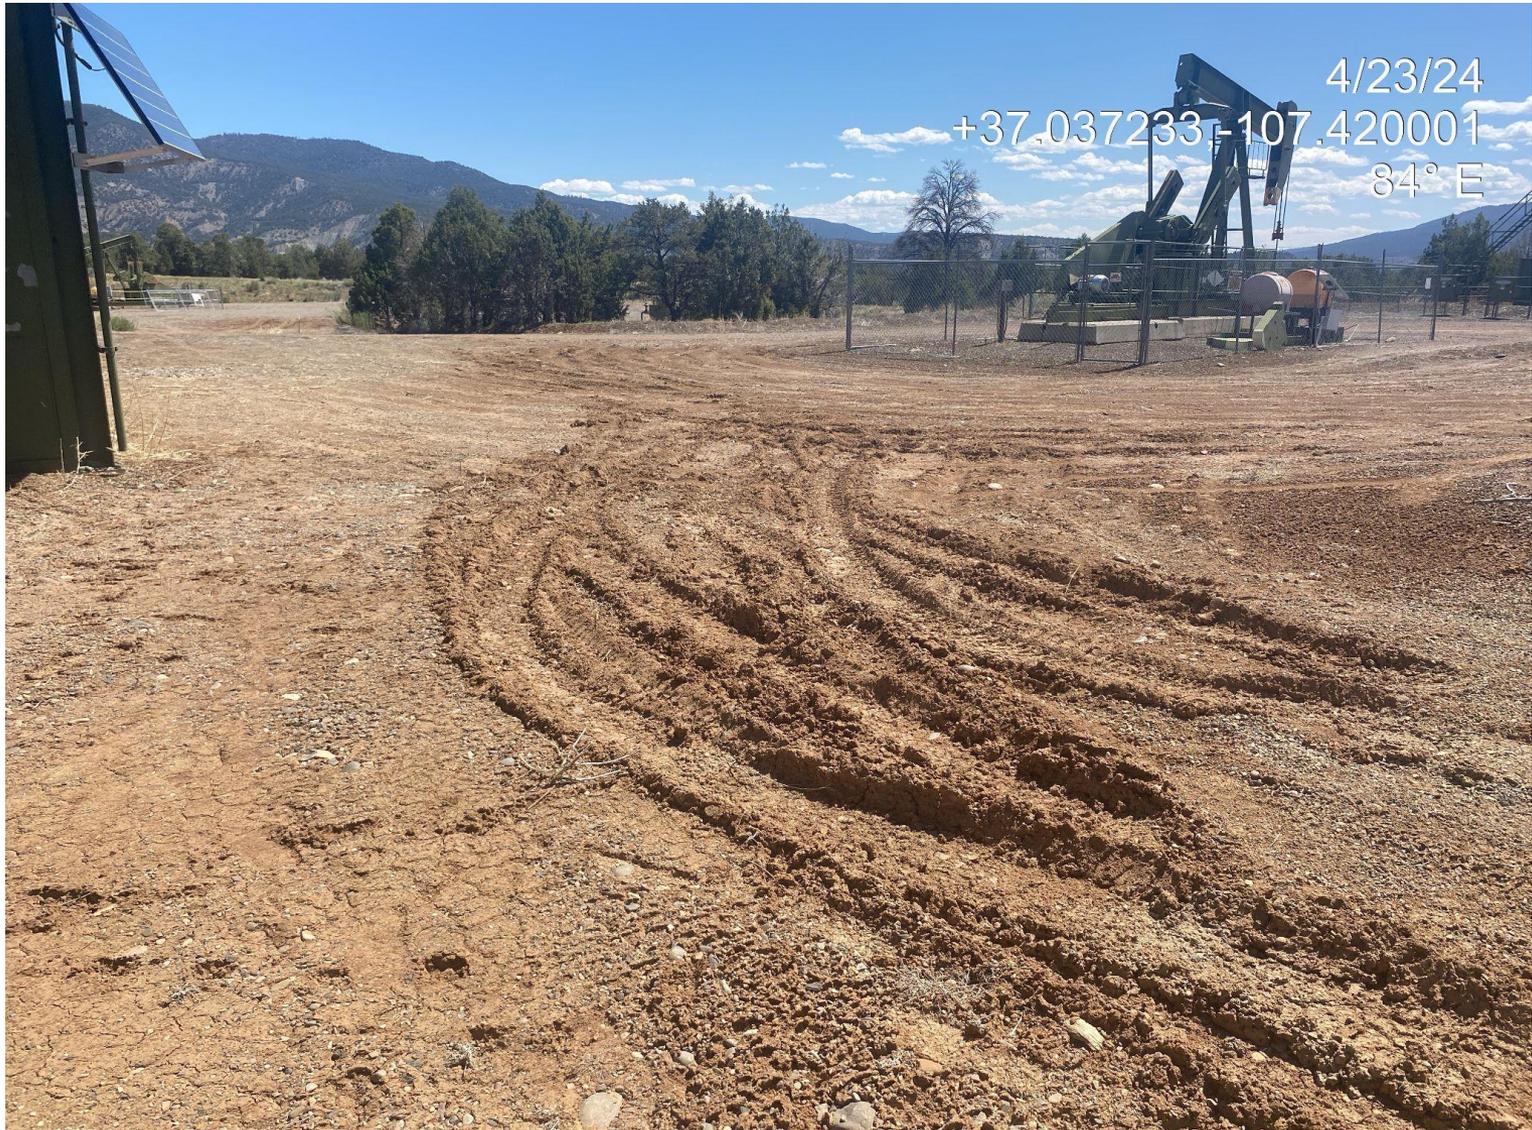
Photo 2. Rutting observed on location, additional stabilization is needed to minimize site degradation.

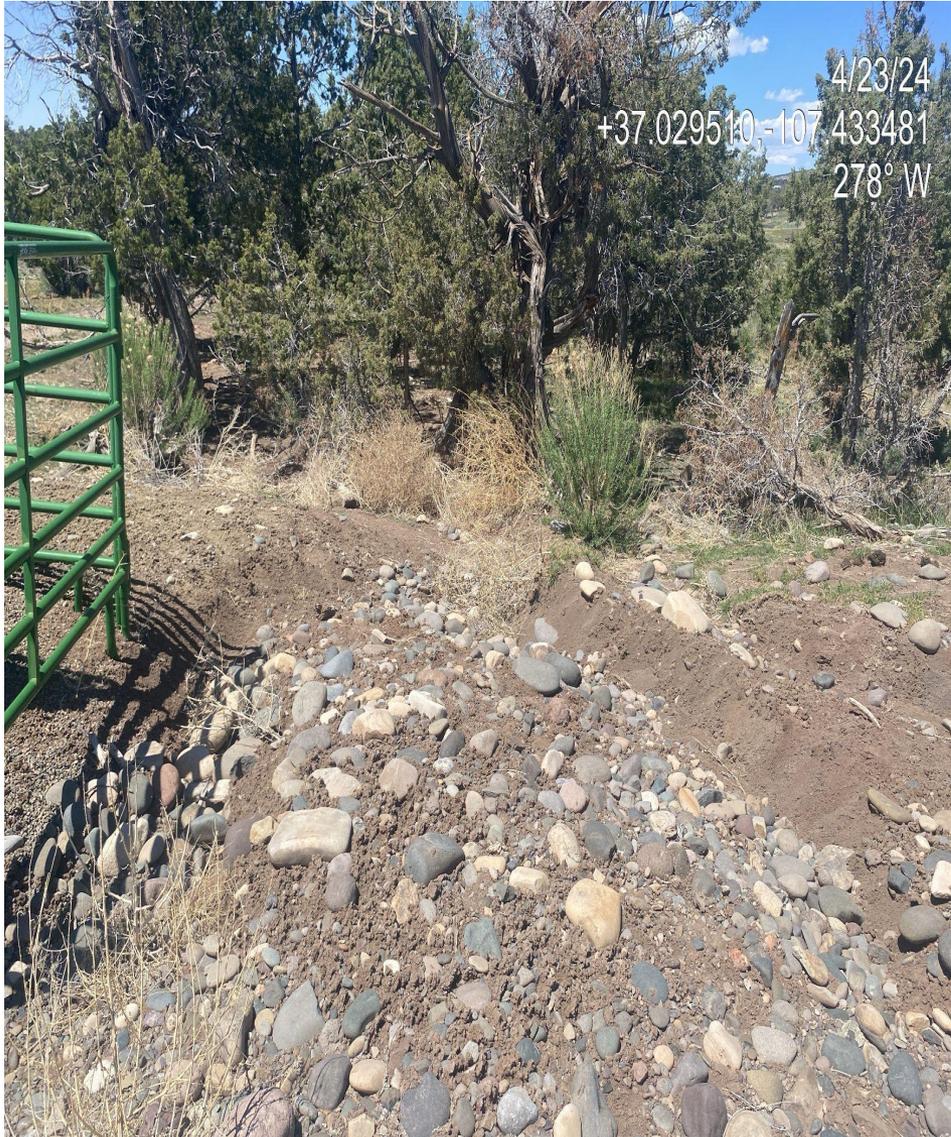
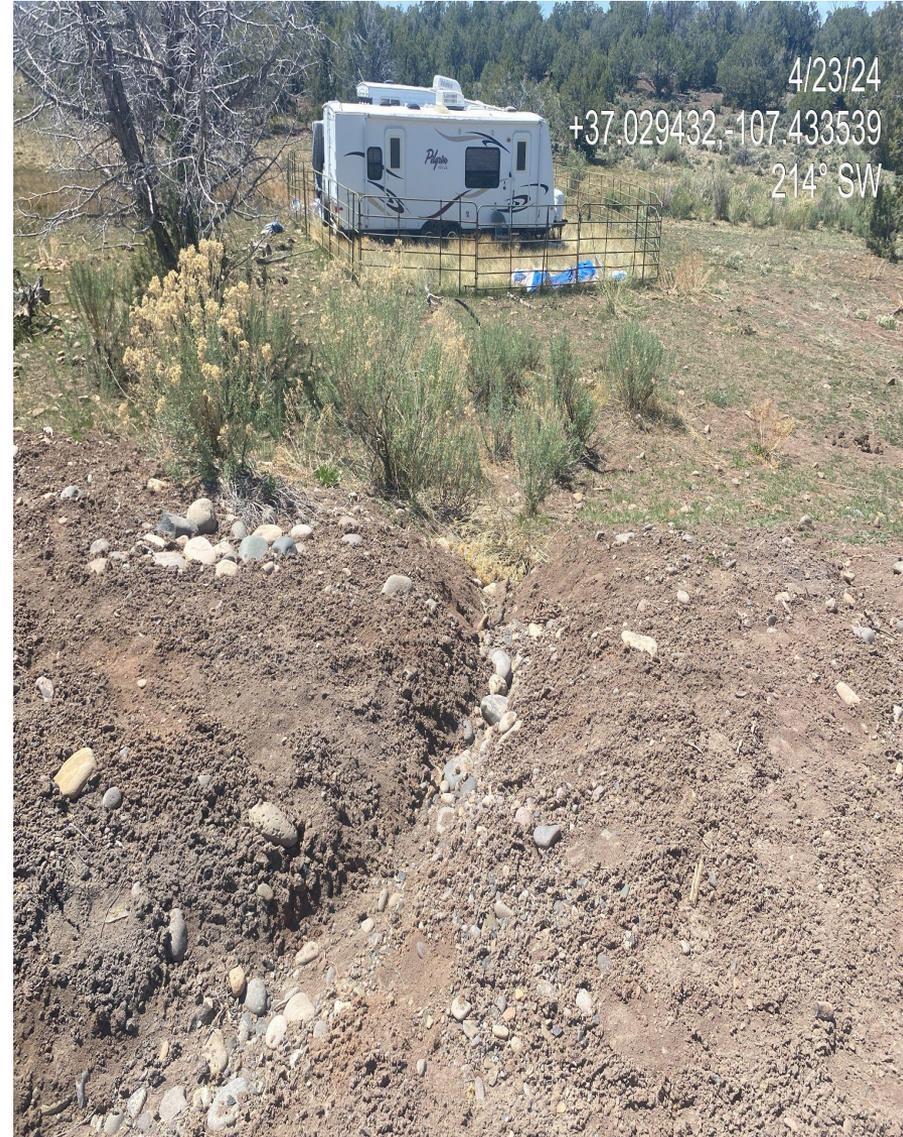
Photo 3. View of unaddressed erosion issues persisting in the western portion of the disturbance.

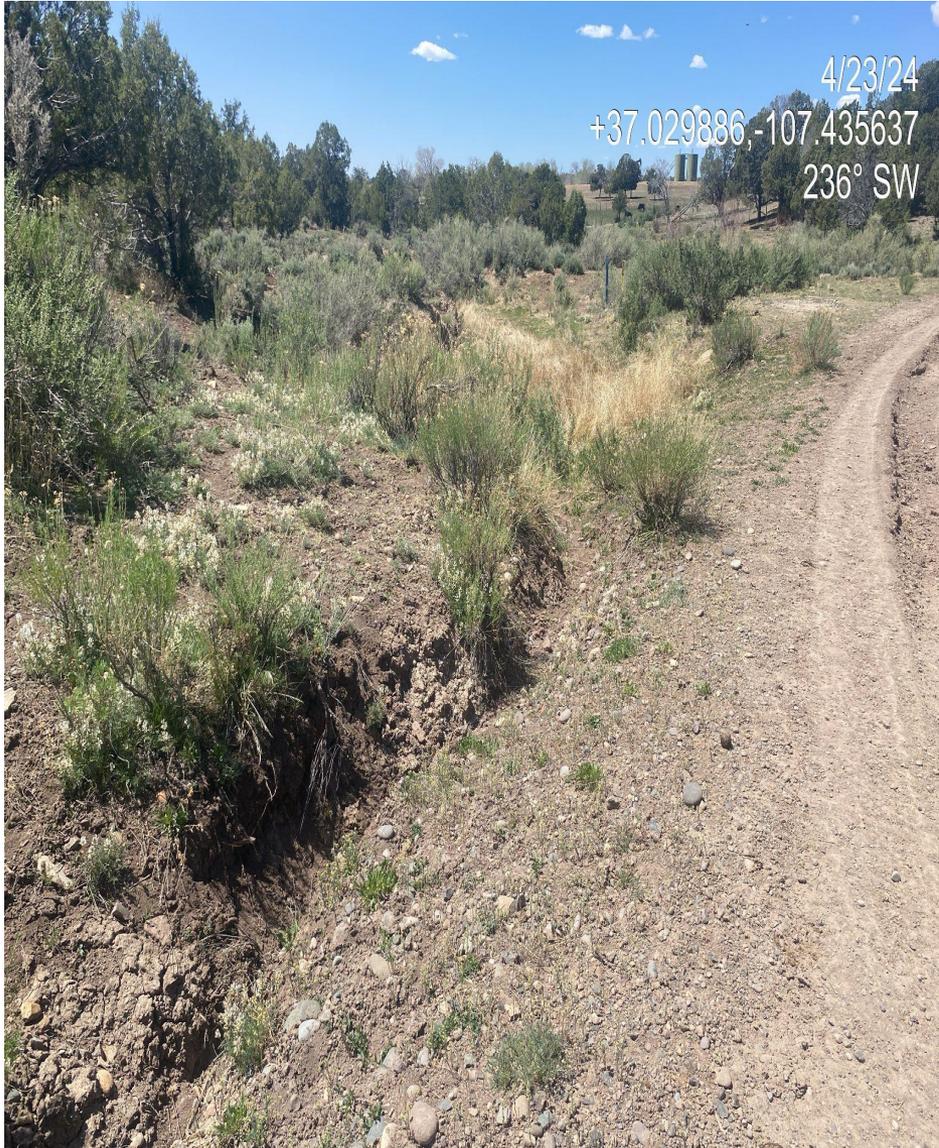
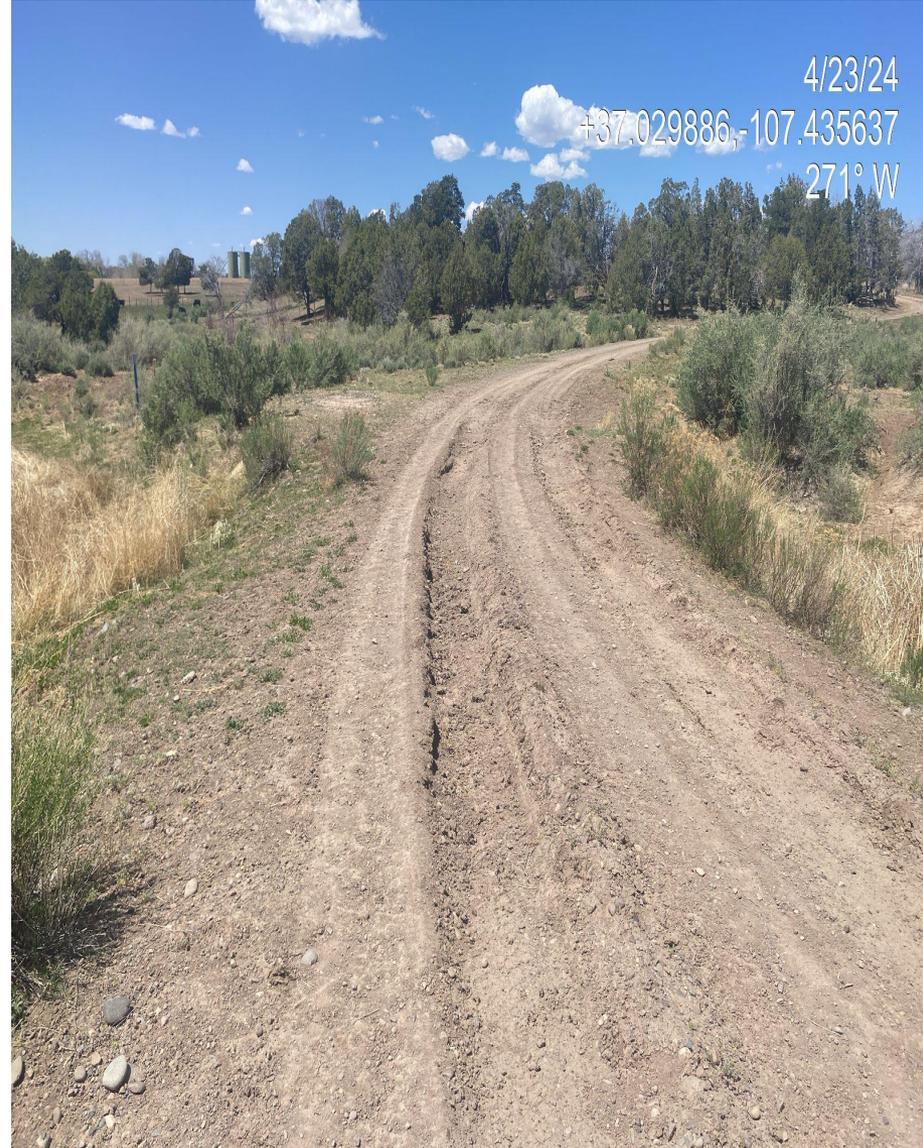
Photo 4. Gully erosion and rutting erosion observed forming along the access road.

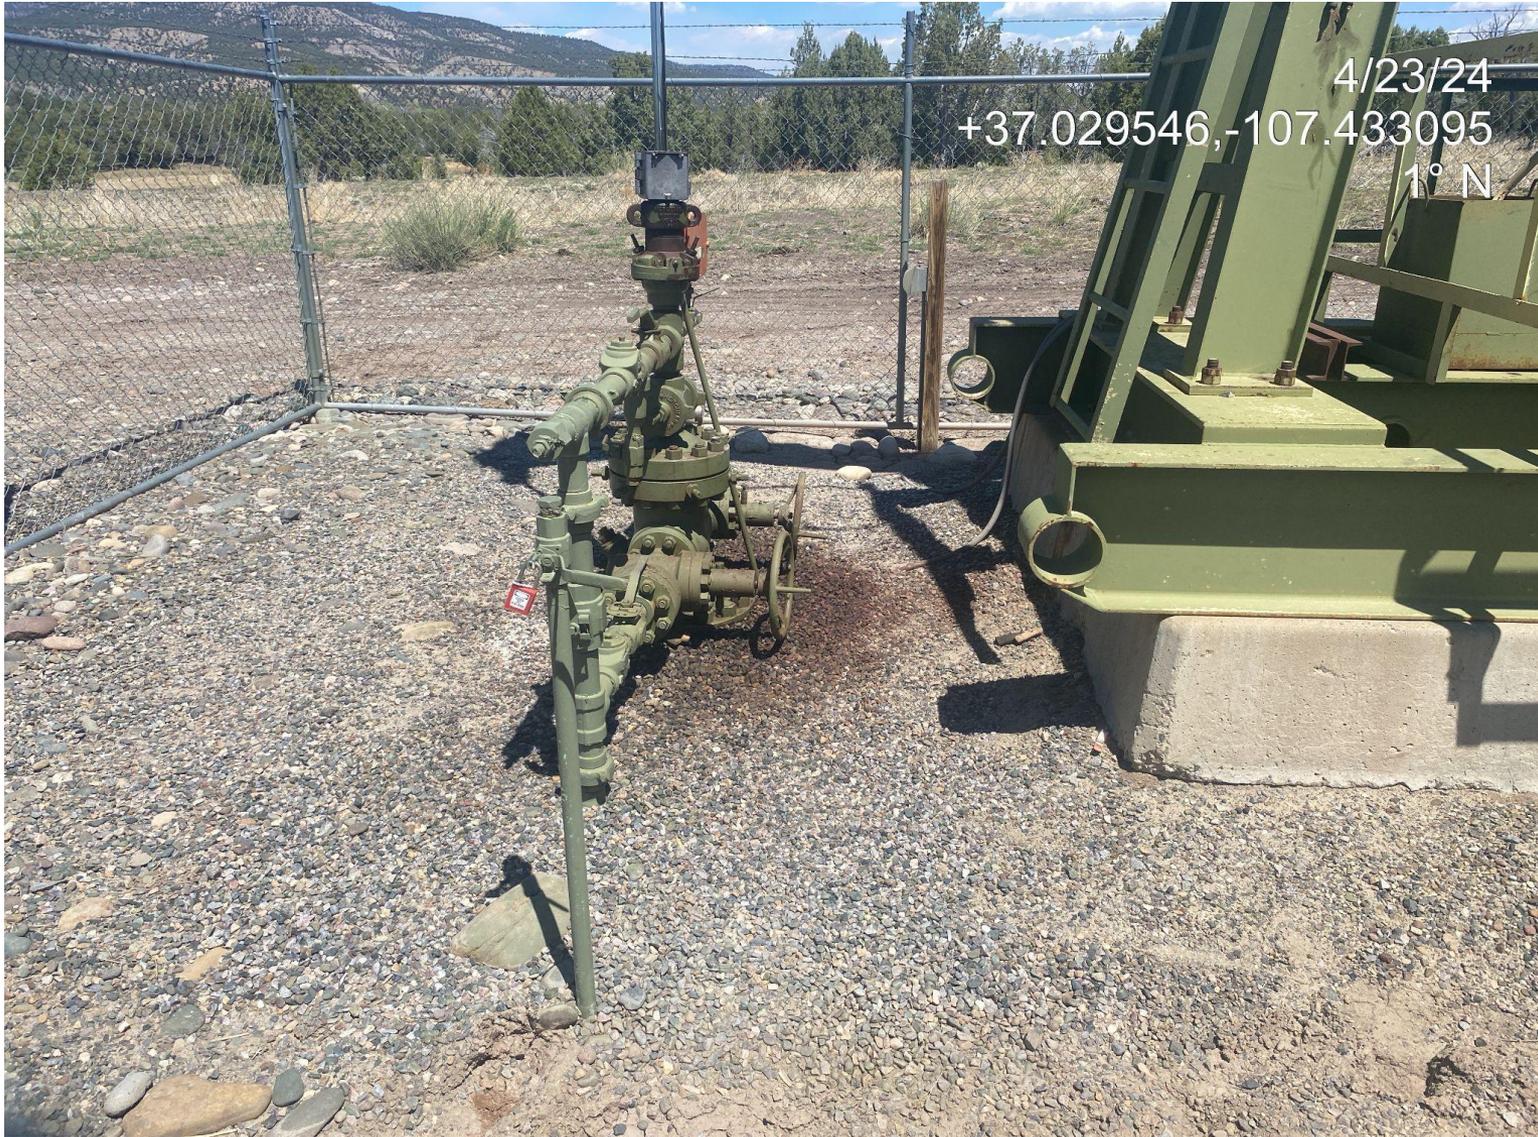
Photo 5. Impacted surface material observed at the well head.

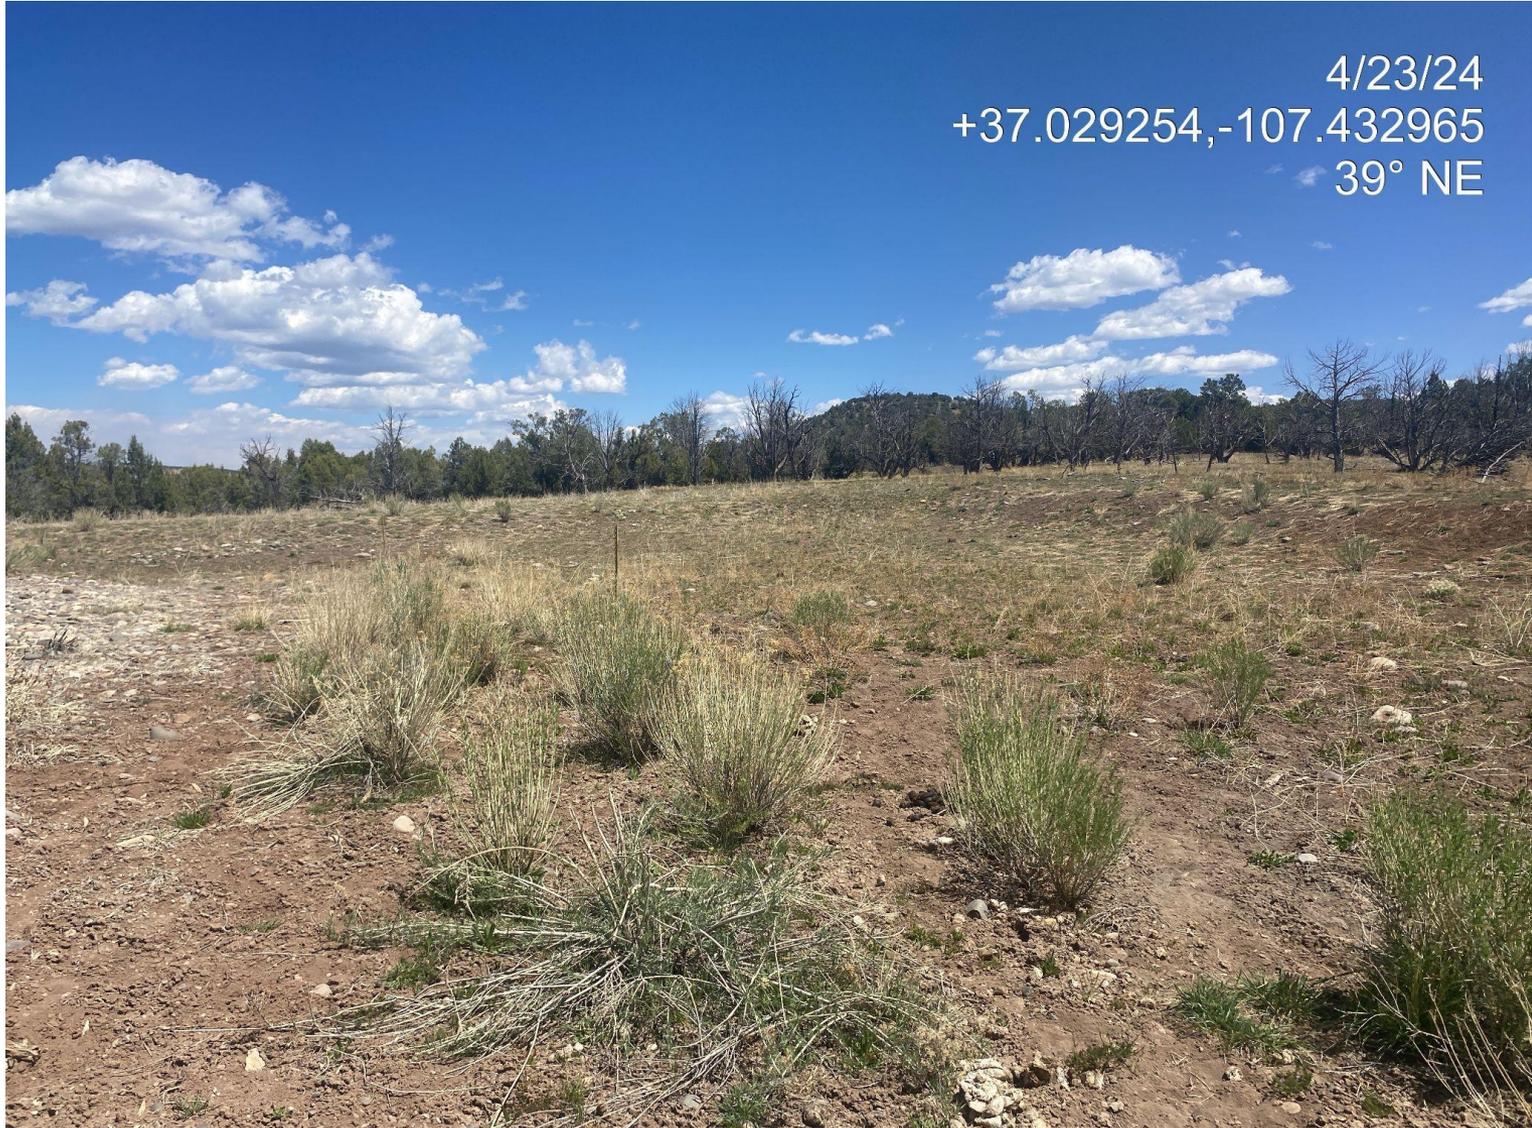
Photo 6. View of the northern interim reclamation area facing north east.
Vegetation comprised of smooth brome and rabbitbrush.

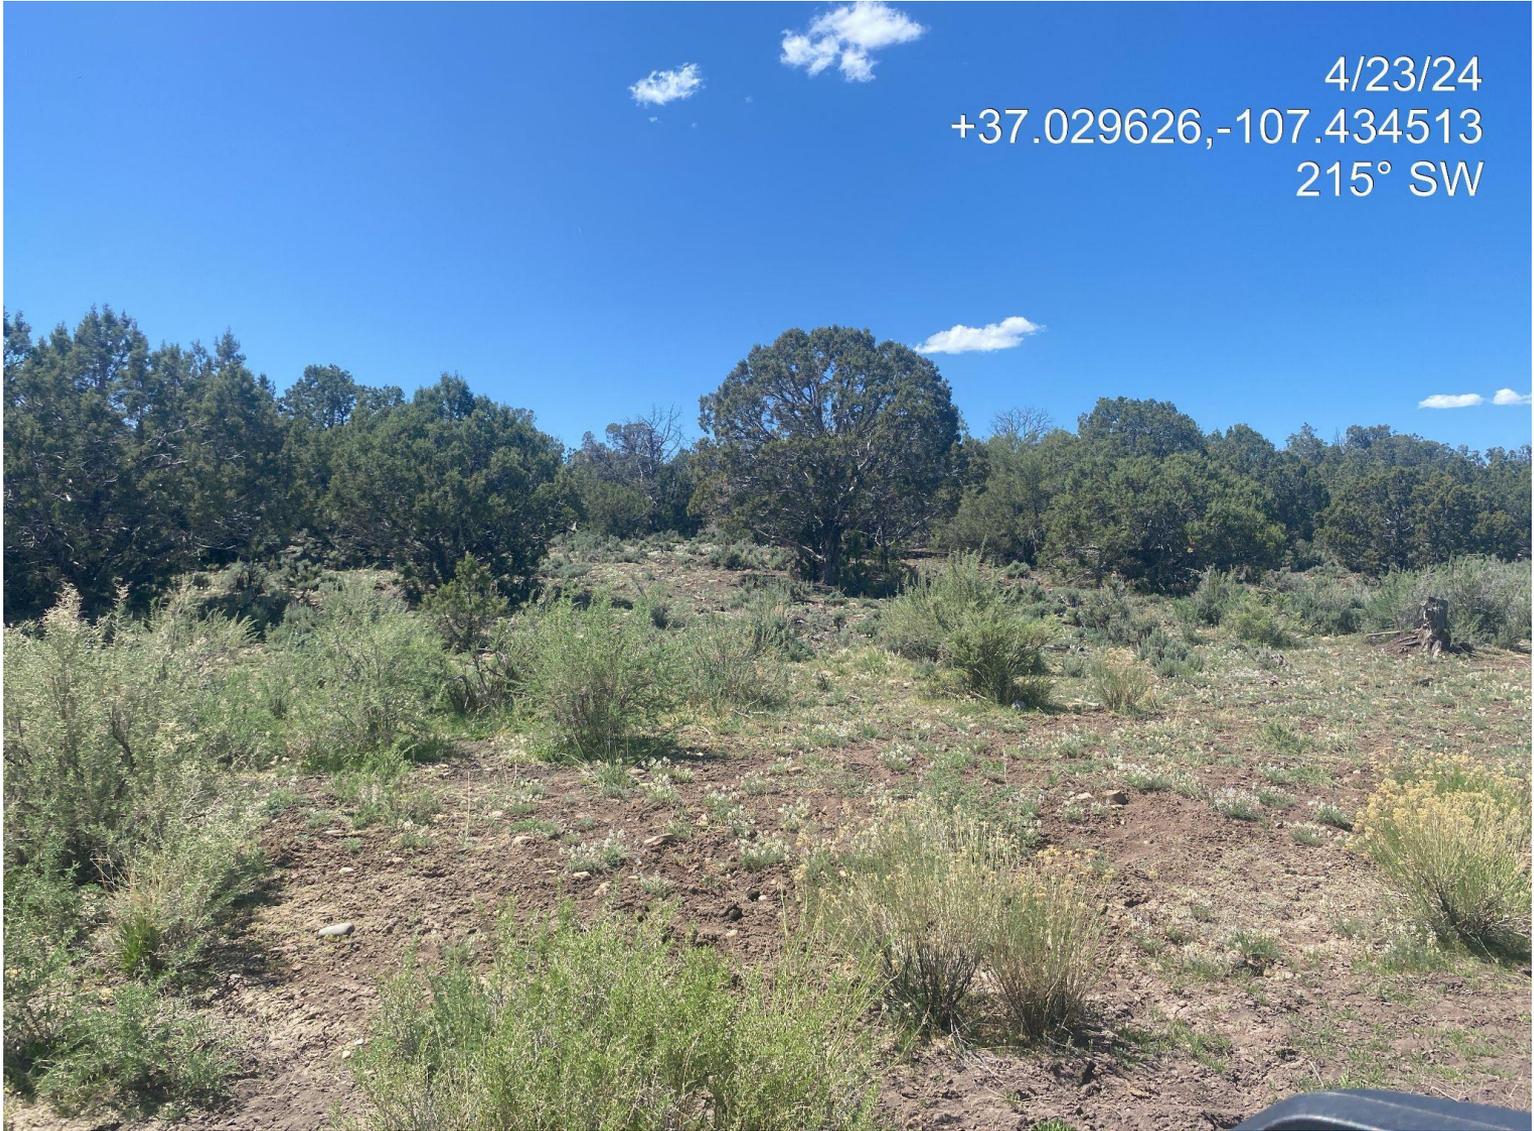
Photo 7. Reference area comprised of rabbitbrush, greasewood, sage brush and juniper.
