## Inspection Photos

Location Name: TEP Rocky Mountain LLC GIBSON GULCH UNIT 4-31 Pad

Location # 335290

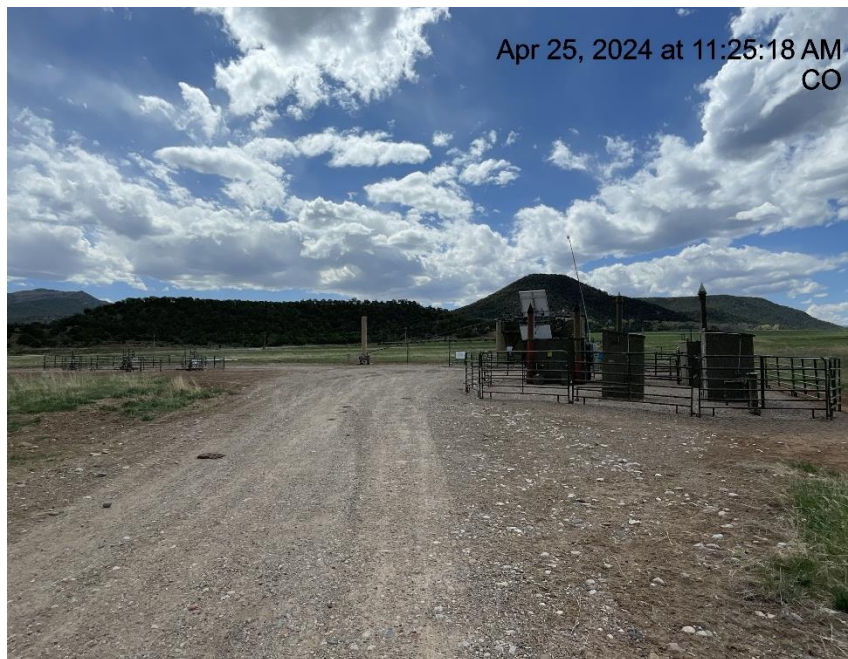
Photo # 4974 From entrance to location

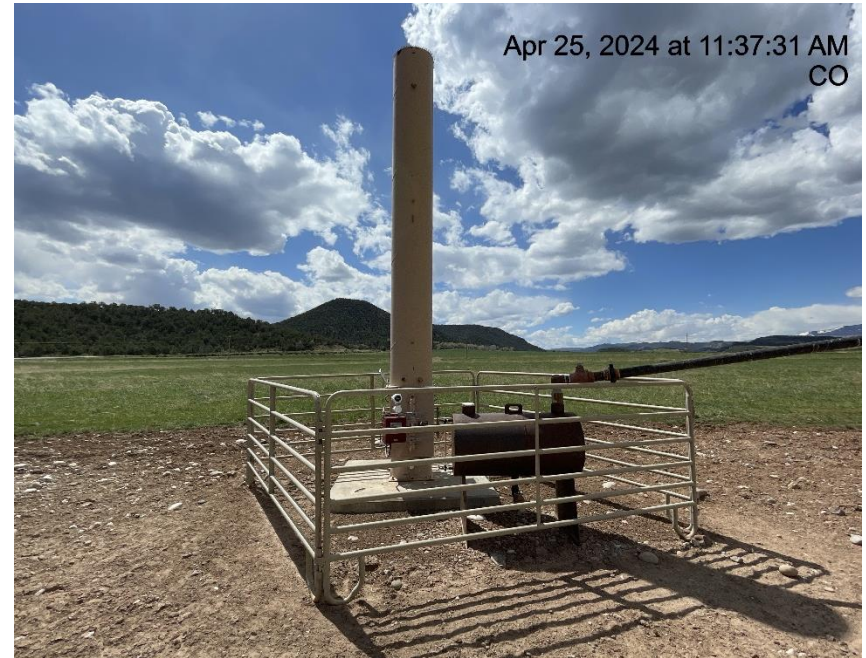
**Photo # 4981 Unused equipment – ECD is disconnected & not in use**

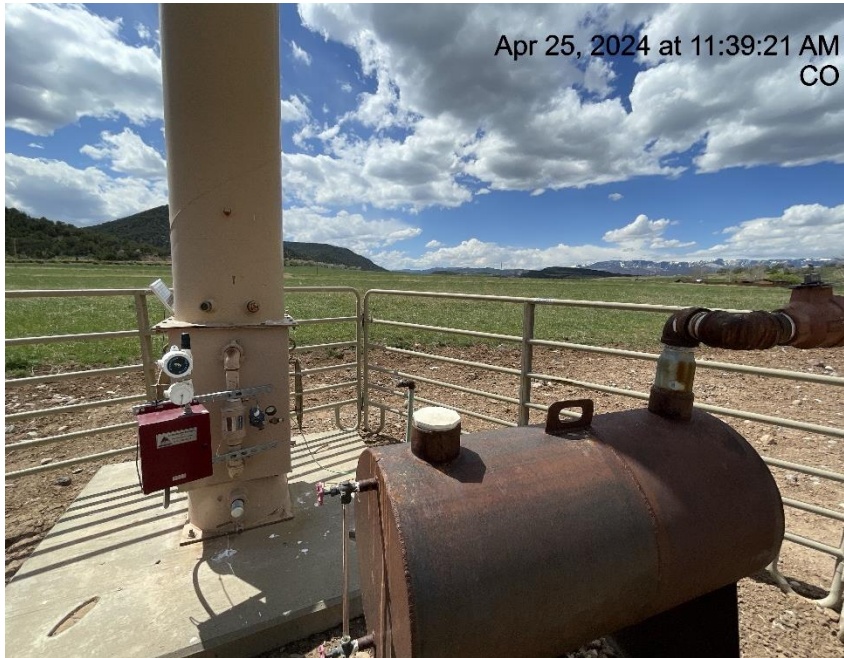
**Photo # 4982 Unused equipment – ECD is disconnected & not in use**

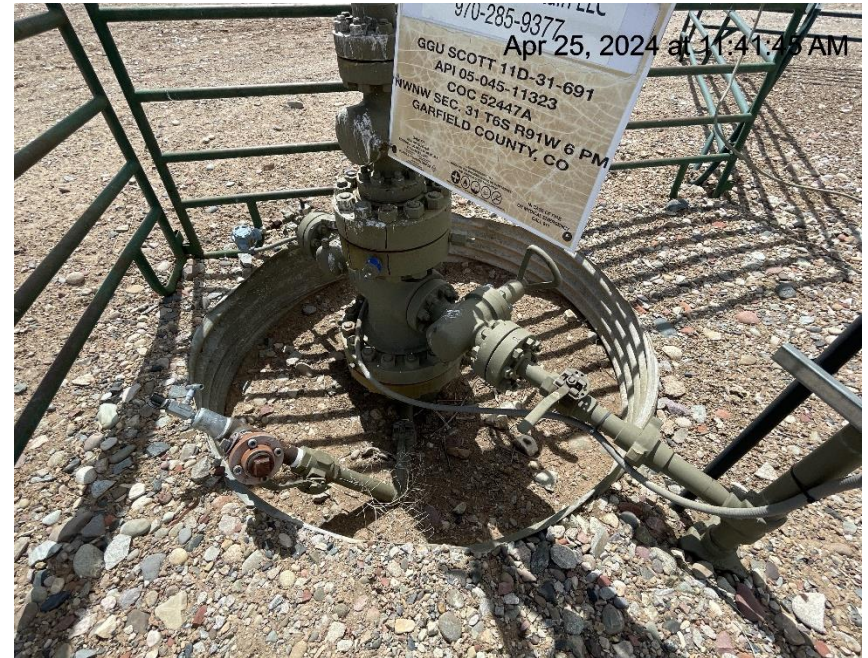
**Photo # 4983 Multiple cellars lack wildlife egress**

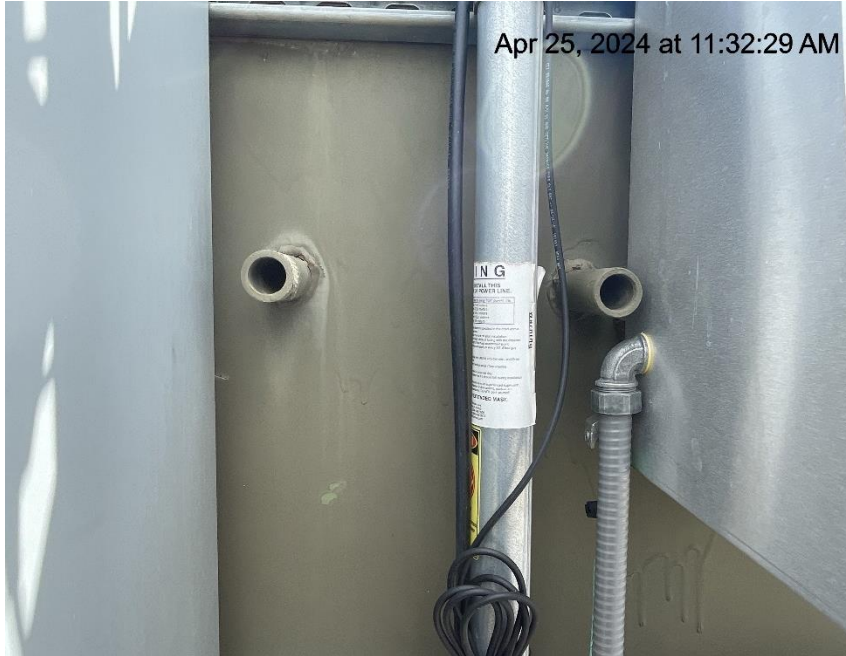
Apr 25, 2024 at 11:32:29 AM

**Photo # 4984 PRV & rupture disc vent lines terminate in an unsafe manner/do not comply with CECMC general safety rules & pressure safety device rules**

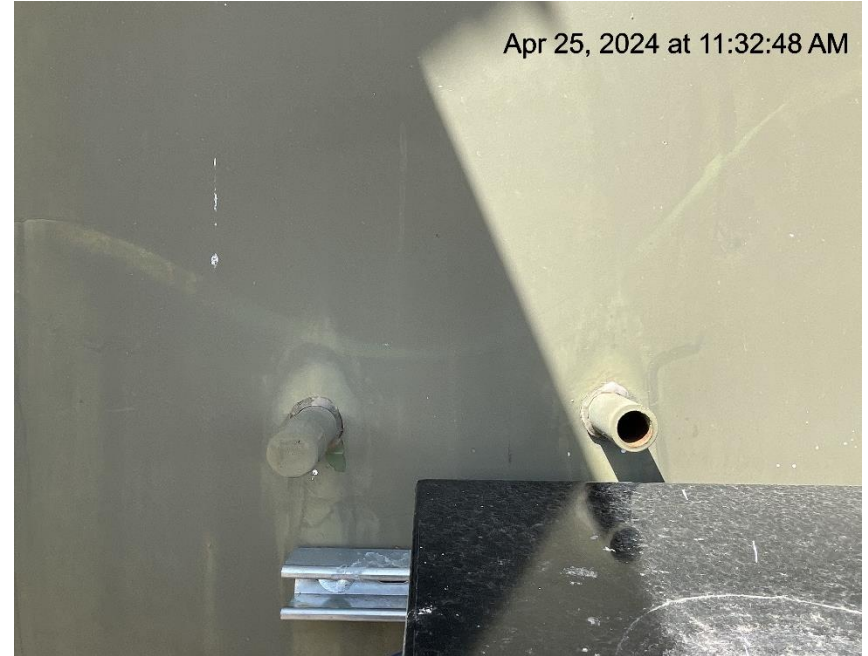
Apr 25, 2024 at 11:32:48 AM

**Photo # 4985 PRV & rupture disc vent lines terminate in an unsafe manner/do not comply with CECMC general safety rules & pressure safety device rules**

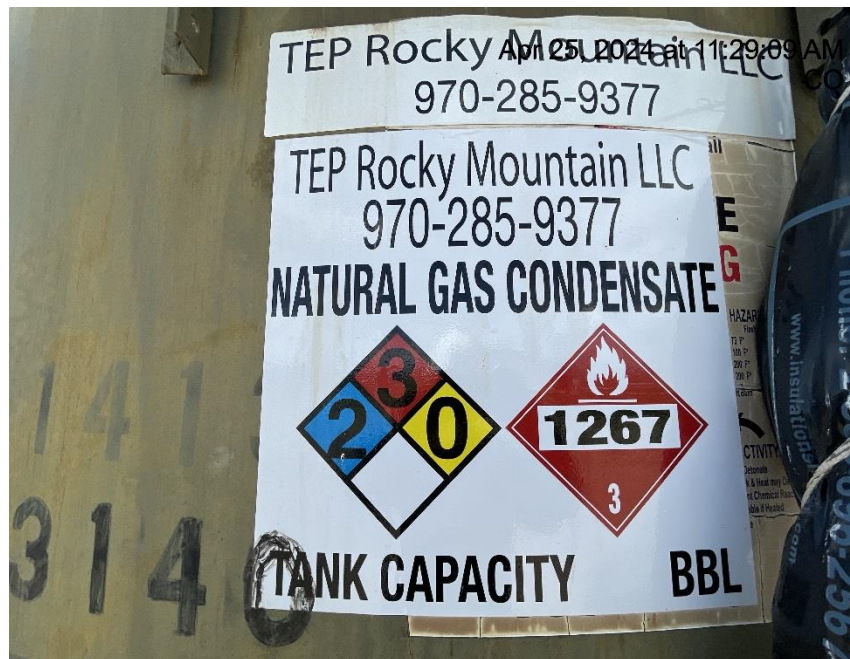
Photo # 4986 Tank label lacks required information
