Inspection Photos

Location Name: TEP Rocky Mountain LLC GIBSON GULCH UNIT 15-30 Pad

Location # 323980

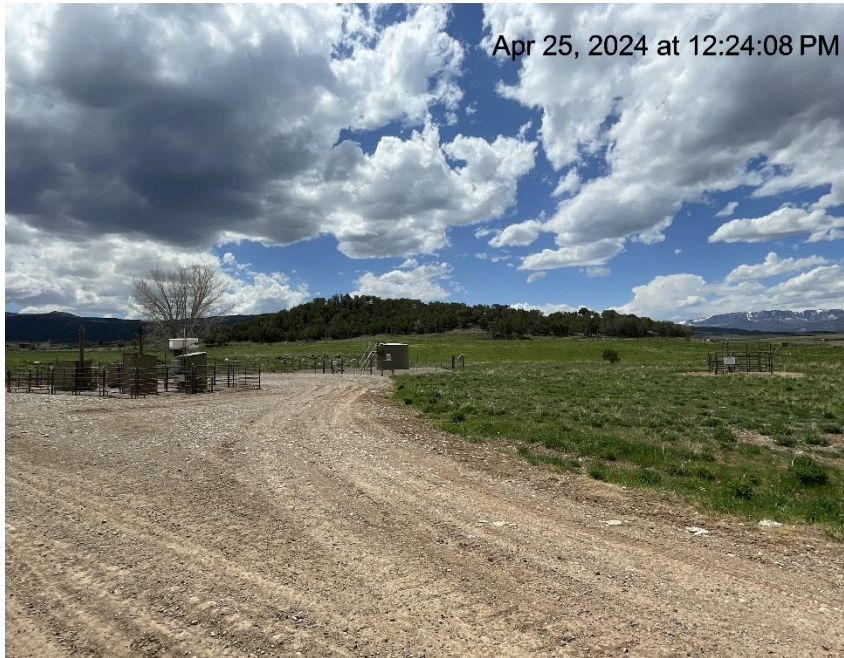
Photo # 5051 From entrance to location

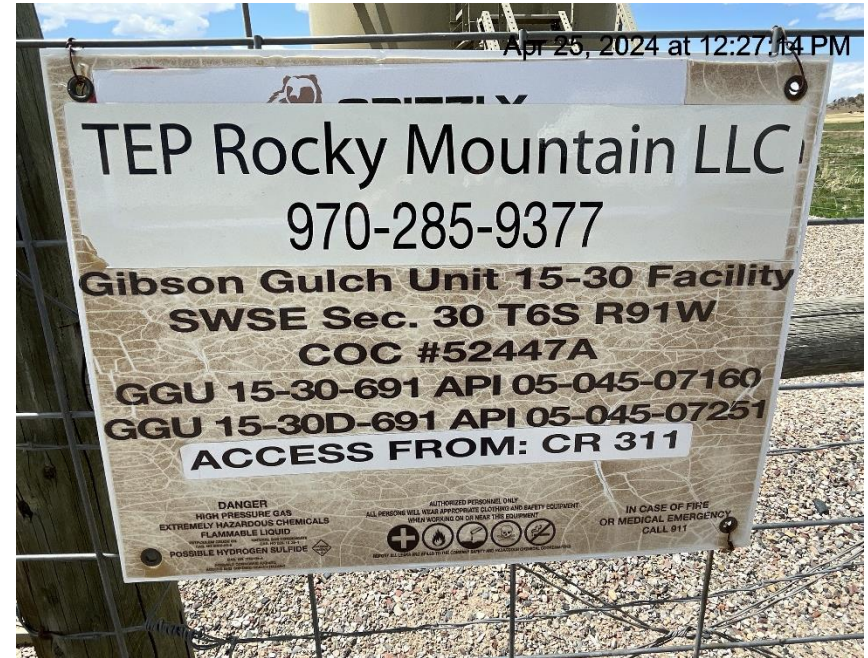
Photo # 5052 Location

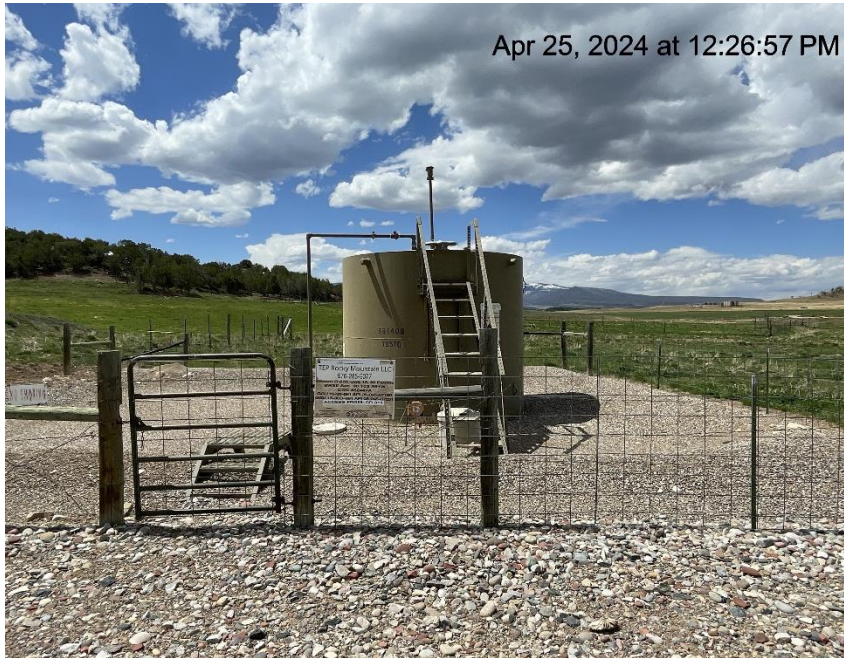
Photo # 5053 Location

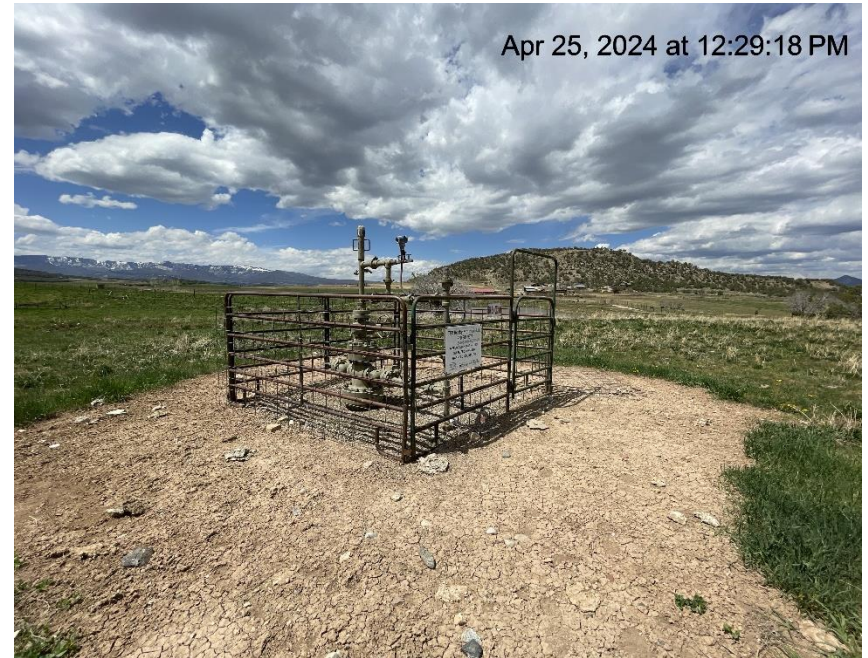
Photo # 5054 Location

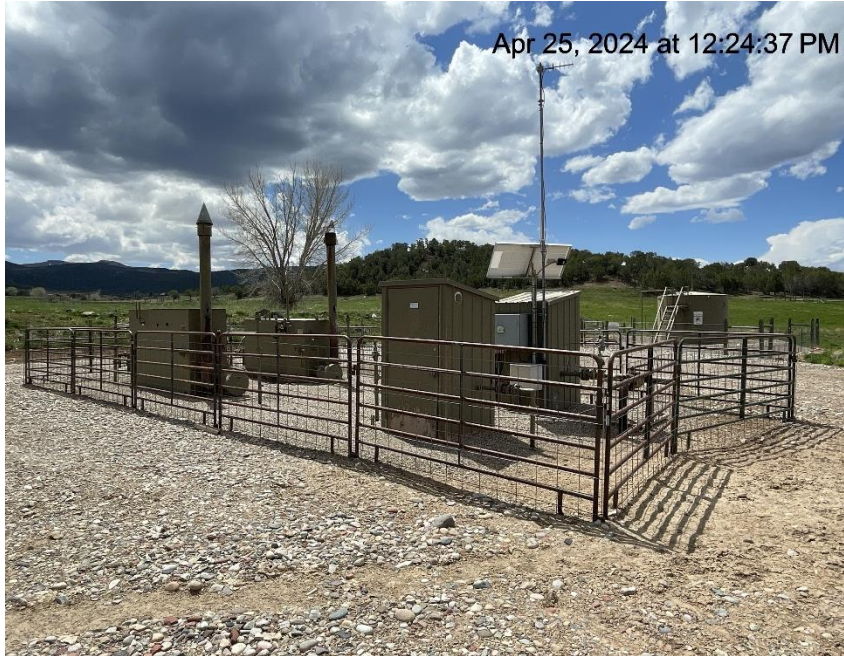
Photo # 5055 Location

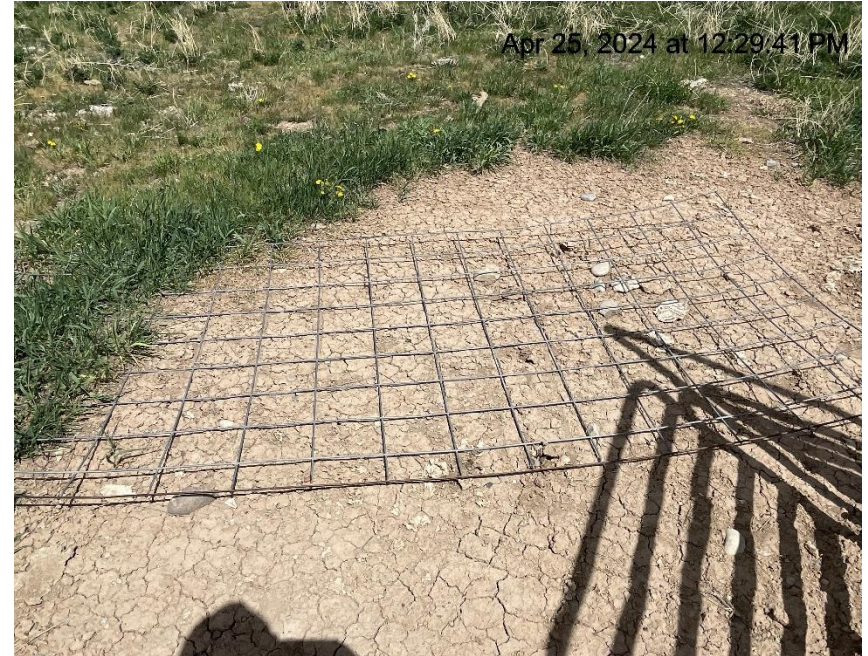
Photo # 5056 Debris

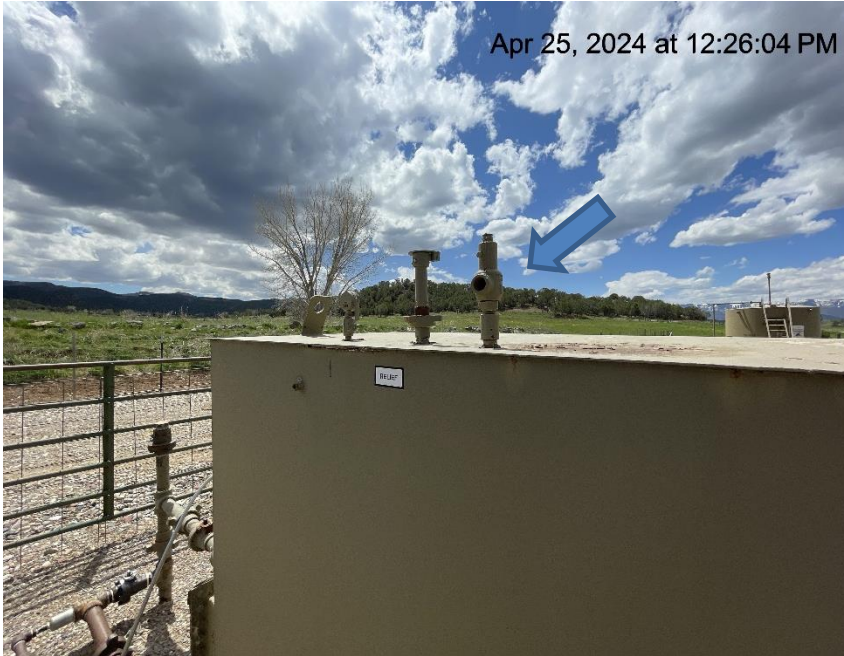
Photo # 5057 PRV terminates in an unsafe manner/does not comply with CECMC general safety rules & pressure safety device rules

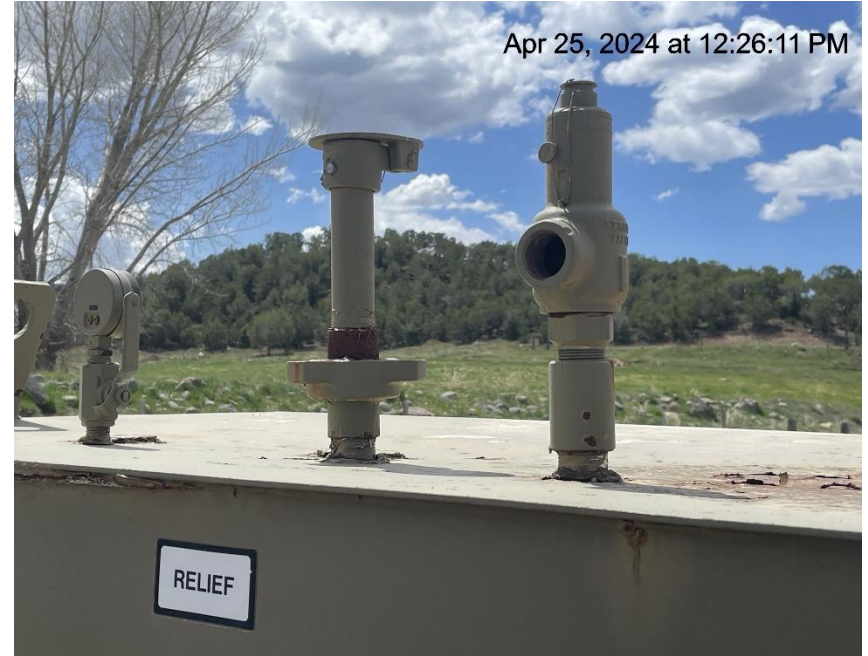
Photo # 5058 PRV terminates in an unsafe manner/does not comply with CECMC general safety rules & pressure safety device rules

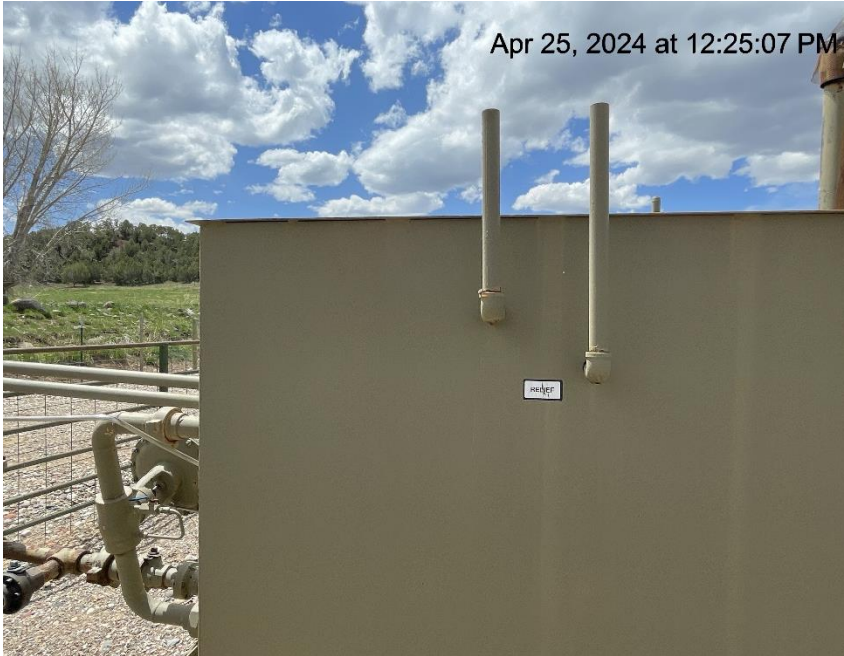
Photo # 5059 PRV & rupture disc vent lines do not comply with CECMC pressure safety device rules

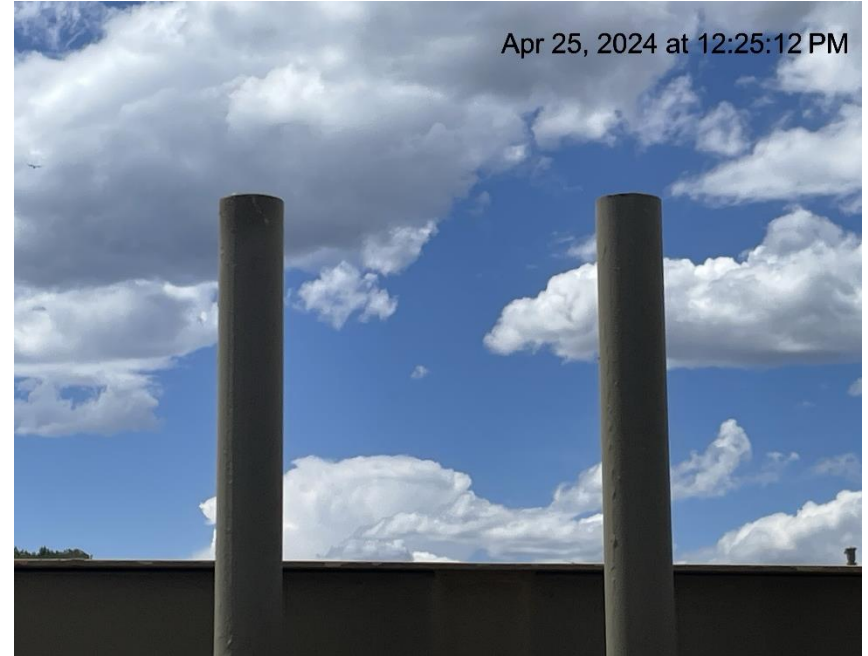
Photo # 5060 PRV & rupture disc vent lines do not comply with CECMC pressure safety device rules
