Inspection Photos
Location Name: TEP Rocky Mountain LLC DEVER A Pad
Location # 311676

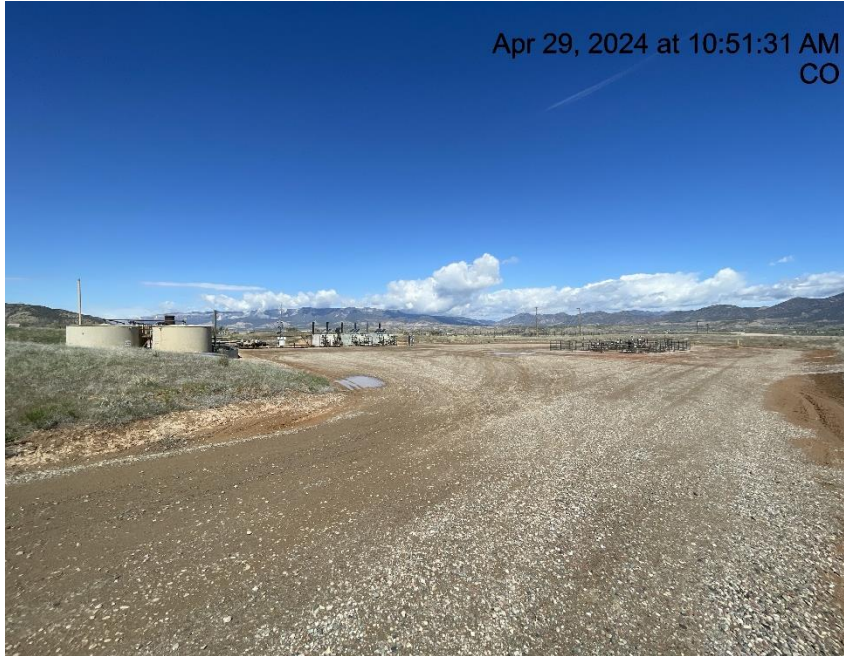
Photo # 5227 From entrance to location

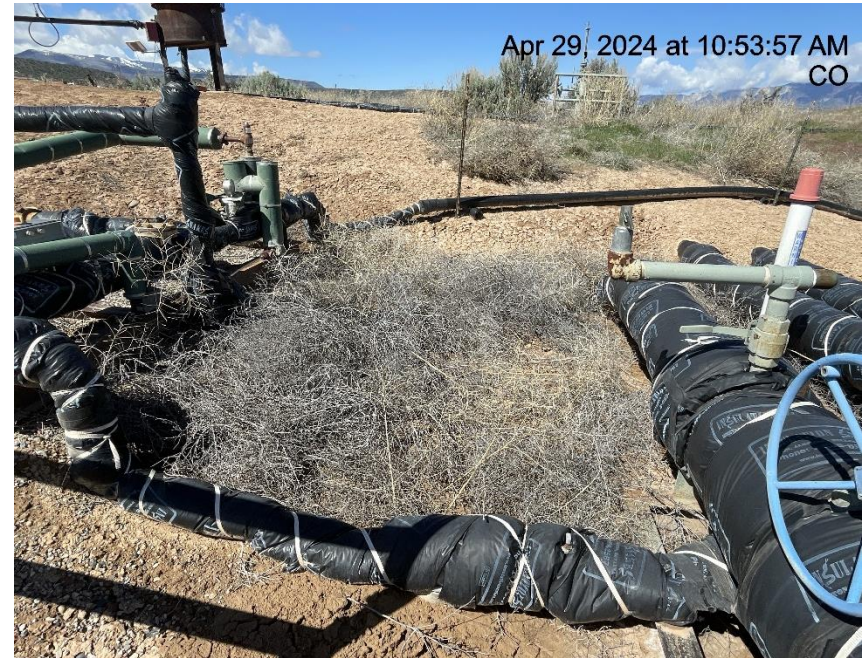
Photo # 5234 Debris

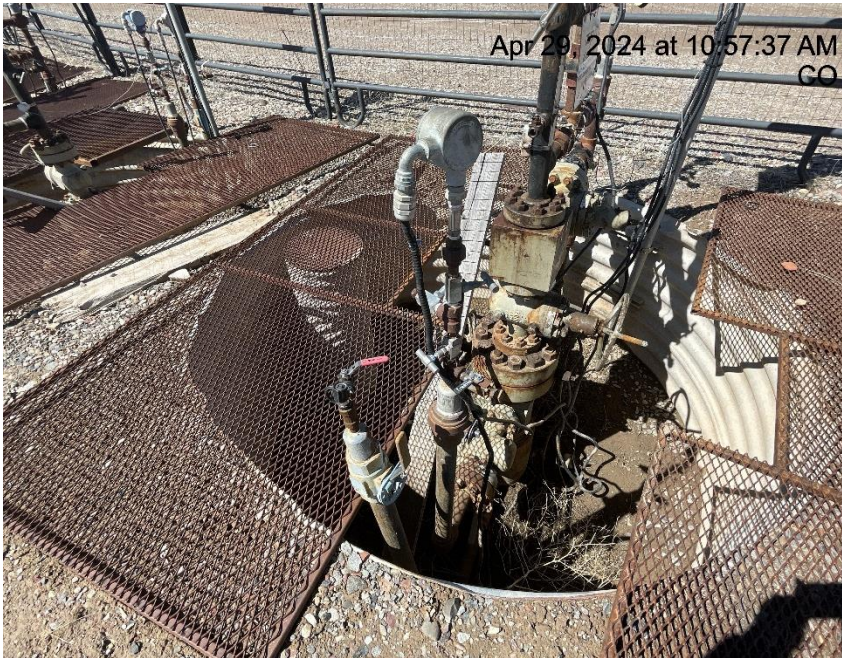
Photo # 5235 Cellar not properly covered/wildlife & personnel hazard

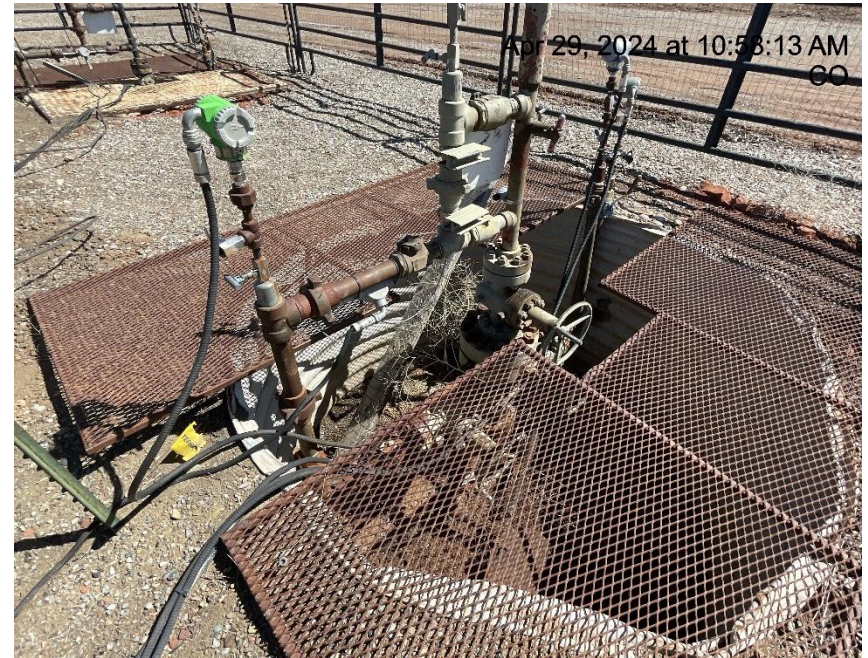
Photo # 5236 Cellar not properly covered/wildlife & personnel hazard

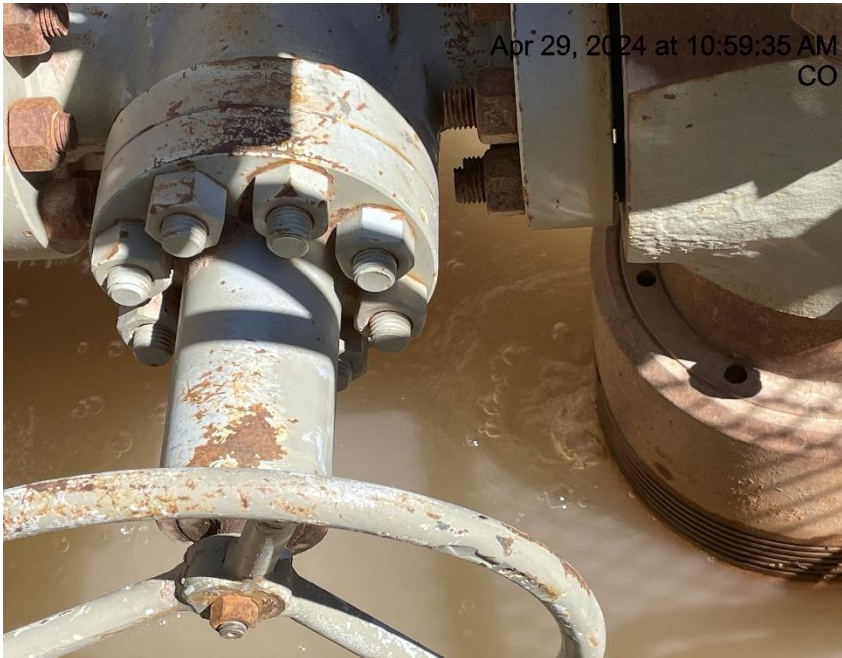
Photo # 5237 Possible wellhead leak/gas bubbling up around wellhead through water in cellar

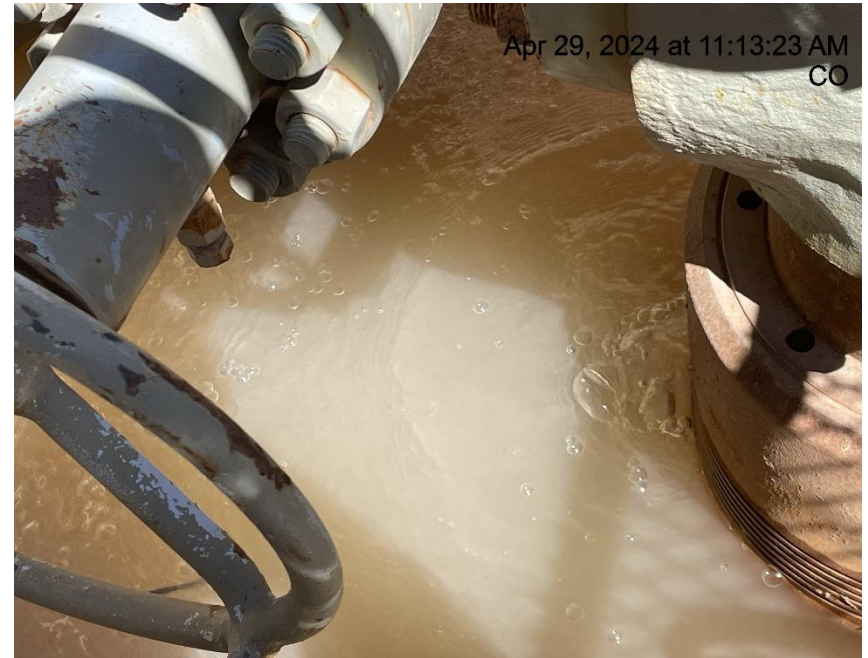
Photo # 5238 Possible wellhead leak/gas bubbling up around wellhead through water in cellar

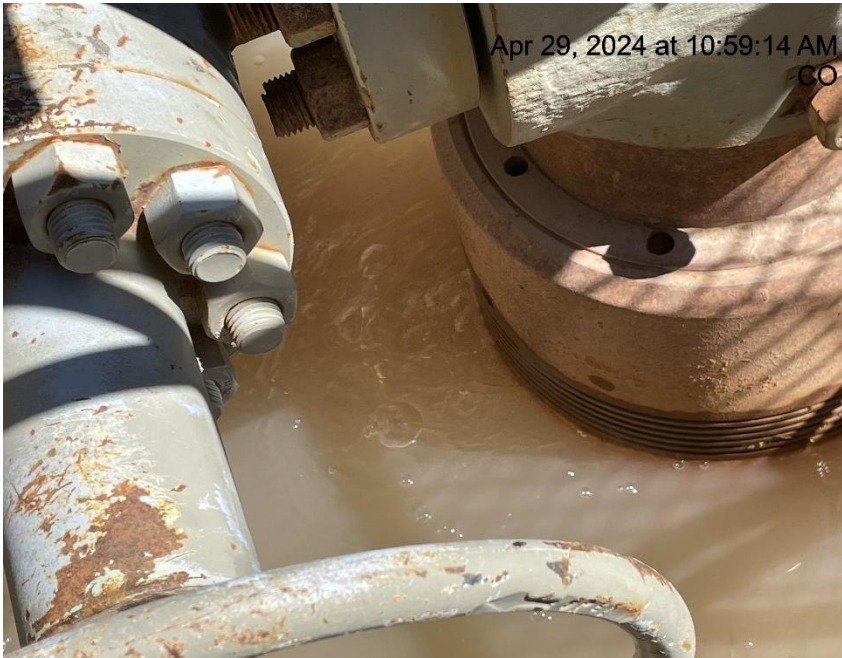
Photo # 5239 Possible wellhead leak/gas bubbling up around wellhead through water in cellar

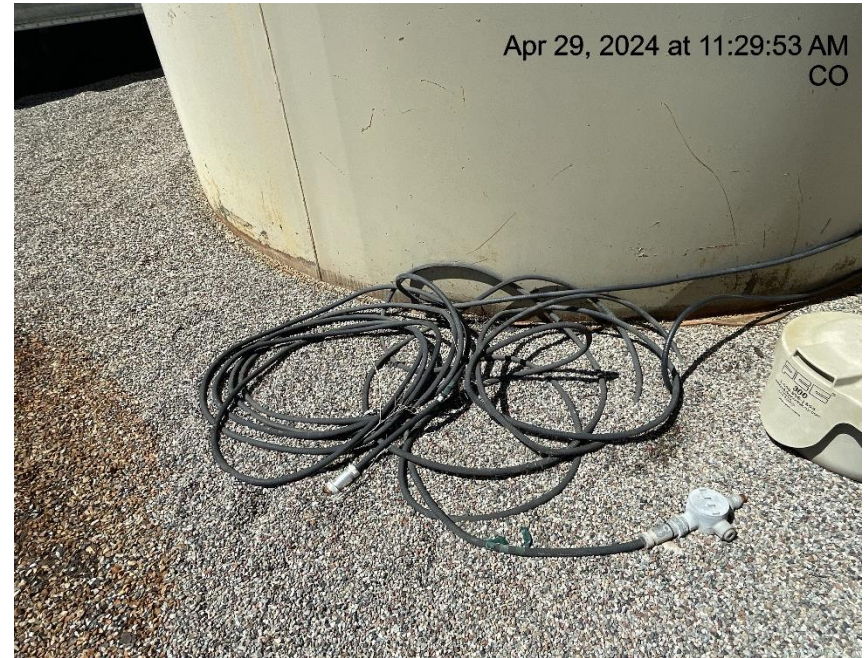
Photo # 5240 Debris

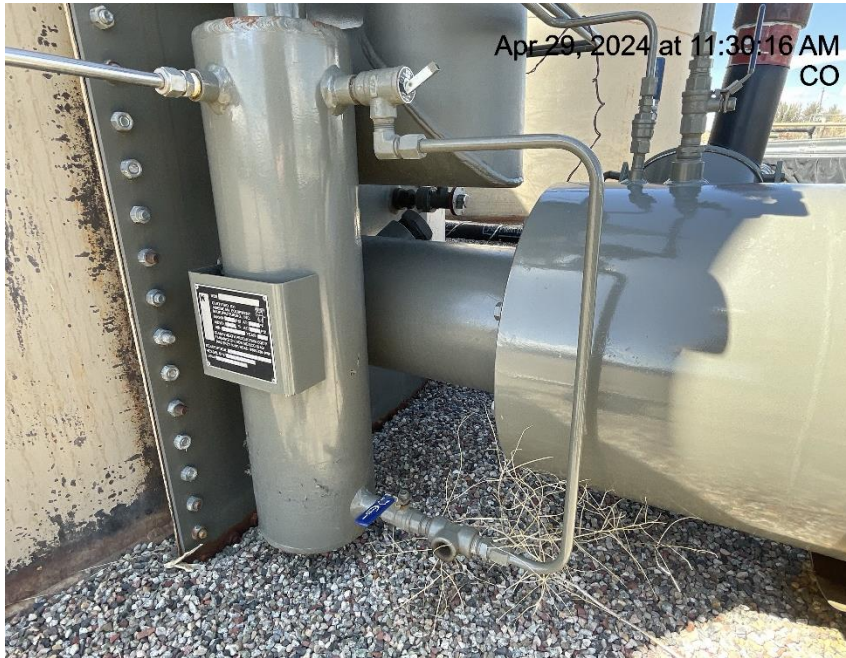
Photo # 5241 PRV vent line terminates in an unsafe manner /does not comply with CECMC pressure safety device rules & general safety rules

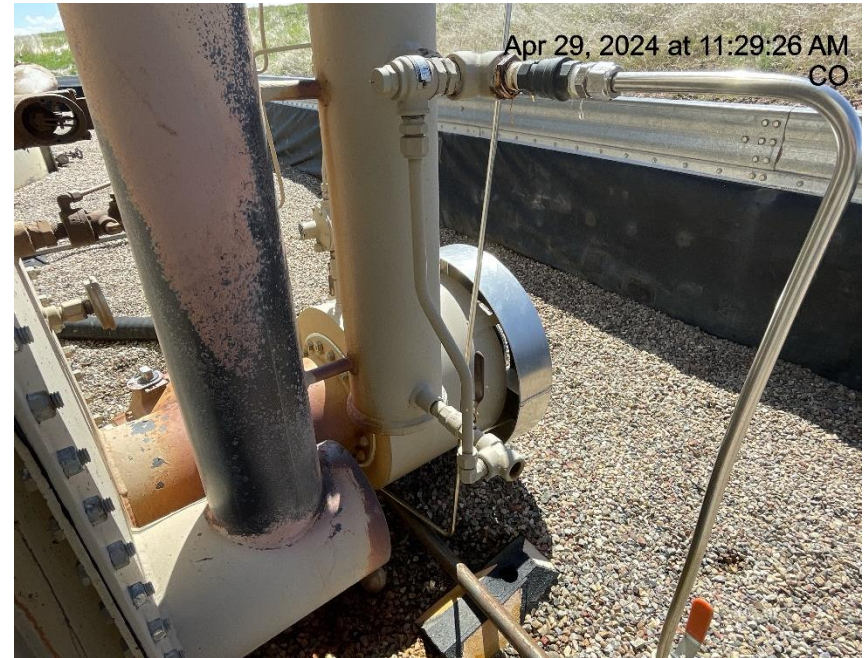
Photo # 5242 PRV vent line terminates in an unsafe manner /does not comply with CECMC pressure safety device rules & general safety rules

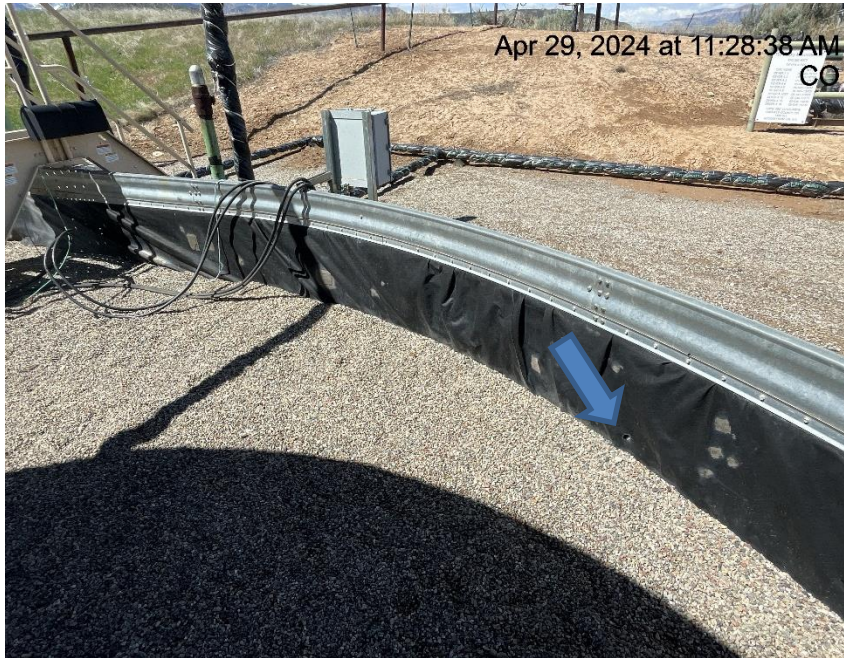
Photo # 5243 Hole in liner/liner needs maintenance

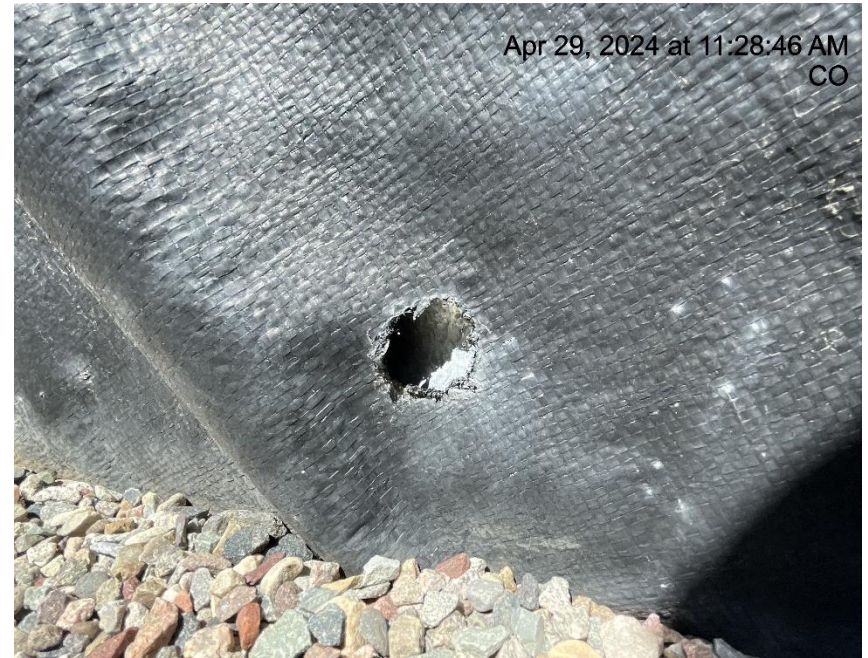
Photo # 5244 Hole in liner/liner needs maintenance
