## Inspection Photos

Location Name: CAERUS PICEANCE LLC TWIN CREEK 1-10C2 (01EB) Pad

Location ID: 416887

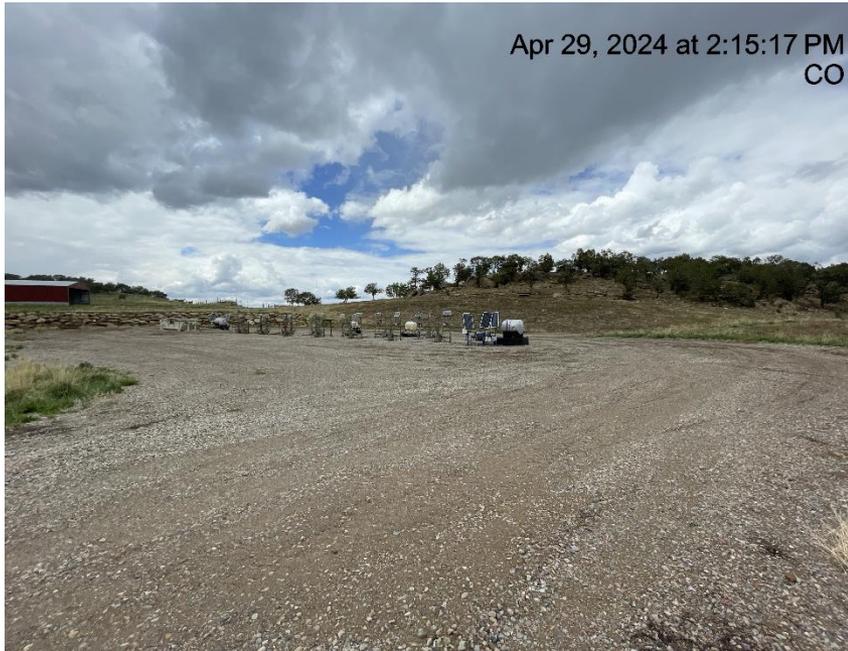
Photo # 5437 From entrance to location

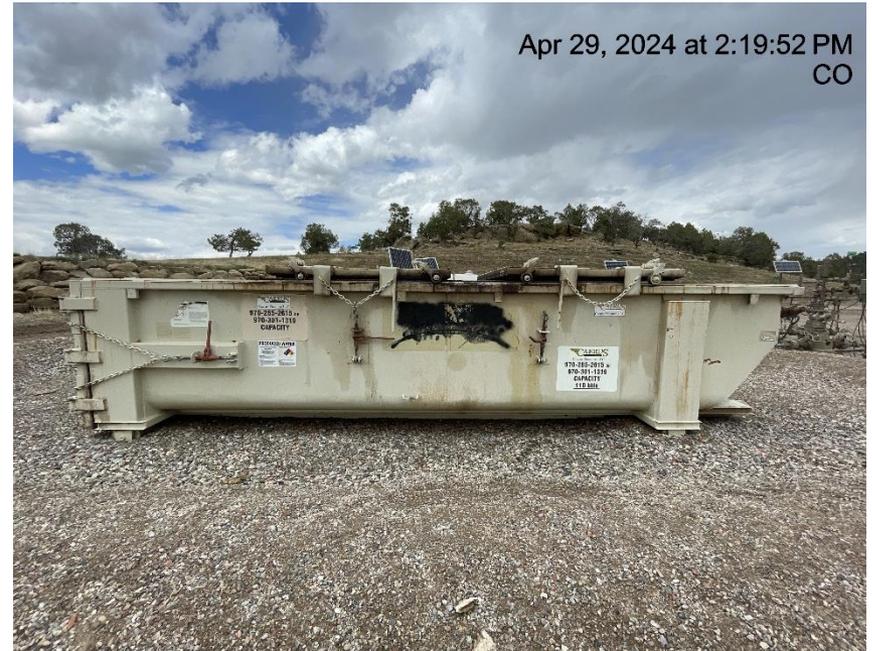
Photo # 5438 Location

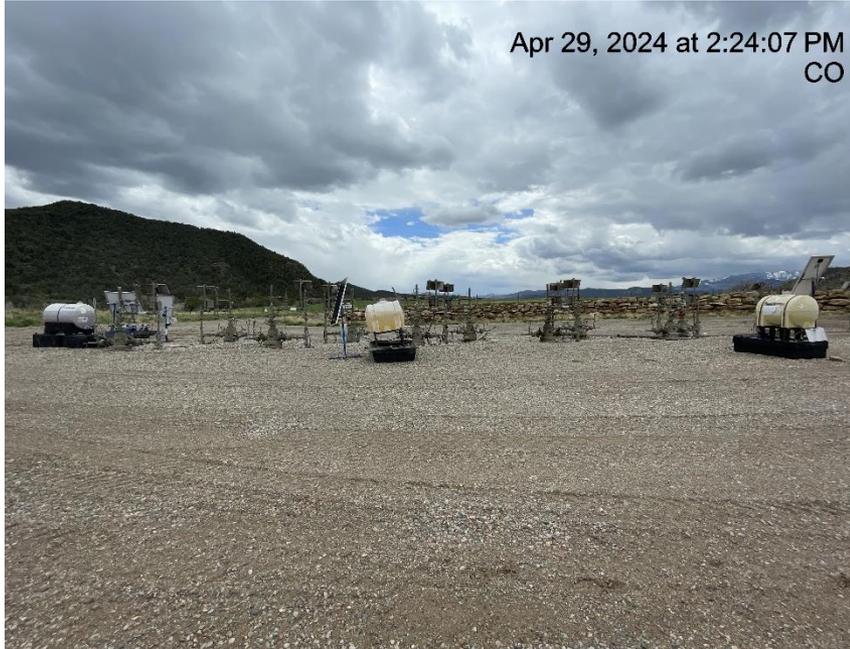
Photo # 5439 Location

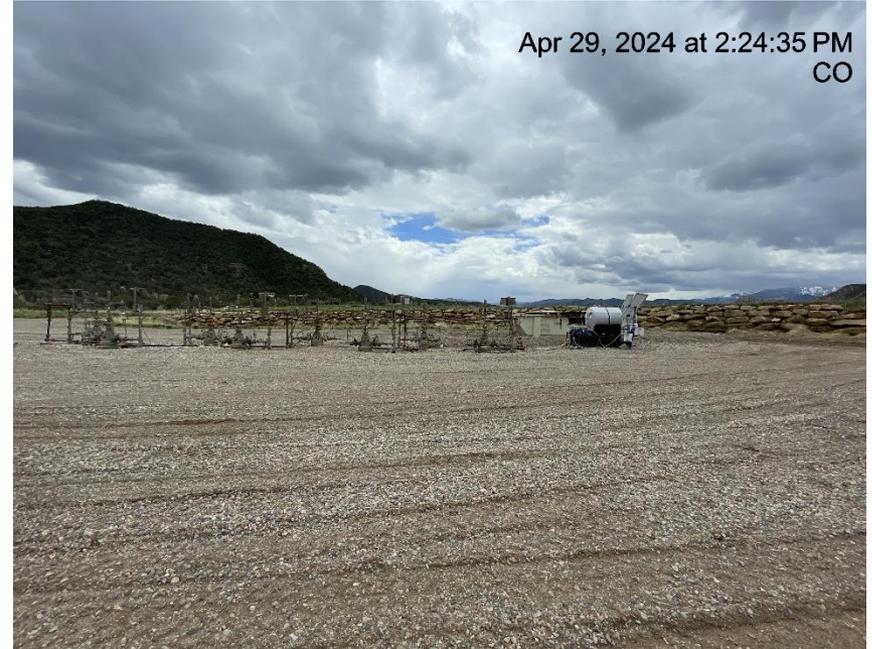
Photo # 5440 Location

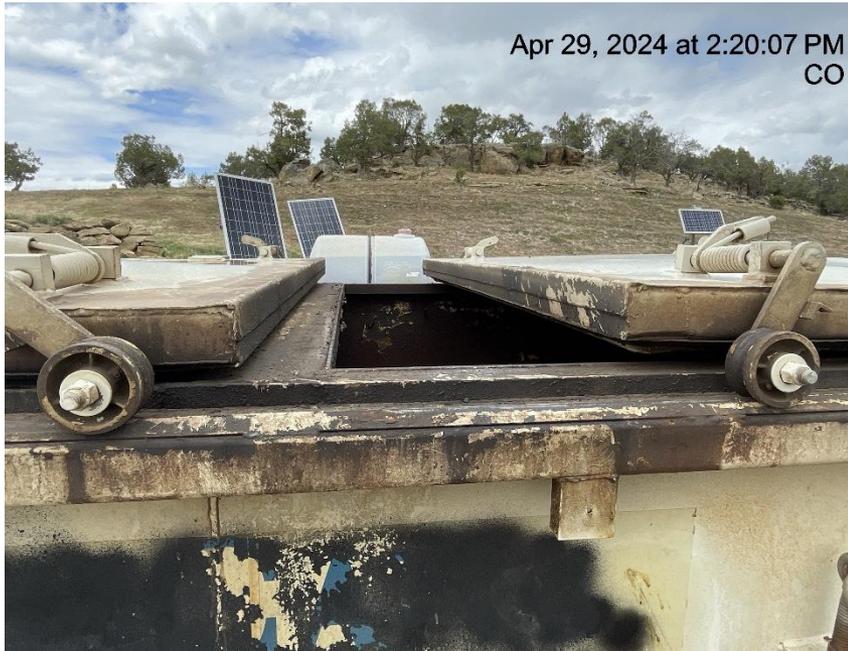
**Photo # 5441 Tank is partially open & available for entry by wildlife/wildlife hazard**

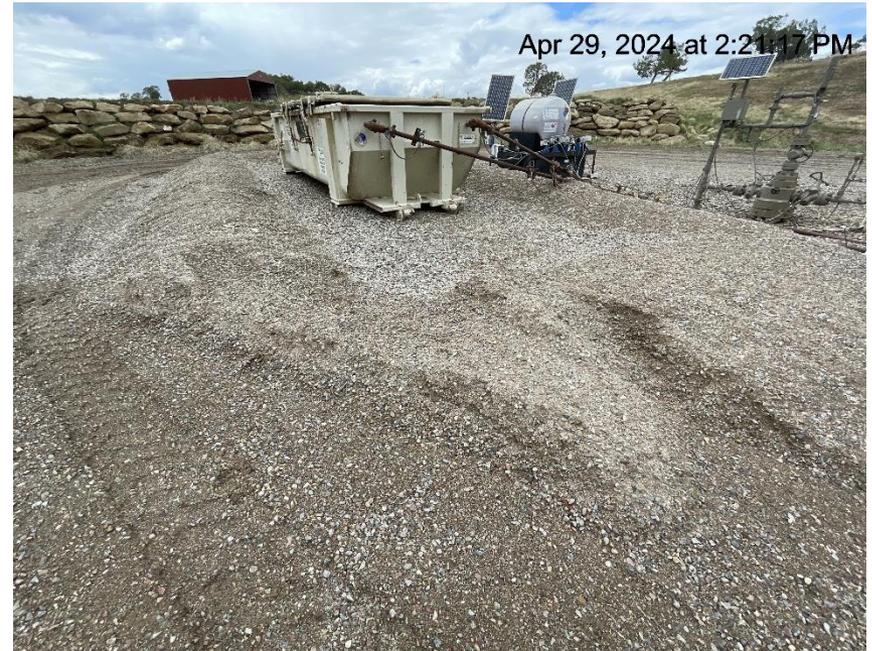
**Photo # 5442 Earthen secondary containment damaged /does not comply with CECMC secondary containment rules**

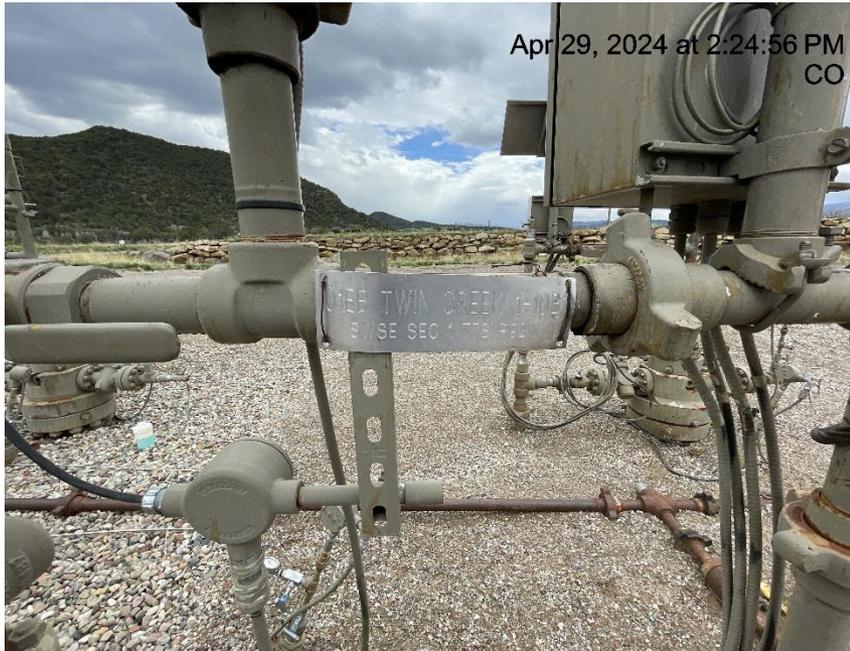
Photo # 5443 Wellhead sign lacks required info

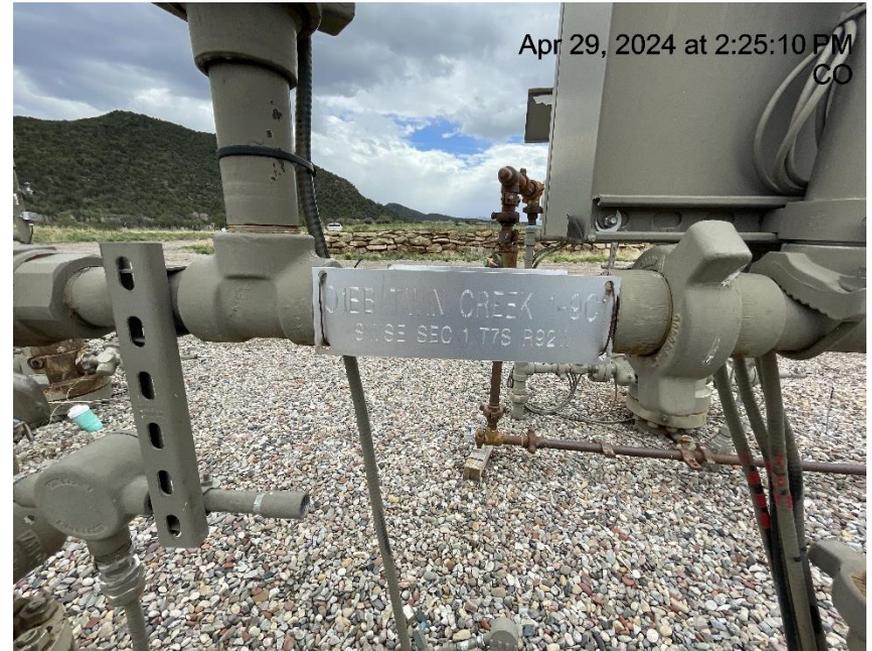
Photo # 5444 Wellhead sign lacks required info

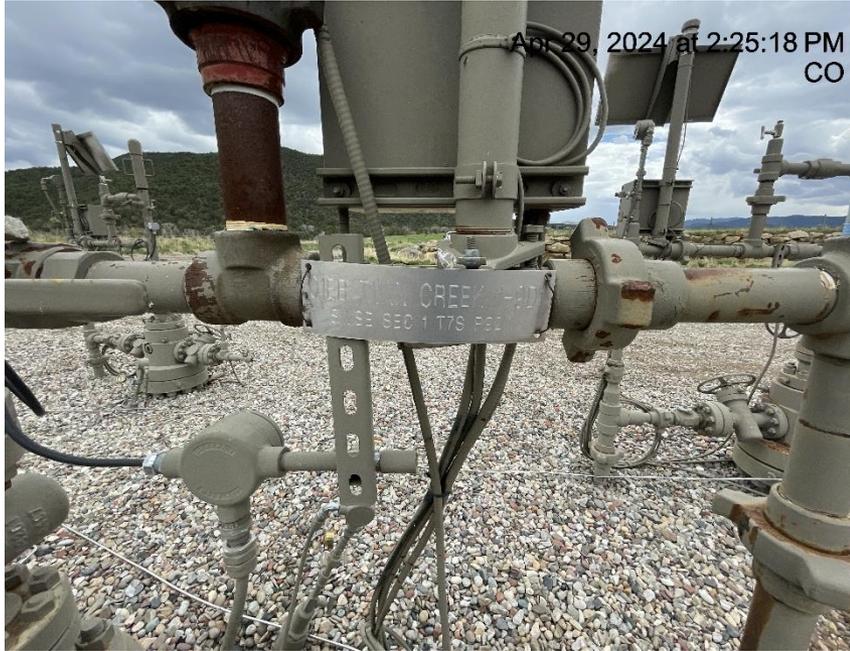
Photo # 5445 Wellhead sign lacks required info

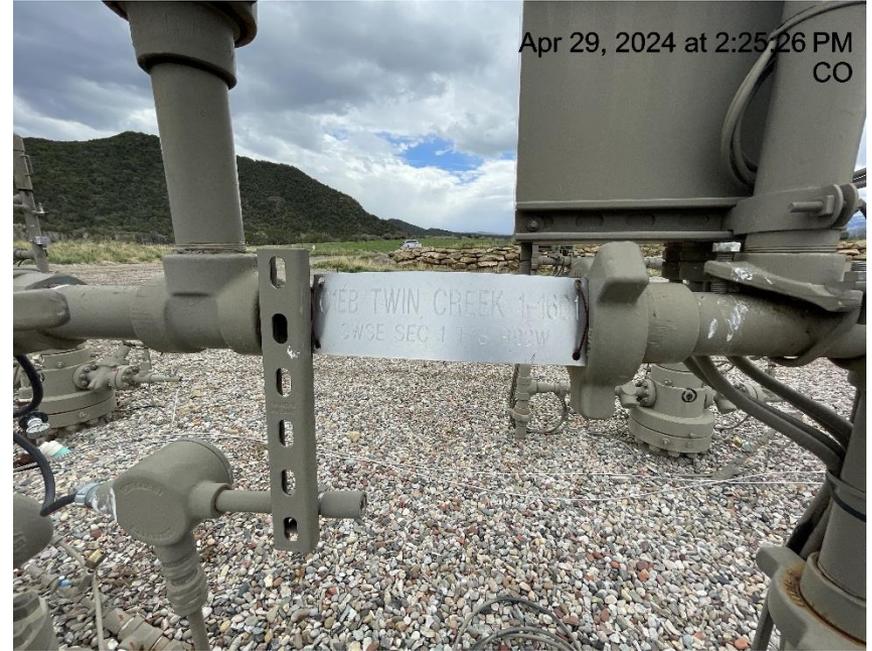
Photo # 5446 Wellhead sign lacks required info

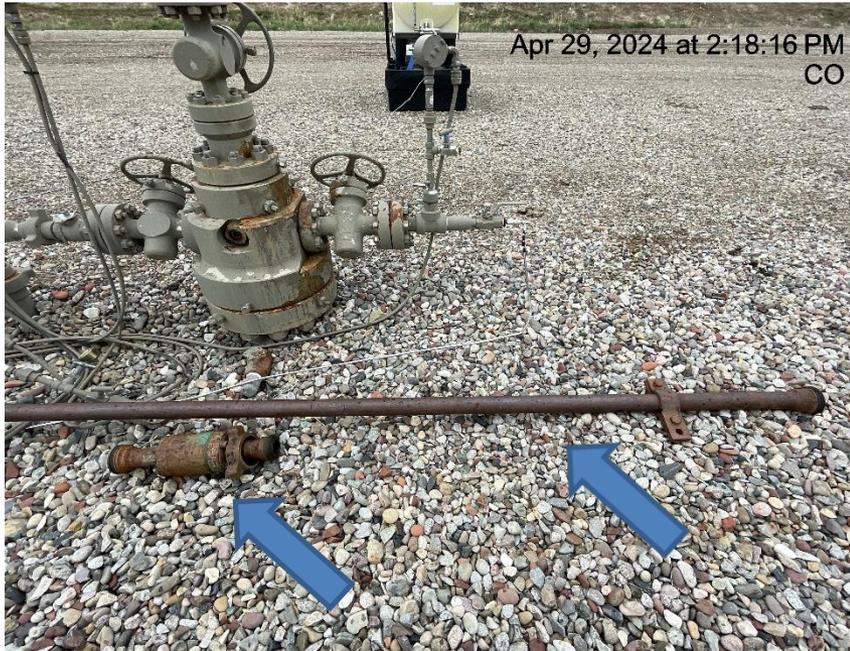
Photo # 5447 Debris
