Inspection Photos

API: 017-07523

Operator: ANADARKO E&P ONSHORE LLC

Inspection Date: 4/1/2024

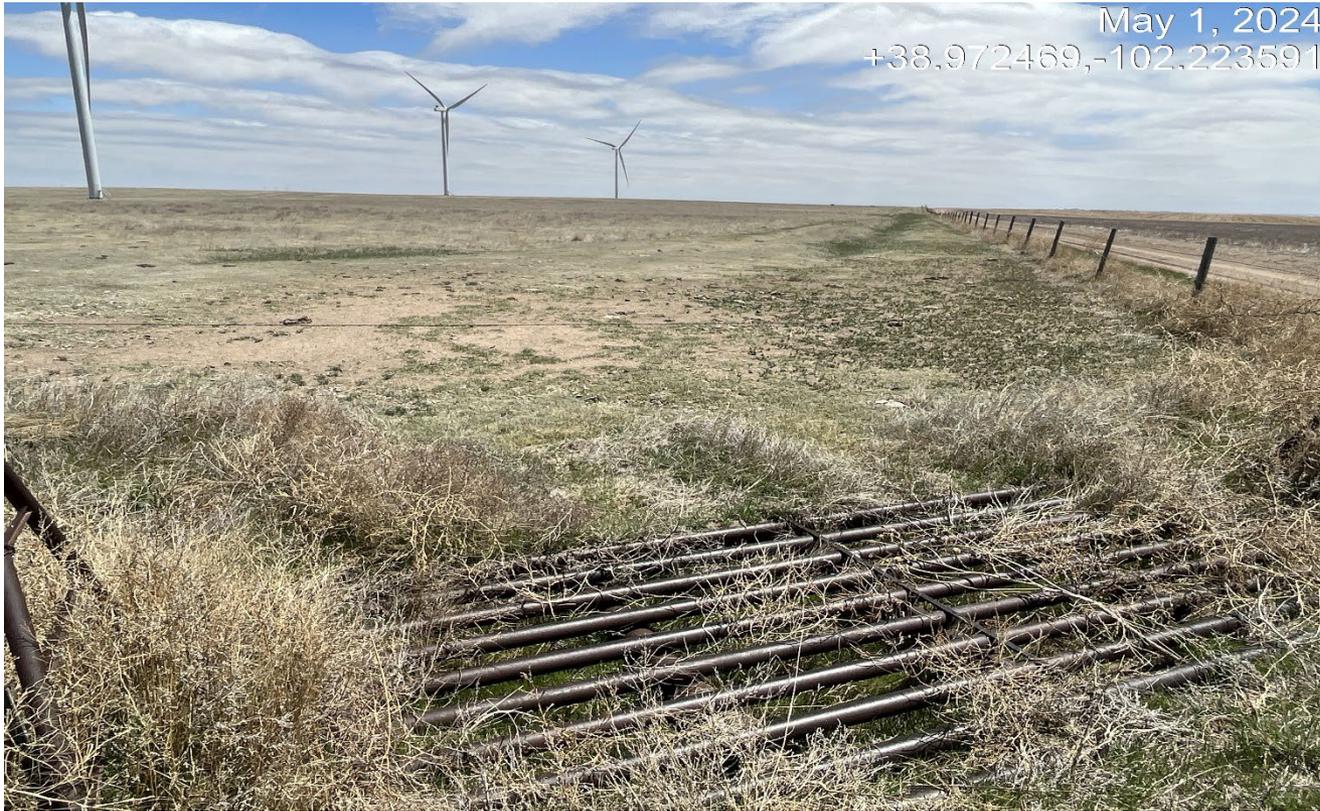
Photo 1. Facing east at the beginning of the access road. The cattleguard has not been removed..

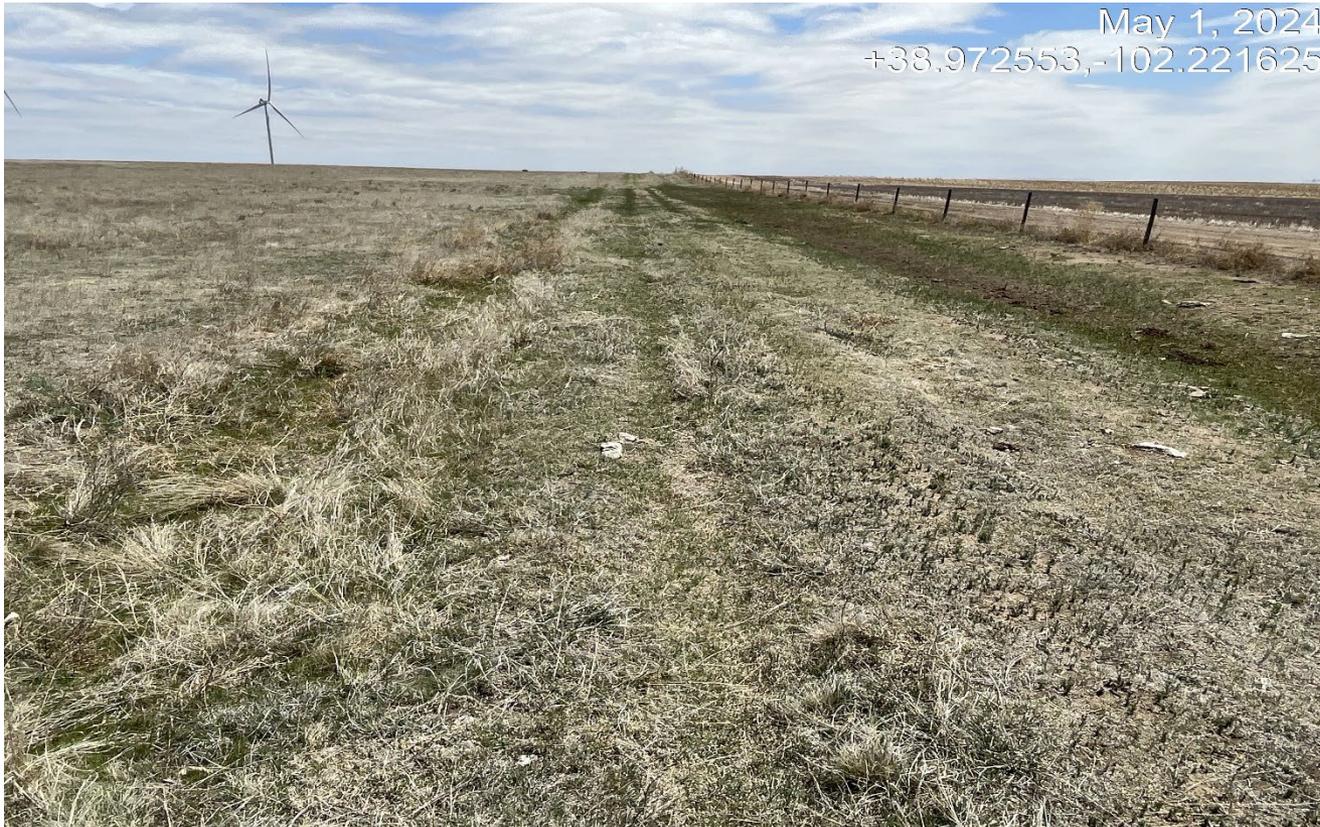
Photo 2. Facing east along the access road. The road was never recontoured. Native vegetation has re-established along the road.

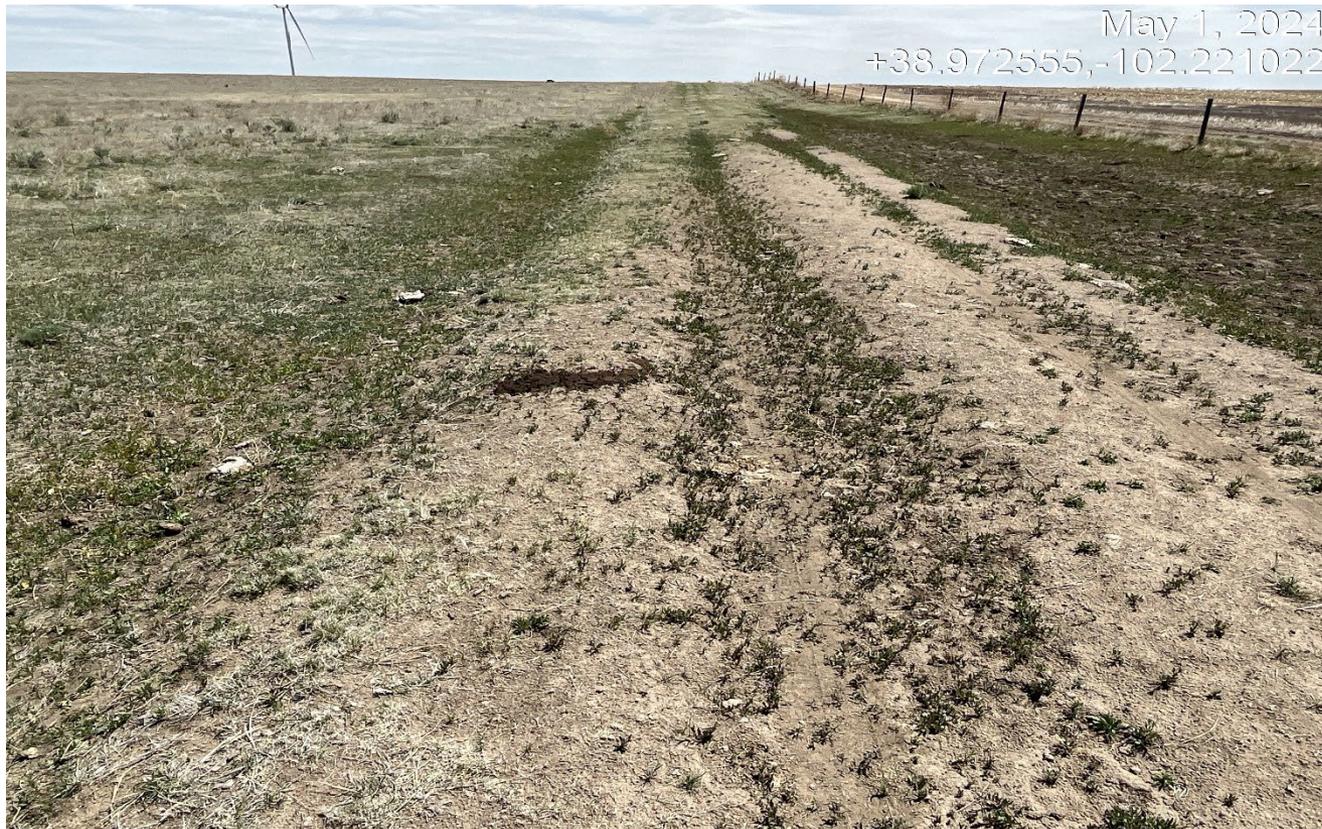
Photo 3. Facing east along the access road. The road was never recontoured.

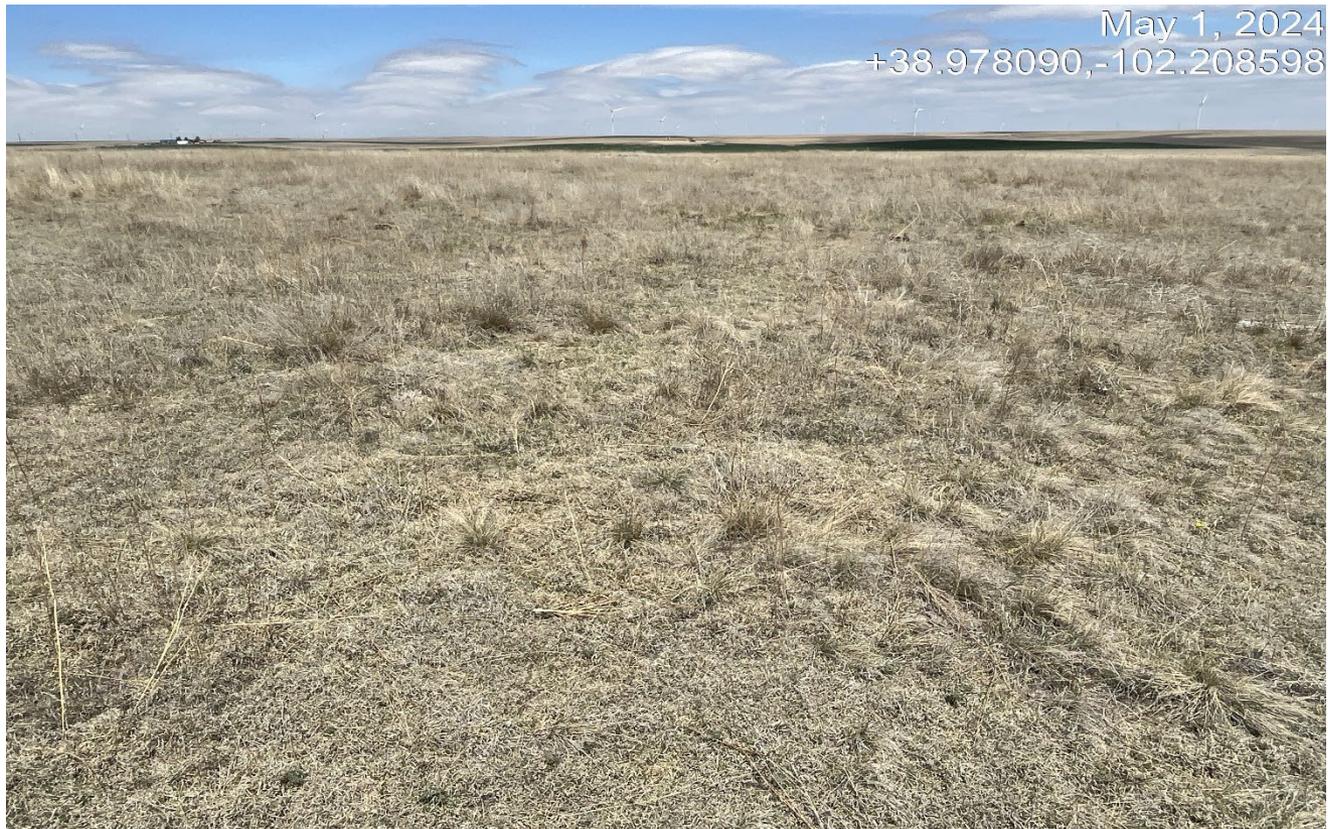
Photo 4. Facing north at the location. The perennial vegetation has fully established throughout the location.

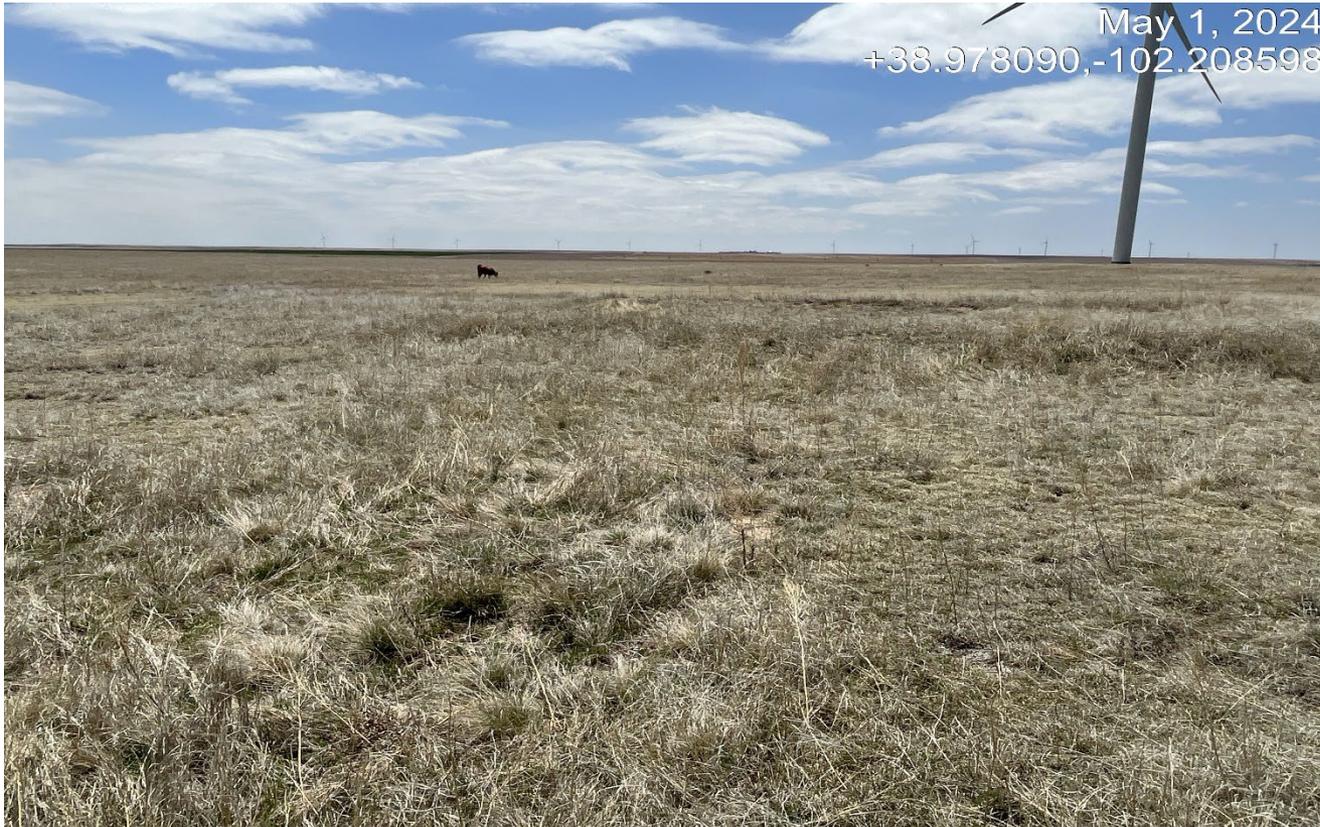
Photo 5. Facing south at the location. The perennial vegetation has fully established throughout the location.

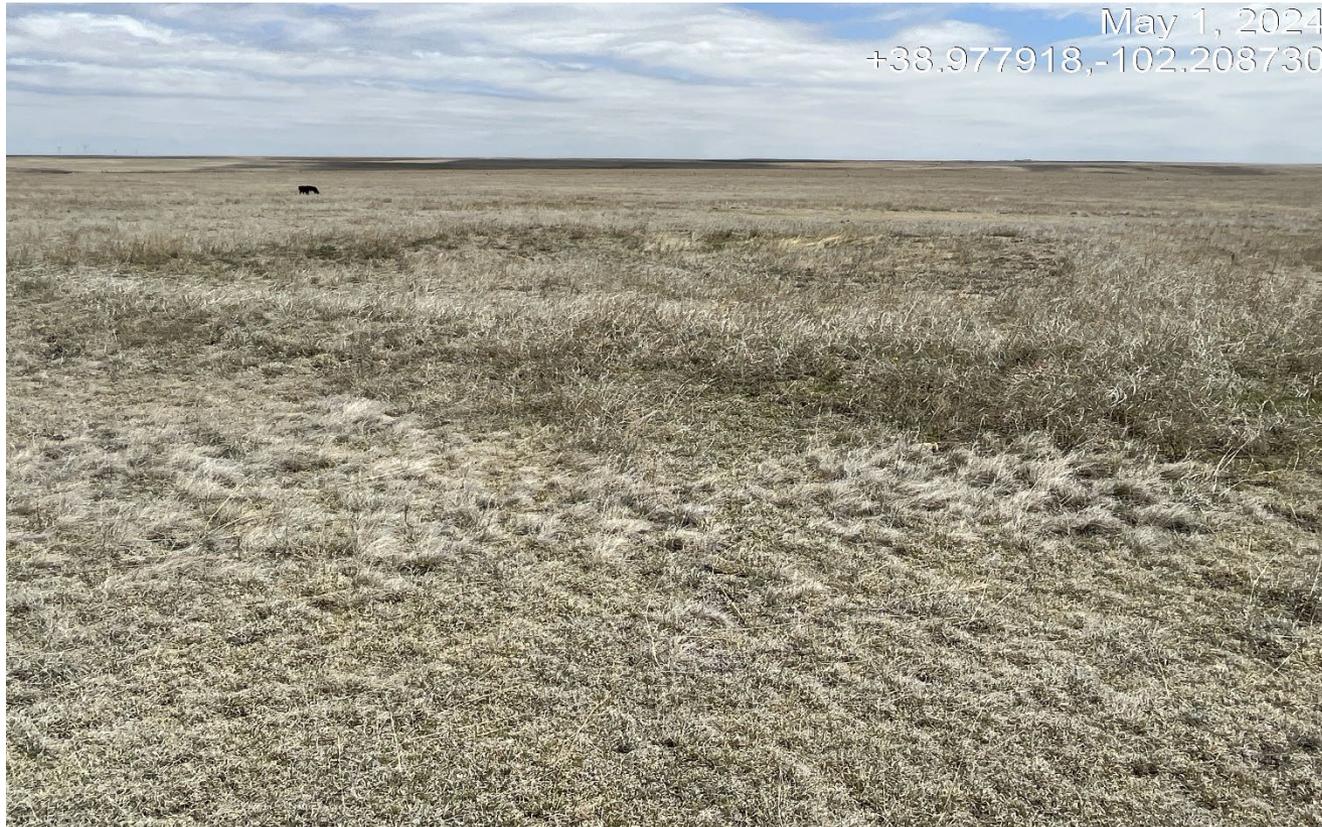
Photo 6. Facing east at the location. There are berms that remain at the location where tank battery was located..
