# Inspection Photos

Location Name: CAERUS PICEANCE LLC Warren 15-9 (PI15) Pad

Location #: 334751

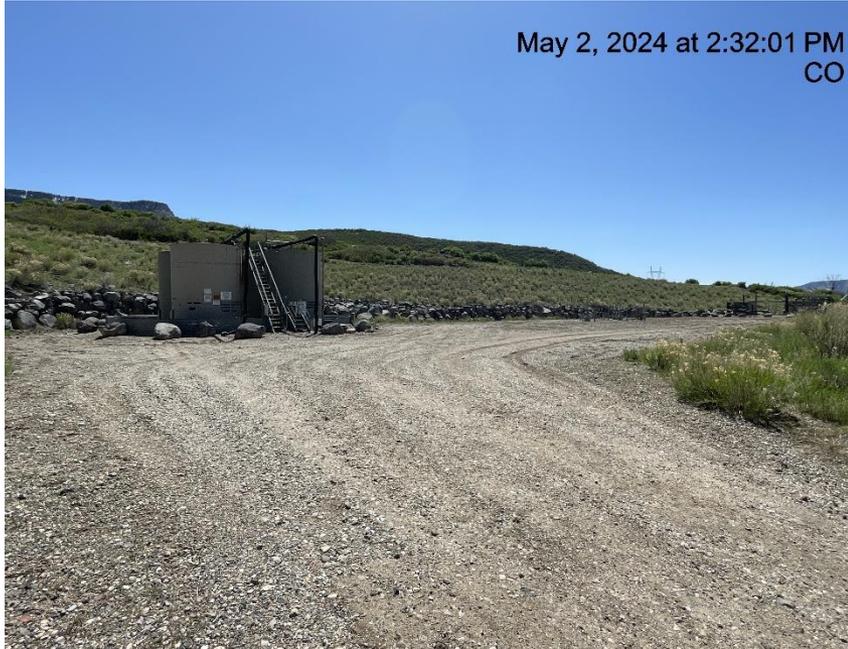
Photo # 5647 From entrance to location

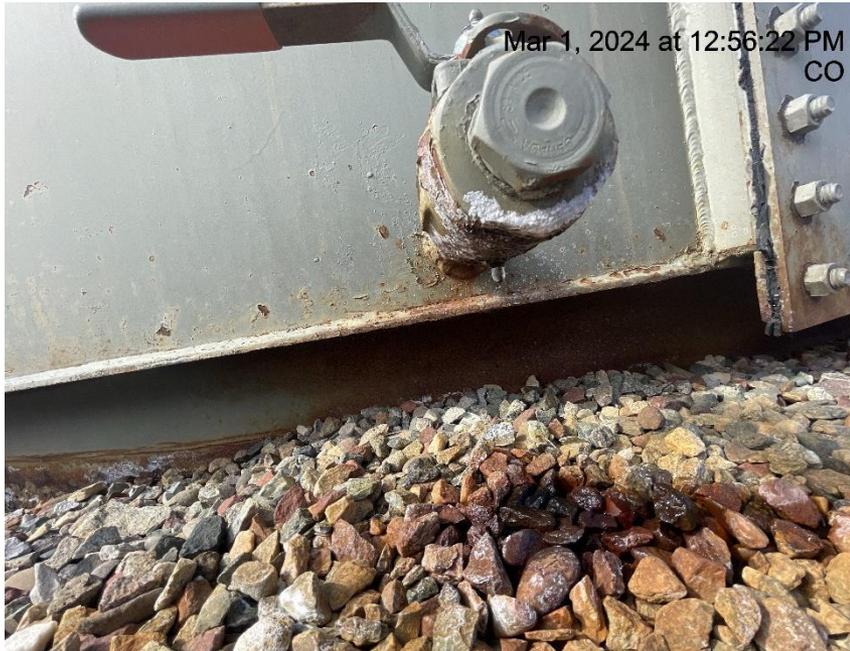
**Photo # 8080 From inspection 708903187 conducted on 03/01/2024 Valve on production tank leaking fluid**

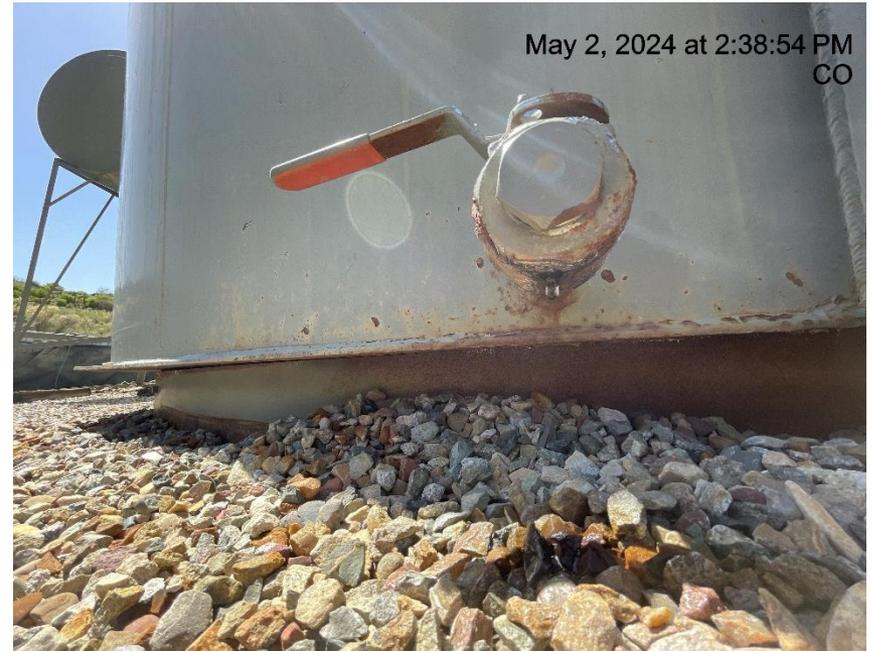
**Photo # 5655 Valve on production tank leaking fluid**

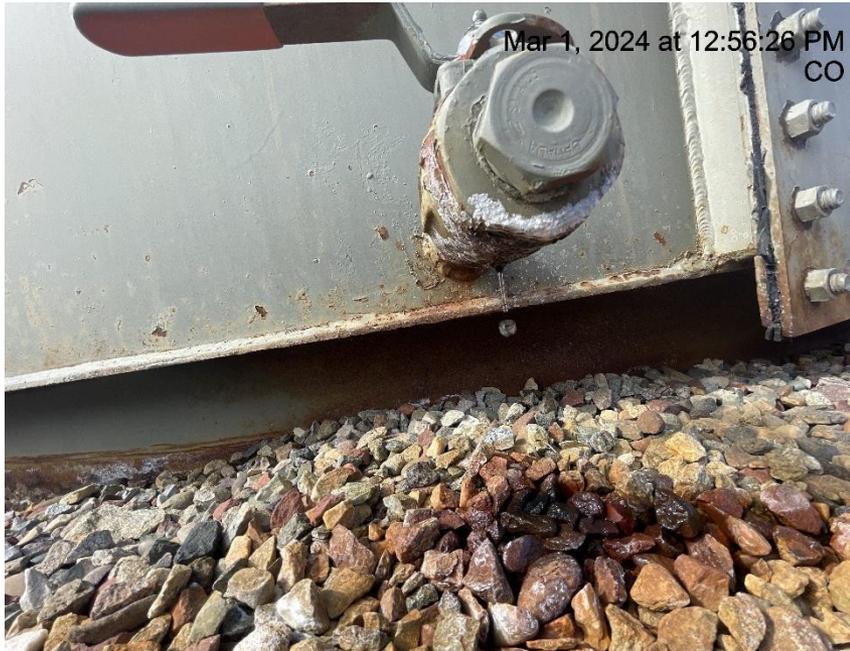
**Photo # 8081 From inspection 708903187 conducted on 03/01/2024 Valve on production tank leaking fluid**

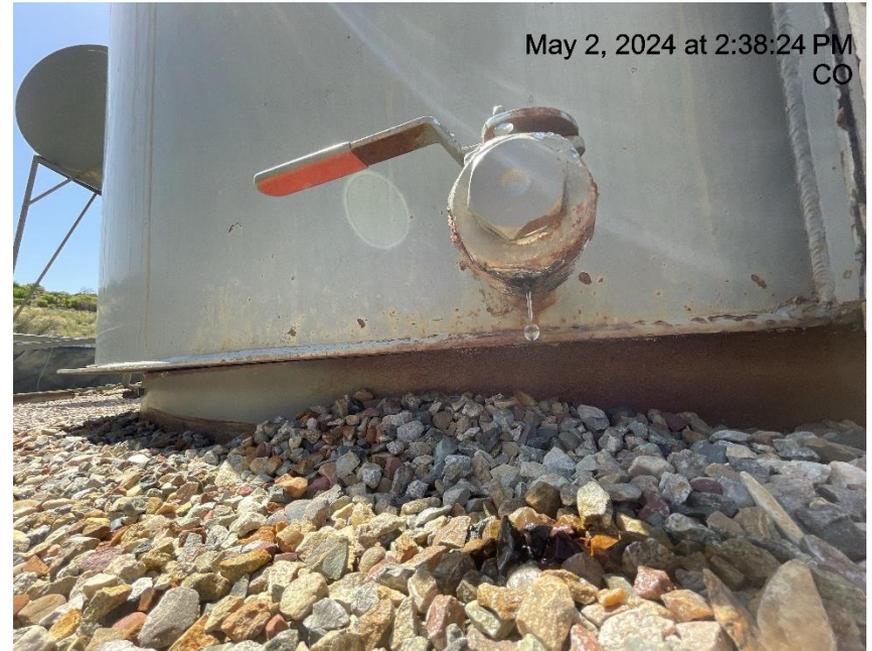
**Photo # 5656 Valve on production tank leaking fluid**

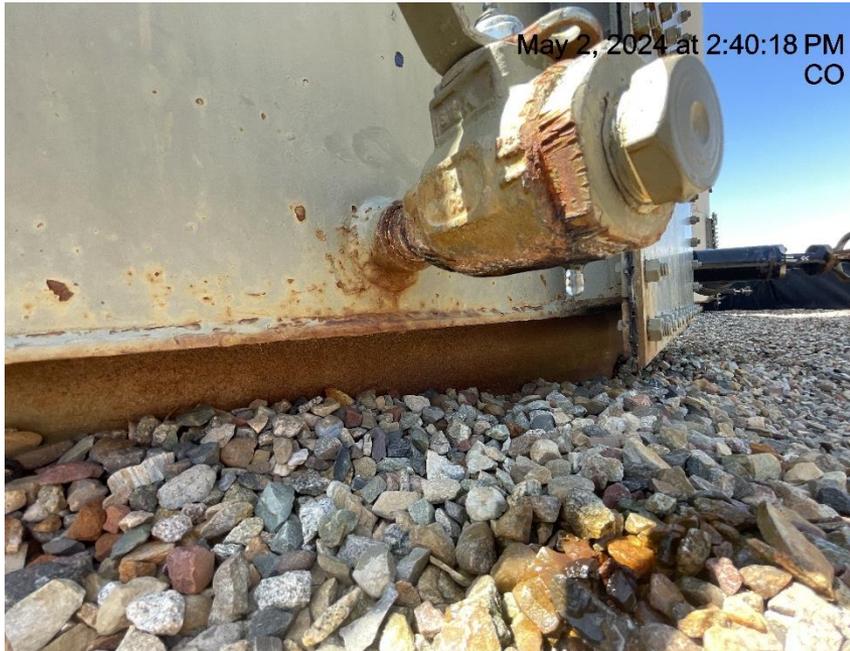
**Photo # 5657 Valve on production tank leaking fluid**

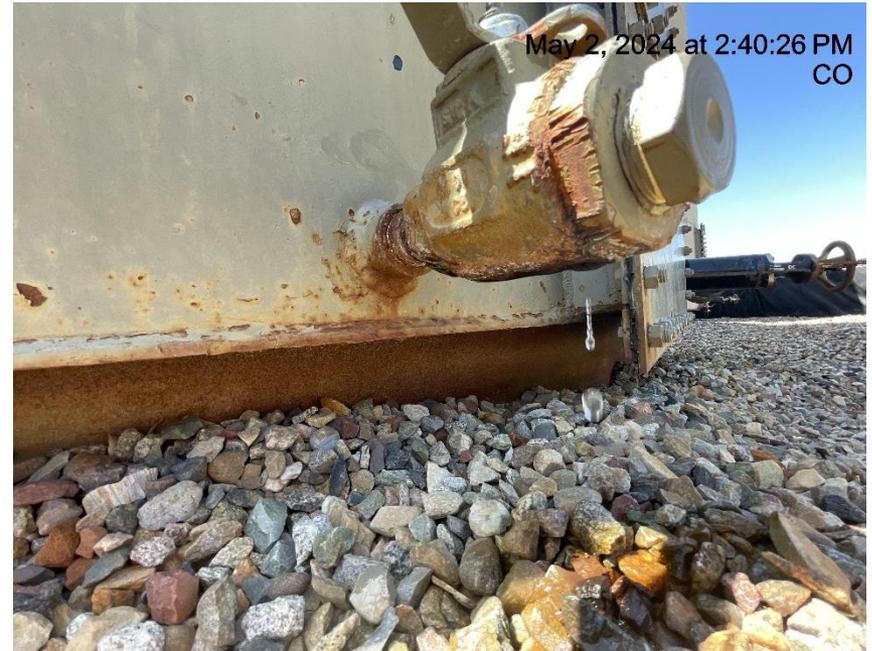
**Photo # 5658 Valve on production tank leaking fluid**
