**Operator: HIGHPOINT OPERATING CORPORATION**

**Location Name: Coffelt 5-61-35\_36 NWNW**

**Loc ID: 439471**

**Inspection: 708201153**

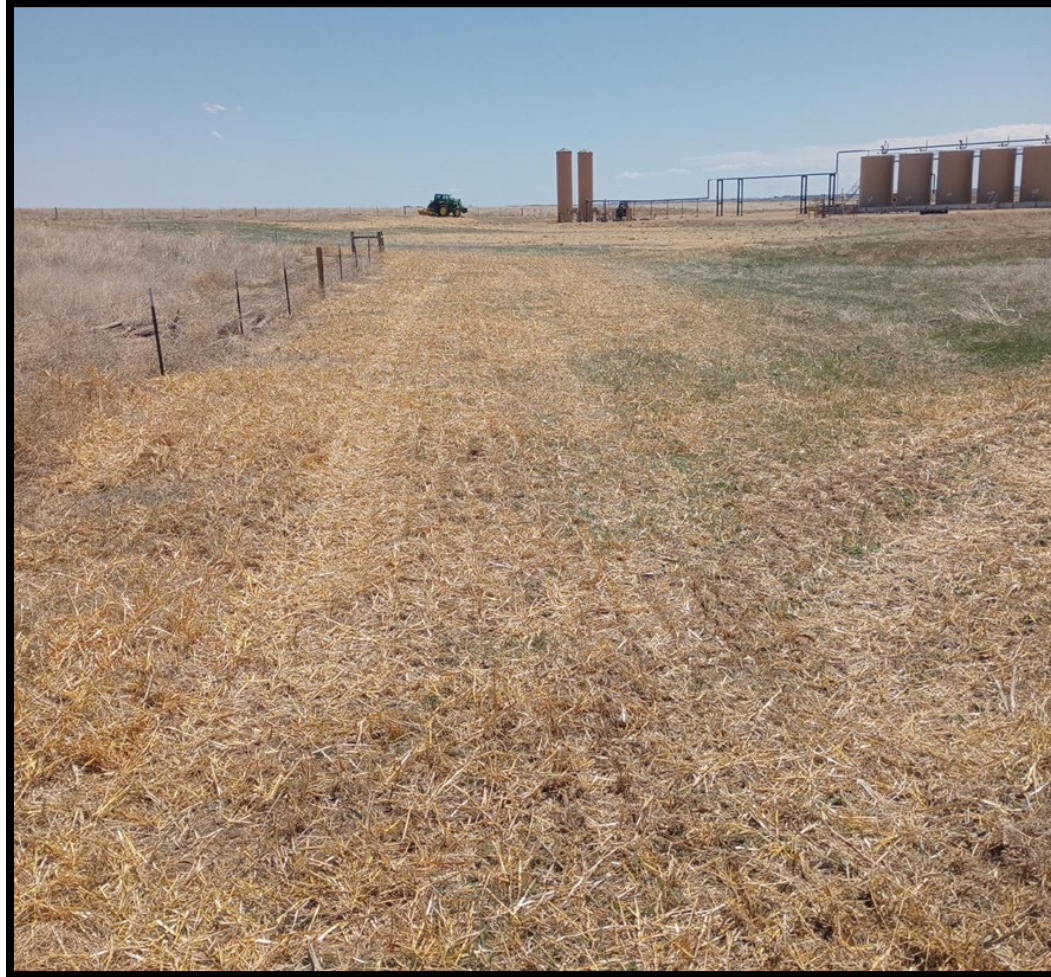
**Exhibit A**

**CA:** This location does not comply with Rule 1003. It was observed that interim areas are not progressing towards vegetative standards. While some desirable vegetation was observed in the northern areas, there is evidence of Russian thistle and kochia in the early growth stages throughout, and the southern portion of the interim areas consist mainly of Russian thistle. Operator will need to perform active weed management and continue to monitor the site until it reaches Rule 1003 standards and regulations. Refer to attached inspection photos. Comply with Rule 1003.

**CA Resolution:** Operator has reported that the location has been mowed, re-seeded, and crimped with straw mulch to encourage desired vegetation growth and to comply with Rule 1003.

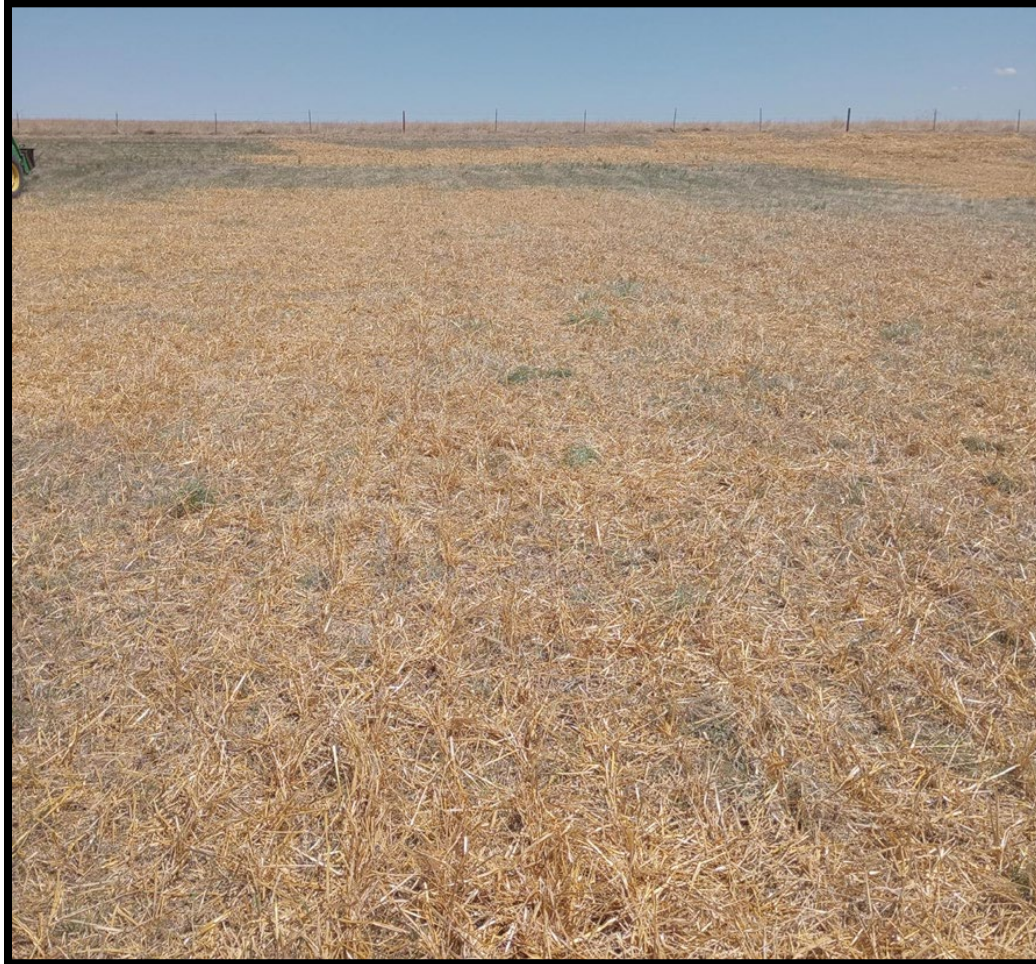
**Exhibit B**

**CA:** Old fence posts/h-brace located in the NE corner of the location remain from the initial location construction (e.g. before production equipment was moved to the south). Any fencing/posts that are not actively being used will need to be removed. Refer to attached inspection photos for additional. Comply with Rule 606 and remove any unused equipment.

**CA Resolution:** Operator has reported that identified unused fencing posts have been removed from location to comply with Rule 606.
