Interim Reclamation and Stormwater Inspection

Date: 05/02/2024

Operator: WESTERN OPERATING COMPANY - 95620

Inspection Photos
Location Name: Propst 1
Location ID: 312291

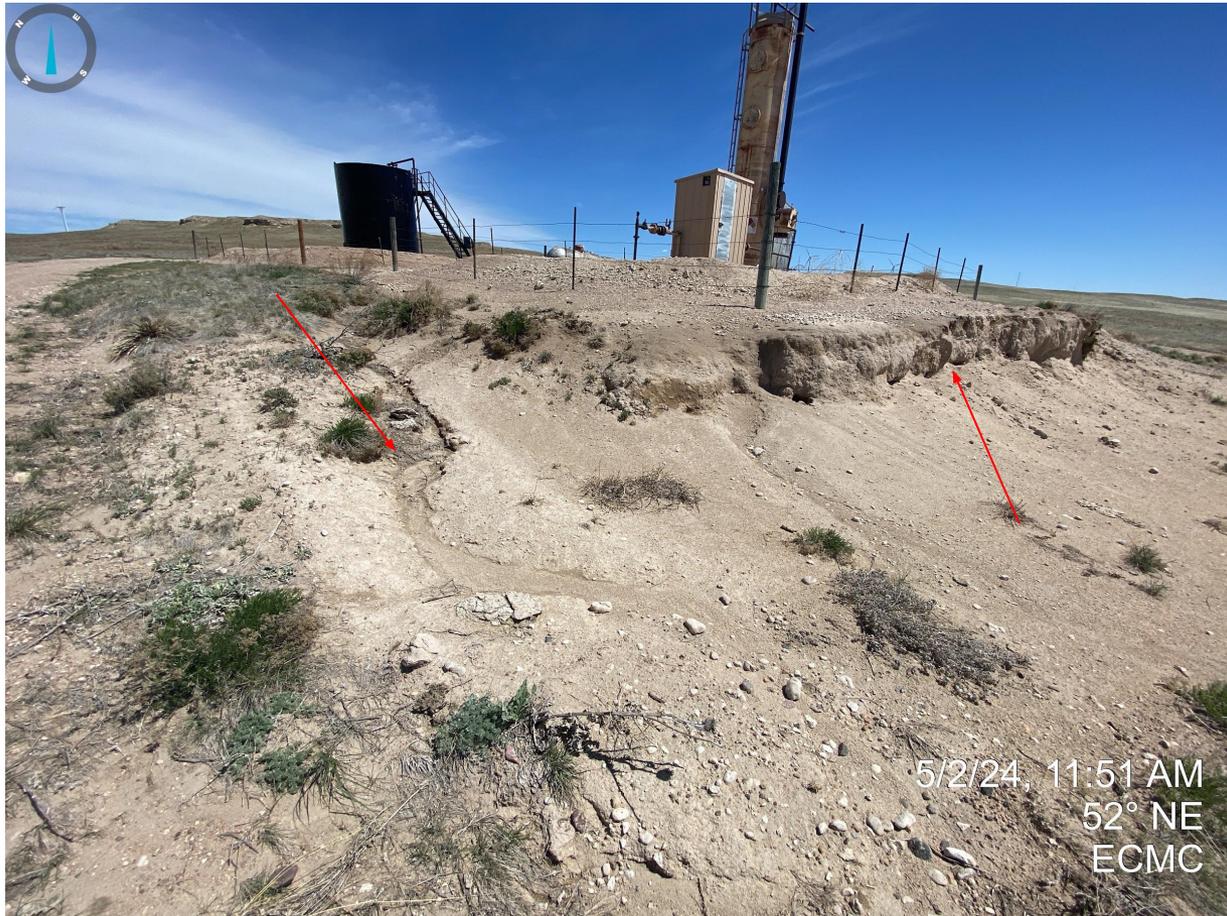
Photo 1. Areas experiencing erosion degradation throughout the production areas do not appear to have been repaired/stabilized and there is no evidence of stormwater controls measures/BMPs having been implemented.

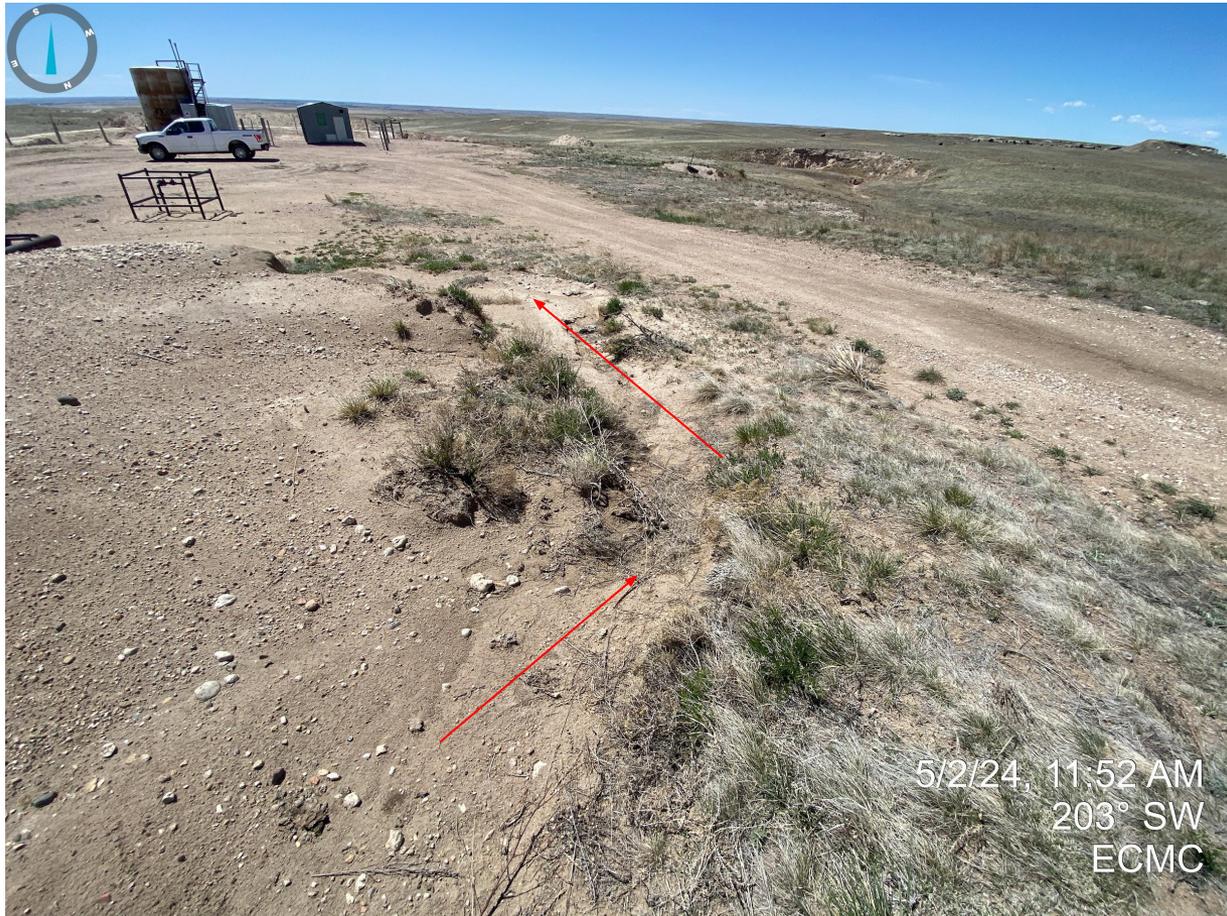
Photo 2. Areas experiencing erosion degradation throughout the production areas do not appear to have been repaired/stabilized and there is no evidence of stormwater controls measures/BMPs having been implemented.

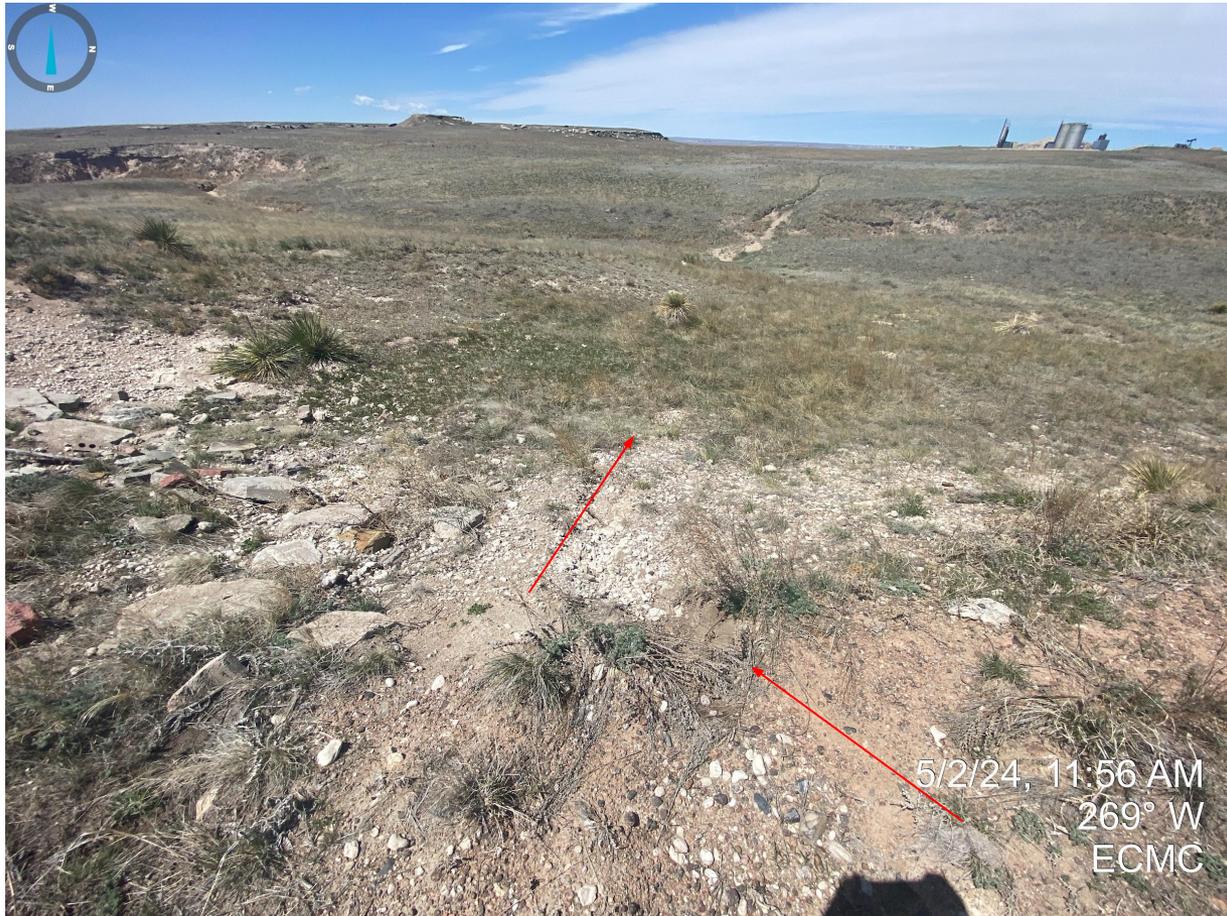
Photo 3. Western portions of the interim areas do not appear to have been repaired/stabilized and there is no evidence of stormwater controls measures/BMPs having been implemented.

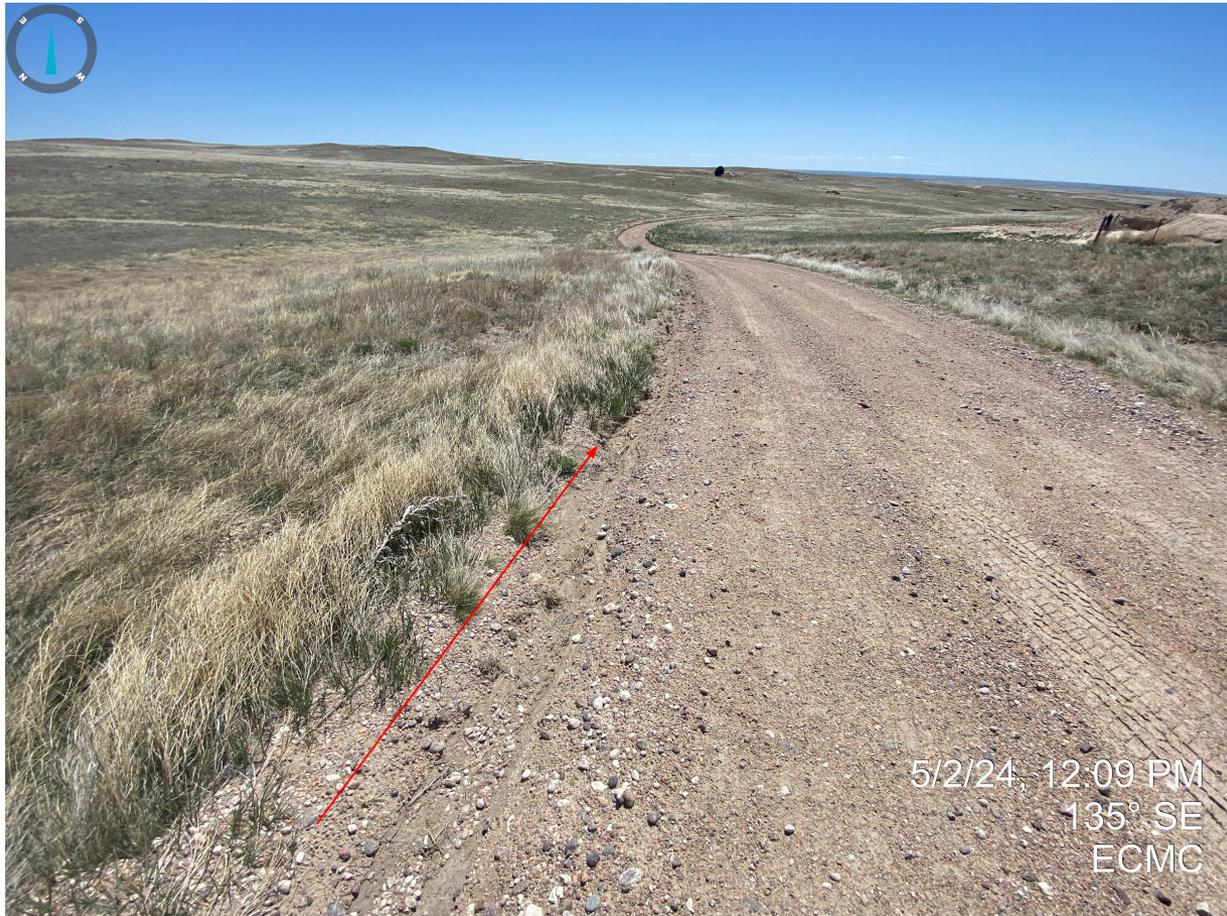
Photo 4. Taken from the access road east of the pit. Evidence of erosion degradation, previously documented, does not appear to have been repaired/stabilized with no evidence of control measures/BMPs observed that would prevent further erosion of the access road.

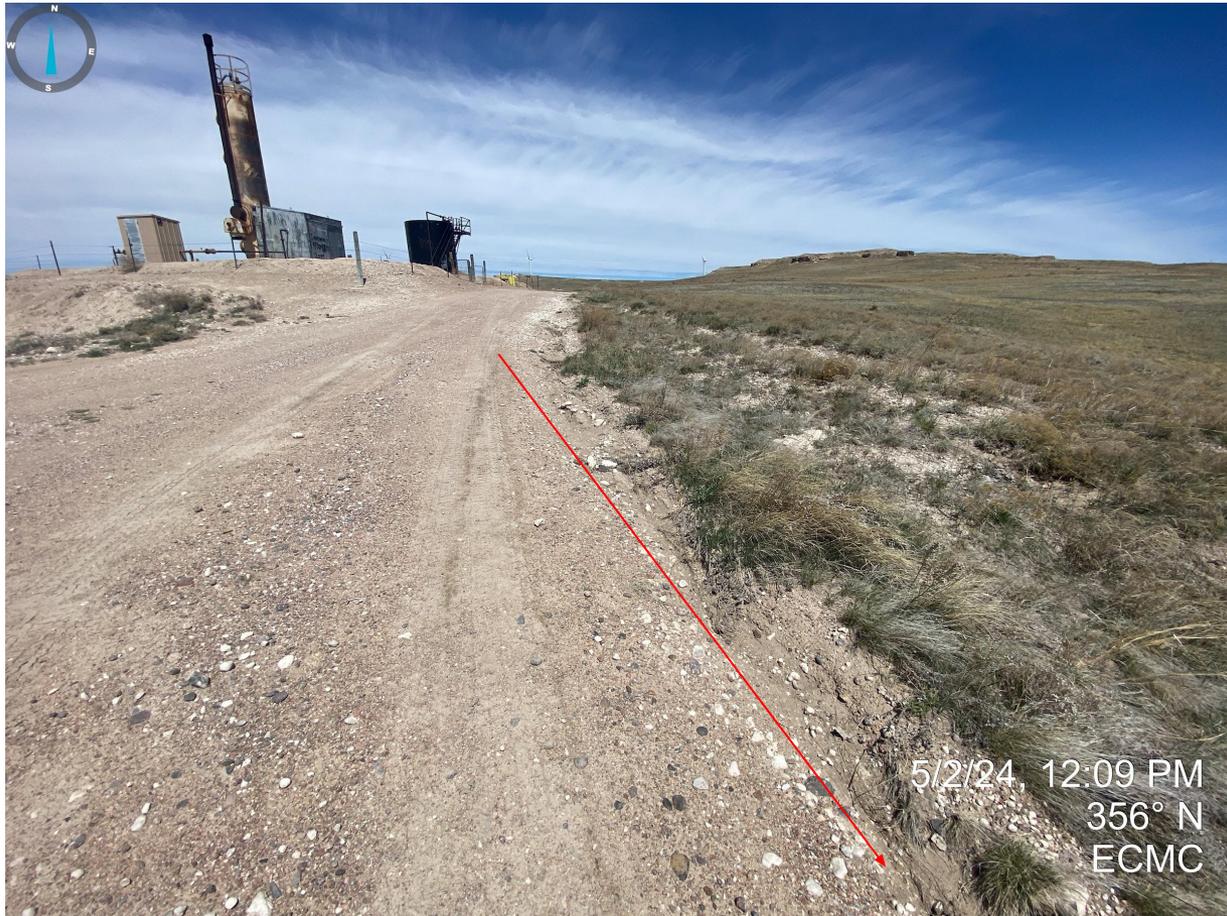
Photo 5. Taken from the production areas, near the access road; see comments in Photo 4.

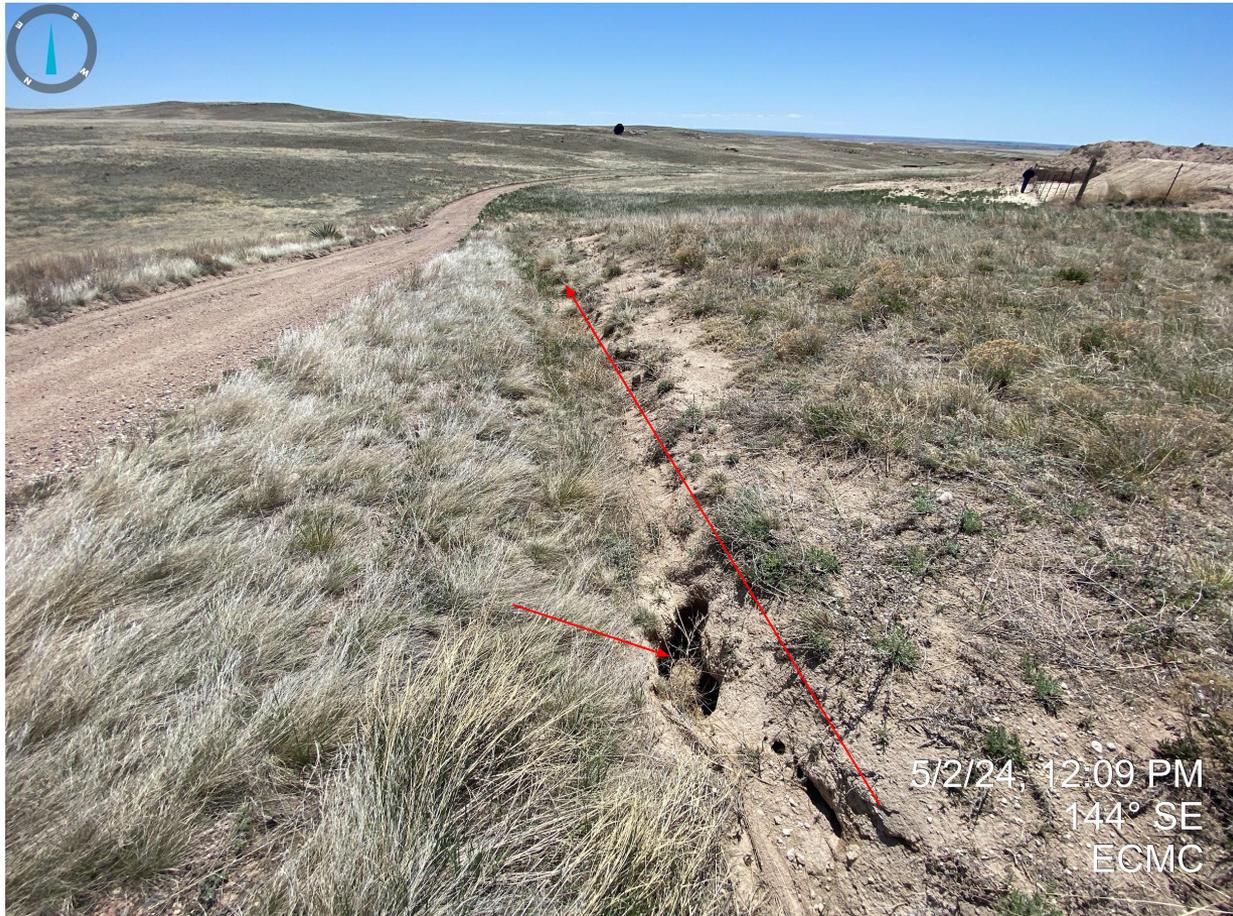
Photo 6. Taken from the access road east of the pit; see comments in Photo 4.

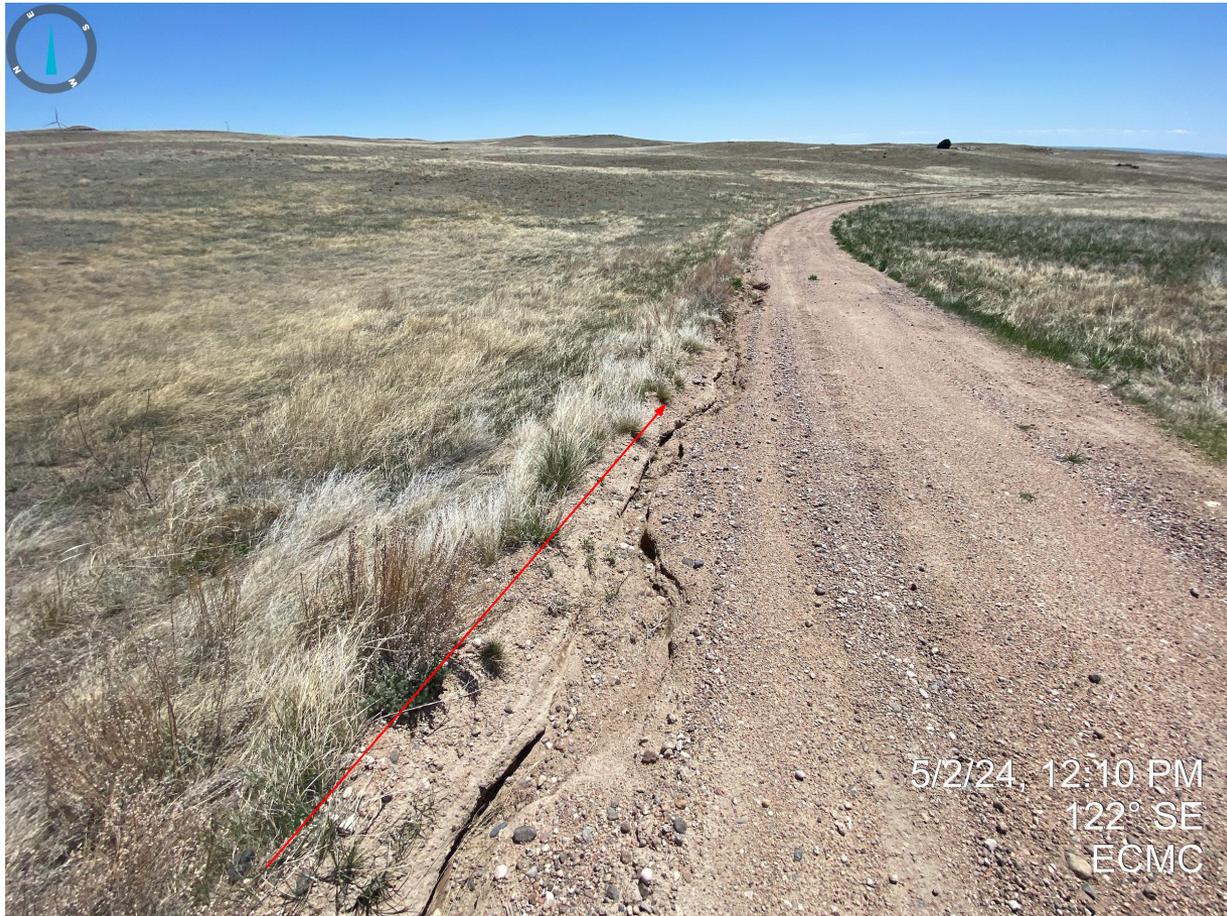
Photo 7. Taken from the access road east of the pit; see comments in Photo 4.

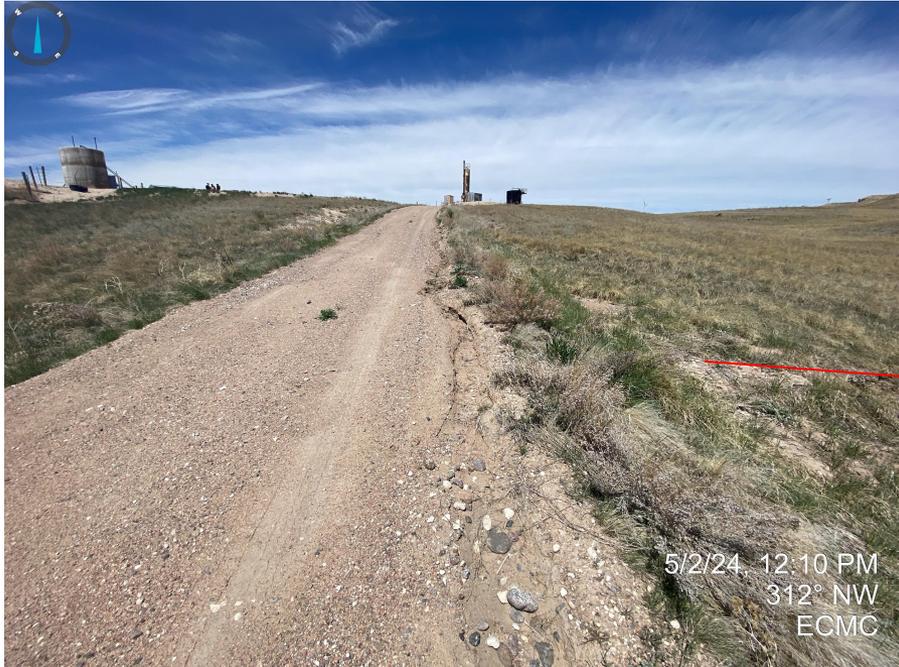
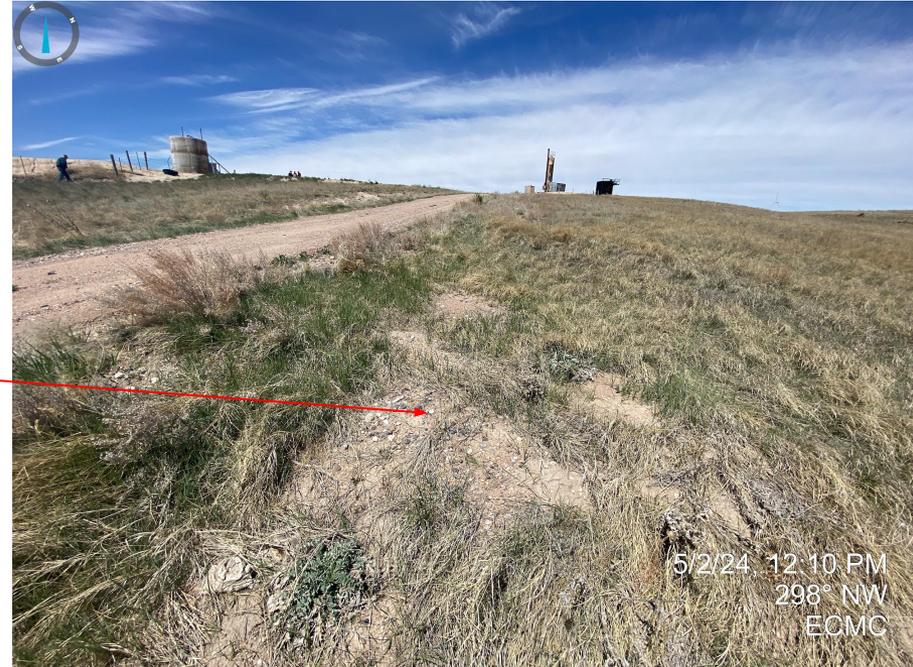
Photos 8 & 9. Taken from the access road east of the pit; see comments in Photo 4.

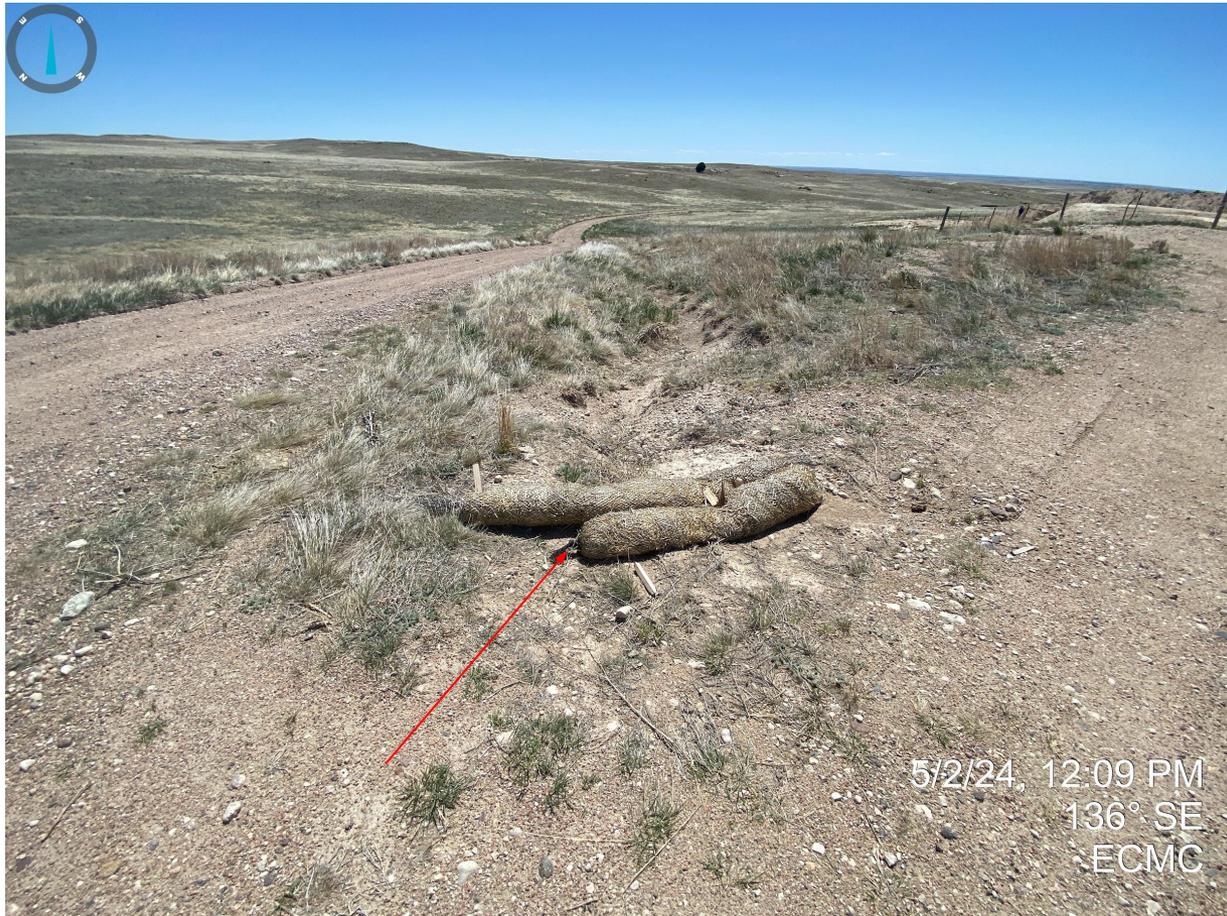
Photo 10. Stormwater control measures installed near the production areas/access road do not appear to be properly installed per good engineering practices (e.g. trenched and backfilled).

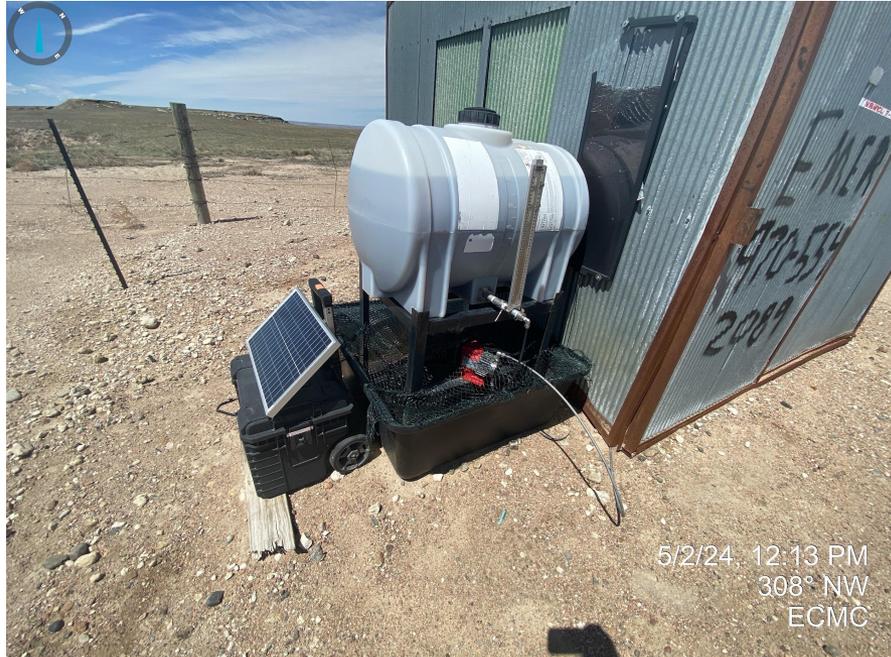
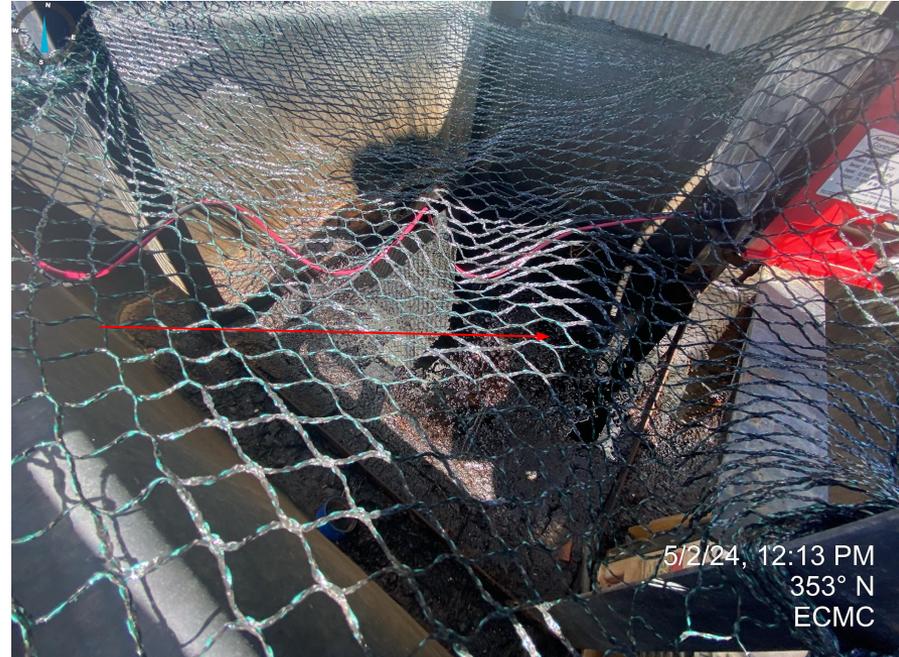
Photos 11 & 12. Free fluids observed within the day tank secondary containment.

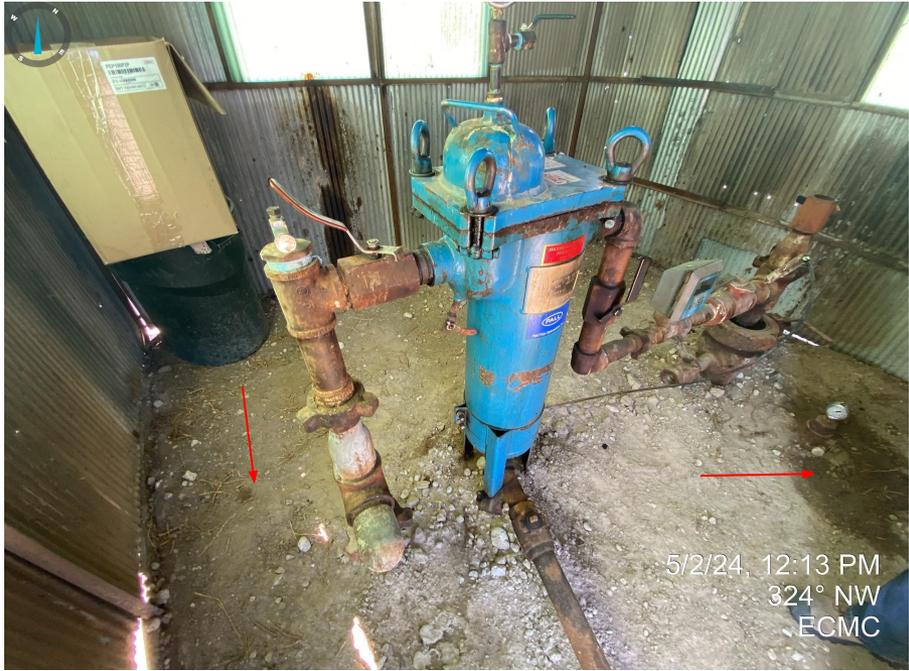
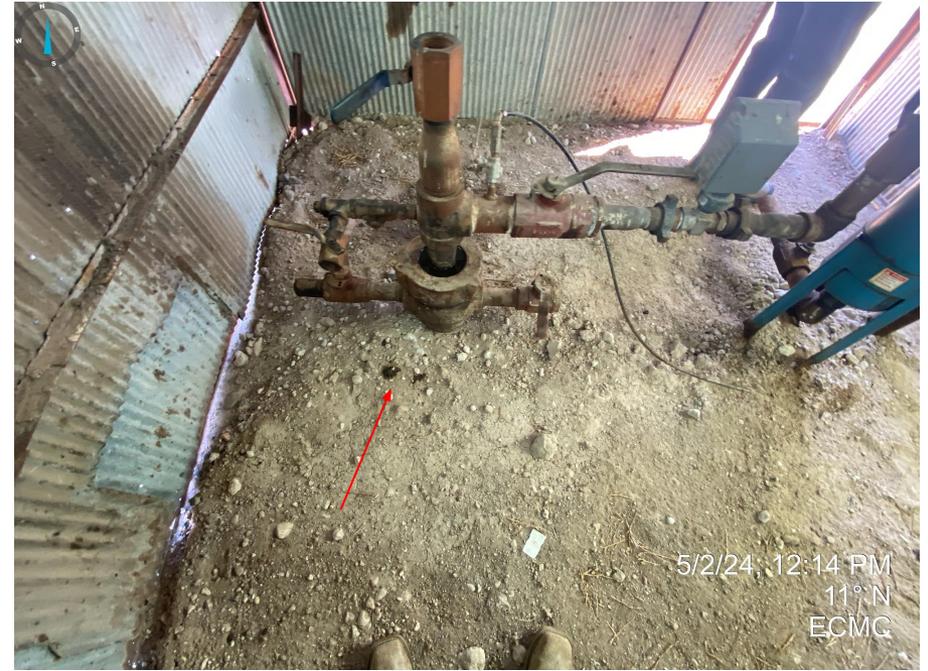
Photo 13 & 14. Stained soil observed within the injection well shed.

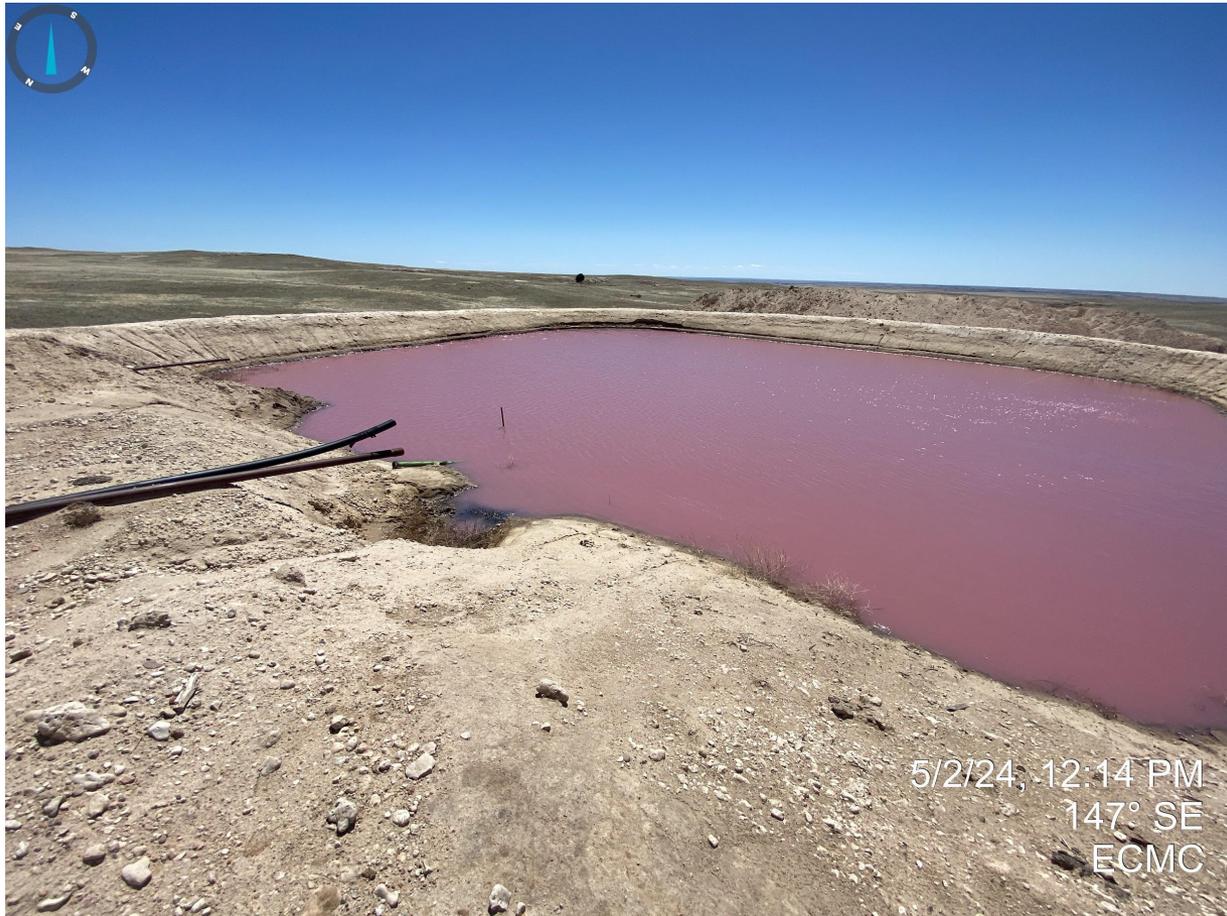
Photo 15. The produced water pit does not have adequate netting that would exclude wildlife entry.

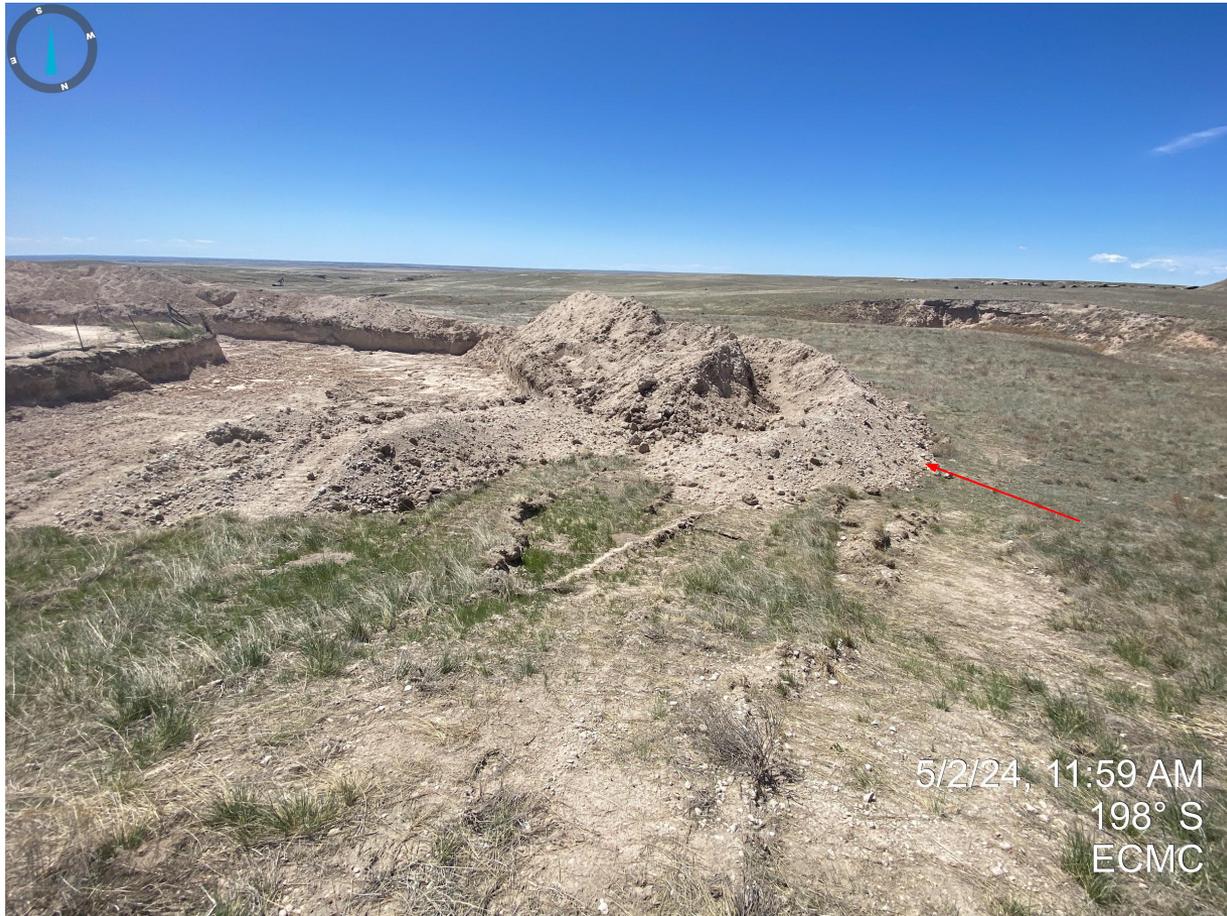
Photo 16. Taken from the north side of the stockpiled soils. No perimeter stormwater control measures/BMPs, or impermeable liners underneath the stockpile were observed during this inspection. Impacted soils appear to have been placed directly on top of undisturbed lands. Additionally, it does not appear that topsoil has been salvaged Per Rule 1002.b prior to stockpiling the soil on undisturbed portions of land.

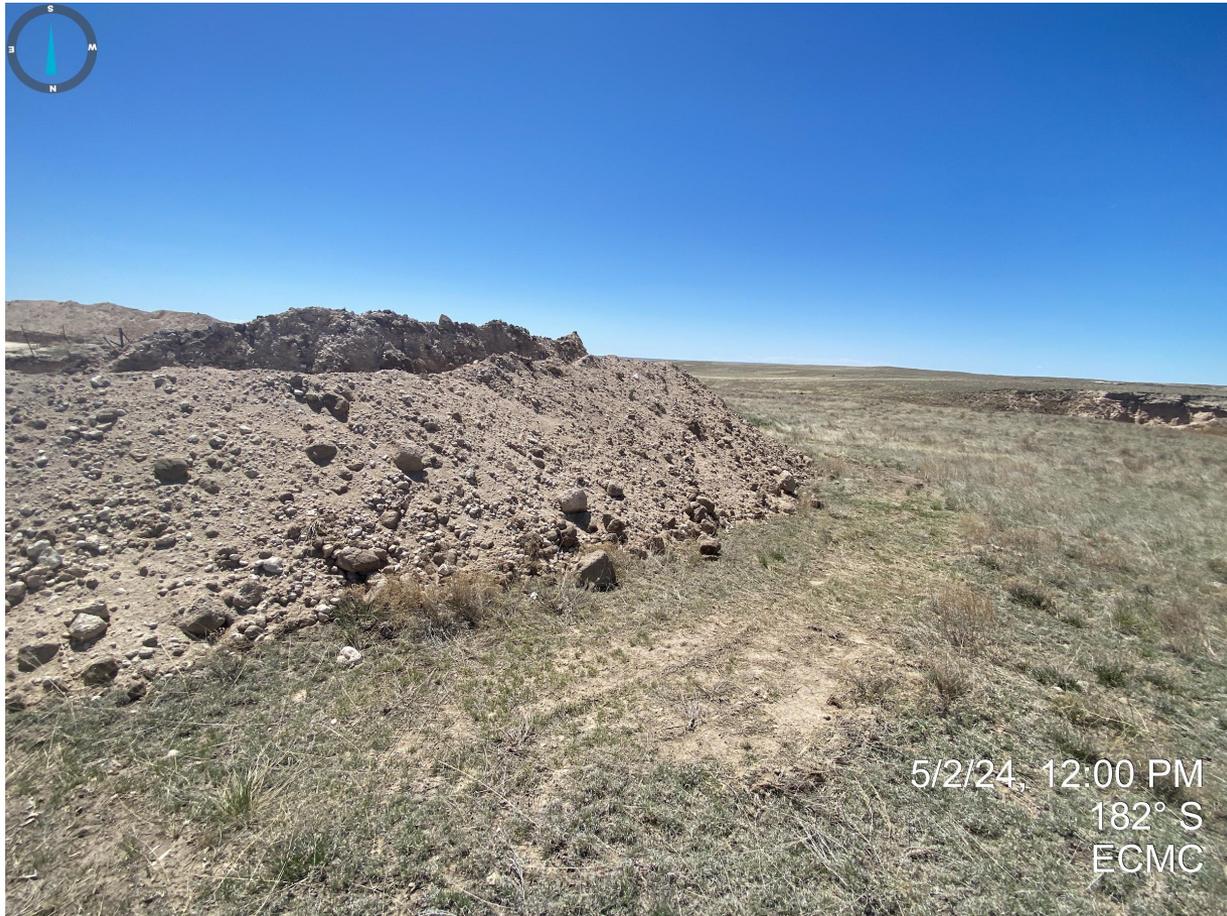
Photo 17. Taken from the west side of the stockpiled soils; see comments in Photo 16.

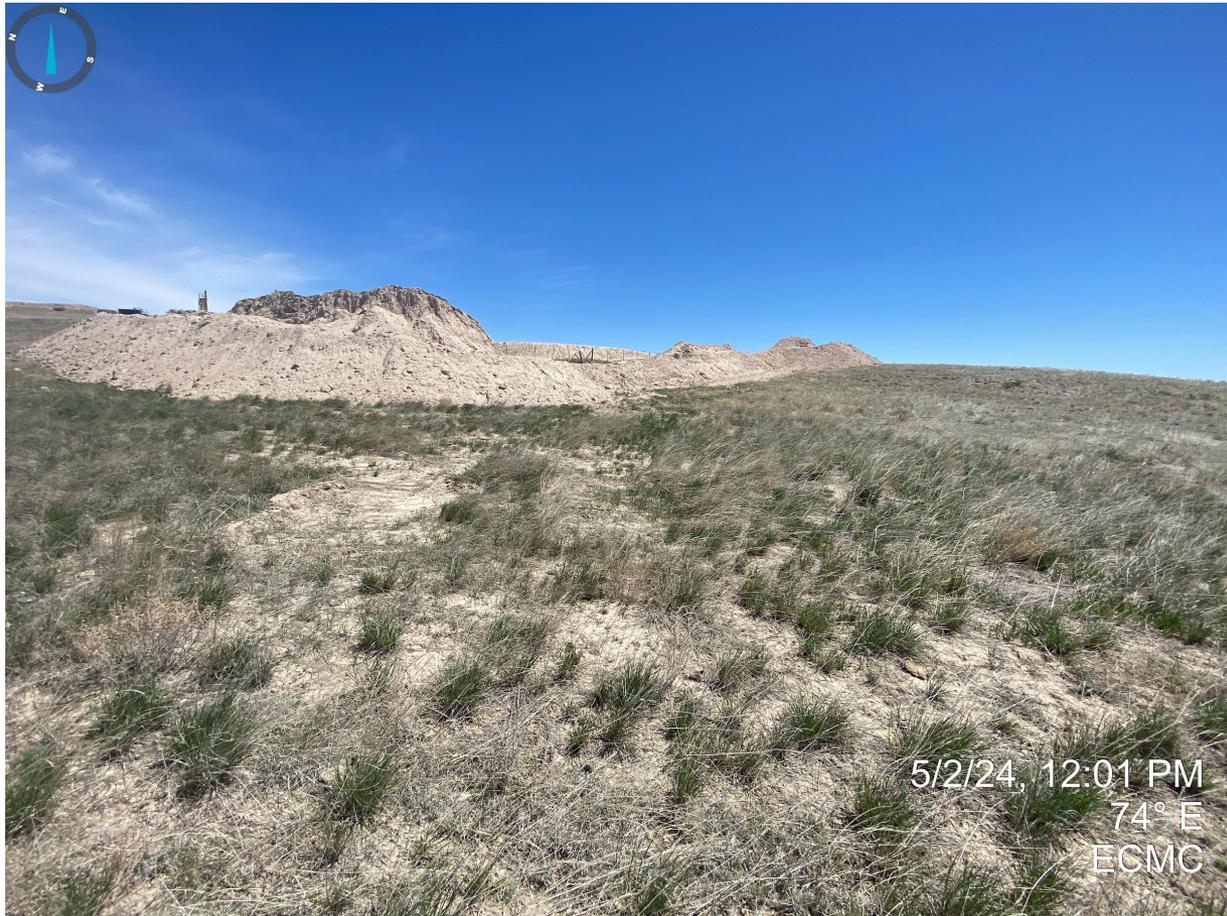
Photo 18. Taken southwest of the excavated area and stockpiled material; see comments in Photo 16.

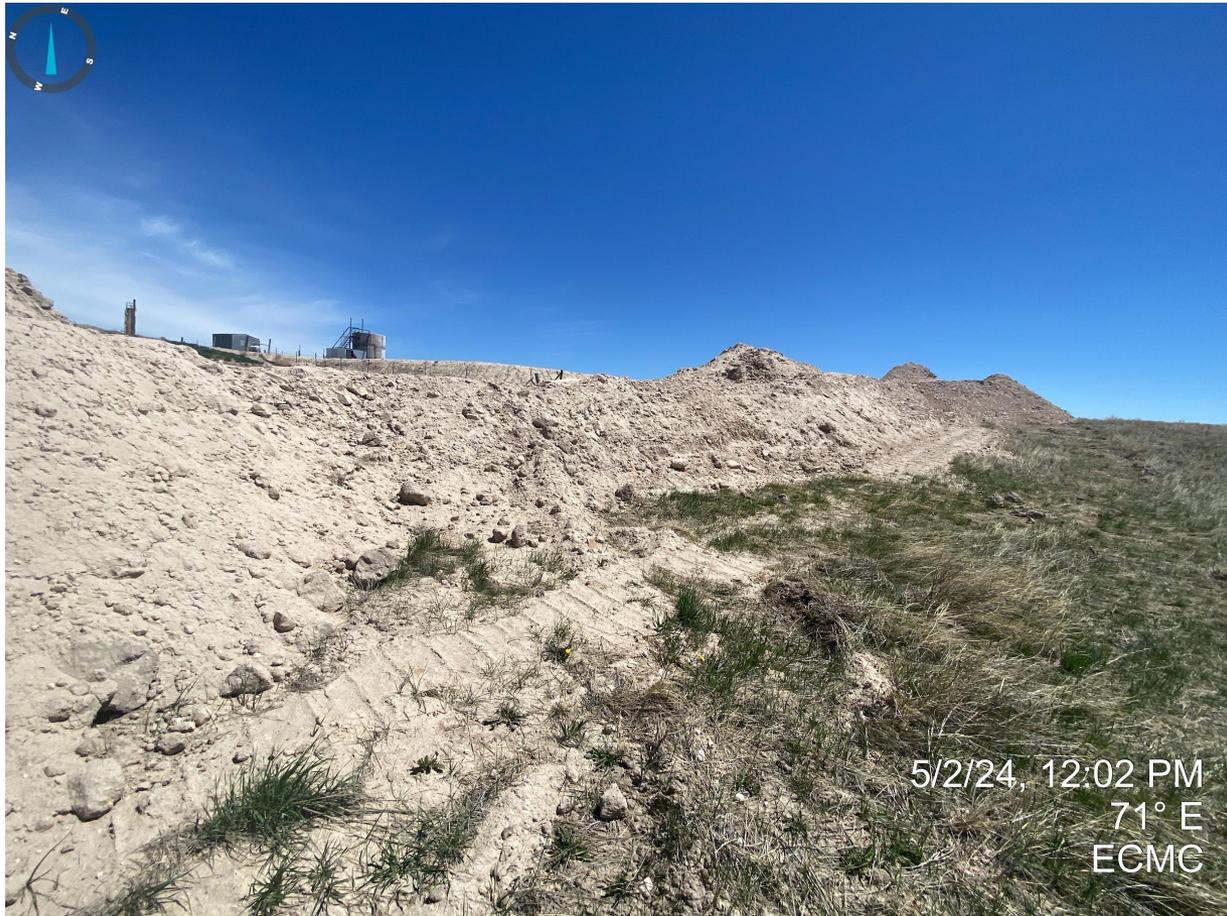
Photo 19. Taken from the southwest corner of the stockpiled material; see comments in Photo 16.

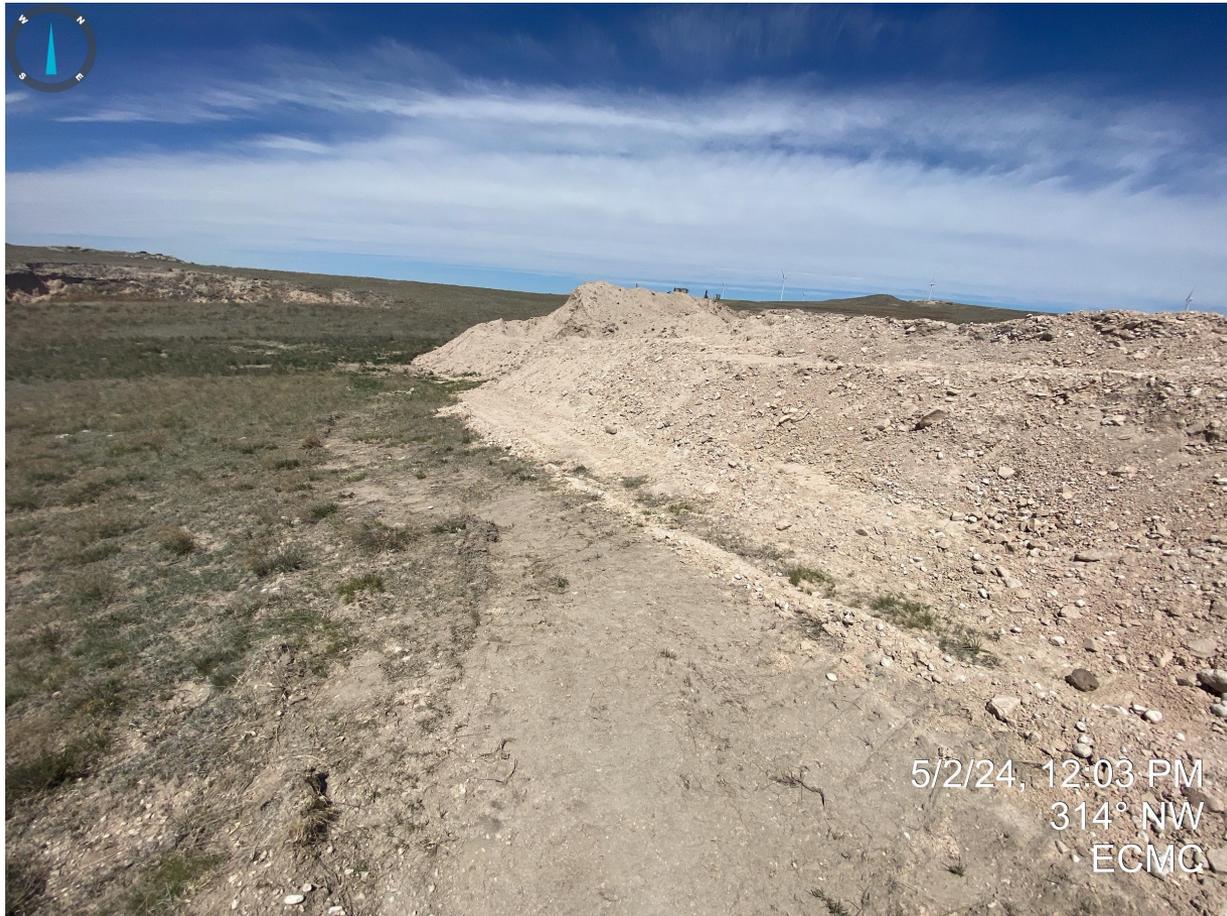
Photo 20. Taken from the southern portion of the stockpiled material; see comments in Photo 16.

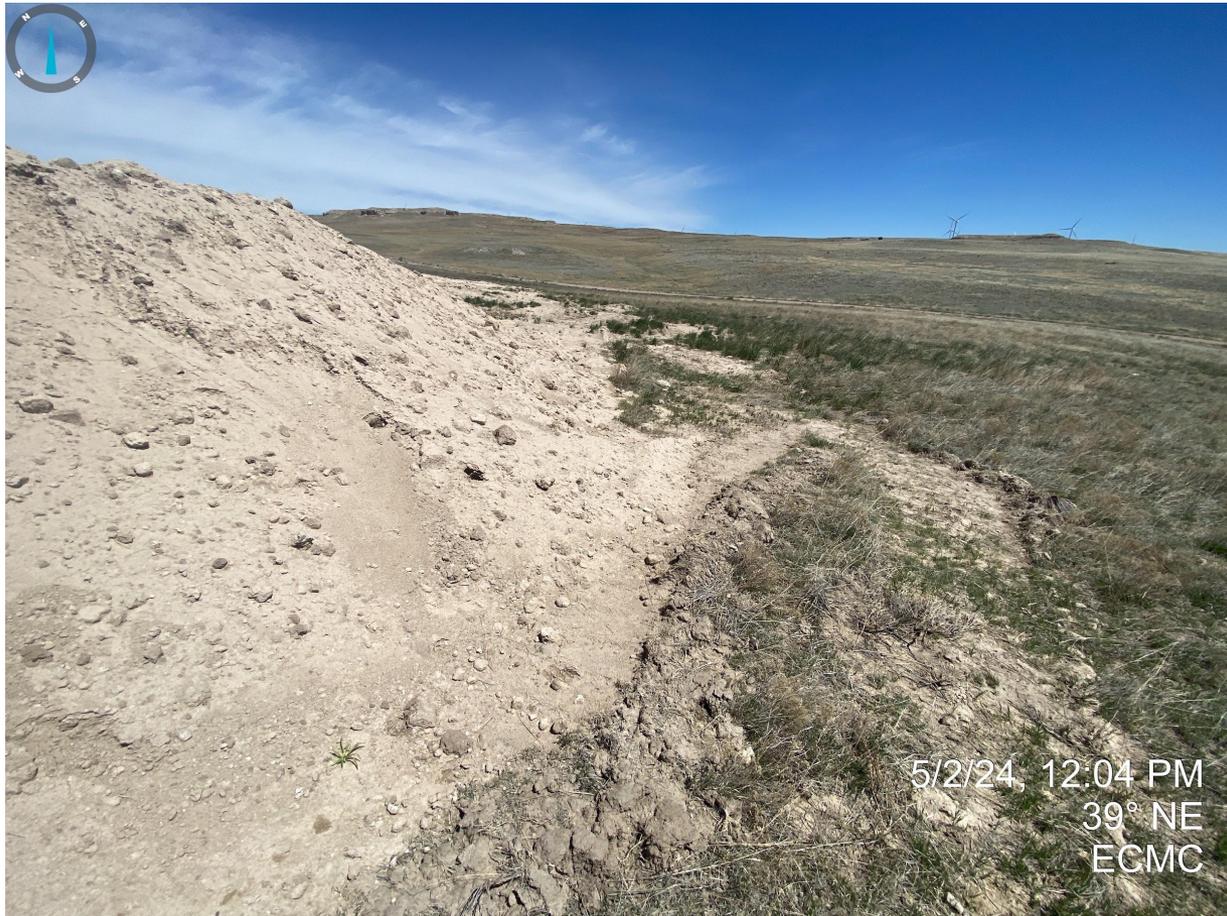
Photo 21. Taken from the southeast corner of the stockpiled material; see comments in Photo 16.

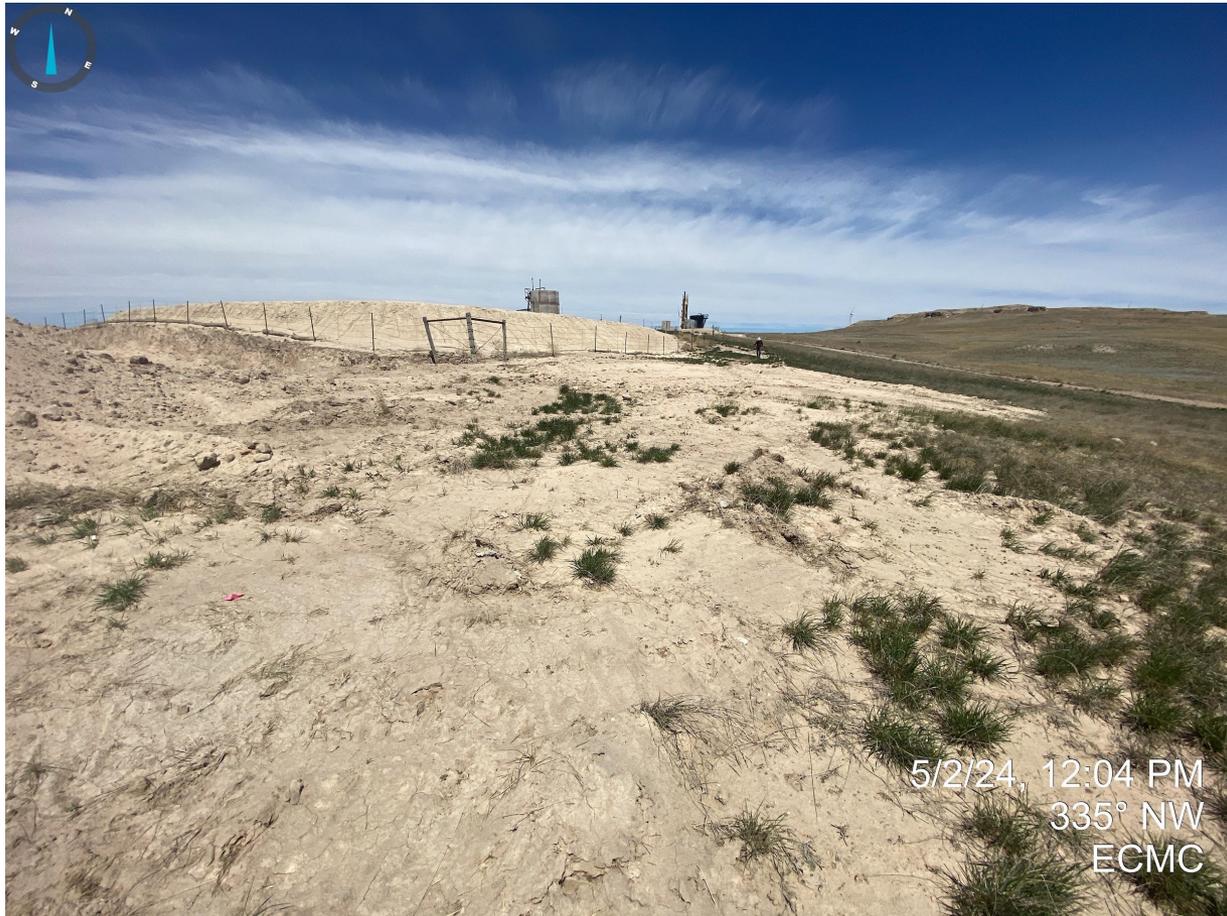
Photo 22. Taken southeast of the excavated area and stockpiled material; see comments in Photo 16.
