Interim Reclamation and Stormwater Inspection

Date: 05/02/2024

Operator: WESTERN OPERATING COMPANY - 95620

Inspection Photos
Location Name: Propst 1
Location ID: 312291

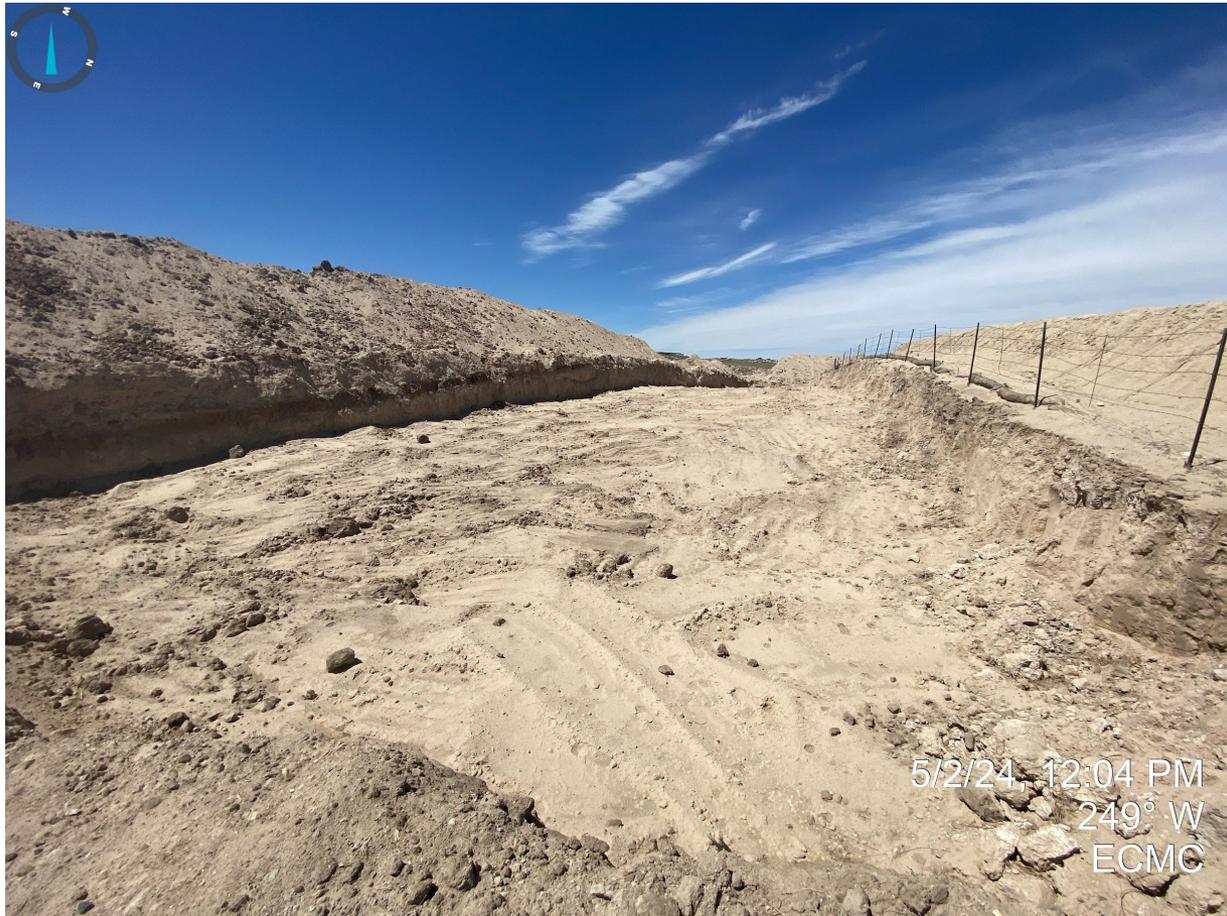
Photo 23. Photo illustrates excavated soil from the previously identified salt kill impacts. Soils within the excavation and stockpiles are not properly stabilized as they have been left unconsolidated. Unconsolidated material can become a potential source of pollution and is susceptible to wind and water erosion degradation.

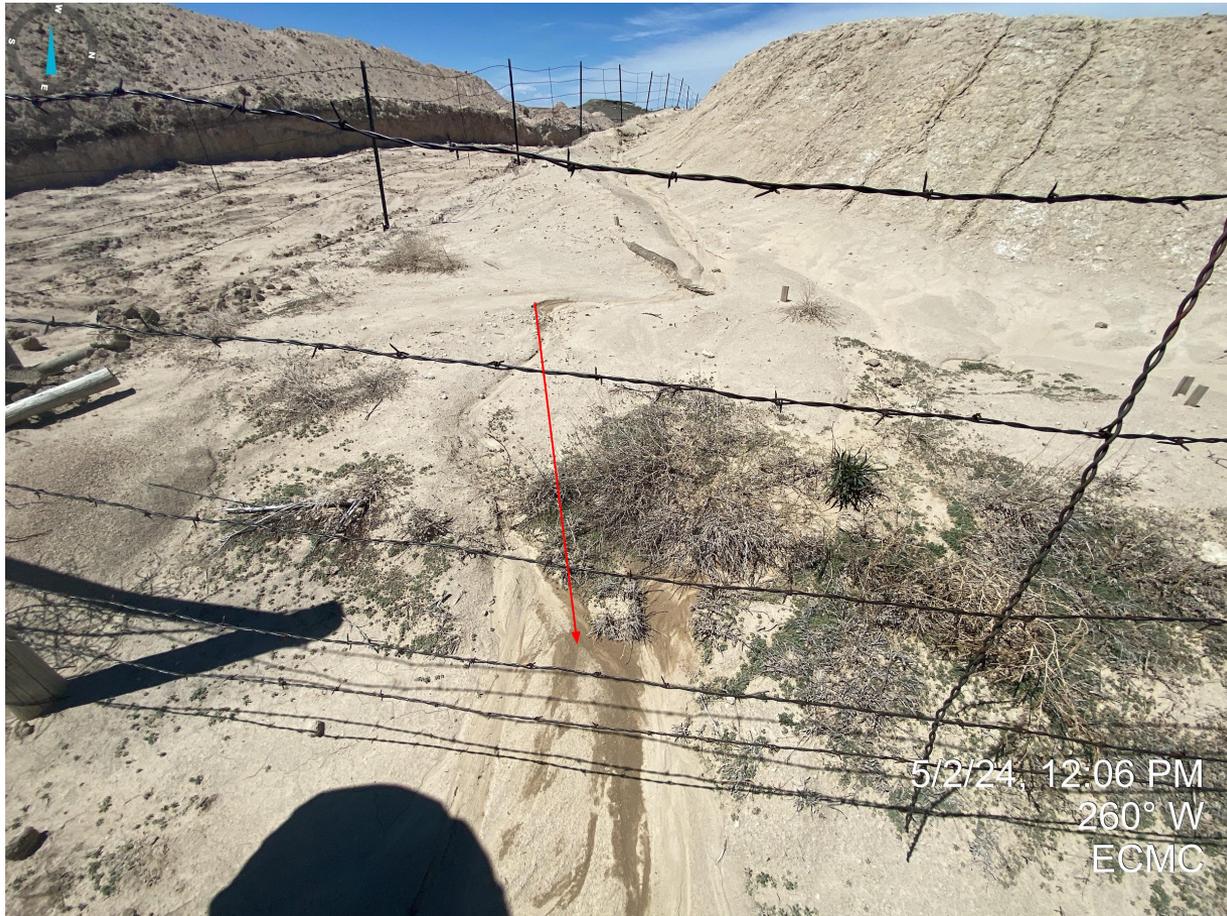
Photo 24. Taken from the southeastern portion of the pit. Photo illustrates erosion degradation on the pit walls and inadequate stormwater control measures around the base, or perimeter, of the pit.

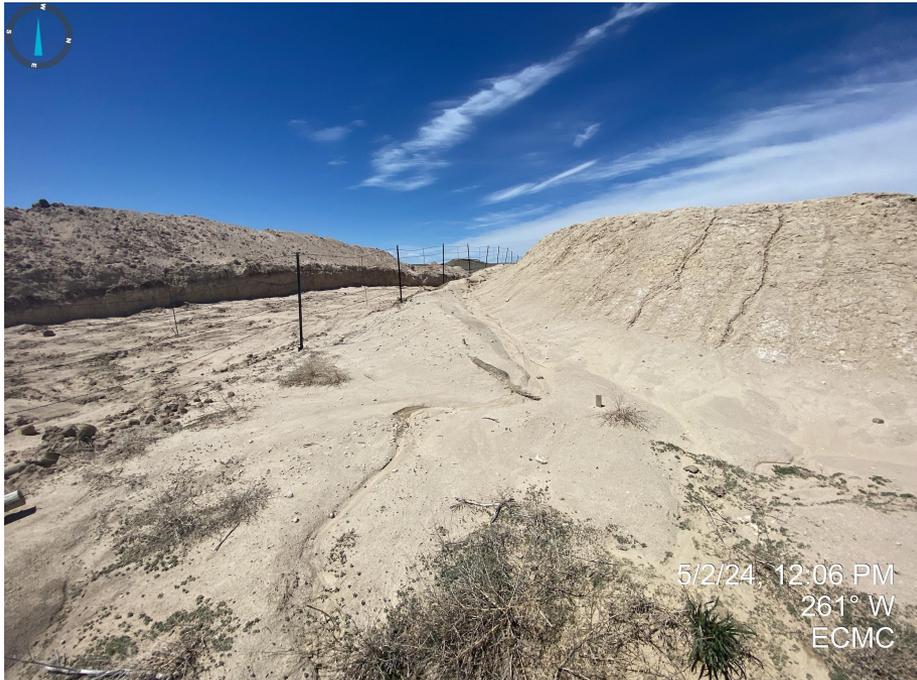
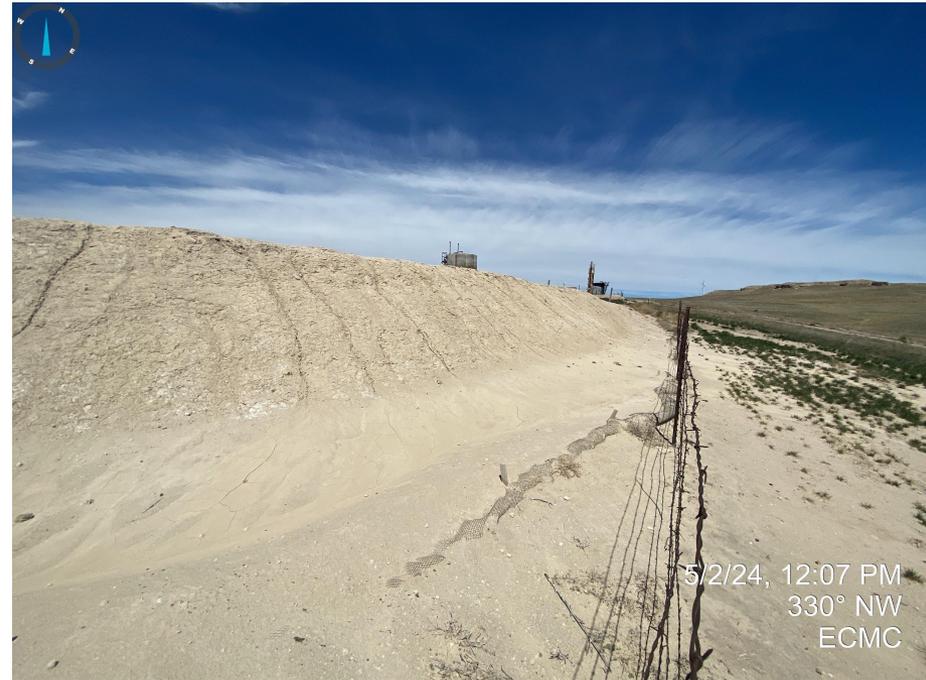
Photo 25 & 26. Southeast corner of the pit; see comments in Photo 24.

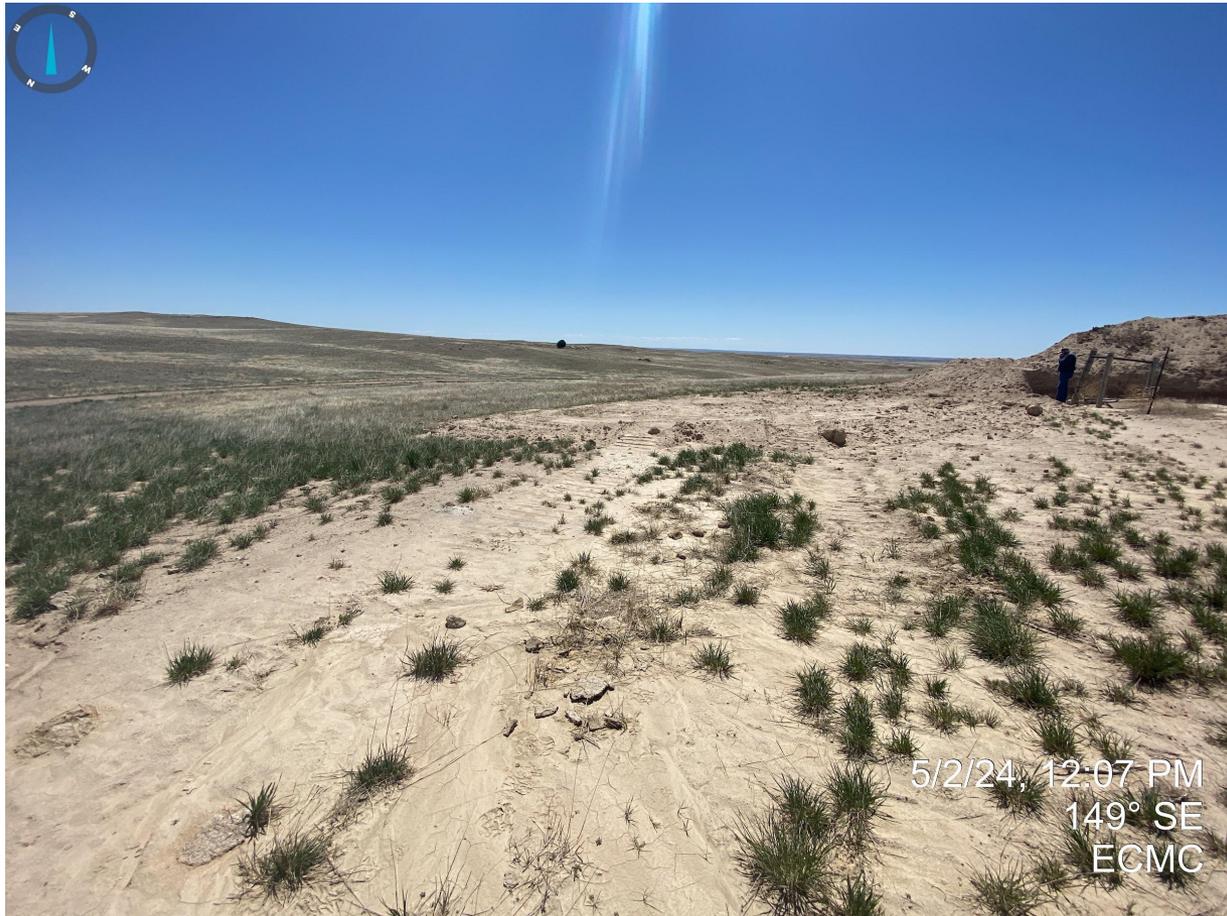
Photo 27. Taken from the east side of the pit; see comments in Photo 24.

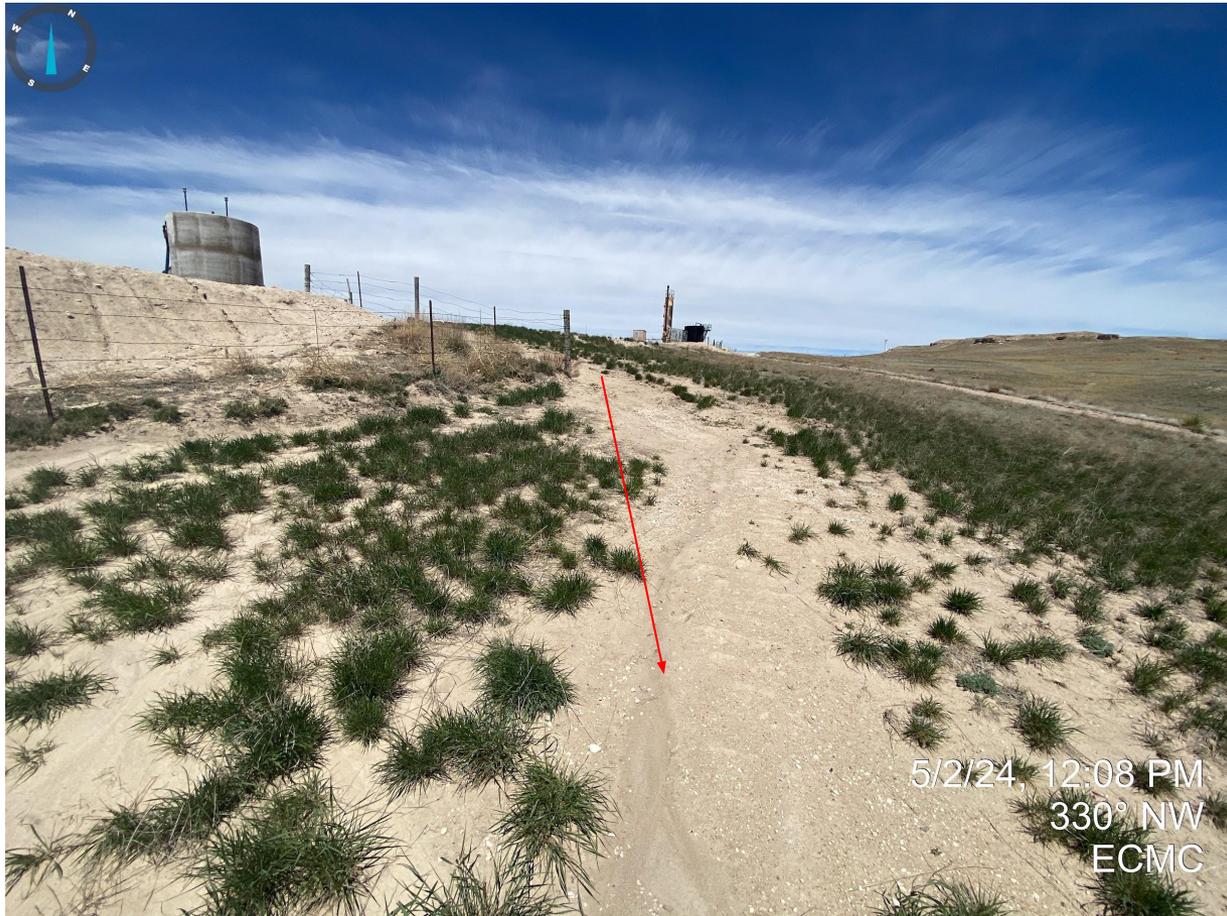
Photo 28. Taken from the east side of the pit; see comments in Photo 24.

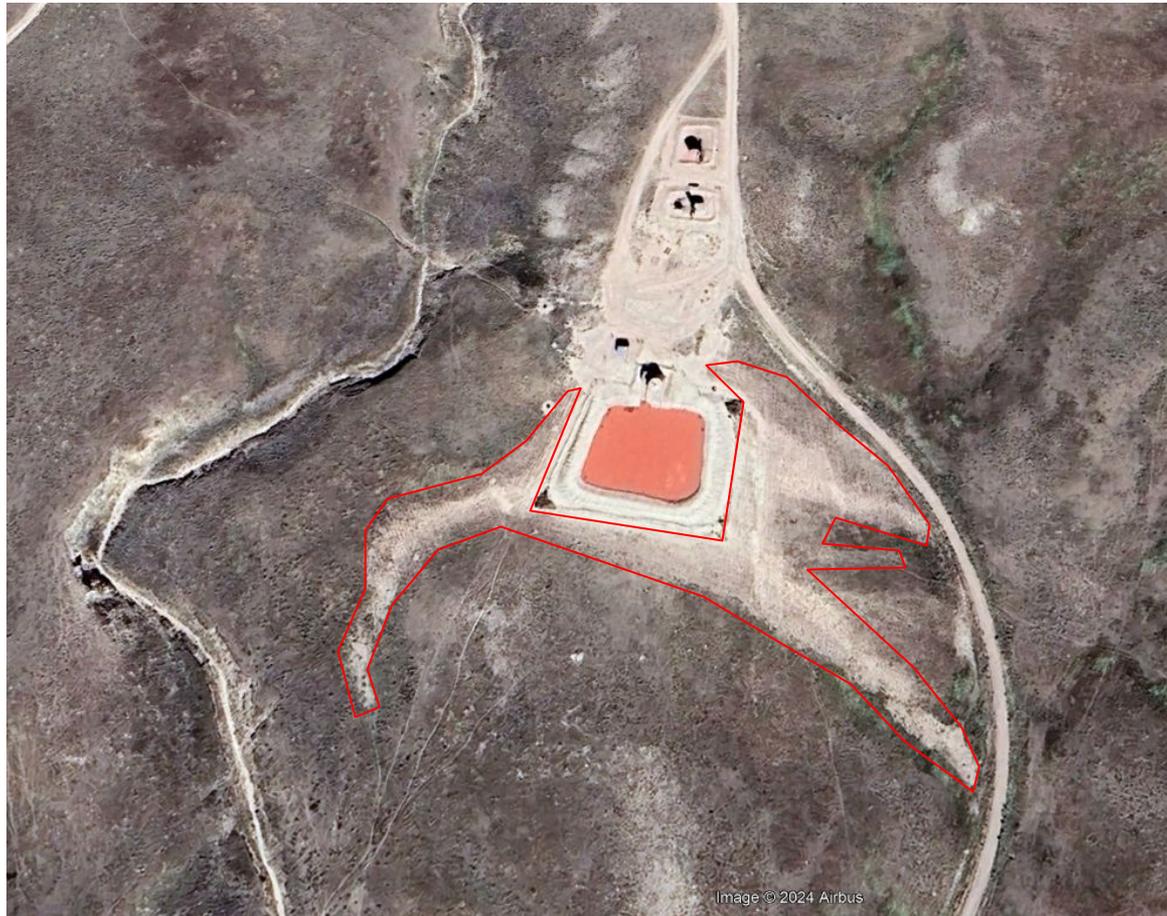
Photo 29. Google Earth aerial imagery taken circa 09/2023. Image illustrates the approximate extent of the impacted salt kill areas, highlighted in red. Note: the red outline is only an approximate extent as the Operator is required to fully delineate the extent of the salt kill impacts.

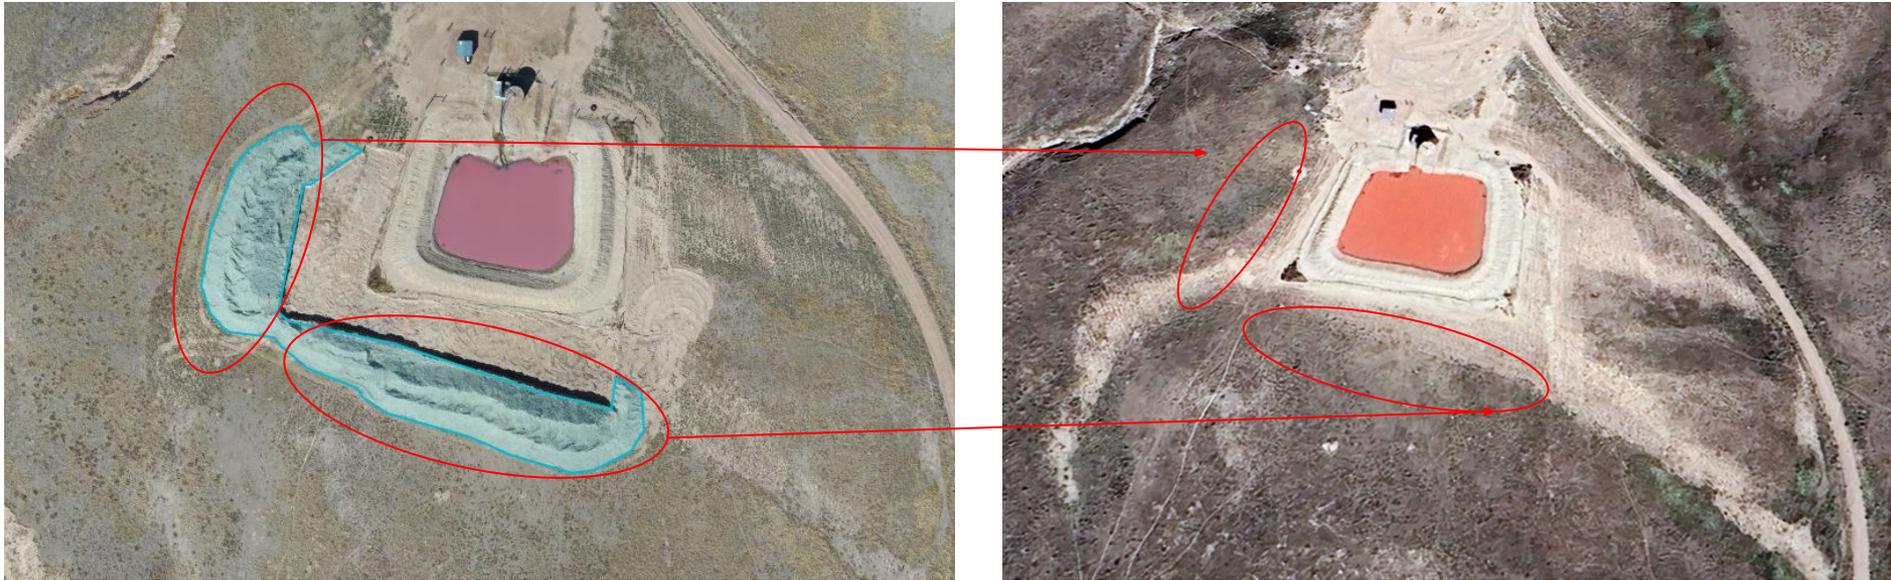
Photo 30 & 31. Drone aerial imagery (03/20/2024) on left; Google Earth Aerial imagery (circa 09/2023) on right. Red polygons illustrate approximate positions of stockpiled soil placed on undisturbed portions of land that also did not have any apparent topsoil salvage.
