Interim Reclamation and Stormwater Inspection

Date: 05/02/2024

Operator: WESTERN OPERATING COMPANY - 95620

Inspection Document #: 708201241

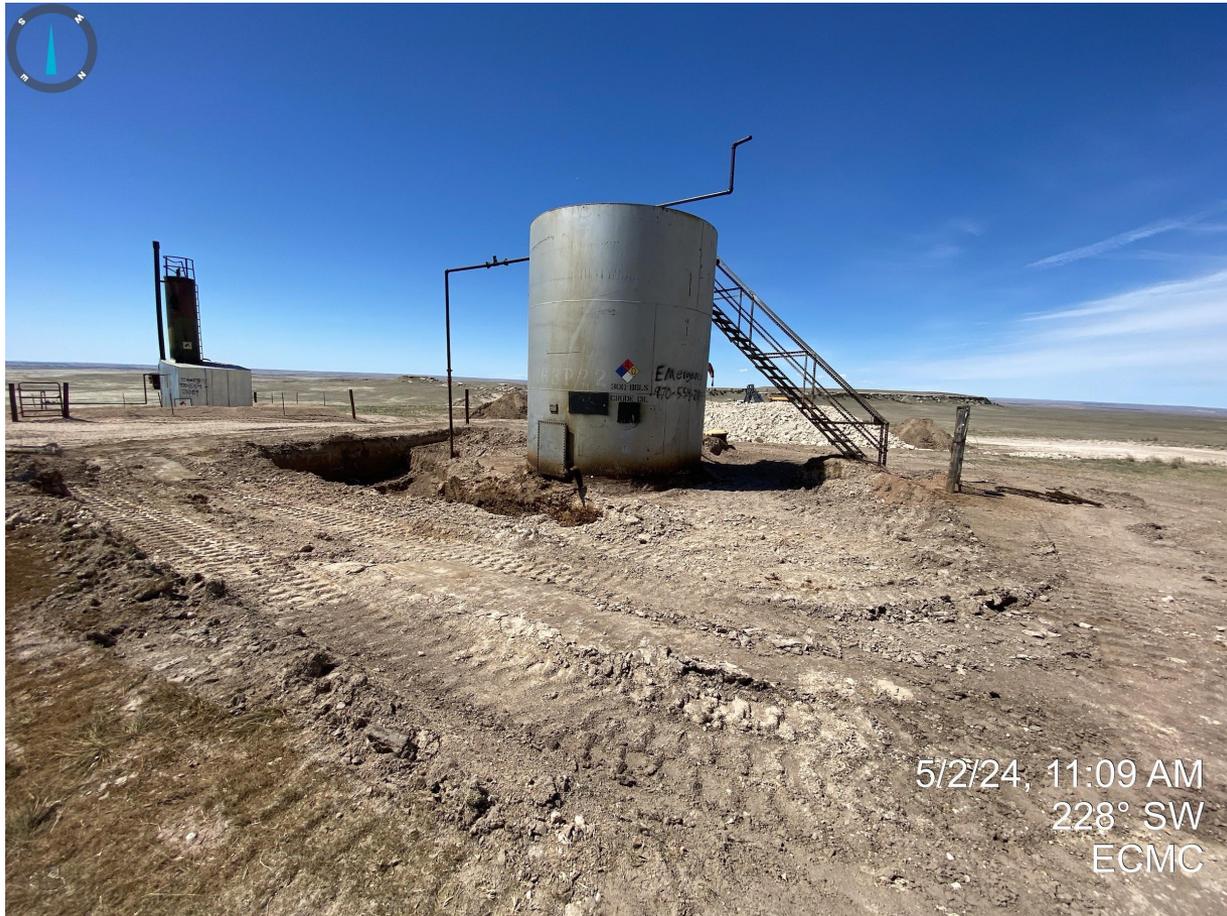
Photo 1. Free hydrocarbons previously observed within the tank battery secondary containment have been removed and the tank battery area has been excavated. Refer to Environmental FIR (doc #709100276) photo log from 04/29/2024 for additional.

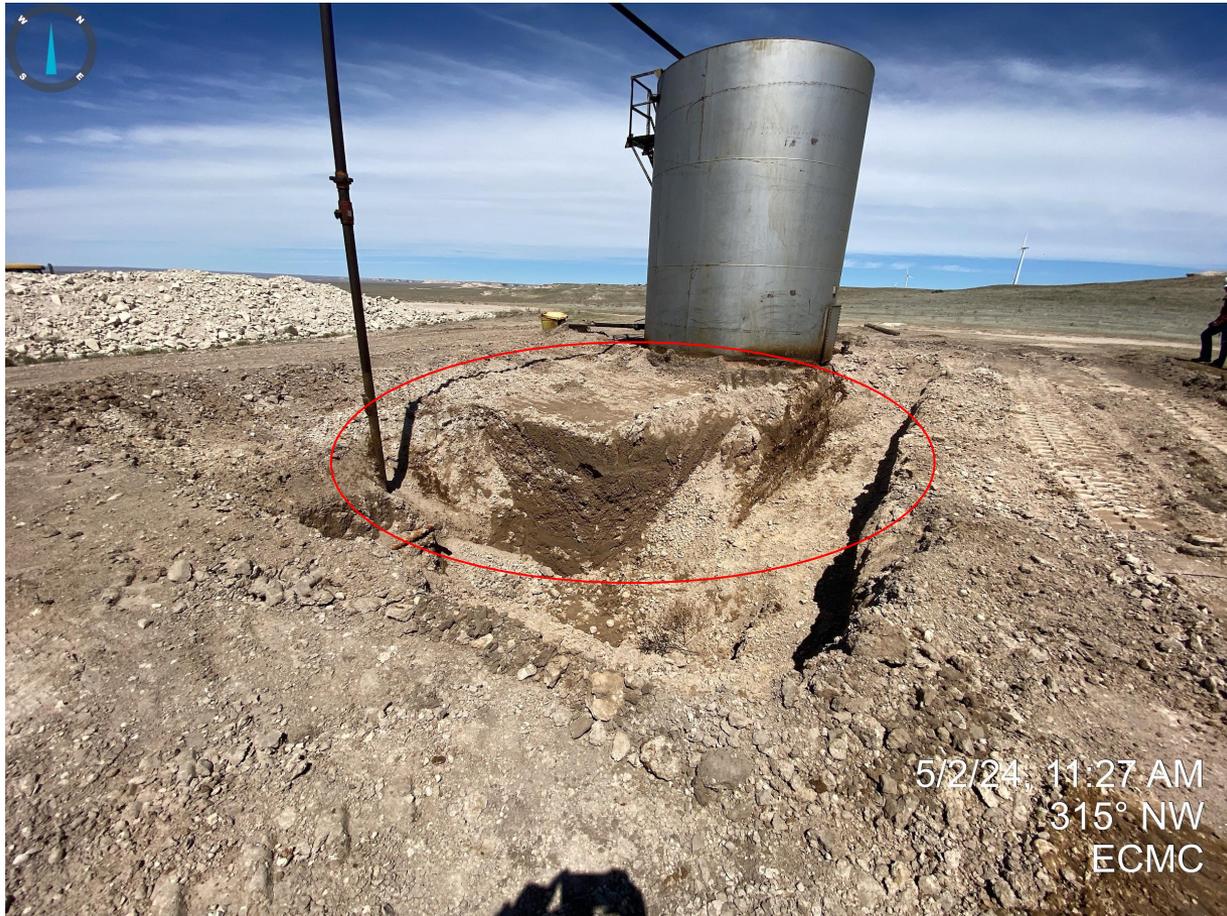
Photo 2. Facing northwest at tank battery; see comments in Photo 1.

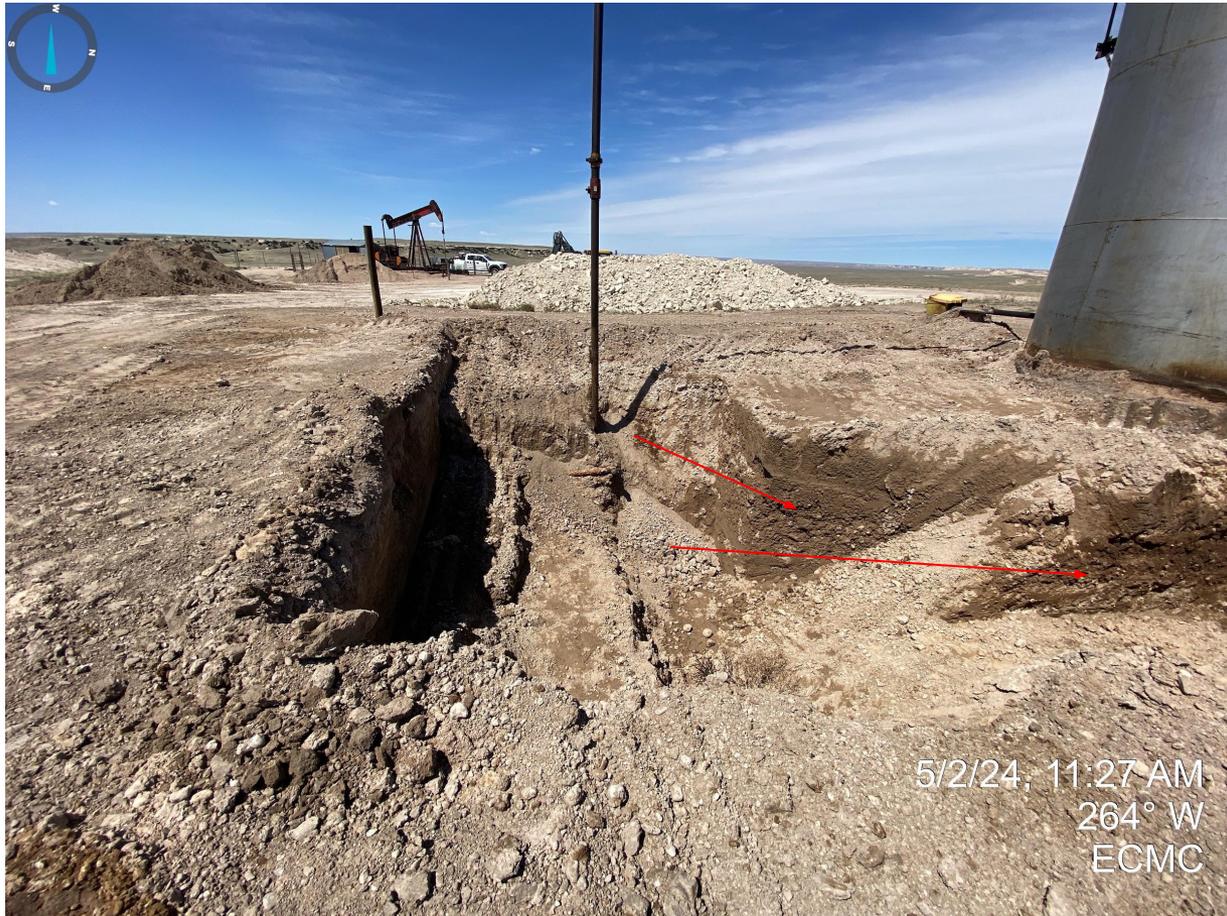
Photo 3. Facing west at tank battery; see comments in Photo 1.

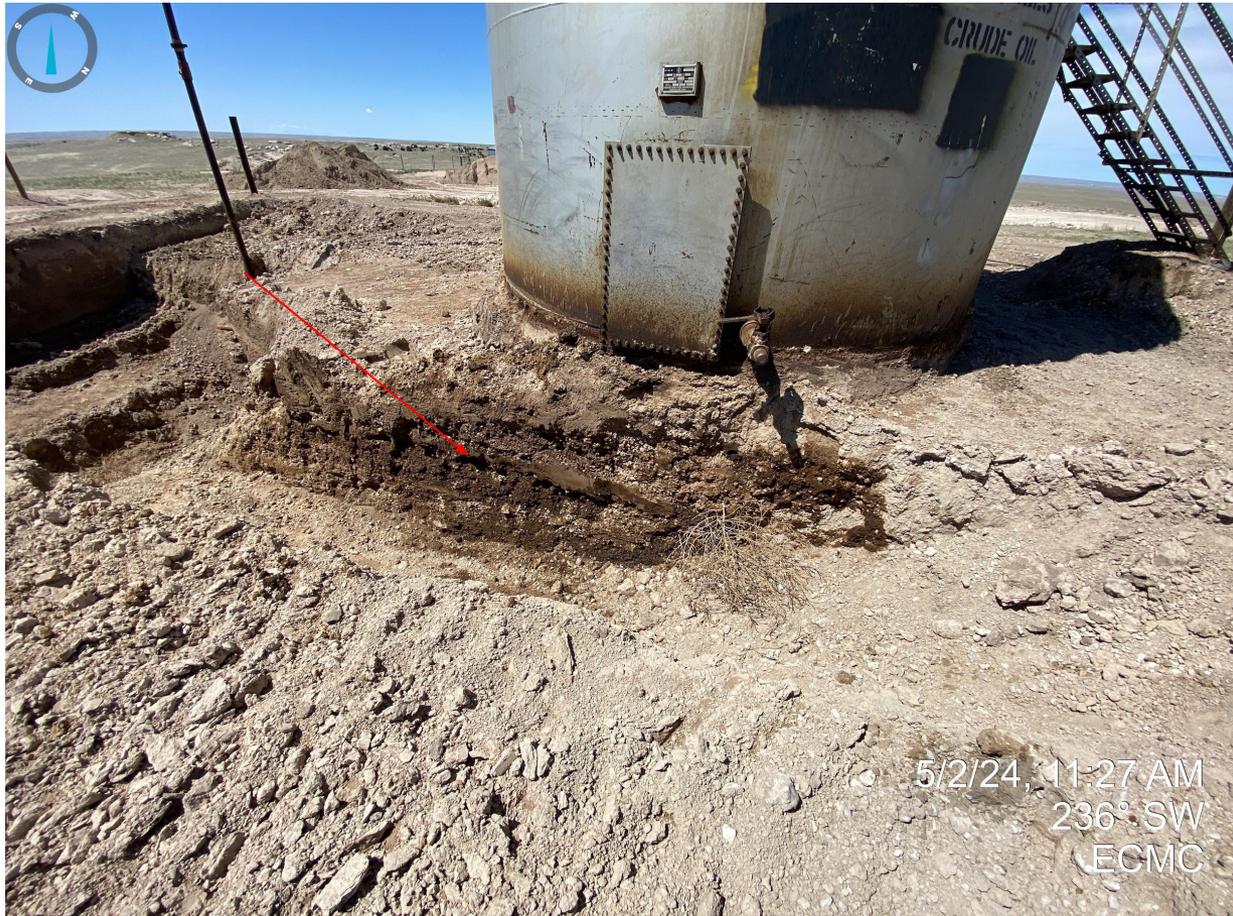
Photo 4. Facing southwest at tank battery; see comments in Photo 1.

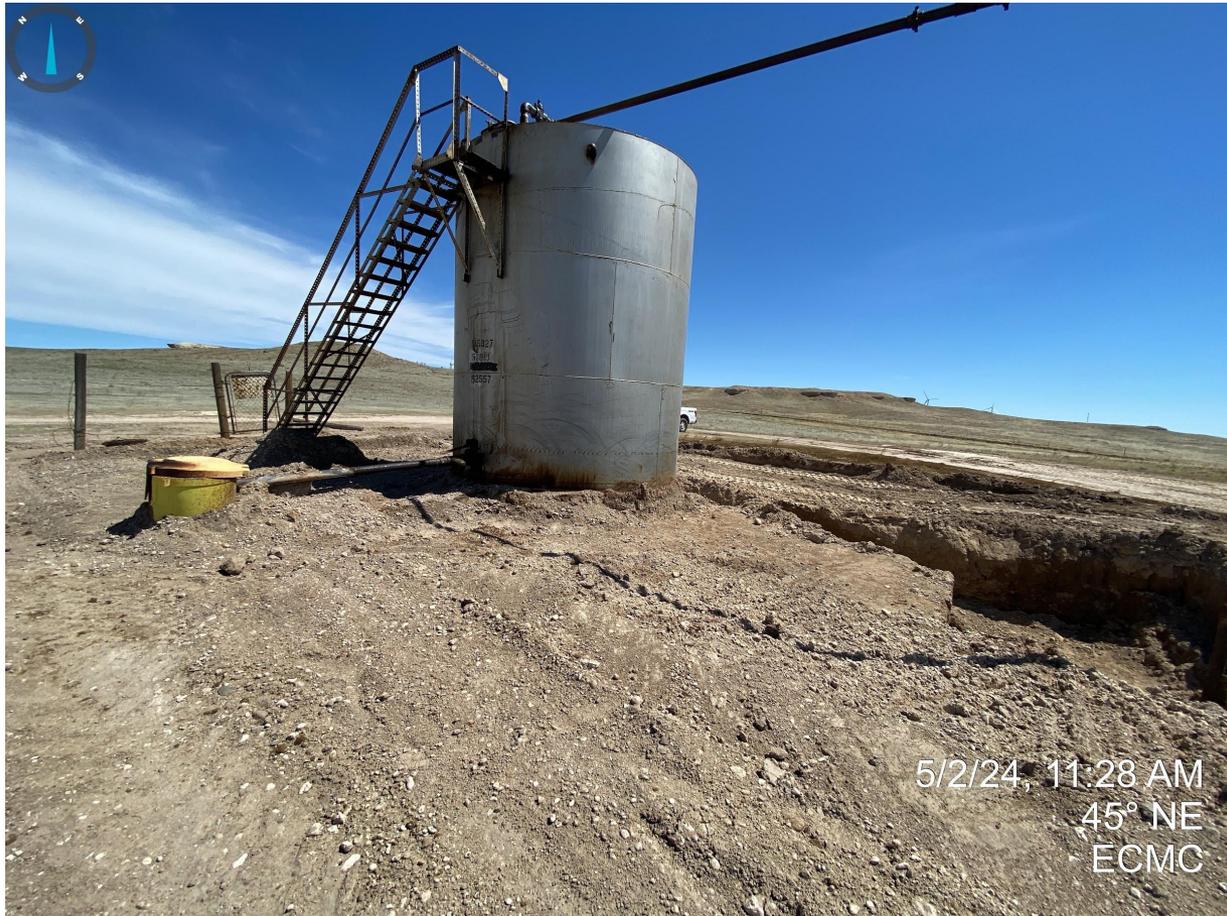
Photo 5. Facing northeast at tank battery; see comments in Photo 1.

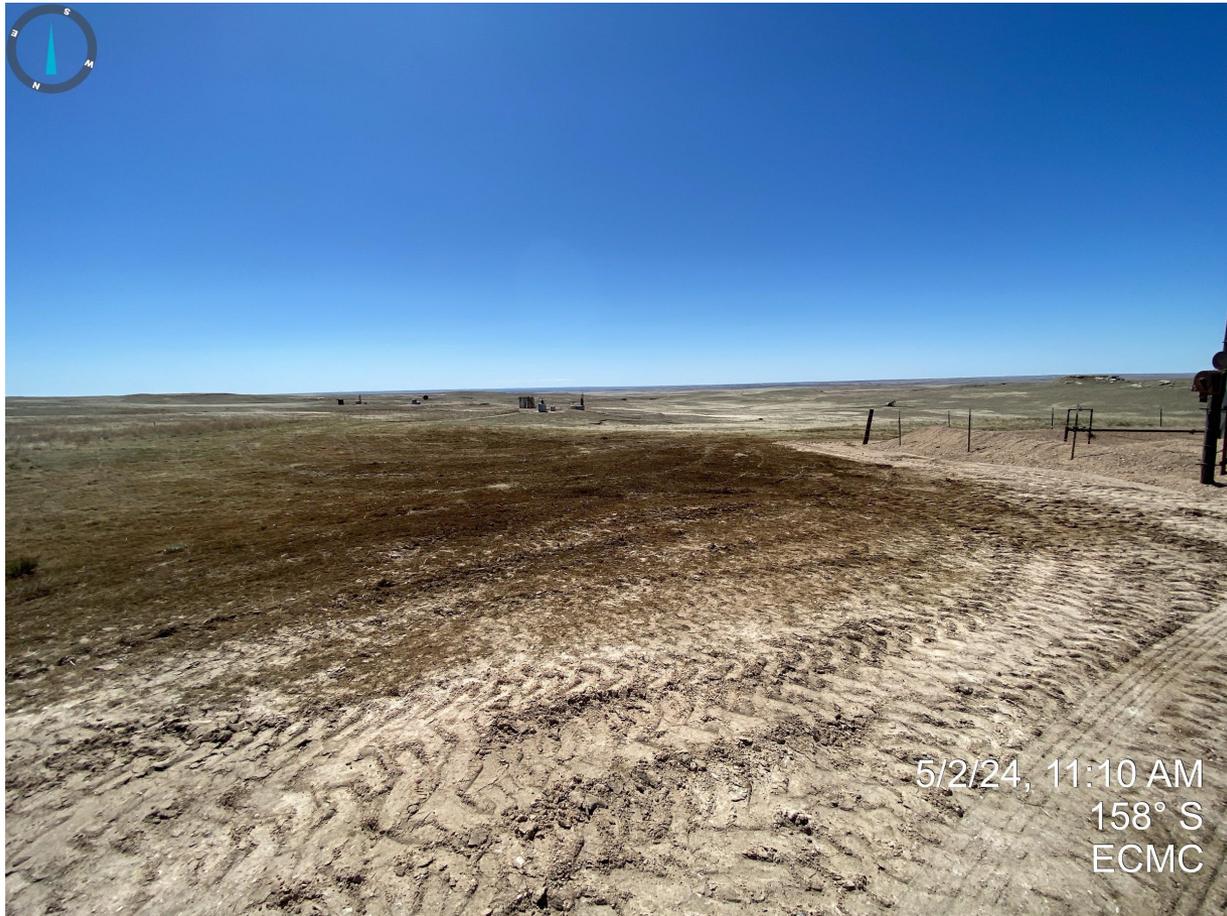
Photo 6. Taken east of the tank battery, facing south. Photo illustrates hydrocarbon impacts from spill/misting onto adjacent areas. It appears that the impacted area was mowed at the time of this inspection.

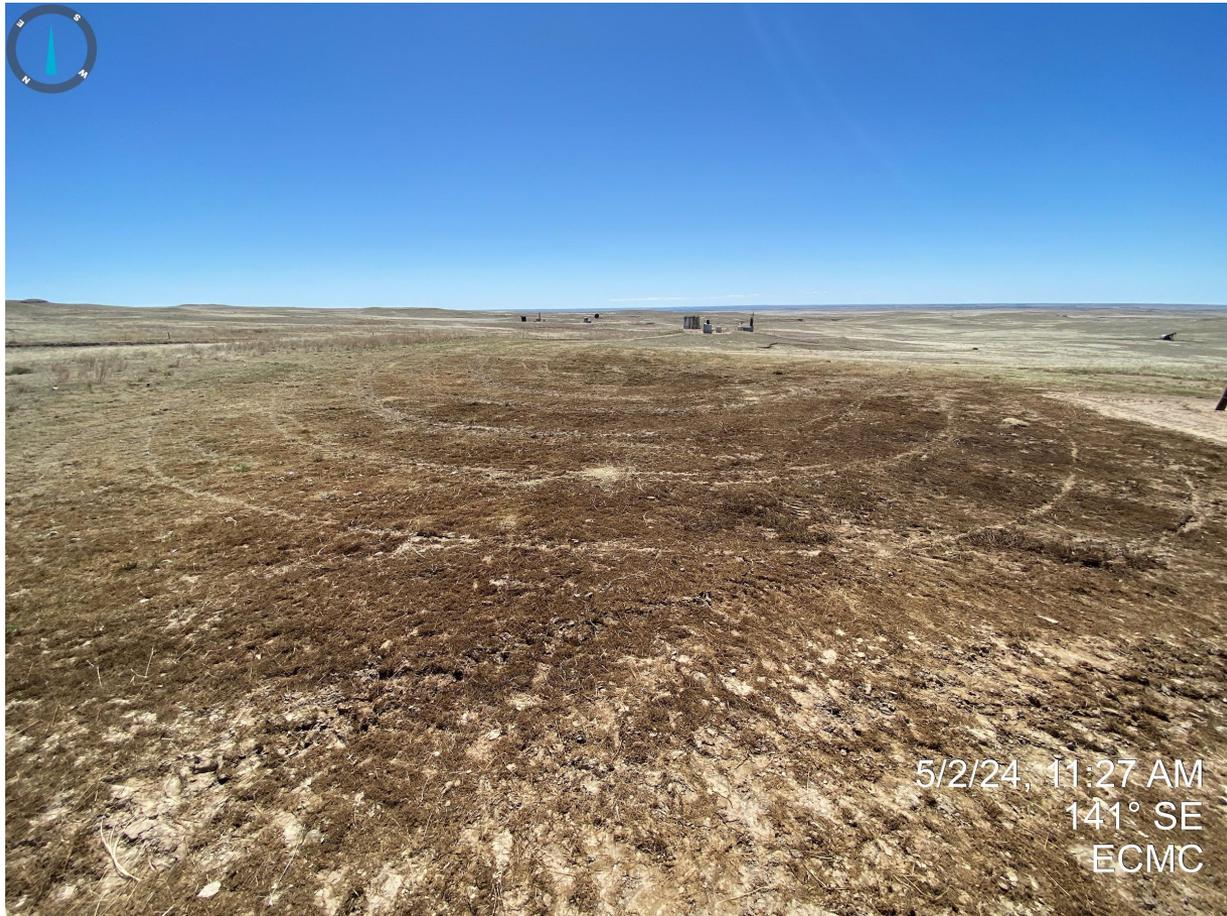
Photo 7. Facing southeast; see comments in Photo 6.

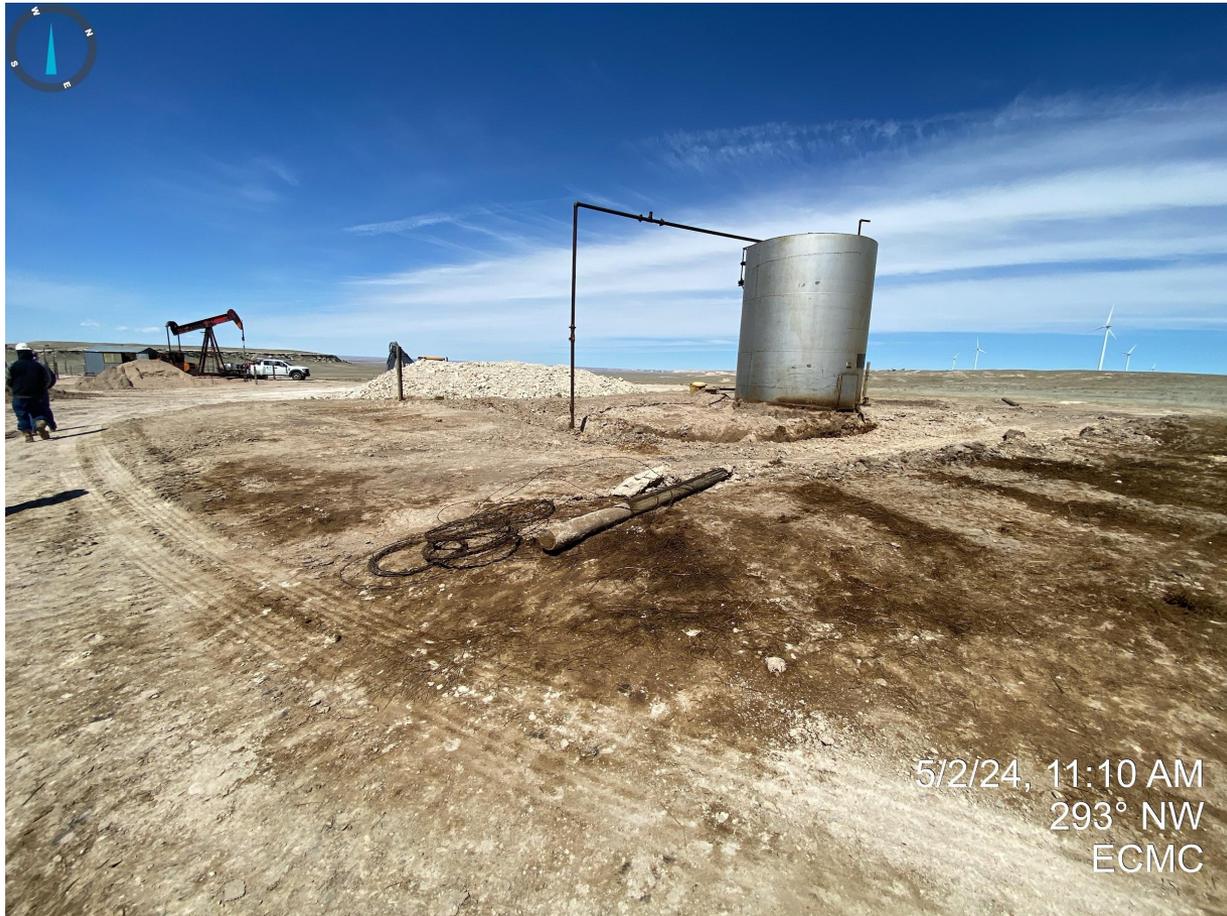
Photo 8. Hydrocarbon impacts observed east/southeast of the tank battery.

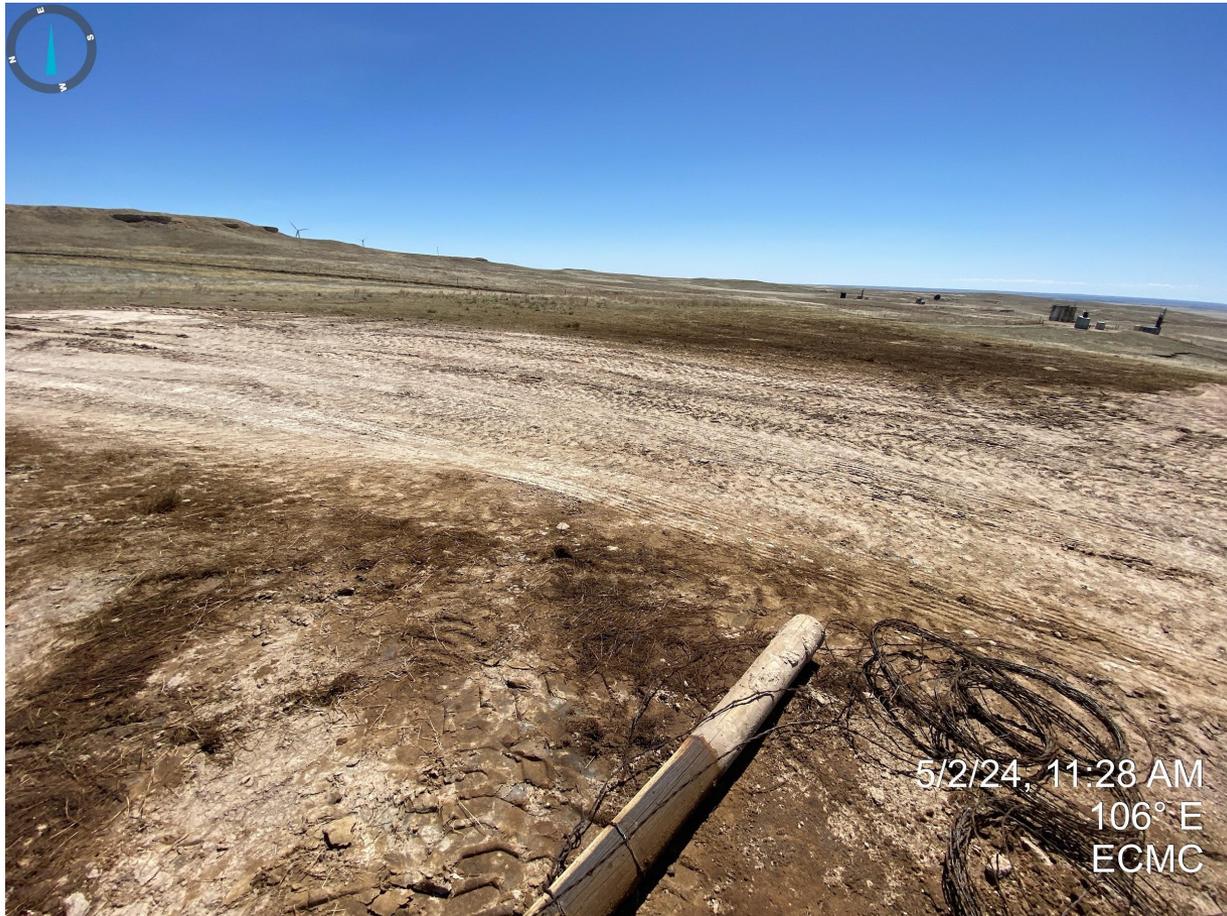
Photo 9. Taken near the tank battery, facing east. See comments in Photo 8.

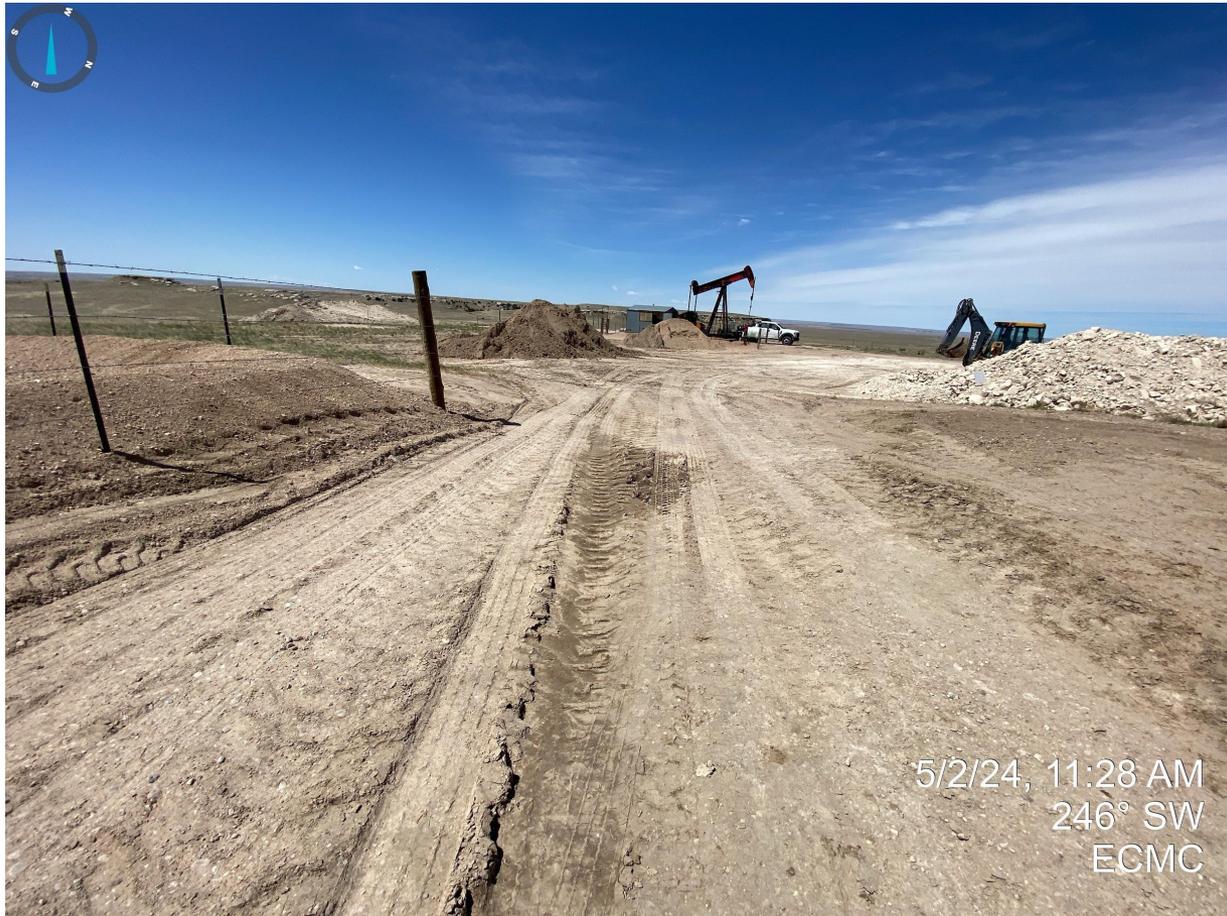
Photo 10. Hydrocarbon impacts previously observed on the production areas/access road appear to have been removed.

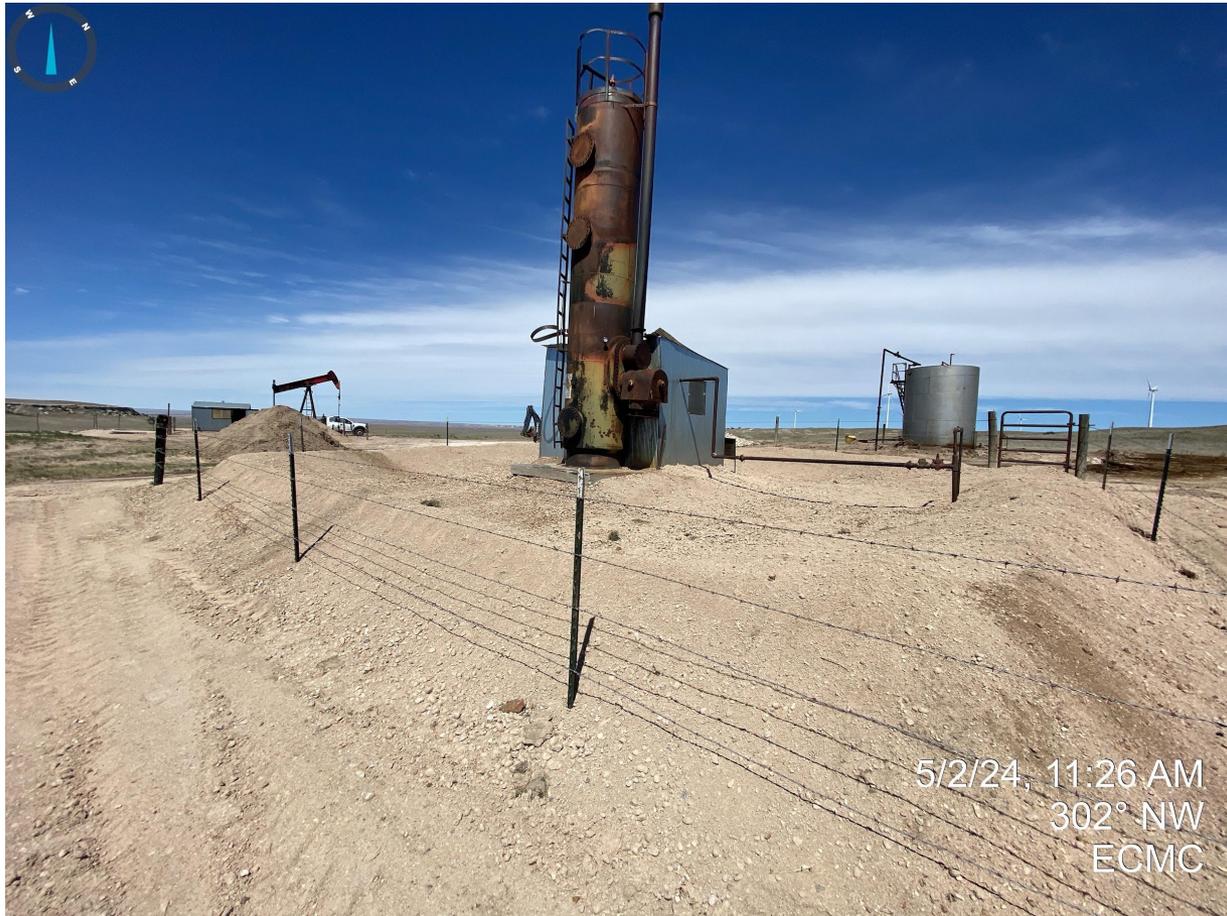
Photo 11. Taken south of the vertical heater treater. Hydrocarbon impacts previously observed appear to have been removed.

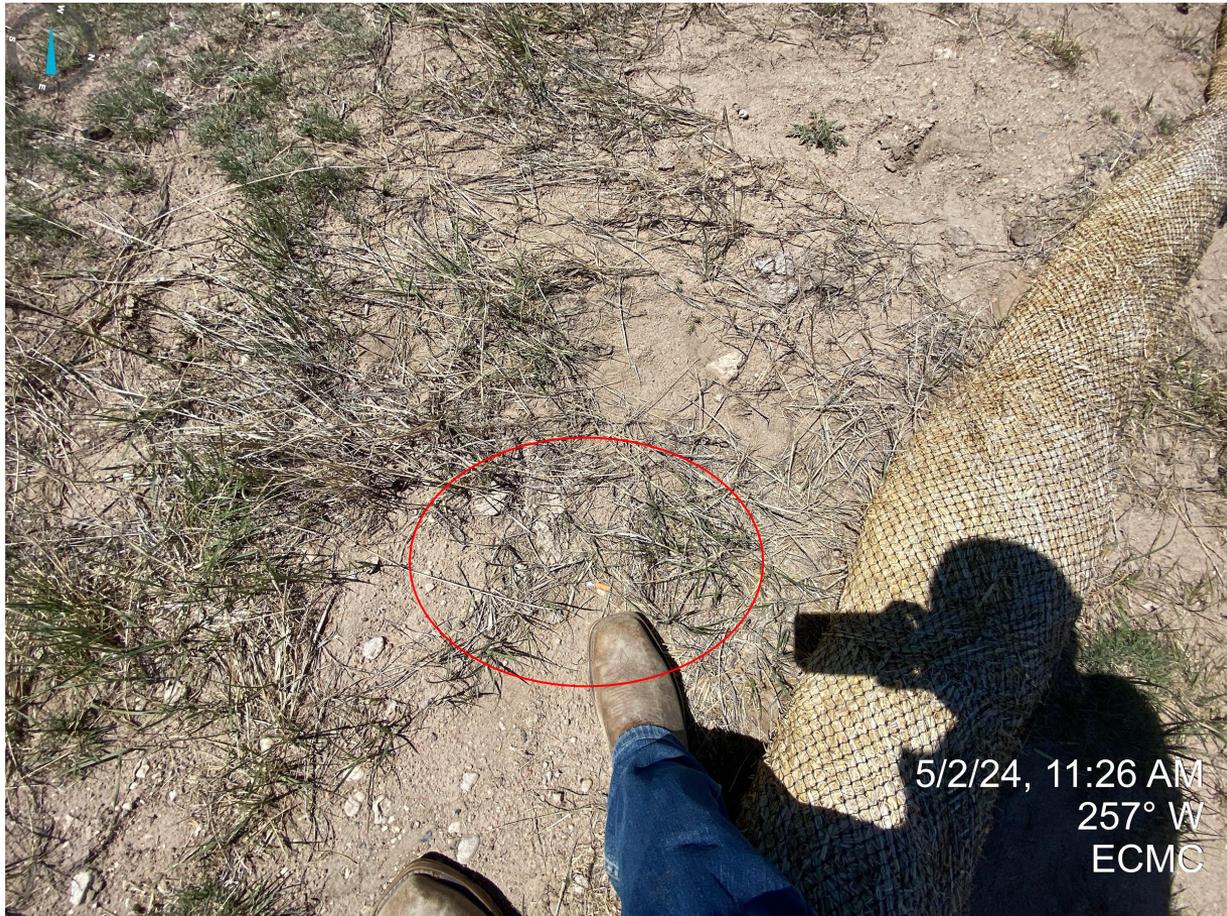
Photo 12. Examples of cigarette butt observed on location, south of the vertical heater treater.

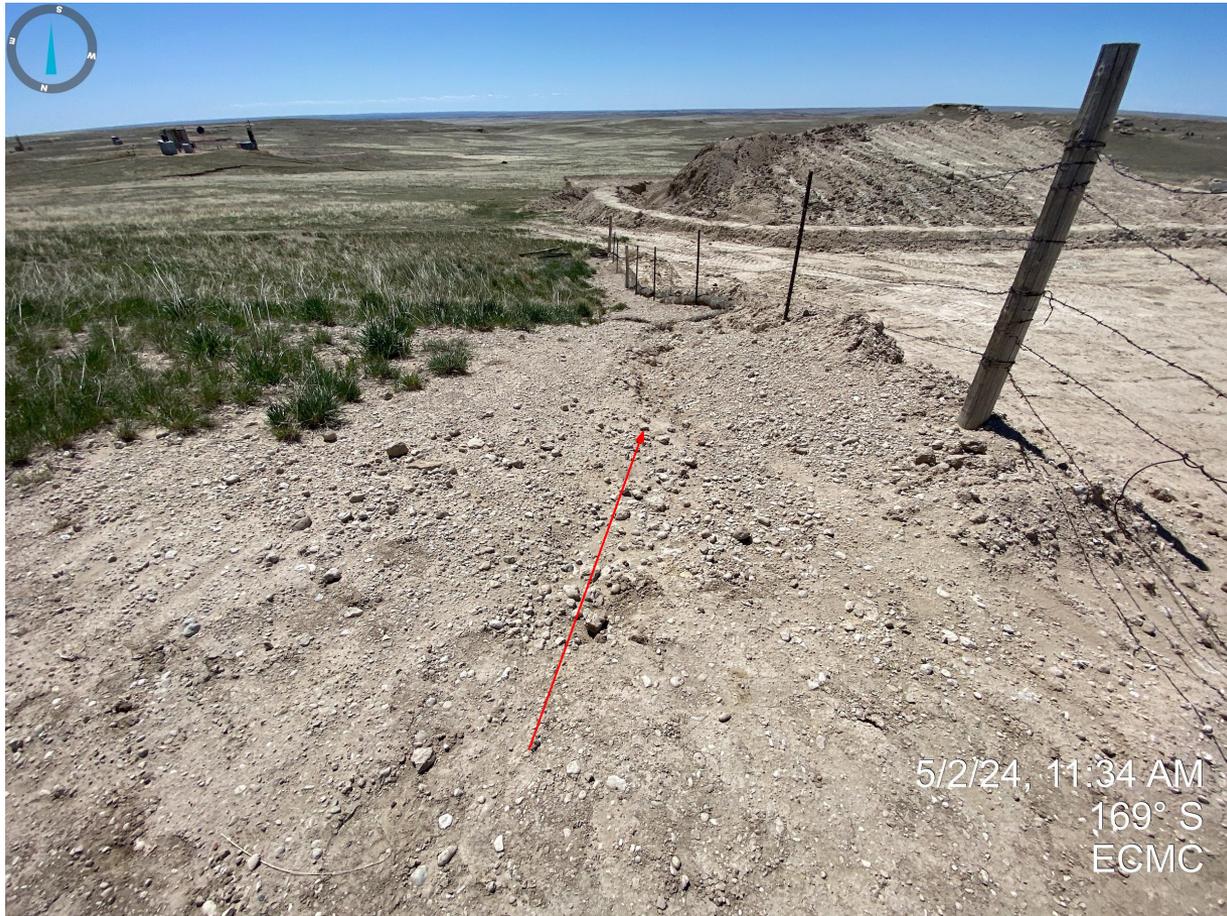
Photo 13. Erosion degradation on the east side of the pit. No stormwater control measures/BMPs observed.

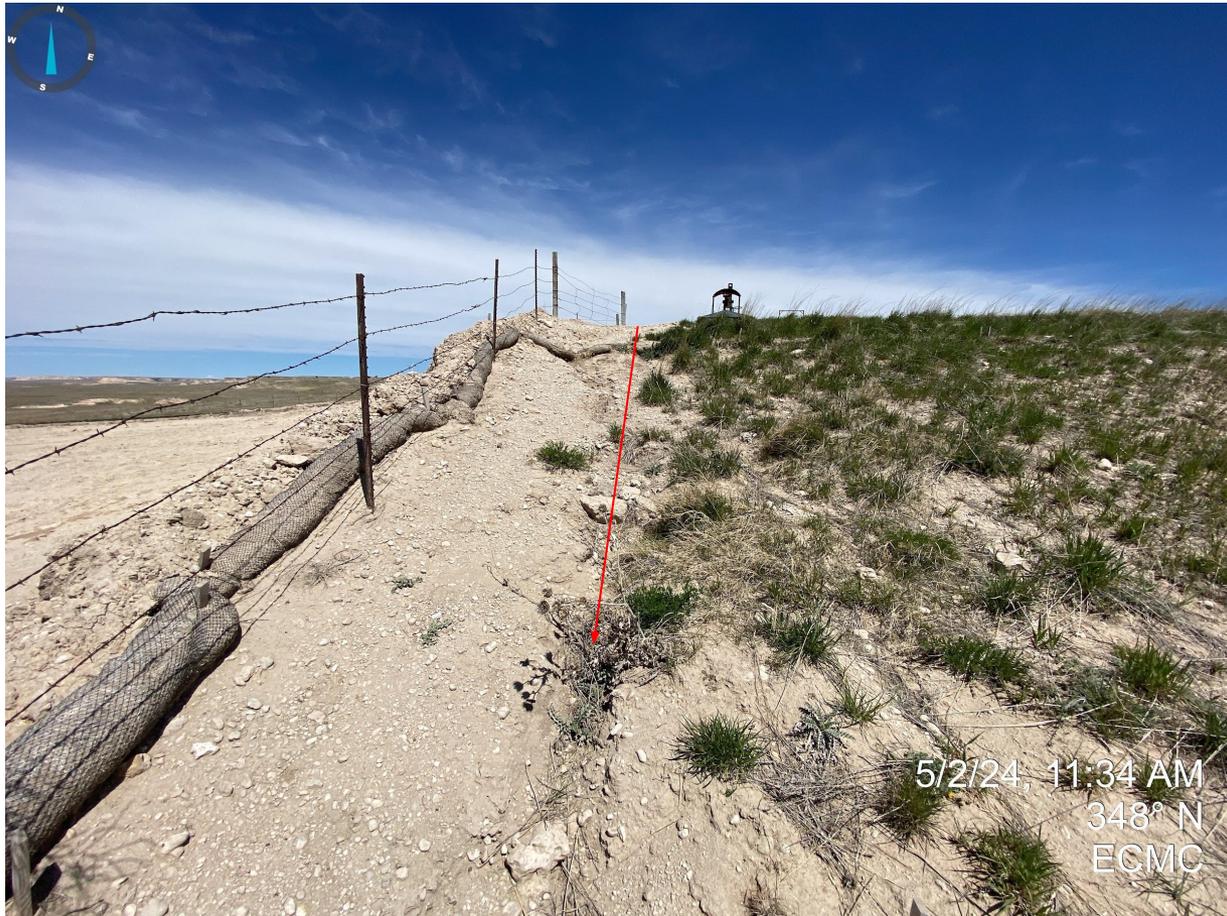
Photo 14. Erosion degradation on the east side of the pit.

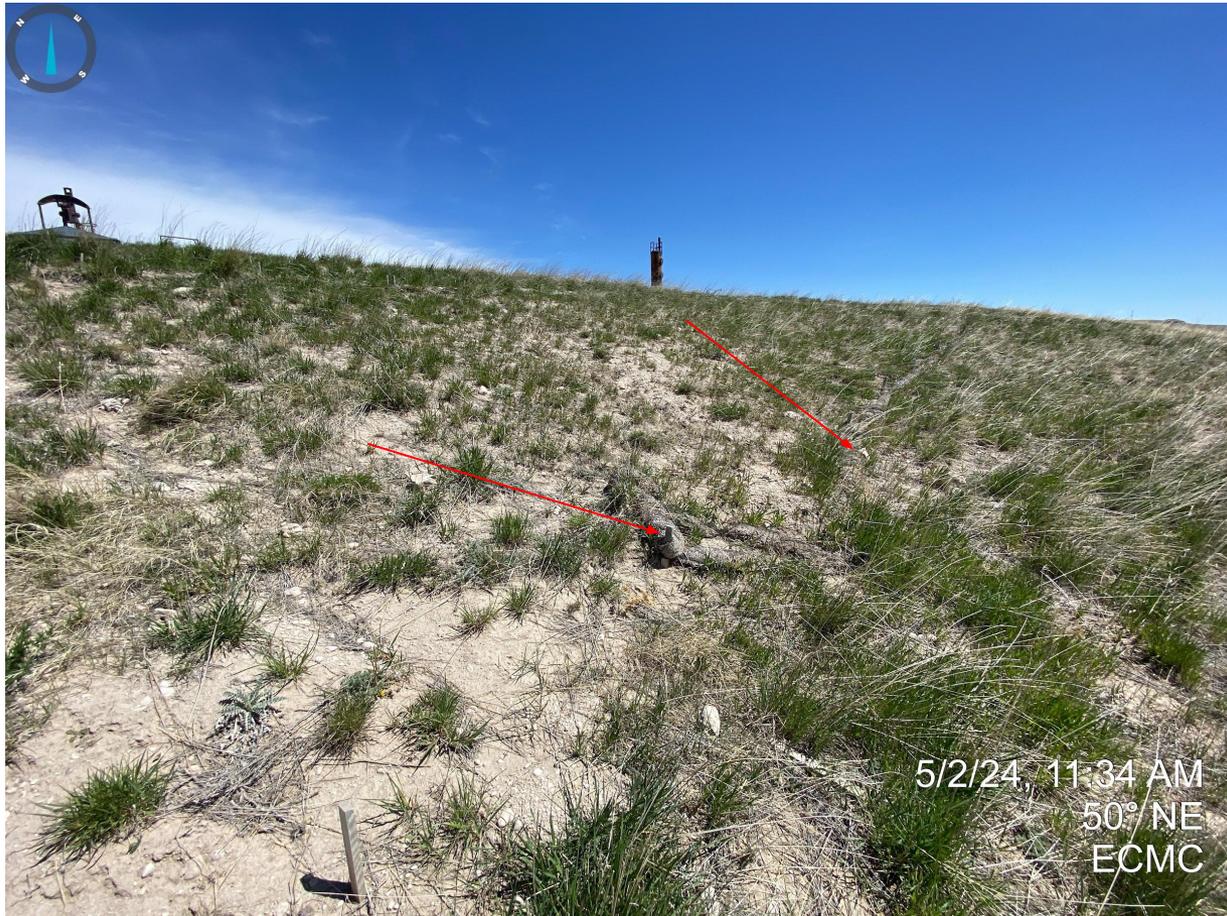
Photo 15. Degraded straw wattles are considered debris as they're beginning to fill with sediment and are no longer adequate or in proper working condition.

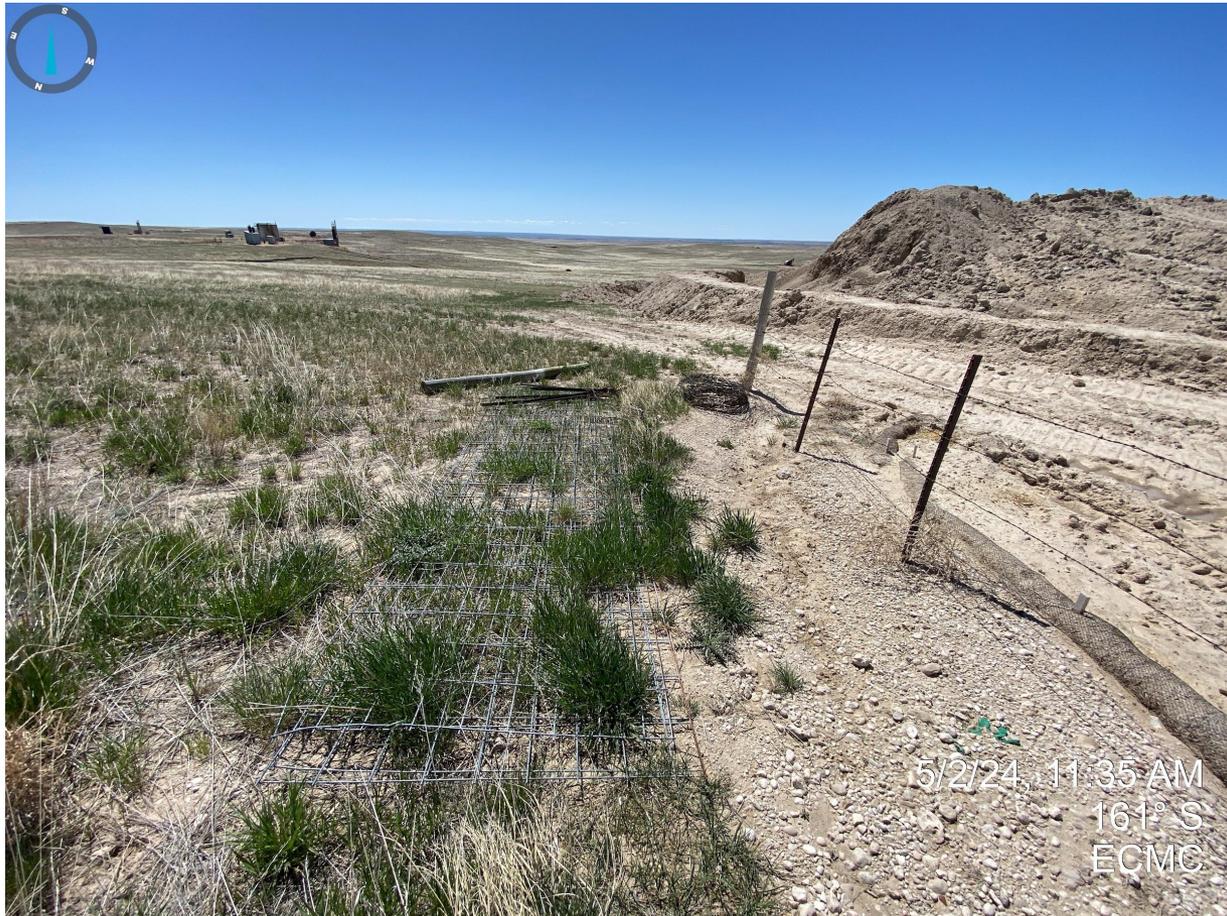
Photo 16. Fencing materials are considered unused equipment/debris and need to be removed or returned to service.

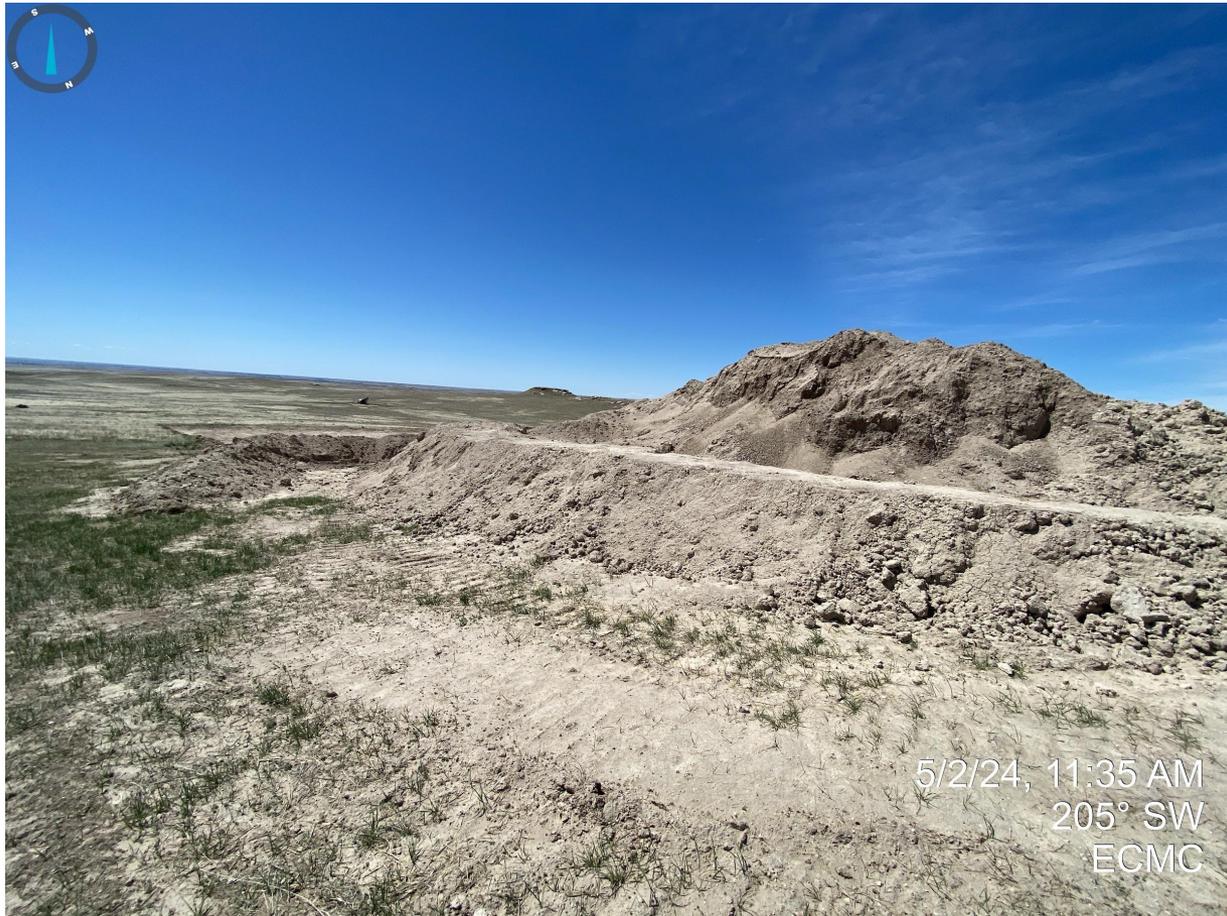
Photo 17. East side of stockpiled pit soils. Photo illustrates that both the stockpile and berms have been left unconsolidated. Unconsolidated materials can become a potential pollution source as it is not properly stabilized. Berms also appear to be built out of impacted material from the salt kill/pit excavation.

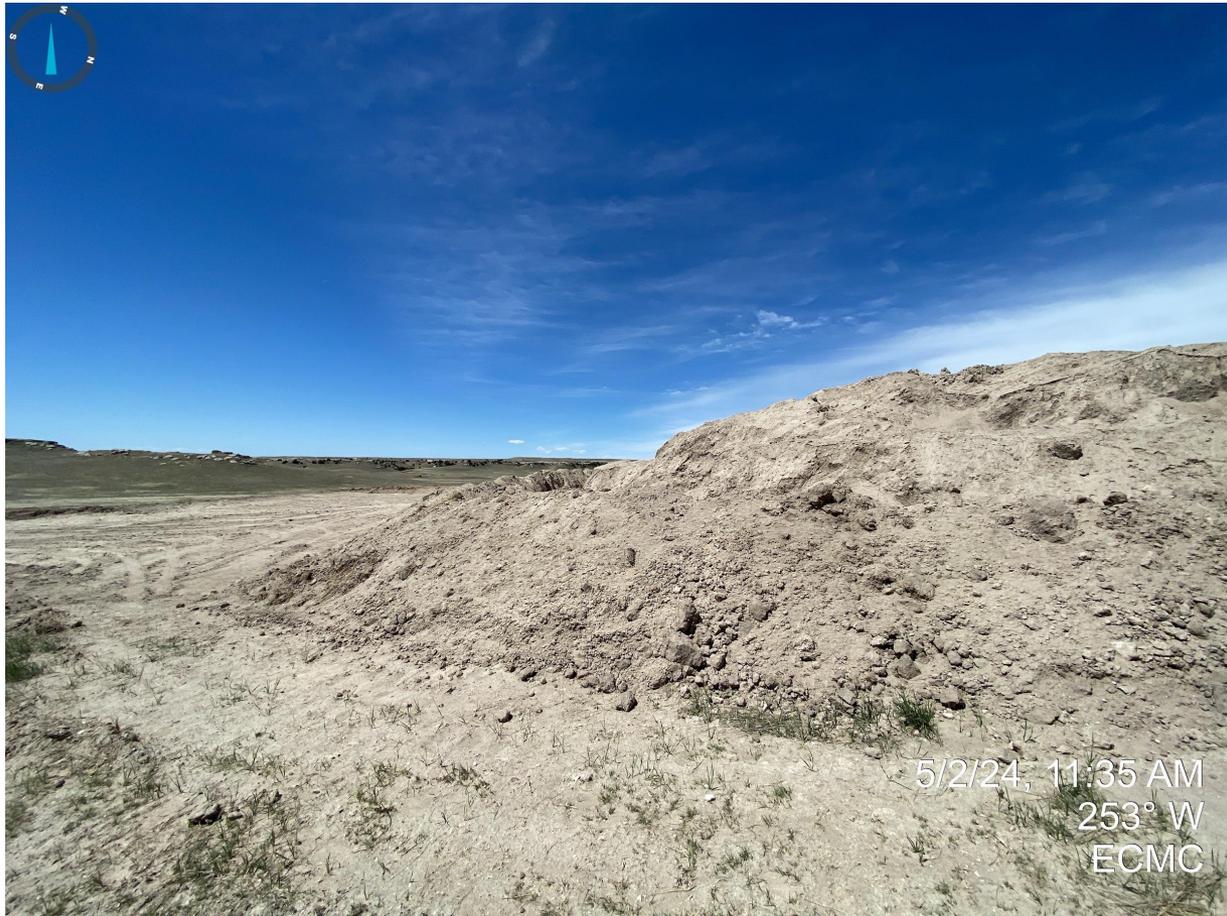
Photo 18. Close up of unconsolidated soils; see comments in Photo 17.

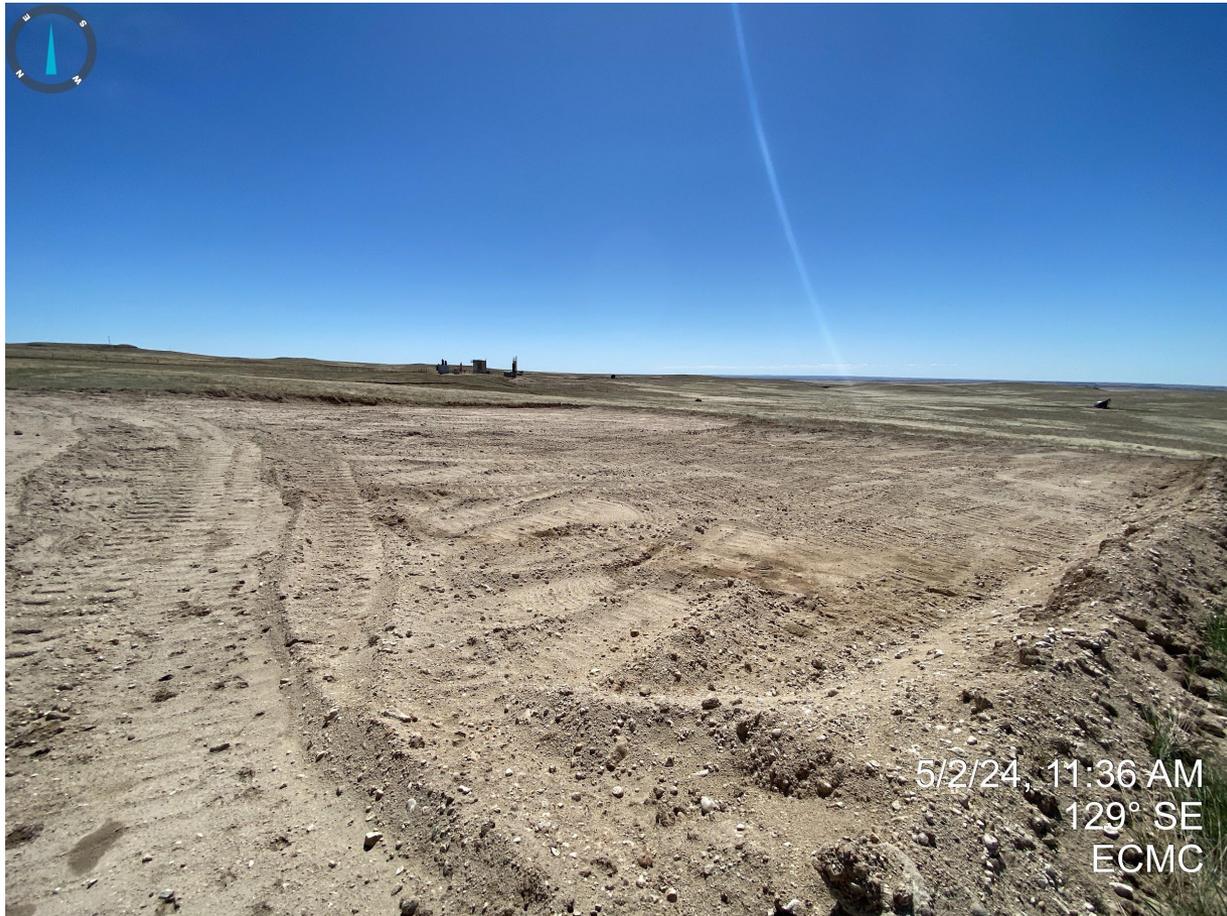
Photo 19. An area approximately 0.50 acres in size has been excavated south of the pit and stockpile. No evidence of stormwater controls measures were observed around the perimeter of the excavated salt kill impacted area.

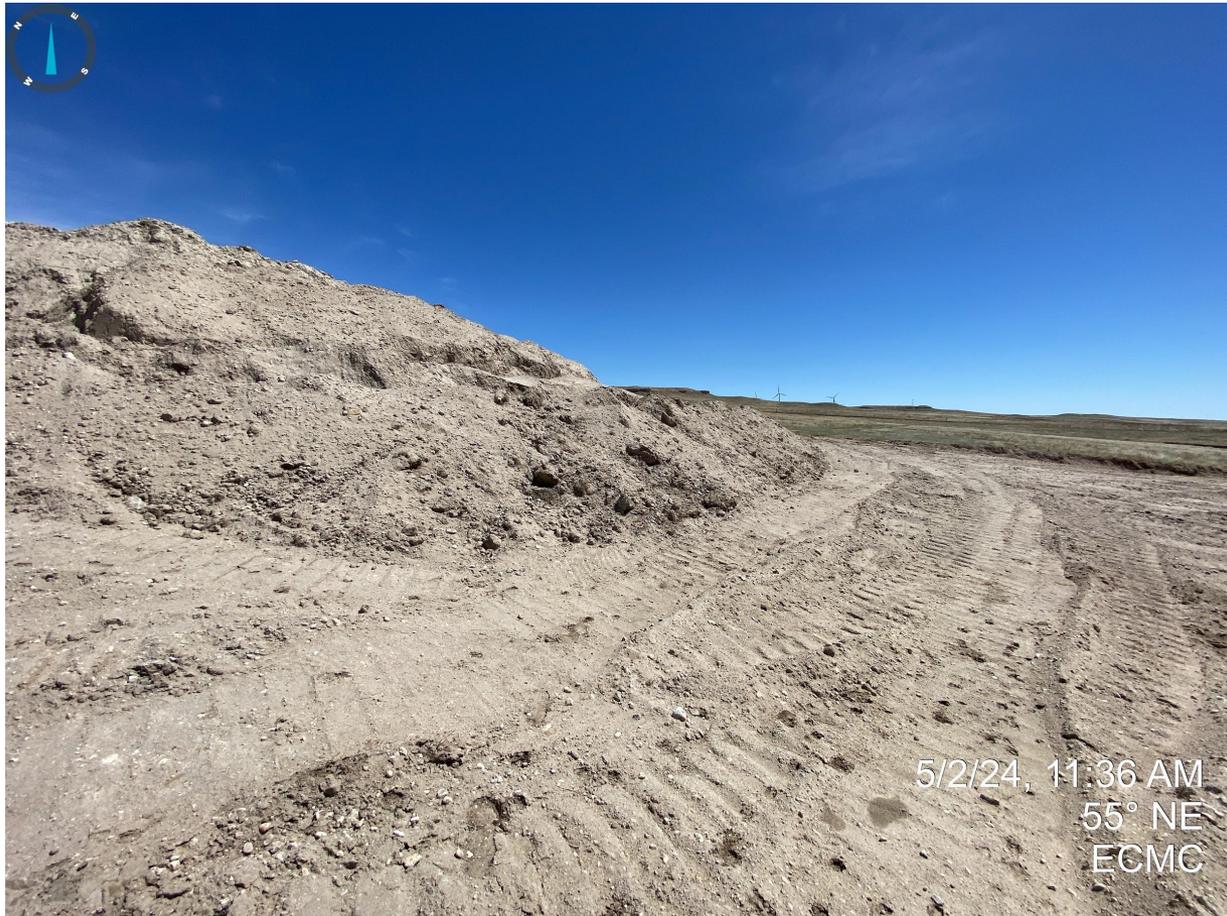
Photo 20. West side of the southern topsoil stockpile; see comments in Photo 17.
