Interim Reclamation and Stormwater Inspection

Date: 05/02/2024

Operator: WESTERN OPERATING COMPANY - 95620

Inspection Document #: 708201241

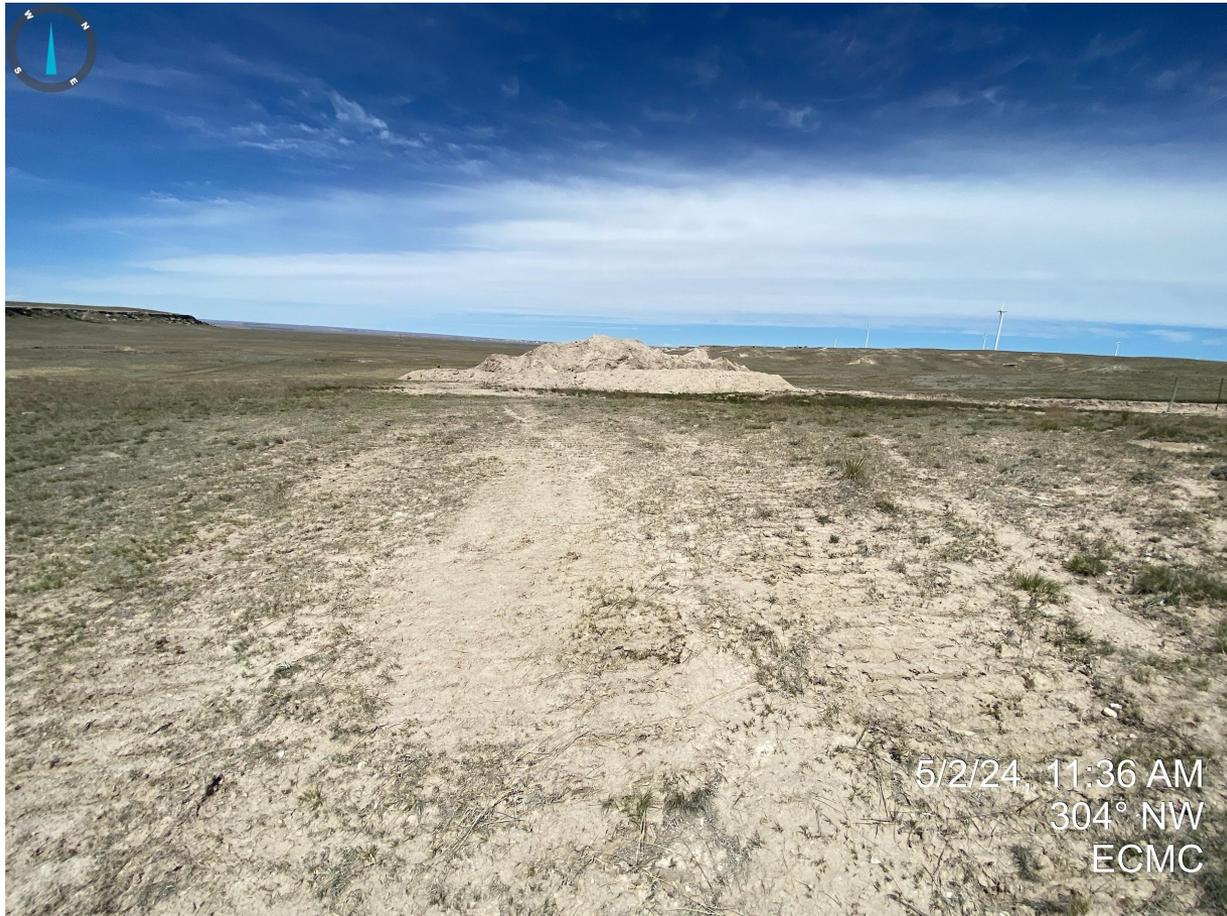
Photo 21. Additional disturbance observed south of the salt kill impacted areas. Any disturbance will need to be reclaimed per the reclamation rules as the area is now susceptible to wind and water erosion degradation.

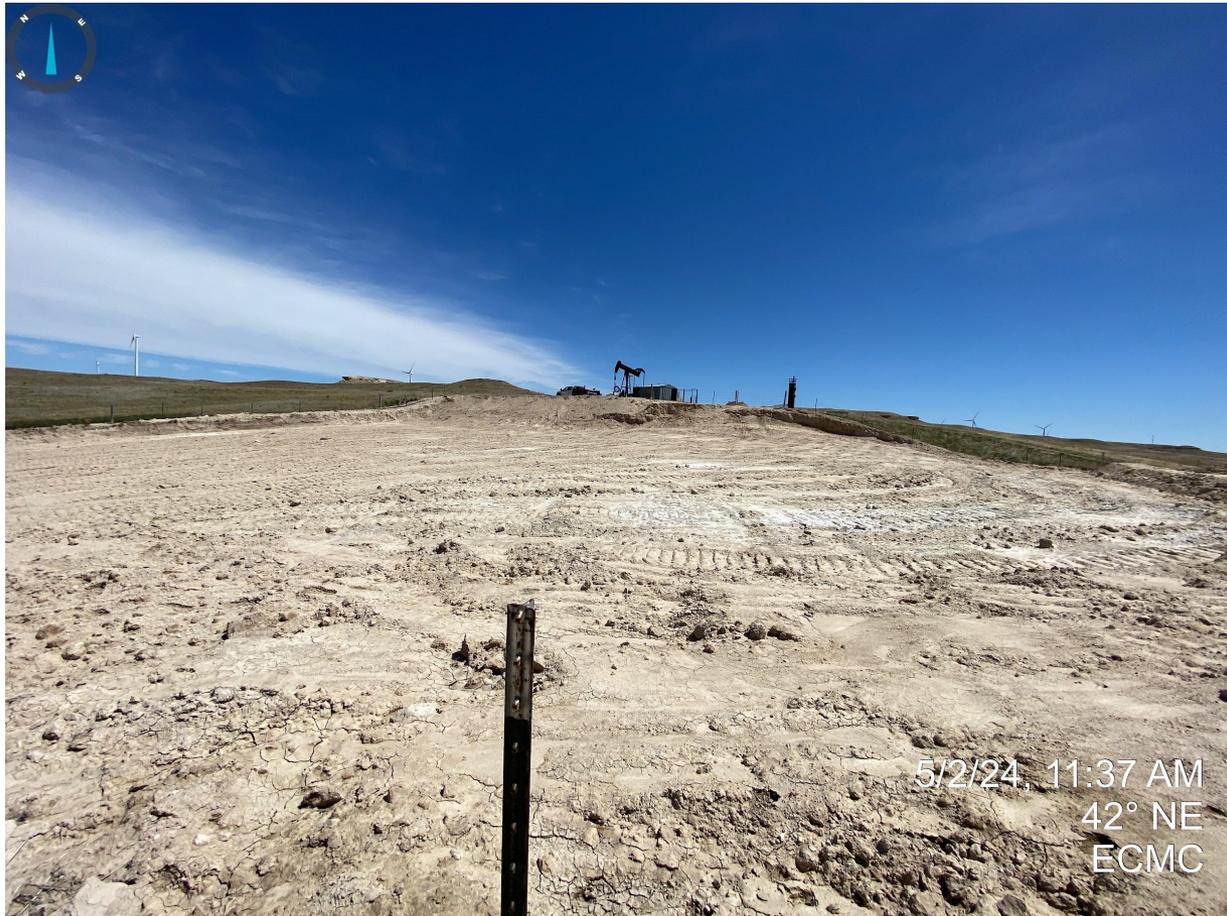
Photo 22. Overview of excavated pit and salt kill area. Soils do not appear to be properly stabilized from wind and water erosion degradation. The open excavation is not properly fenced to exclude wildlife, livestock or unauthorized personnel.

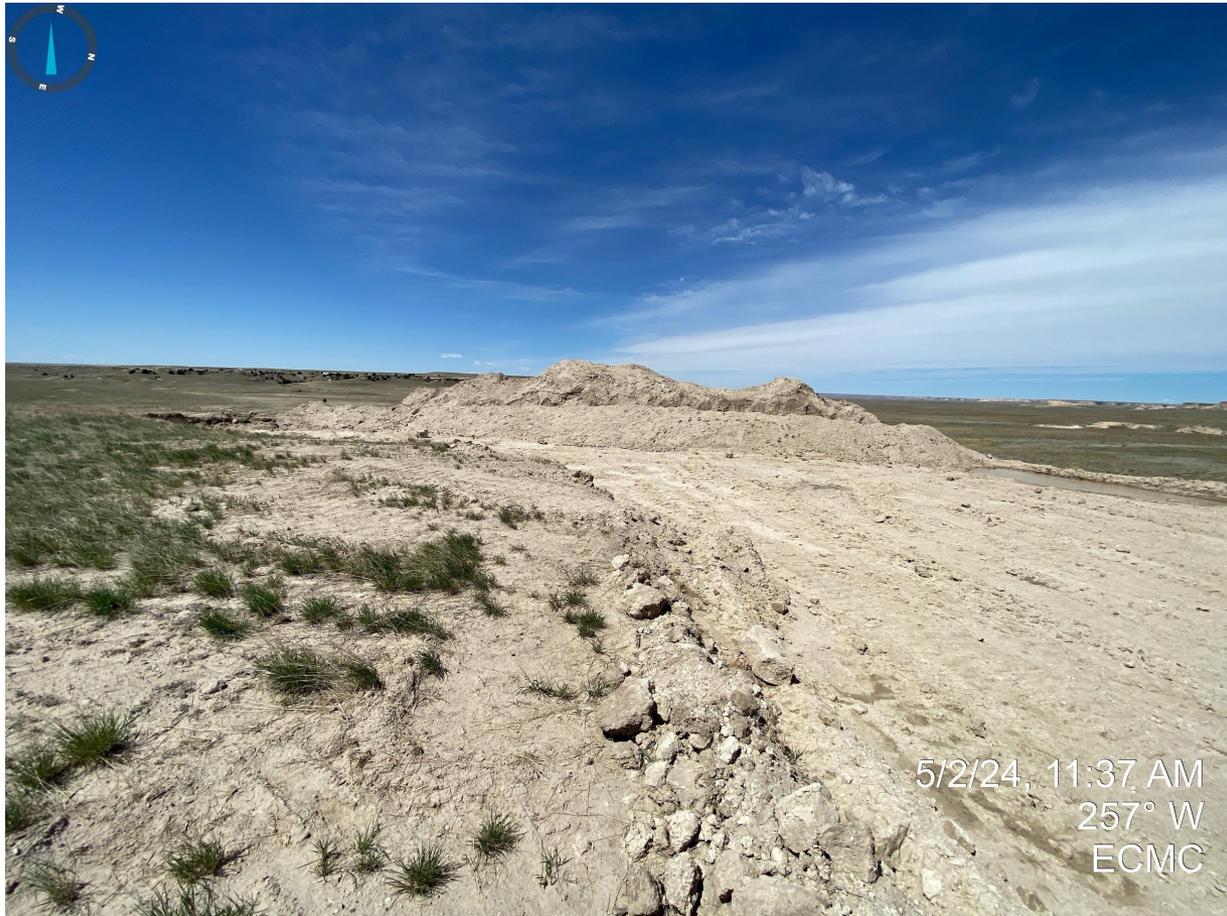
Photo 23. Overview of excavated pit and salt kill area. Soils do not appear to be properly stabilized from wind and water erosion degradation. The open excavation is not properly fenced to exclude wildlife, livestock or unauthorized personnel.

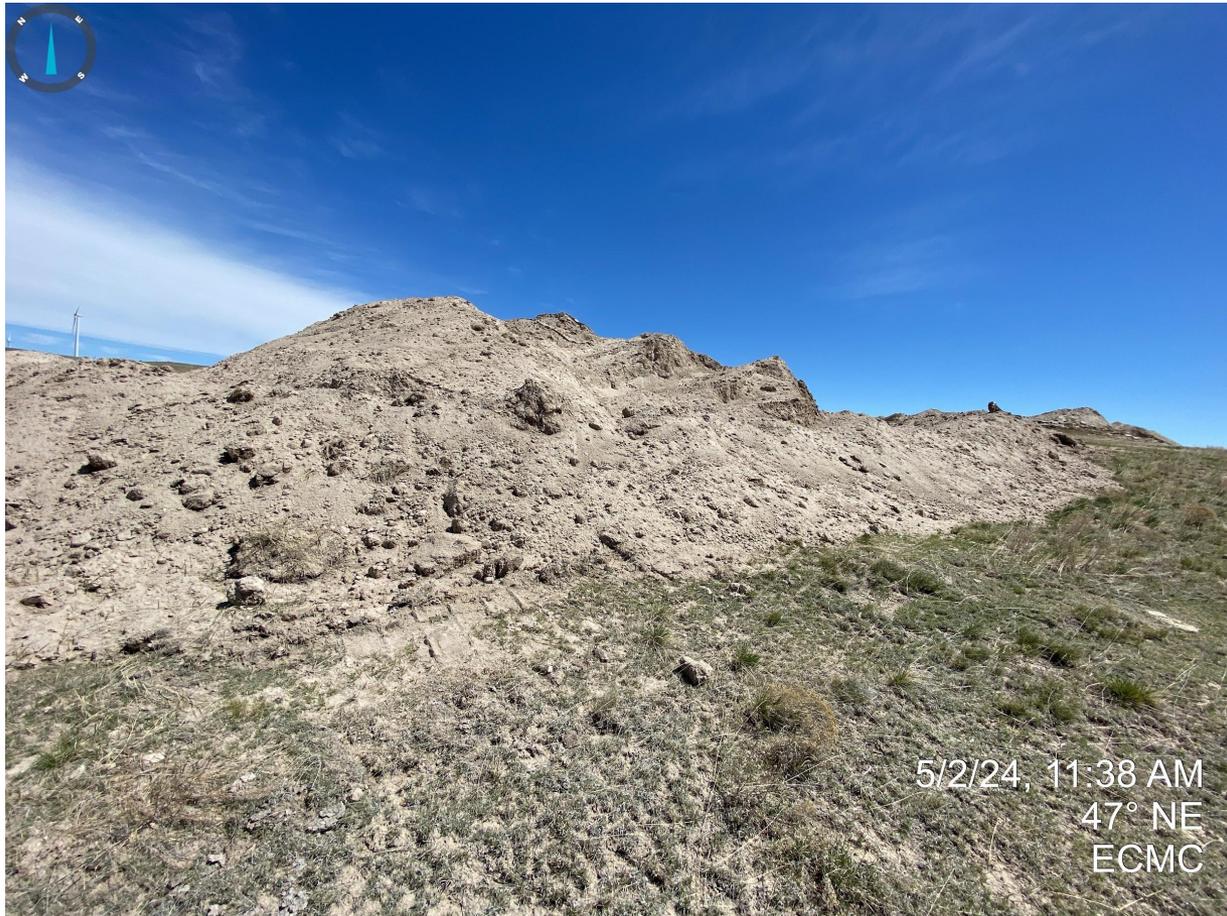
Photo 24. Western stockpiled material is not properly stabilized with evidence of unconsolidated materials.

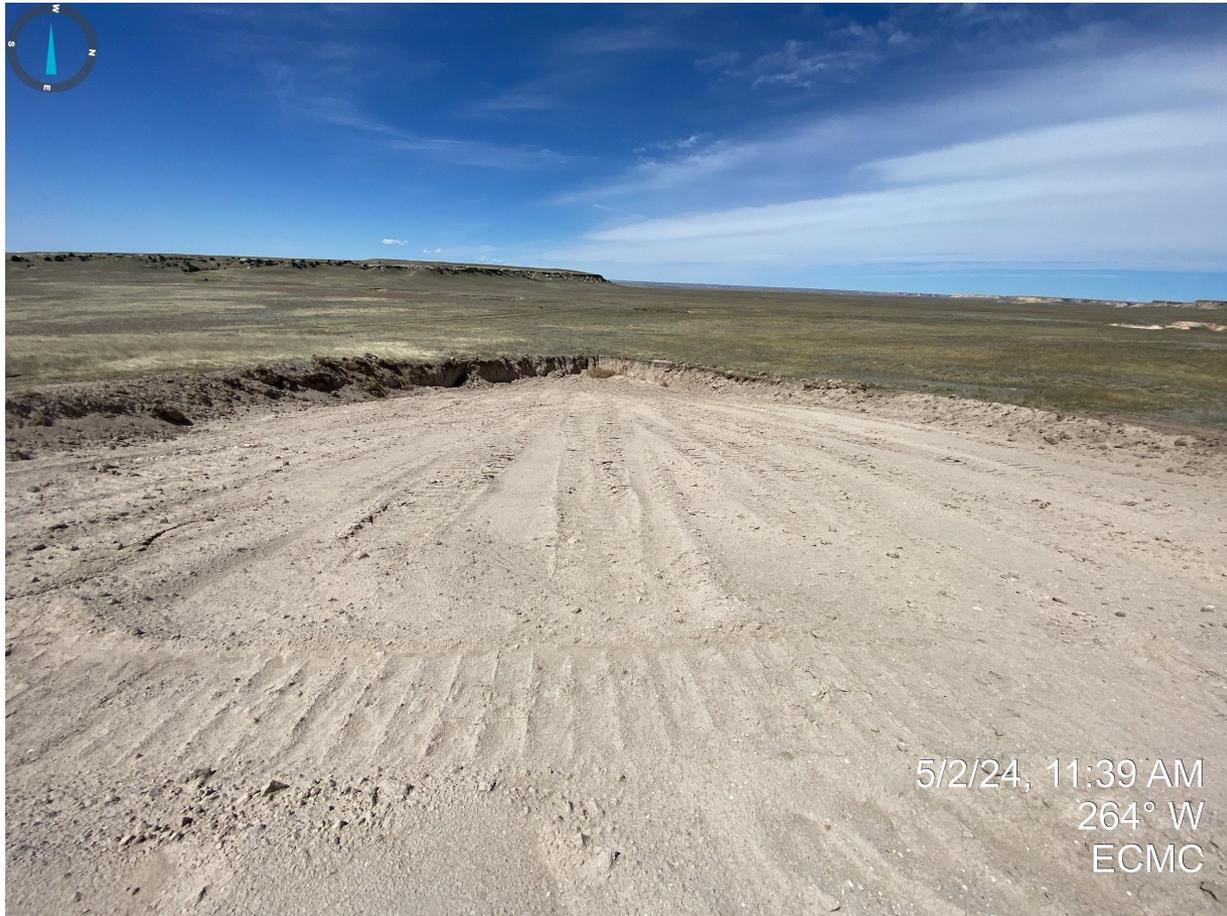
Photo 25. Overview of western most excavation area. The open excavation is not properly fenced to exclude wildlife, livestock or unauthorized personnel.

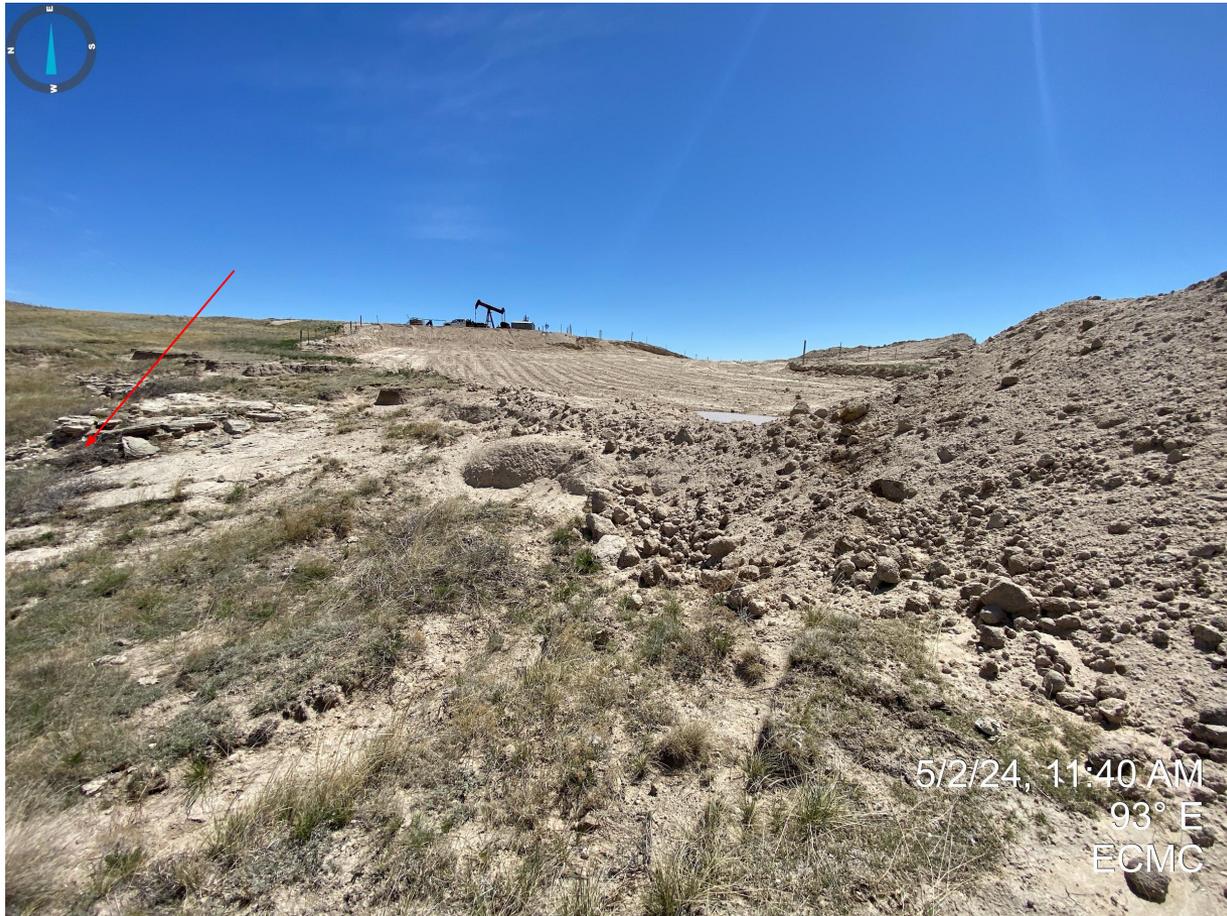
Photo 26. North side of excavation. No stormwater control measures were observed around the perimeter of the excavated area that would prevent off location stormwater discharge from entering nearby drainage (indicated by red arrow).

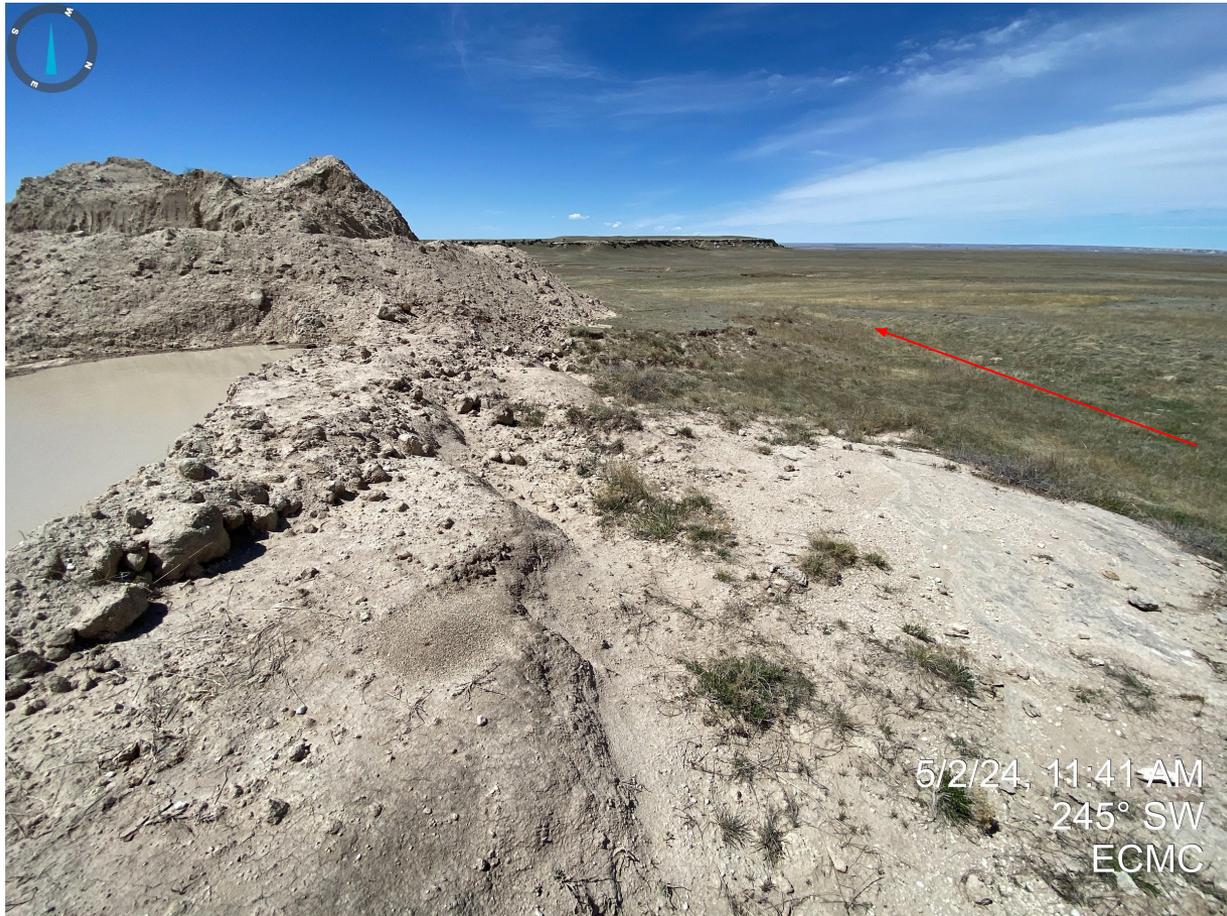
Photo 27. Continued from Photo 26, facing southwest.

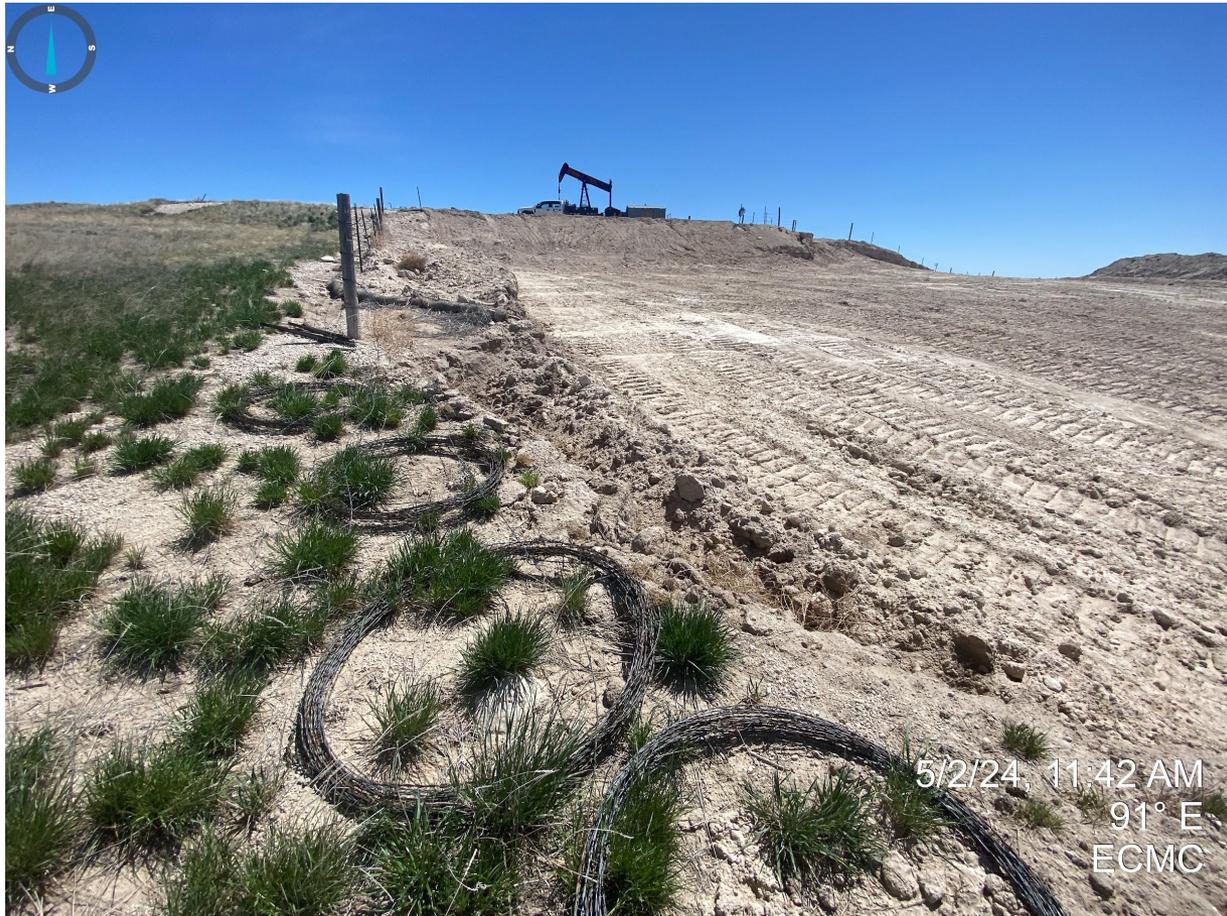
Photo 28. Unused fencing material needs to be removed from the location or returned to service as it poses a potential hazard to personnel, livestock and wildlife resources.

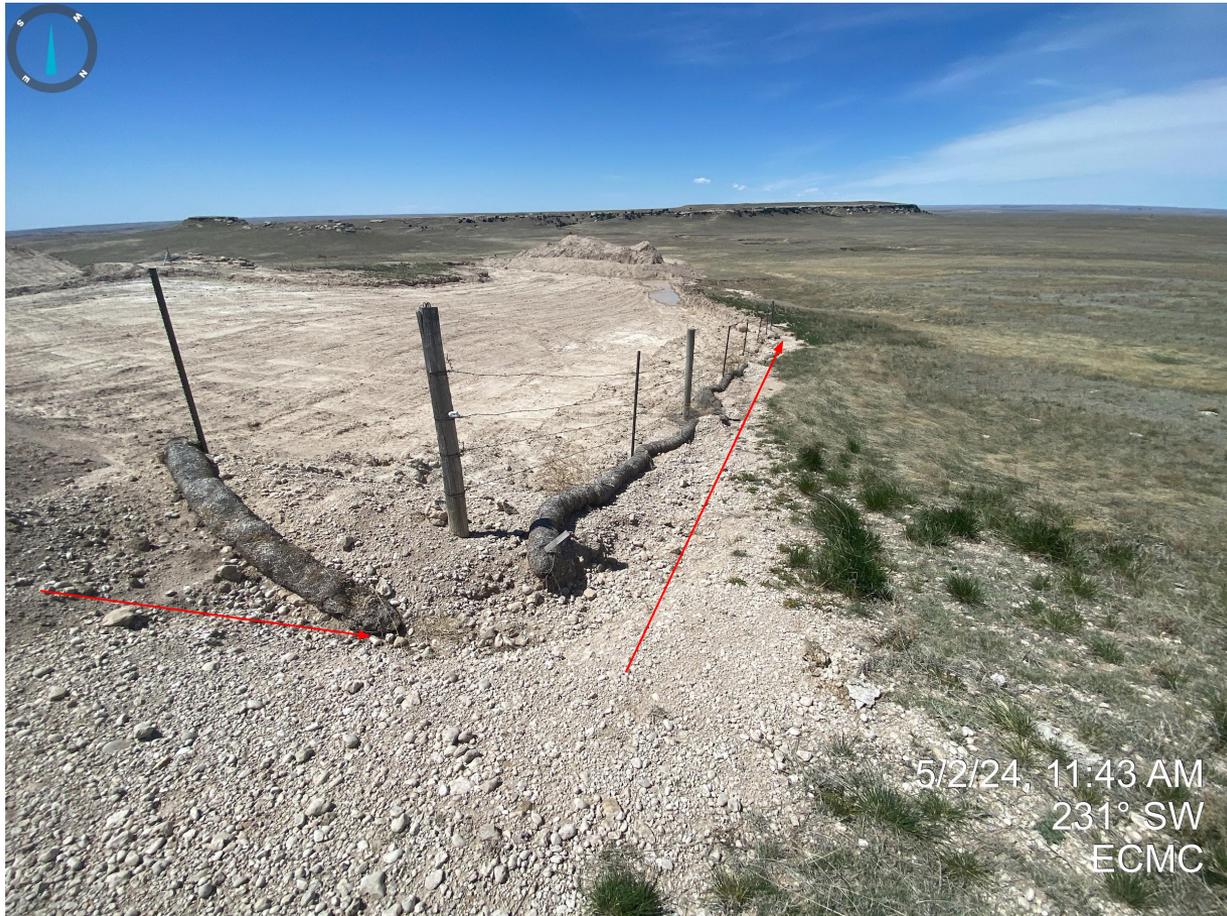
Photo 29. Taken from the north side of the pit. It does not appear that any erosion degradation has been properly stabilized or repaired, and stormwater control measure remain inadequate as the straw wattles are either degraded or not installed properly.
