**Inspection Photos**  
**Location Name: C. Korf 2-19**  
**API Number: 125-06977**

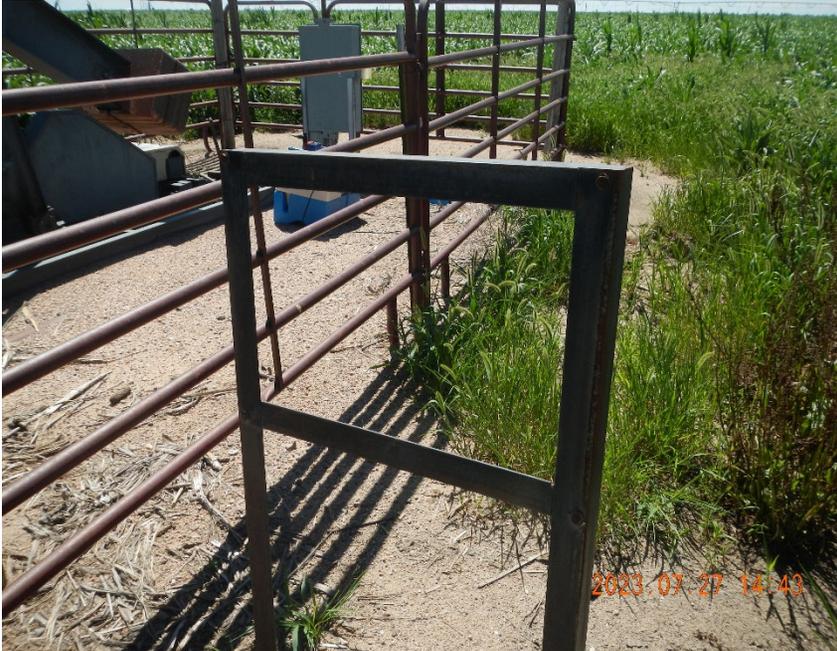
**1. Sign bracket missing sign from 7/27/2023 inspection.**

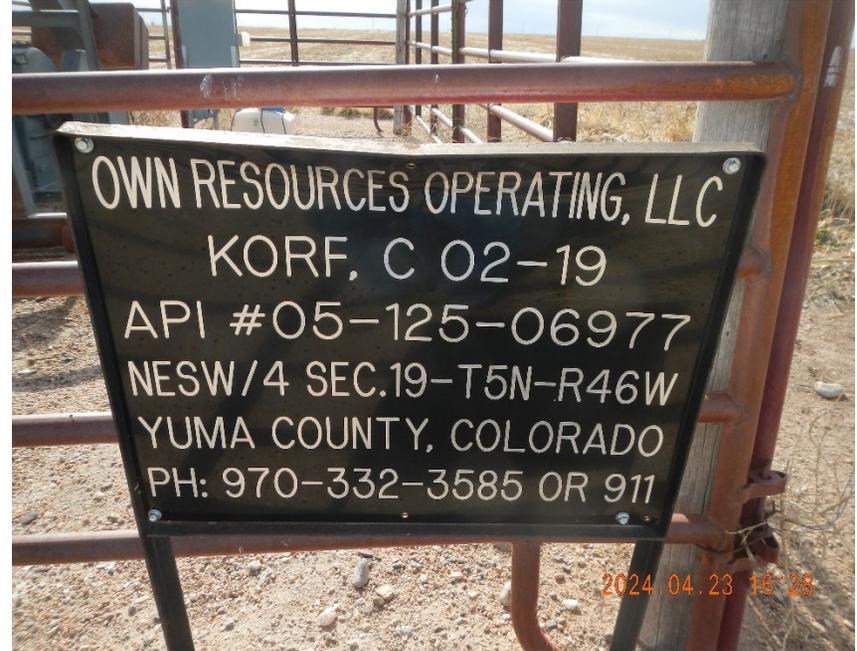
**2. Replaced well lease sign.**

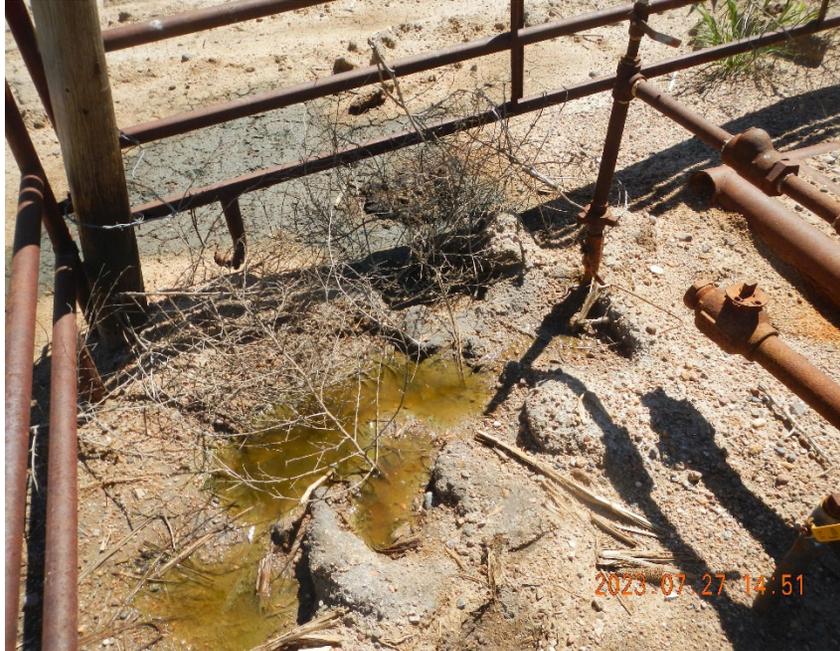
**3. View of water leg leaking at valve and hammer union  
7/27/2023 inspection.**

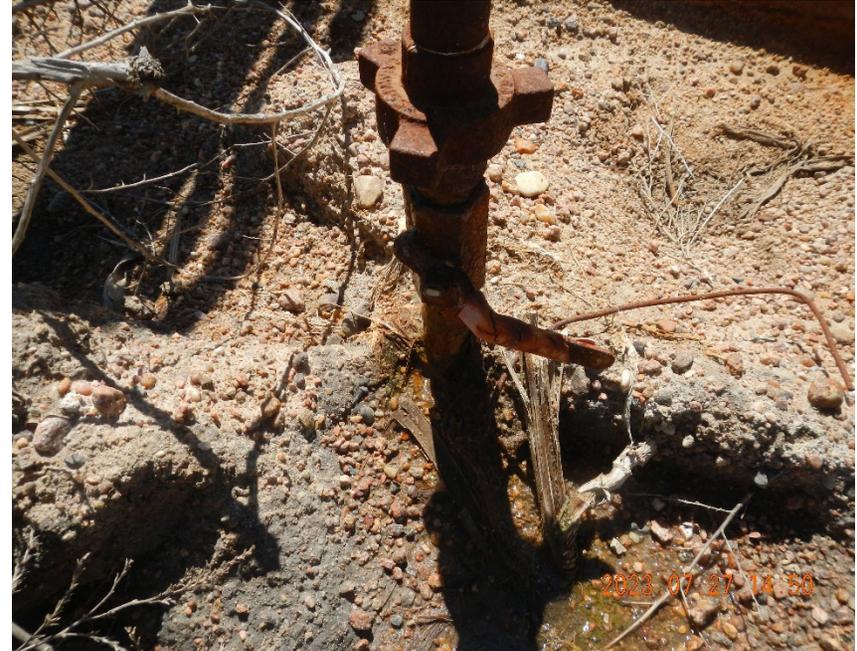
**4. Closer view of hammer union and valve 7/27/2023  
inspection.**

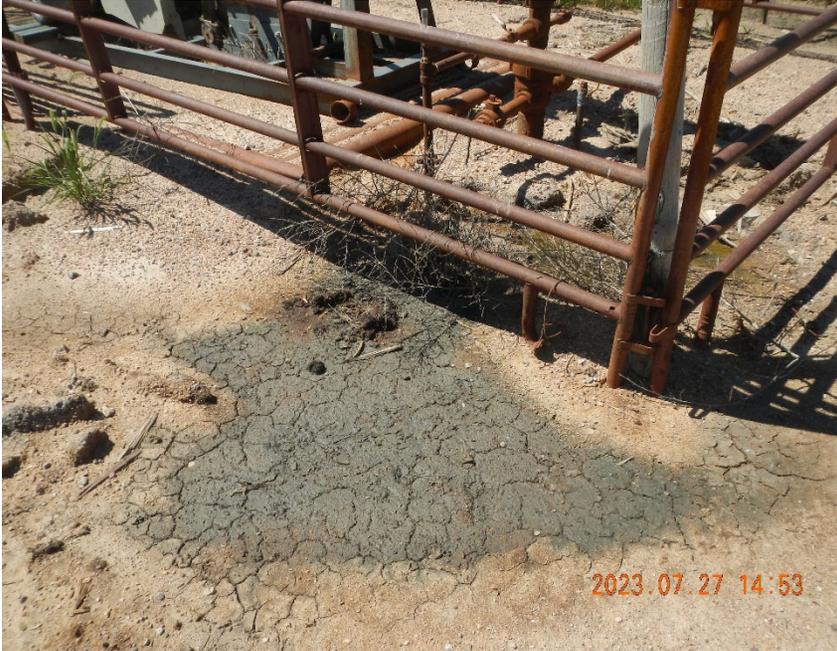
**5. Wet area at wells water leg inside and outside fencing  
7/27/2023 inspection.**

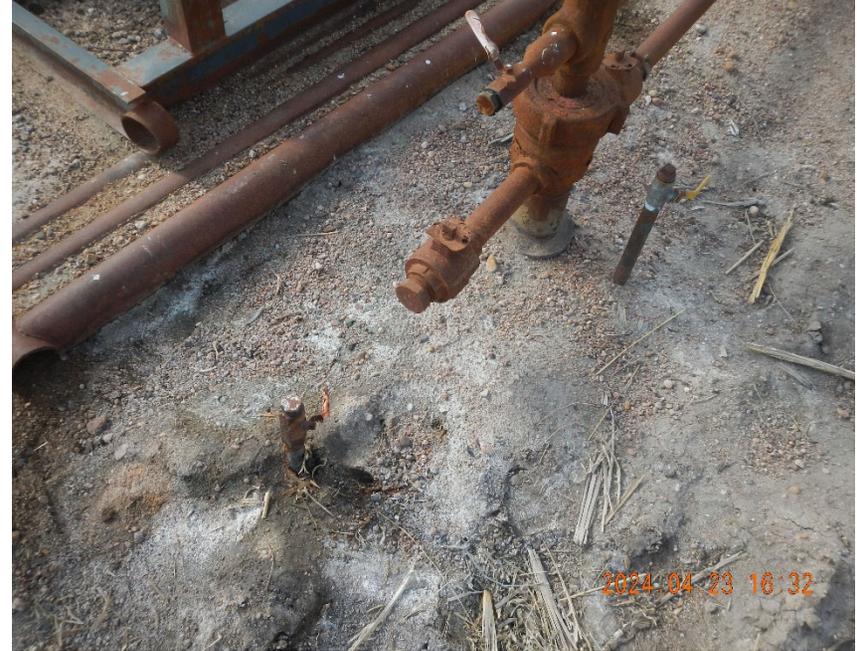
**6. View of removed pipe section and fittings on water leg.**

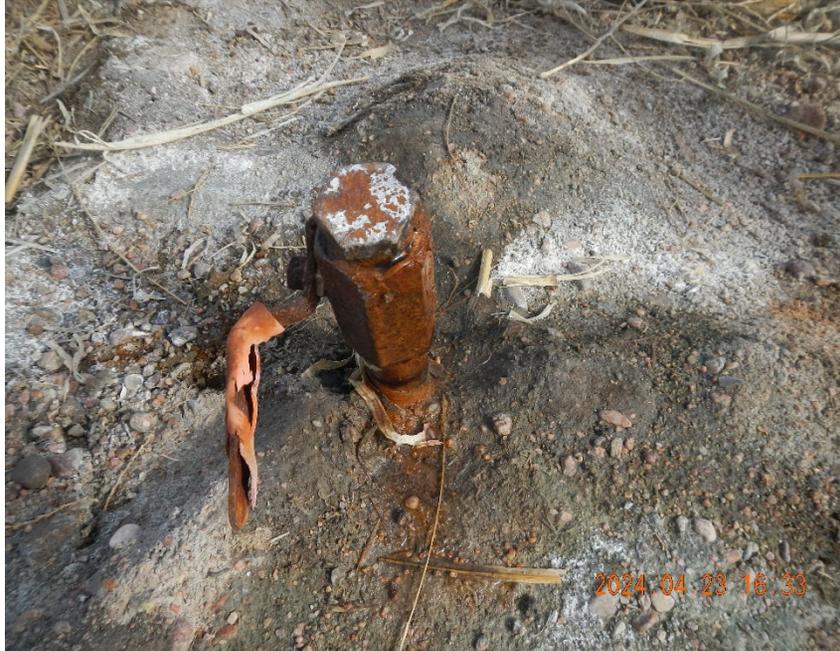
**7. View of continued water seep at valve and plug.**

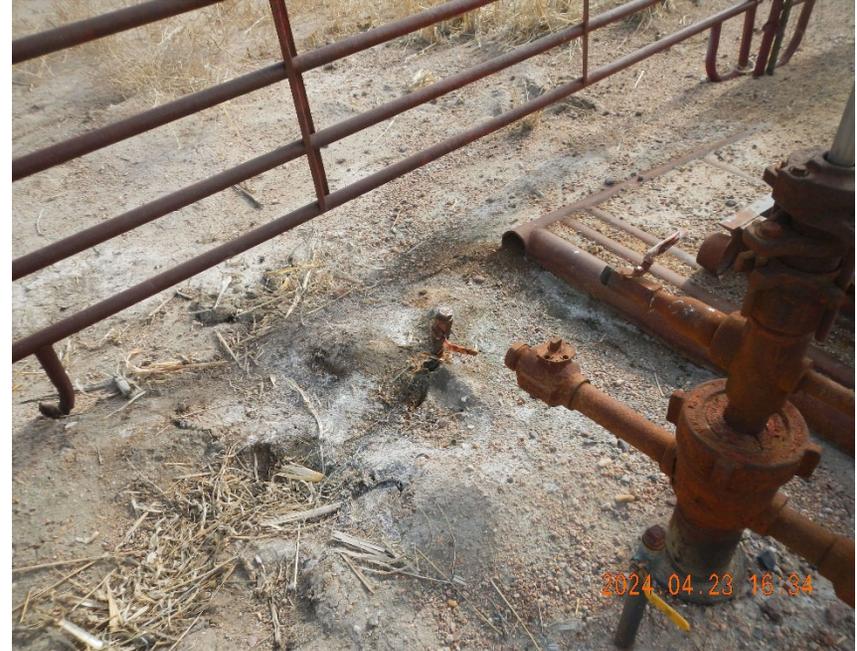
**8. Damp soil and salt ring around riser with seep at valve and plug.**
