Inspection Photos
Location Name: Zarlengo B 1
Location ID: 320326

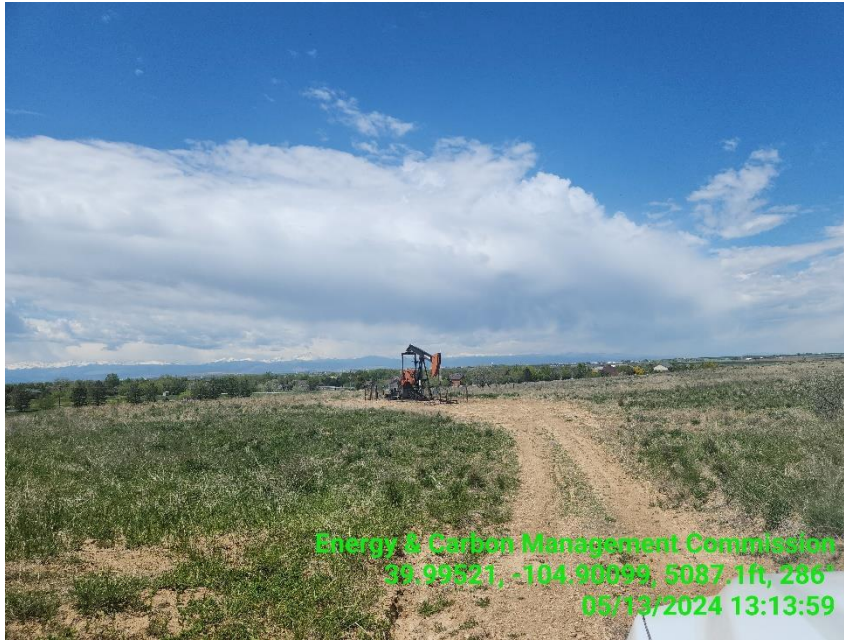
Photo 1 Location.

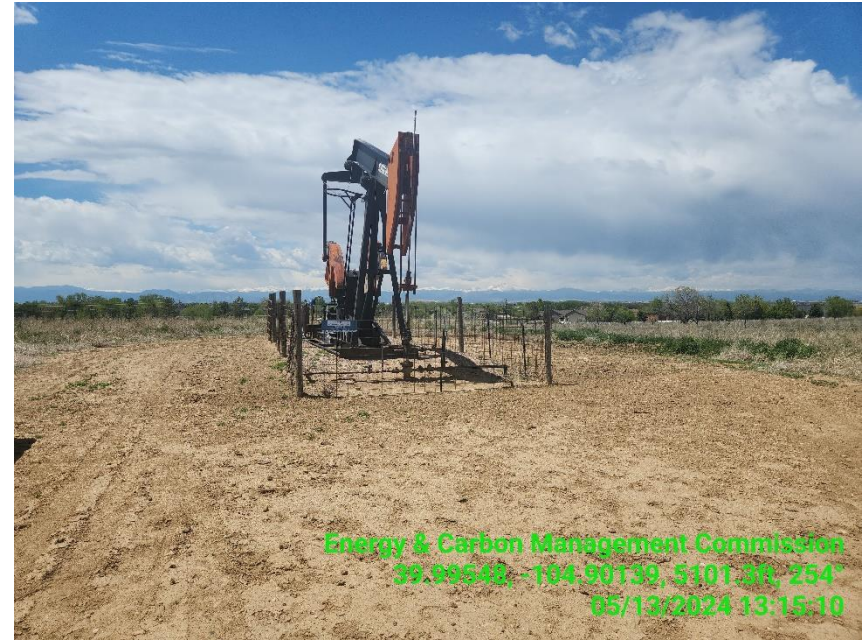
Photo 2 Wellsite.

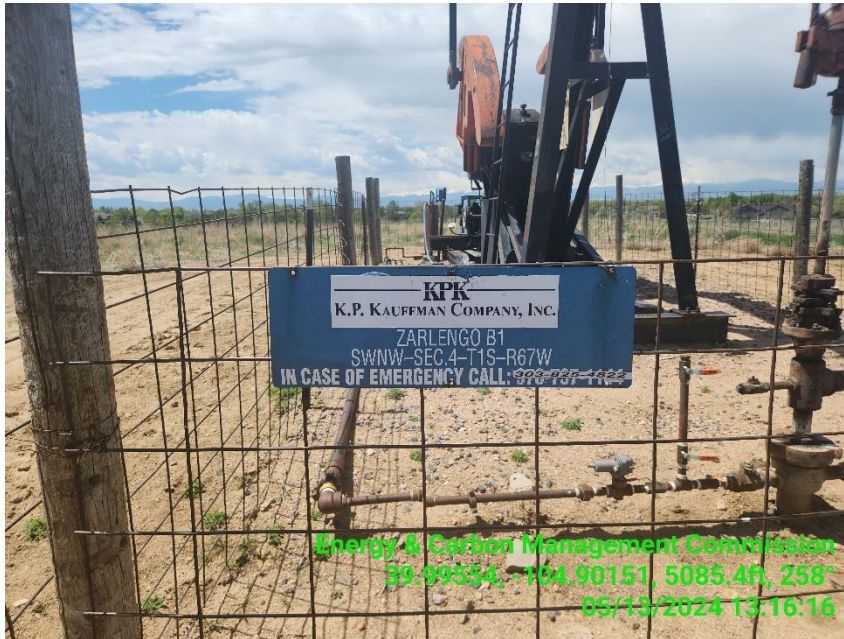
Photo 3 WH sign.

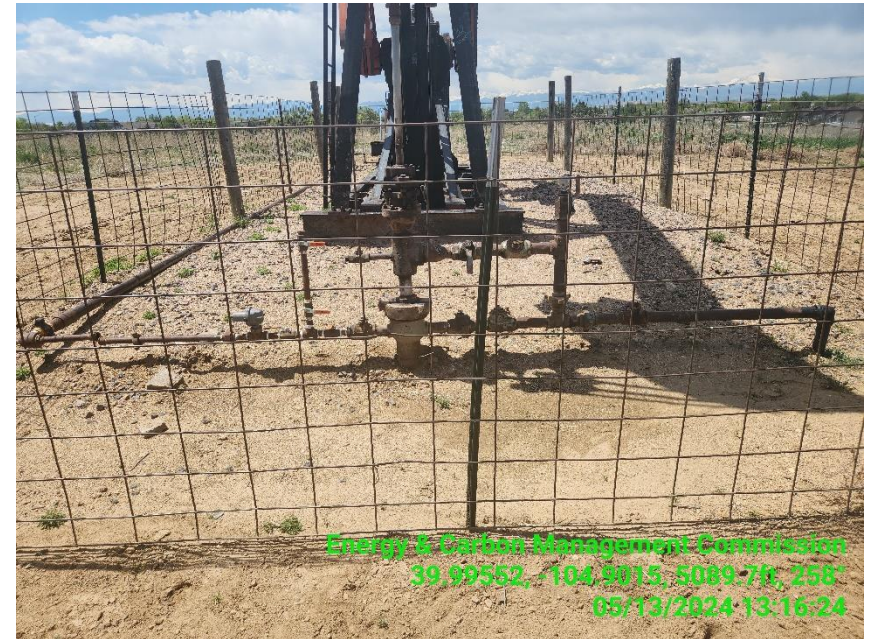
Photo 4 WH.

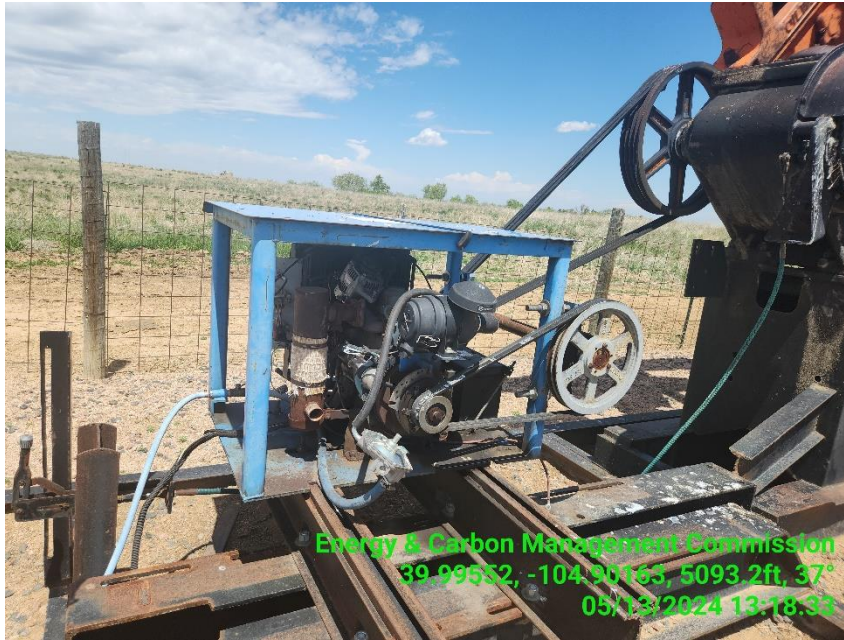
Photo 5 Gas engine is not operational due to the alternator being disconnected.

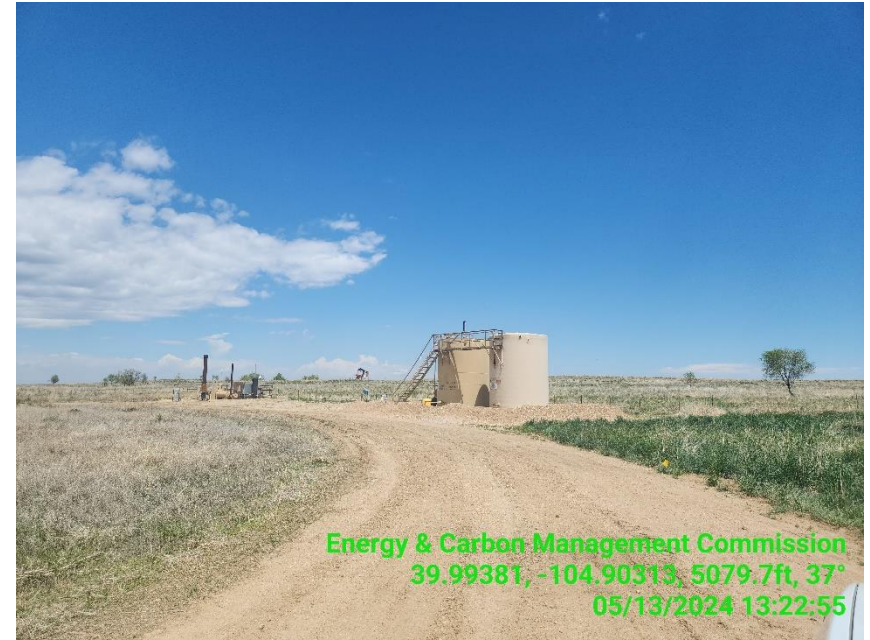
Photo 6 TB Location.

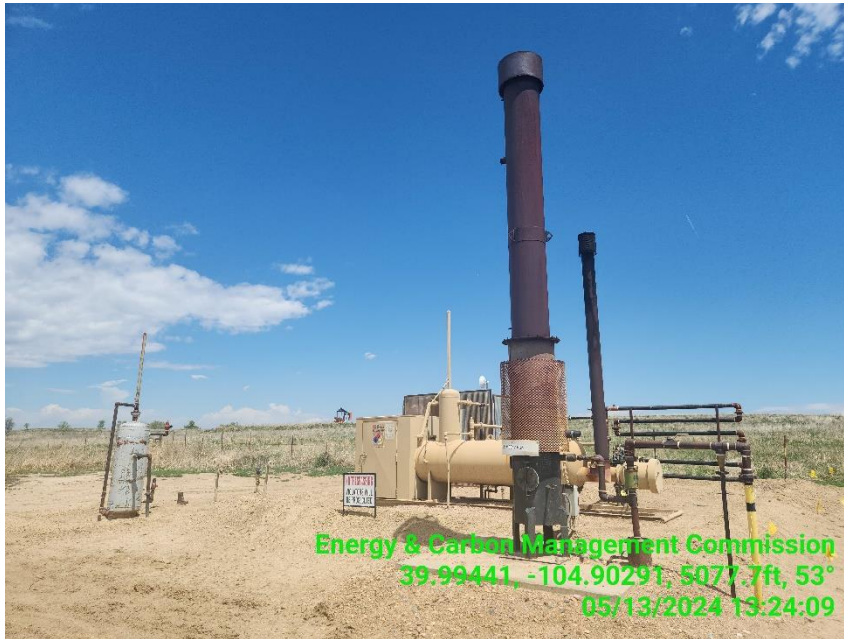
Photo 7 ECD.

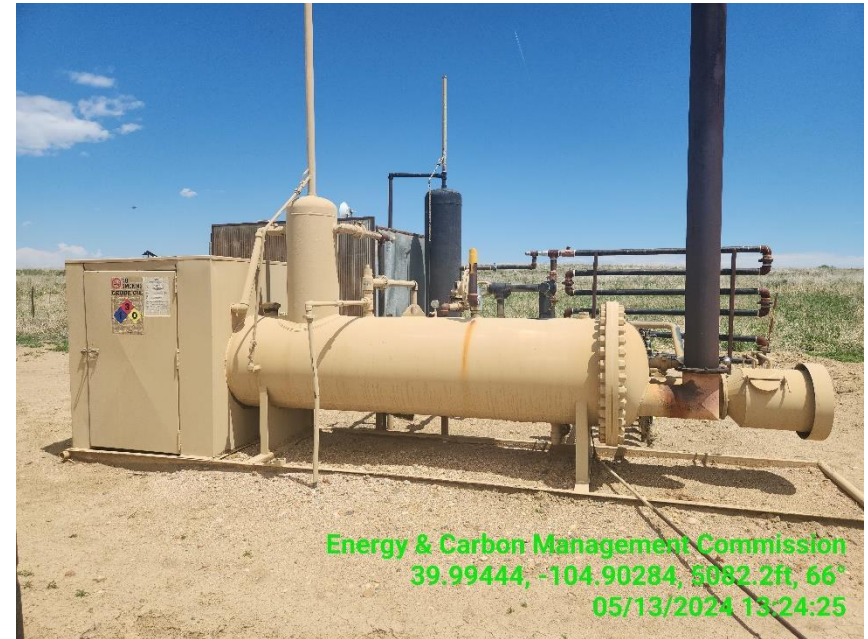
Photo 8 Horizontal Heated separator.

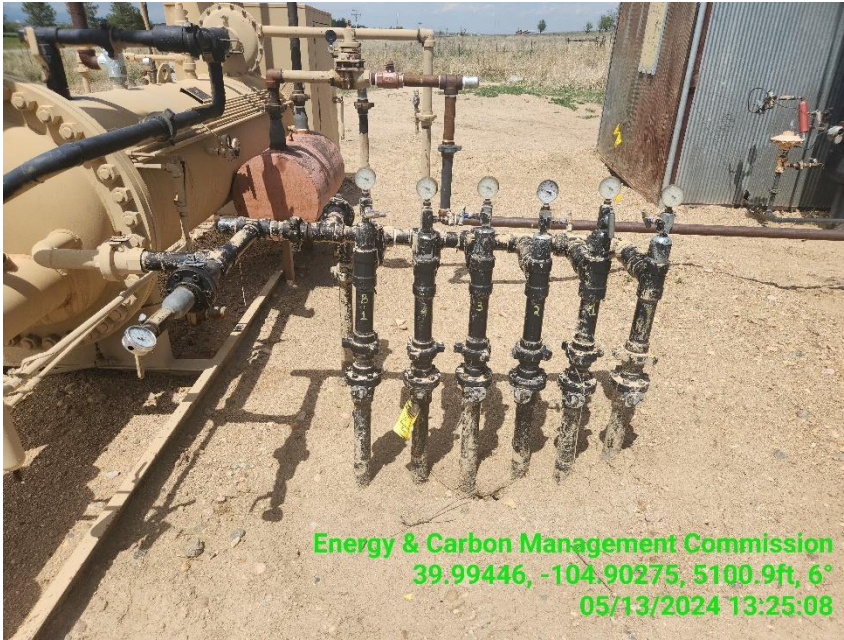
Photo 9 Flow line manifold.

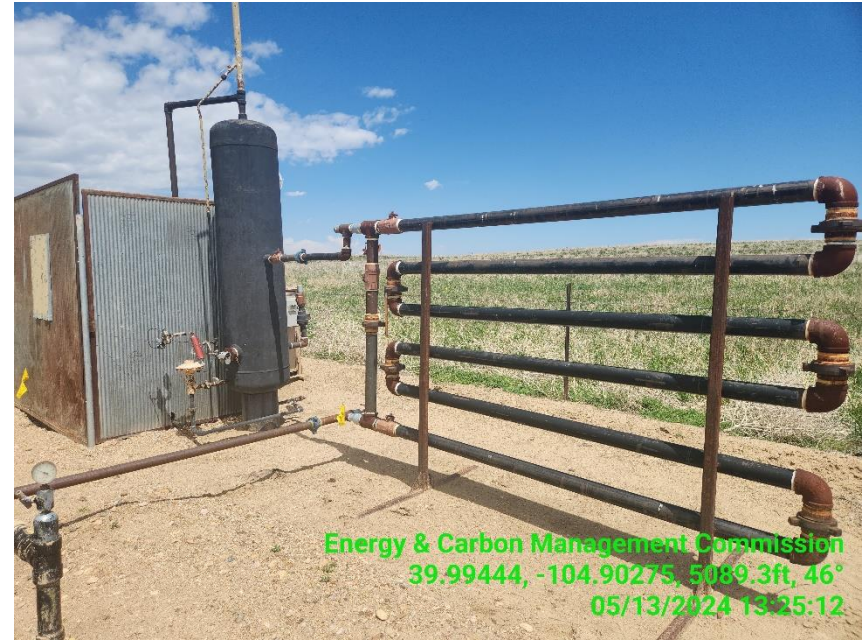
Photo 10 Vertical Separator at the recirculation pump.

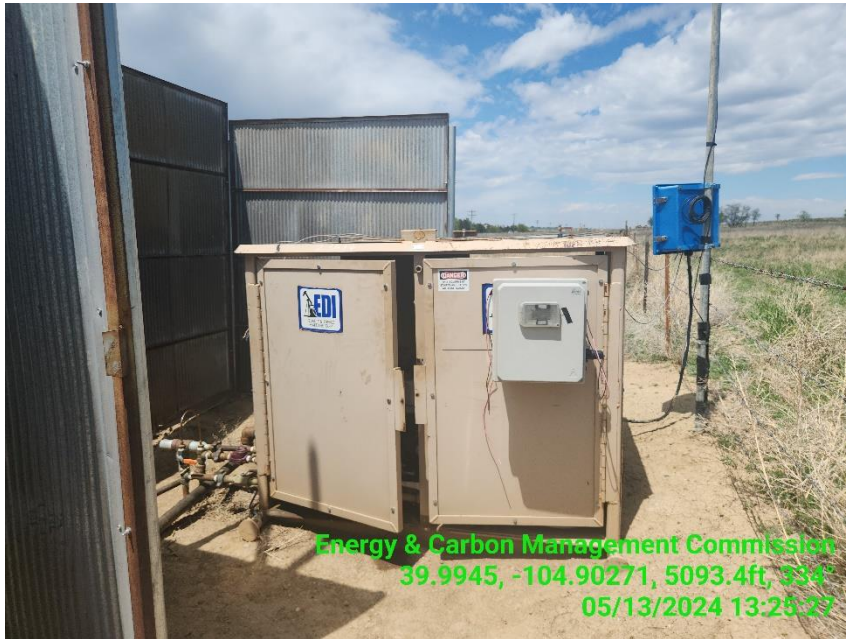
Photo 11 Recirculation pump partially enclosed by 3 sound walls.

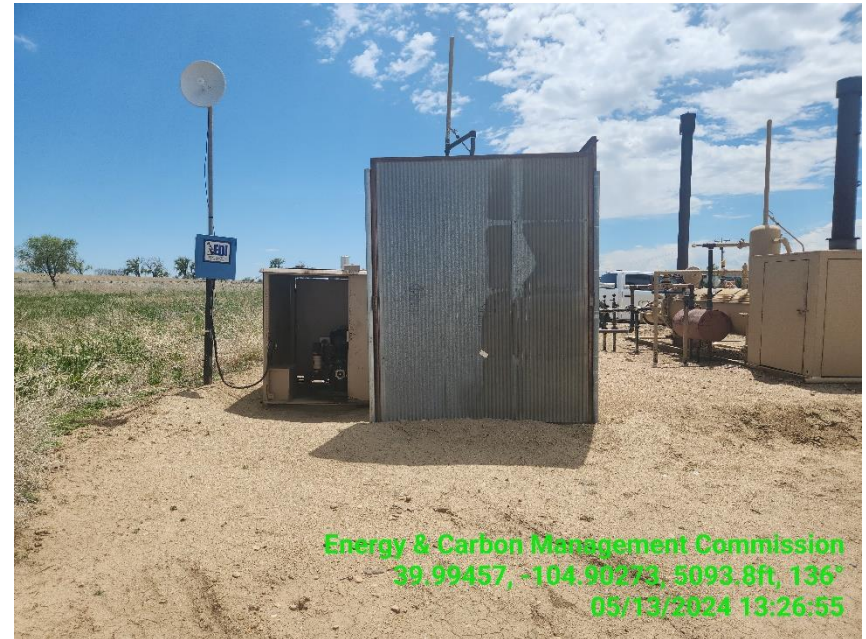
Photo 12 Recirculation pump partially enclosed by 3 sound walls.

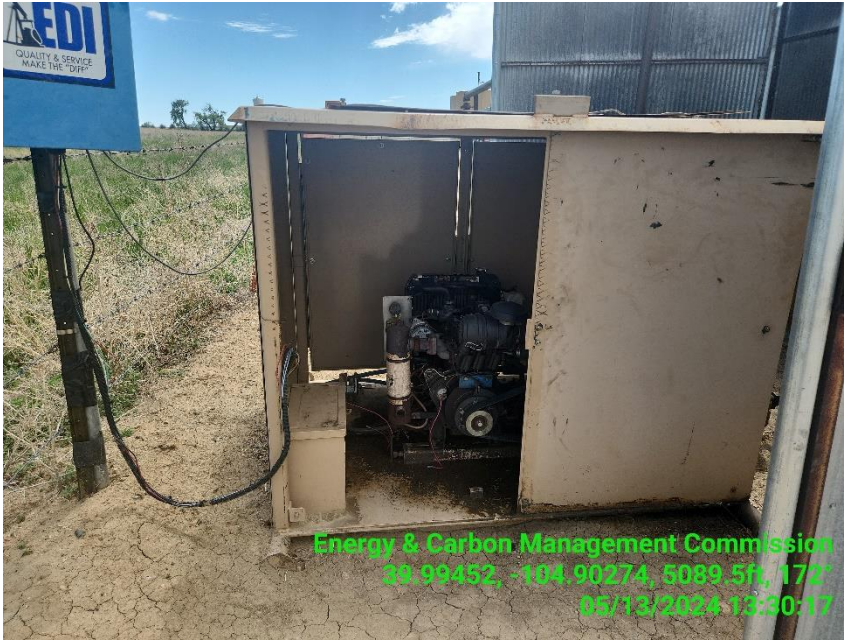
Photo 13 Recirculation pump Missing the panel on the north side of the pump.

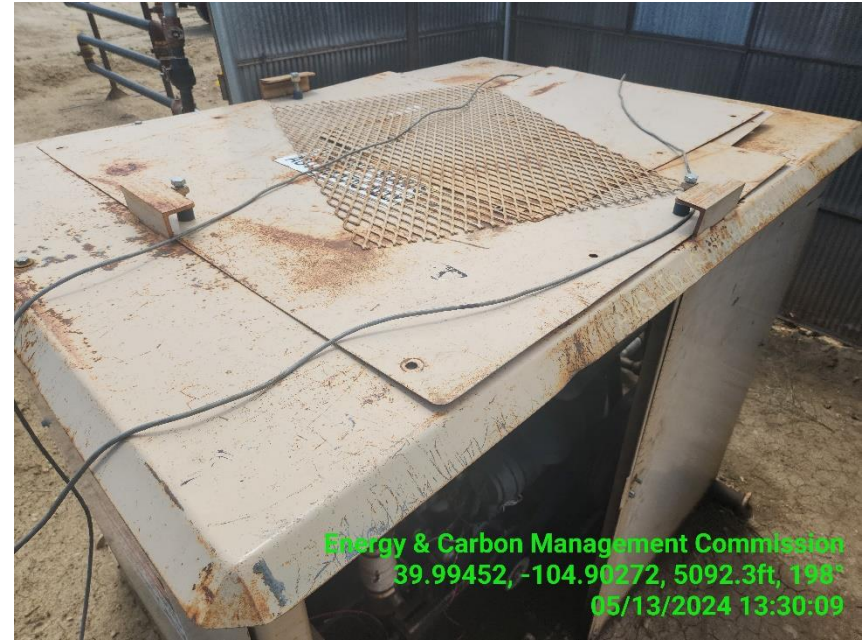
Photo 14 Side panel set on top of the pump housing.

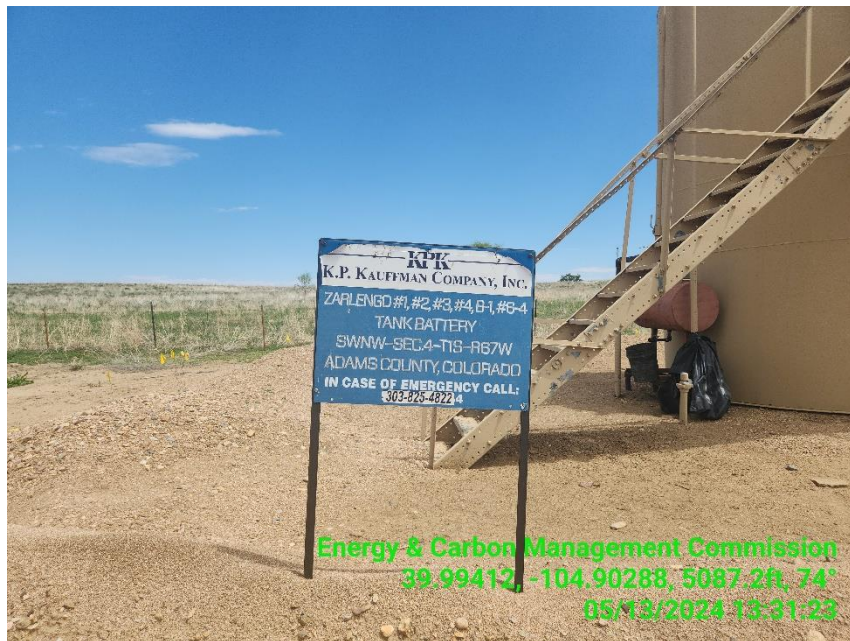
Photo 15 TB sign.

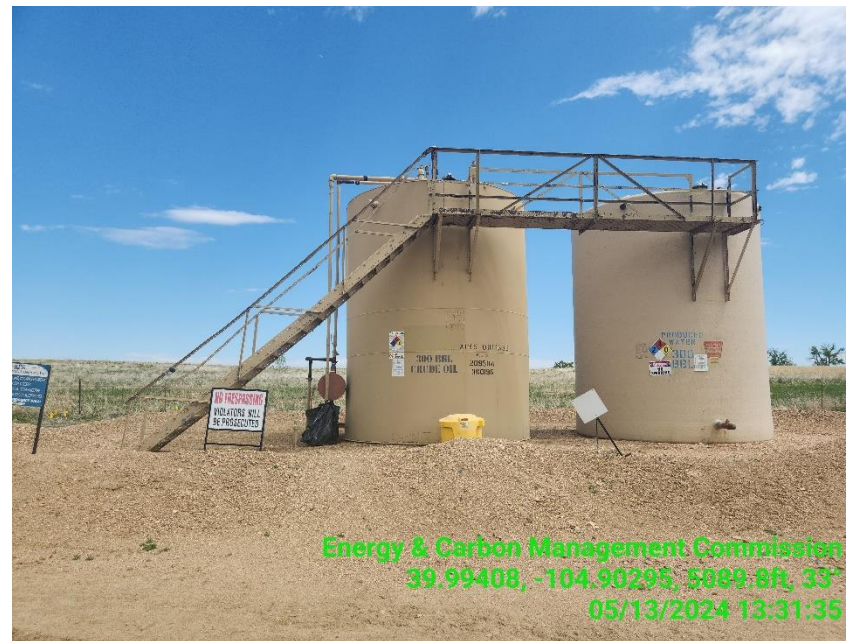
Photo 16 TB.
