Interim Reclamation and Stormwater Inspection

April 15, 2024

Operator: FULCRUM ENERGY OPERATING LLC- #10805

Location ID: 436801

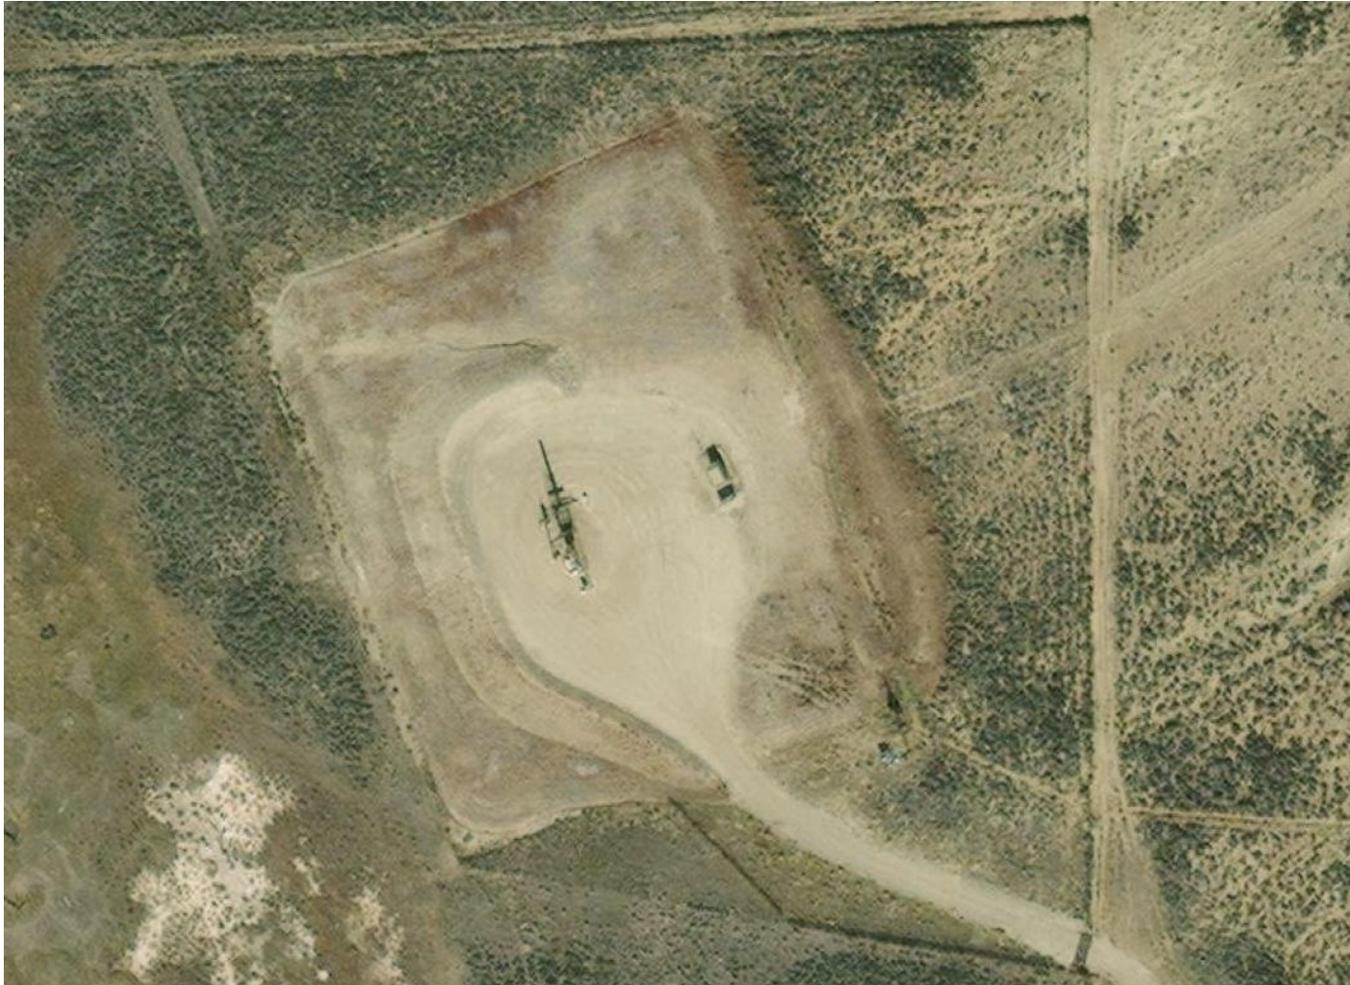
Photo 1. 2023 NAIP illustrates the location that has been interim reclaimed.

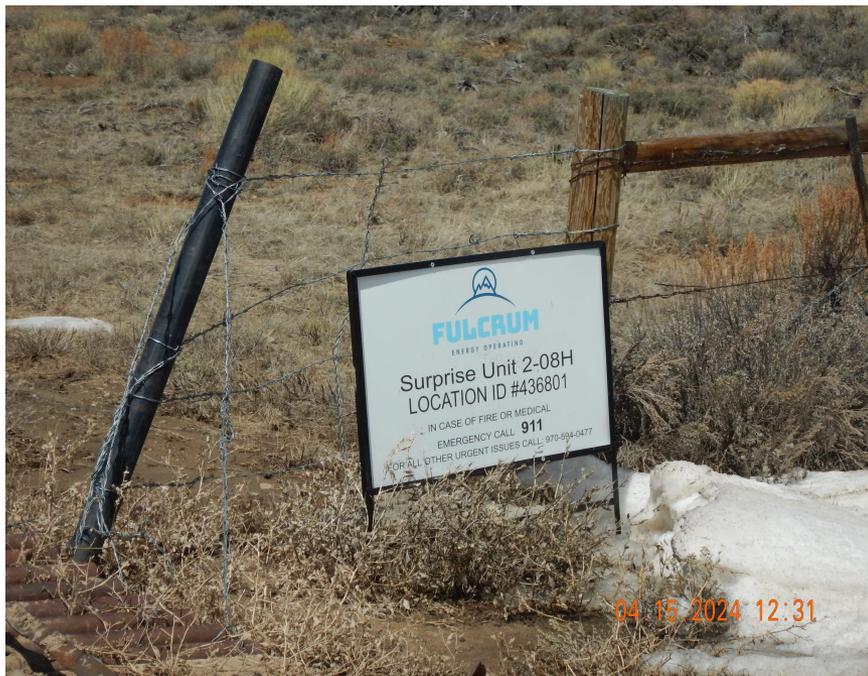
Photo 2. Photo taken from the entrance of location. Photo illustrates the Location Operator sign.

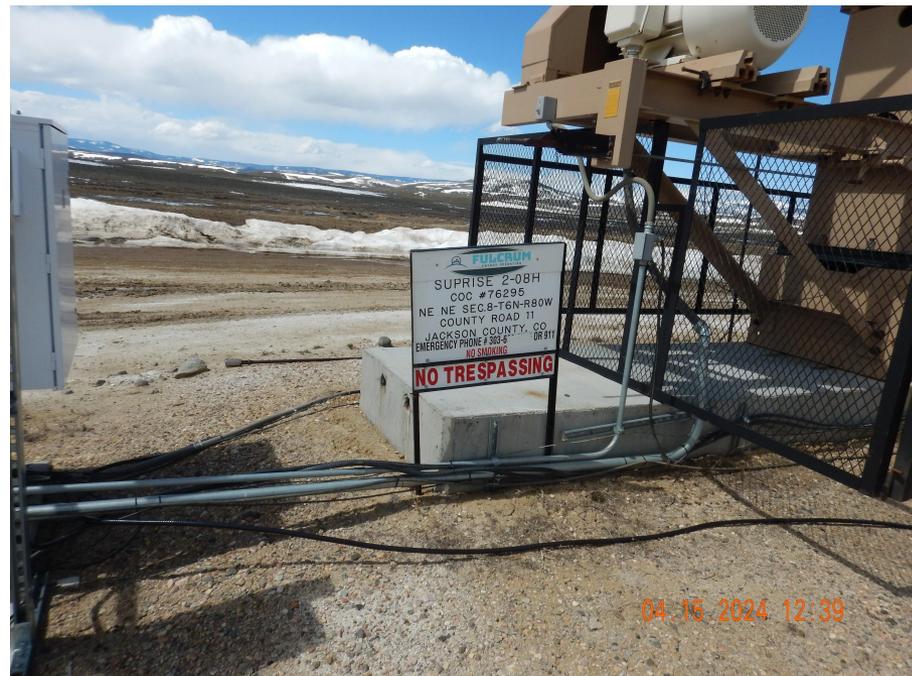
Photo 3. Photo taken from the wellhead, facing West. Photo illustrates the well signage that lacks API information.

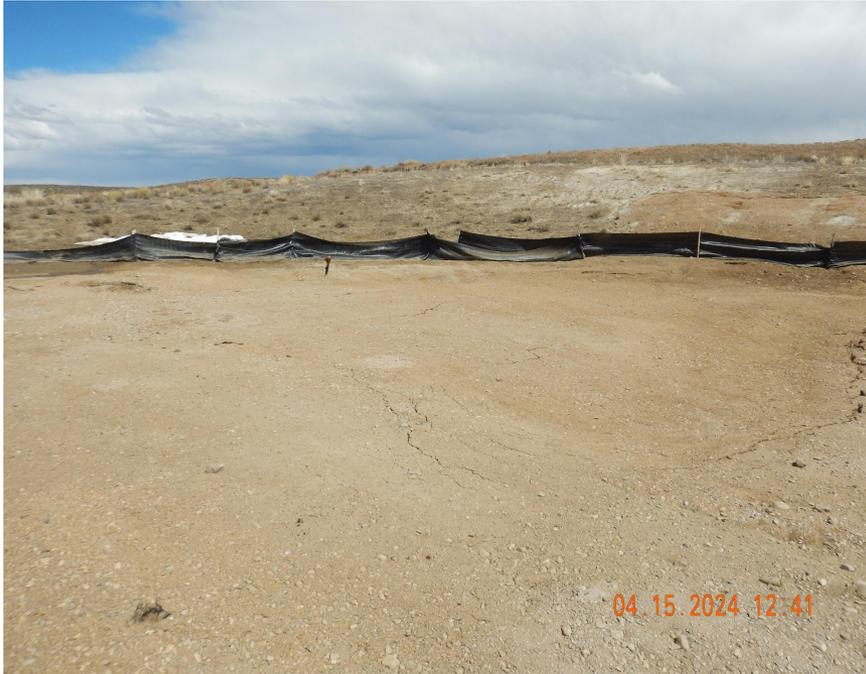
Photo 4. Photo taken from the location, facing East. Photo illustrates the silt fence BMP is in disrepair and has not been properly installed.

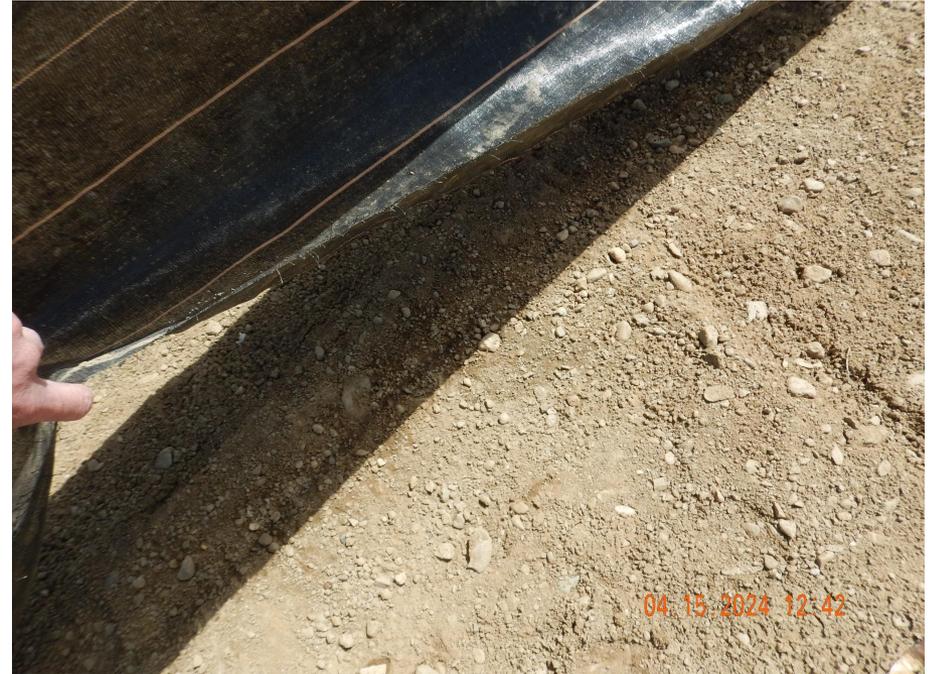
Photo 5. Close up photo taken of the improperly installed silt fence BMP.

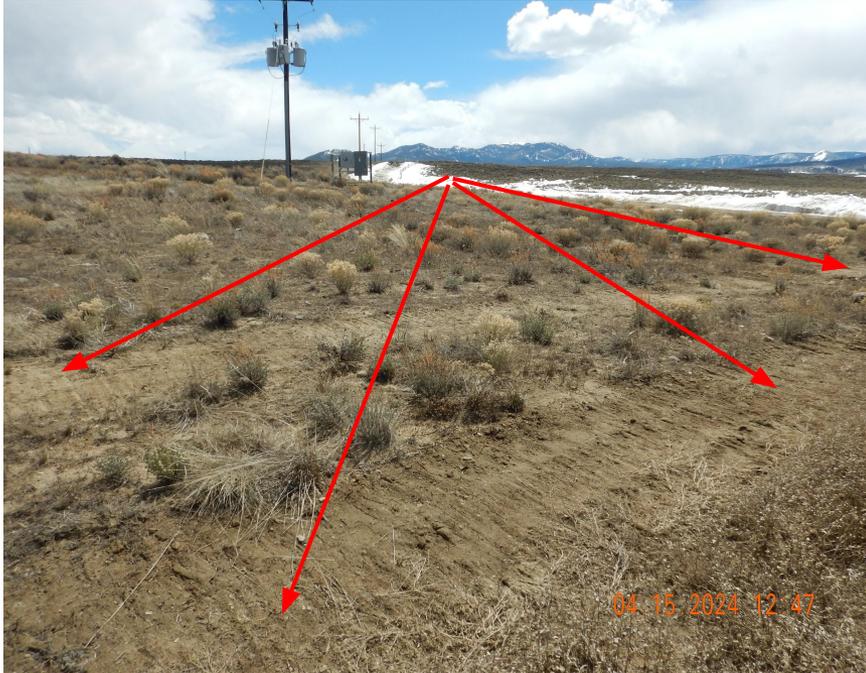
Photo 6. Photo taken from the eastern interim reclamation area, facing Southeast. Photo illustrates disturbances that appear to be related to a remediation project.

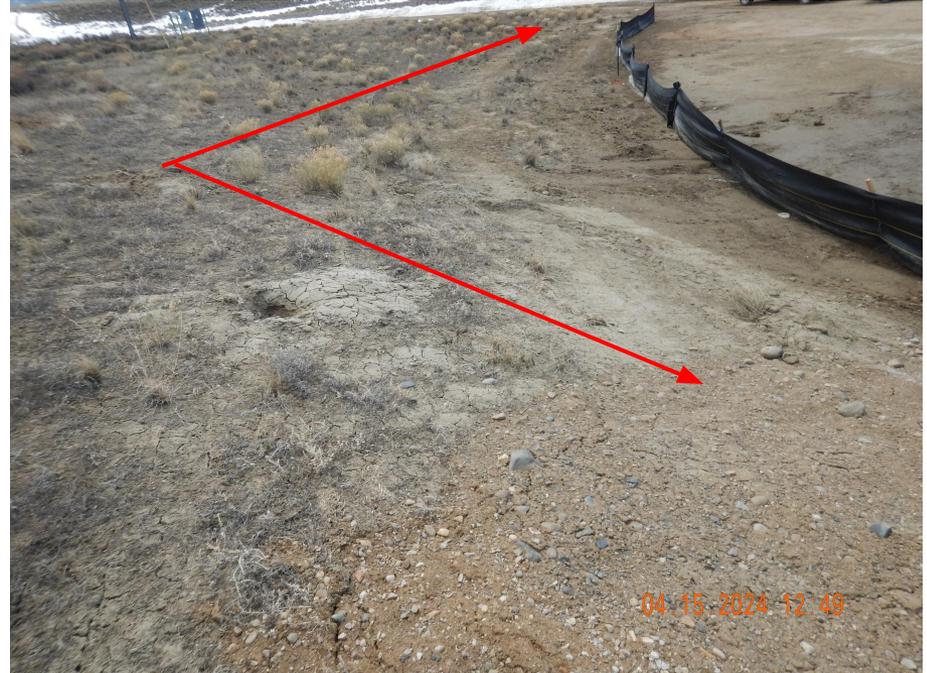
Photo 7. Photo taken from the eastern interim reclamation area, facing South. See comments under Photo 6.

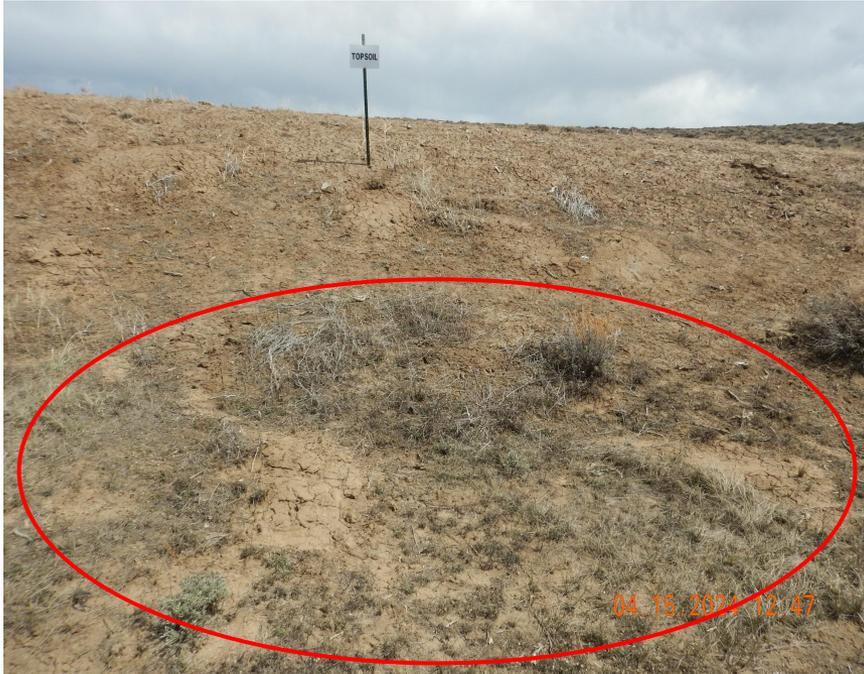
Photo 8. Photo taken from the eastern interim reclamation area, facing East. Photo illustrates the topsoil stockpile which is not properly stabilized with evidence of erosion without a perimeter BMP.

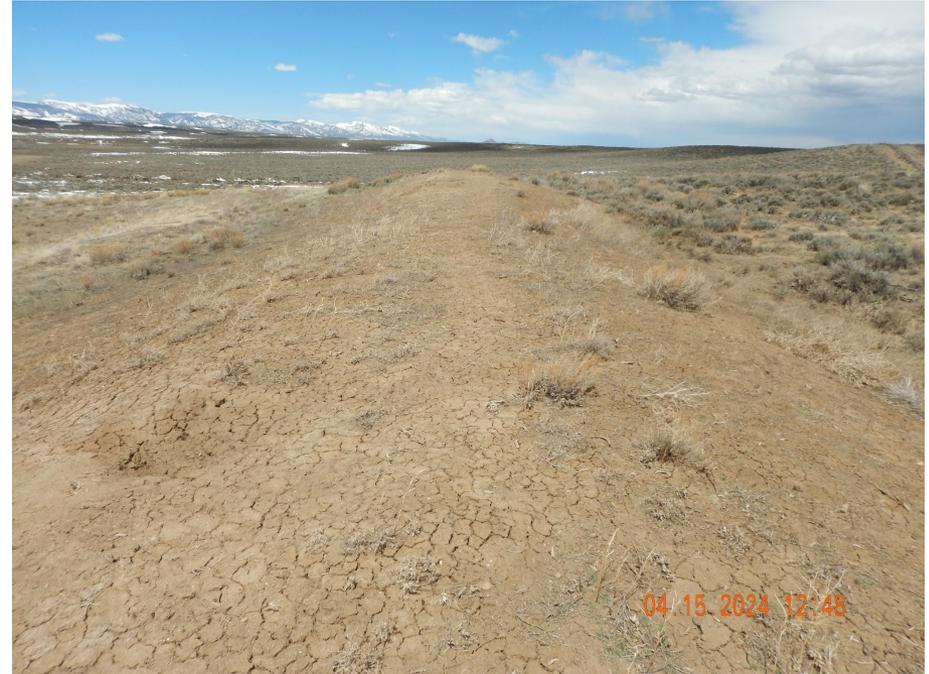
Photo 9. Photo taken from the topsoil stockpile, facing North. Photo illustrates the topsoil stockpile has not been properly stabilized for long-term stabilization.

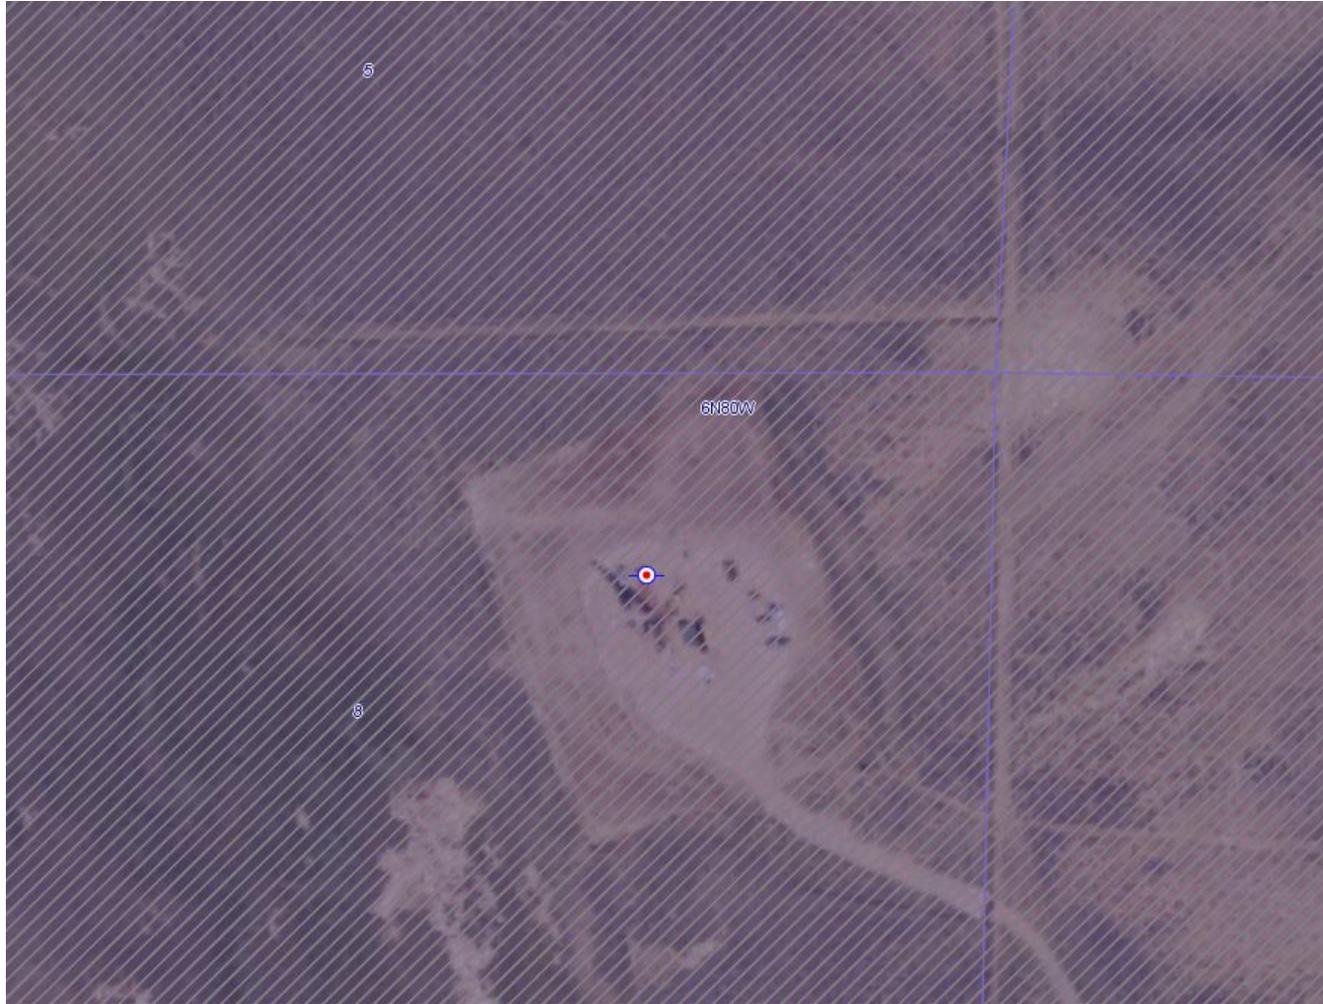
Photo 10. ECMC GIS aerial imagery illustrates the location falls within Greater Sage Grouse Priority Habitat Management Area.
