Interim Reclamation and Stormwater Inspection

Operator: FULCRUM ENERGY OPERATING LLC- #10805

Location ID: 449274

Inspection Document #: 697505287

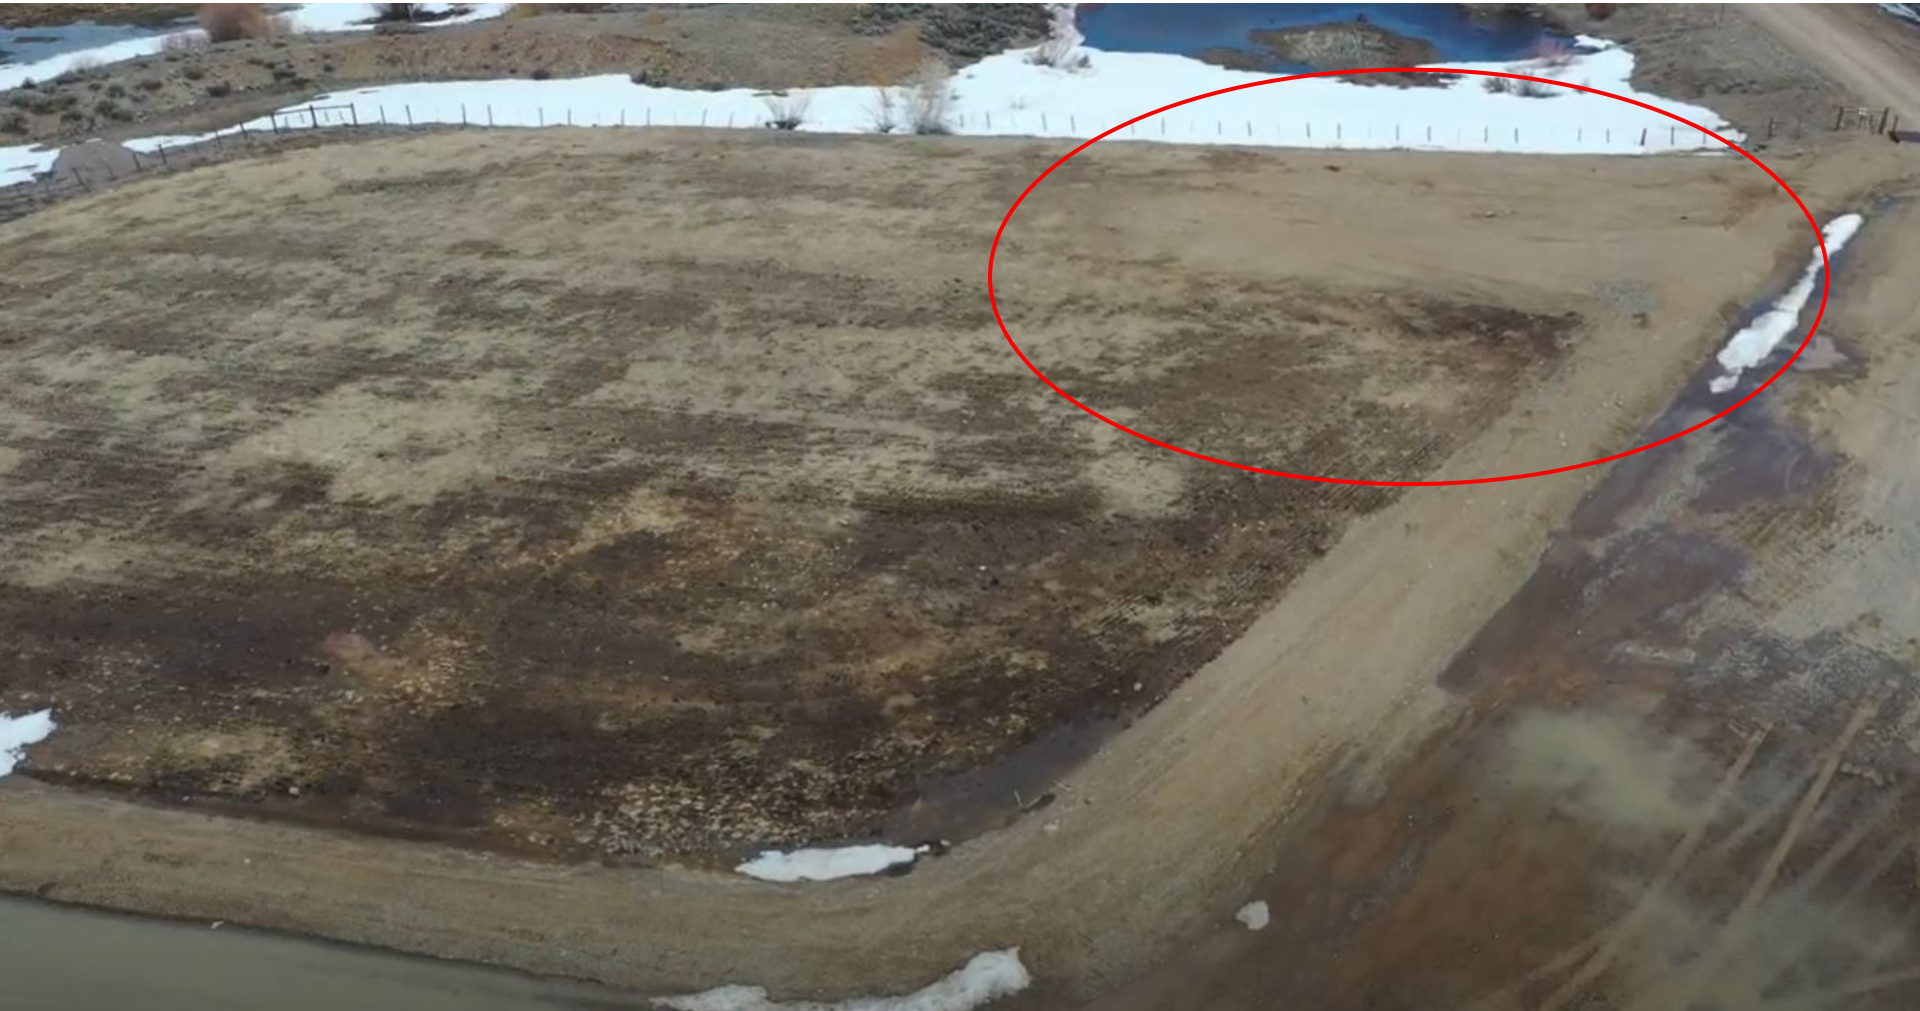
Photo 1. Drone imagery illustrates a portion of the interim reclamation area needs to be reclaimed. Refer to Photo 4.

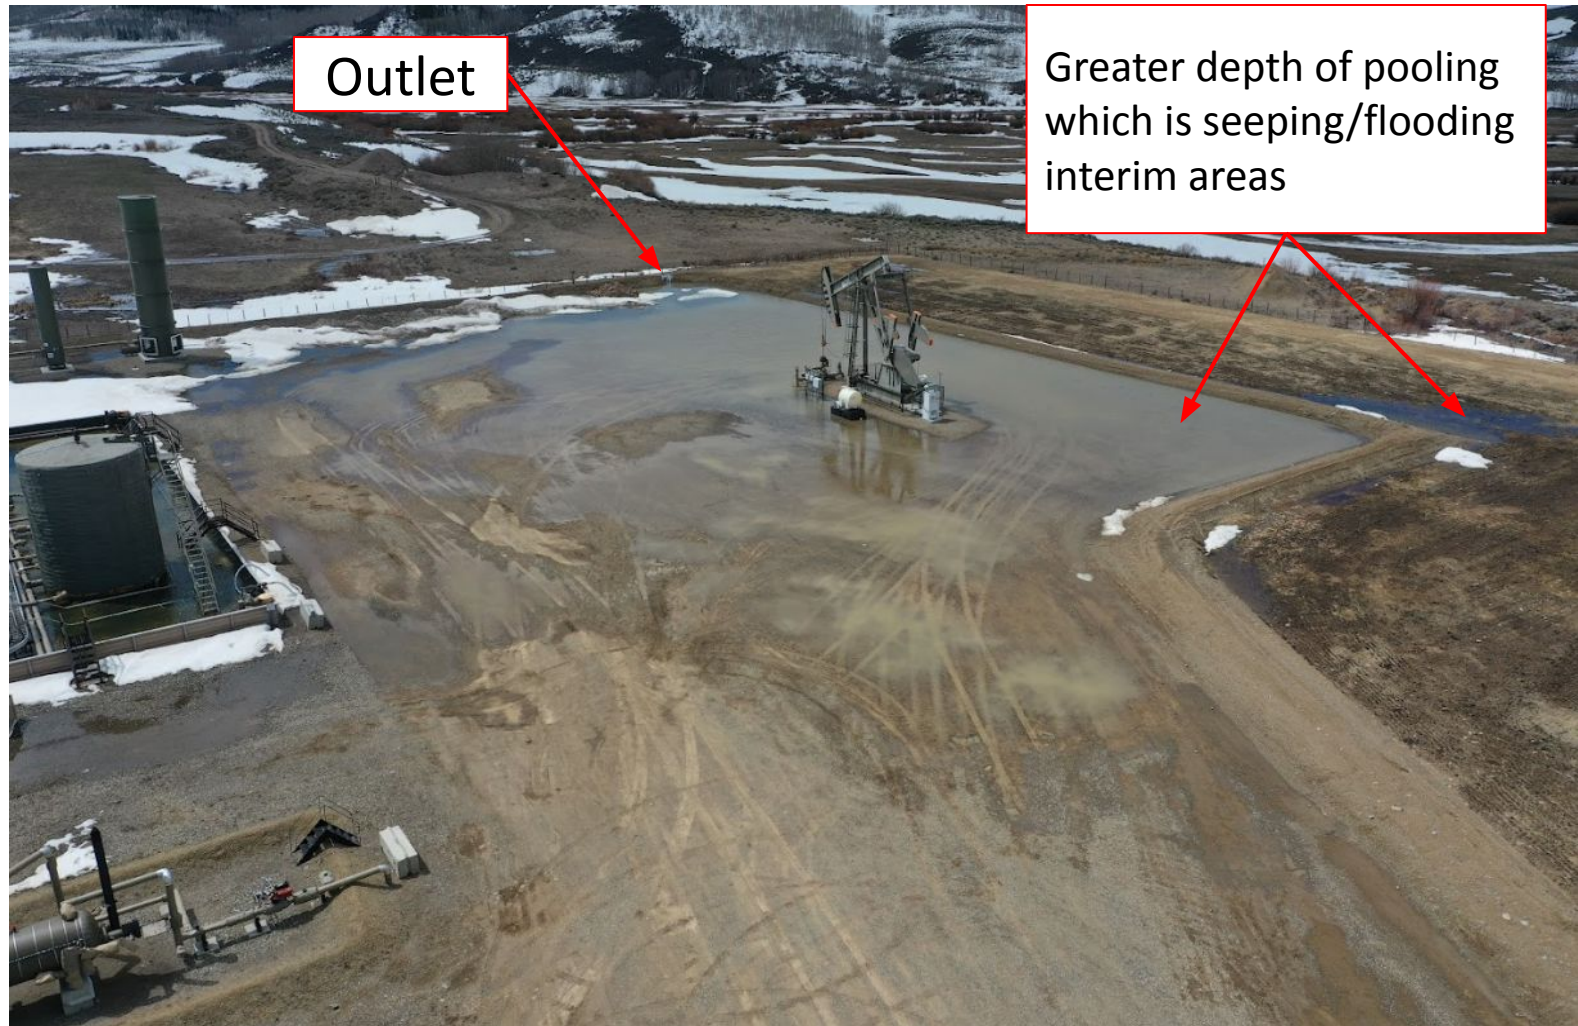
Photo 2. Drone imagery illustrates ponding of snowmelt. It appears the working pad surface could be better contoured to allow for better drainage to the outlet. Note- Operator needs to be aware of E&P waste discharging off location via the outlet while draining ponding snowmelt.

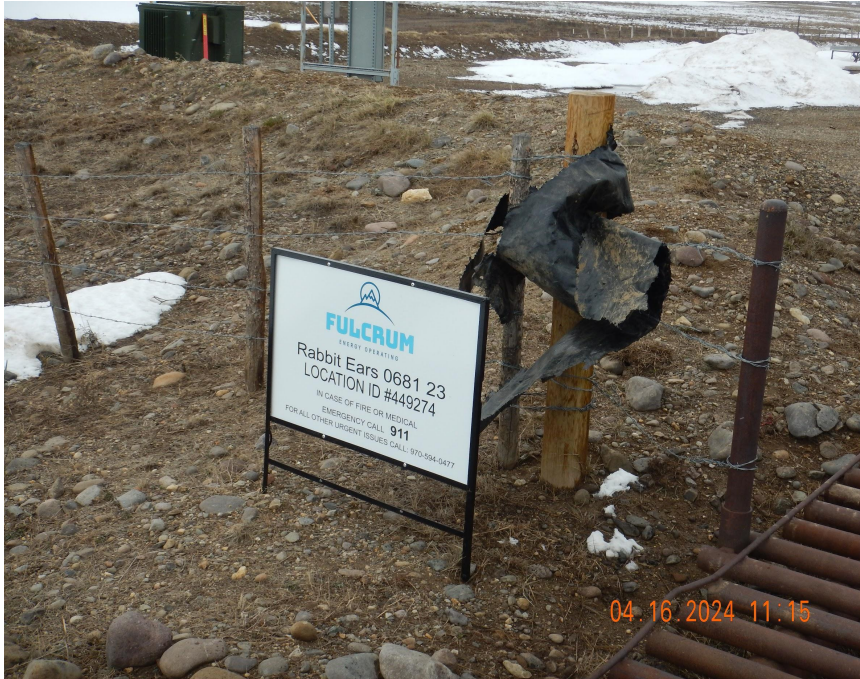
Photo 3. Photo taken from the entrance of location. Photo illustrates the Location Operator sign and debris caught in the fencing. This appears to have been removed based on the most recent inspection conducted on May 1, 2024.

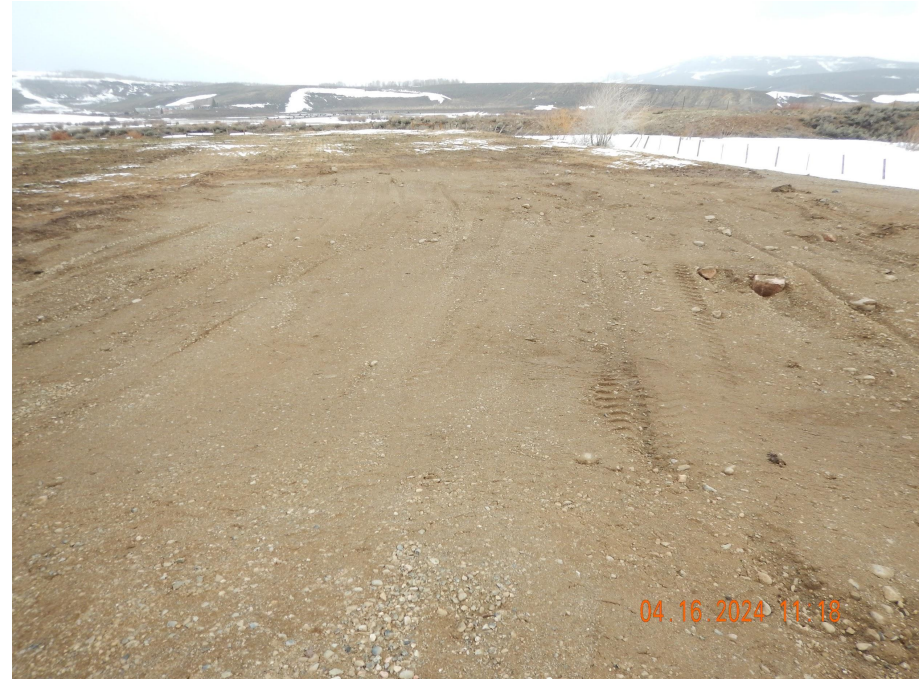
Photo 4. Photo taken from the eastern interim reclamation area, facing North. Photo illustrates an area that needs to be reclaimed.

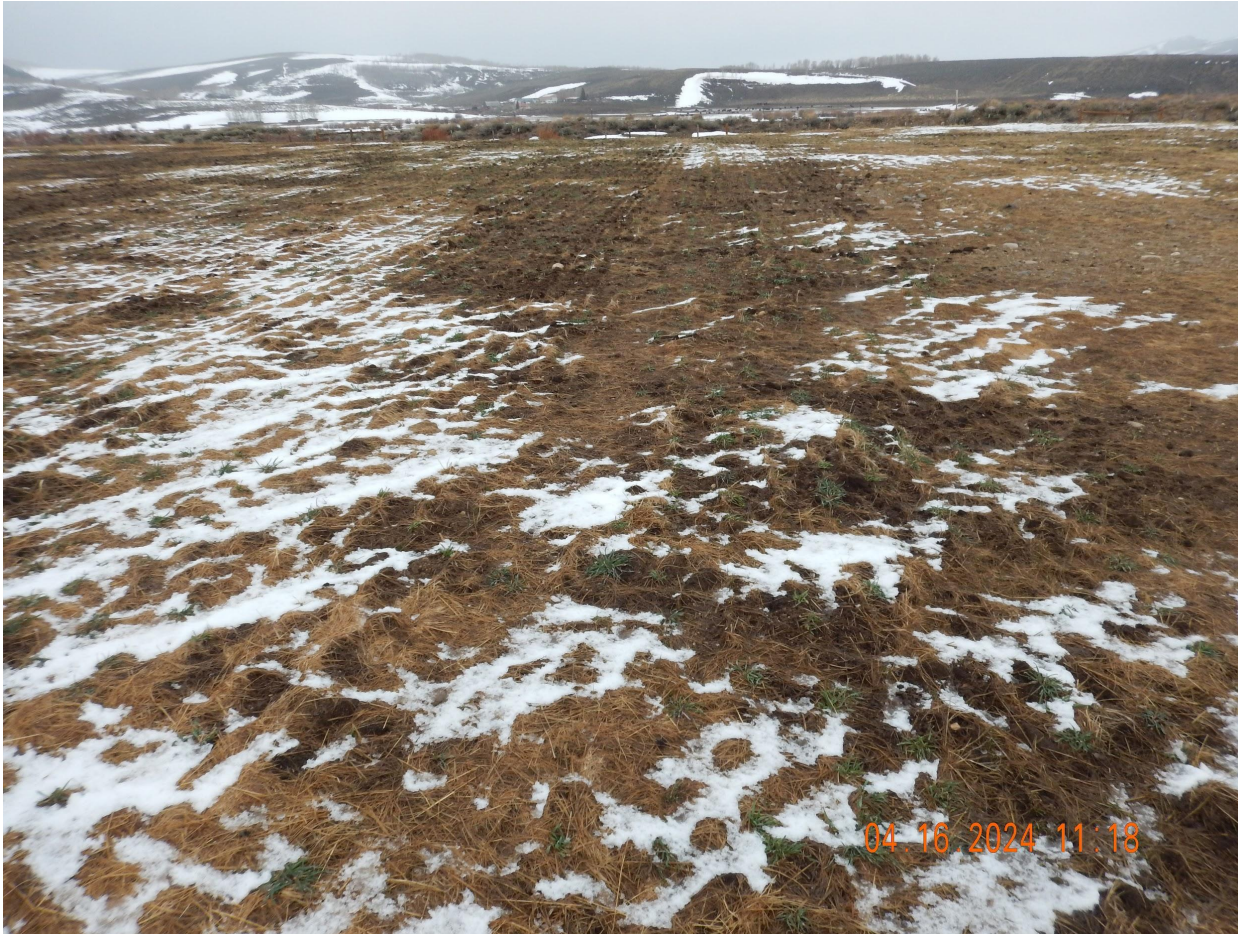
Photo 5. Photo taken from the eastern interim reclamation area, facing North. Photo illustrates interim reclamation has been performed with the evidence of germination of grass species and straw crimped mulch.

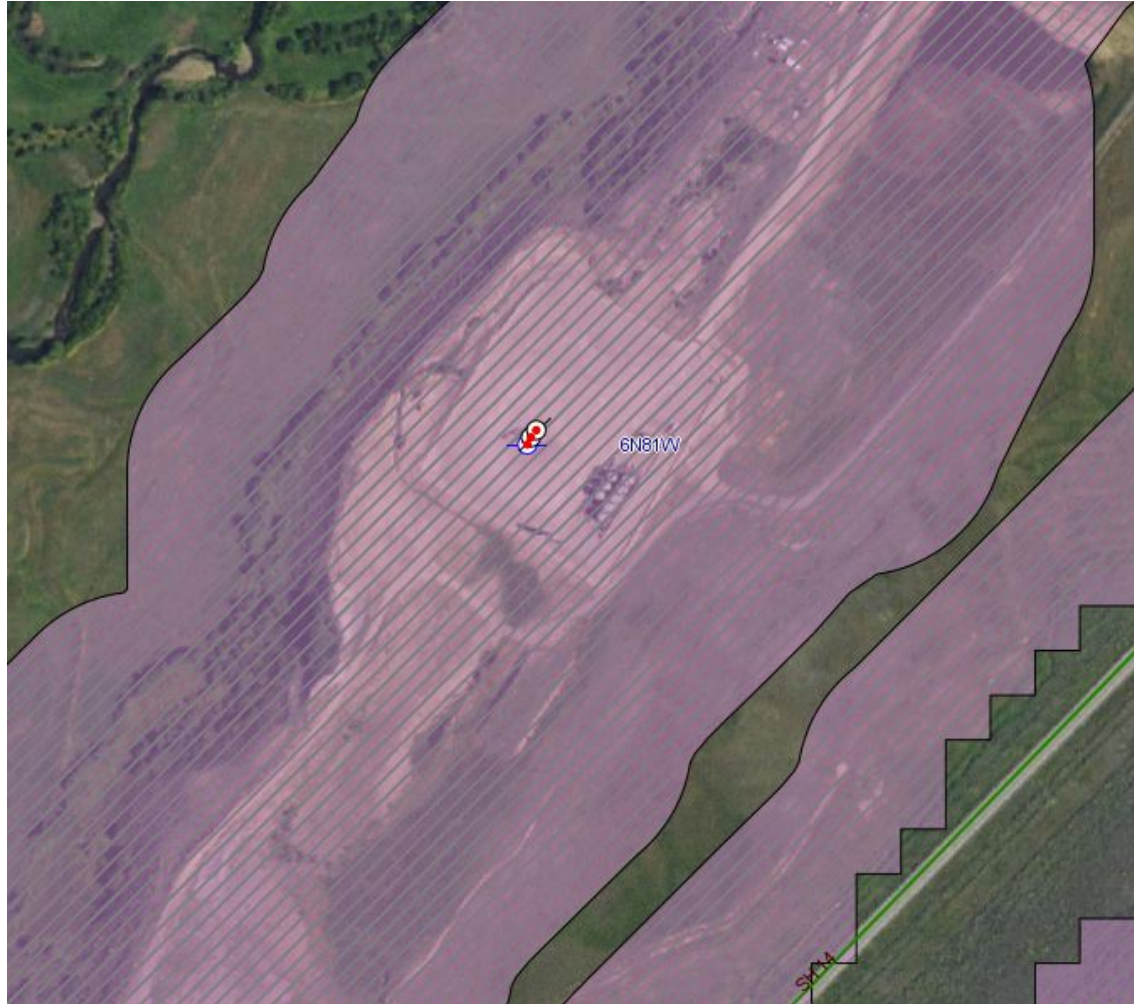
Photo 6. ECMC GIS aerial imagery illustrates the location falls within Greater Sage Grouse General Habitat Management Area.
