Inspection Photos

Location Name: MUSTANG RESOURCES LLC JUHAN ASTRAL FED FEE 1-26-6S-94W Pad

Location ID: 311532

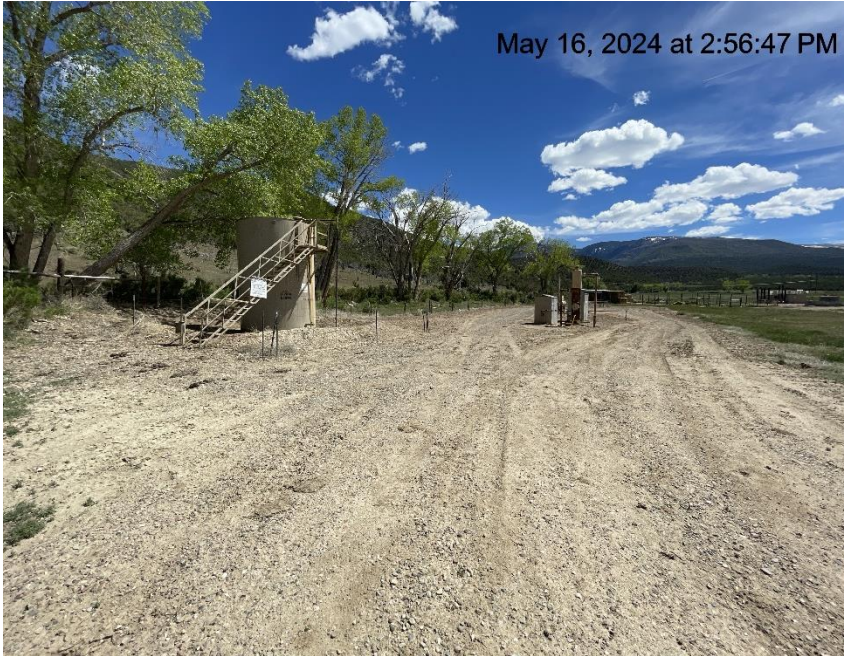
Photo # 7490 From entrance to location

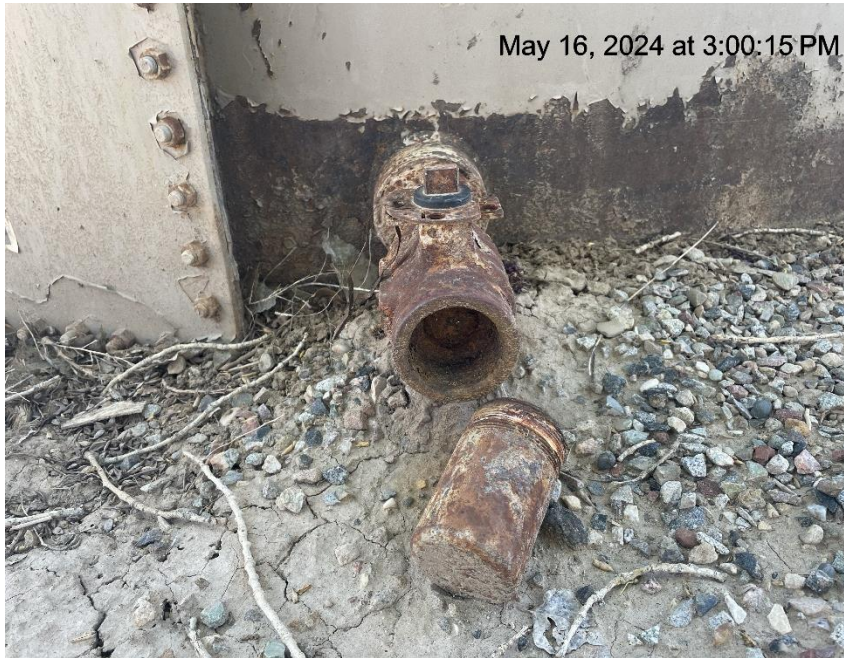
Photo # 7496 Open ended load line

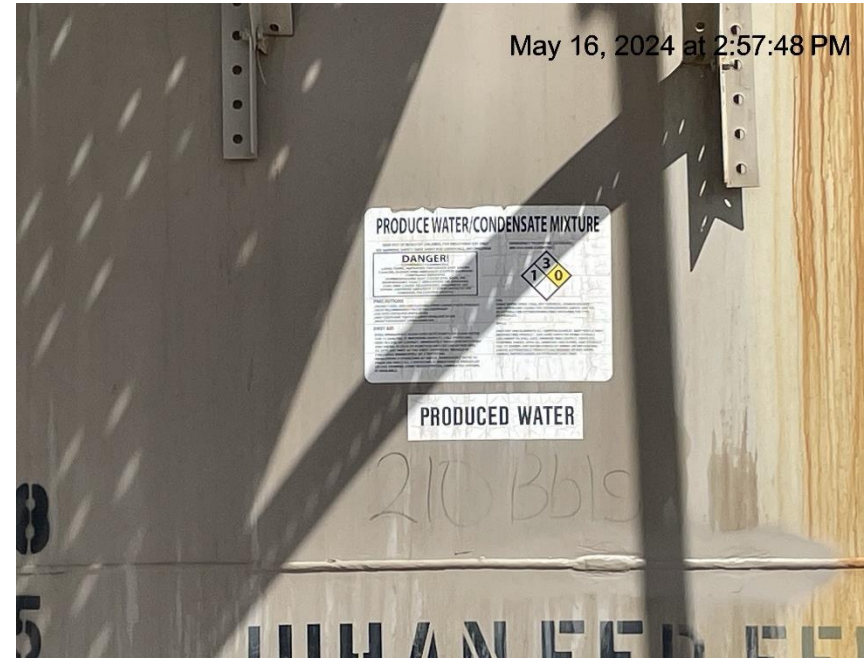
Photo # 7497 Production tank missing required information

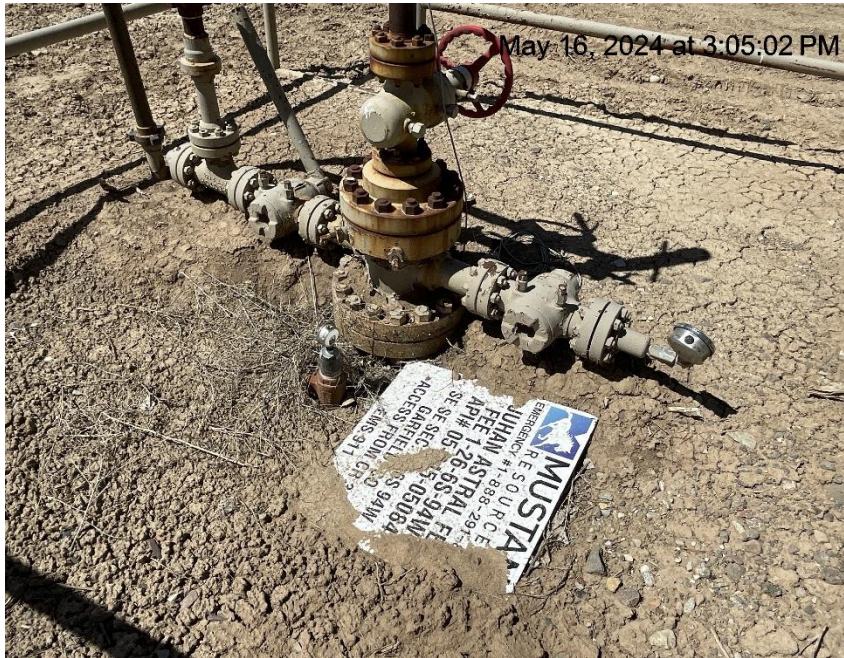
Photo # 7498 Wellhead sign not properly posted

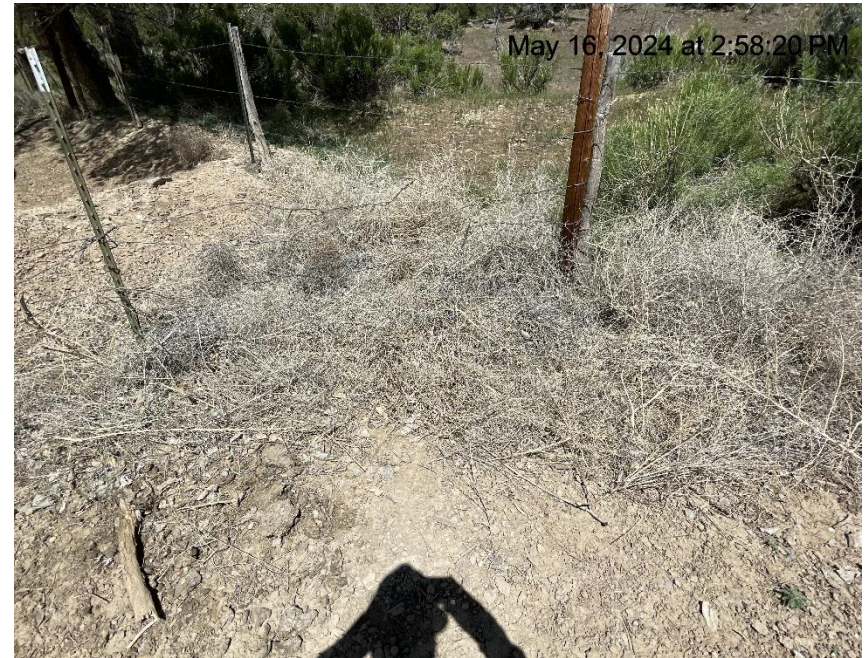
Photo # 7499 Dead weeds/debris

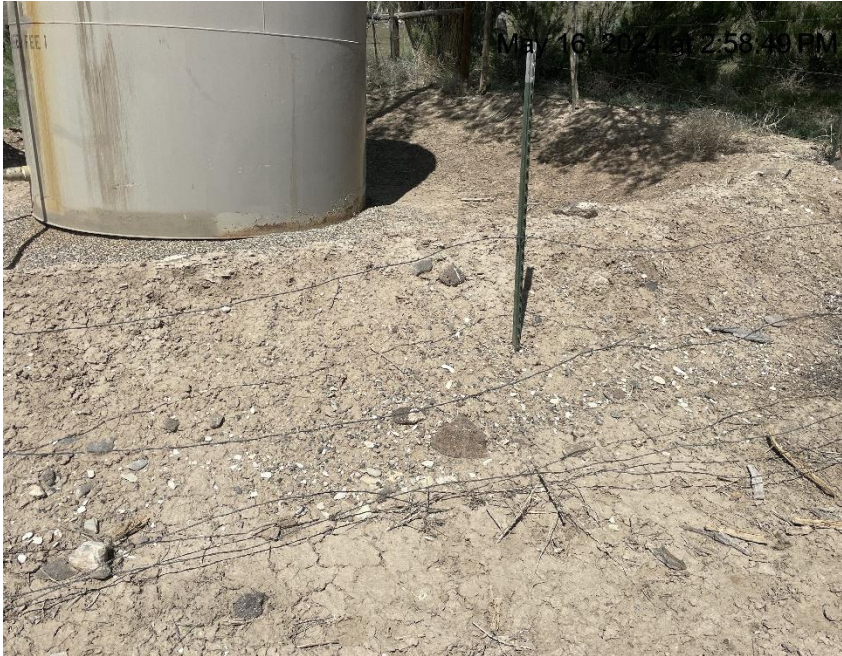
Photo # 7500 Wire fencing around tank battery needs maintenance

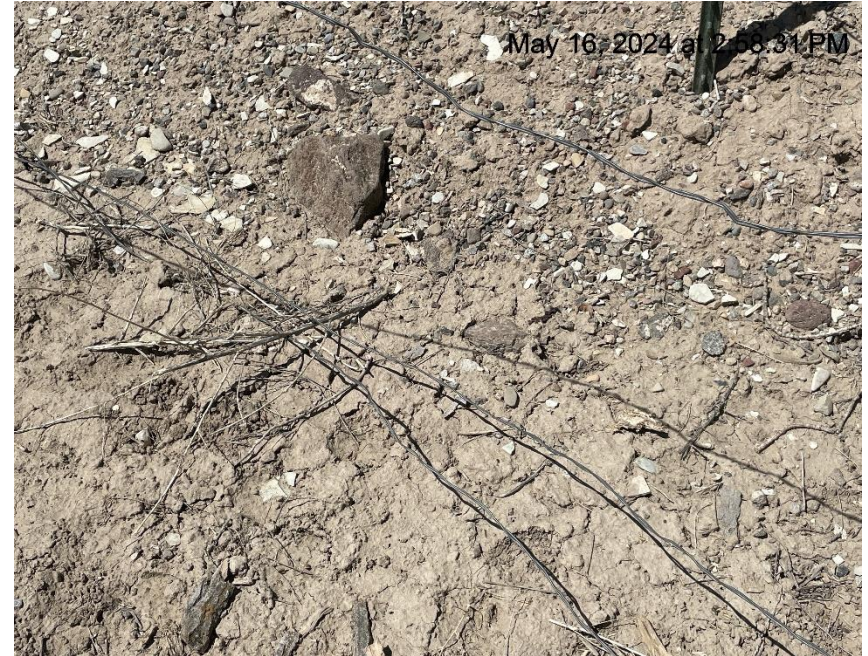
Photo # 7501 Wire fencing around tank battery needs maintenance
