Interim Reclamation and Stormwater Inspection

Date: 5/7/24

Operator: Kerr McGee Oil & Gas Onshore LP - 47120

Location ID: 416717

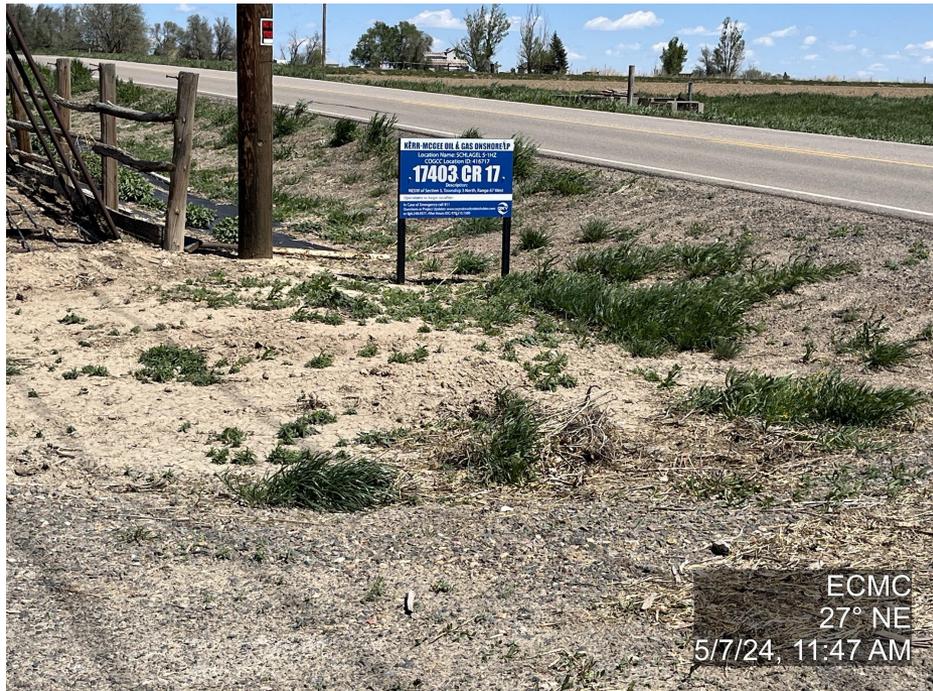
Photo 1. The photo was taken at the entrance to the well location facing Northeast. The photo illustrates the Operator location sign.

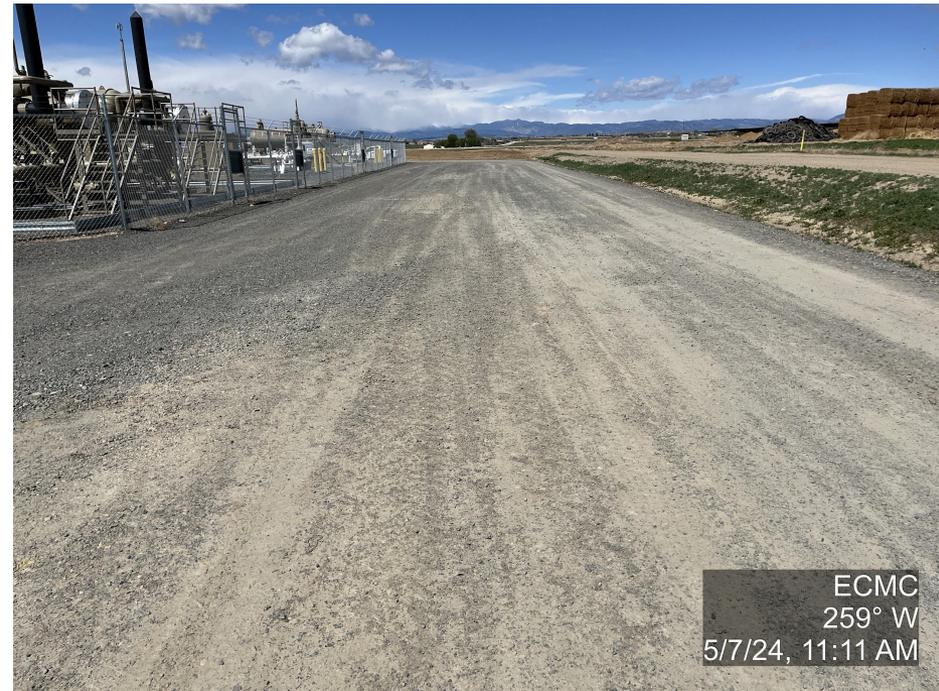
Photo 2. The photo was taken at the well location facing West. The photo illustrates the North side of the production pad and fencing around production equipment.

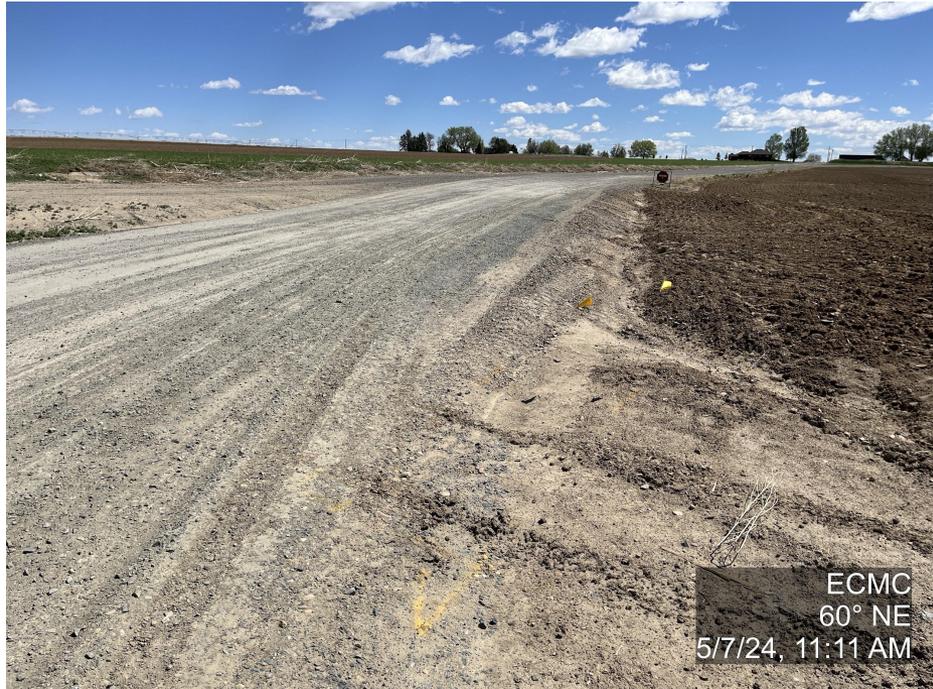
Photo 3. The photo was taken at the well location facing Northeast. The photo illustrates the access road.

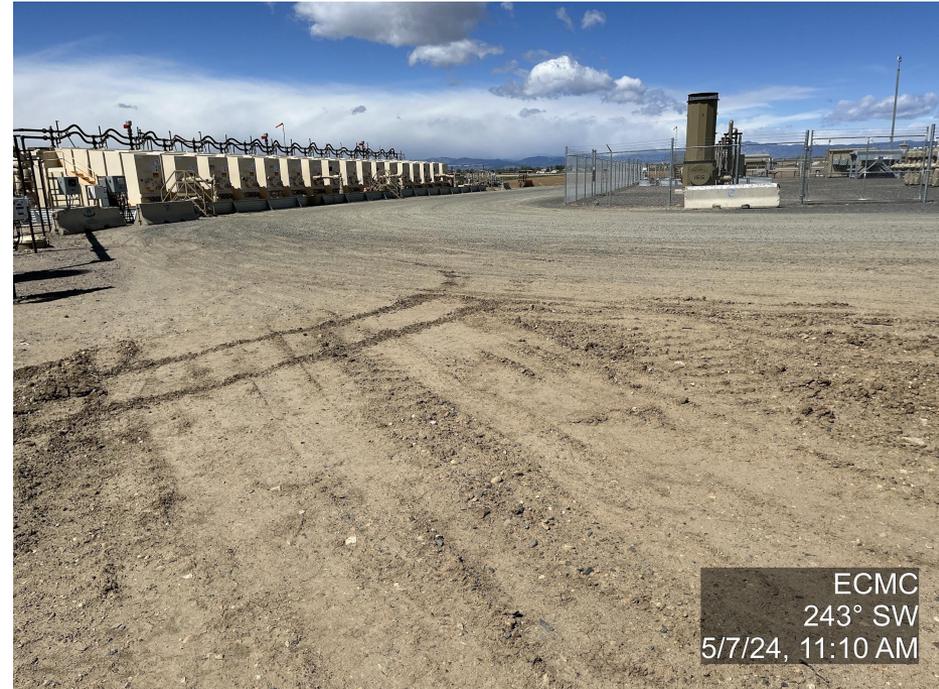
Photo 4. The photo was taken at the well location facing Southwest. The photo illustrates the South side of the production pad.

Note - Operator representative on location mentioned temporary tanks are to be removed in the near future.

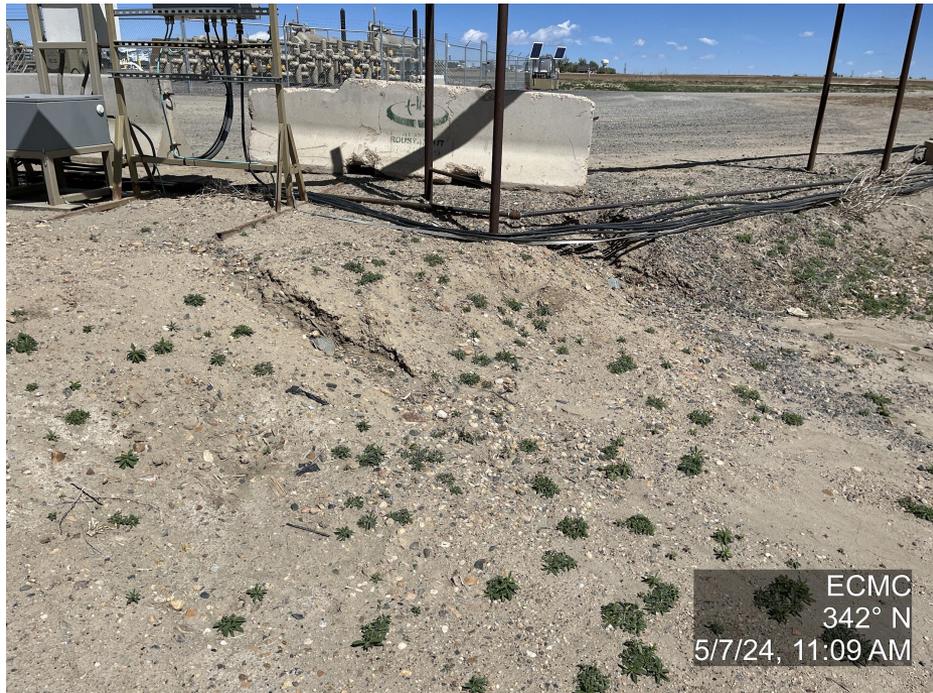
Photo 5. The photo was taken from the well location facing North. The photo illustrates rill erosion on the Southeast side of the production facility.

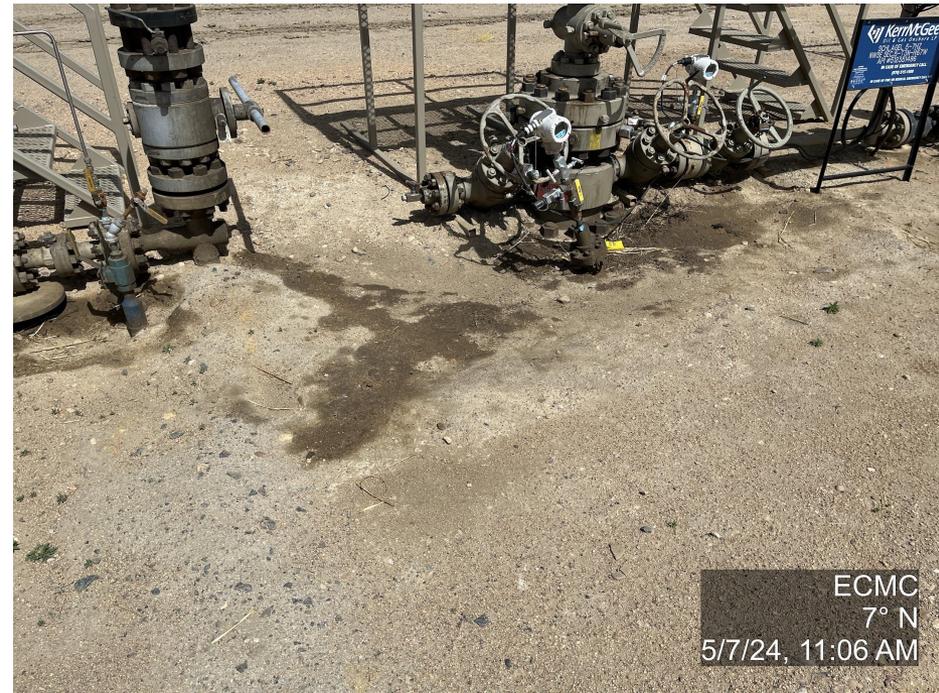
Photo 6. The photo was taken at the well location facing North. The photo illustrates stained soil around the wellheads.

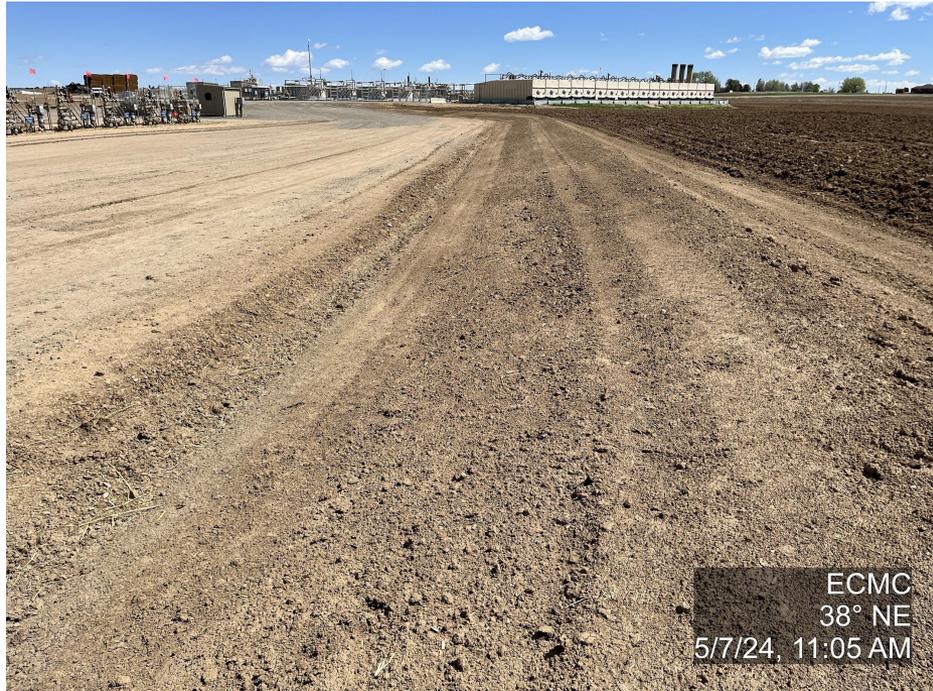
Photo 7. The photo was taken from the well location facing Northeast. The photo illustrates the perimeter ditch and berm around the wellhead pad.

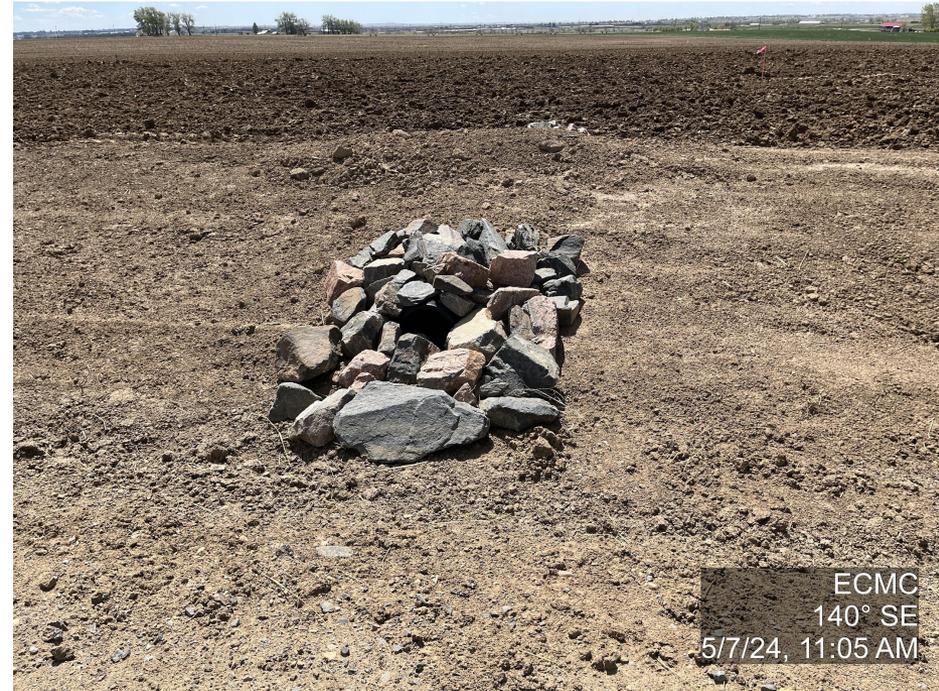
Photo 8. The photo was taken at the well location facing Southeast. The photo illustrates a rip-rap protected outflow.

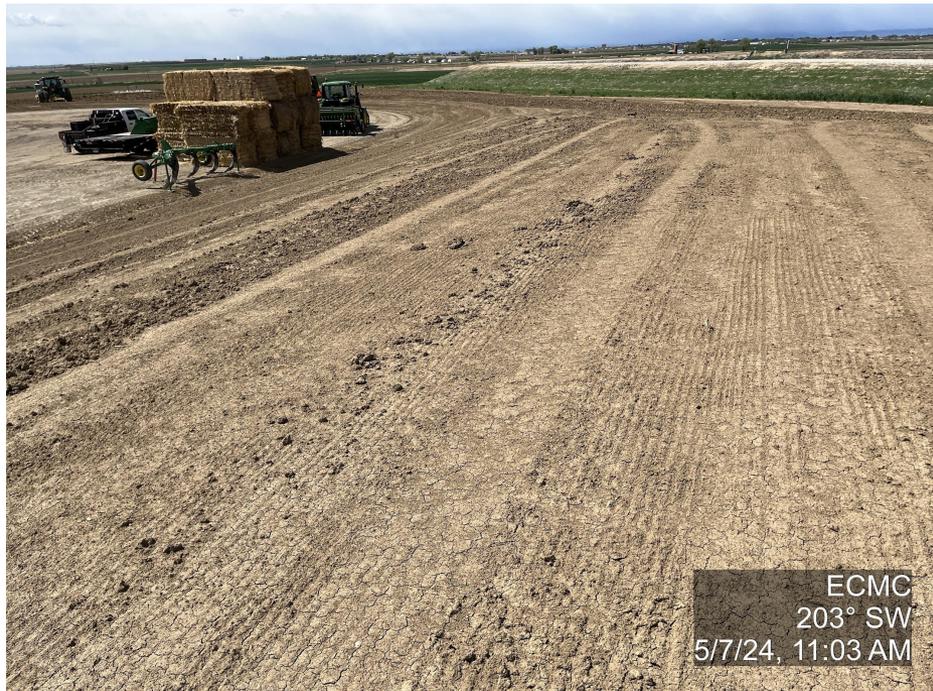
Photo 9. The photo was taken from the well location facing Southwest. The photo illustrates the apparent unprotected topsoil stockpile and equipment being stored on the wellhead pad.

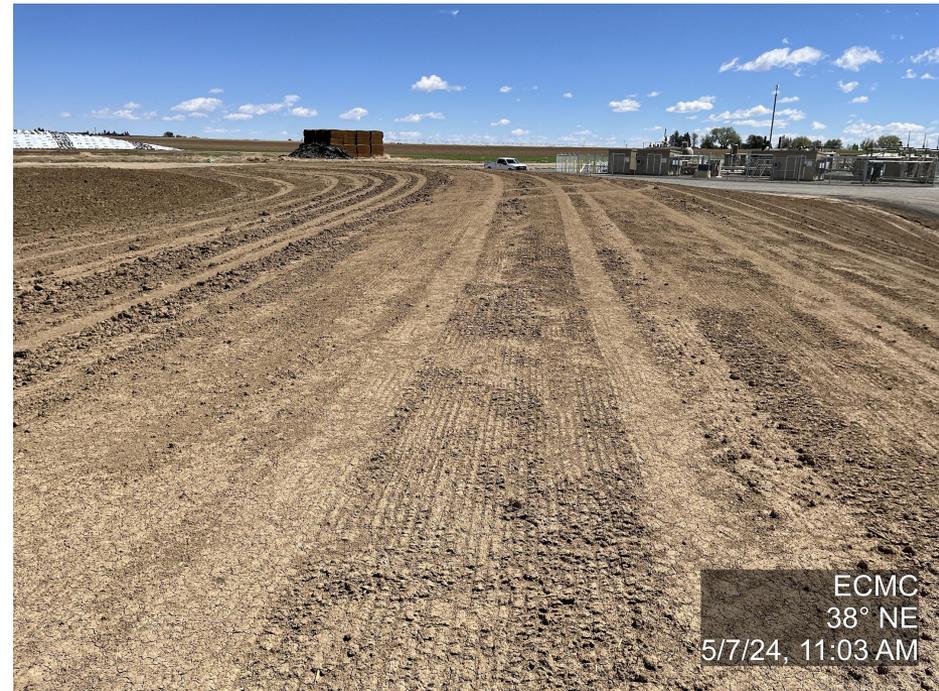
Photo 10. The photo was taken at the well location facing Northeast. The photo illustrates the unprotected topsoil stockpile.

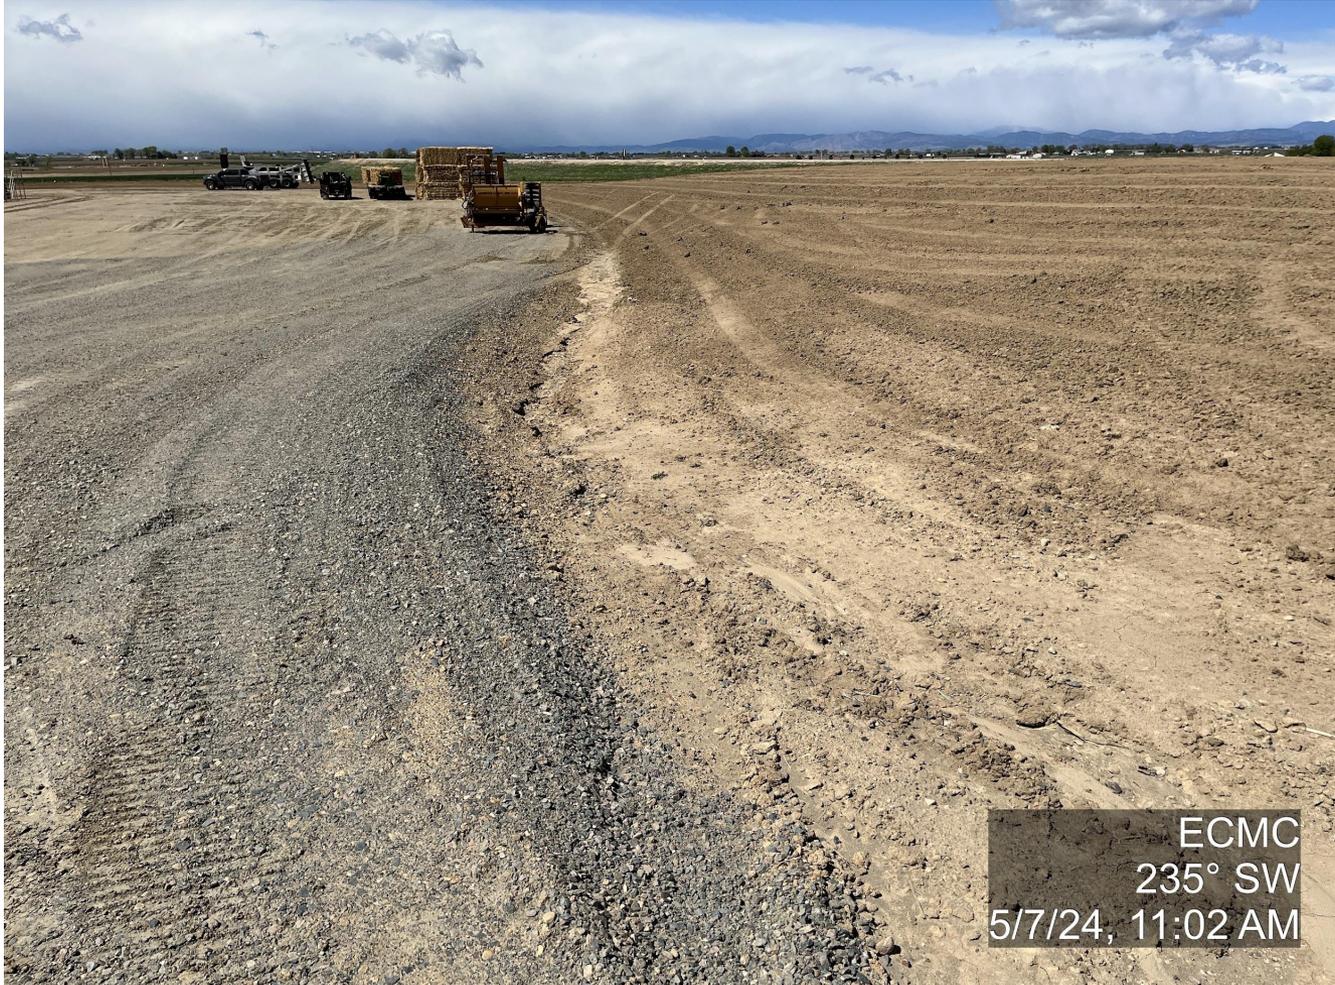
Photo 11. The photo was taken at the well location facing Southwest. The photo illustrates some erosion along the base of the unprotected stockpile and equipment being stored on the wellhead pad.
