Caerus Piceance LLC
Piceance Creek Unit T32X-33G
Location ID: 316301

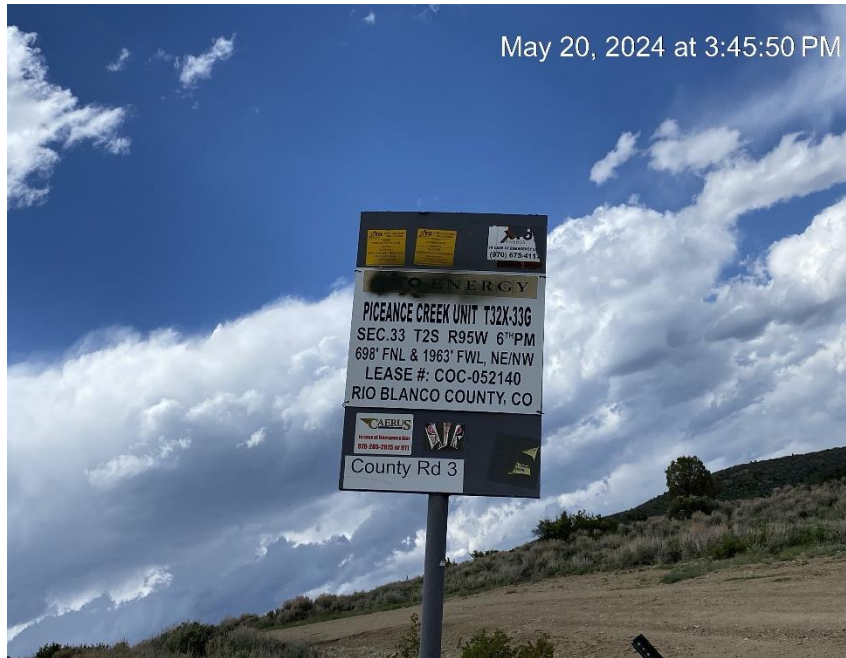
As signs are replaced additional information is required.
Needs turned facing entrance.

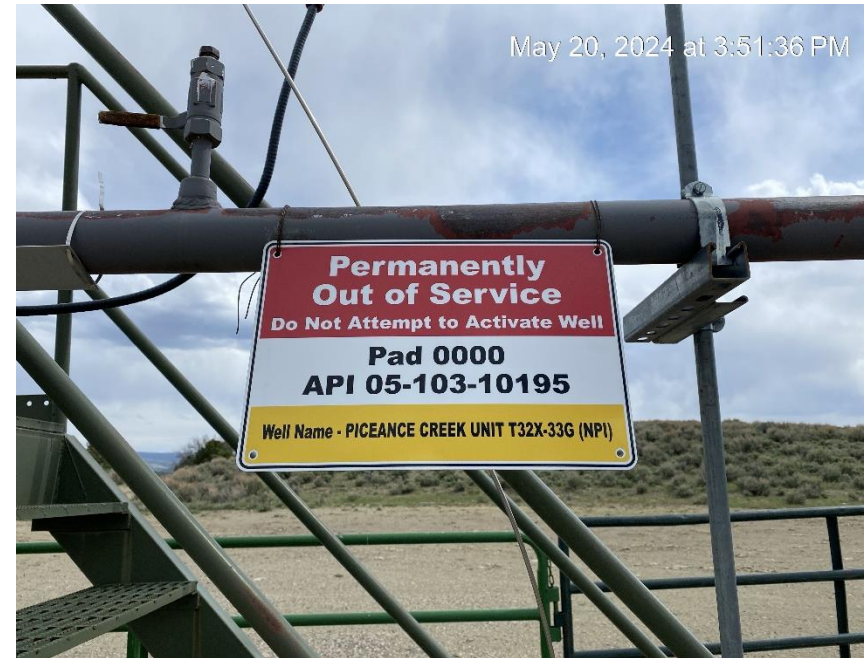
As signs are replaced additional information is required

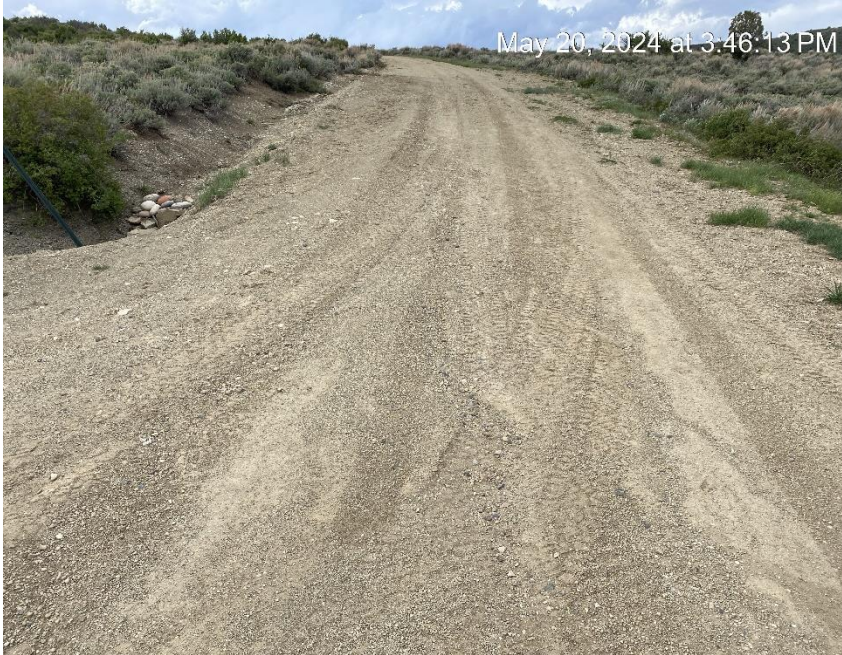
Lack of Stormwater BMP maintenance.

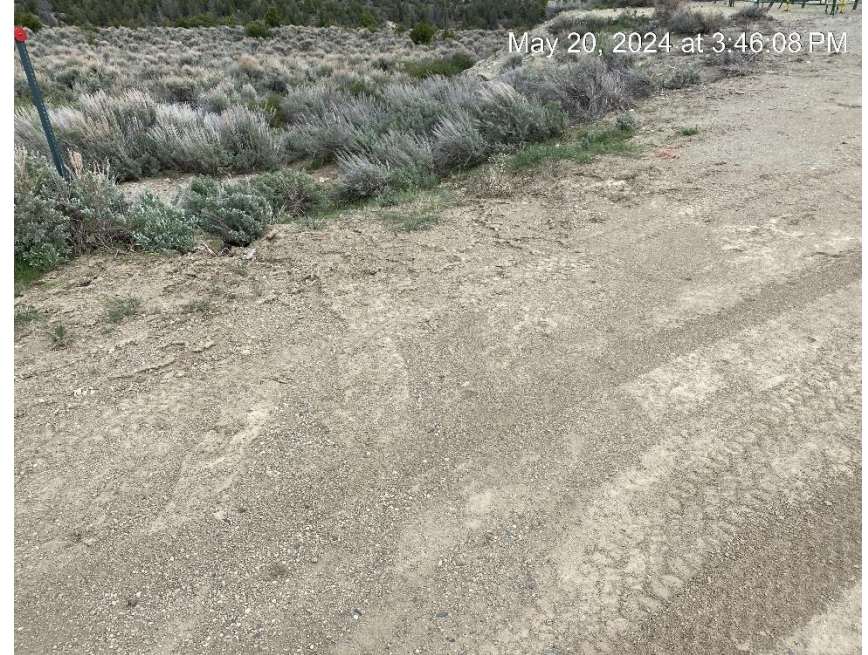
Lack of Stormwater BMP maintenance.

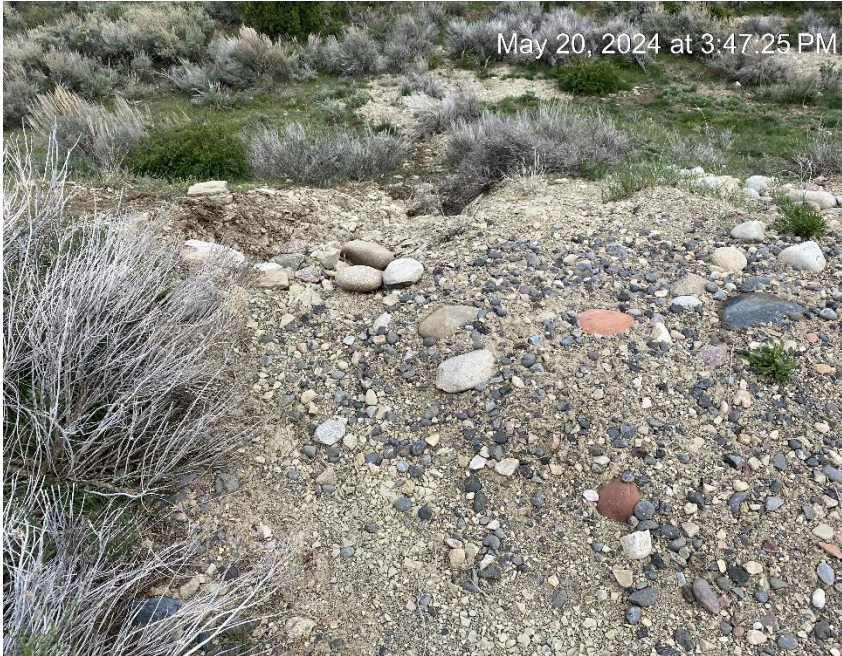
Erosion and sediment migration

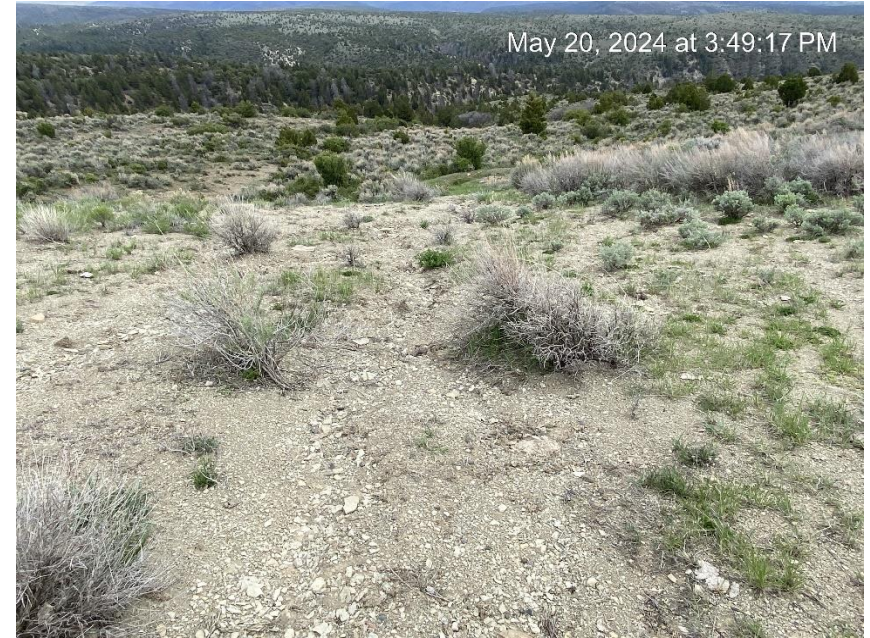
Erosion and sediment migration

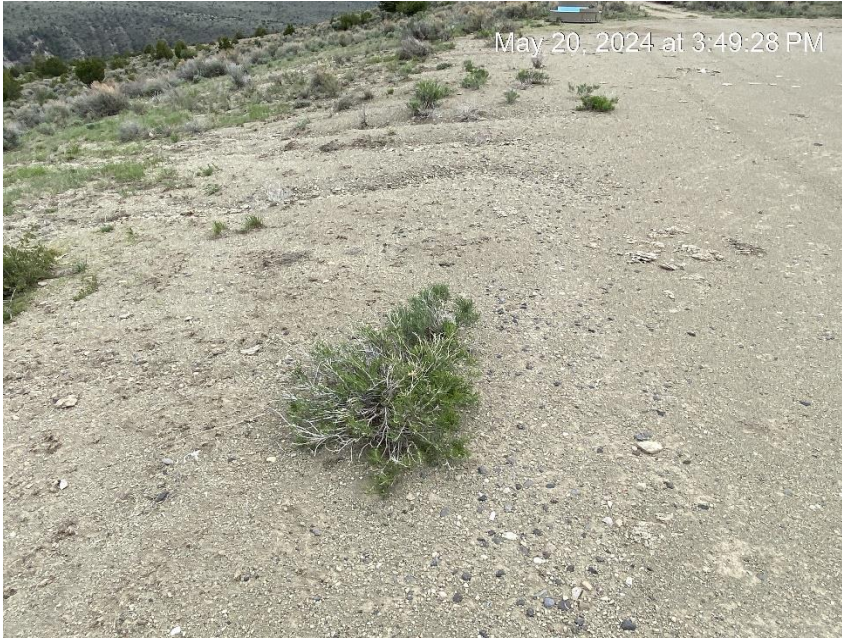
Stormwater BMPs need maintenance

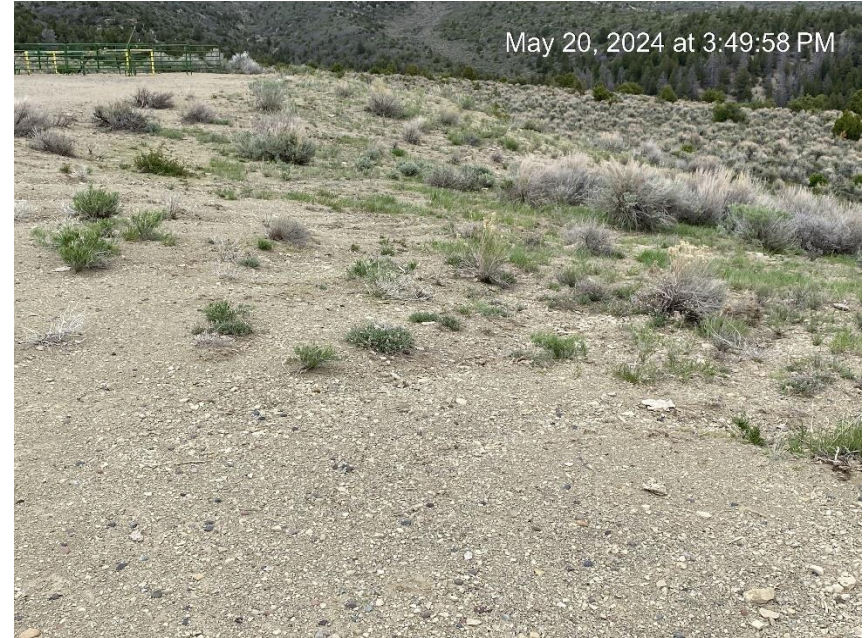
Stormwater BMPs need maintenance

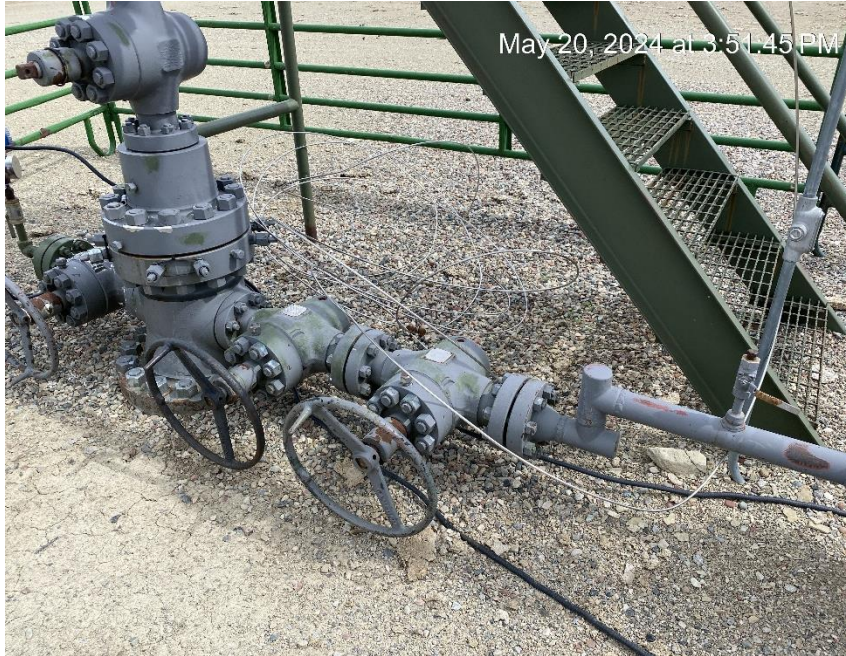
Debris

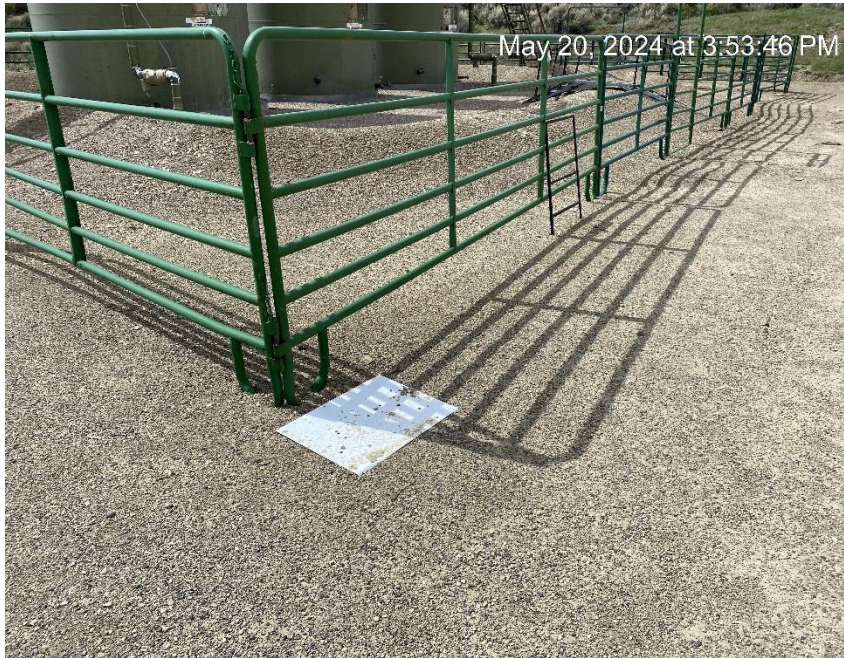
Tank battery sign not displayed
