ECMC Field Inspection Report Response (FIRR) Photographic Log

Fluharty Tank Battery

Field Inspection Form #: 711900661

(May 8, 2024)

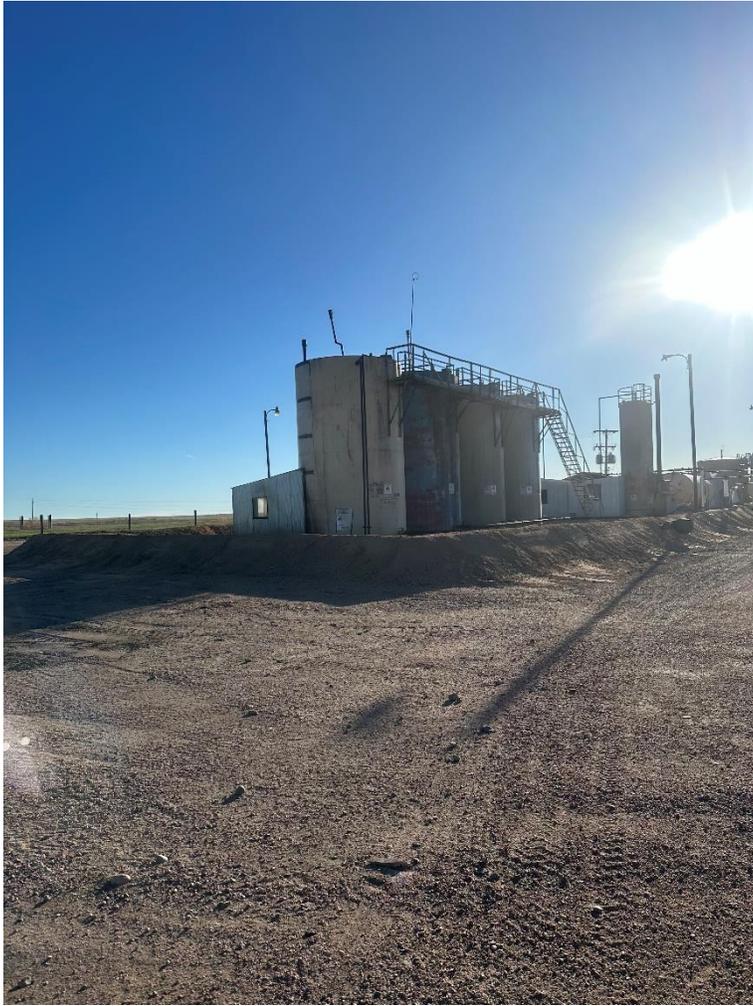
Description:
West Padroni Tank
Battery with
fiberglass insulated
tank removed

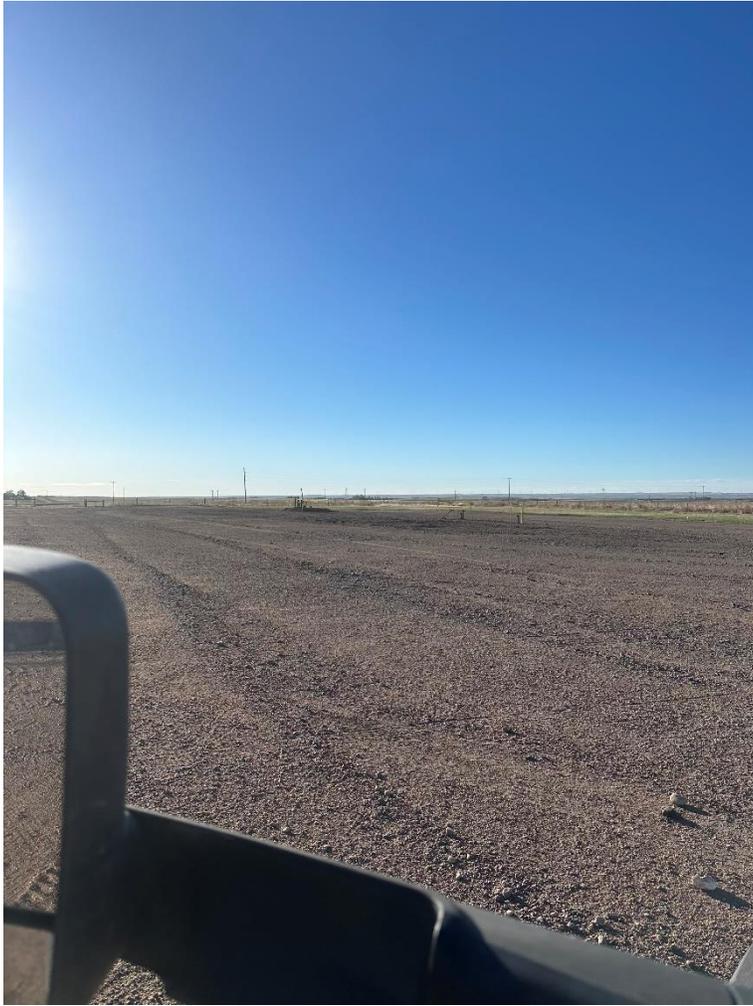
Description:
Fluharty Tank
Battery equipment
tank removed
looking NE from the
West Padroni Tank
Battery access road

Note: Flowline
risers still present in
photo, but lines
shall be removed or
abandoned per the
ECMC
requirements.

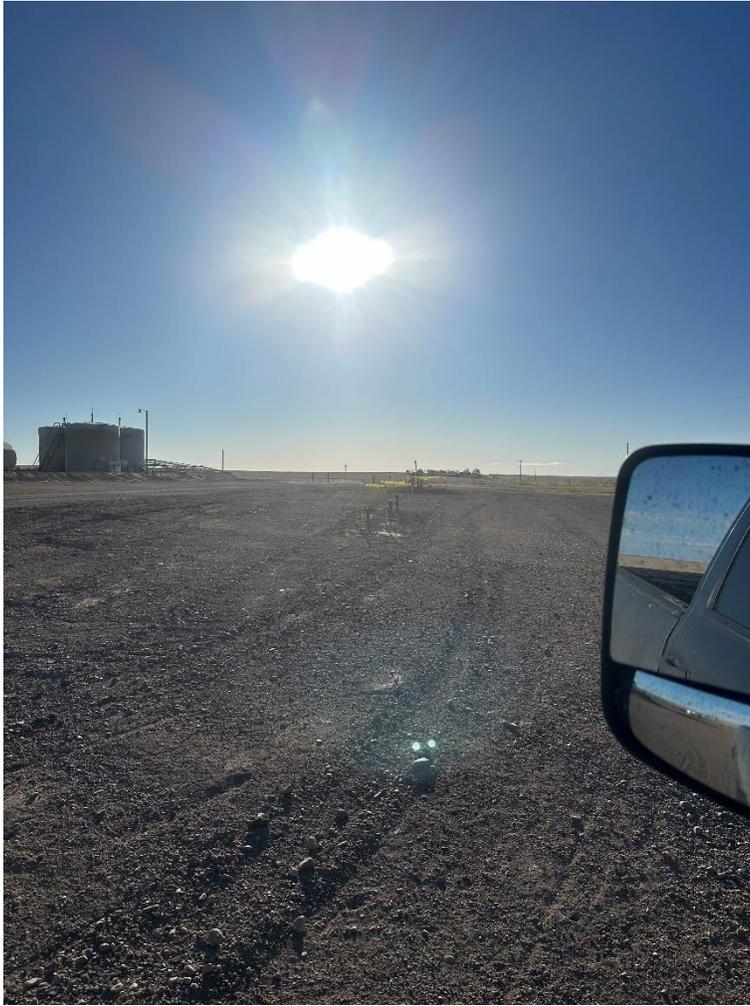
Description:
Fluharty Tank
Battery equipment
tank removed
looking E from the
West Padroni Tank
Battery access
road.

Note: Flowline
risers still present in
photo, but lines
shall be removed or
abandoned per the
ECMC
requirements.

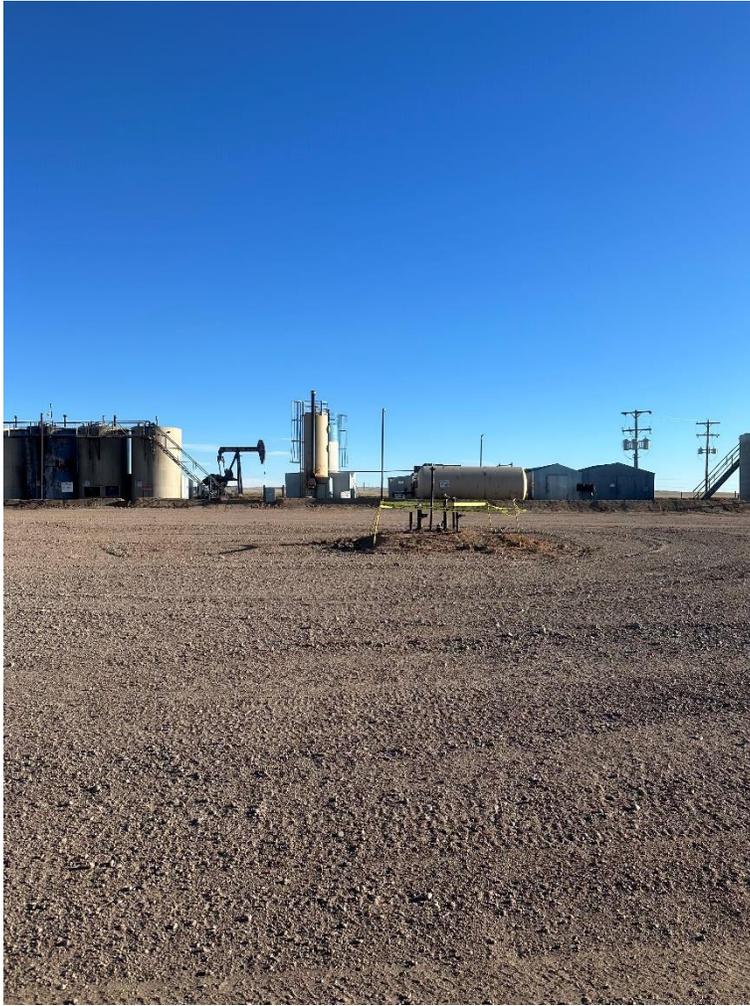
Description:
Fluharty Tank
Battery equipment
tank removed
looking N.

Note: Flowline
risers still present in
photo, but lines
shall be removed or
abandoned per the
ECMC
requirements.
