Inspection Photos

May 21st 2024

Operator: Hilcorp Energy Company - 10133

Location ID: 326297

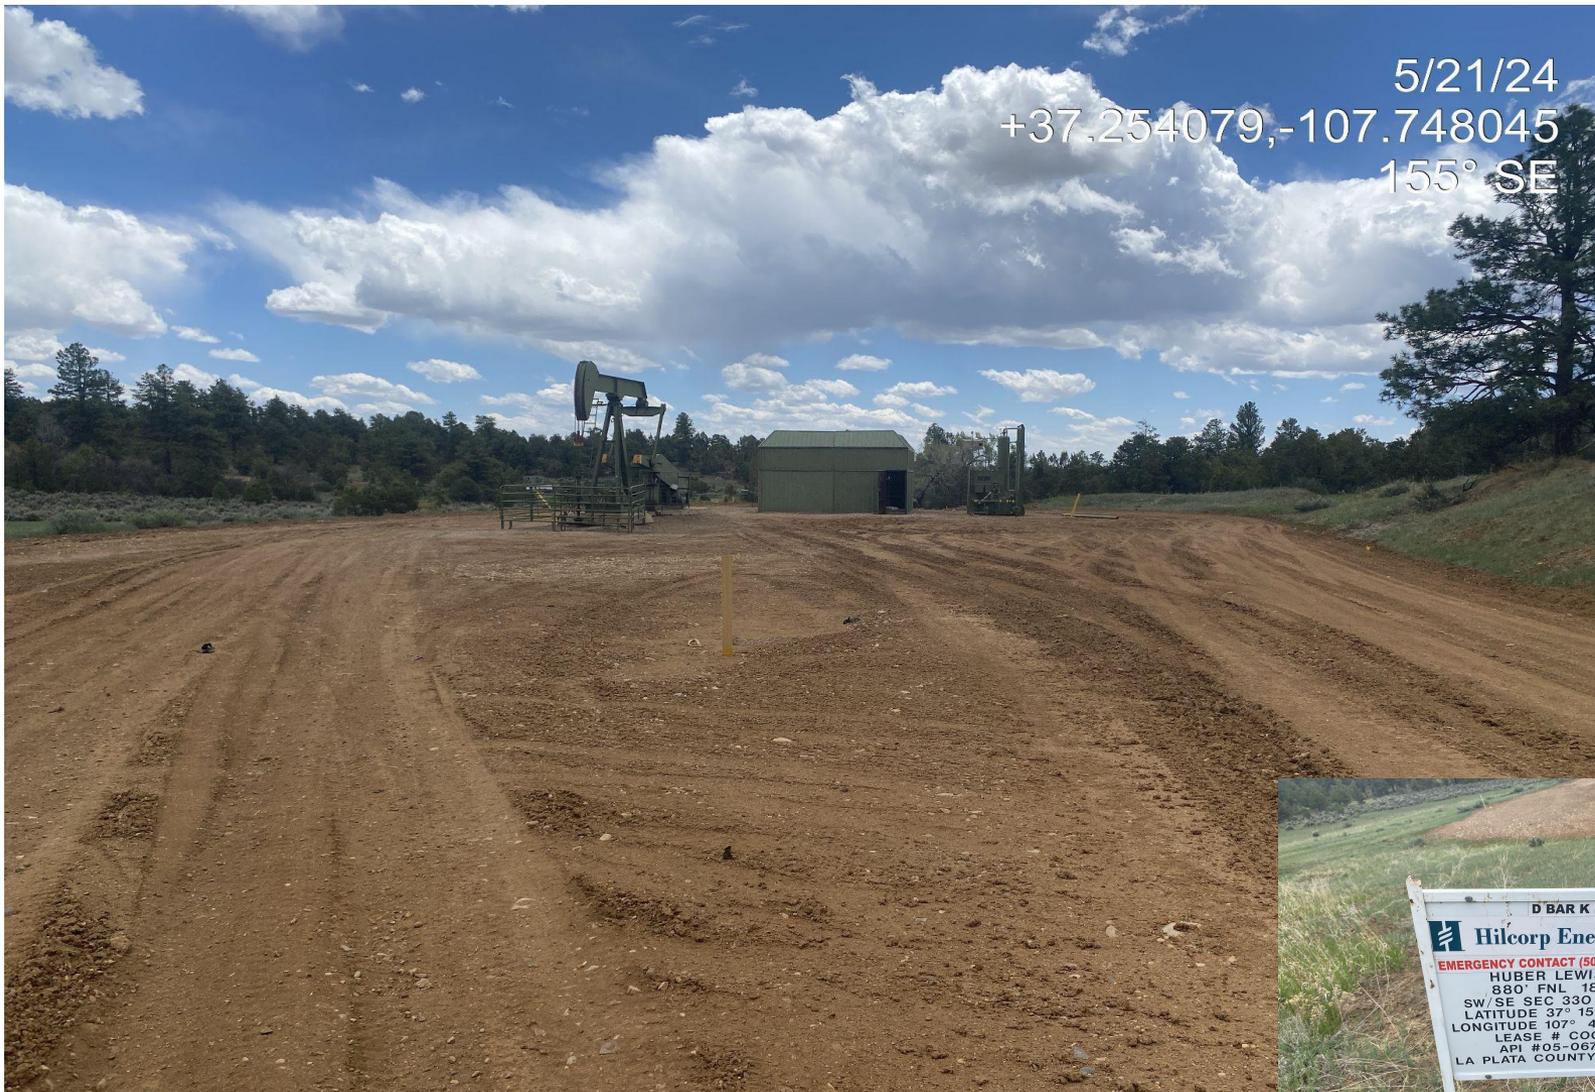
Photo 1. View of the well pad taken from the access point facing center.

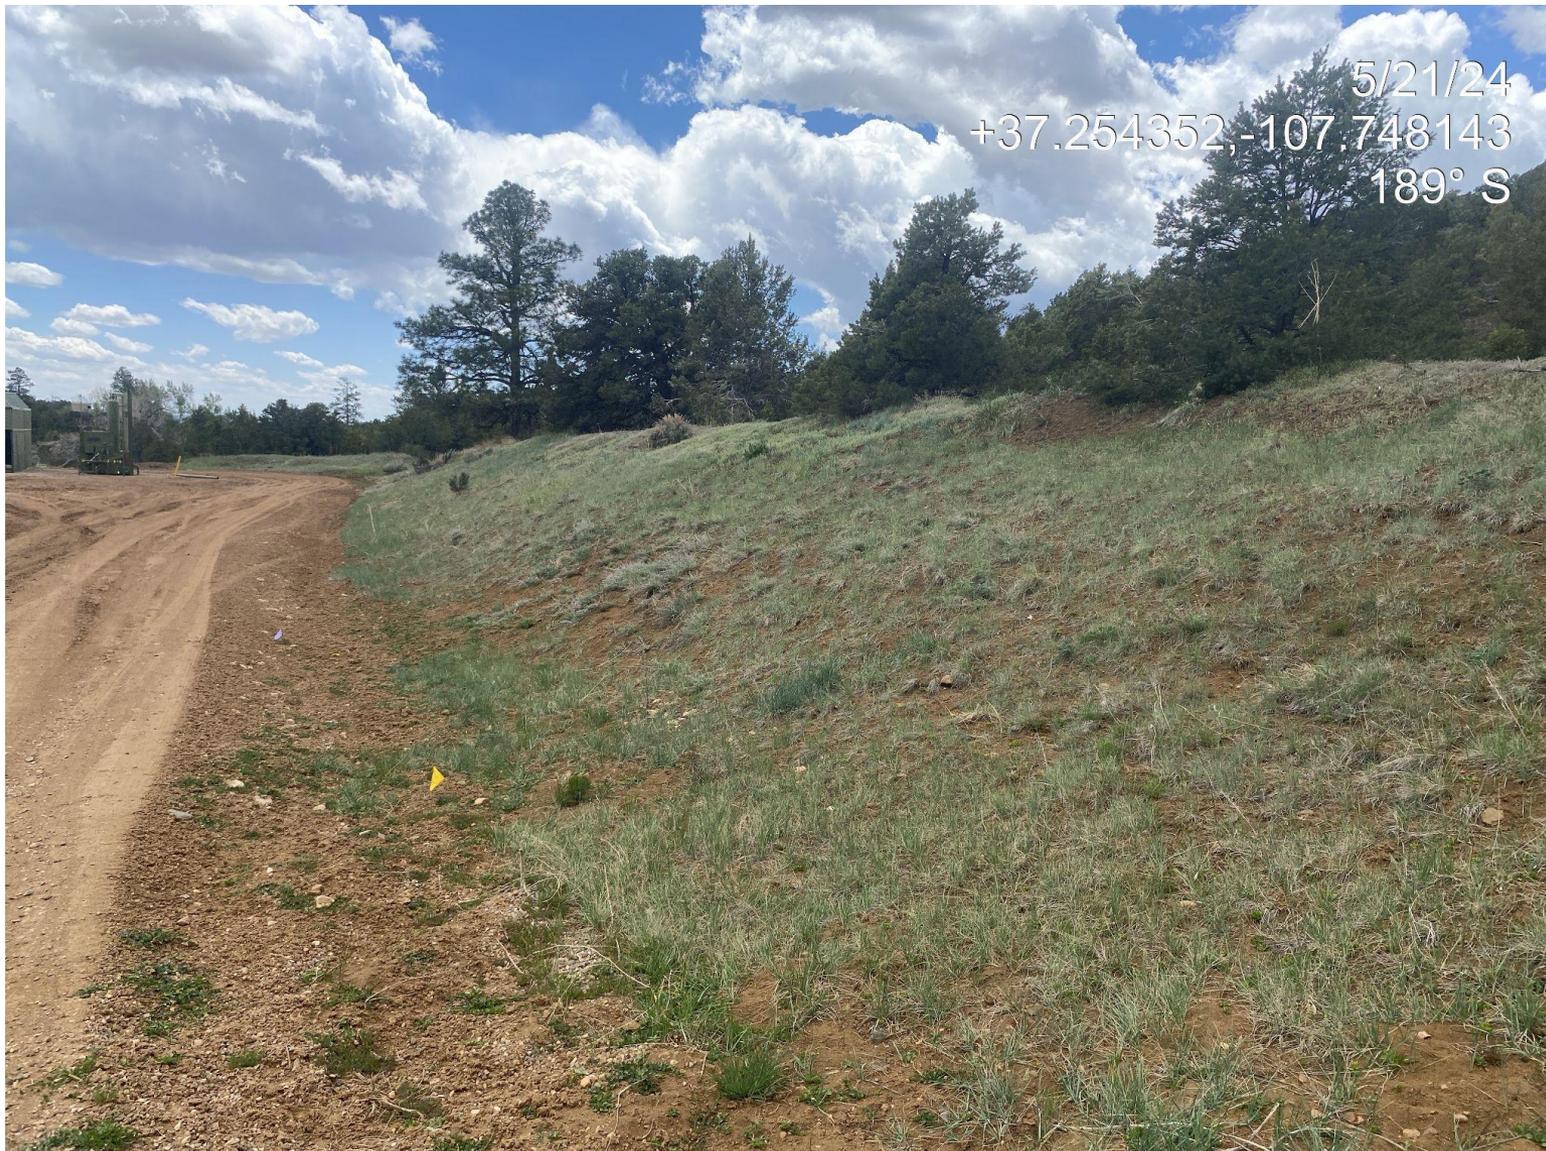
Photo 2. View of the western interim reclamation area facing south. Vegetation predominately comprised of western wheatgrass.

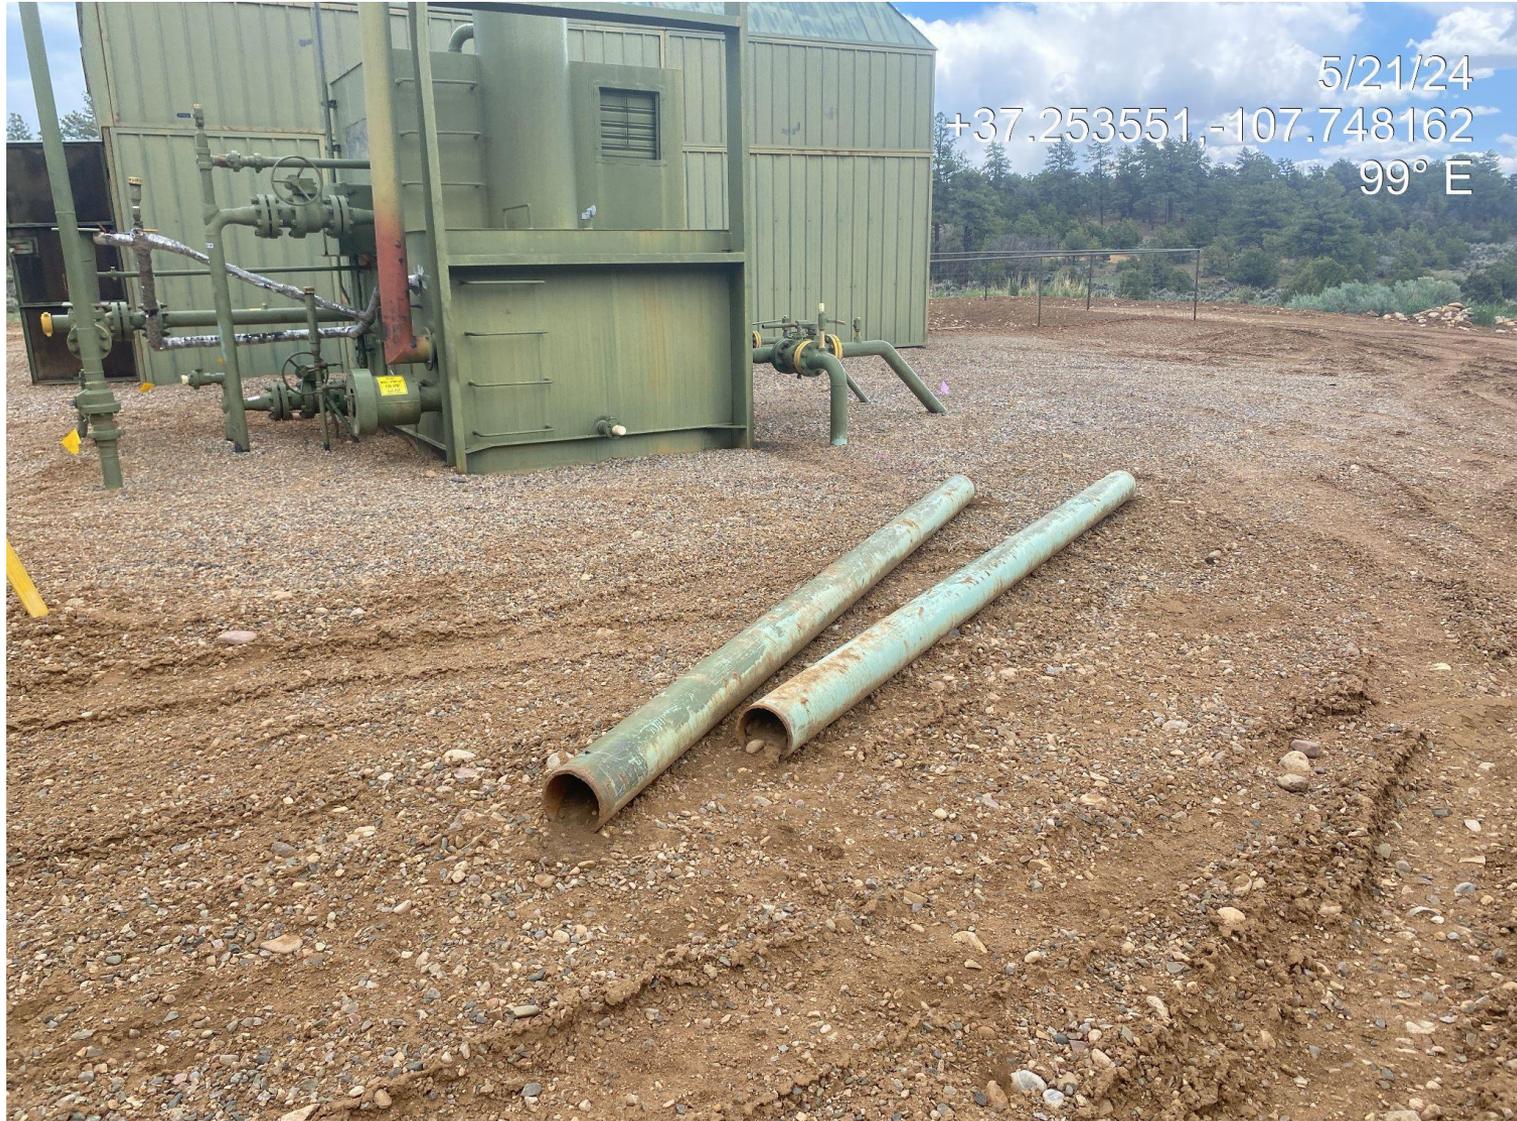
Photo 3. Unused oil and gas piping equipment observed on location.

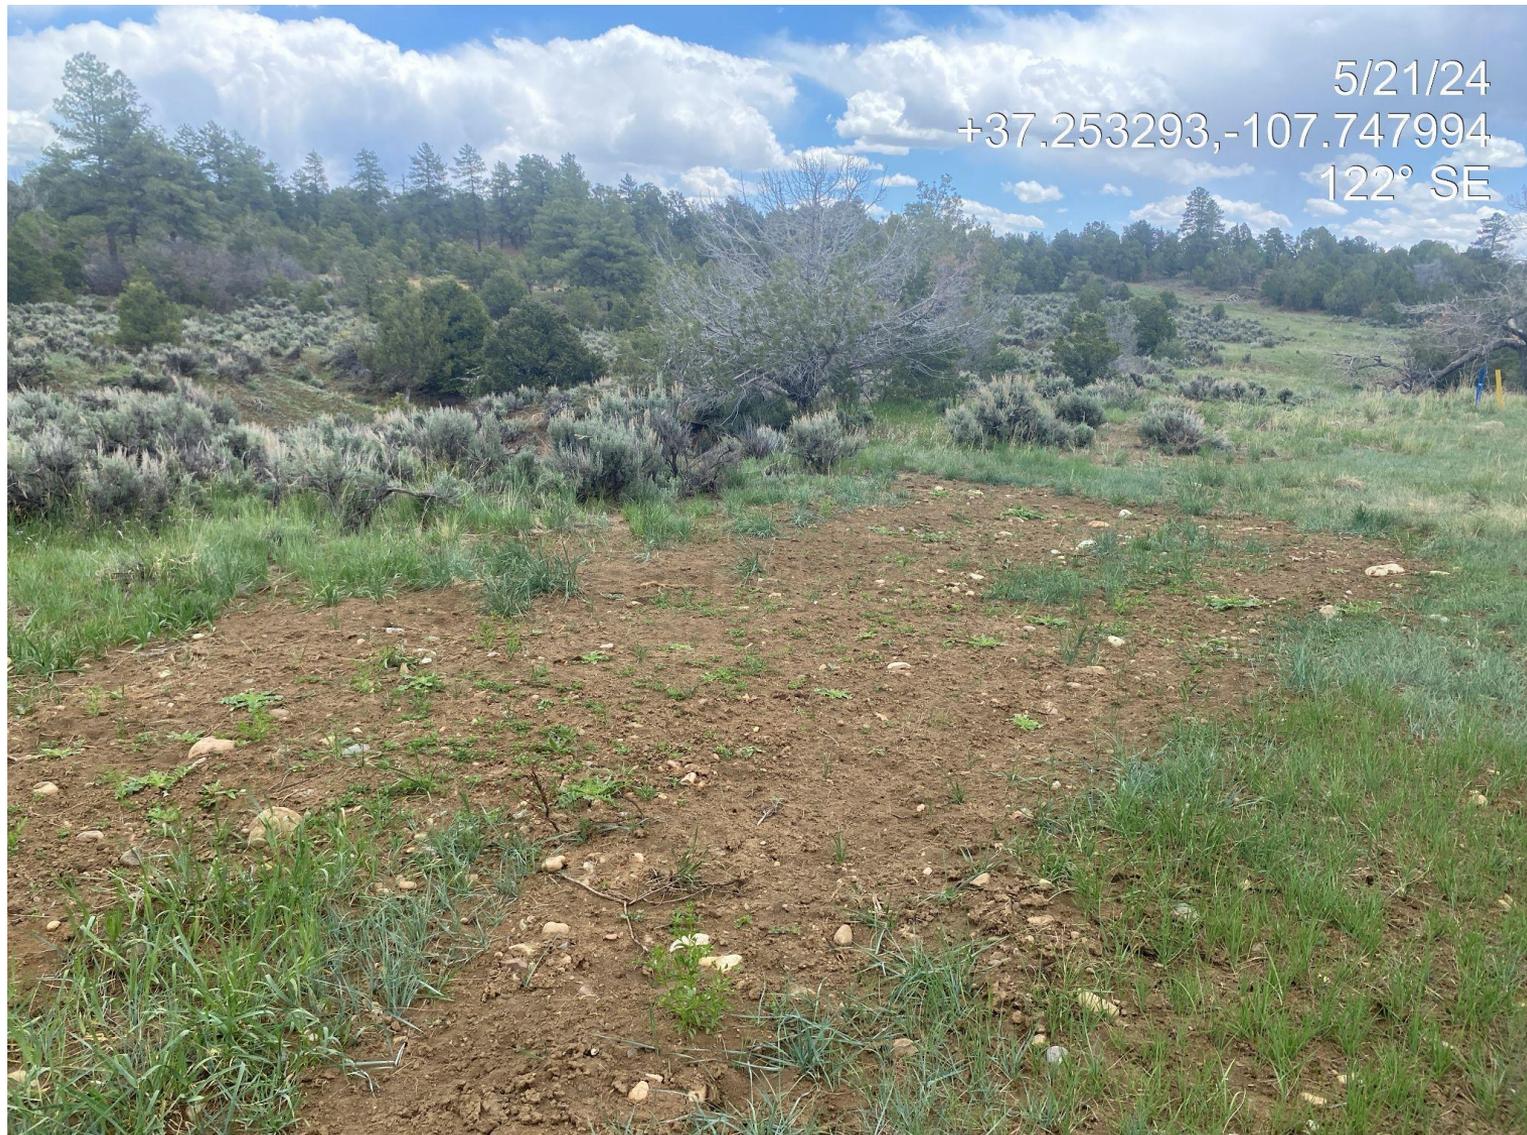
Photo 4. View of gully erosion identified in previous inspection doc that has been collapsed, regraded and reseeded. Germination of western wheatgrass observed.

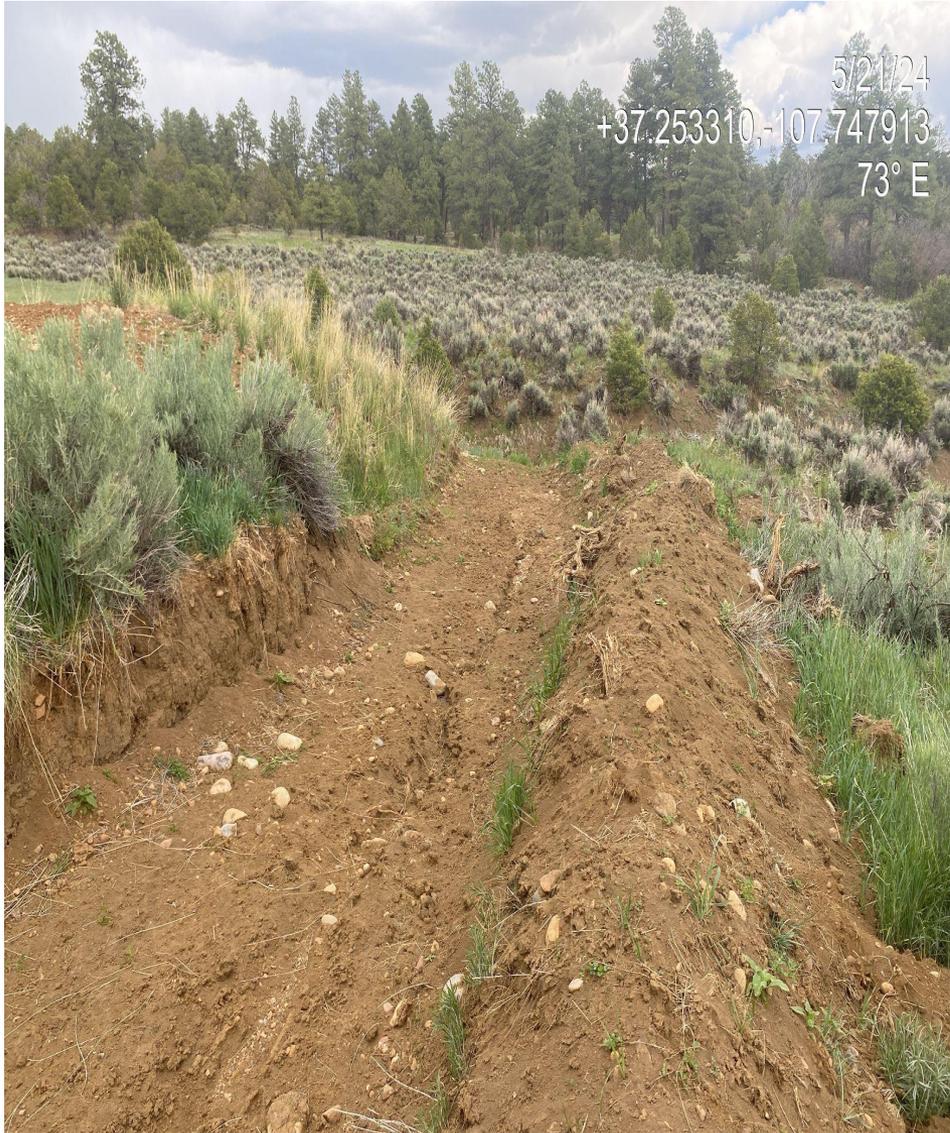
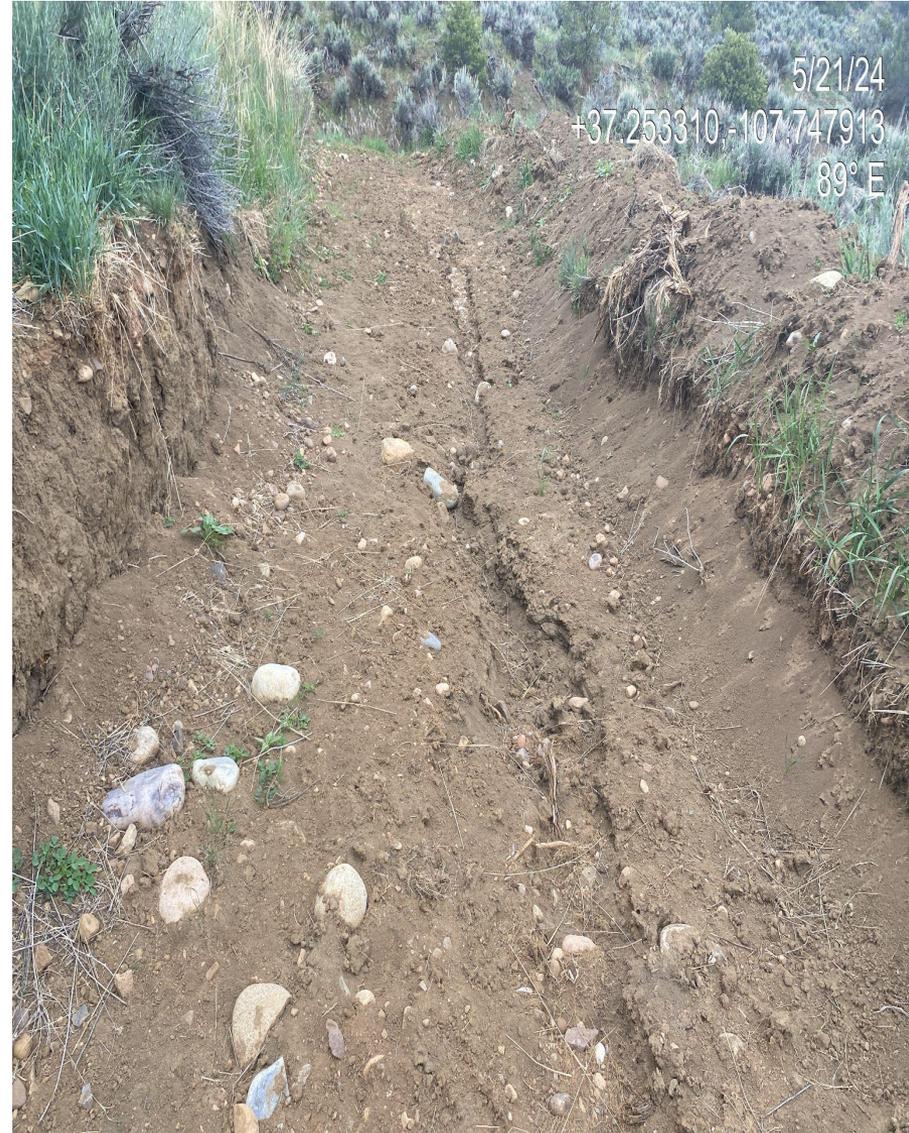
Photo 5. New storm water divergent channel has not been installed per good engineering practices. Rill erosion and evidence of sediment transport persists, additional stabilization is needed in this area.

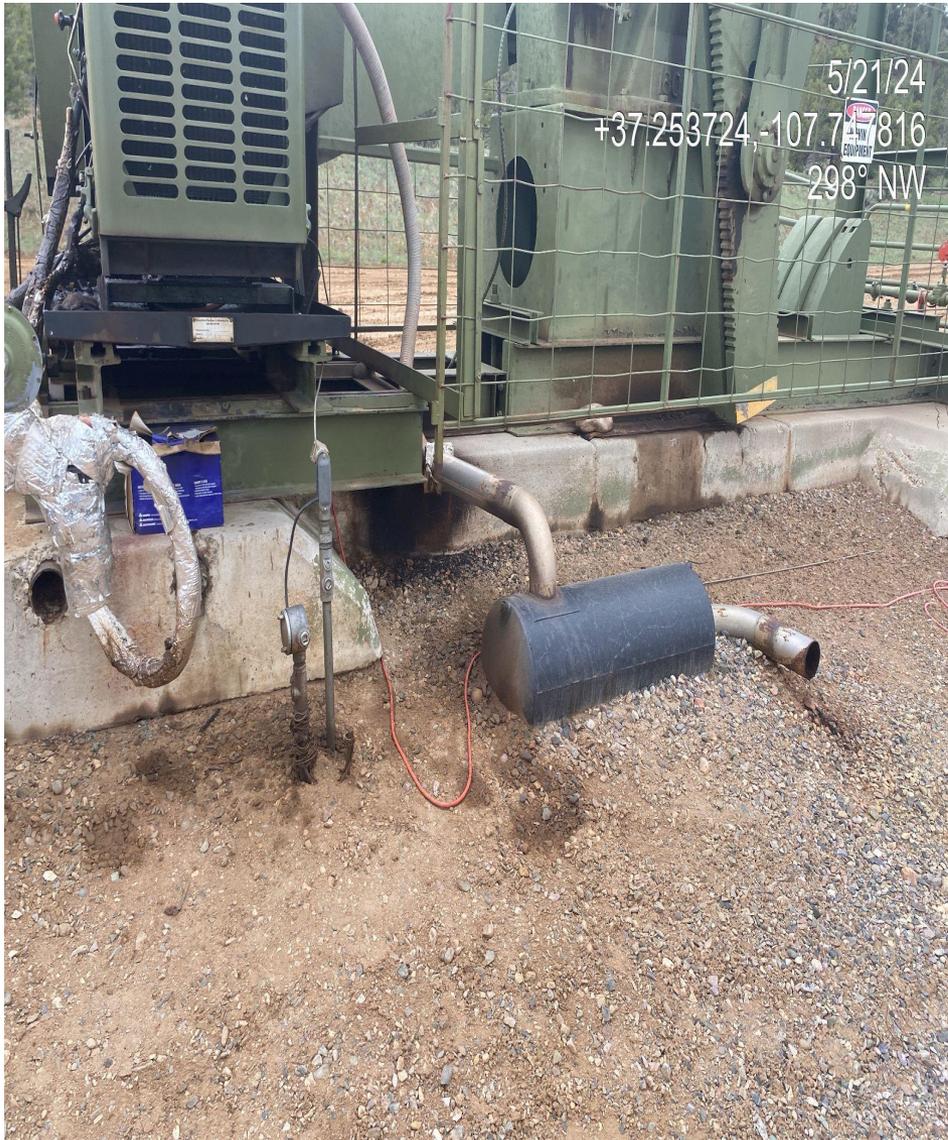
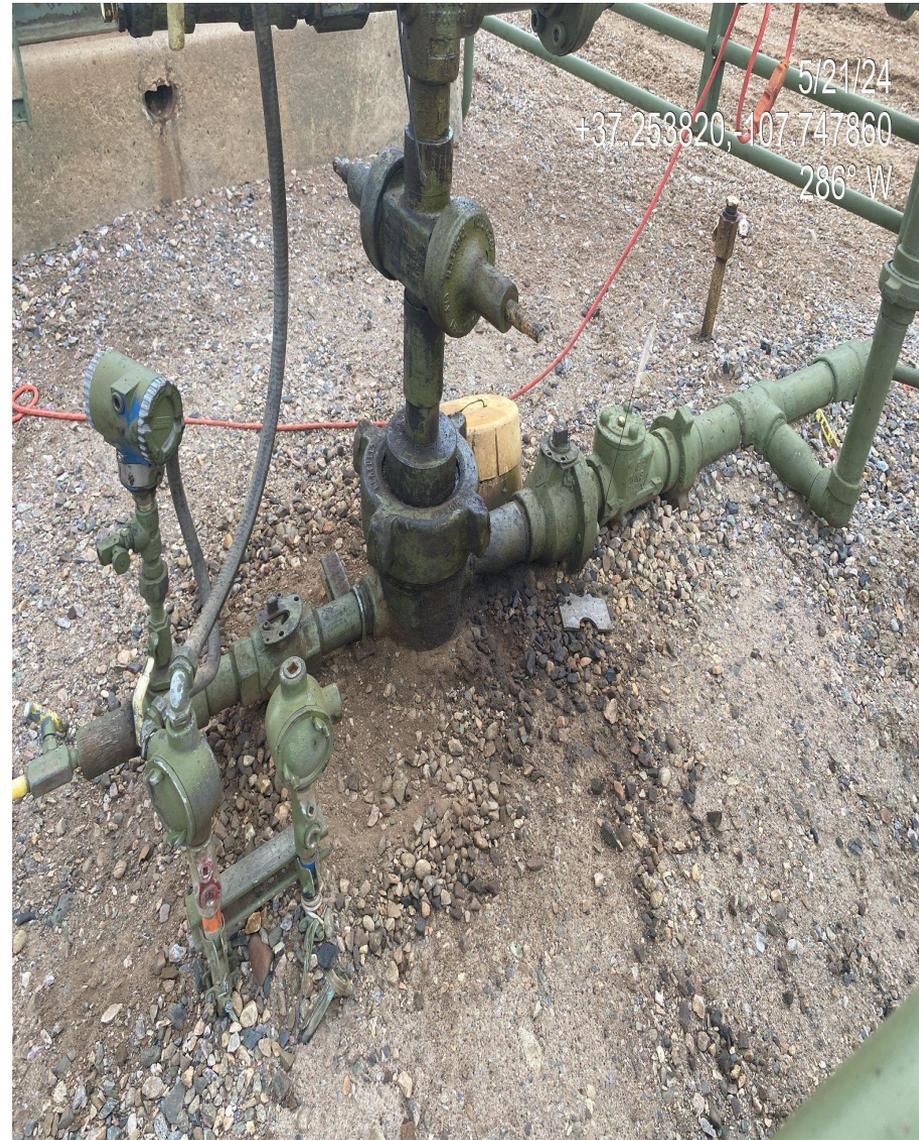
Photo 6. Impacted surface material observed at the pump jack muffler and well head.

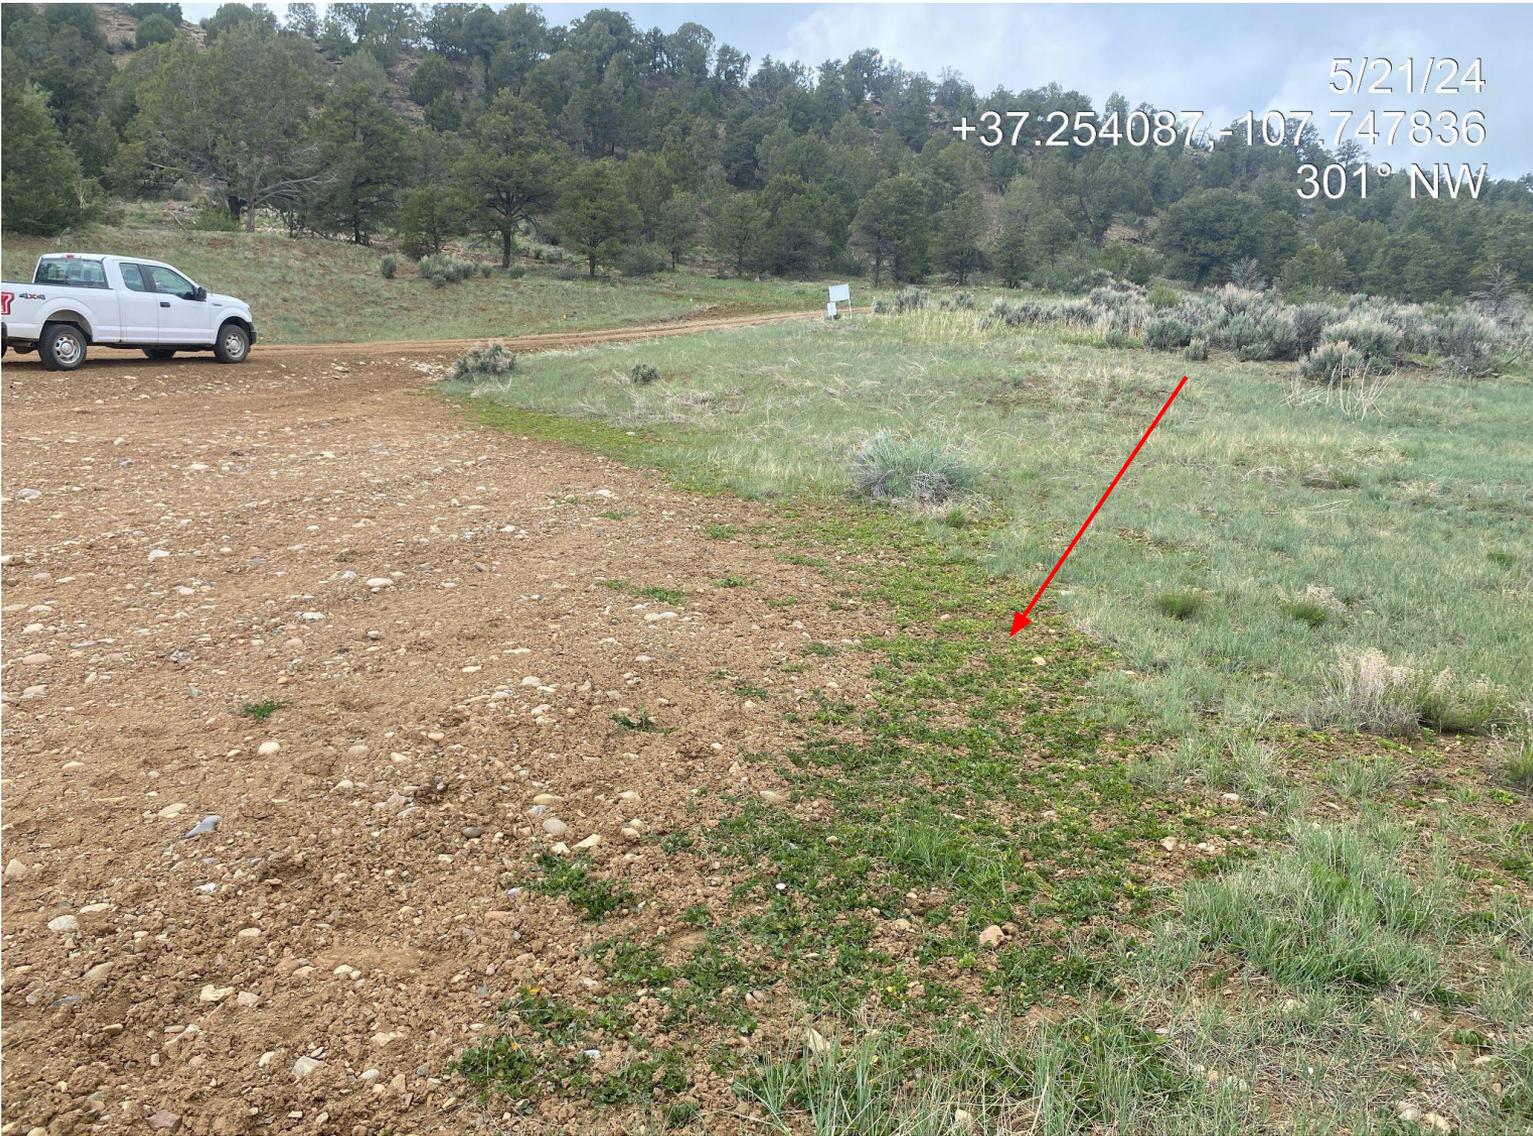
Photo 7. Large patch of field bindweed observed in the northeast corner of the disturbance.

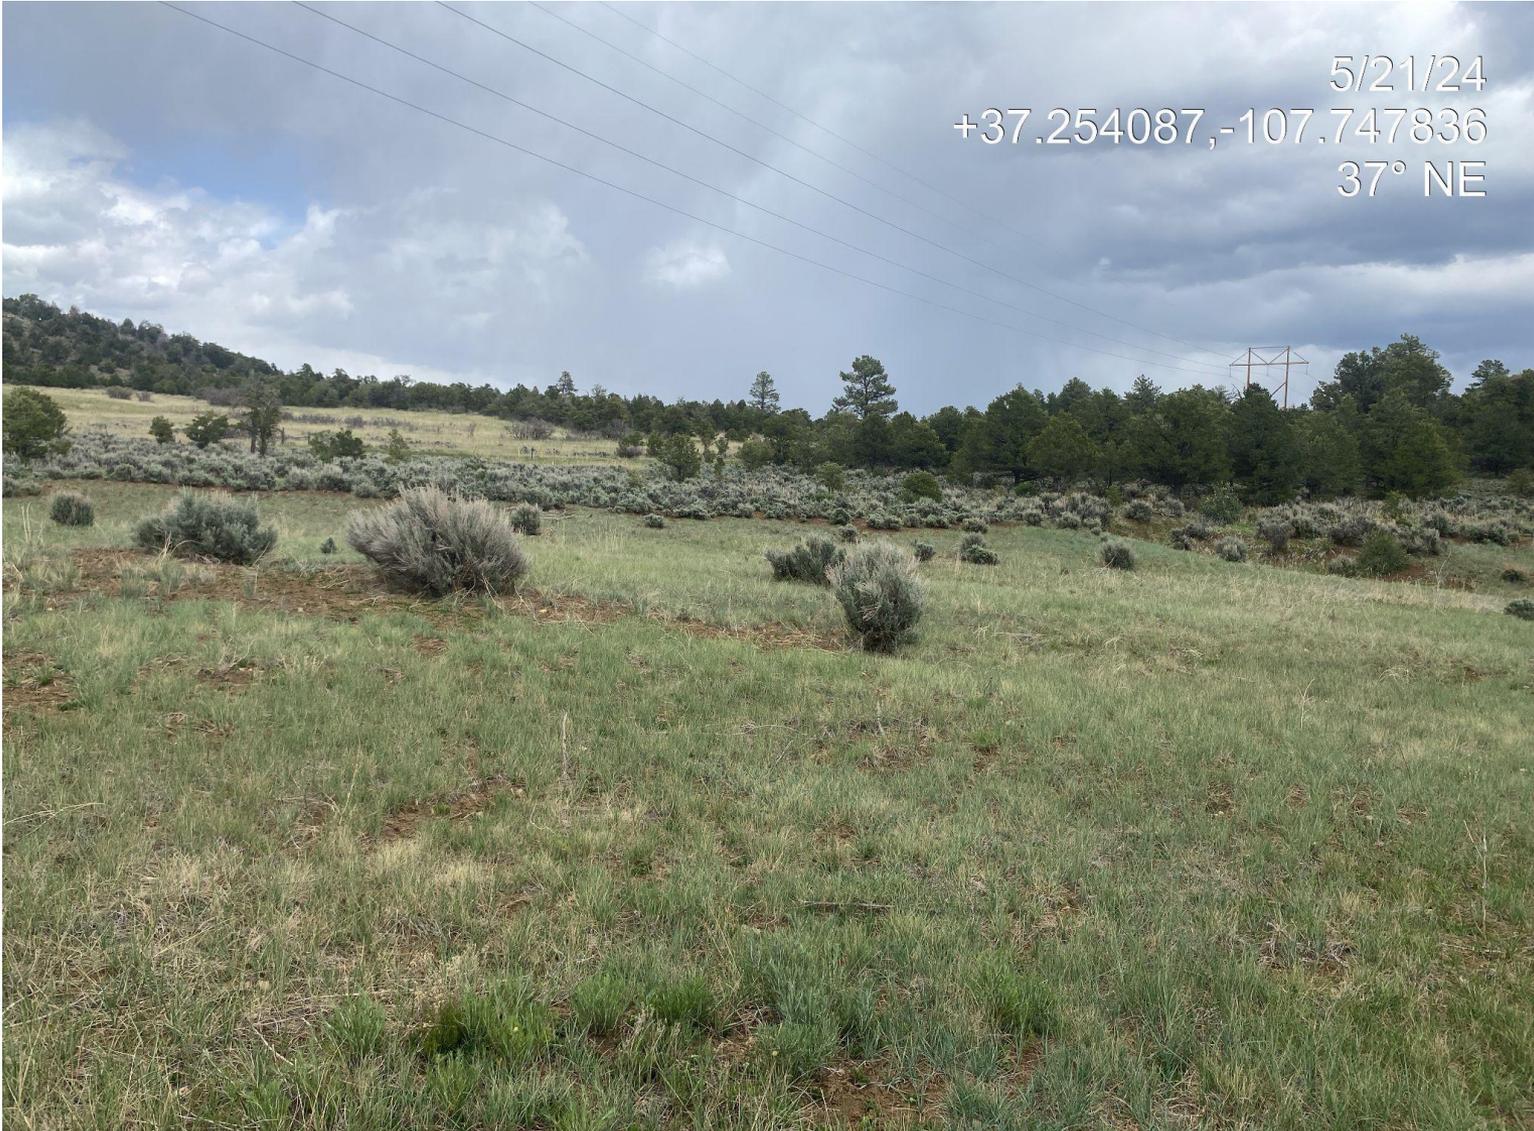
Photo 8. View of the reference area predominantly comprised of western wheatgrass and sagebrush.
