# Interim Reclamation and Stormwater Inspection

Date: 5/14/24

Operator: Renegade Oil & Gas Company LLC - 74165

Location Name: Lowry State-65S65W 25SWSW

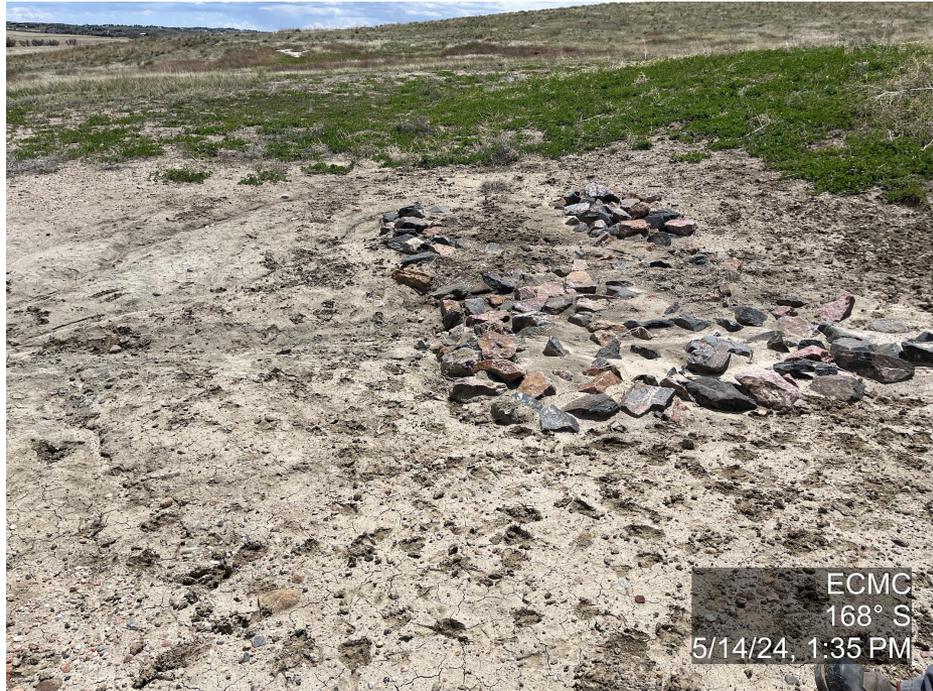
**Photo 1.** The photo was taken at the tank battery location facing South. The photo illustrates erosion has filled and overtopped the rip rap check dam.

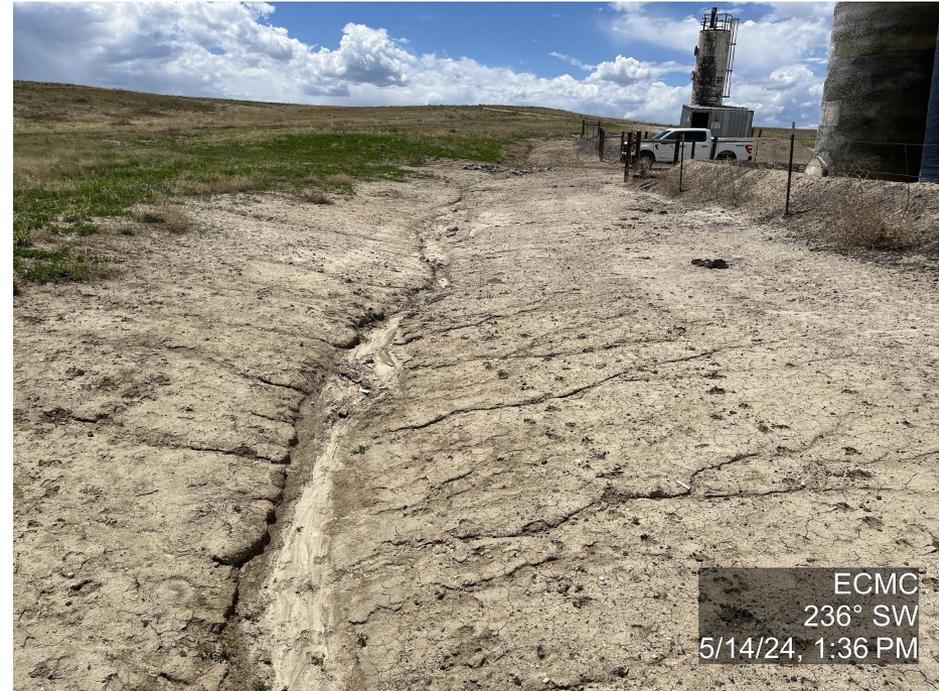
**Photo 2.** The photo was taken at the tank battery location facing Southwest. The photo illustrates the erosion along the West side of the tank battery pad.

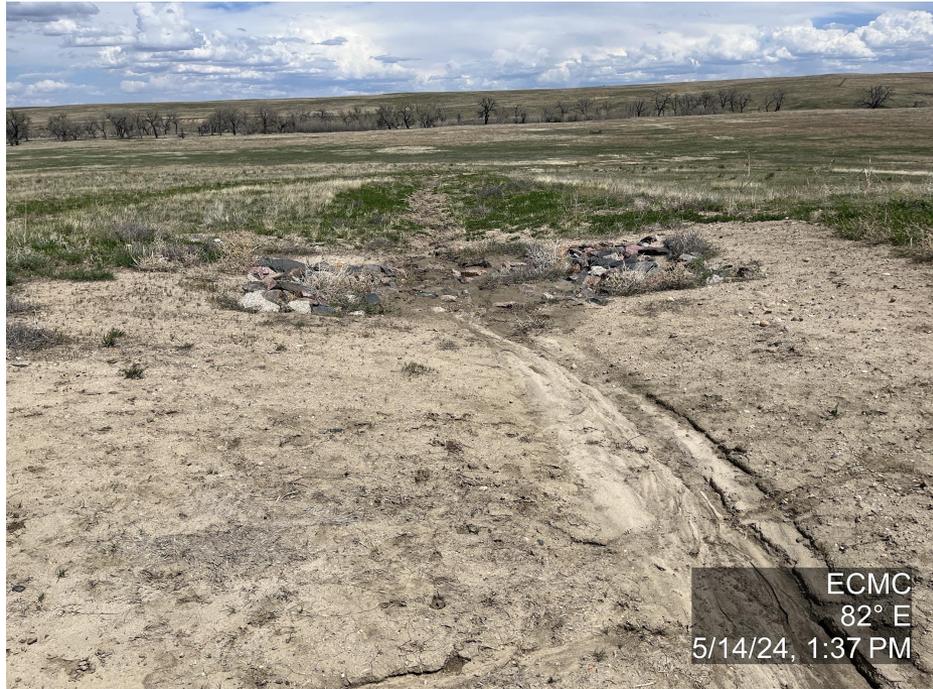
**Photo 3.** The photo was taken at the tank battery location facing East. The photo illustrates erosion leaving the tank battery location beyond another rip rap check dam.

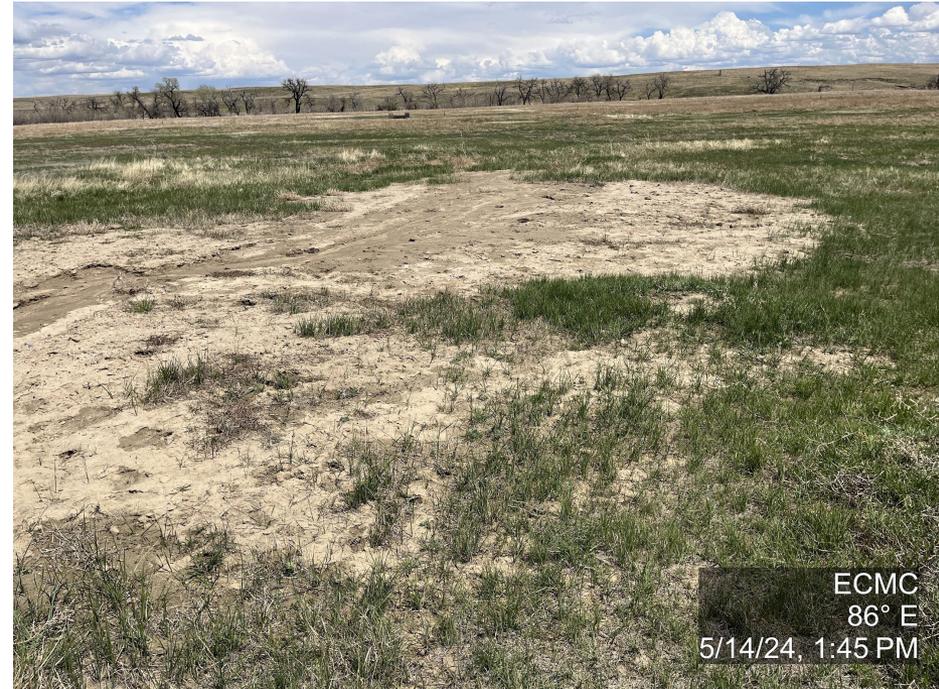
**Photo 4.** The photo was taken at the tank battery location facing East. The photo illustrates the end of the sedimentation off the tank battery location.

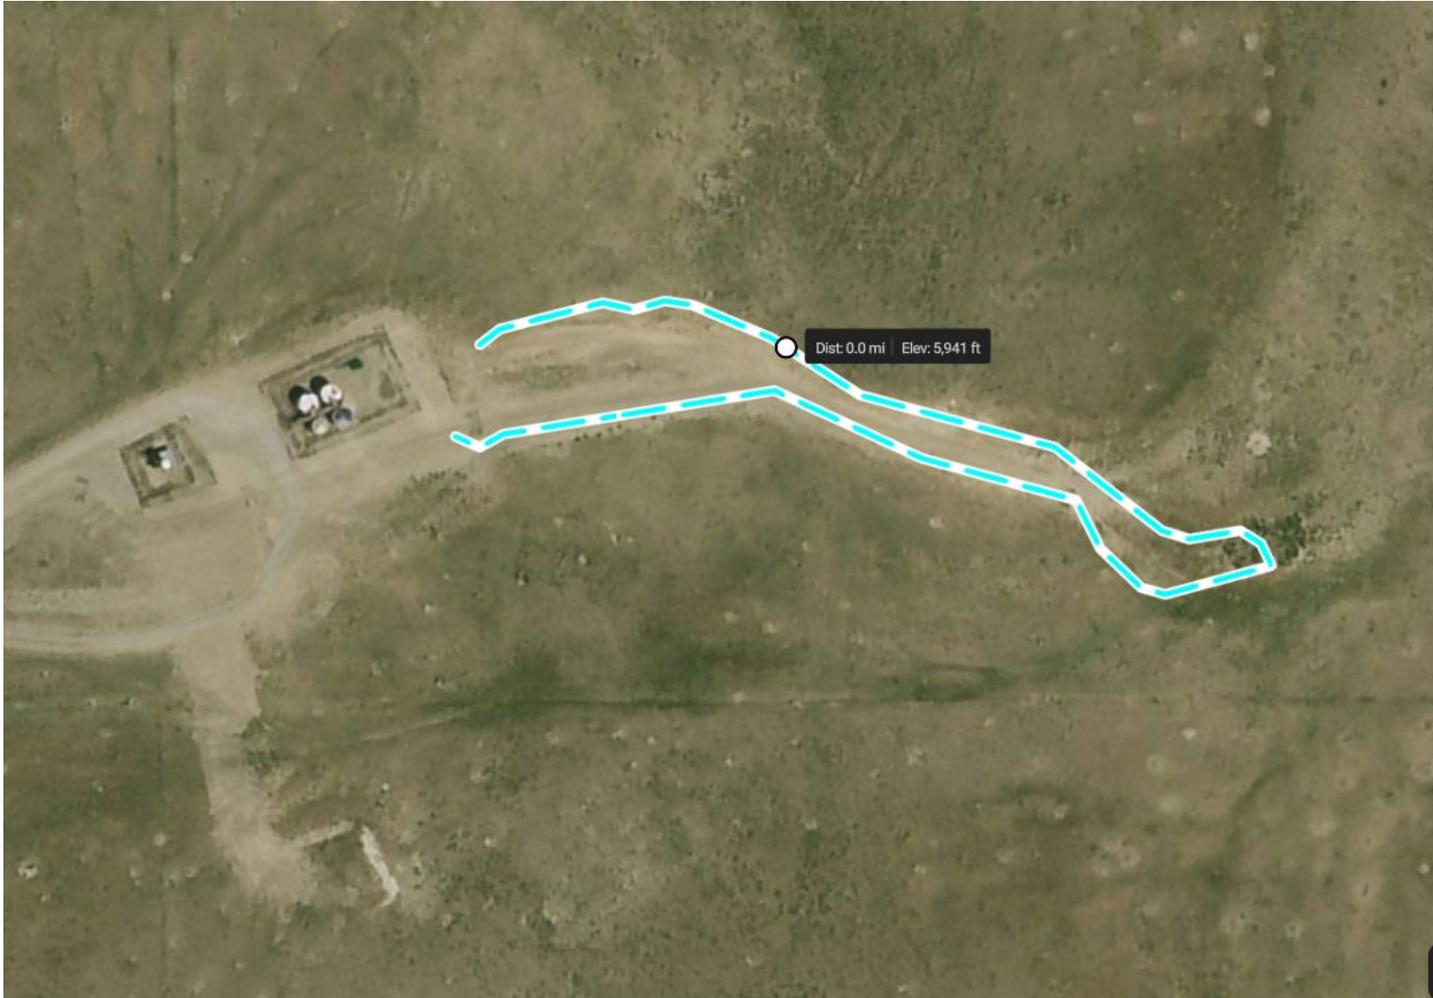
**Photo 5.** The photo was taken from onX imagery of the tank battery location. The photo illustrates the mapped boundary of erosion of the location. Sediment was observed approximately 550ft off location.

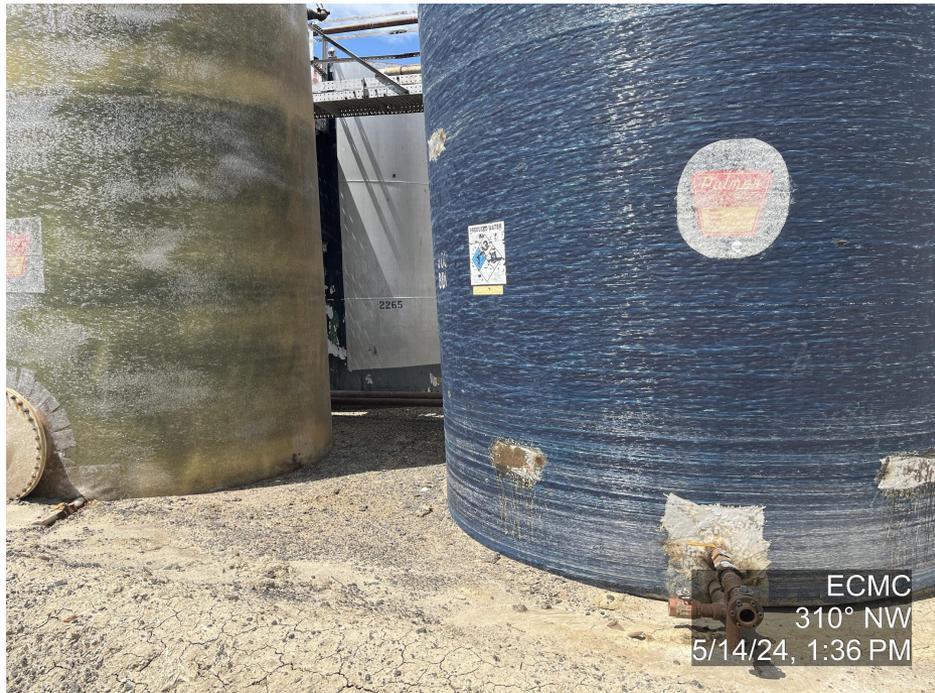
**Photo 6.** The photo was taken at the tank battery location facing Northwest. The photo illustrates tank placards are cracking and need replaced.

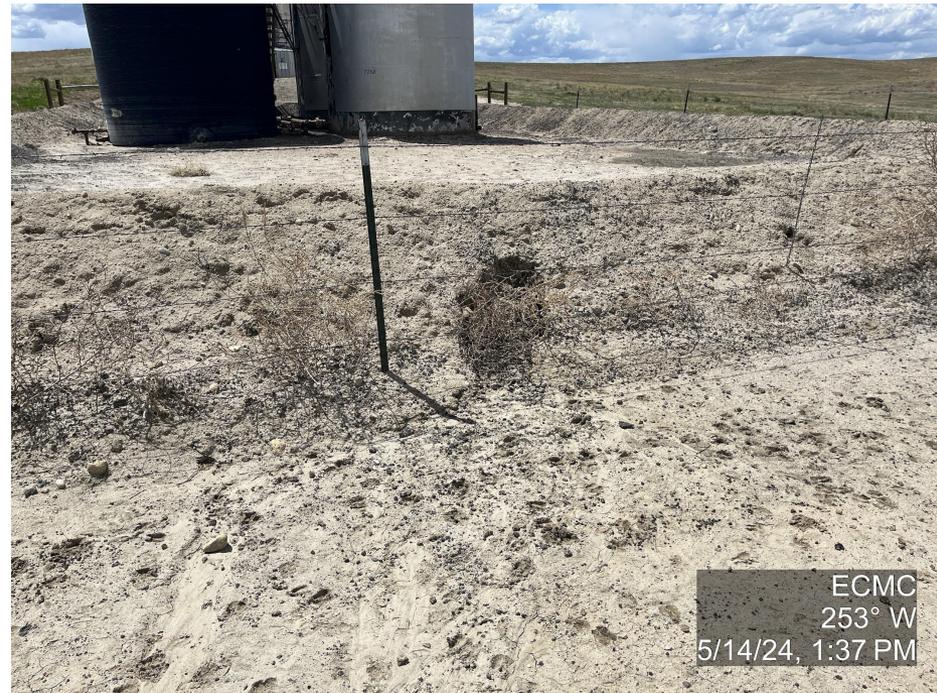
**Photo 7.** The photo was taken at the tank battery location facing West. The photo illustrates erosion has pushed a hole through the secondary containment berm of the tank batteries.

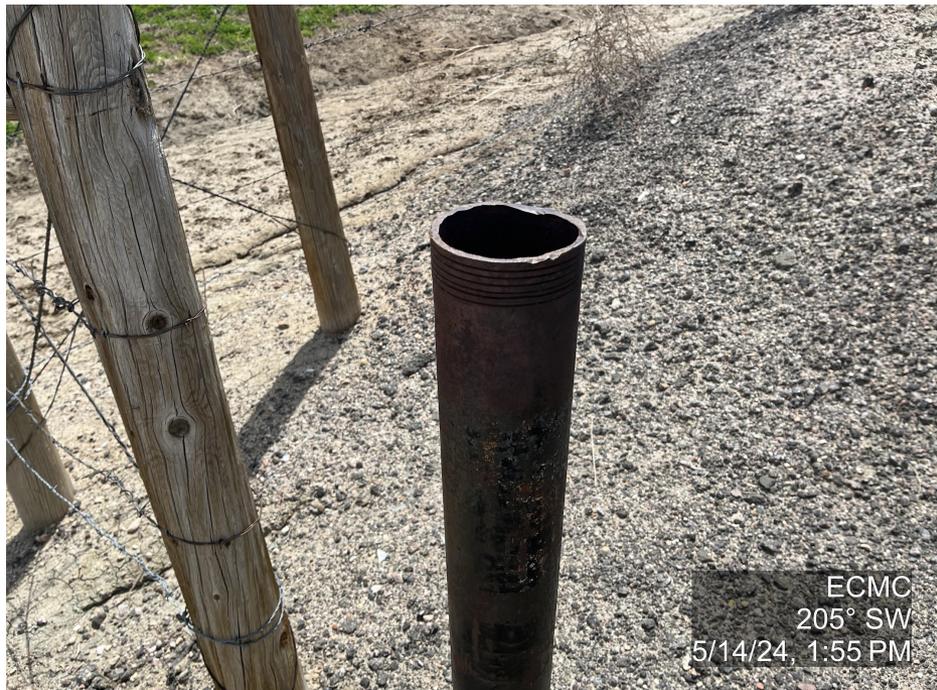
**Photo 8.** The photo was taken at the tank battery location facing Southwest. The photo illustrates an open pipe with no cap or other wildlife BMP.

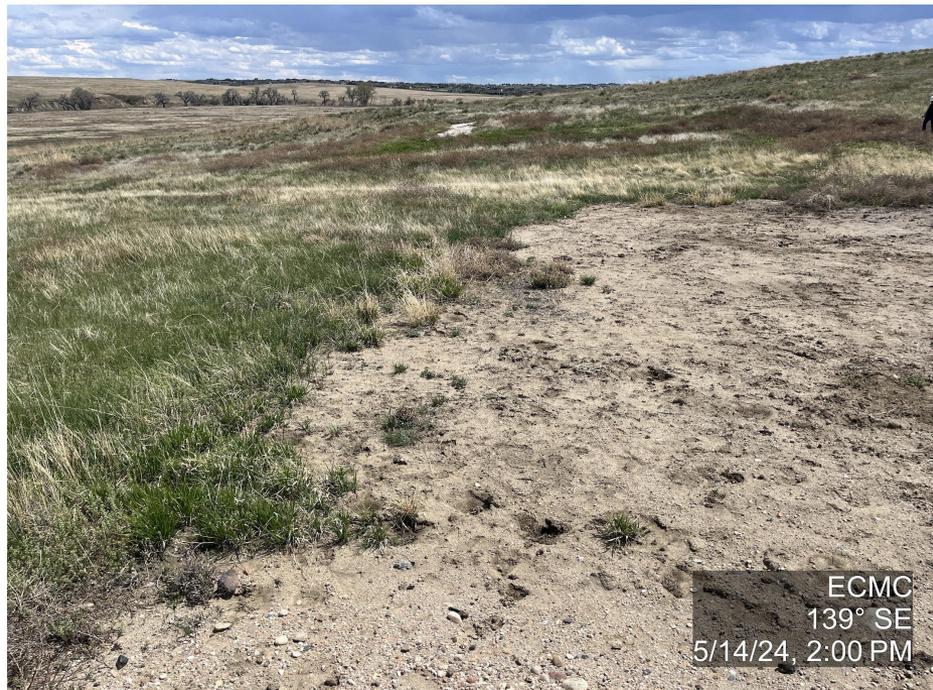
**Photo 9.** The photo was taken at the tank battery location facing Southeast. The photo illustrates bare areas of soil around what appears to be a former pit as well as other oil & gas equipment.

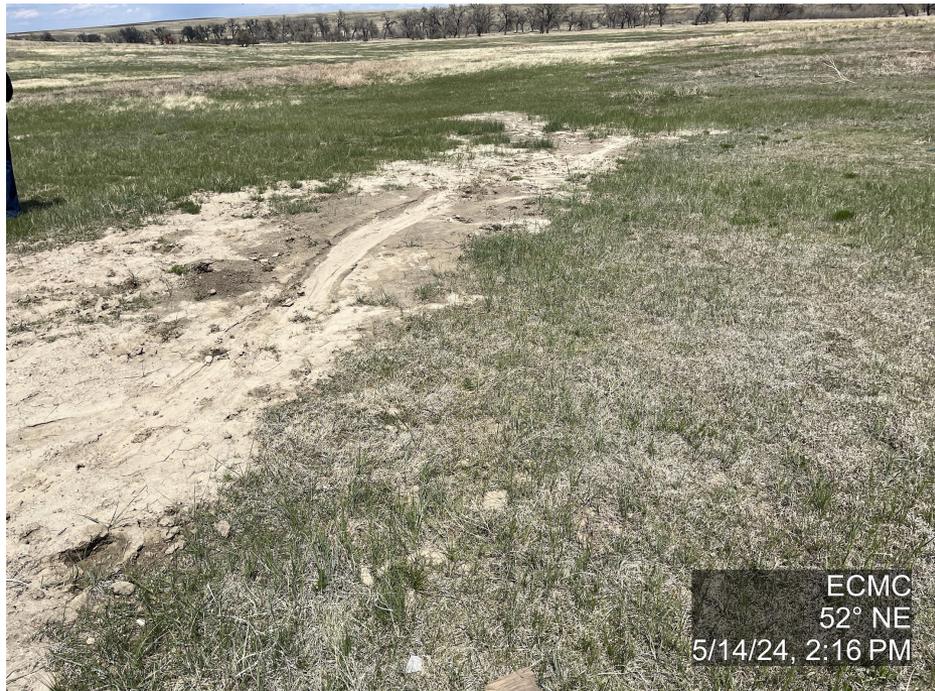
**Photo 10.** The photo was taken at the well location facing Northeast. The photo illustrates erosion off the well location.

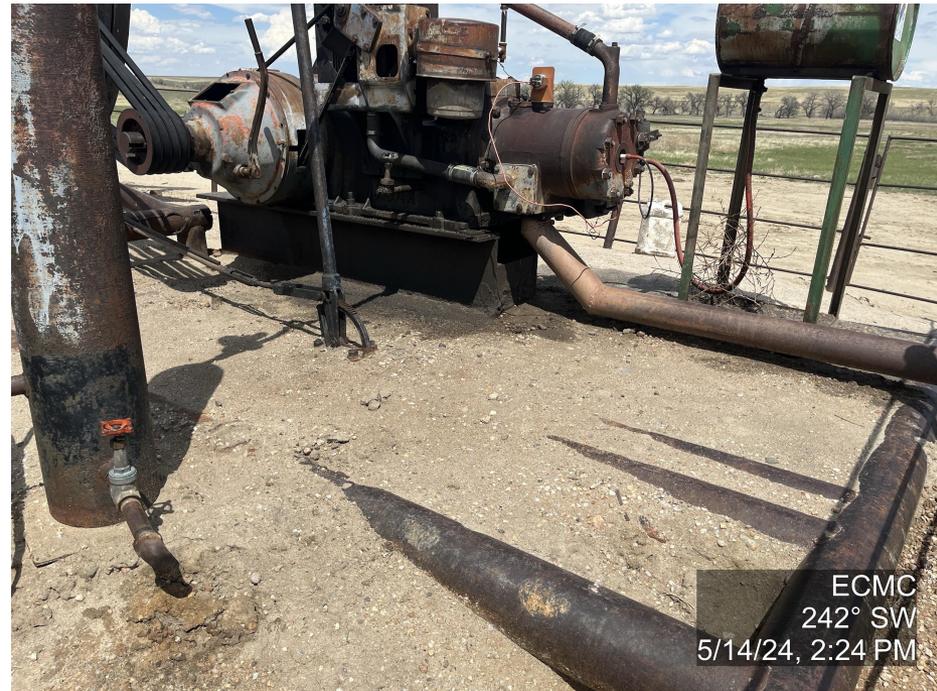
**Photo 11.** The photo was taken at the well location facing Southwest. The photo illustrates an example of soil staining that occurs across the well location.

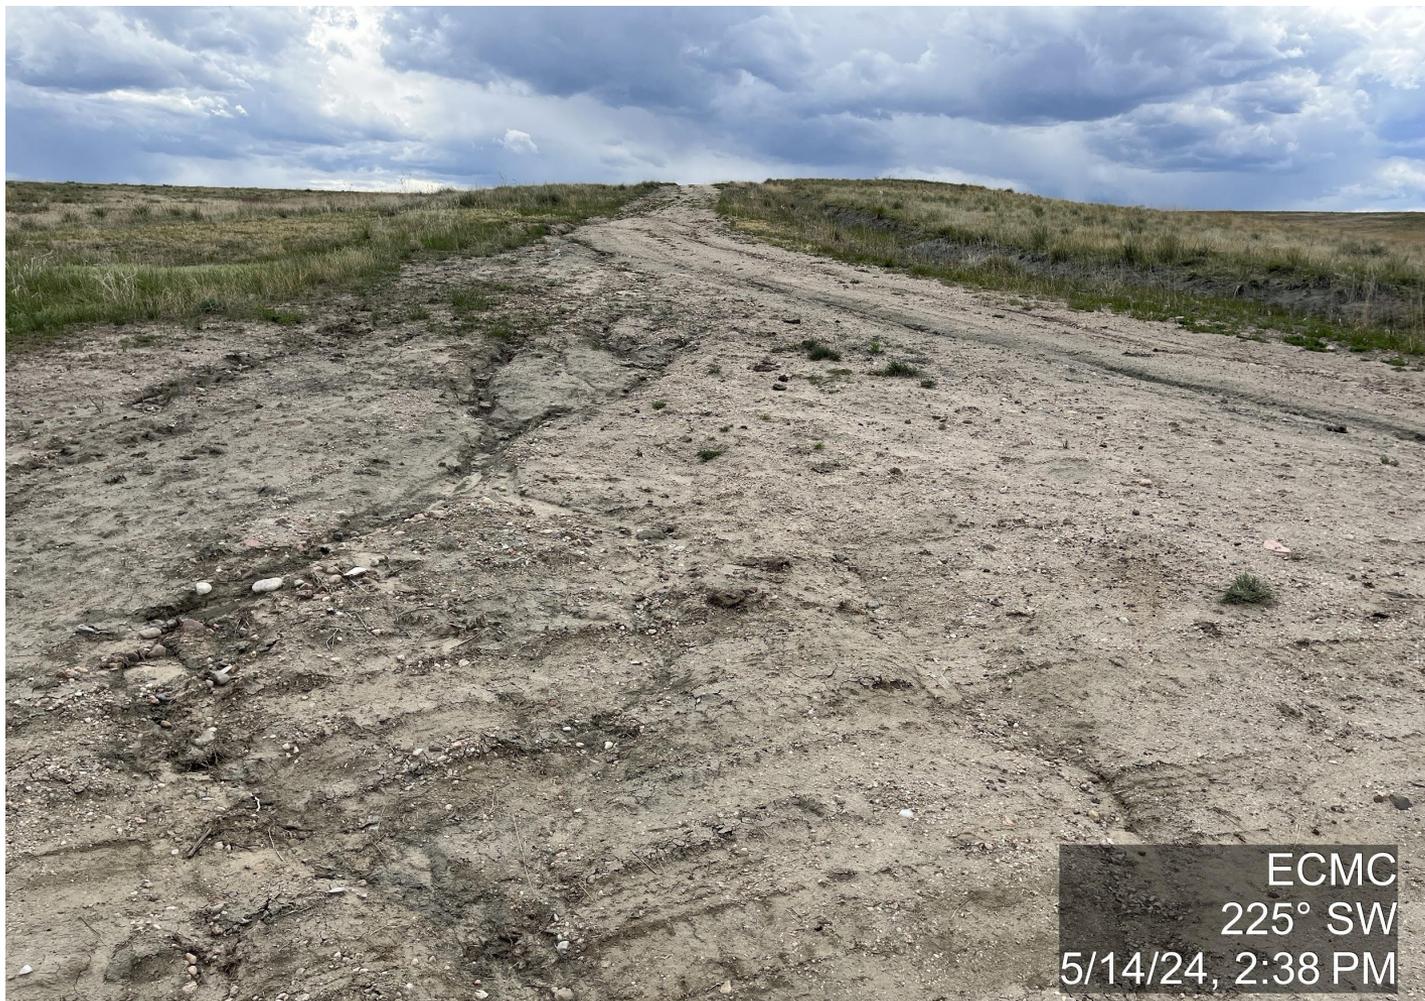
**Photo 12.** The photo was taken at the tank battery location facing Southwest. The photo illustrates the erosion for both the well and tank battery locations begins above the location on the access road and should be treated from top to bottom.
