Interim Reclamation and Stormwater Inspection

Operator: Renegade Oil & Gas Company LLC - 74165

Location ID: 320648

Inspection Document #: 713900628

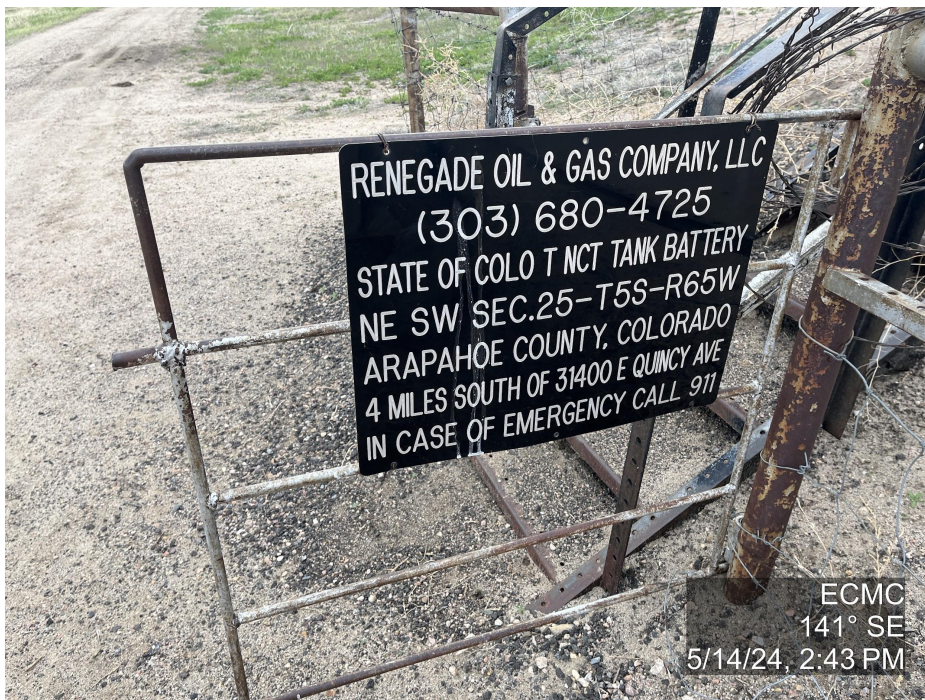
Photo 1. The photo was taken at the well location facing Southeast. The photo illustrates the Operator sign.

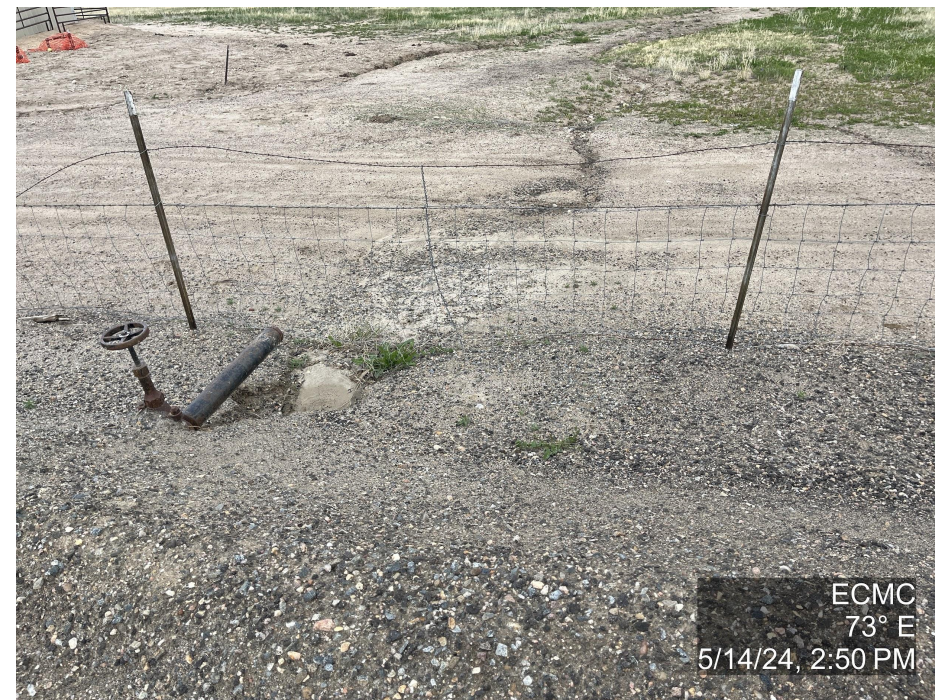
Photo 2. The photo was taken at the tank battery location facing East. The photo illustrates erosion created from the secondary containment drain.

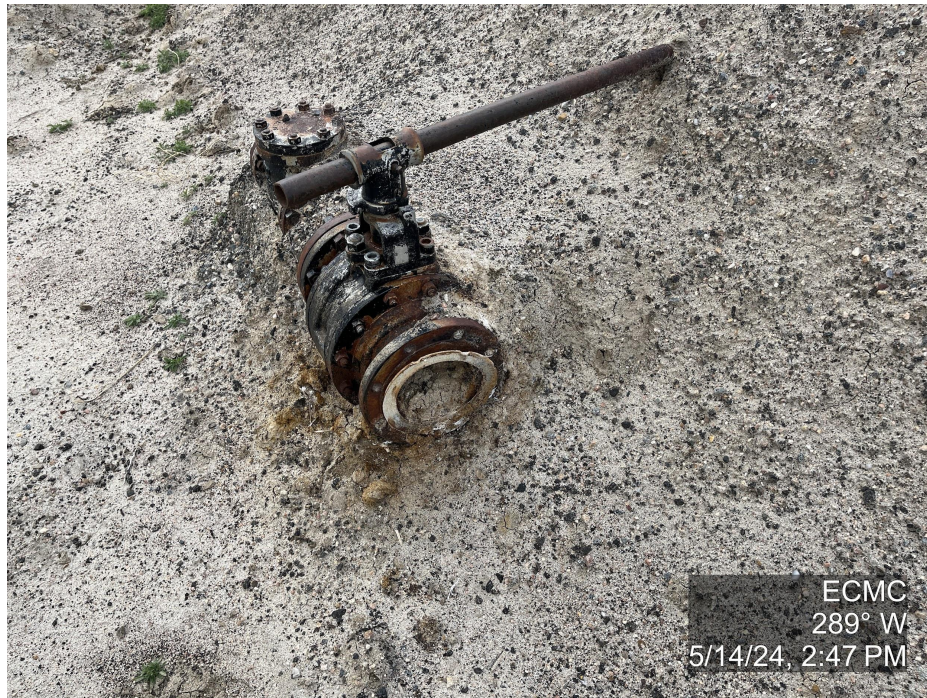
Photo 3. The photo was taken at the tank battery location facing West. The photo illustrates the unused equipment within the secondary containment of the tank batteries.

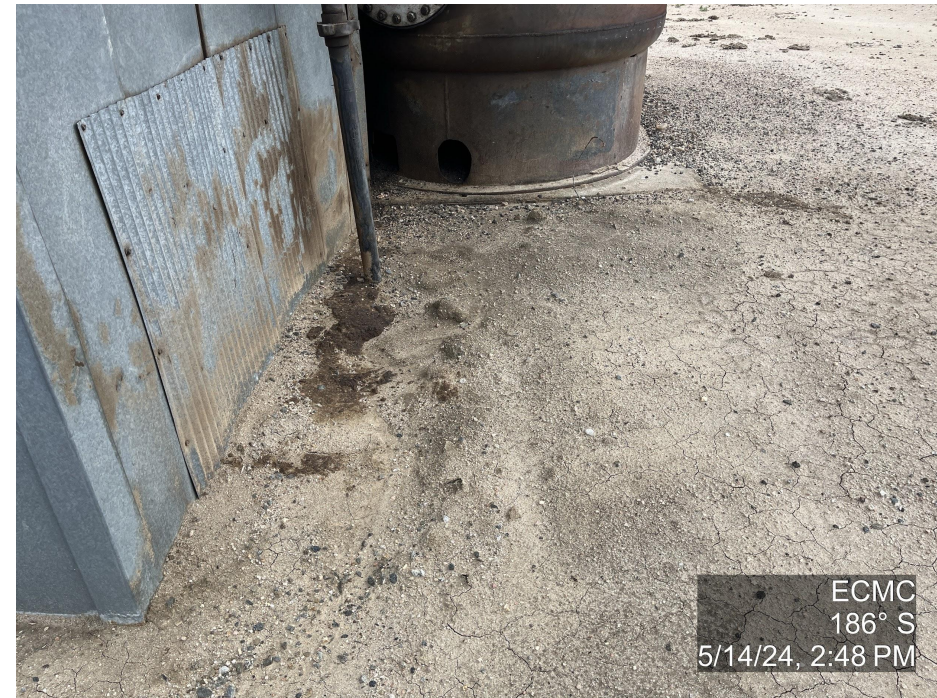
Photo 4. The photo was taken at the tank battery location facing South. The photo illustrates stained soil within the tank battery area.

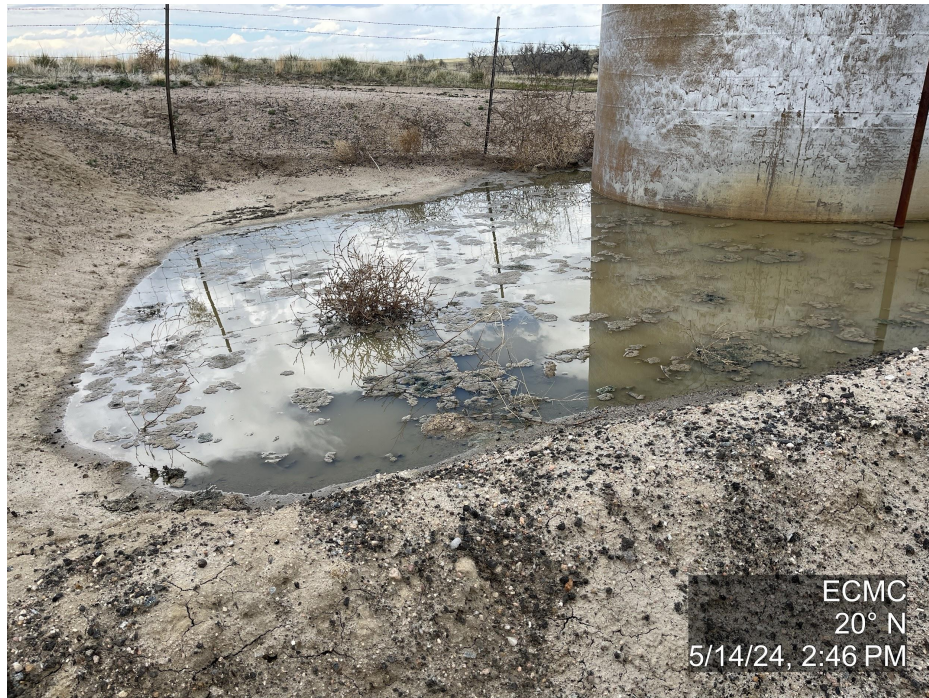
Photo 5. The photo was taken at the tank battery location facing North. The photo illustrates standing water within secondary containment of the tank battery.

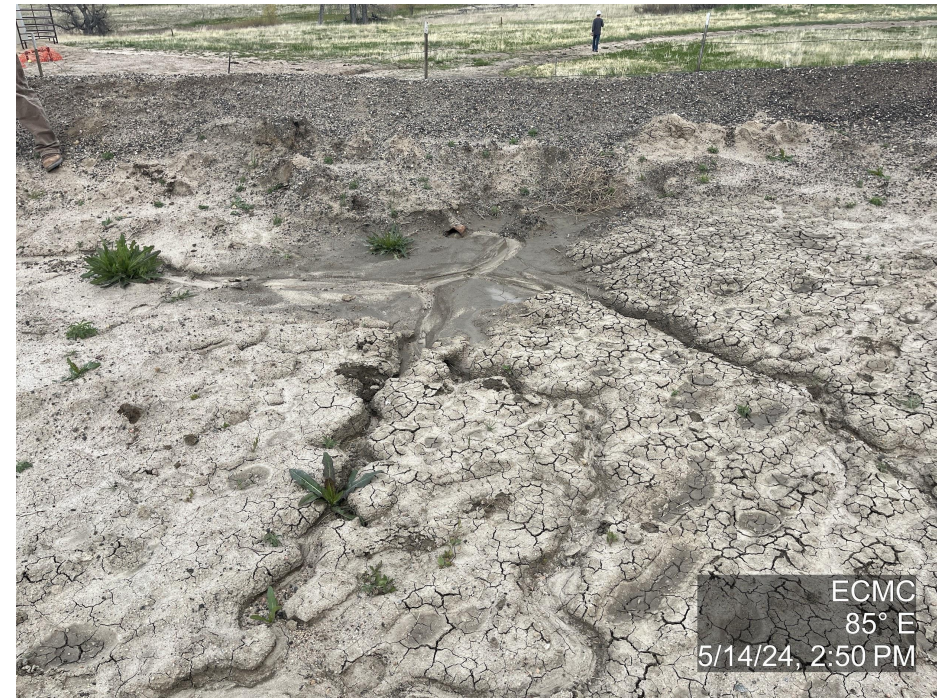
Photo 6. The photo was taken at the tank battery location facing East. The photo illustrates erosion/sedimentation pooling into the secondary containment drain.

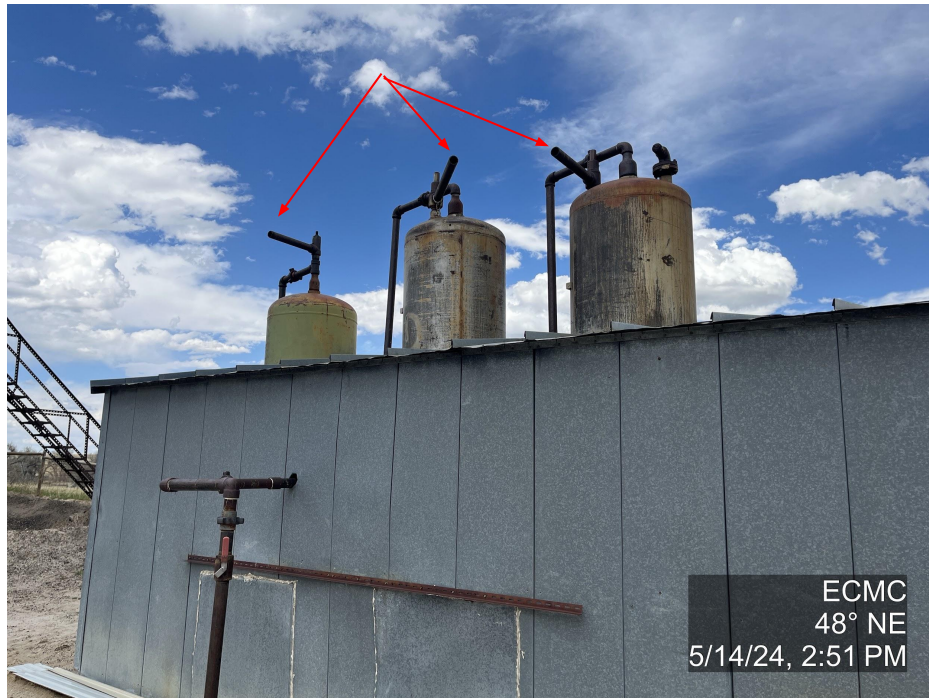
Photo 7. The photo was taken at the tank battery location facing Northeast. The photo illustrates uncapped pipes on production equipment.

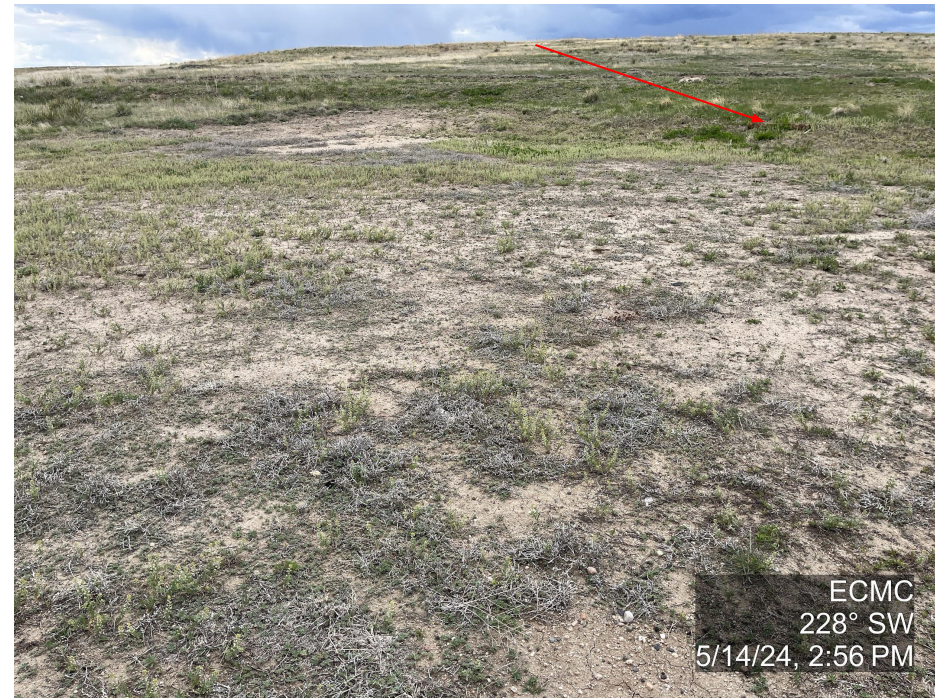
Photo 8. The photo was taken at the tank battery location facing Southwest. The photo illustrates an area of former disturbance that is still in the process of being restored as well as unused equipment indicated by the red arrow.

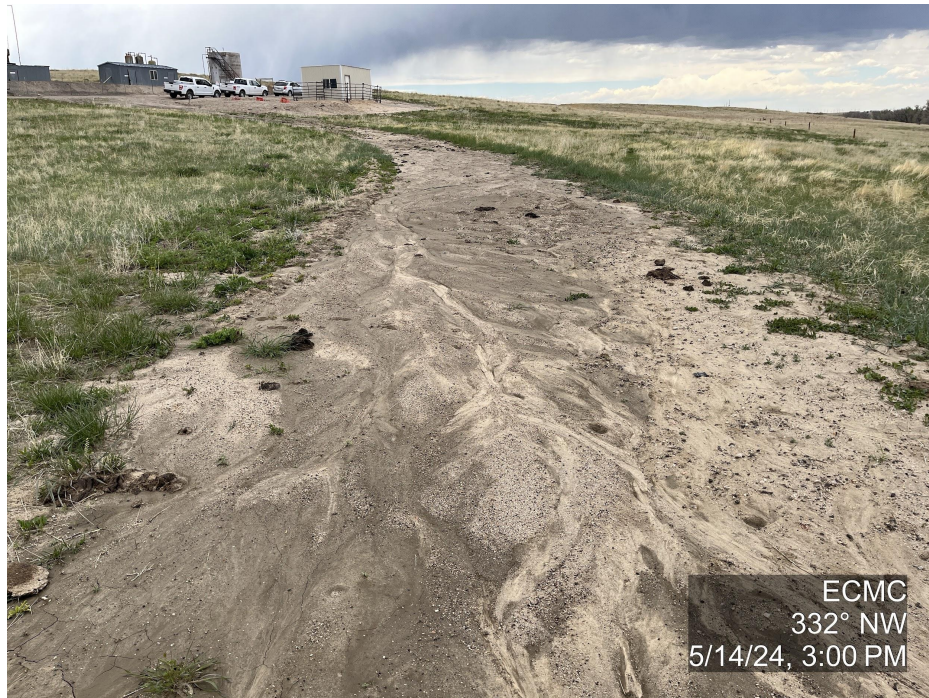
Photo 9. The photo was taken at the well location facing Northwest. The photo illustrates sediment carried along the access road between the tank battery to wellhead pads.

Note - Erosion appears to be moving from the tank battery pad down the access road and pooling on the wellhead pad. Sediment and stormwater did not appear to be flowing off location at the time of inspection.

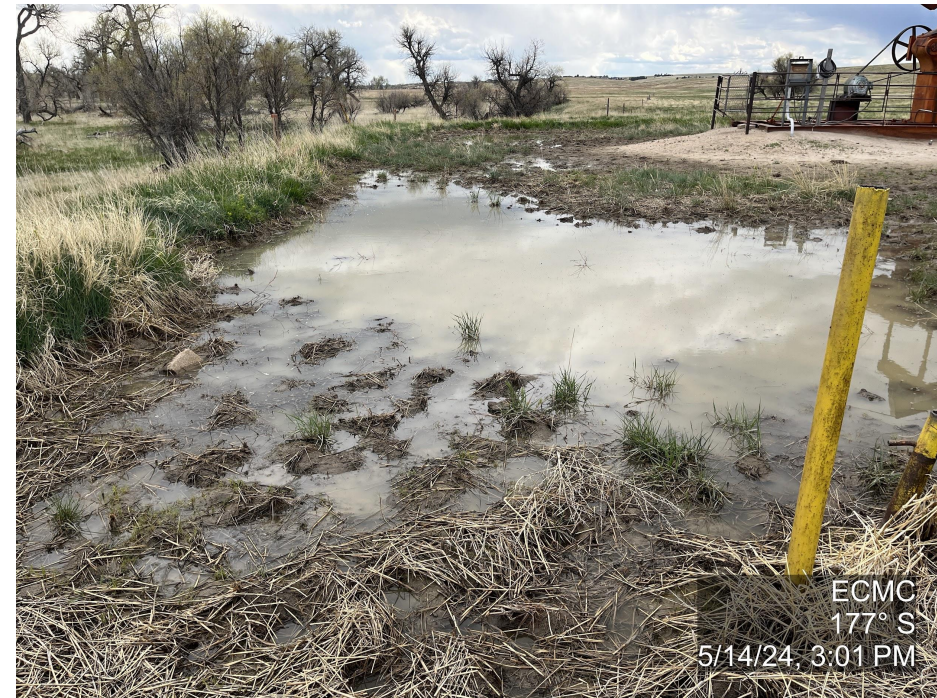
Photo 10. The photo was taken at the wellhead location facing South. The photo illustrates standing water on the wellhead pad.

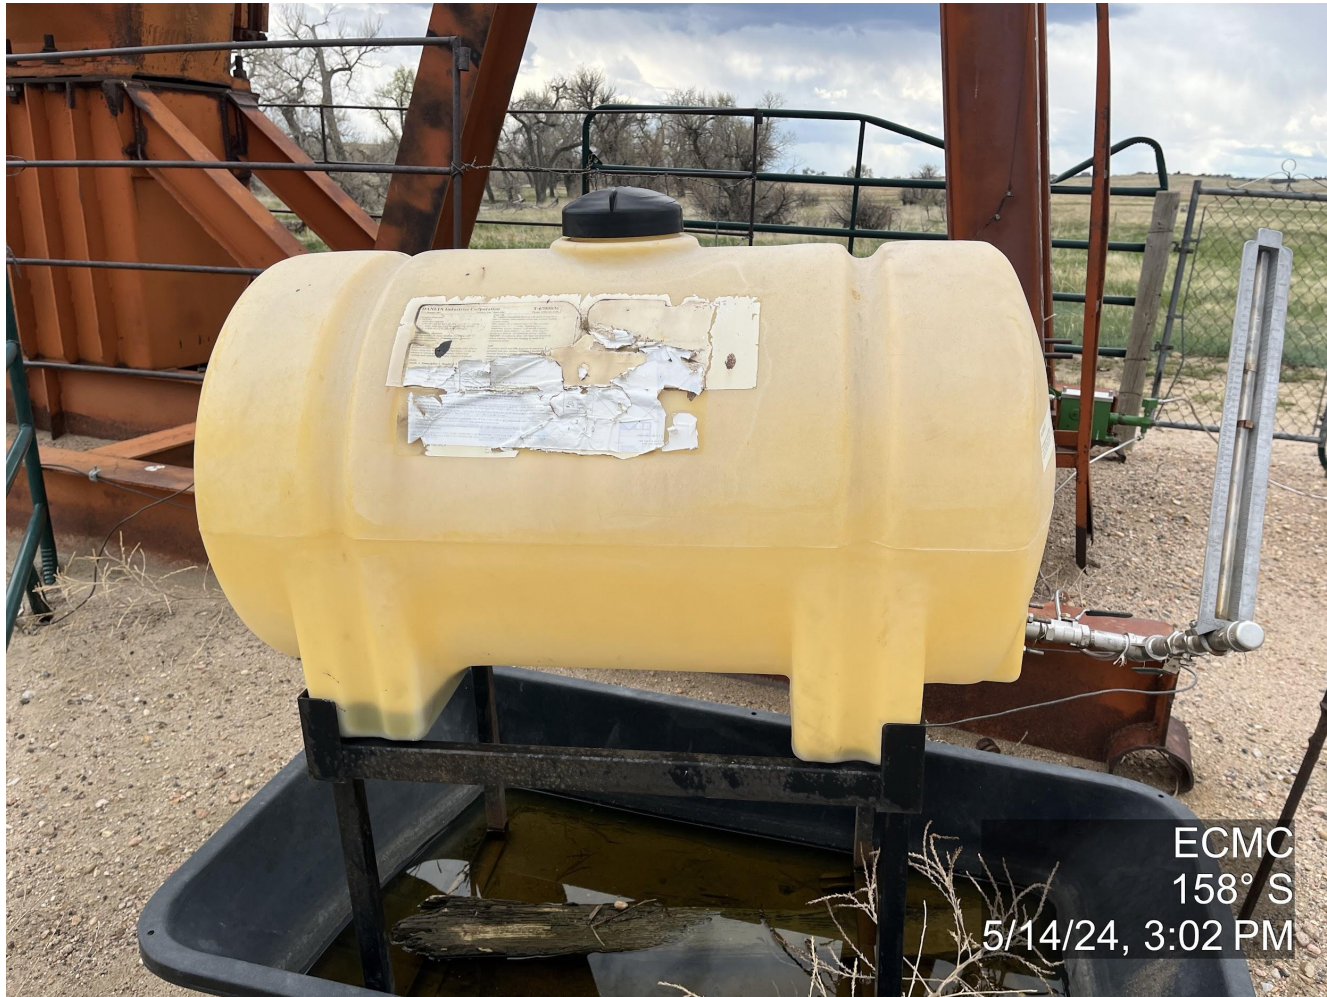
Photo 11. The photo was taken at the well location facing South. The photo illustrates tank placards need replacing and secondary containment is missing wildlife netting.
